Downpipe & Hopper

Proposed Replacements

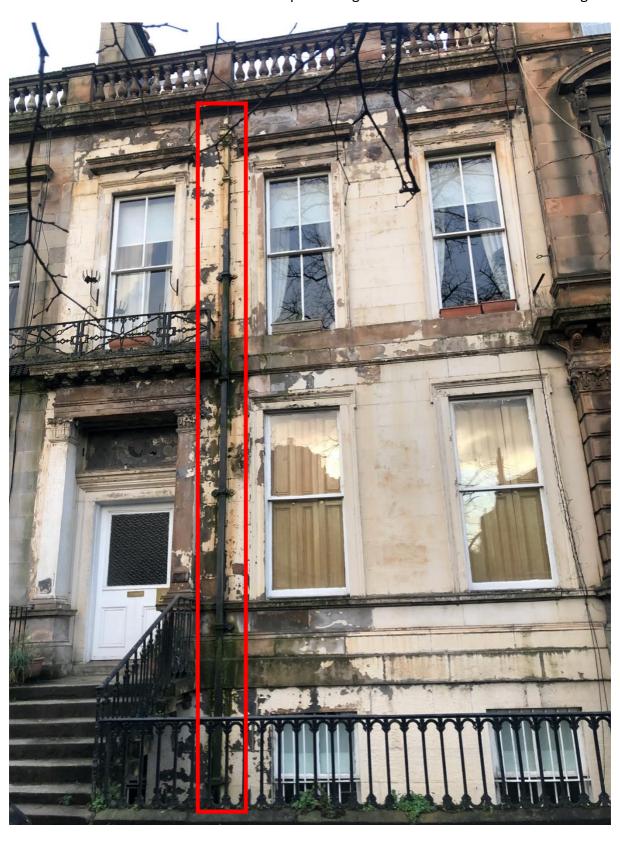
Front (south) elevation showing downpipe, hopper and brackets to be replaced, outlined in red. This is an urgent repair. The pipe is burst near the hopper, has been for some time and the stone is now saturated and moisture is presenting issues on the inside of the building.

We understand the downpipe is to be cast iron. The current rectangular pipe is 70mm x 80mm and in some areas, is set into notches in the stonework. This size today is irregular and unable to be sourced.

We propose to replace the rectangular pipe with 4" black cast iron round pipe, as per the rest of the terrace (shown below – the neighbouring property at No.11 Ruskin Terrace).

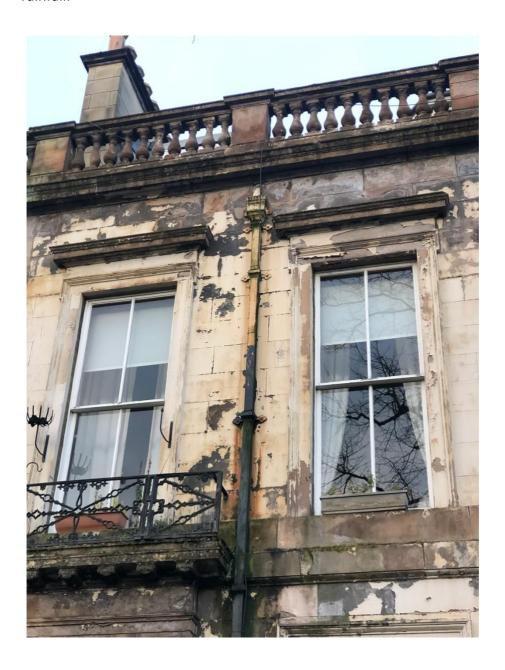
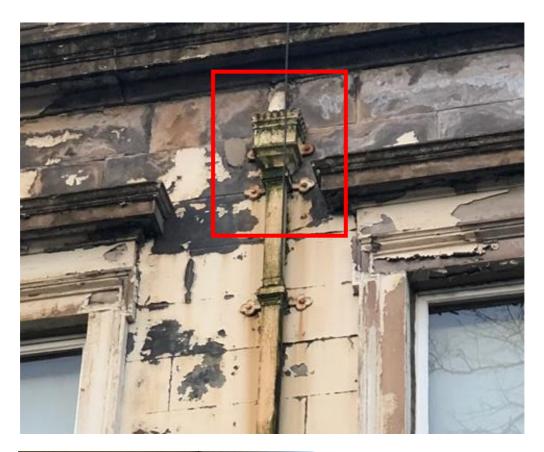
Hopper also needs to be replaced, slightly increased in size to be able to cope with increased rainfall.

The current hopper is too small to cope with today's increased rainfall. We propose to change this to a slightly larger Victorian style ornamental hopper (outlined in red below) in cast iron. This will give a greater volume and keep the Victorian style rather than a plain box style. The style of hopper on the rest of the terrace is unable to be sourced.

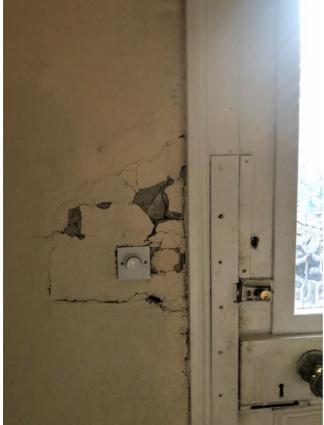
Stone is saturated through to the inside of the building. Shown here is the inside of the building, next to electrical switch. The plaster has lost its key and is crumbling away from the wall
