52-56 Garden Street, Sheffield

Level 2 Historic Building Recording

ArcHeritage 2019

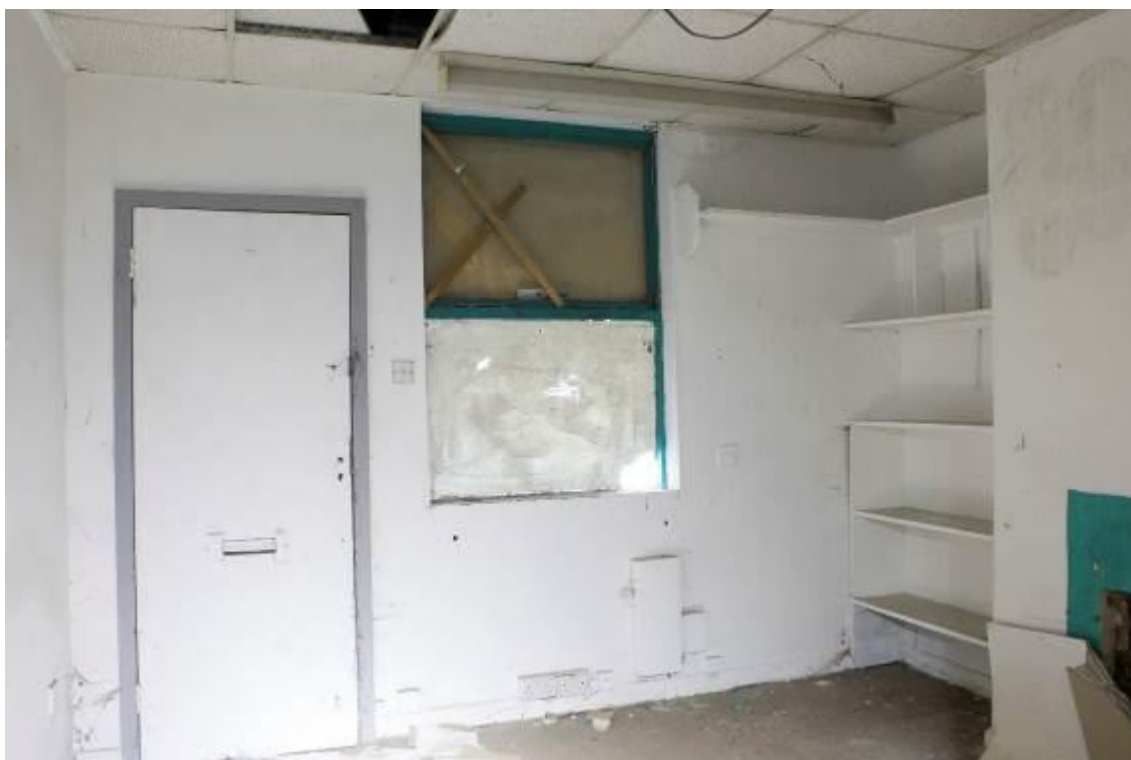
Plate 9: West range, ground floor south room, facing south (1813_001)

The south room, although formerly domestic in nature has few surviving features (Plate 9). An external doorway with a modern door leads out to Garden Street whilst a wooden door to the north leads to a staircase and the rest of the building. The room has an *in-situ* chimney breast with no fireplace. The floor is chipboard, presumably over softwood planks and the walls appear to be modern plaster. The ceiling is hidden behind a modern suspended ceiling; however, a moulded cornice can be seen behind a loose tile.

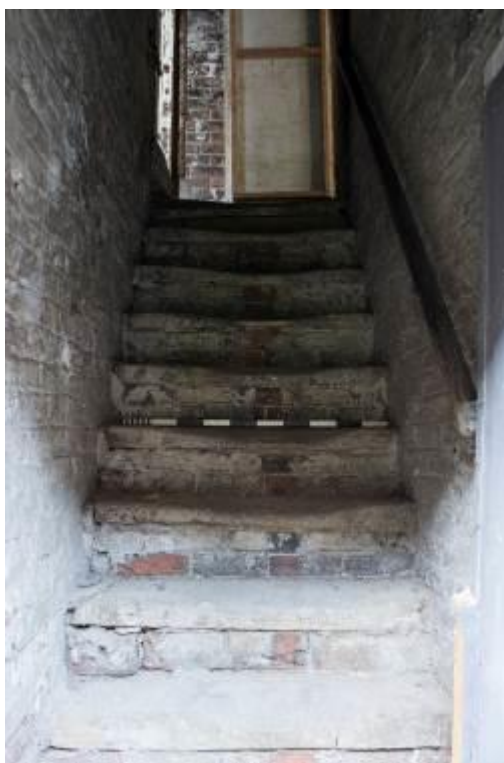
Plate 19: West range, north staircase between ground and first floors, facing west (1813_019)

The first floor is accessed via two staircases. The south staircase lies between the two southern rooms and is a typical timber staircase and domestic in nature. The second staircase lies between the fourth and fifth rooms and is accessed externally. This staircase is constructed from stone slab treads and brick risers and is heavily worn (Plate 19). Both staircases access two rooms each from their top landings.

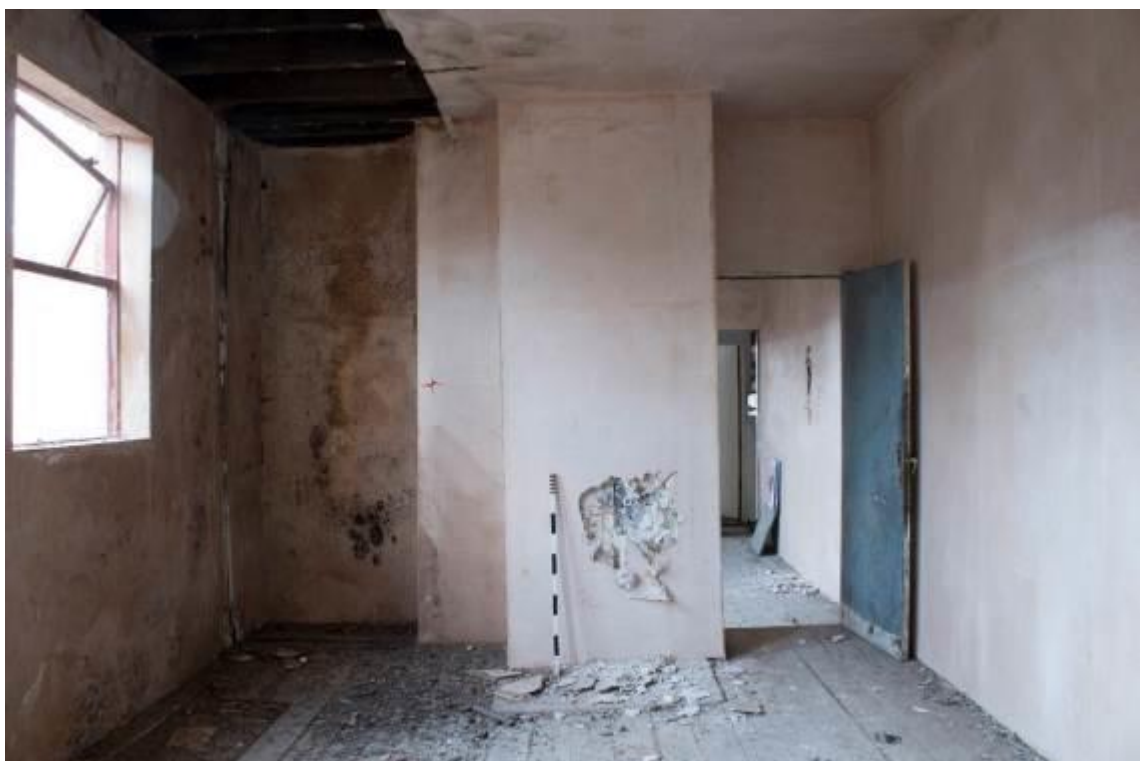
Plate 22: West range, first floor, third room from the south, facing south (1813_029)

The third room is double length and is accessed from doorways to the south and north with modern doors (Plate 22). The room is lit by three windows in the east wall and has walls and a ceiling clad in modern plasterboard. There is a blocked fireplace at the south end and the floor is decked with rough and irregular softwood boards. The boards have patchy repairs and scars where workbenches once stood, indicating a former use as a workshop.

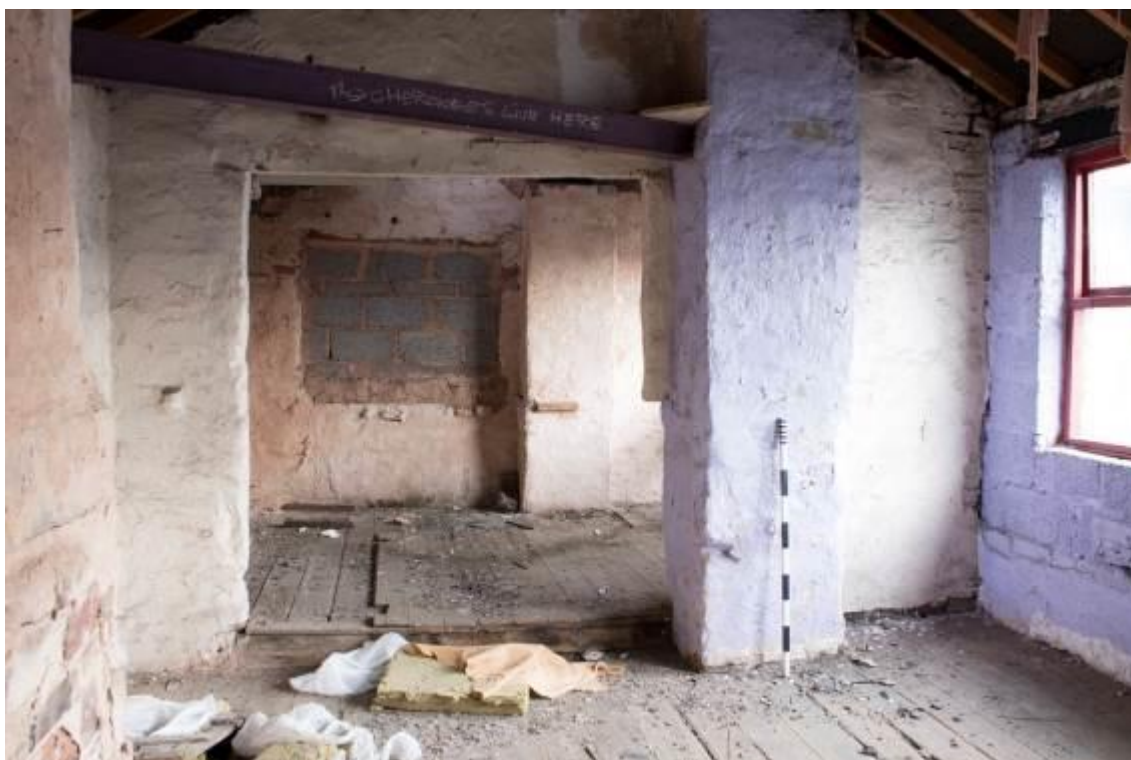
Plate 31: West range, second floor, north room, facing north (1813_038)

At the north end of the second floor the two most northerly rooms have been joined as one (Plate 31). The rooms are also open to the roof, which consists of purlins resting in the partition walls. The common rafters have all been replaced recently. The room is accessed from the staircase to the south through a doorway with a modern door. The walls are mainly whitewashed or rendered brick; however significant parts of the west wall are constructed of breeze block, suggesting they may have been rebuilt. The two rooms are divided by a brick wall, through which a wide opening has been inserted. The wall also has a chimneystack rising against but with no sign of a fireplace. There are also stacks on the west wall of the south room and the north and west walls of the north room. The rooms are floored with softwood boards and there is a step up to the northernmost room. The south room is lit with three windows in the east wall and has a blocked window to the west. The north room has two windows to the east and a blocked window to the north. The north room also has the remains of a workbench built against the east wall (Plate 32).
