# Hollis Croft Phase 3, Sheffield Archaeological and Heritage Appraisal

ArcHeritage Report 2017/75  
October 2017

**Hollis Croft Phase 3, Sheffield:  
Archaeological and Heritage Appraisal**

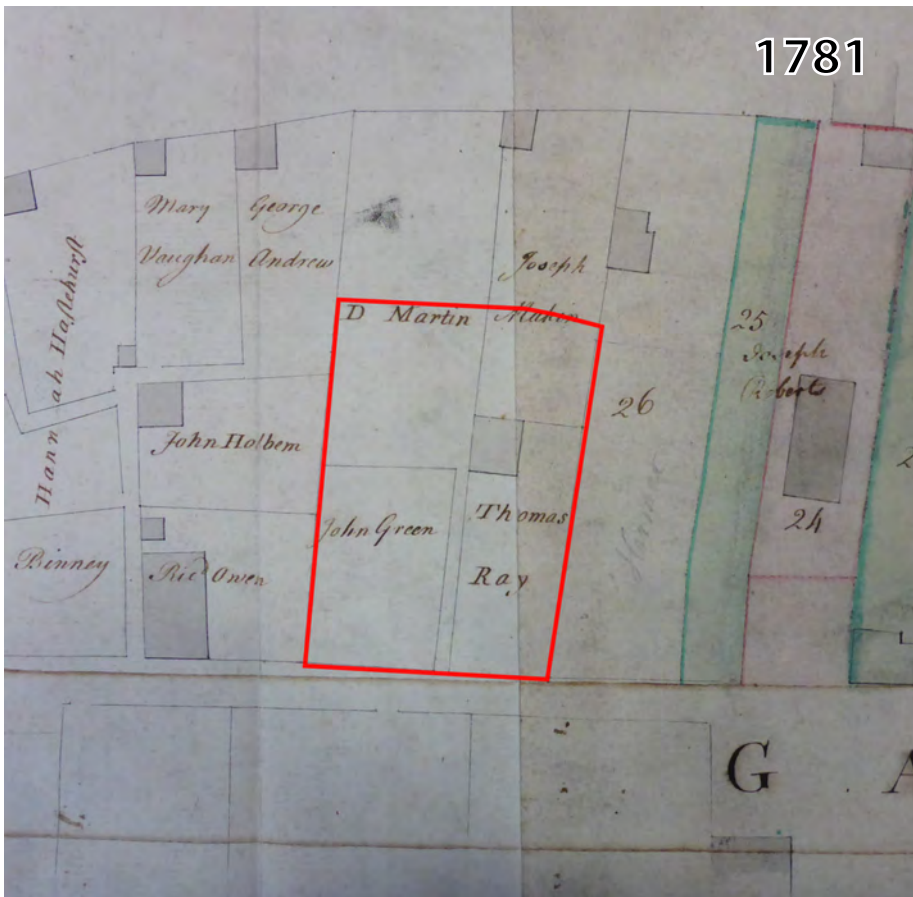
Figure 3: 1768 and 1781 Faribank plans

that had been sub-divided into a series of gardens by the time of a 1768 William Fairbank plan (Figure 3). The gardens were accessed via a broad path that ran east-west along what would subsequently become the northern part of the Garden Street carriageway.

Fairbank showed the Site as two pairs of gardens, separated by a narrow, central track. Small detached buildings stood in the north-west corners of two of the plots. The largest of these was described in the accompanying key as a 'Garden House' (SA ACM/Maps SheS 1532aL). While the precise form of the building is unclear, it may have been akin to a small summer house rather than a simple shed. While Fairbank marked the locations of the gates in the boundaries of each of the gardens, it is not clear if the plots were demarcated by hedges, walls or fences in 1768.

Due to the scale of the map, no details of the Site were shown on William Fairbank's 1771 map of Sheffield. With the exception of the smaller of the two garden houses, all of the features that had been shown within the Site on the 1768 plan continued to be shown on a 1779 Fairbank plan. By the time of a 1781 Fairbank plan (Figure 3), however, the northern plot boundaries had been removed, the boundaries of the westernmost plots had been made more regular and the central path had been shortened in length. The large garden house that had been shown within the Site in 1768 and 1779 continued to be shown on the 1781 plan.

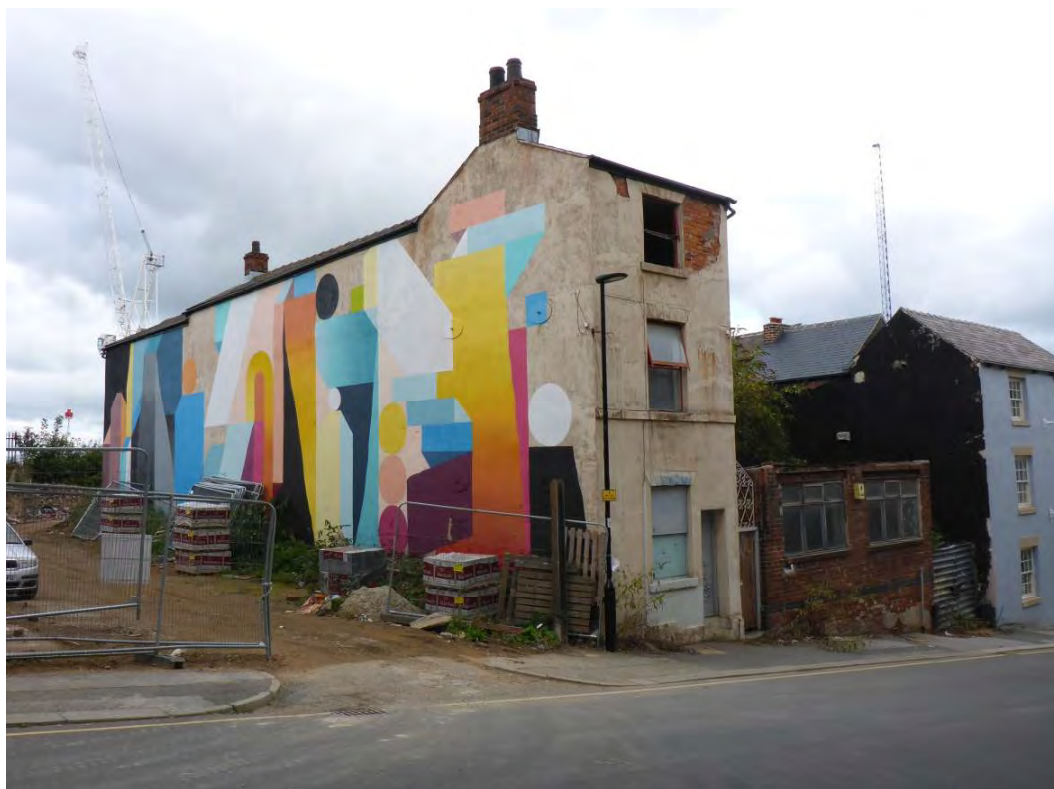
Plate 1: 52-56 Garden Street, looking north-east

On the south elevation, each floor of the building has a single, centrally-located, two-pane window. These have stone lintels and stone sills, with the exception of the first-floor window, where a string course replaces the sill. Several metal bolt-and-plate wall-ties are visible on the building's east elevation. While on the east elevation, the cement render is present only beneath the roofline of the offices, it covers the full length of the west elevation. Here, a painted collage of abstract, geometric shapes had been added since 2016 (Plate 1).

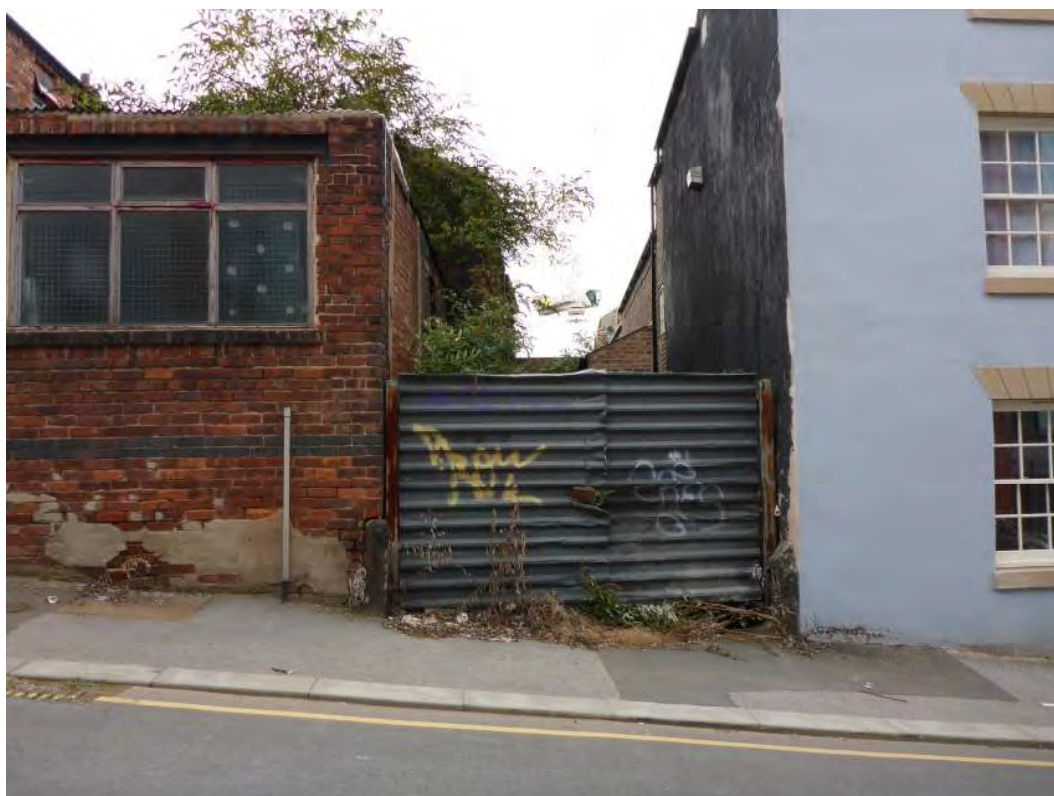
Plate 3: Former site entrance

At the building's south-east corner, a metal shield protects the brickwork from potential impacts stemming from vehicles entering the yard. Evidence of repair and extension is evident on the building's east elevation, with vertical bands of cement, much of it now fallen, while the use of different bricks suggests phasing. Several metal bands have been affixed to the roof and upper courses of brickwork in order to prevent the bowing of the walls. A single, one-pane window is present in this elevation, while the adjacent entrance into the works' main yard has been secured with Herras fencing (Plate 5). Due to extensive vegetation, this area was inaccessible at the time of the site visit (Plates 3, 4 and 10).

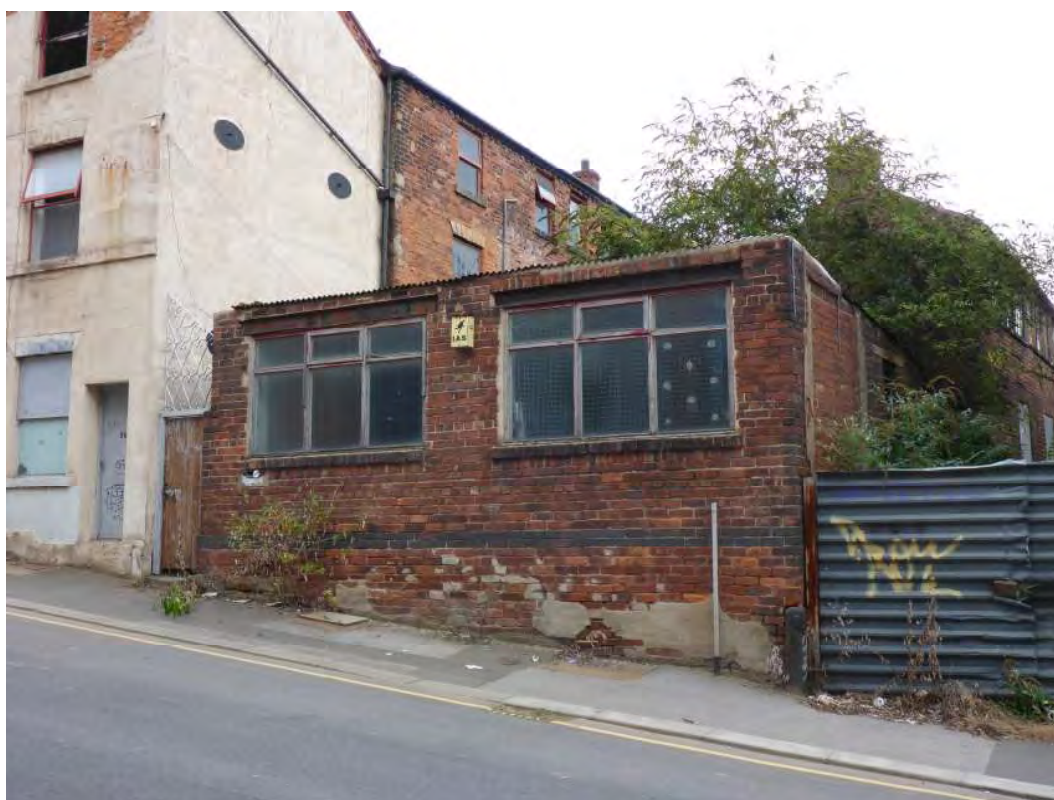
Plate 6: Mid-20<sup>th</sup>-century building, looking north-west

While the existing building at this location is included in the Site's Grade II list entry, it is described as 'a mid C19 block...reduced to single storey' (HE 1988, 3). This is not the case, as the 1935 Ordnance Survey map clearly shows that the 19<sup>th</sup>-century building had been demolished and its site cleared. In addition, the standing building is constructed from machine-made bricks, is referenced for the first time in Kelly's 1951 directory of Sheffield and is shown for the first time on the 1954 OS map (Figure 6).

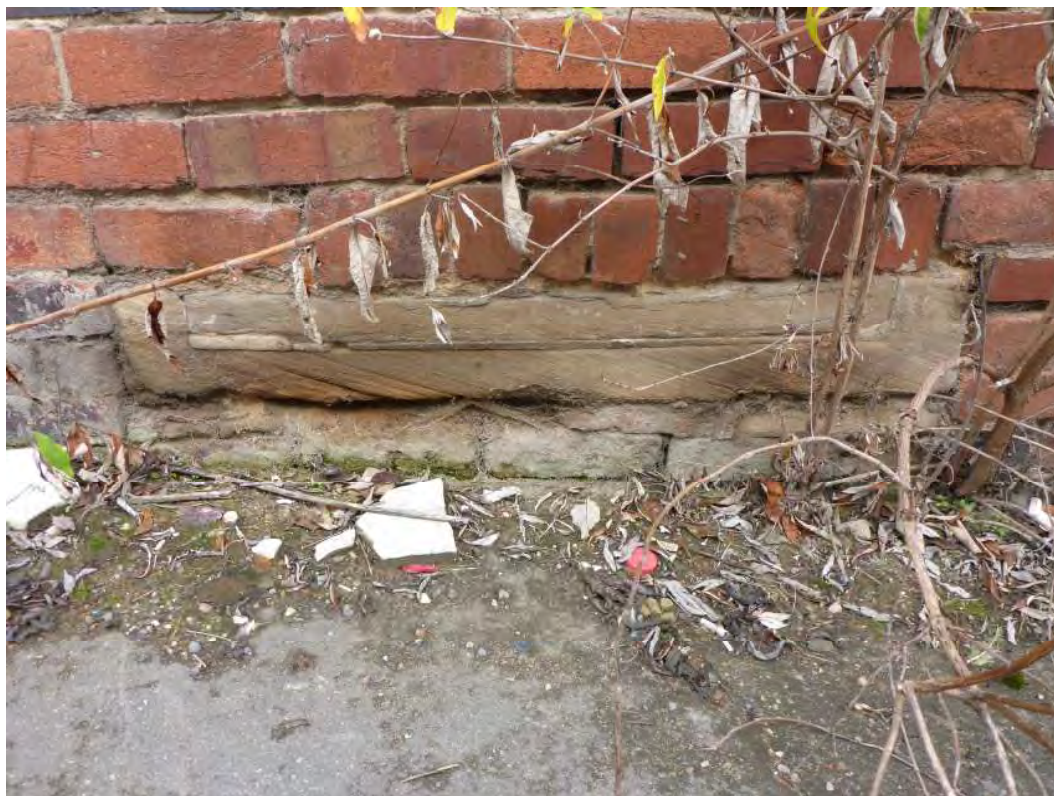
Plate 7: *In situ* 19<sup>th</sup>-century step in fabric of mid-20<sup>th</sup>-century building

Below the letterbox, a worn sandstone step sits on two courses of handmade bricks at ground-level (Plate 7). These features are likely to be surviving elements of the 19<sup>th</sup>-century building that stood at this location until 1923, but which had been demolished by 1935. Coal chutes are present in the pavement, indicating the presence of cellars beneath the single-storey building. The western coal chute is secured by a sheet of unfixed chipboard (Plate 8) and visual inspection from the pavement demonstrates that the cellar is constructed from handmade bricks. This suggests that the 19<sup>th</sup>-century buildings were demolished to ground level, with the existing building being constructed on the foundations of the former building.

The fabric of the single-storey building includes a worn sandstone doorstep sitting on two courses of truncated handmade bricks. These appear to be the only surviving above-ground remains of the 19<sup>th</sup>-century buildings, although the 19<sup>th</sup>-century cellars remain extant below. This indicates that the original buildings were demolished to ground level, with the single-storey building being constructed on their foundations.

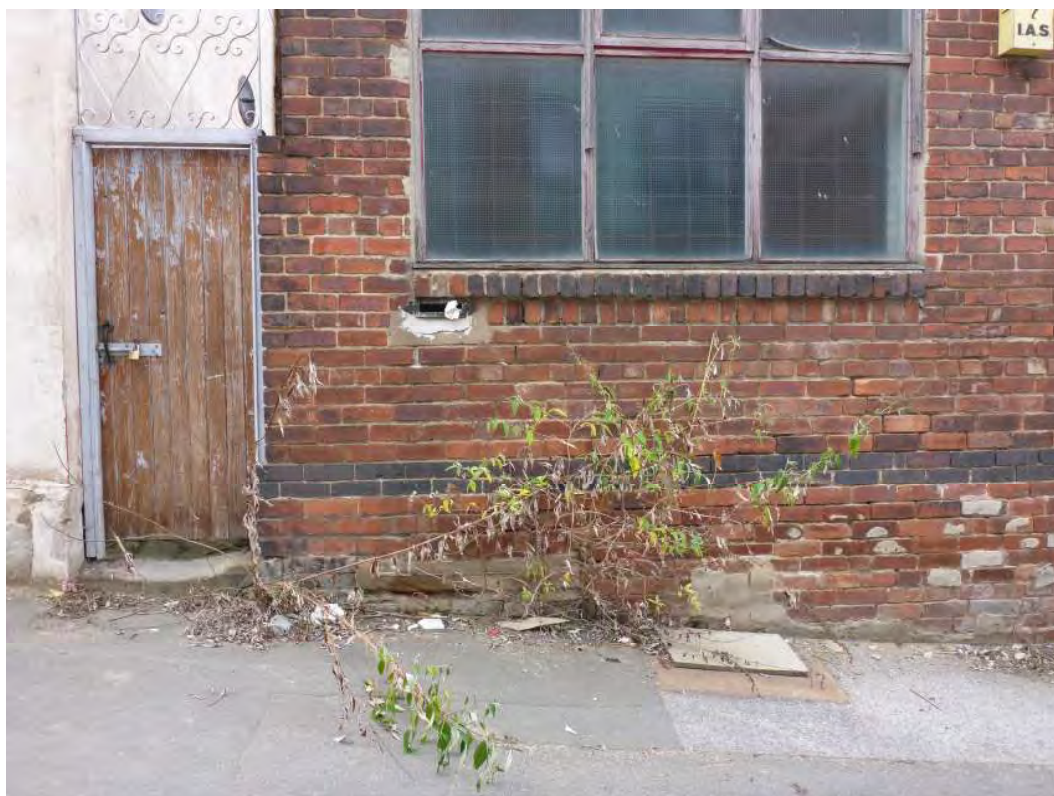
Plate 9: Site of former covered passage at left

On the west side of the building, a wooden door topped by metal railings secures the passage between nos 52-54 and no.56 (Plate 9). The door occupies the site of the entrance to the covered passage that led into the main works' yard on the 19<sup>th</sup>- and early 20<sup>th</sup>-century Ordnance Survey maps. A degraded sandstone step and similarly decayed flags along the route of the former passage are likely to be *in situ* survivals (Plate 10).

A covered passage shown on the 1853 to 1923 Ordnance Survey maps was removed when the buildings in the centre of the street frontage were demolished. Any scars from the lost buildings have been obscured by the cement render that has since been applied to the exterior of no.56 Garden Street. A worn sandstone step at the former entrance to the passage survives *in situ*. A wooden door shown at this location in the various 1990s photographs remains extant. A metal security railing has been added above the door.

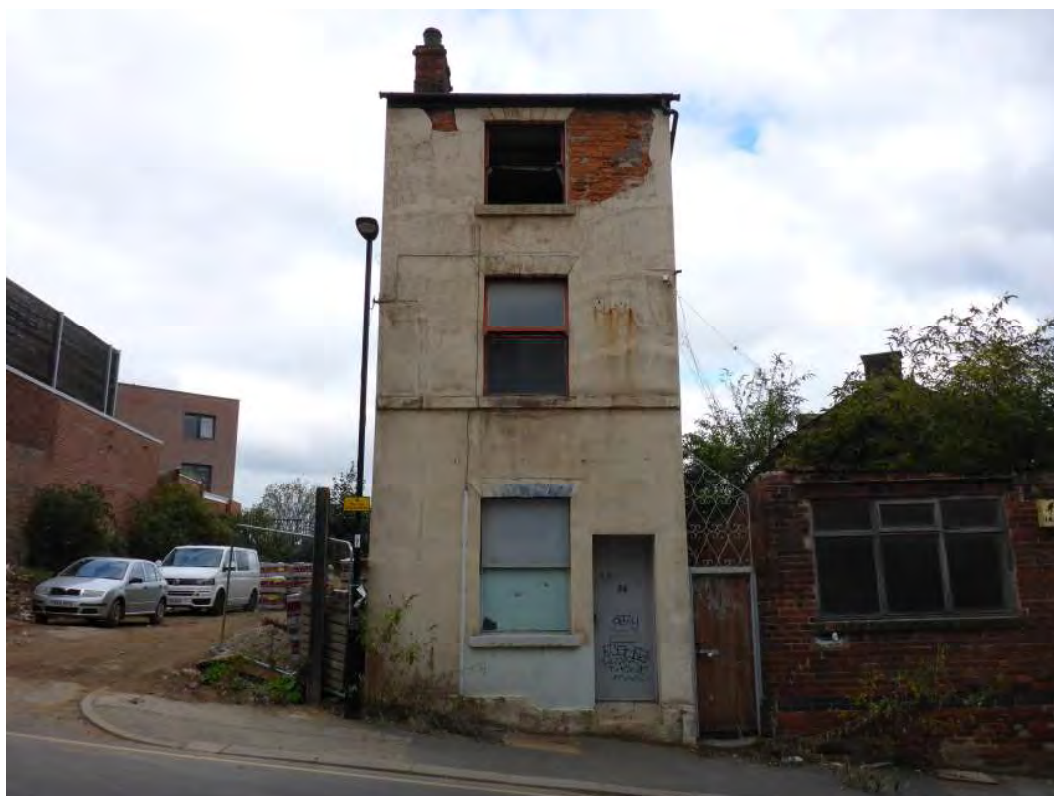
Plate 11: No.56 Garden Street, south elevation

To the west of the passage, the street frontage of no.56 Garden Street is a three-storey building constructed of handmade bricks, overlaid with an off-white cement render (Plate 11). Much of the latter has been lost to the right of the second-floor window. The early to mid-19<sup>th</sup>-century former 'house' has been converted into offices. At ground-level, a stone pediment contains a Georgian 'scoop' beneath the single, central window, while a worn sandstone step leads to an inset doorway. A coal chute in the pavement indicates the presence of a basement or cellar beneath no.56.

The cement render on no.56 had been applied by the time of the 1990s photographs. While the render was complete and in relatively good condition at that time, a large area of render to the right of the second-floor window has since fallen, exposing the handmade brickwork beneath. A smaller area of brickwork is also exposed to the left of the window. The render has obscured the original doorway of no.56. Any wooden door casement that may have been present has been removed and the existing entrance is a utilitarian inset doorway with a plain wooden door. These features were extant at the time of the 1990s photographs. A coal chute in the pavement demonstrates that no.56 possesses a cellar or basement.

The 1990s photographs show that each of the original windows in the south elevation of no.56 has been replaced by modern, two-pane windows. These remain extant, although the ground-floor window has been boarded-up and the glass has been lost from the first-floor frame. Several metal bolt-and-frame wall ties have been inserted into the east and west elevations of the building. These had been inserted by the 1990s.

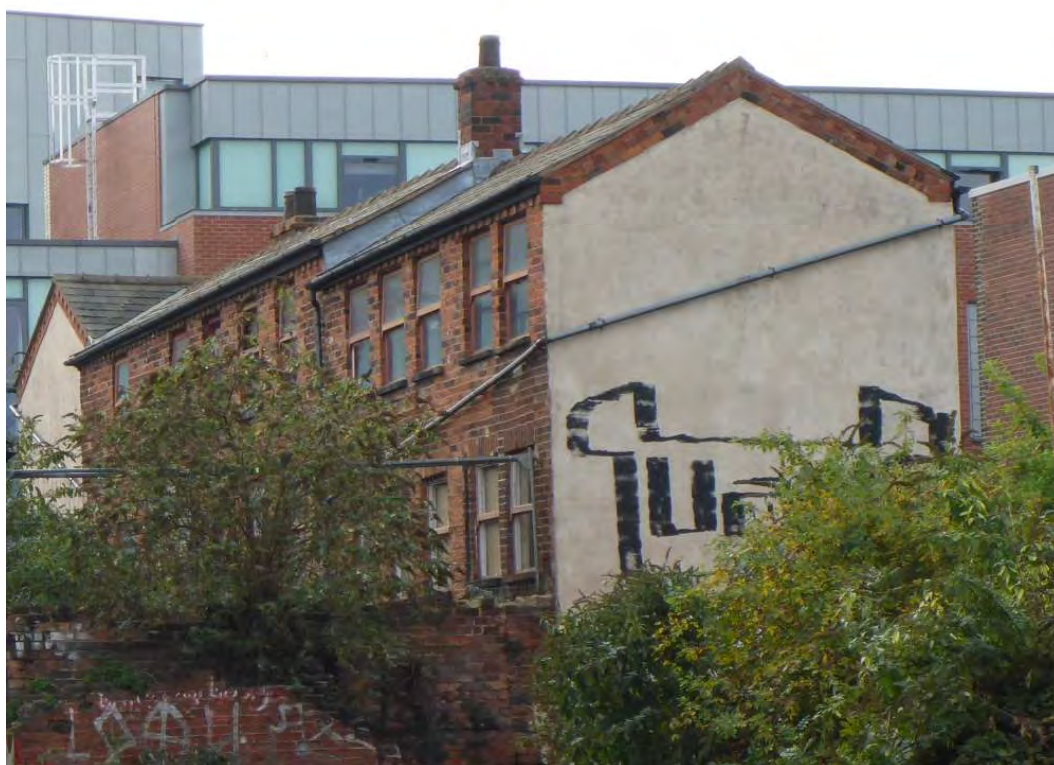
Plate 13: No.56, east elevation, looking south

The western workshops are three-storeys in height, constructed from handmade bricks and have a split-level roofline. This may indicate different phases of construction, although the same dentiled brickwork is present at eaves-level on both parts of the workshop range and on the offices along the street frontage. Between the offices and the principal workshops, a narrow area has only a single window on each floor (Plate 12). These have the same stone lintels as those on the offices. A series of several, more closely-spaced two-pane windows are present at ground- and first-floor level in the east elevations of the workshop proper (Plate 13). These possess 'soldier' (upright) brickwork lintels. At ground-floor level, two large, segmental-headed former openings have been blocked. A cement render is present on the building's north elevation (Plate 13).

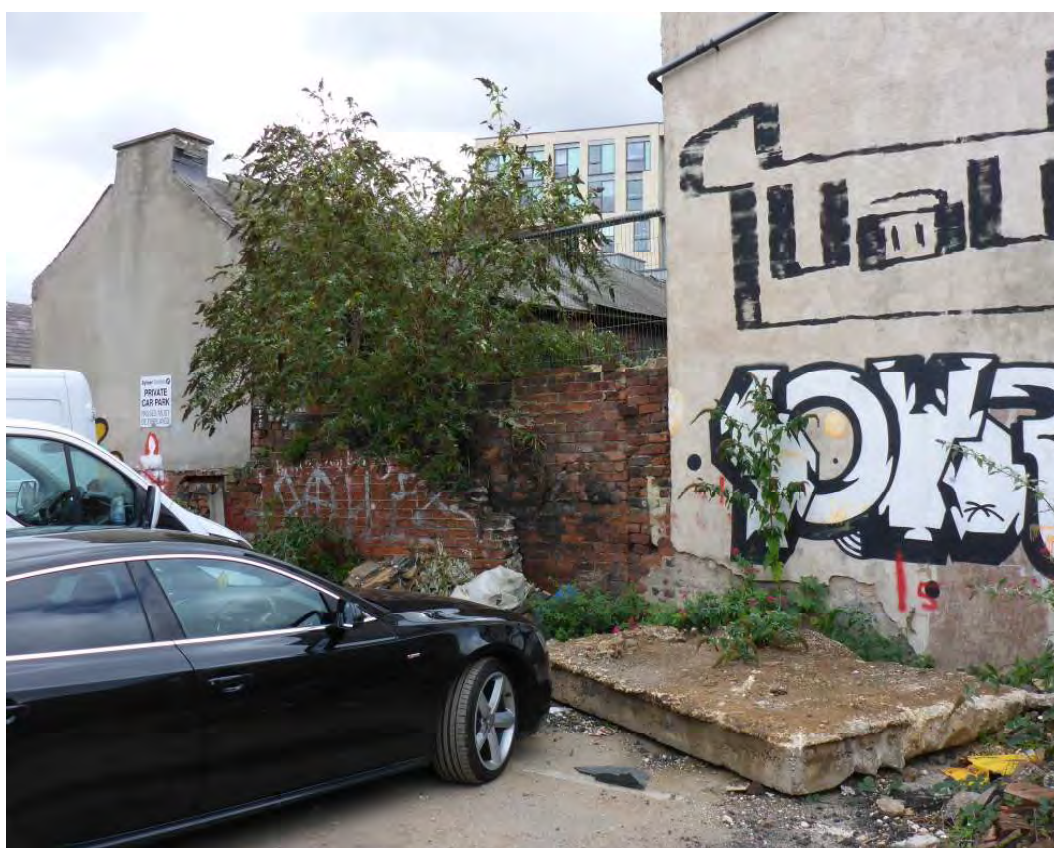
Plate 14: Rebuilt northern boundary wall

Between the workshops on either side of the main yard, the northern boundary wall has been rebuilt and includes a straight joint, indicating that the phases are not keyed-in to each other (Plate 14). This is likely to have occurred between 1905 and 1923, when the 19<sup>th</sup>-century building that stood in this area was demolished. Extensive, dense vegetation, some of which has grown to the height of the second-floor windows, obscures many of the buildings and features in the works' main yard (Plate 15).

The eastern workshops are a three-storey, brick-built range (Plate 16), the northern part of which is constructed from handmade bricks, with the remainder and a number of insertions being built from machine-made imperial bricks. This supports the suggestion in the 1999 RCHME report that the northern end of the range survives from the building that was shown here on the 1853 OS map, with the remainder being the range that was shown on the 1890 map (Giles 1999, 3). A cement render is present on the building's north elevation (Plate 14).
