## **BAT SURVEY REPORT**

Bilton Kennels  
138 Main Road,  
Bilton  
East Riding of Yorkshire  
HU11 4AA

Date: 7<sup>th</sup> October 2020

Reference no: CE0836 & CE0837

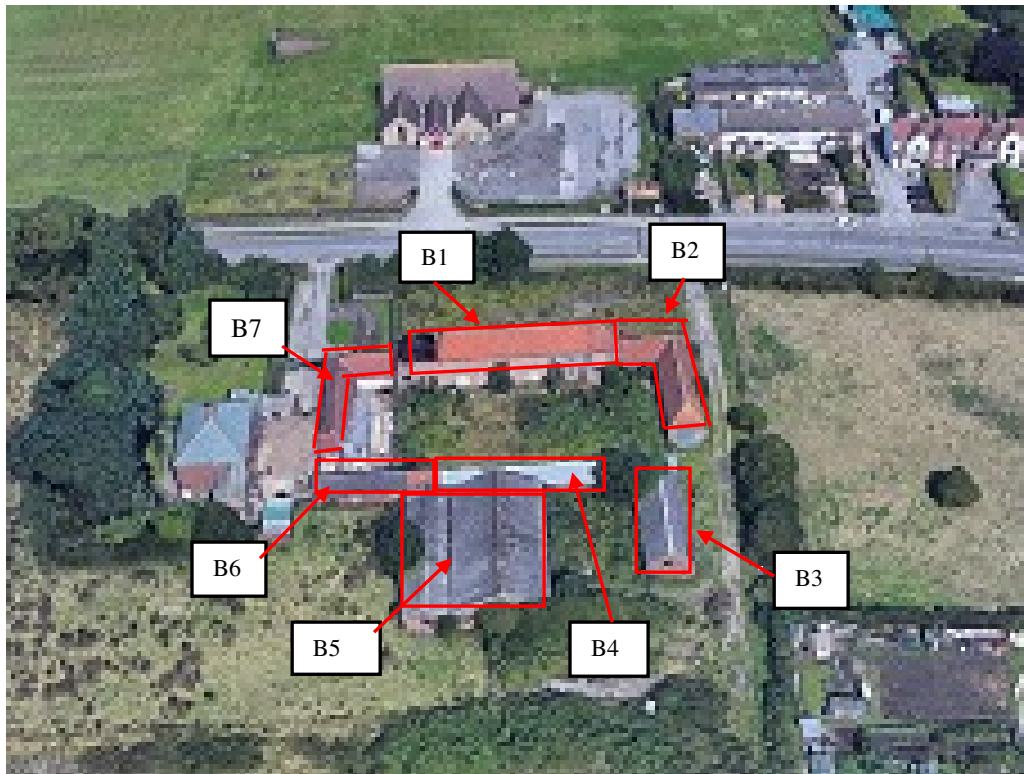
Figure 3. Existing site layout with the individual buildings identified.

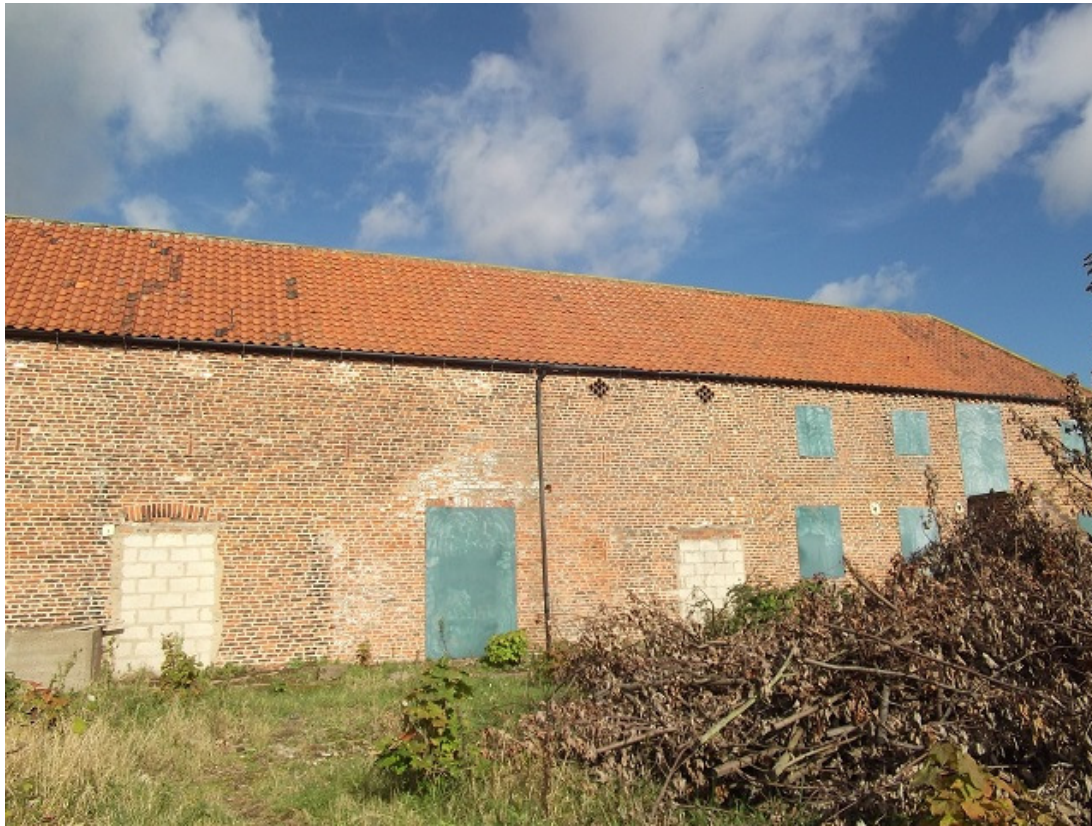
Plate 1. Looking towards the south elevation of Building 1.

Building 1 is a two-storey solid brick barn with a pantile roof covering. The external walls appeared to be in mostly good condition, with only the occasional hole seen within the mortar lines. Gaps were also noted between several the header bricks on the south elevation. Two traditional style brick air vents were built in at eaves level on both the north and south elevations. Timber framed windows were seen on both the north and south elevations all of which had been boarded or bricked up, with no gaps noted.

Internally the brick walls looked to be in good condition with no significant holes or gaps seen. There was a large hole in the eastern wall which gave direct access to Building 2. Mezzanine floors were noted at both ends of the building; access could not be gained to either of the floor levels. The floor to the western most end had been re-built recently.

King post timber trusses with rafters and purlins supported the pantile roof covering, several tiles were noted to have lifted/slipped on the south elevation and the east gable. A small number of gaps were also seen under the ridge tiles where the bedding mortar had come away over time. A mix of bitumastic roofing felt and breathable roof membrane was found throughout the roof structure.

- Gaps in header bricks
- Lifted/slipped tiles
- Gaps under ridge tiles.

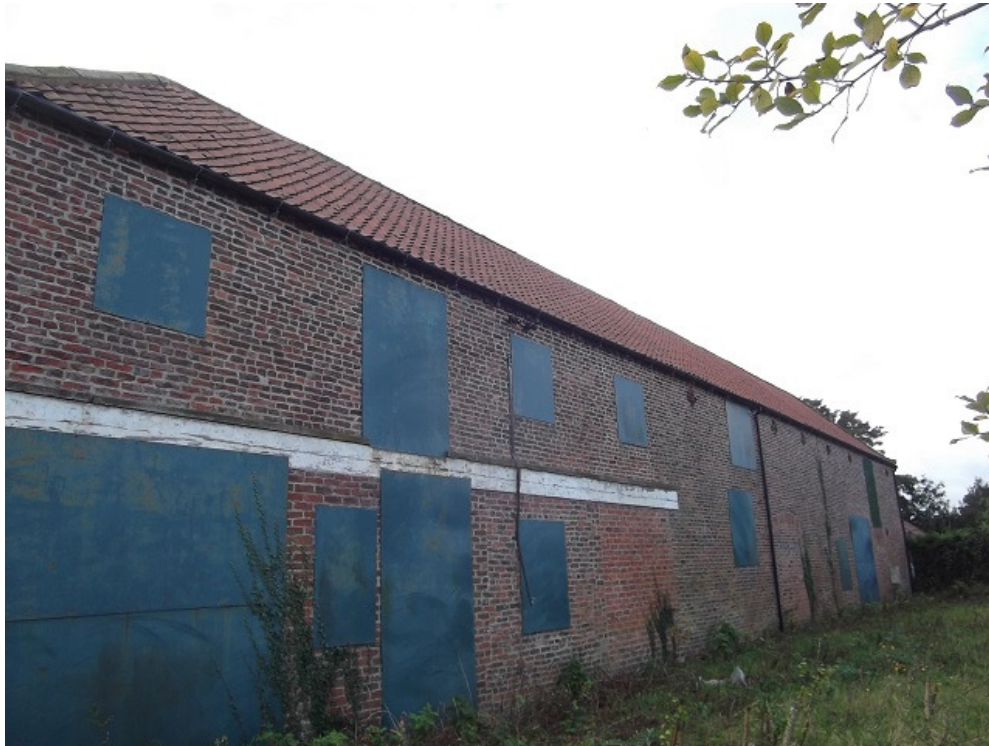
Plate 2. The north elevation of Building 1.

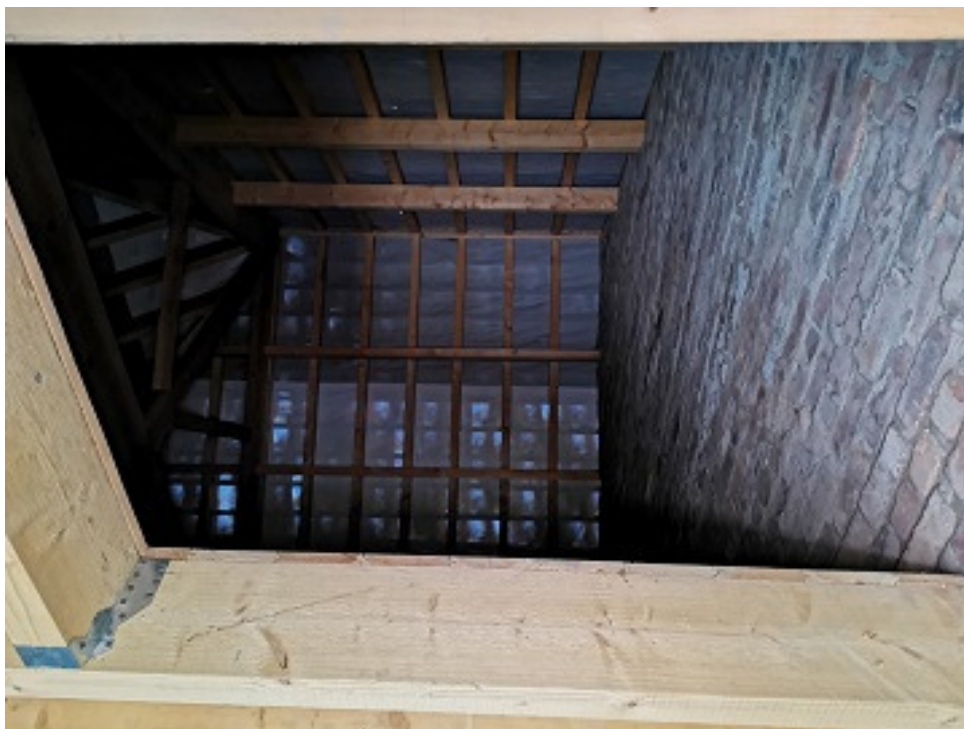
Plate 3. Shows the interior roof structure above the mezzanine floor

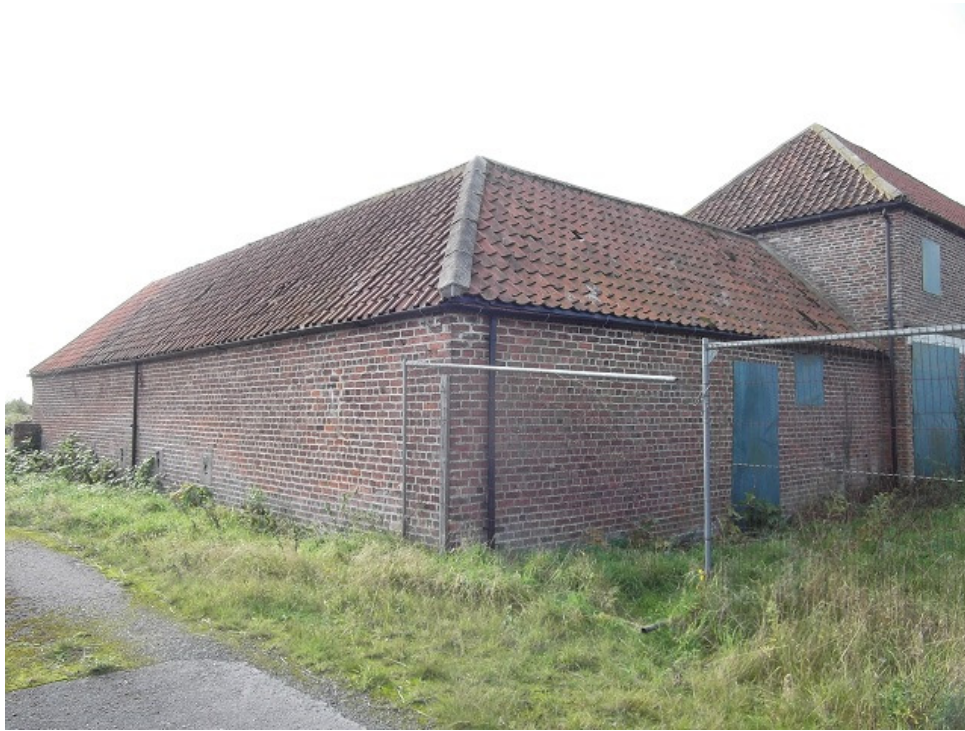
Plate 4. Shows the north and east elevations of Building 2.

Building 2 is a single storey 'L' Shaped building, the external walls all have varying degrees of age-related disintegration with some gaps noted between the bricks where the mortar had come away in places. Windows on the east and west elevation has been boarded up with plywood sheets which were well fitted with no gaps. Double doors on the south gable has also been boarded with ply sheets which had warped over time leaving some small gaps between the brickwork and ply sheets. Access could not be gained inside the building.

Several pantiles had lifted/slipped leaving gaps with a small number of tiles had come away completely, leaving several holes. The ridge line appeared to be in good condition with no gaps noted on the day of the building's assessment.

- Lifted, Slipped & Missing tiles
- Gaps between bricks
- No access inside the building.

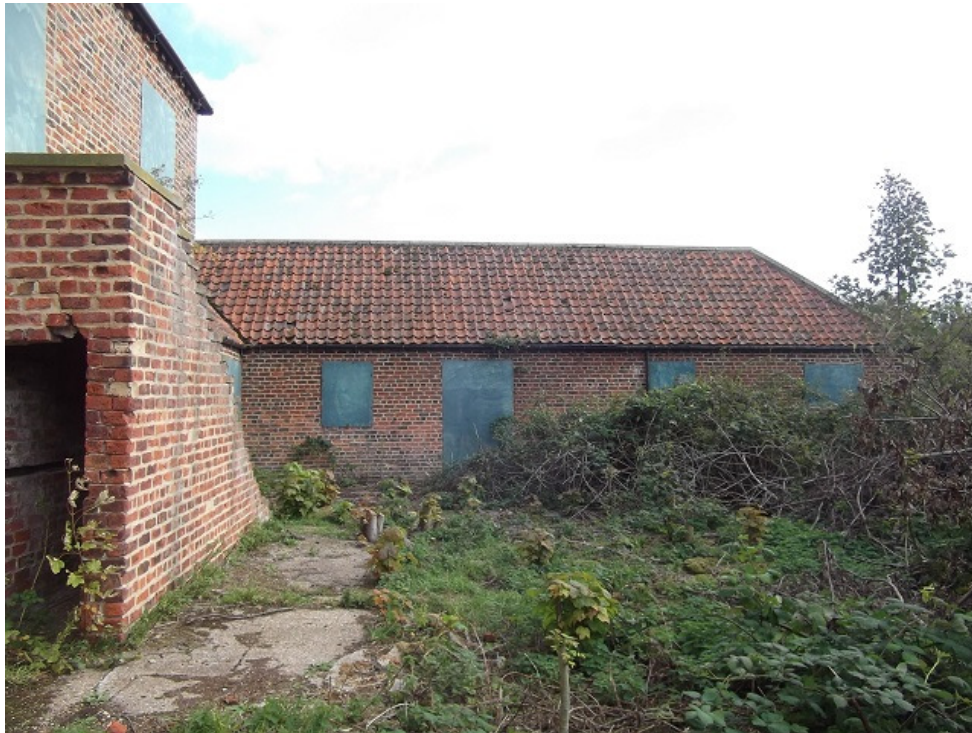
Plate 5. Looking towards the west elevation of Building 2.

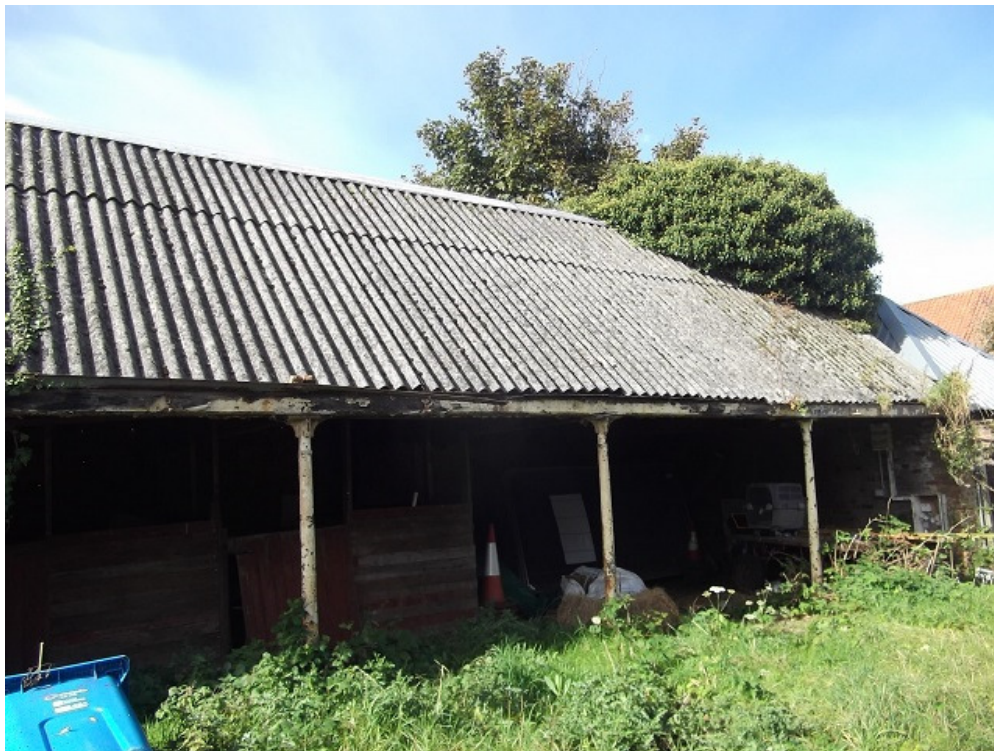
Plate 6. Shows east elevation of Building 3.

Building 3 is an open fronted brick barn with corrugated asbestos sheet roof covering. The east elevation is open with the roof structure supported by 4 steel posts. The external brickwork on south elevation had varying degrees of age-related decay of both the mortar lines and brickwork itself, along with several deeper holes on the mortar lines, whilst the north and west external walls were both covered by dense vegetation.

Internally the walls had a moderate number of deep holes and cracks of varying proportions with several larger cracks noted on the north wall.

- Moderate number of deep holes and cracks in both external and internal walls

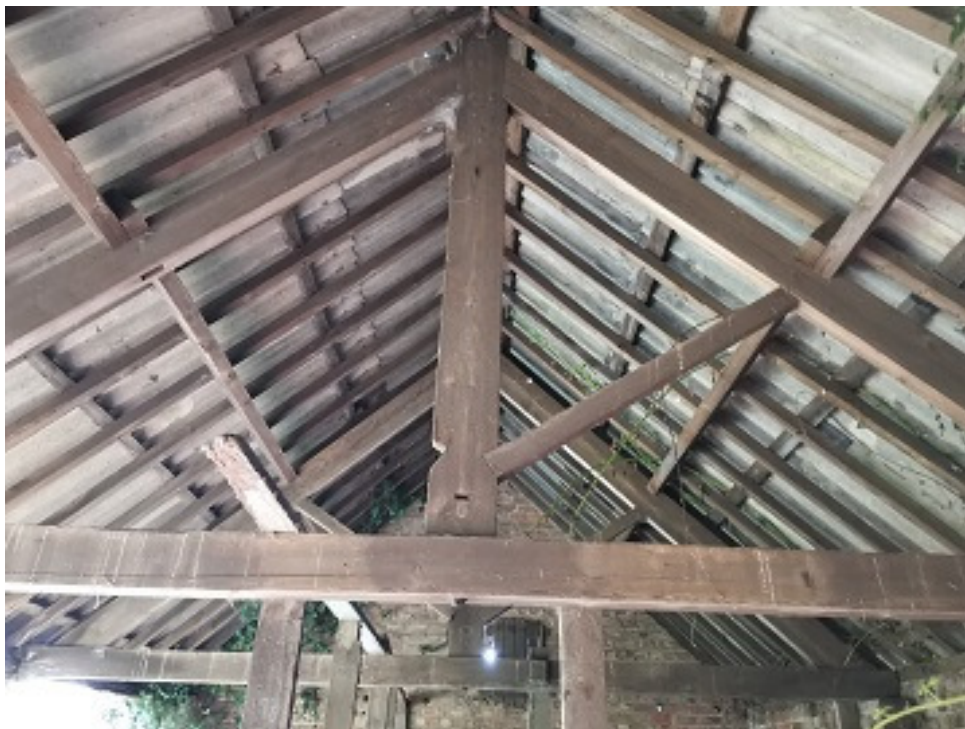
Plate 7. Shows the timber trusses within Building 3

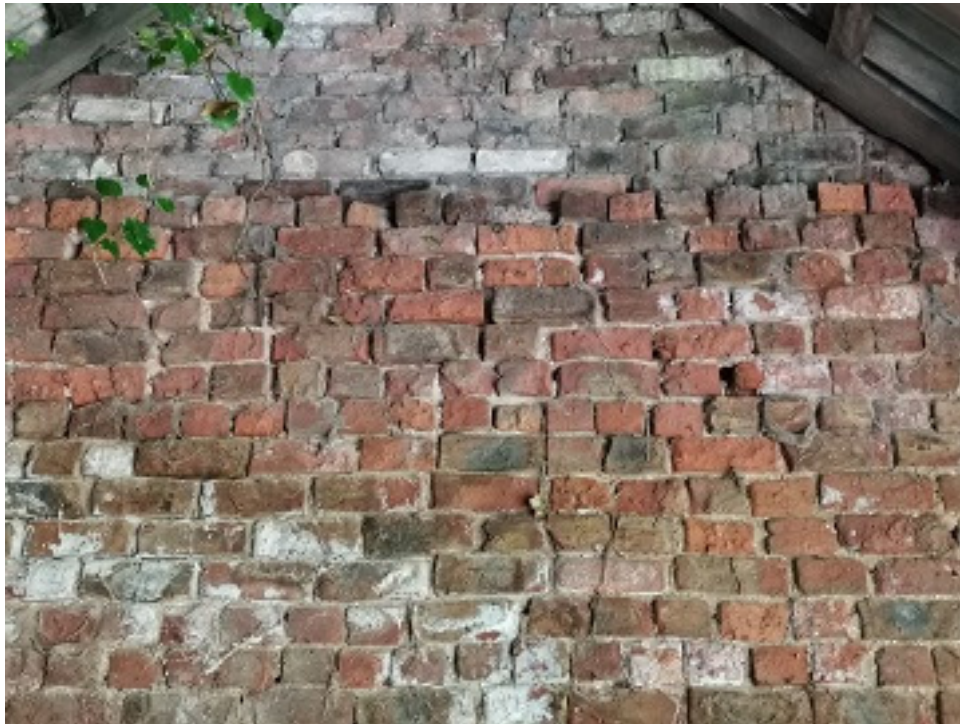
Plate 8. Example of holes in internal wall of Building 3

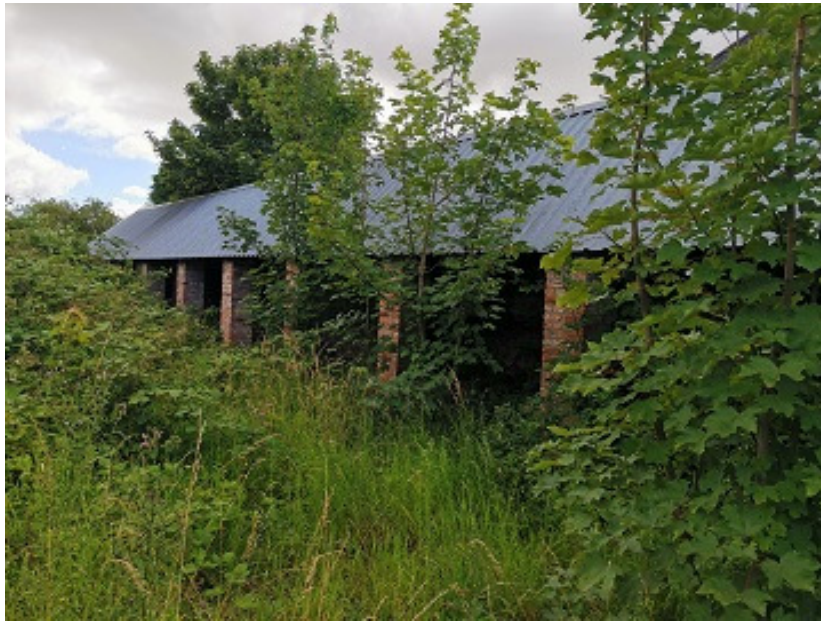
Plate 9. Looking towards the north elevation of Building 4.

Building 4 is an open fronted building with a box profile steel roof covering. The north elevation is supported by eight brick pillars which look to be in good condition with no holes or cracks noted. The south elevation has timber batons attached directly to the external wall of Building 5, the east gable is fully open.

Building 4 has been assessed as having Negligible potential for bat habitation.

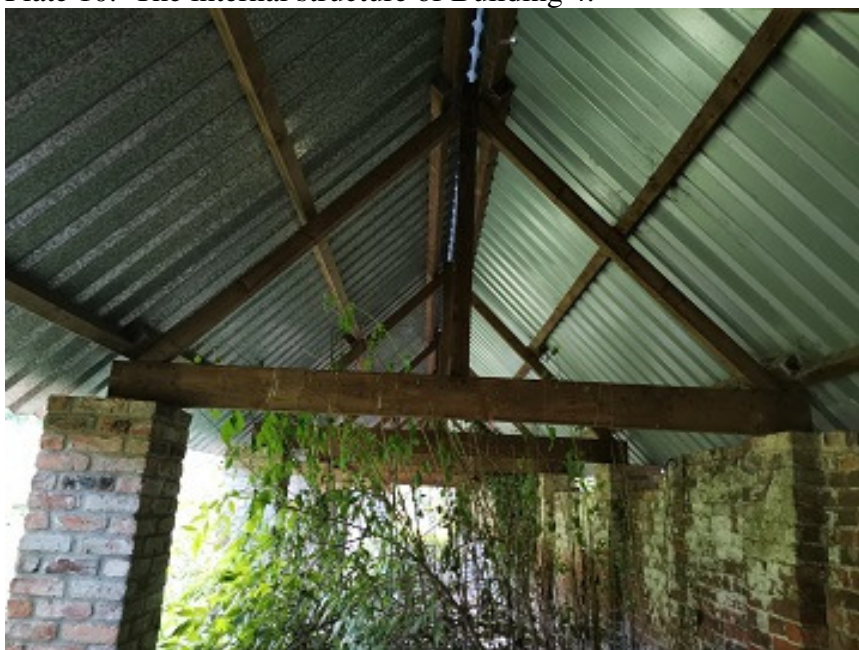
King post trusses with purlins and a central ridge board support the box profile metal roof covering. There was no lining present throughout the building.

Plate 10. The internal structure of Building 4.

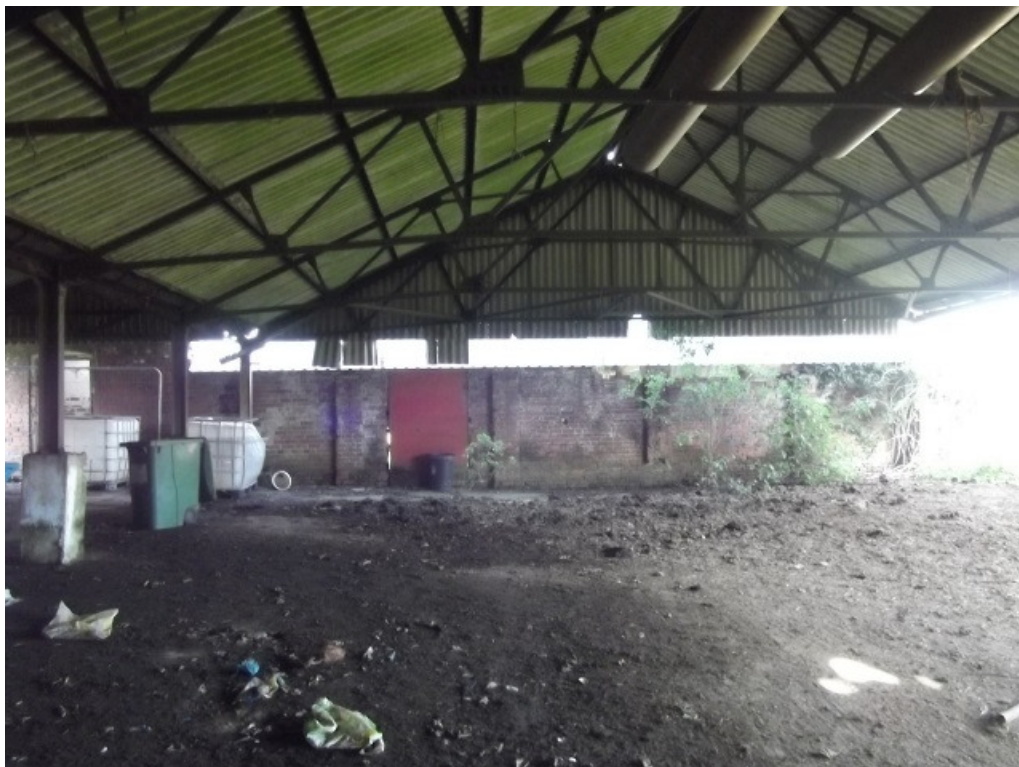
Buildings 5 is a twin apex barn, with a small outbuilding to the southwest corner. The east elevation is supported by steel stantions, which look to be in good condition the north elevation is constructed from an approximately 2m high solid brick wall with corrugated asbestos above up to eaves level, there was a 0.5m gap between the top of the wall and the bottom of the corrugated asbestos sheets. Both the south and west elevations are a solid brick walls with varying degrees of age-related decay.

Internally the building has a small room to the south west corner which is currently been used to bed horses. The walls internally were noted to have occasional holes within the mortar lines

- Occasional holes in both the internal and external brick walls

Plate 11. Shows internal framework of Building 5.

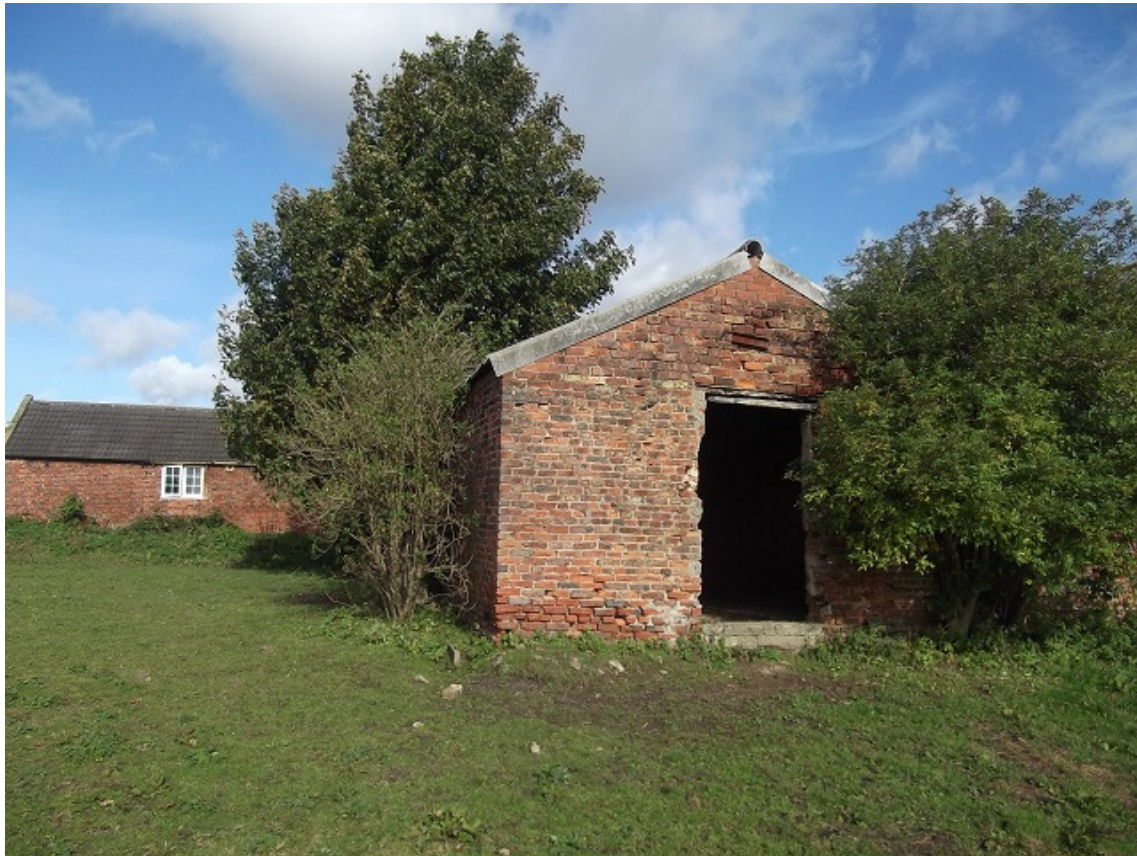
Plate 12. The south gable of the small outbuilding.

A Barn owl box is located in the small outbuilding with pellets noted on the floor, which were all observed from the open doorway in the south gable. This building was not entered due to the possible presence of Barn owl

Without suitable mitigation the conversion of the existing redundant agricultural barns would result in the destruction/loss of the existing roosting/nesting site found within Building 5. Therefore to address these findings and to enable both the Continued Ecological Functionality and to maintain the Favourable Conservation Status of this bird species the following Mitigation Strategy has been proposed.

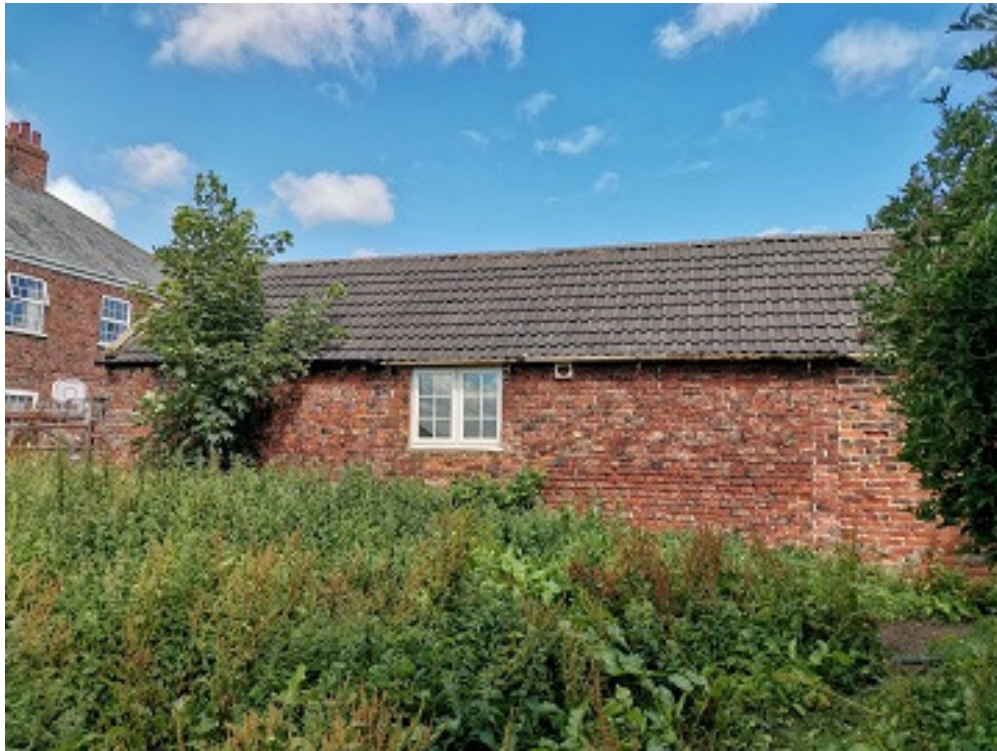
Plate 13. Shows south elevation of Building 6

Building 6 is a single storey solid brick walled outbuilding with a concrete interlocking tile roof covering.

The external walls all appeared to be in good condition with only superficial decay of the brickwork and mortar lines. UPVC windows were noted on both the north and south elevations and a timber framed door on the west gable, all appeared to be in good condition with no holes or gaps noted. Access could not be gained inside the building due to Covid-19 restrictions.

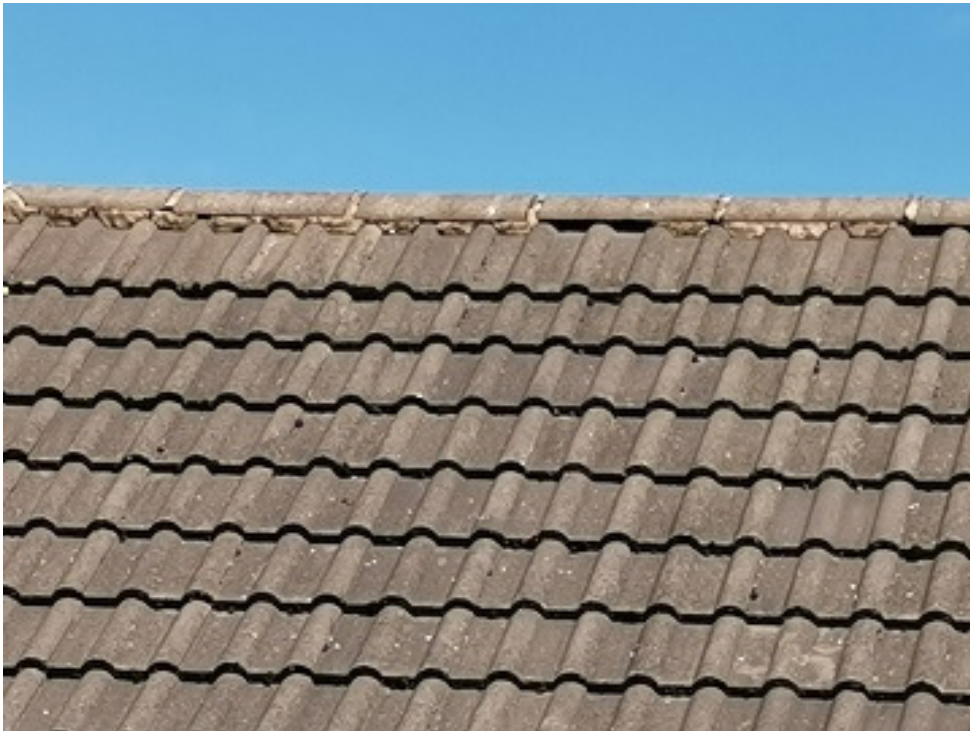
The concrete interlocking tiles were all well fitted with no gaps noted on the day of the survey. Sections of bedding mortar had come away from under the ridge tiles leaving occasional holes.

- Gaps under ridge tiles
- No access internally

Plate 14. Shows gaps under ridge tiles on Building 6

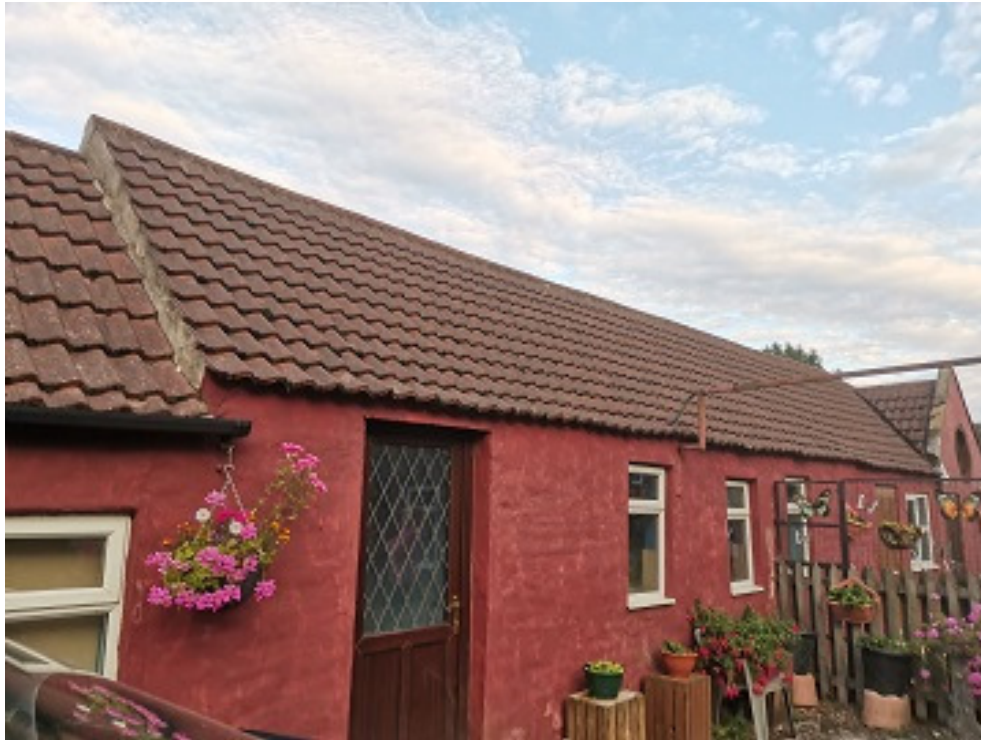
Building 7 is a range of working dog kennels located to the west of the site. Constructed with solid brick walls with a roof covering to the west roof aspect of concrete Marley tiles and Roman concrete tiles to the eastern aspect. The walls were in good condition with only occasional superficial decay noted on the eastern elevation. The UPVC windows and doors are all in good condition with no gaps noted between the frames and surrounding brickwork. The ridge tiles are all well bedded with no holes or gaps noted and the verges were all well pointed up. External security lighting is present along the western elevation. Overall this range of buildings were in good condition and well maintained, there was no historical evidence of bat habitation and from the observations made Building 7 has been assessed as having Negligible potential for bat habitation.

Plate 15. Looking towards the west elevation of Building 7.

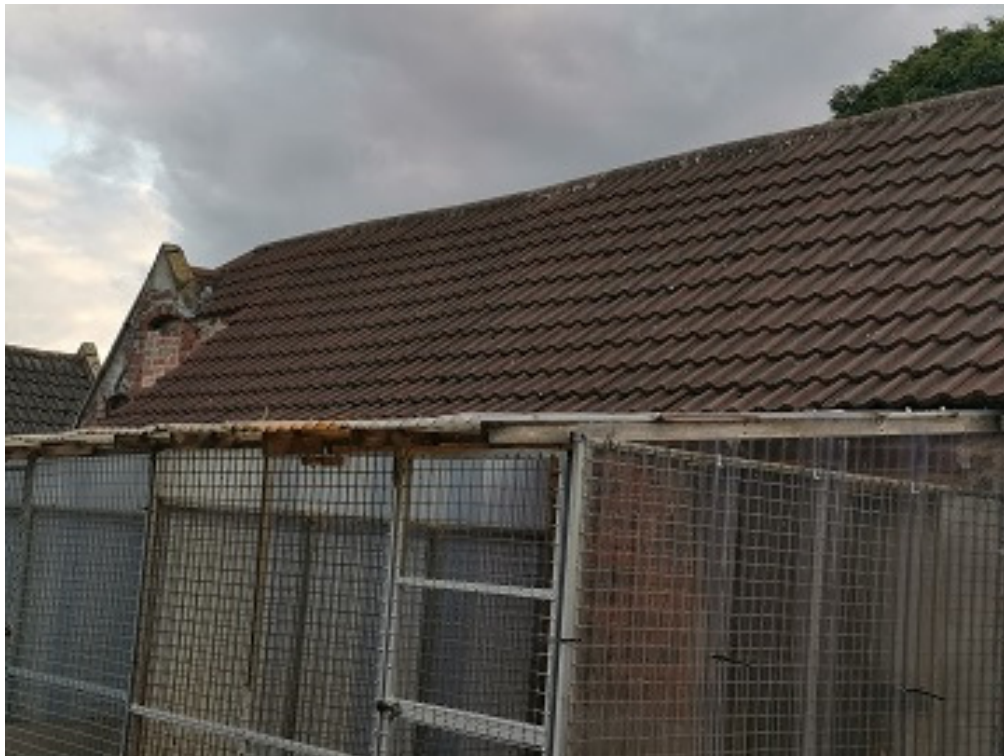
Plate 16. The eastern elevation of Building 7.

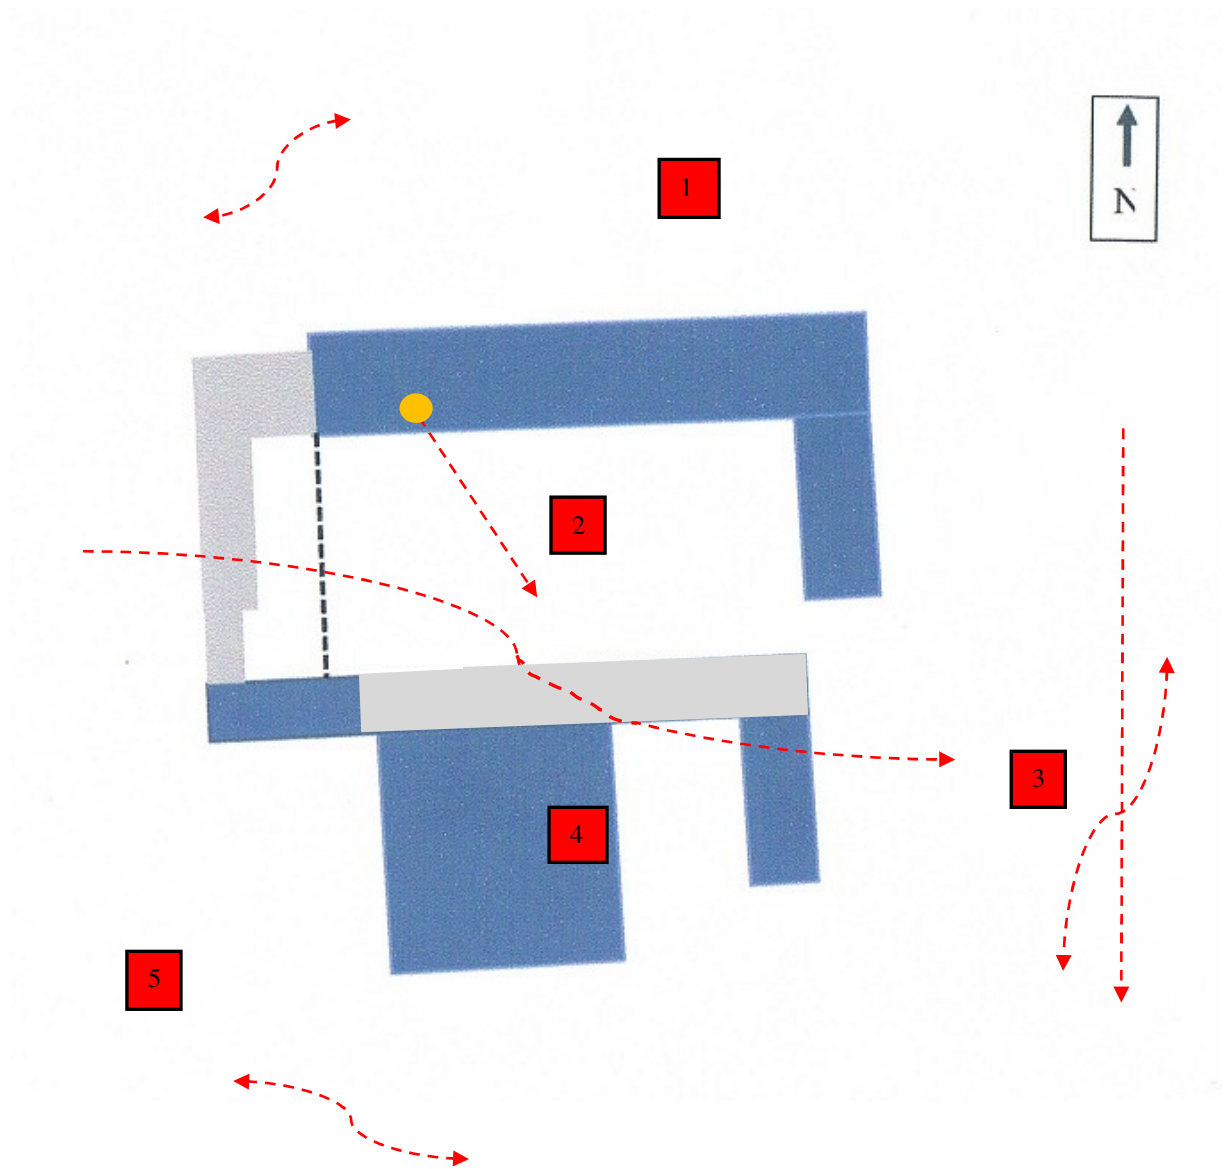
Dusk bat activity plan 3<sup>rd</sup> August 2020

<b>Location</b>	<b>Time</b>	<b>Observations made</b>
	20.35	Survey start
1	21.19	1 Common pipistrelle heard briefly; direction not ascertained
3	21.20	1 Common pipistrelle commuting north to south
2	21.29	1 Common pipistrelle emerged from under a tile on the south elevation of building 1 before foraging around yard
4	21.33	1 Common pipistrelle heard foraging; direction not ascertained.
1	21.24	1 Common pipistrelle foraging to the north of the study site.
5	21.38	1 Common pipistrelle foraging to the south west of the study site.
1, 3 & 4	21.46	1 Common pipistrelle foraging west to east
3	21.52	1 Common pipistrelle foraging to the east of the site
1	22.08 – 22.10	1 Common pipistrelle foraging along the north elevation of building 1
	22.35	Survey End

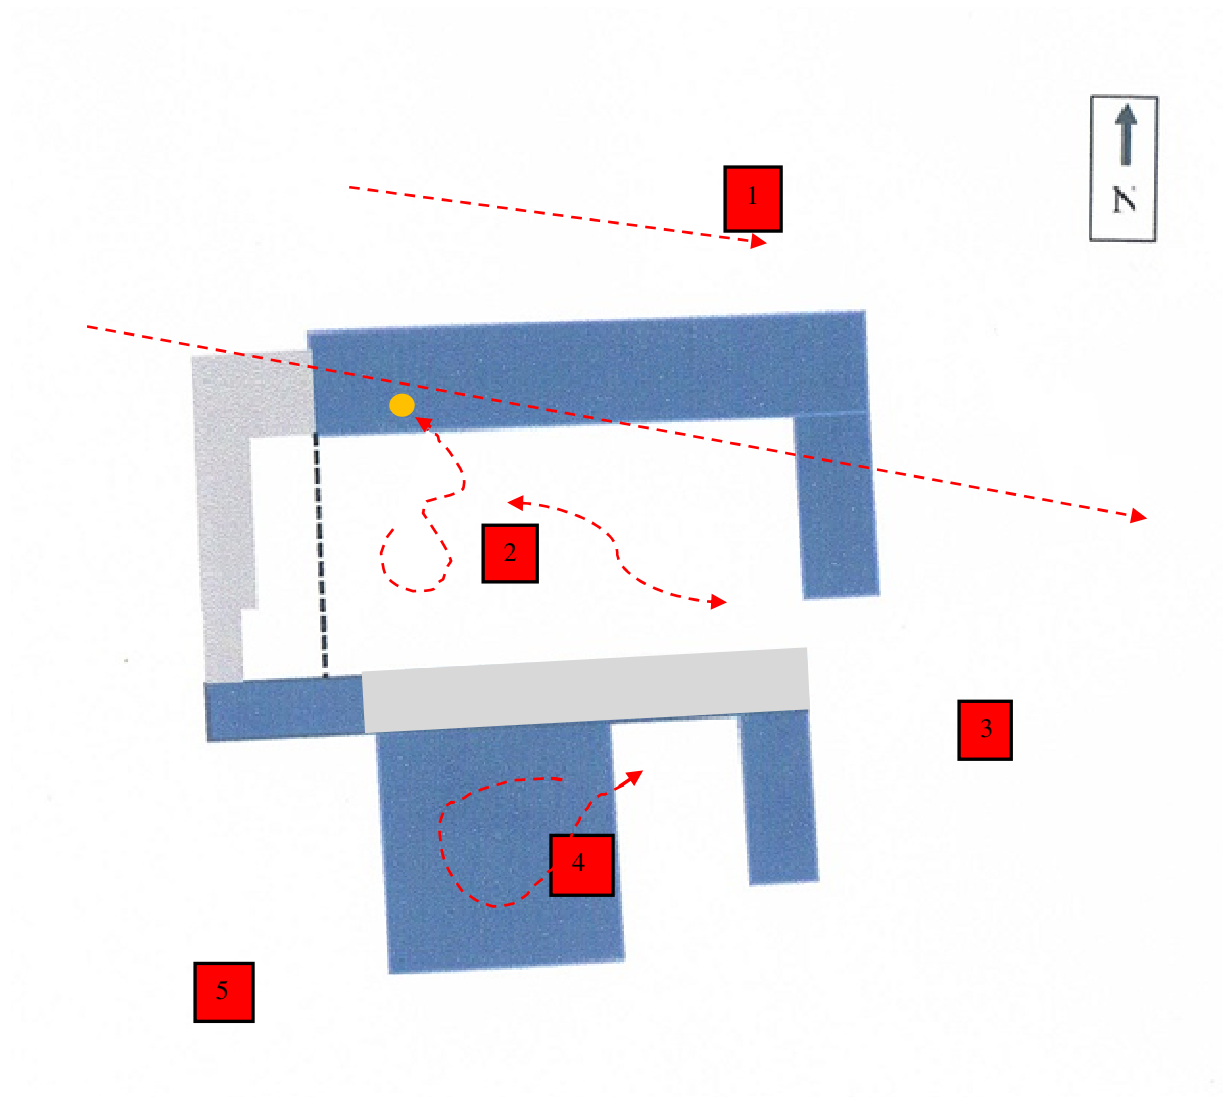
Dawn bat activity plan 19<sup>th</sup> August 2020

06.10	Survey End

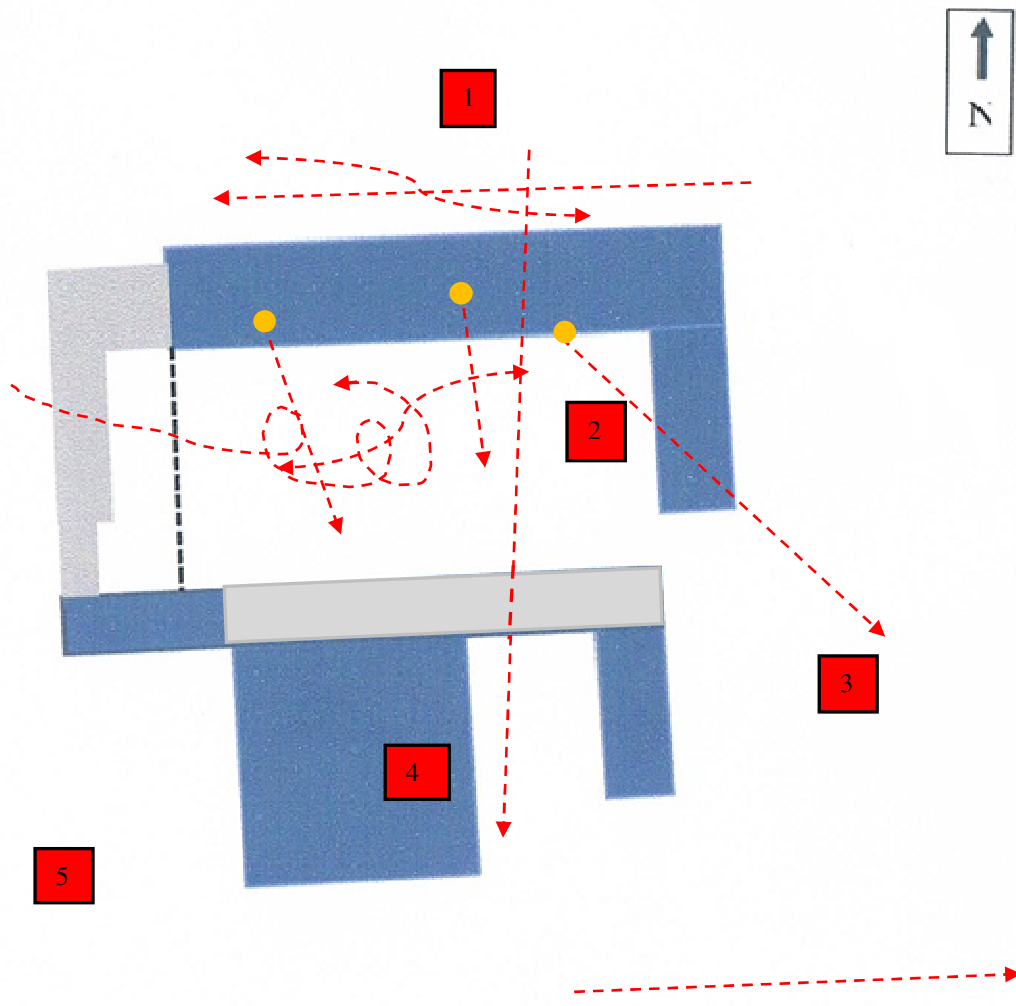
Dusk bat activity plan 3<sup>rd</sup> September 2020

Location	Time	Observations made.
	19.30	Survey Start
2	20.01	1 Common pipistrelle emerged from under a tile on the south elevation of Building 1
1	20.08	1 Common pipistrelle commuting east to west
2	20.09	1 Common pipistrelle emerged from in between the header bricks on the south elevation of Building 1
2	20.11	1 Common pipistrelle out from under a tile on the south elevation of Building 1
3	20.13	1 Common pipistrelle commuting west to east
1, 2 & 4	20.16	1 Common pipistrelle commuting north to south
2	20.18 – 20.25	1 or 2 Common pipistrelle foraging in yard
1	20.17 – 20.23	1 Common pipistrelle foraging along north elevation of Building 1
2	20.43 – 20.56	1 Common pipistrelle flew in from the west before foraging in yard
2	21.12 – 21.15	1 Common pipistrelle briefly foraged in yard before flying off east
	21.45	Survey End

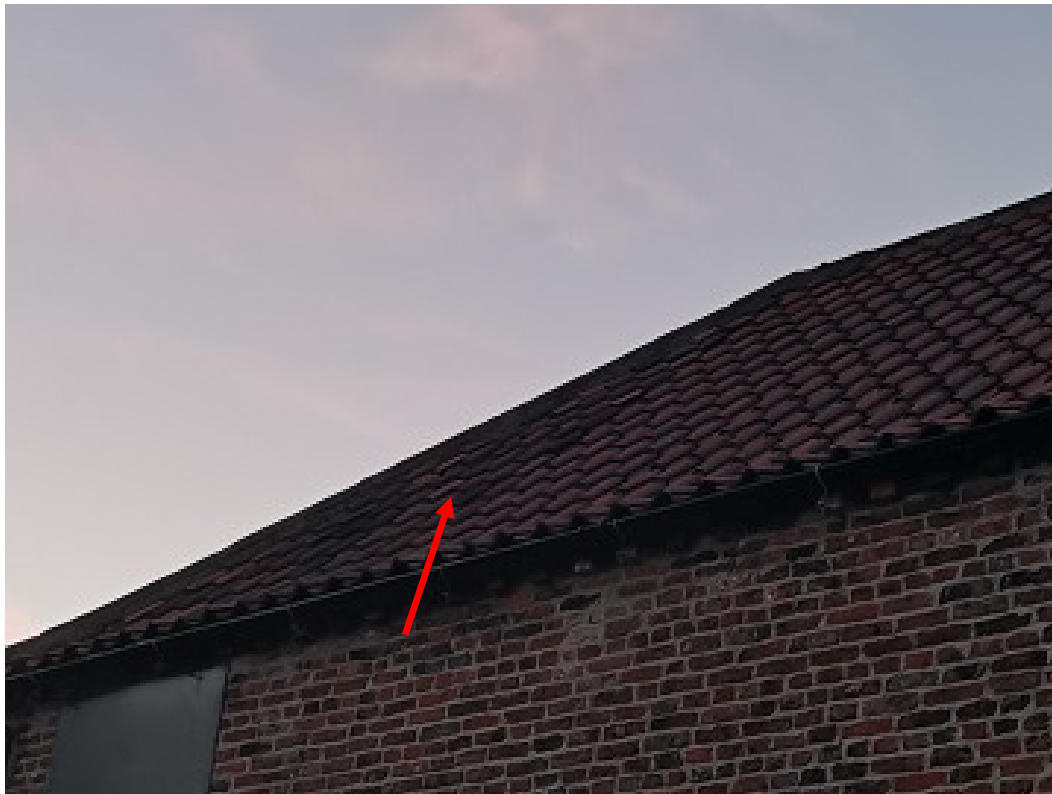
During the dusk activity survey undertaken on the 3<sup>rd</sup> September 2020, one Common Pipistrelle *pipistrellus pipistrellus* under a tile on the south elevation of Building 1 @ 20.01hrs ( Roost 1, Plate 13) A second Common pipistrelle *pipistrellus pipistrellus* emerged from a day between two header bricks on the south elevation of Building 1 @ 20.14 hrs (Roost 2, Plate 18.) At 20.11hrs one Common pipistrelle *pipistrellus pipistrellus* emerged from under a tile in the centre of the south elevation of Building 1. (Roost 3, Plate 19)

Plate 17. Shows position of Day Roost 1.

Mitigation is required to avoid or limit the impact of the proposed conversion / demolition of the study buildings on both roosting and foraging bats. Any mitigation is designed to meet the needs of the bat species present within the roost, in this case, three Common pipistrelle *Pipistrellus pipistrellus*. Therefore as the day roosts that are present at the time of the nocturnal surveys within the Building 1 are of a common bat species, which are found widespread throughout Yorkshire, then replacement roosts can be incorporated into the new dwellings to provide compensation. The loss of the existing day roosts is unlikely have a significant impact on this one common bat species at a local, regional or national level. Compensation should ensure that the Favourable Conservation Status and Continued Ecological Functionality of the identified bat population within the buildings is not adversely affected by the development proposals.

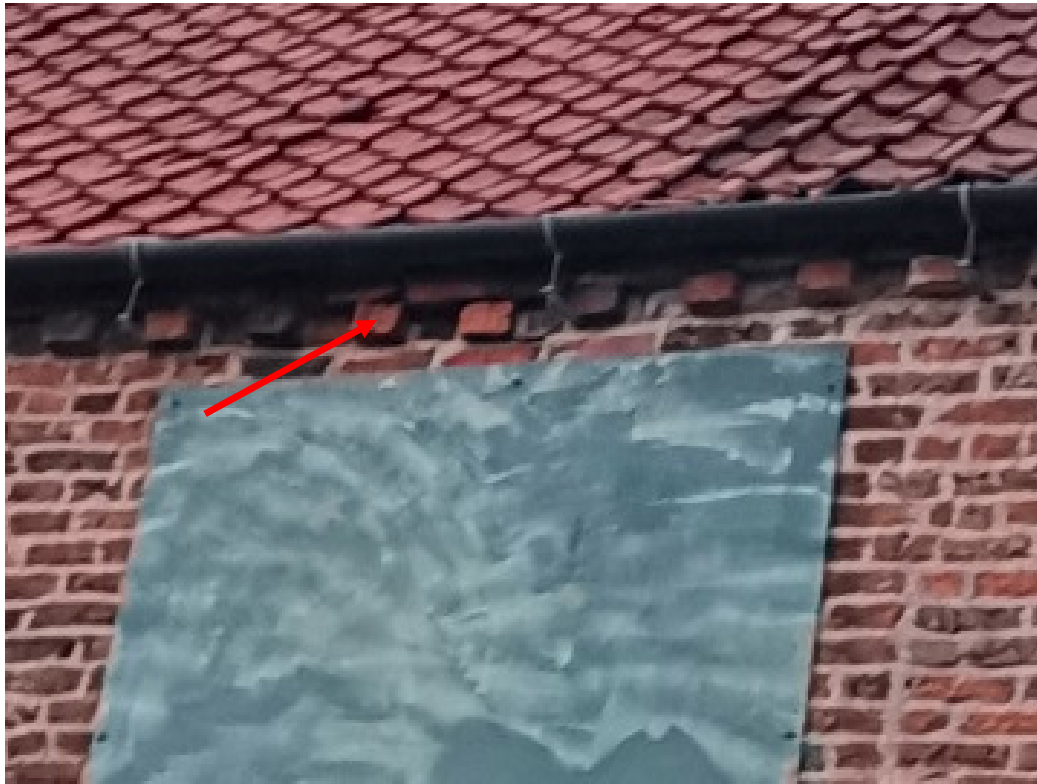
Plate 18. Shows position of Day Roost 2.

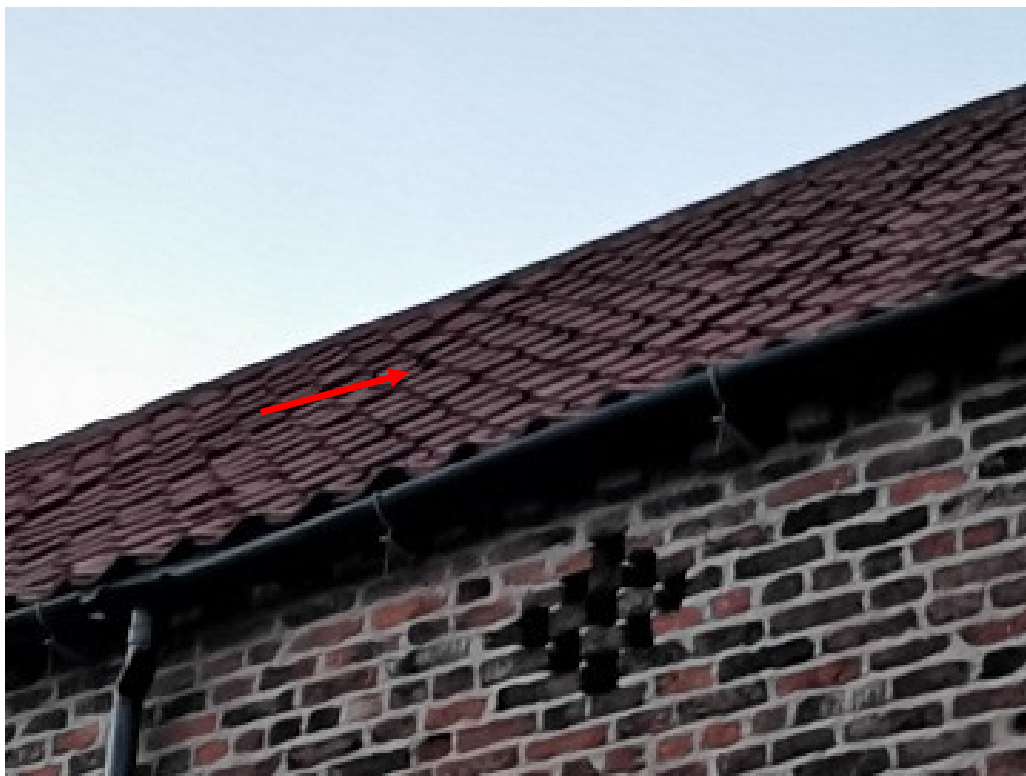
Plate 19. Shows position of Day Roost 3
