# Appendix C Arup Desk Study

Sartorial Spirits  
**A-Dhann United Downs**  
Desk Study of Ground Conditions

Issue | 20 December 2019

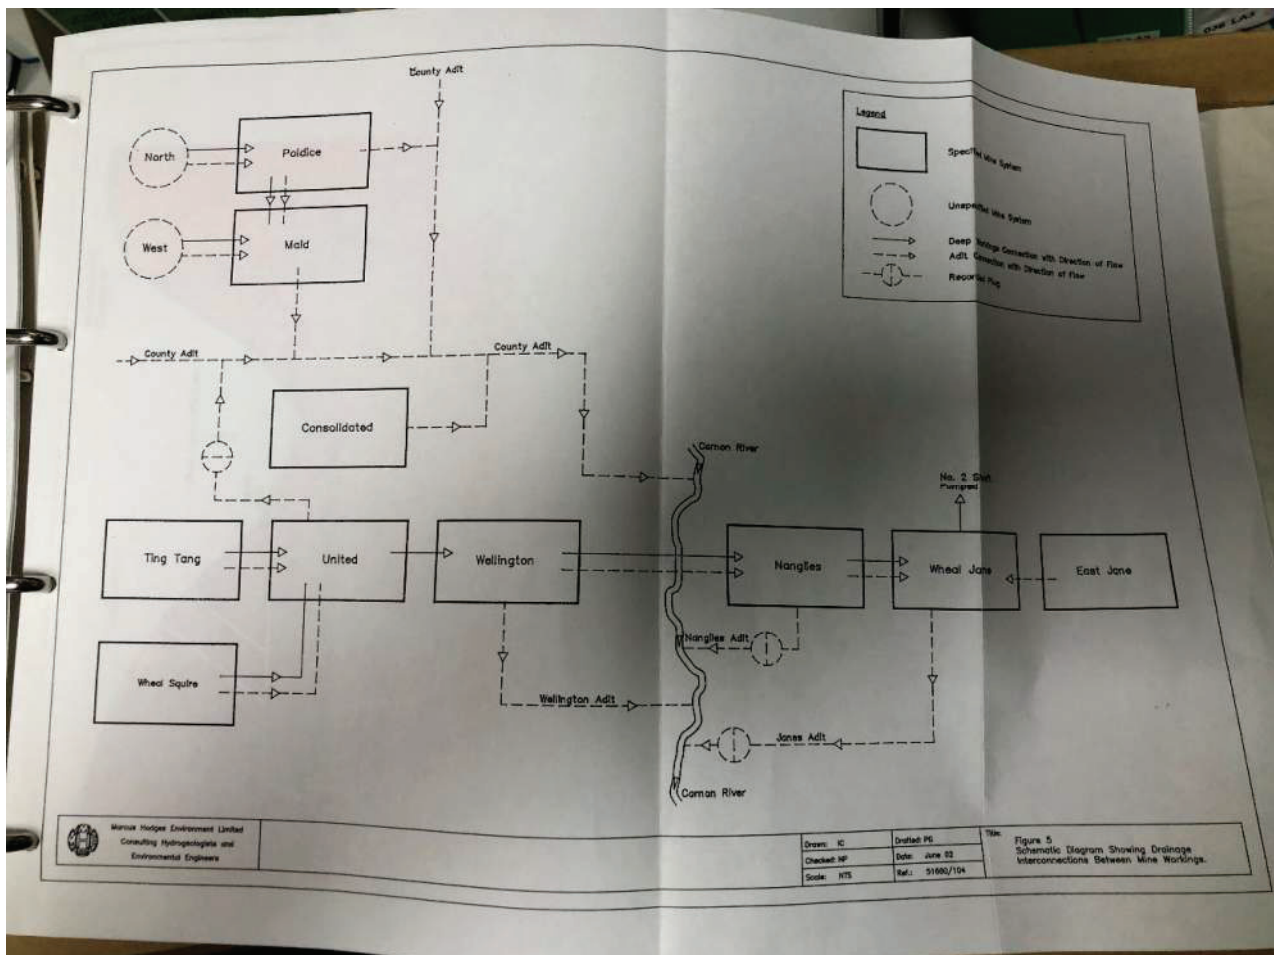
Figure 5. Process & Instrumentation Diagram of Drainage Connections between Mineworkings [8].

Groundwater flow in the locale of the site is reportedly dominated by the County, Wellington, and Wheal Jane adits [2]. A conduit/tunnel system is believed to be hydraulically connected to the site providing a preferential route for groundwater flow in a north easterly direction with discharge of groundwater and mine water into the River Carnon just below Twelveheads Village (Figure 5) [2].

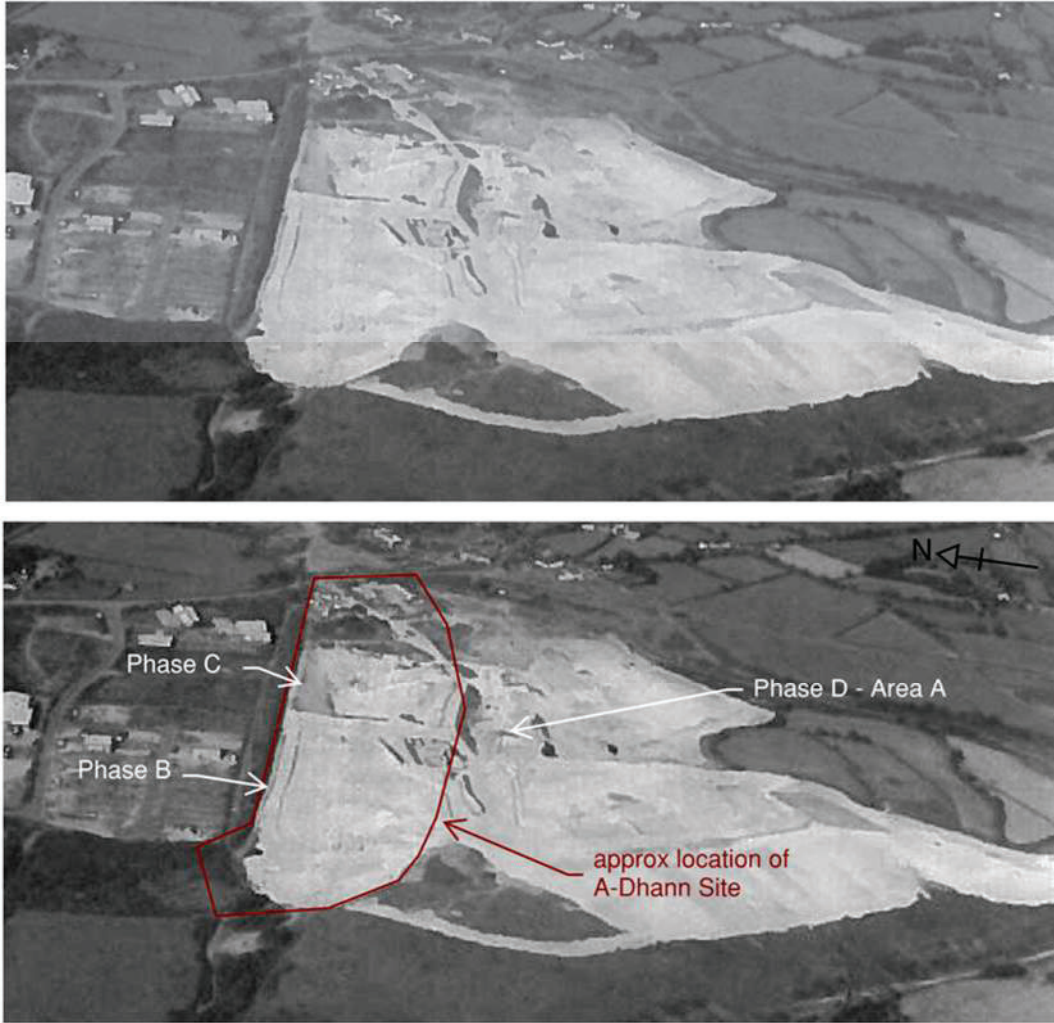
Figure 7. Oblique Aerial Image (1995) – Original (top image) and Annotated (bottom image).

1995 (oblique aerial photo)	<p>Side slopes of Phase C (Phase 3) and Phase 4A (Phase D – Area A) visible on aerial image. Cells appear not to have been filled at this point. Phase 1 and Phase B (Phase 2) appear to have already been filled. (see Figure 7).</p>	<p>Further development at the Industrial Park to the north of the site</p>
2000	<p>The entire site area is now shown to have been subject to infilling, with the exception of a small area in the east, separated from the waste by a drain. There has been slight amendment to the access tracks crossing the site area to accommodate the filling works. The recycling facility remains in the eastern site area. The small shed remains on the western boundary of the site.</p>	<p>The United Downs industrial park has been subject to further expansion to the north. To the south the landfill extends to Arsenic Wood (the separator drain remains) and the sewage works.</p>

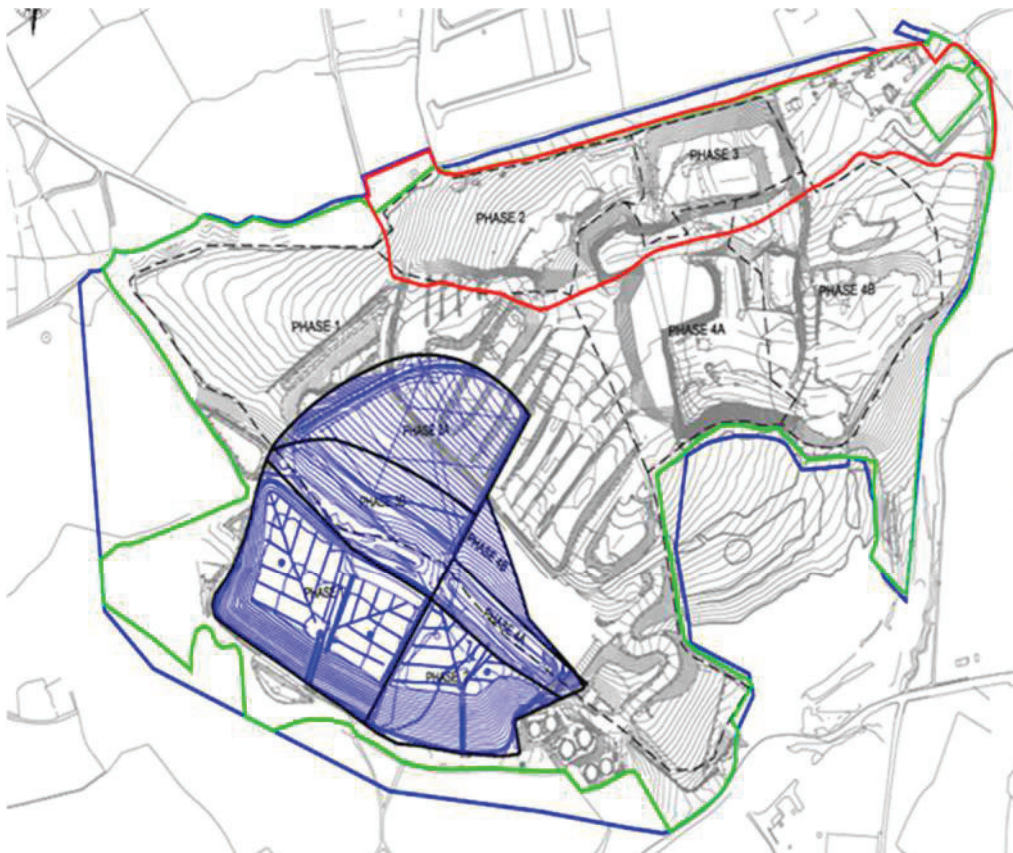
Figure 9. Landfill Cell Base Plan (Drawing Utm-LCD-0316-01-A3).

A review of the landfill base plan (Figure 9), show the original labelling of the older landfill cells, with the A-Dhann site comprising Phase 2, Phase 3, the northern area of Phases 4a and 4b and a small area of Phase 1. The eastern site area remains outside the landfill cell layout.

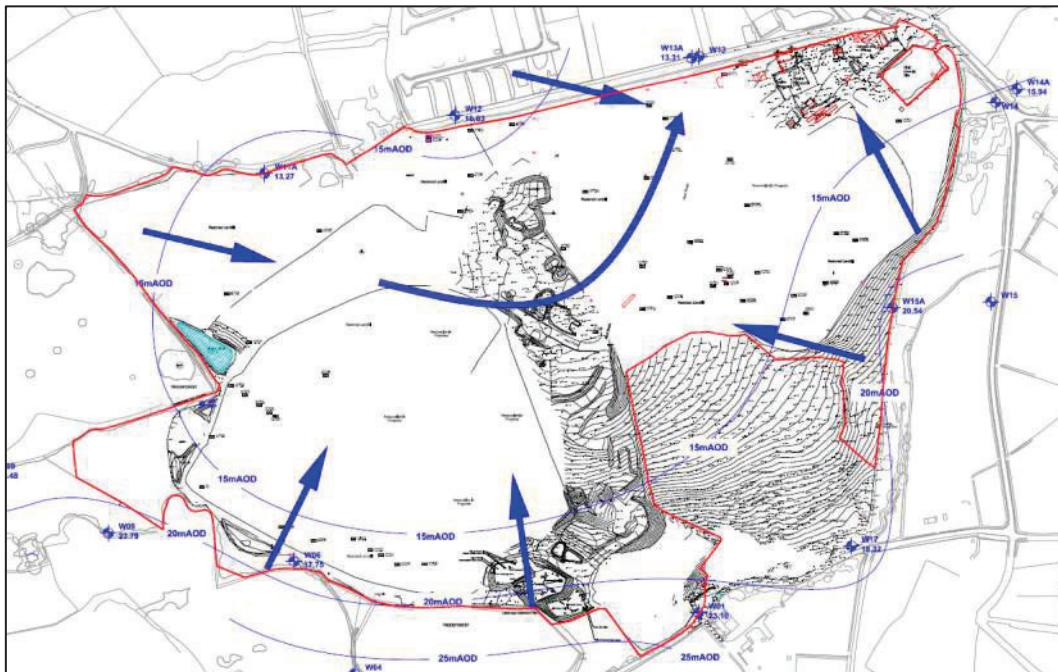
Figure 11. Groundwater Contours and Flow Directions per 2013 HRA [5].

Groundwater monitoring undertaken at the site in 2012, from the locations shown in the extract below, was used to create inferred groundwater flow contours as part of the 2013 HRA. The contour plot created for groundwater beneath the landfill as part of the 2013 HRA is shown below as Figure 11; which indicates that the A-Dhann site is likely to receive groundwater flow from the north east, and also the south and south eastern landfill area.

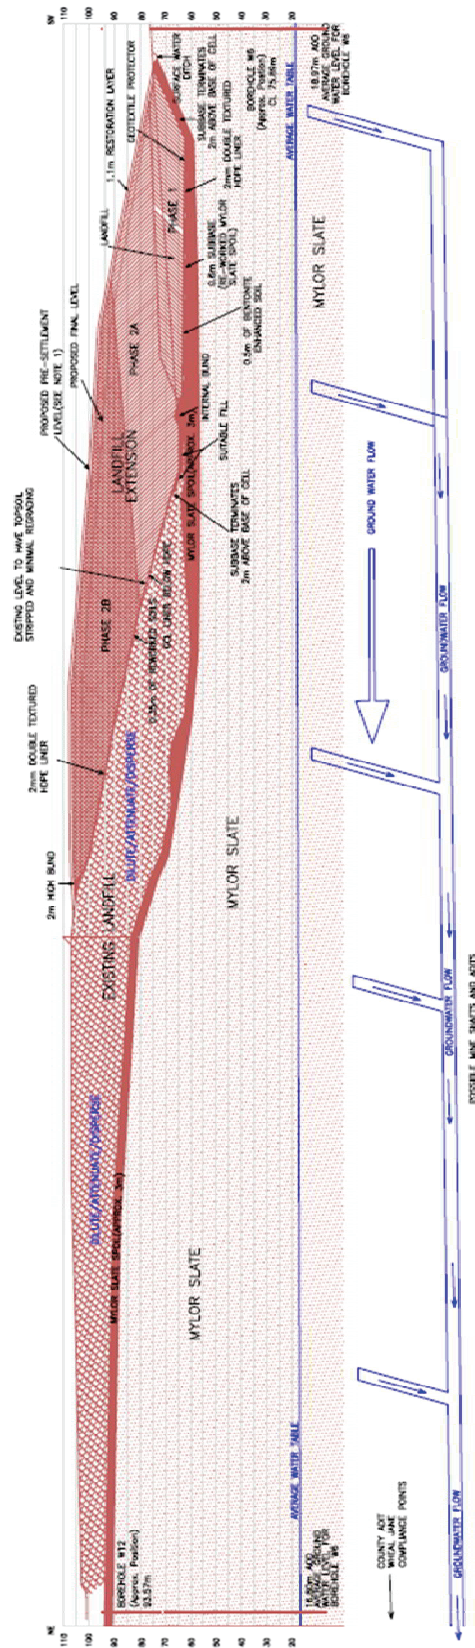
Figure 12. Hydrogeological Conceptual Schematic (per 2007 HRA) [4].

SCHEMATIC CROSS SECTION B-B TO SHOW HYDROGEOLOGY  
SCALE @ A1 1:1000
