# **Bat Survey Report for The Coachhouse, Parkhill Estate, Dyce**

**Friday 21<sup>st</sup> August 2020**

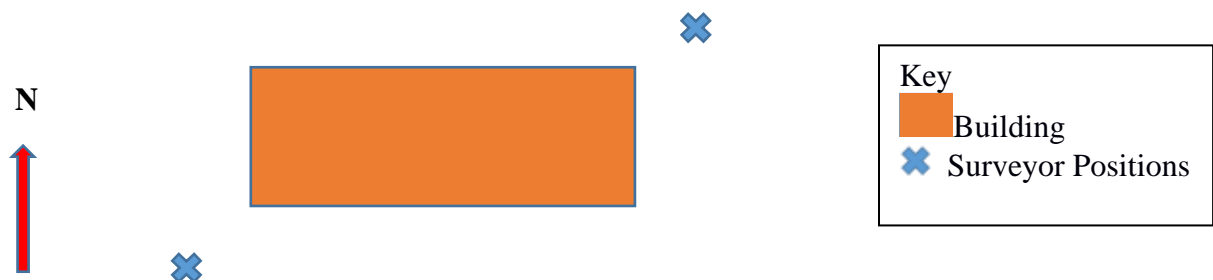
The survey covered all elevations of the property externally and internally. Two surveyors were positioned at opposite sides of the building, over 1 dusk and 1 dawn survey, which took place 2 weeks apart to cover all elevations as shown below.

**Diagram showing simplified property plan and surveyor positions** (not to scale)

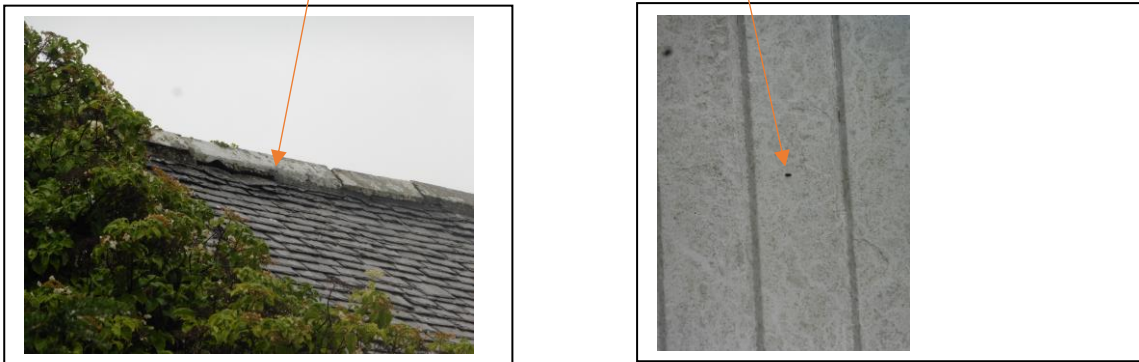
Descriptions of potential roost features	Evidence of bats found	Areas not surveyed/why
Gaps under roof ridge and around chimney	None	n/a
Gaps between walls and roof	Small numbers pipistrelle sp. droppings on east window and on 2 north doors	n/a
Gaps between slate roof and sarking	None	n/a

Table 5.2 above, shows that the potential roost features include gaps under roof ridge and gaps between walls and roof. Pipistrelle species bat droppings were visible externally on the east window, and on 2 of the north elevation doors. Droppings were in single figures of less than 5 where they were recorded.

Examples of potential roost locations and evidence of bats (droppings) on doors

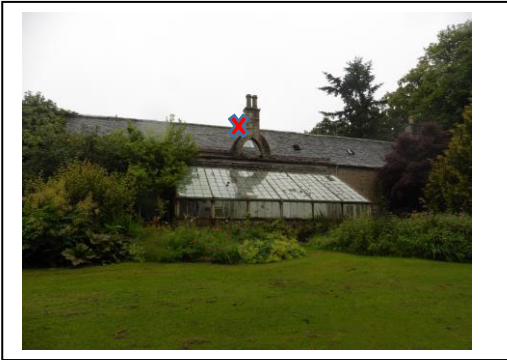
The first bat was recorded at 21.43, 20 minutes after sunset, it was a Soprano pipistrelle which emerged from Roost 1, underneath the roof ridge on the south elevation. A 2<sup>nd</sup> Soprano pipistrelle was recorded emerging from Roost 1 at 21.48. At 21.51 2 Soprano pipistrelles were recorded foraging around the north-east elevation.

Roost **1** location on south elevation

Medium term impact	<ul style="list-style-type: none"> <li>• Retain bat box in tree or structure.</li> <li>• Install a bat roost in the roof on the south elevation eg. bat slate, raised section roof ridge.</li> </ul>
Long-term impact	<ul style="list-style-type: none"> <li>• If the above is followed there will not be a long-lasting negative impact on the bat population and no further mitigation measures will be required.</li> </ul>

5. Bat box to be retained as alternative roost and replacement roost provided on south elevation eg. bat slate or raised section of roof ridge.
6. There is always the possibility that bats can be found unexpectedly once building work commences. If this is the case a bat ecologist and Scottish Natural Heritage should be contacted immediately.
