BAT AND BIRD ASSESSMENT

Boulders
Higher Penquite
St Breward

Client	Susannah Levers
Project reference	318/20
Surveyor and licence numbers	Samantha Smith BSc MRSB Registered Consultant RC101 2018-35700-CLS-CLS Level 3 2019-42249-CLS-CLS-1 Level 4 Barn owl: CL29/00030
Date of survey	28 April 2020
Author	Samantha Smith MRSB
Issue date	30 April 2020

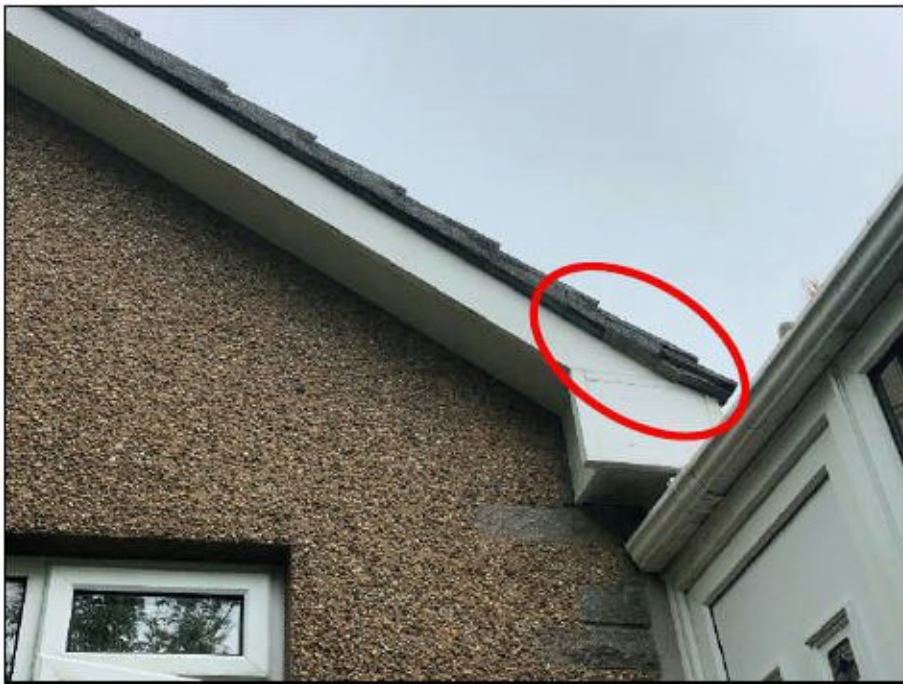
The only areas identified as having potential access for bats were at the gable on the west elevation where there are some gaps at the end of the roof tiles (Figure 4) and possibly around lead flashing of the chimney and skylights.

Figure 4 Gaps in roof tiles

The property known as Boulders is considered to have low potential to support bats due to the limited potential access points and sub optimal roosting features. There are gaps under the roof tiles which may provide roosting areas between the tiles and the underfelt.

Further surveys are therefore recommended to determine whether or not bats are present within this property. This should be in the form of a single emergence/re-entry survey during the active season for bats (mid-May to August). This single survey carried out at a suitable time and in suitable weather conditions will be sufficient to confirm a negative result (Collins, 2016).

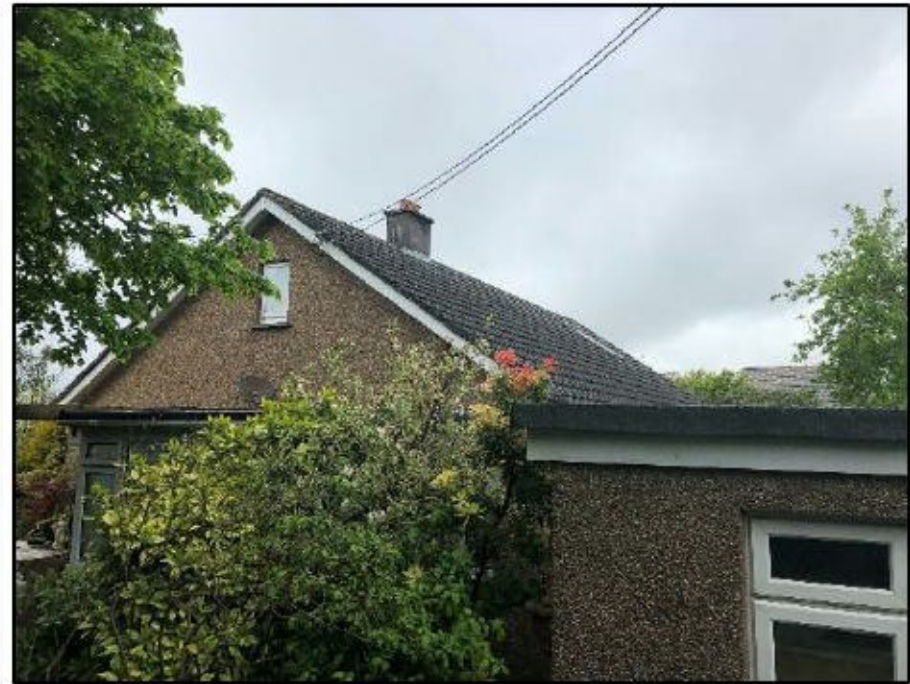
Boulders is a dormer bungalow constructed from brick and block work which is for the majority of the building is externally rendered. It is assumed that there are cavity walls present but unknown if these are insulated. The roof consists of concrete tiles. There is a conservatory area on the west elevation and a flat roof garage on the east. There are UPVC fascia's and soffits in place and these appear to be well sealed.

Figure 5 Rear with flat roof garage
