# 44-46 Coldharbour Road, Bristol

# **Arboricultural Report containing:**

Prepared by: Chris Wright M.Arbor.A, Tech. Cert. (Arbor. A.) Arboricultural Consultant November 2019

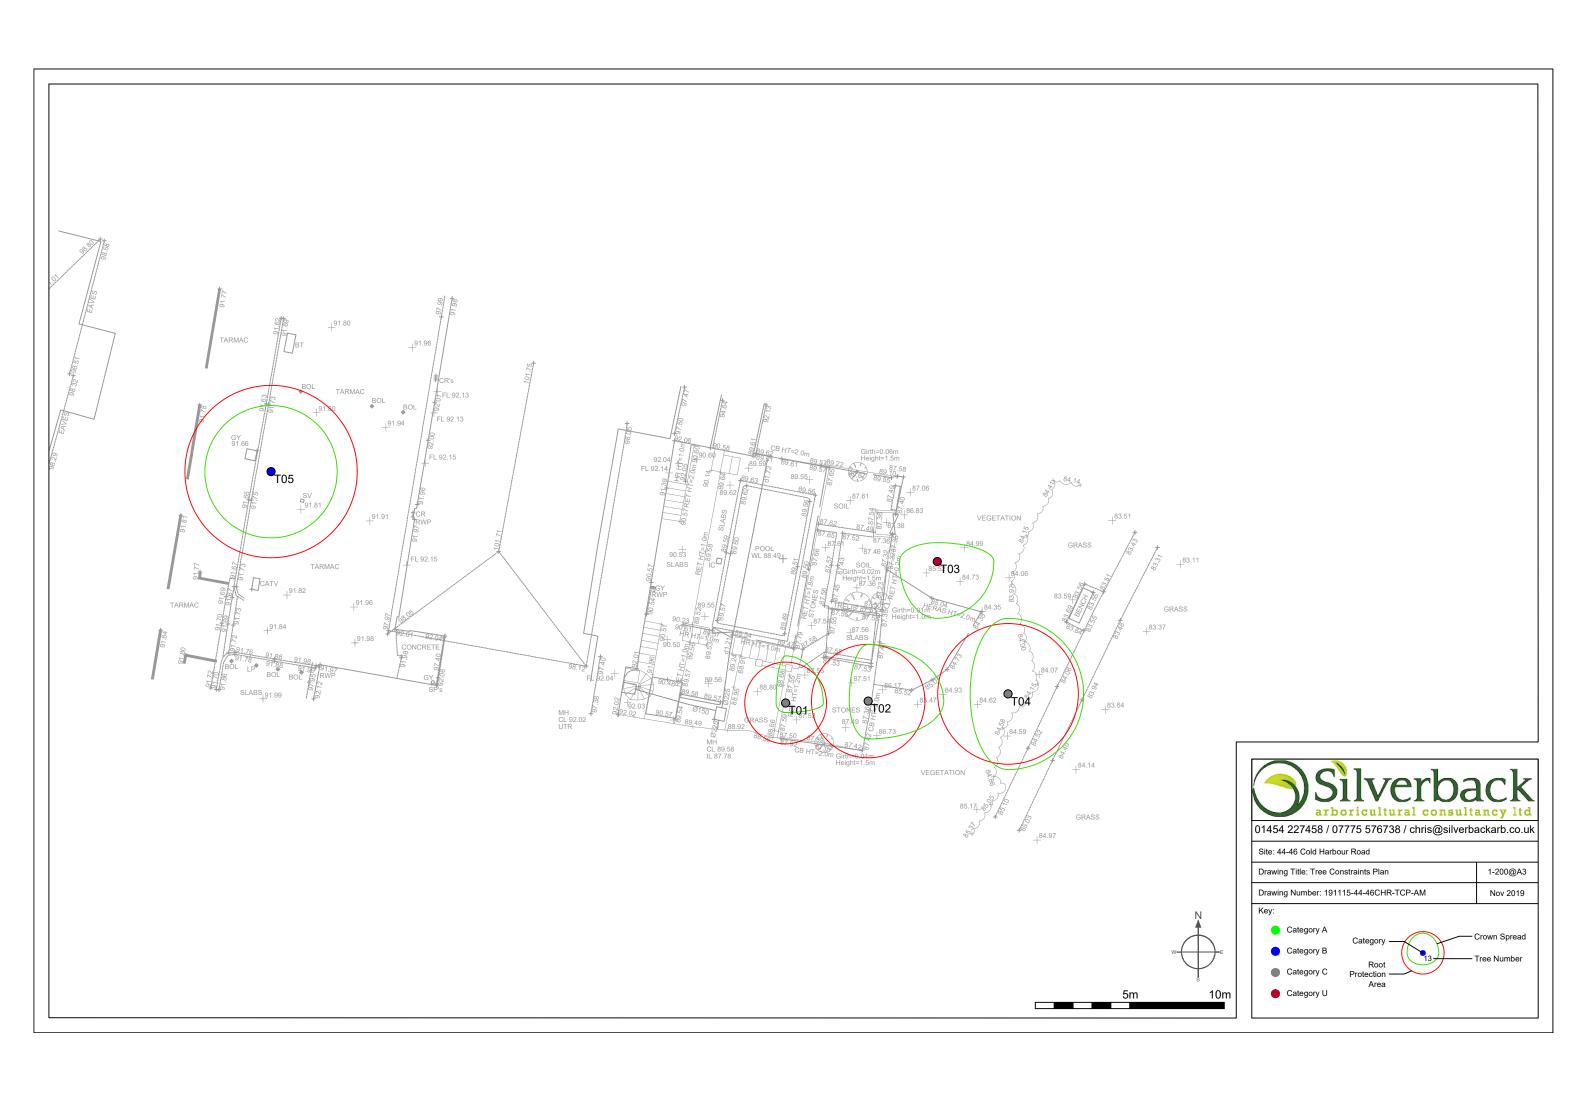
Tree constraints plan (TCP)

These constraints are also considered in the main body of the report below and recommended remedial works and mitigating measures.
- 6.3 The Tree Constraints Plan (TCP), (appendix 2), shows the Root Protection Areas (RPAs) for the individual trees identified in the tree schedule tables. This represents the minimum area in m<sup>2</sup> which ideally, should be left undisturbed around each tree were it to be retained. The TCP also shows a representation of the crown spread of each tree measured in four cardinal directions. The RPA has been calculated in accordance with Section 4.6 of BS5837:2012 Trees in relation to design, demolition and construction Recommendations.

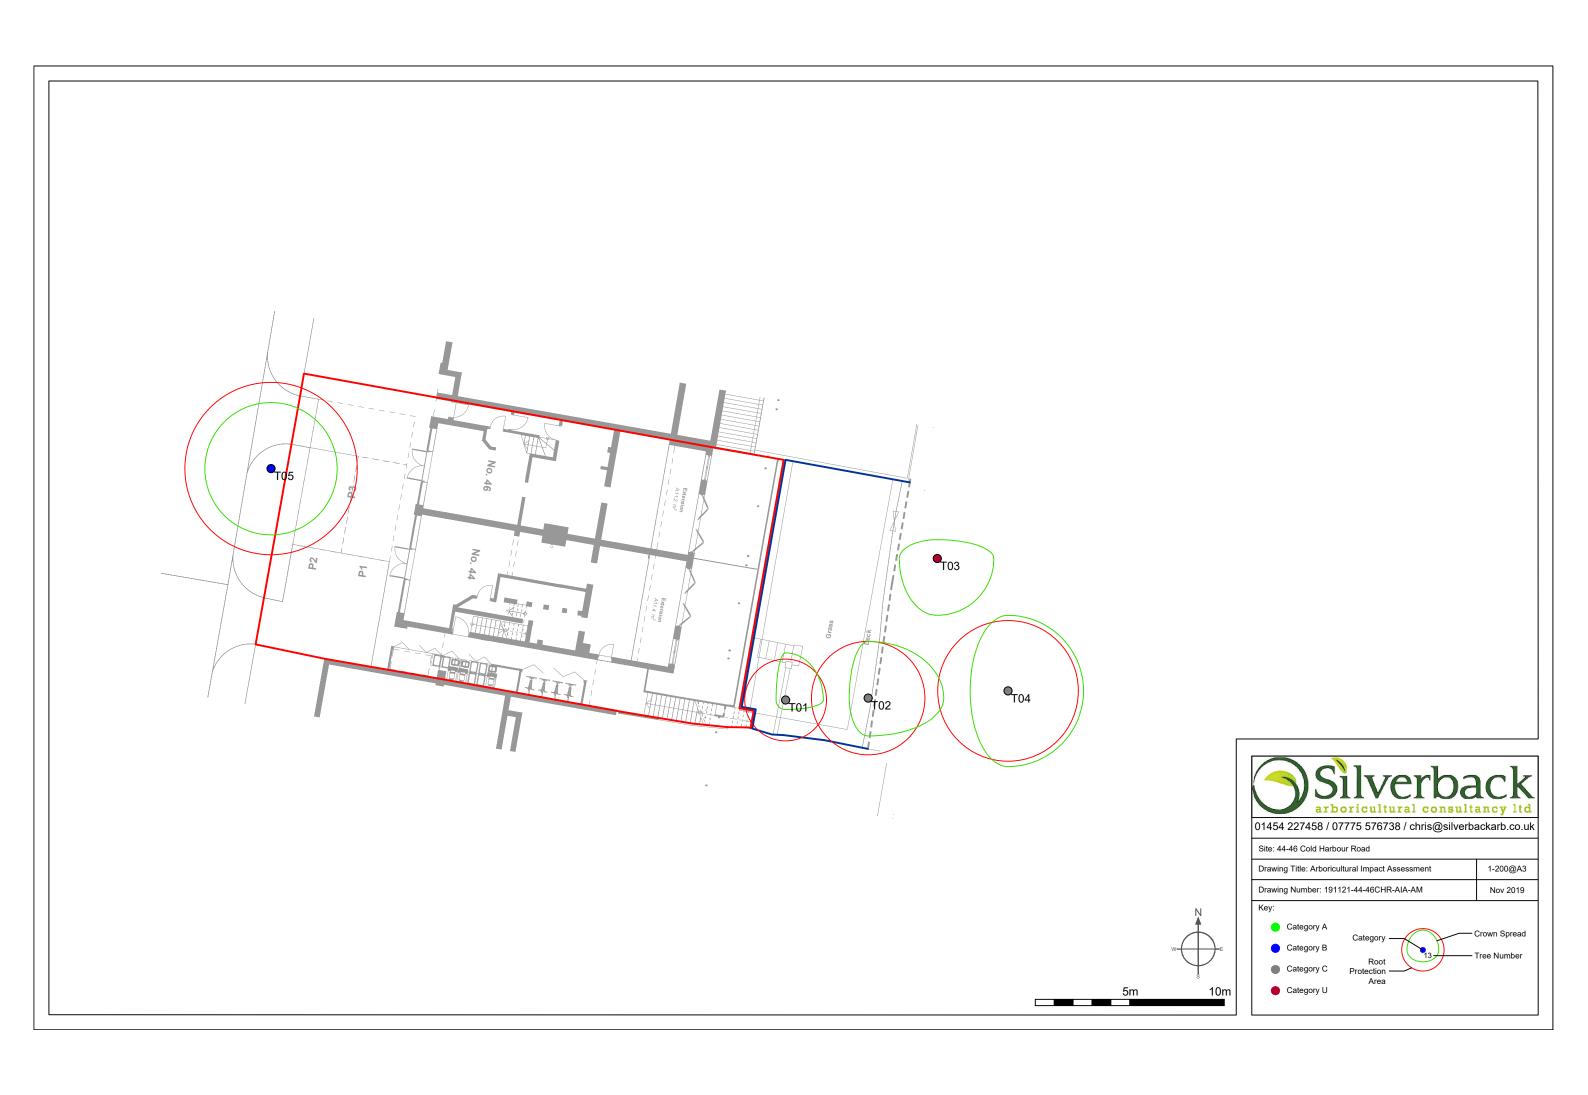
Arboricultural impact assessment plan (AIA)

- 7.1 The position of the new self-contained dwelling is outside the calculated root protection area of existing trees. Any excavation or soil compaction in this area could potentially lead to root severance or damage. This could subsequently lead to a reduction in the trees ability to take up water and nutrients, which may lead to a deterioration in the trees health.

- The proposed development area is separated from the lower area, containing the trees, by a low ornamental concrete wall. It is considered that no additional protective fencing is required as the different ground levels and existing wall will prevent any unauthorised access within the root protection area of the trees during the proposed works.
