**STRUCTURAL REPORT ON LAND AT
AIR BALLOON ROAD,
BRISTOL BS5 8LD**

In Respect of Coal Mining Investigation

For Moosehead Ltd

Ref 7451

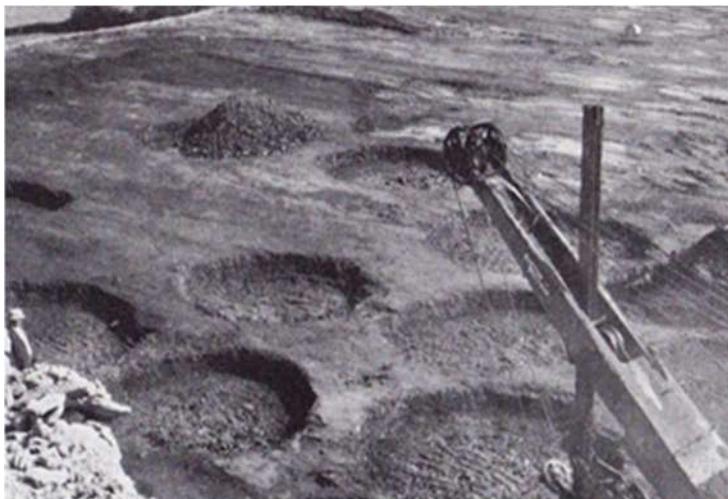
Left: Bell pits uncovered by opencast mining in Derbyshire. These circles are the bottom of the pits

The area of extracted coal could be 12-18ft (3.7-5.5m) in diameter, and with seams 3-4ft (0.9 -1.2m) thick void migration, even after a long time, is and has been seen to be, entirely possible. Once exhausted, or unsafe, a new shaft would be sunk close to the earlier one, about 20-30ft (6-9m) distant as the photograph above illustrates.

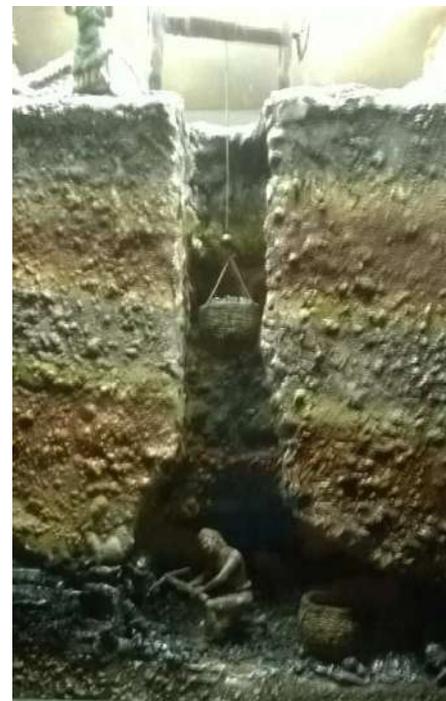
Right: A model of a bell pit, representing a sinking about 20ft (6m) deep. (Brora Heritage Museum)

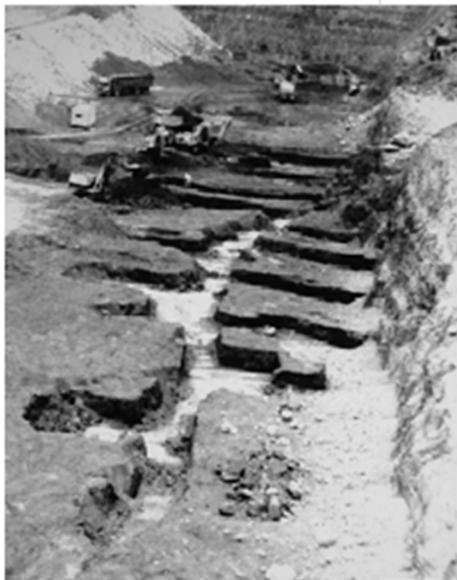
Evidence of early heading and stall mining uncovered in South Wales in 2002 at Morrision, near Swansea. Photo courtesy of Richard Jones©

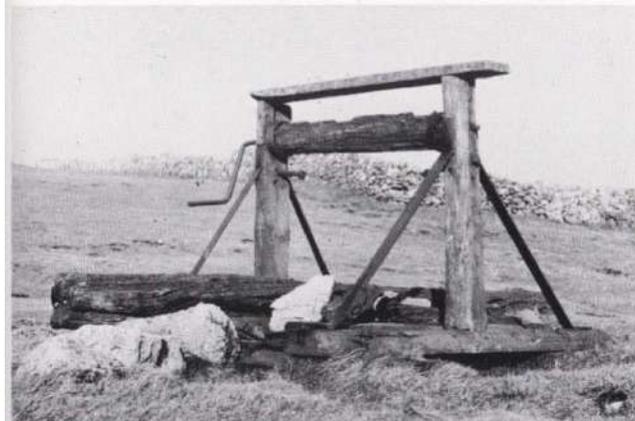
This windlass over a shaft is from a Derbyshire lead mine, but those serving coal pits in Bristol and beyond were almost exactly the same.

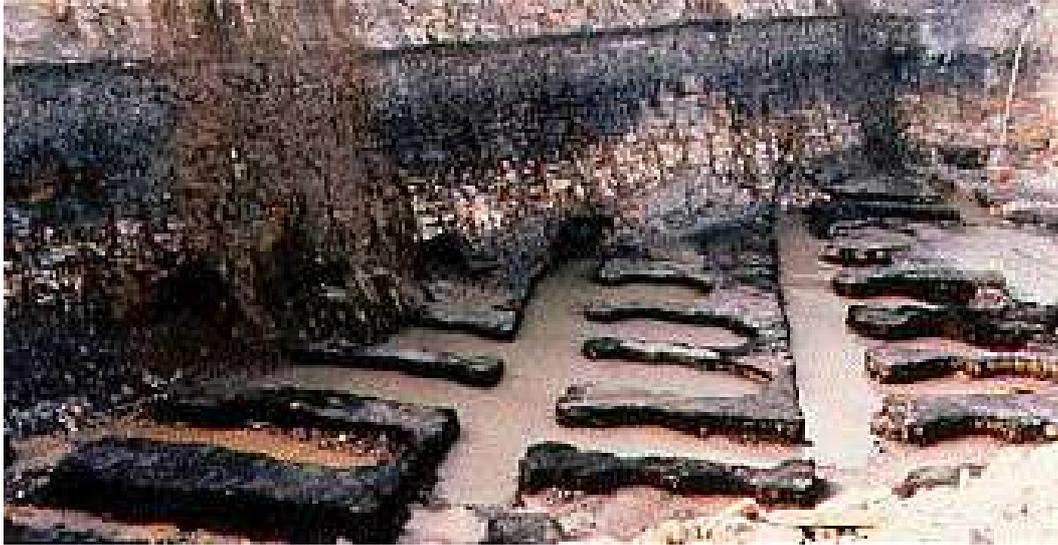
Workings uncovered at Heage in Derbyshire in the 20th century by open cast workings. These were only 20ft (6m) below the surface and show the overburden. Photo courtesy of Robert Bradley.

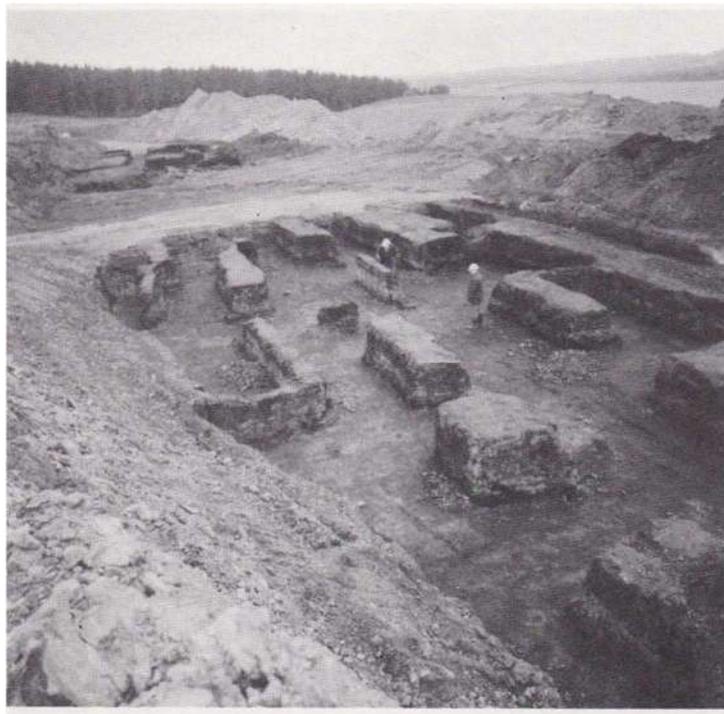
Second phase working in Derbyshire uncovered by opencast working.

Second phase working involved removing or robbing the coal in the supporting pillars. This happened progressively on the retreat (meaning the extraction began at the furthest point first and then the coal worked back toward the starting point) and was done to increase the productivity of the pit by winning more coal. This meant working at the furthest point first and returning toward the shaft over months or years at the end of the life of the seam.

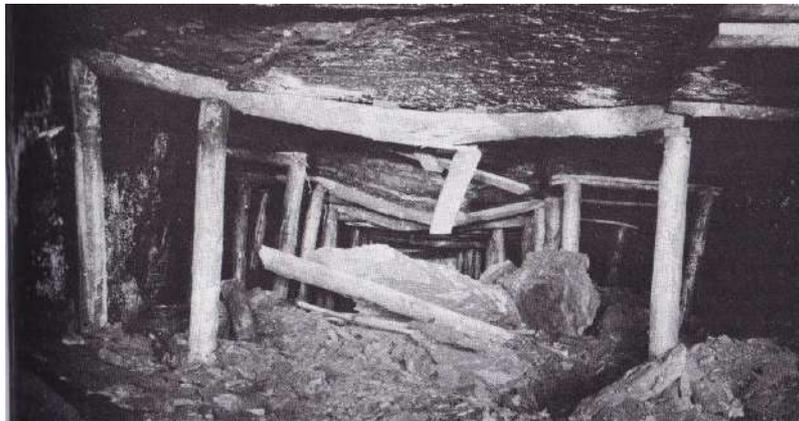
Typical settlement in a timber supported roadway

Failure of roof supports in abandoned underground roadways. This can be long after abandonment where props were of strong and water resistant timber. Oak props and bars, still in good condition after around 250 years of service were found in an underground roadway during excavations when the Bristol ring road was under construction in the 1980s near Barr's Court, south west of Cock Road, in the east of Bristol near Warmley and Longwell Green.

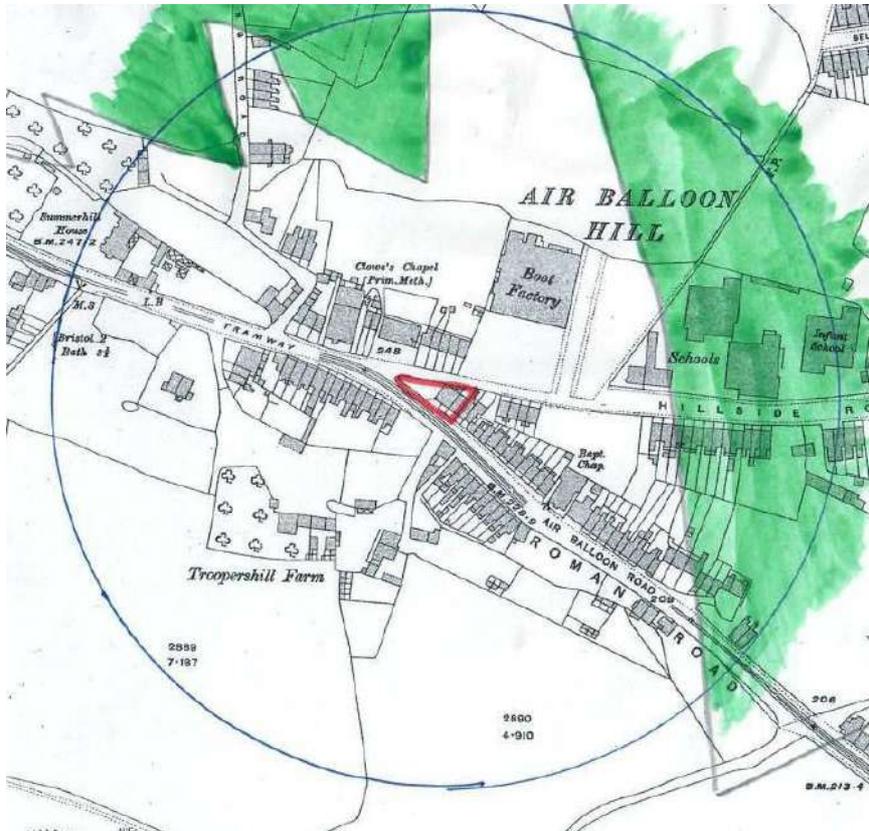
Workings in the Kingswood Great Vein post 1872 according to the Howard Humphreys study (Theme Map H7 (ii)) plotted on the 1918 composite OS county map

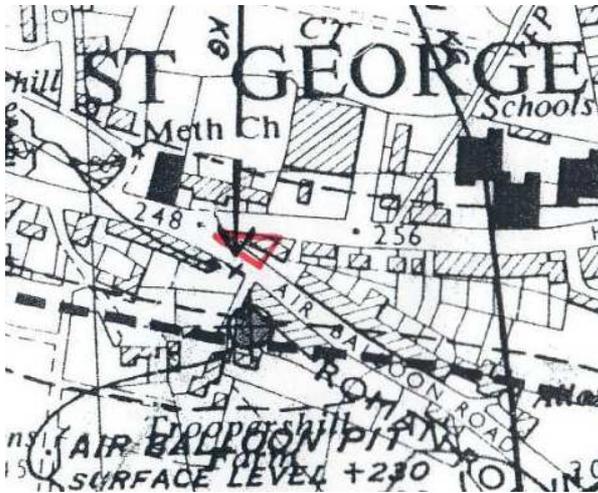
Surface geology at the site from Geological sheet ST67 SW

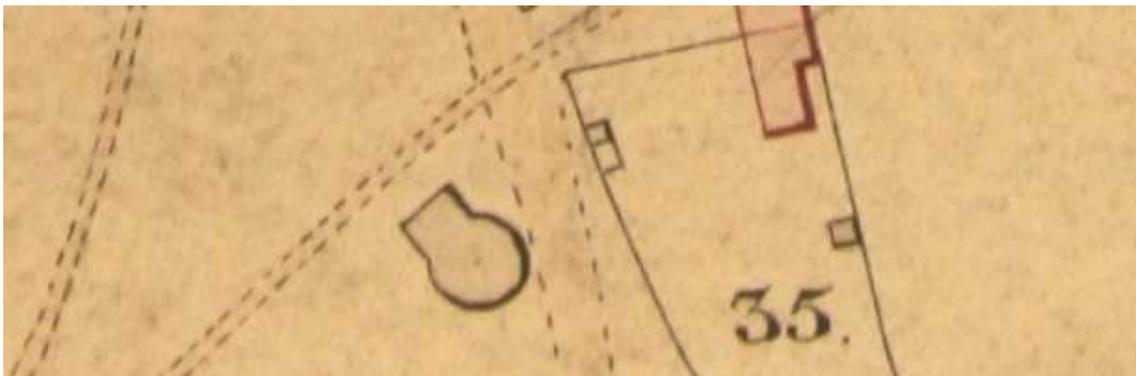
Later maps such as those produced under the tithe laws, often date from the 1820-1850 periods and can show features of mining heritage with considerable detail. This might mean ventilation fans, horse gins, and engine houses or spoil heaps among the most visible. A good example of these features when they are shown can be seen at Siston, where horse gins are shown along with their distinctive houses (see below) working pits, which were in the region of 100-120ft (30-37m) deep.

These worked the coal in close proximity to each other over a narrow band, ranging from formerly worked areas to deeper inaccessible coal.

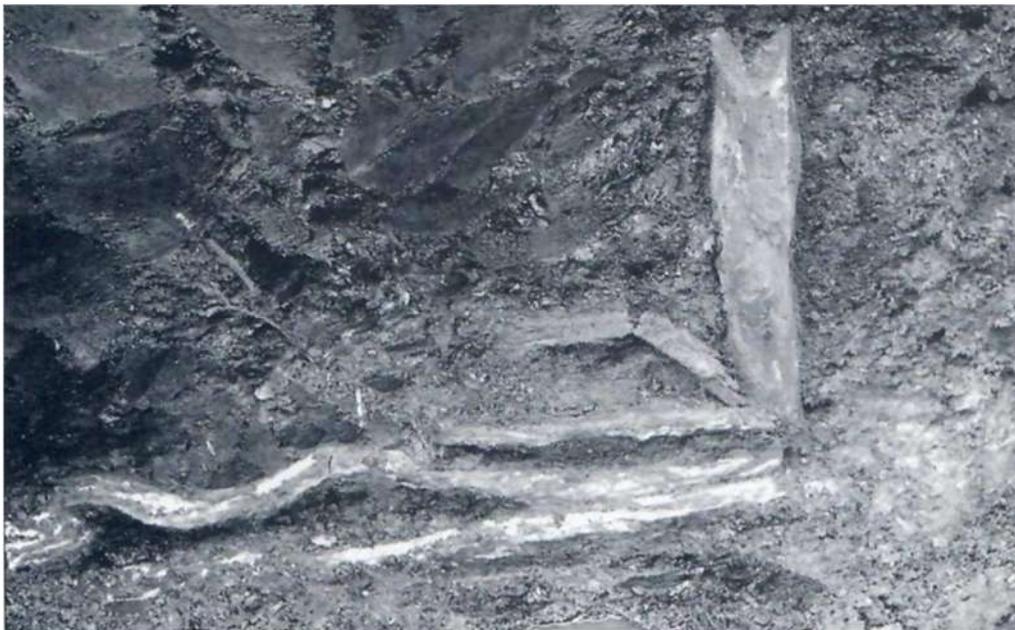
The photo below shows pit props from mining of this kind, from the 17th century, in Hanham. The workings were in Buff Vein and were excavated in the 1980s. Nothing of this nature has been found here.

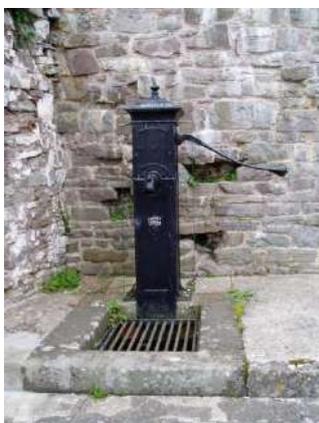
(b). Pump shafts & wells

There are two shafts one of which was sunk as a well and the other as a pump shaft to the west of the site and which were once associated with the farm, which occupied the ground on the south western side of Air Balloon Road prior to the development of the area. None appear on, or within 100m of the property.

These pump shafts and wells are recorded on the County Series Map and the Howard Humphreys Study. A pump shaft is a well in which a hand pump once was fitted, and not a pump engine shaft as is sometimes thought. As the County series map records, those which are shown here are a domestic water drawing shaft of the kind similar to that shown left.

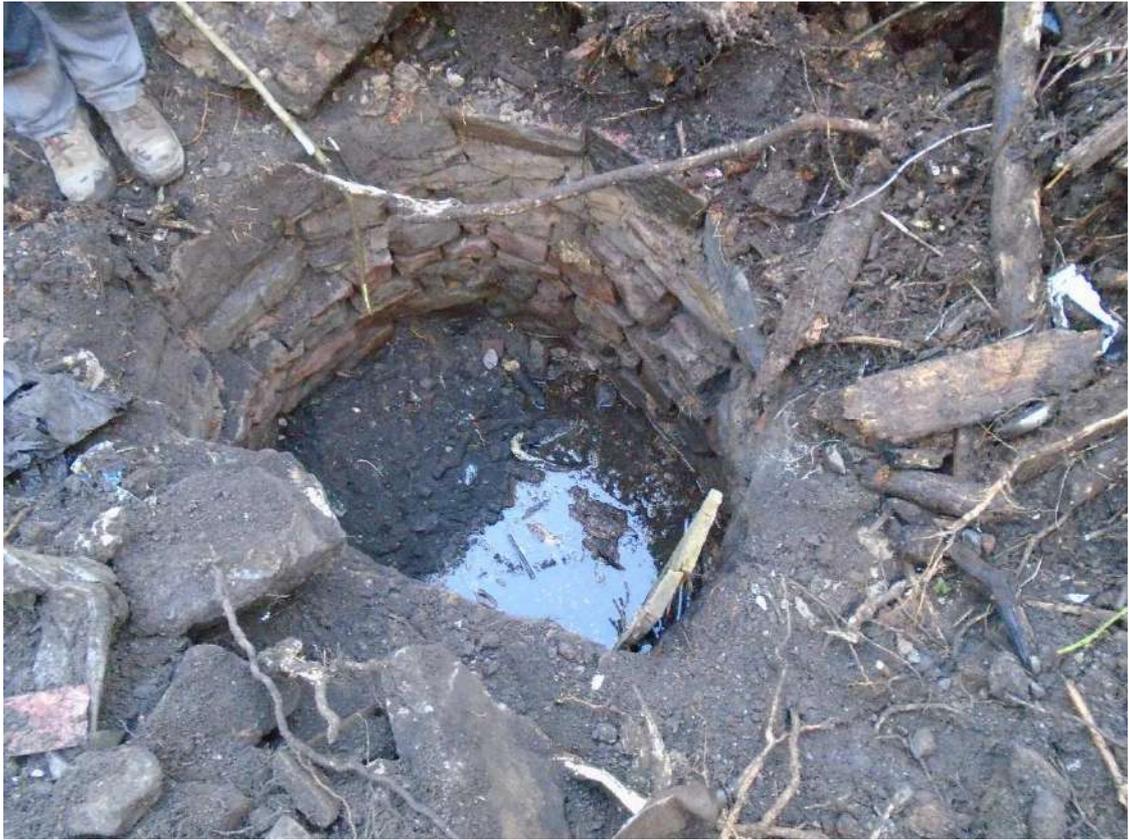
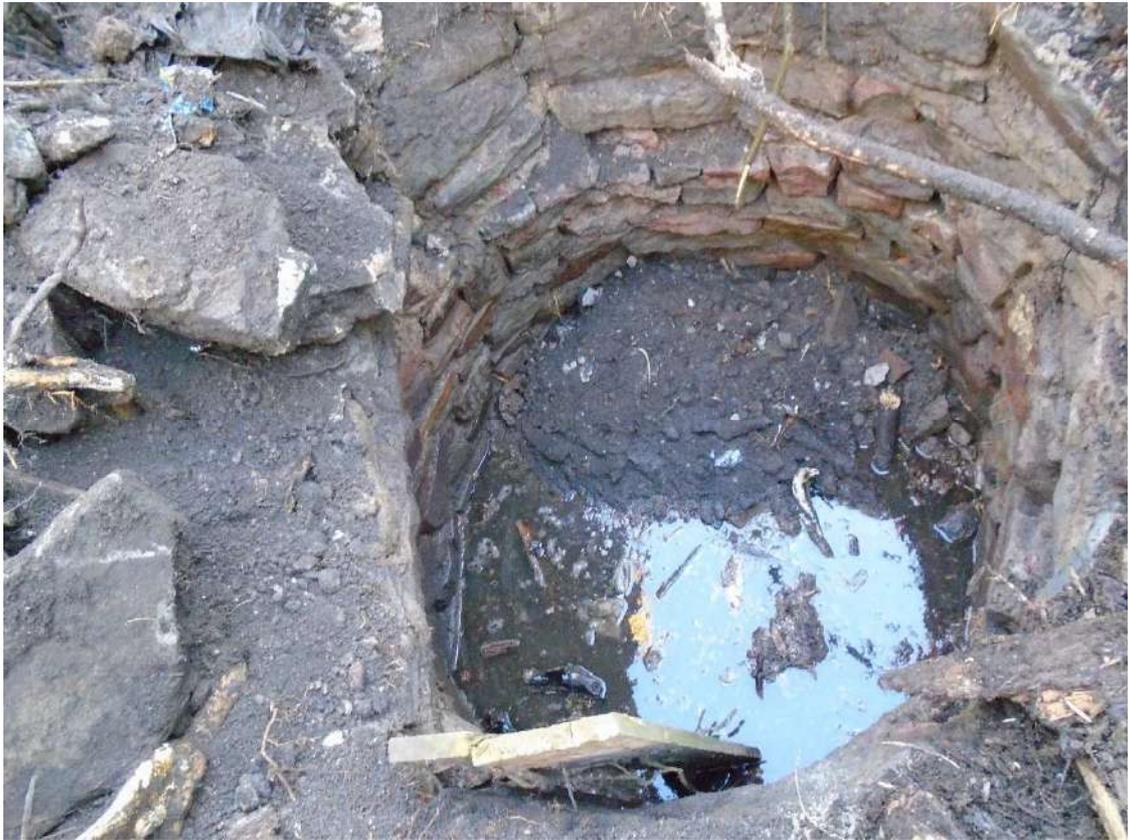
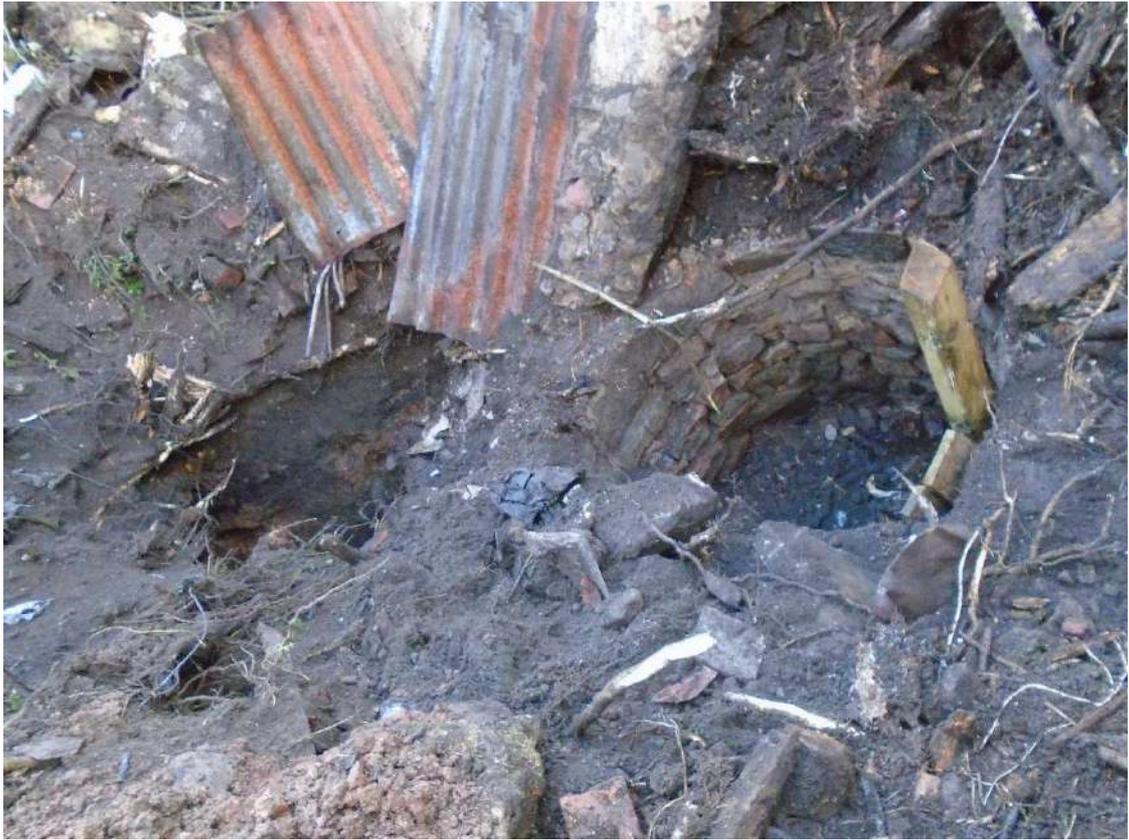
Title	Ref	Date
Photograph of a Well		2 Jan 2018

A possible shaft was found on the site in the course of site clearance; this was discussed with Bristol Coal Mining Archives, but it was thought to be a well.
