Heritage Statement

This Heritage Statement is in support of the Planning Application, portal reference PP-07836886 which seeks Full Planning Approval for the proposed window replacement at Thornton Hill, Church Road, Thornton in Craven, Skipton, North Yorkshire, BD23 3TR

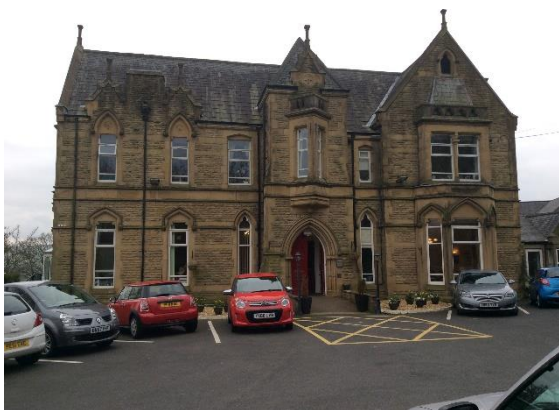
Thornton Hill Residential Home, Church Road is an undesignated building and was constructed sympathetically with the surrounding area. The property was built using coursed Limestone and dressed limestone for buildings, Sandstone quoins and window dressings and timber casements/sashes painted white. The roof is Westmorland stone slate.

Front elevation viewed from Church Road

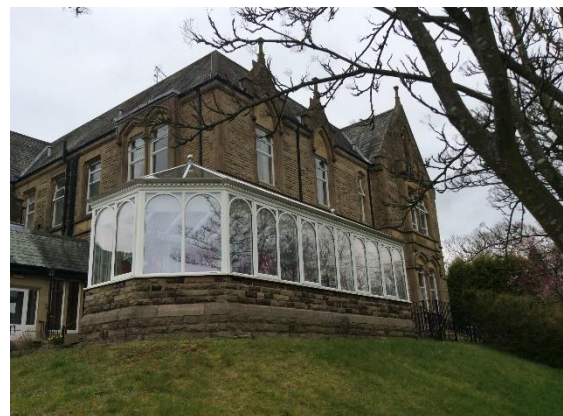
Side elevation viewed from the A56

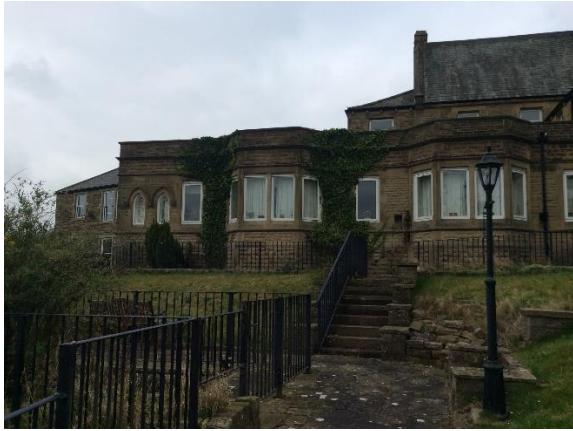
Side elevation from the A56

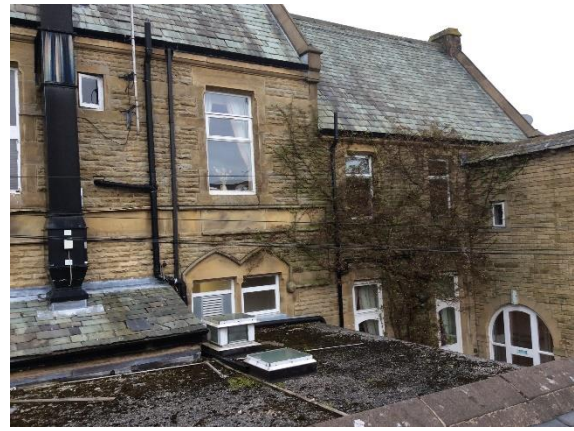
West facing elevation

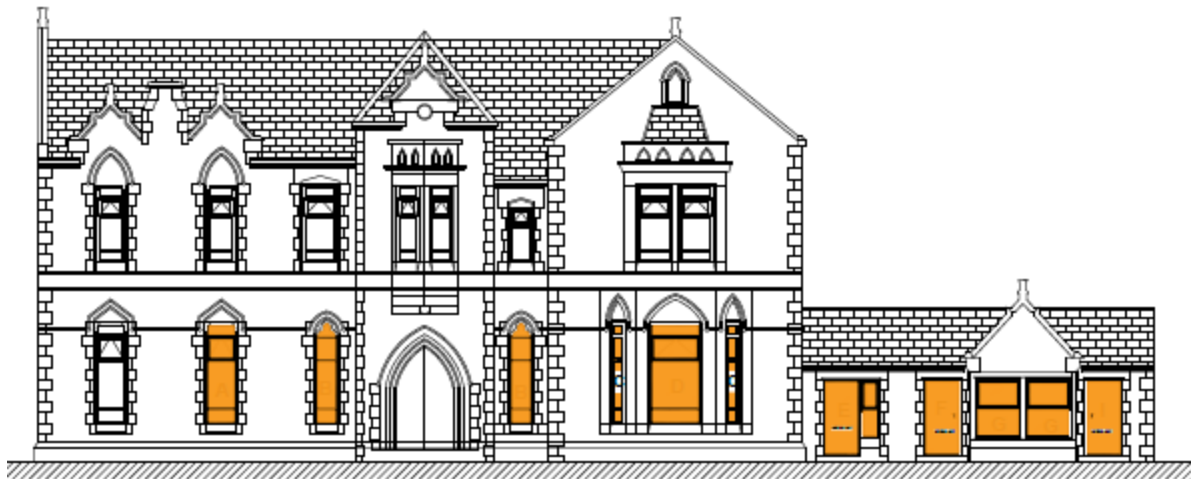
The existing windows need replacement due in part to lack of thermal performance, security and condition. The extent of the project is to replace the rotten windows and doors identified, with high performance timber windows and doors to include double glazing units. The existing window frames and doors will be replaced on a like-for-like basis, to replicate the existing and openings will remain dimensionally unchanged.

Example of front elevation identifying proposed replacements

The design of the proposed windows is the same as the existing frames, which does not affect the balance of the building. It is believed that the proposed works will enhance the appearance and will not detract from the existing scale of the property.

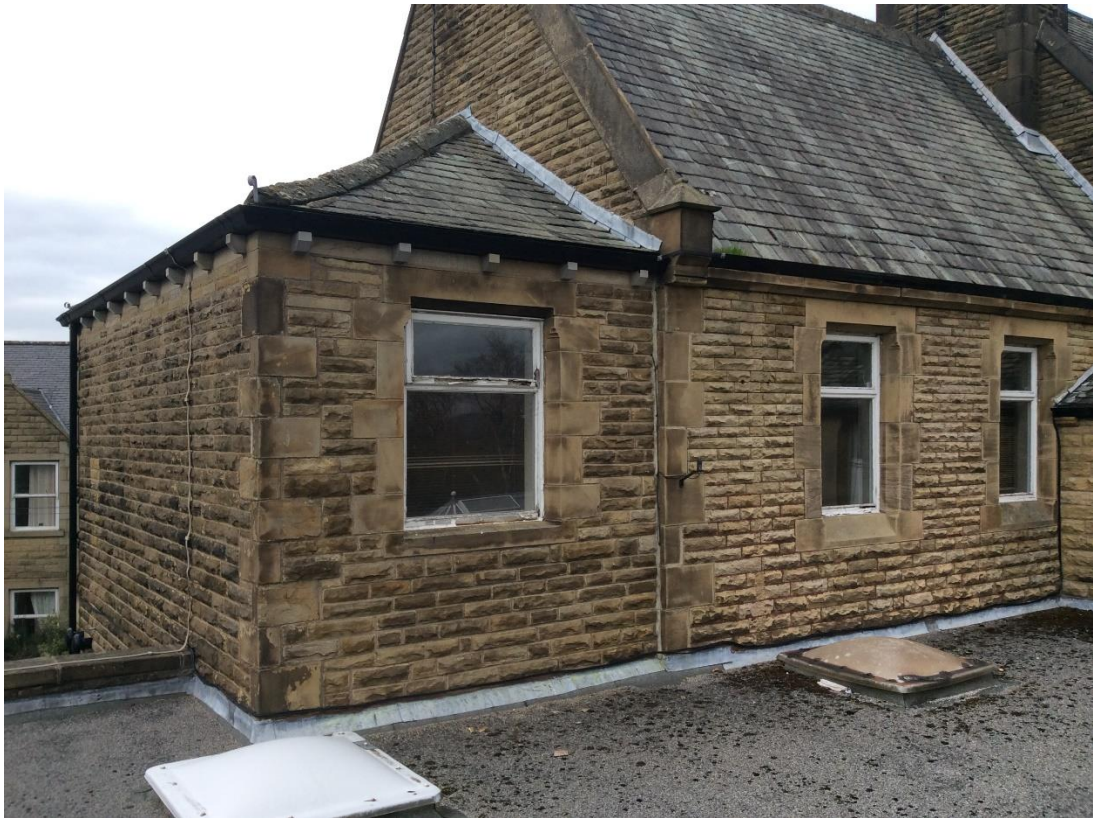
Example of rotten windows
