Bat Roost Survey

Lodge House, Nonsuch Park, London
Road, Ewell, KT17 2DL
(Grid Ref: TQ 2263 6341)

CLIENT:	Product 2
SURVEYS:	23 rd /24 th August 2020
ISSUE DATE:	10 th October 2020

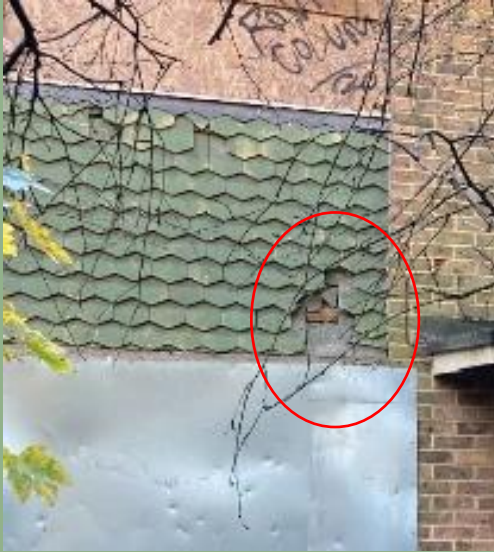
Building Reference (see Appendix 3)	Description	Suitability for roosting bats
B1	<p>Two storey residential building, brick built with apex tiled roof. All brick work and soffits are in good condition. The majority of the roof tiles are in good condition. Tiled wall area with missing / damaged tiles.</p>

A photograph showing a close-up of a tiled roof. The tiles are dark green and arranged in a pattern. A red circle highlights a specific area where a tile is missing or damaged, revealing the underlying structure. The background shows a brick wall and some bare tree branches.	Low
