Preliminary Bat Roost Assessment

324 Kingston Road, Ewell

January 2021

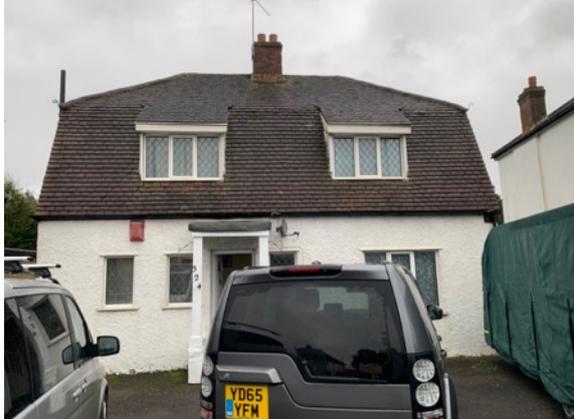
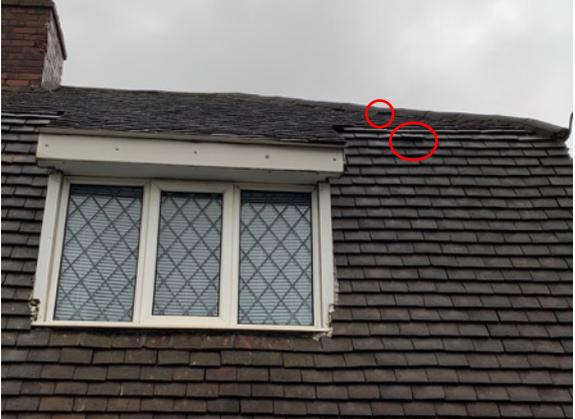
The residential property was a two-storey detached house with a tiled gambrel roof and was constructed in the 1920s/30s. It had uPVC double glazed windows and doors and uPVC soffits around the windows. The ground floor was covered with painted pebble dash render along with the entire gable ends.

<p>Photograph 1: Front elevation of 324 Kingston Road</p>

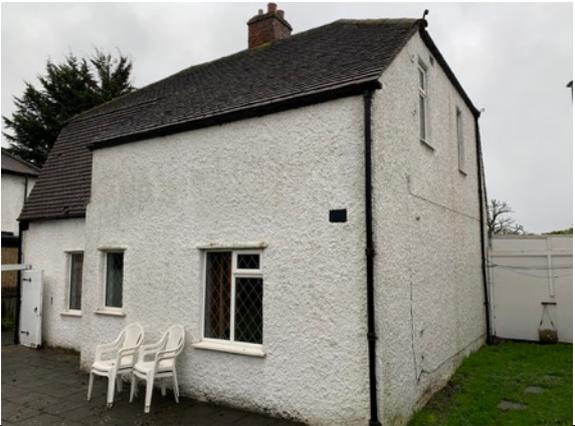
No features of value were identified on the side elevations of the property

<p>Photograph 5: South east side elevation.</p>	<p>Photograph 6: South west side elevation.</p>

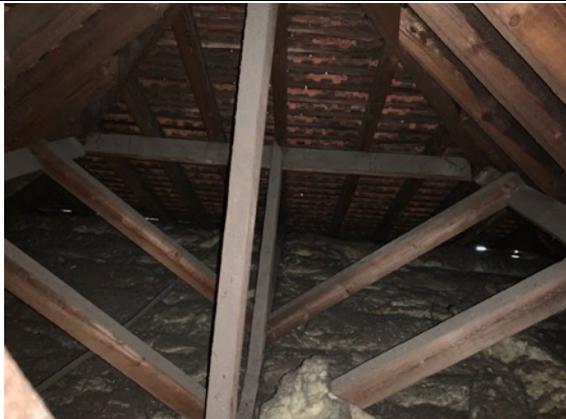
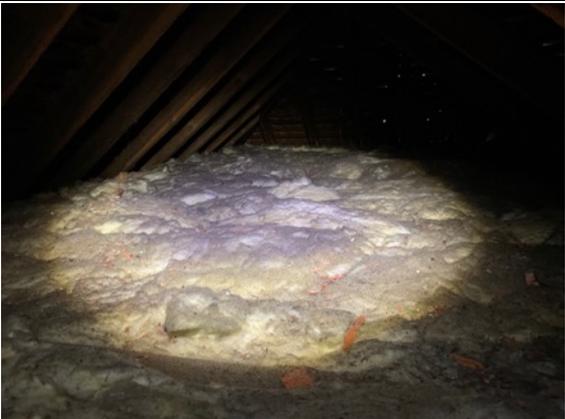
The property contained one large open void measuring approximately 8m long x 4.5m wide x 1.8m high which was accessible from a loft hatch above the stairs. None of the loft was boarded and therefore only a partial inspection was possible from the rafters around the loft hatch.

The roof void was formed from original rough-hewn timber trusses. There were two covered water tanks and fibreglass insulation throughout. The insulation was covered in a high level of dirt and debris. The roof tiles were not lined and natural light entered from beneath the tiles and at the eaves. Without lining and with the large gaps at the eaves, the roof void was very draughty and considered likely to be highly variable in temperature, being consistent with the ambient outside temperature at the time of the survey.

<p>Photograph 1: Inside main loft void</p>	<p>Photograph 2: Debris all over insulation.</p>

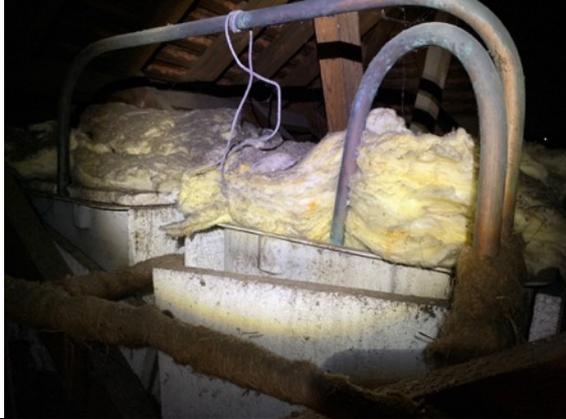
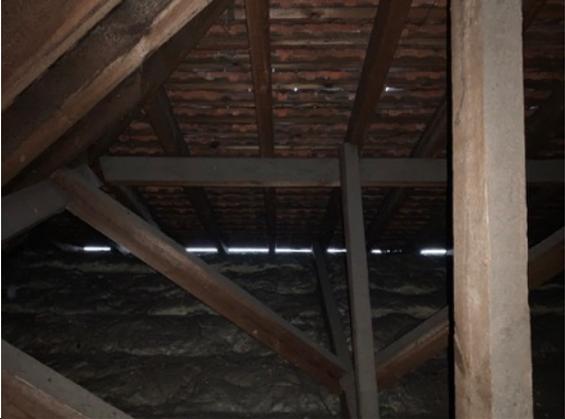
<p>Photograph 3: Covered water tanks.</p>	<p>Photograph 4: Underside of tiles and daylight visible at the eaves.</p>

The main house within the site had one large roof void which could be accessed by multiple gaps within the roof and at the eaves. However, the void was considered too draughty and liable to extreme temperature fluctuations to support a maternity colony of bats or a high conservation value roost. It was considered more likely to support single or low numbers of bats. The soffit box on the front elevation was also considered to offer potential to support single or low numbers of bats on a transitory basis.

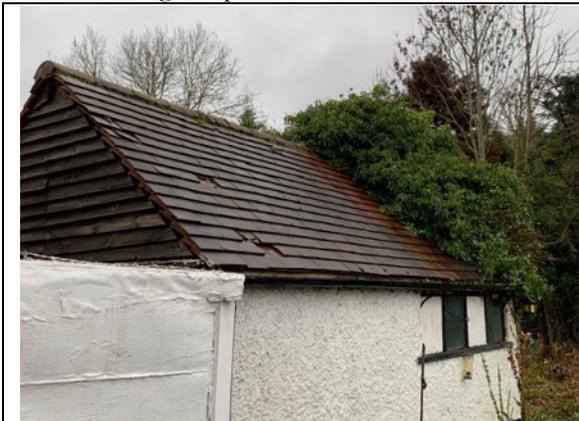
Photograph 1: Garage roof with obvious missing tiles.

The inside of the garage was light and lacked suitable crevices for roosting bats. The slipped tiles offered potential to support single or low numbers of crevice dwelling species.

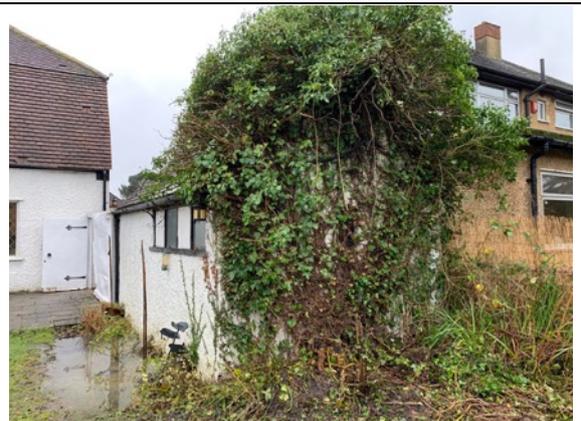
Photograph 2: Rear of the garage with ivy cover.

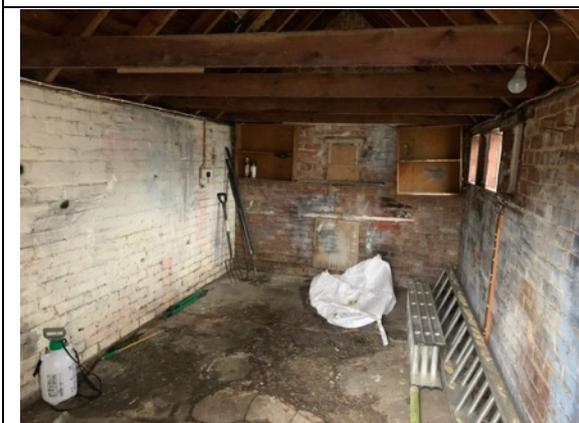
Photograph 3: Inside garage

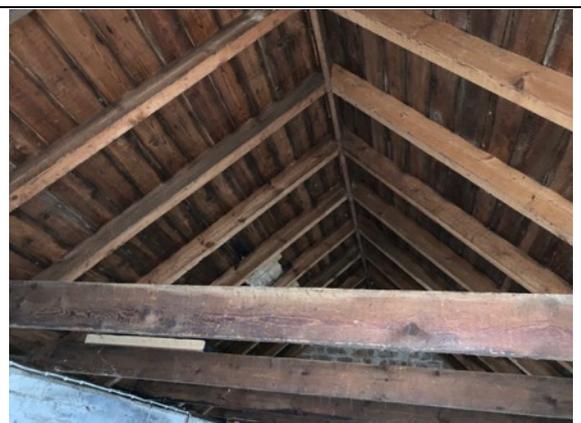
Photograph 4: Timber sarking boards.

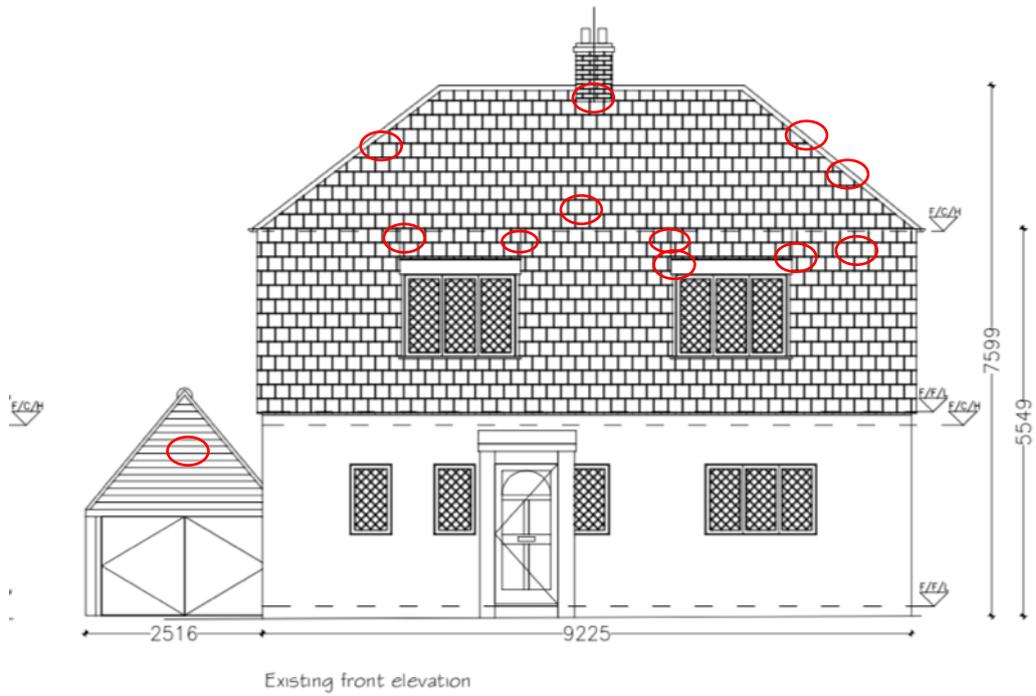
- A gap leading into the window soffit above the first-floor window;
- Lifted tiles along the roof junction;
- Missing mortar beneath ridge tiles; and
- Lifted/missing/slipped tiles on the roof.

Figure 1: Approximate location of potential features of value to roosting bats on front elevations.

Both the house and garage building were considered to offer low potential to support roosting bats. Therefore, a further survey of each building is required to determine if 324 Kingstone Road supports bat roosts.

The survey should comprise a single dusk emergence or re-entry survey between May and September. The visit should follow standard survey guidelines (Collins, 2016) and can only be undertaken during optimal weather conditions. It is considered that a total of two surveyors and at least one infra-red camera are required in order to cover all potential access points on both buildings.

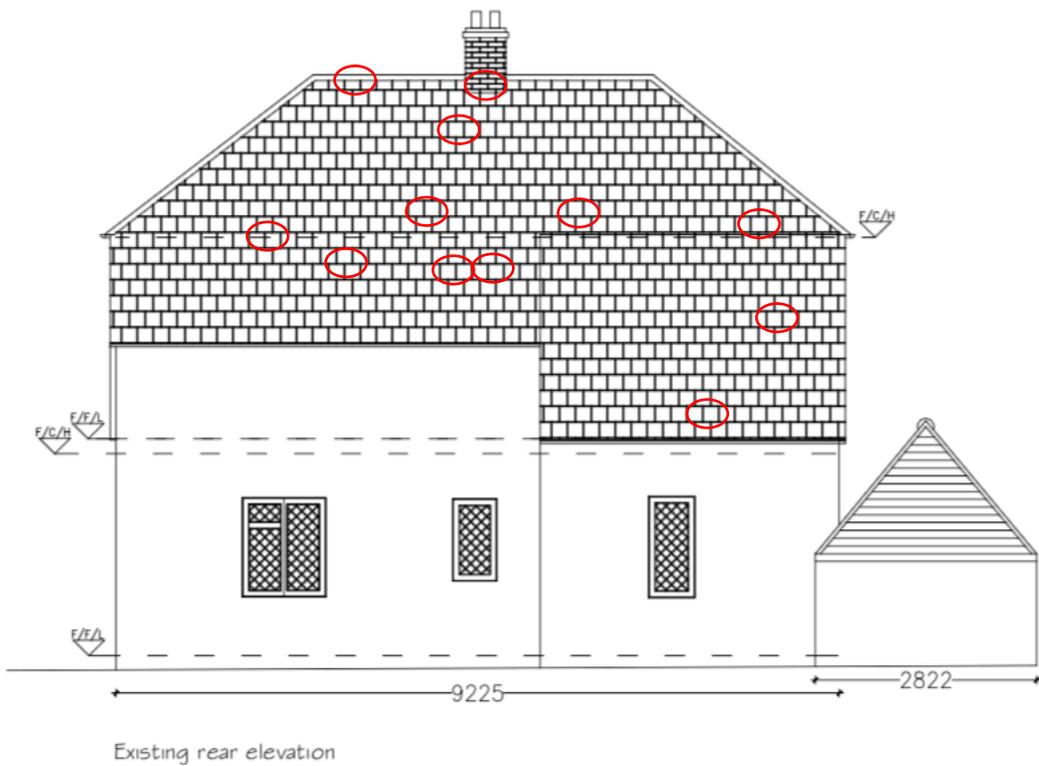
- Missing mortar around the chimney;
- Missing mortar beneath the main ridge tiles; and
- Missing/slipped tiles on the main roof.

Figure 2: Approximate location of potential features of value to roosting bats on rear elevations.

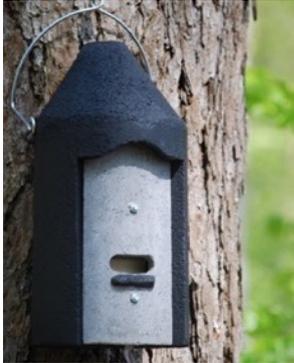
- In advance of the works, in order to compensate for the temporary loss of the roosts during the course of the works, a bat box should be hung on suitable trees within the grounds of the application site.
- The bat box would also be used in the unlikely event that bats are encountered during the works.
- The box used would be suitable to support the species recorded within the site.
- For example, a Schwegler 2F double-fronted bat box (see **Figure 1**).
- It should be positioned in a shady position, 3-5m above ground level, and face in a south/south-westerly direction with a clear flight path to and from the entrance.

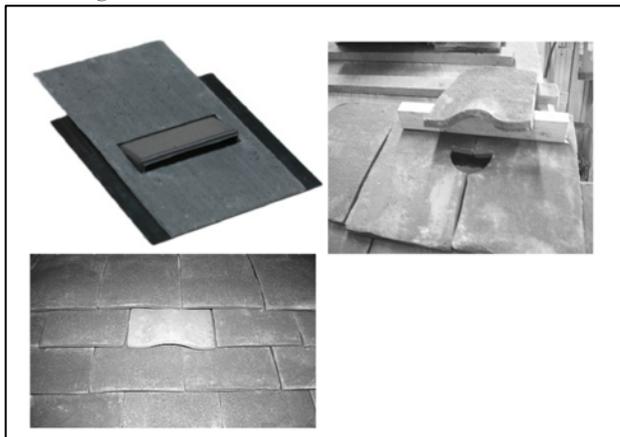
Depending on the outcome of the proposed 2021 survey, it may be necessary for the detailed design to incorporate integral bespoke bat roosting features. This could include the use of roost access tiles (see **Figure 2**) onto the roof of the property to allow access by bats to the crevice between the roof tiles and the lining underneath.

Figure 2: Example bat access tiles

- Inclusion of new roost features (see **Appendix D**) - bat access tiles or bat tubes which would provide compensation for the loss of roosting locations and to provide additional roosting locations;
