Heritage Statement

Randolph Hotel
Vehicle Entrance
Stone cleaning and repairs

Ref 2020 20/03207/LBC

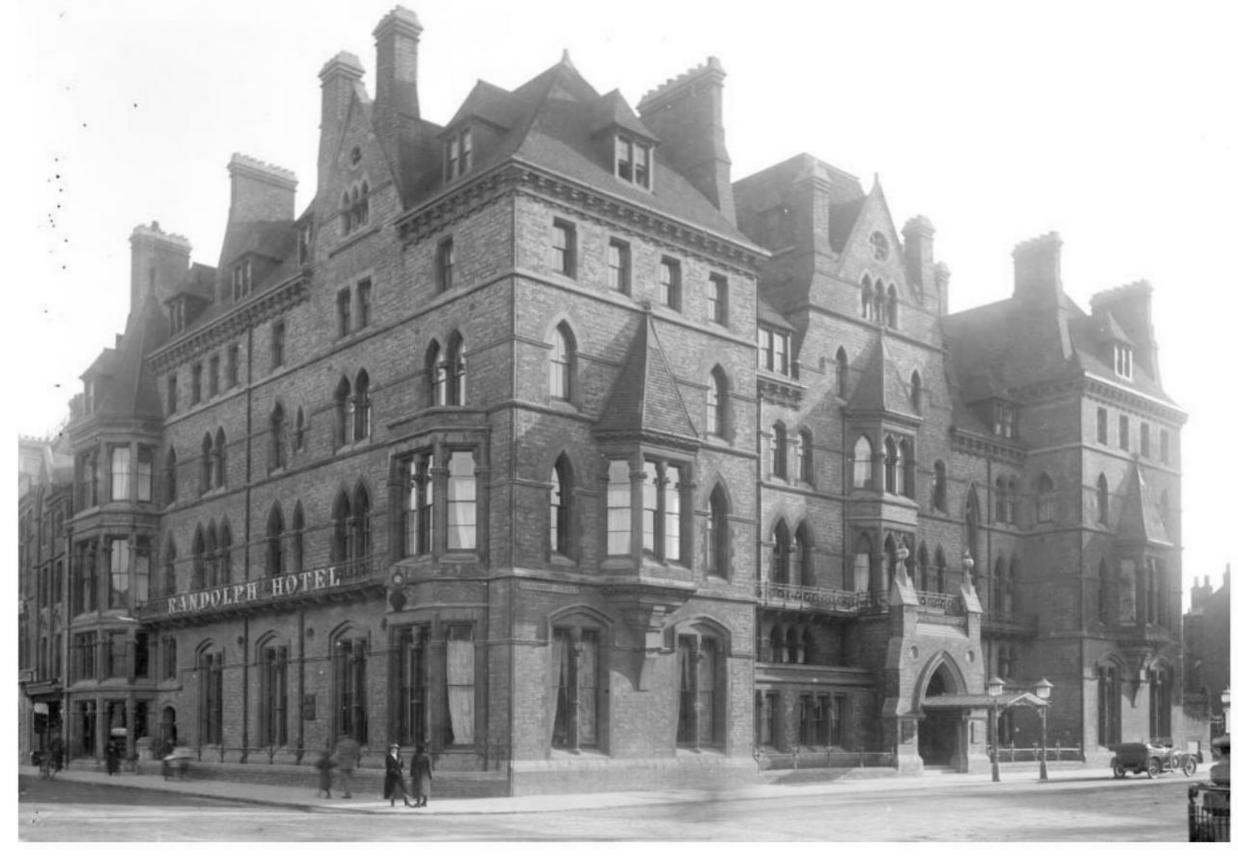
source: Historic England archive

The original Beaumont St elevation of the hotel was a symmetrical construction comprising five bays with the entrance archway positioned centrally, as shown in this image from 1915:

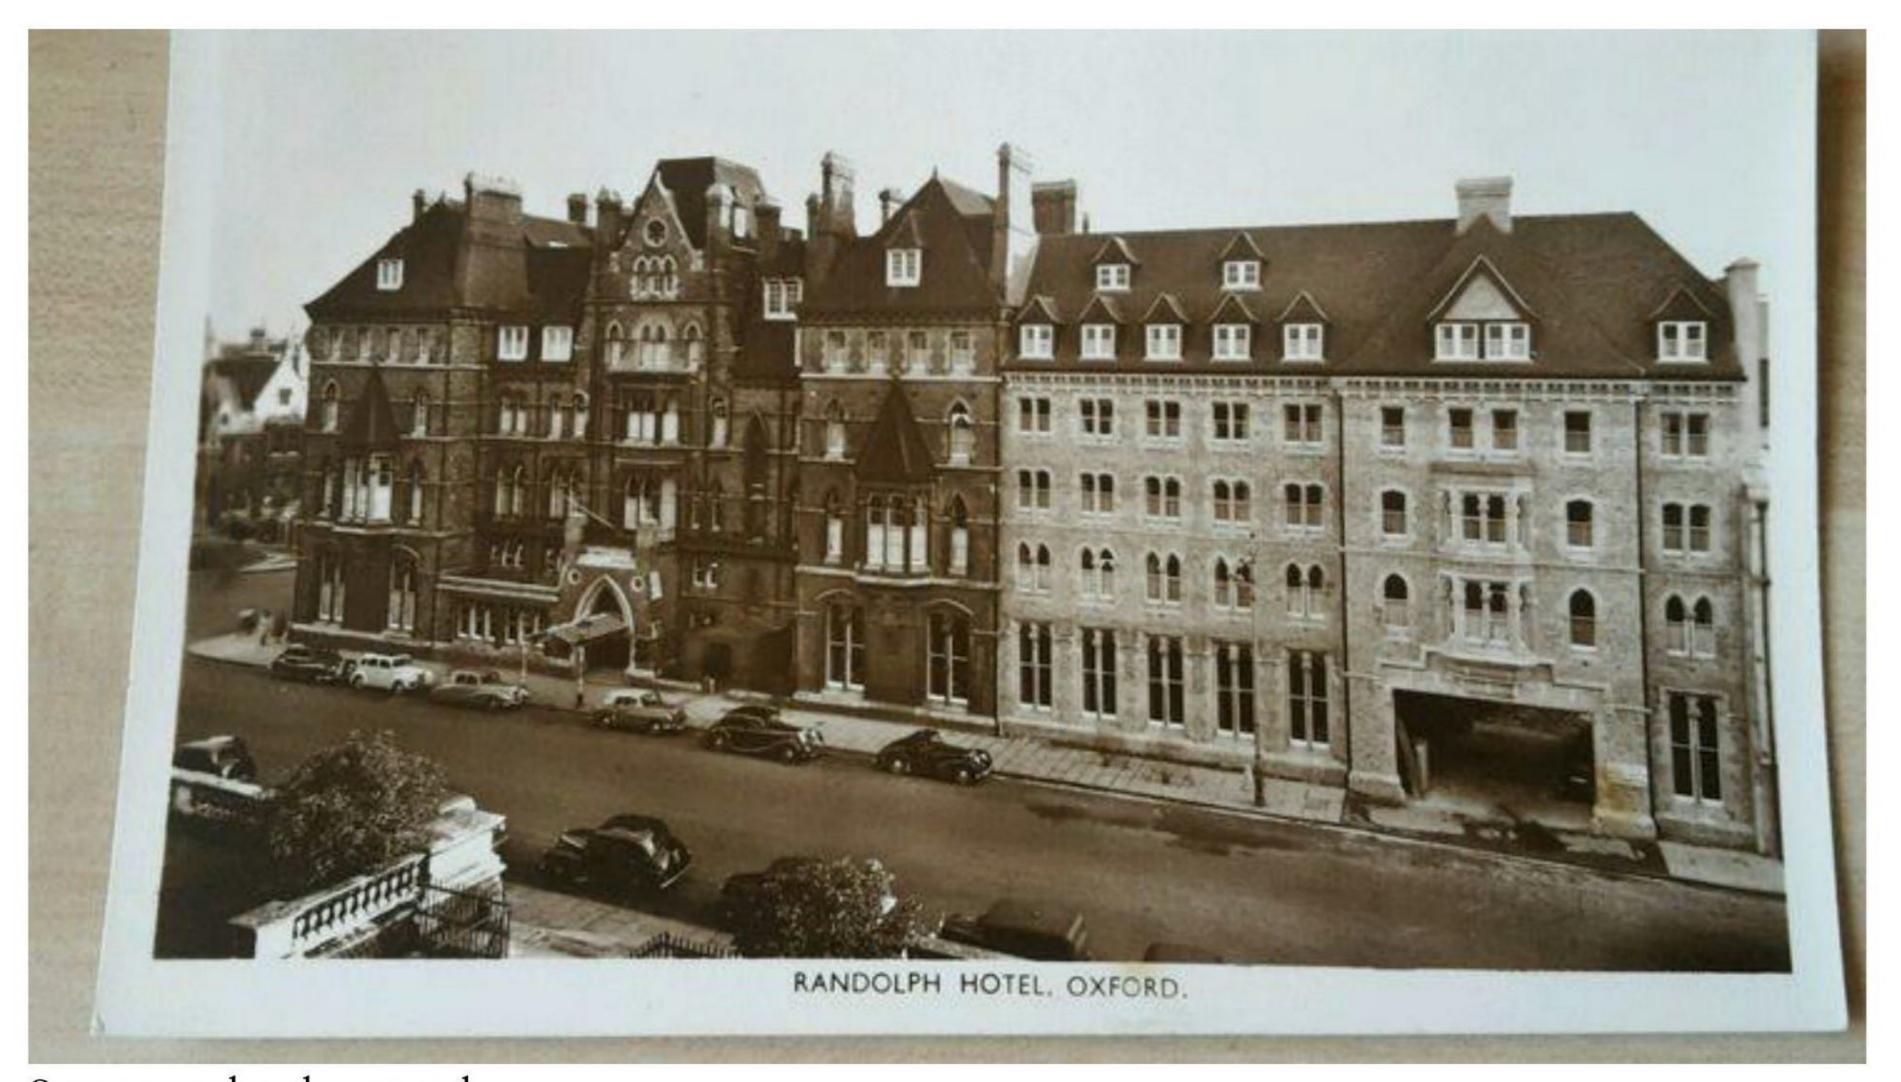
Source: undated postcard

One significant innovation of the extension was that it included a vehicle entrance to an off-street carpark, as shown in this photograph:
