FORMER CONSERVATIVE CLUB, BETWEEN TOWNS ROAD, OXFORD

Preliminary Ecological Appraisal and Bat Survey

September 2019

Bioscan report ref: E1996r1

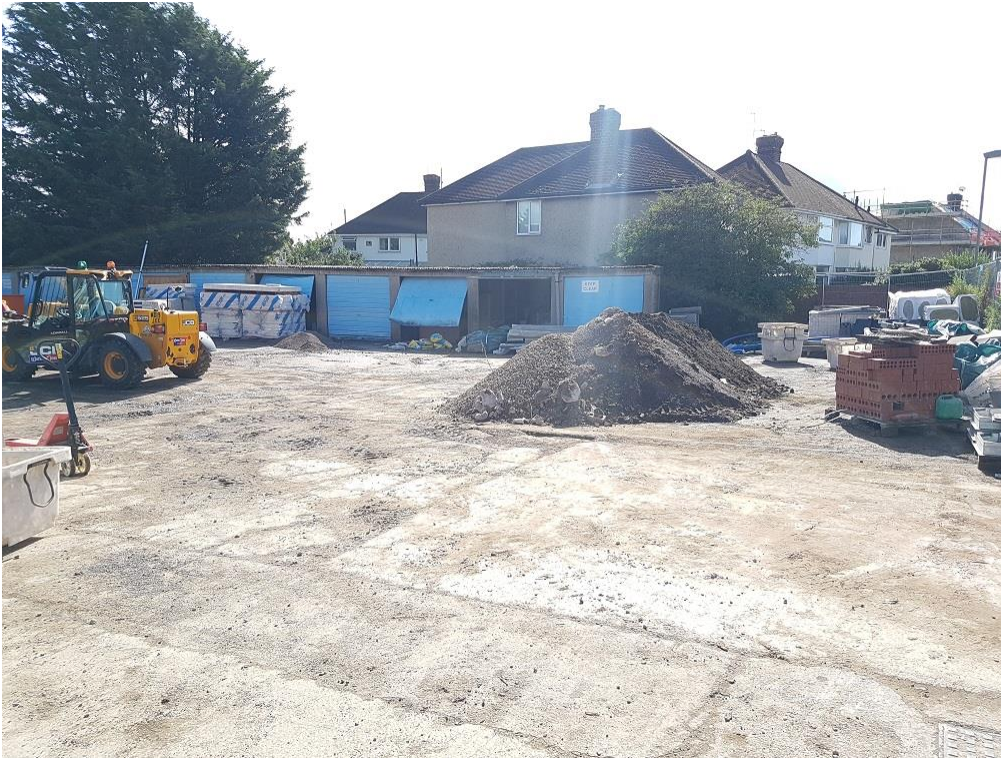
Photo 1

2.1.1 Other than the buildings, which are described in more detail below, the site contains a former car park that presumably served the club when operational. At the time of the survey, this was being used as a site compound and storage area (see Photo 1) by Watkin Jones Group during the construction of a new student accommodation block to the north of the study site and was therefore subject to a high degree of disturbance. As a result, much of this area was devoid of vegetation, with the remainder of the site also having very little vegetation. Where it was present, a limited range of ubiquitous species was noted that included prickly lettuce *Lactuca serriol*, Canadian fleabane *Erigeron canadensis*, bristly oxtongue *Helminthotheca echioides*, buddleia *Buddleja davidii* and groundsel *Senecio vulgaris*.

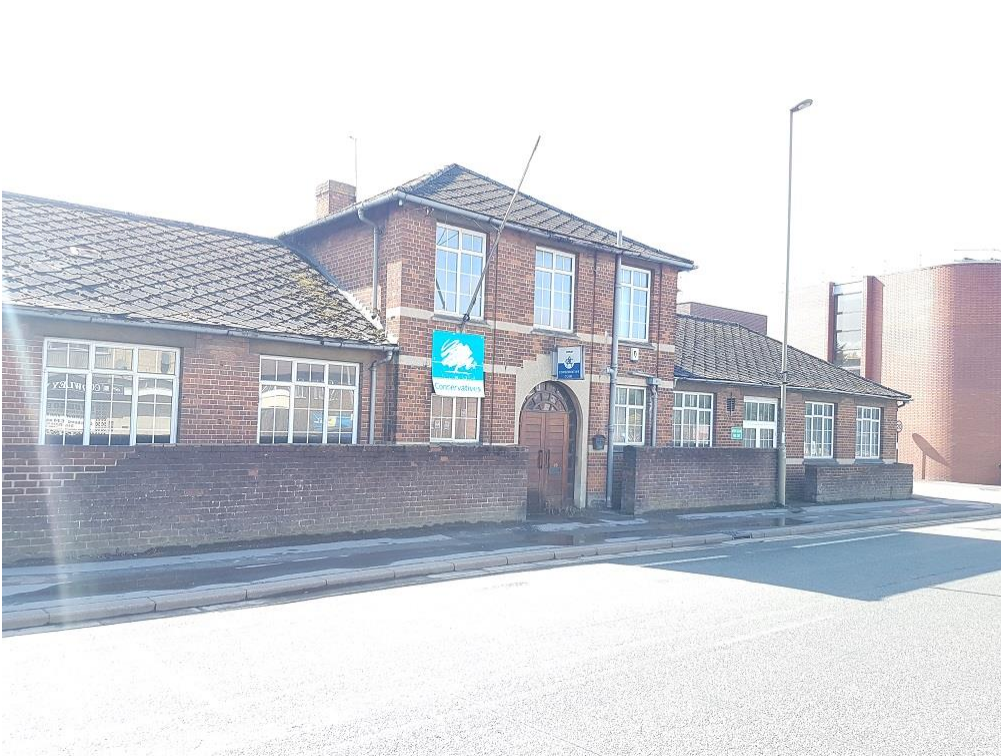
Photo 2

2.2.1 This building appears to have been extensively extended, with, what appears to be, the original two storey building fronting Between Towns Road constructed of red brick with a concrete tile roof (see Photo 2). To the rear (southeast) of this is a collection of flat roofed, one and two storey extensions that are of modern brick construction, with a bitumen felt covering.

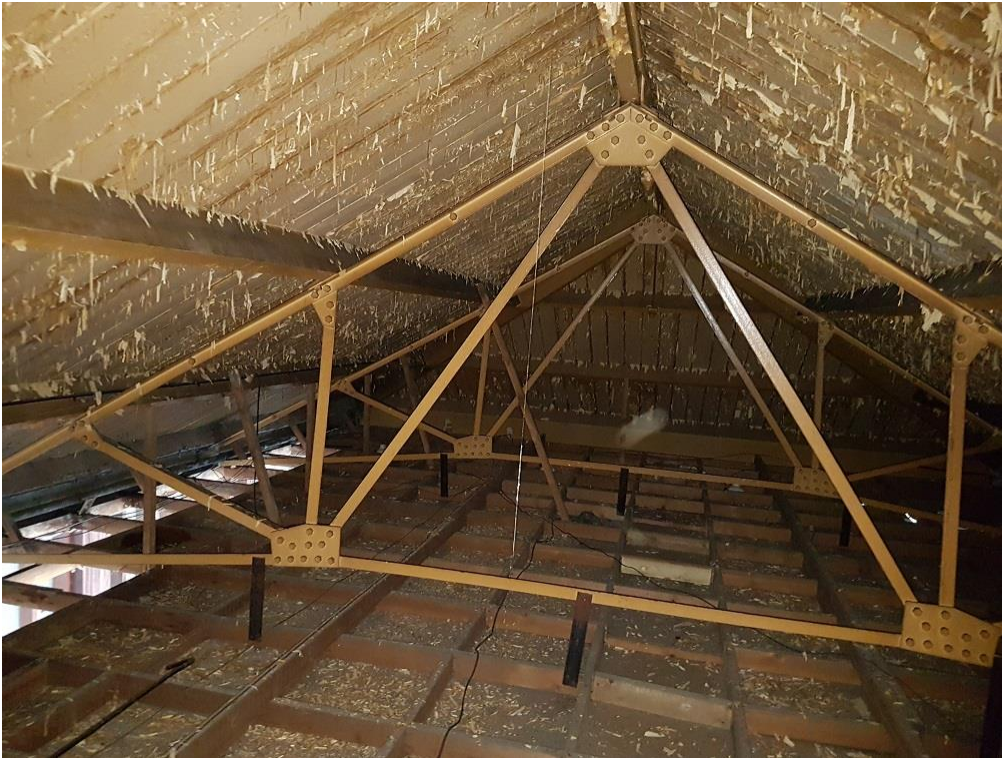
Photo 3

2.2.2 Internally, the only contained roof voids are those in the original part of the building. The central void has a wooden frame, whilst the voids either side of this have a metal frame. All three have wooden sarking, although this is painted in the two outer voids (see Photo 3).

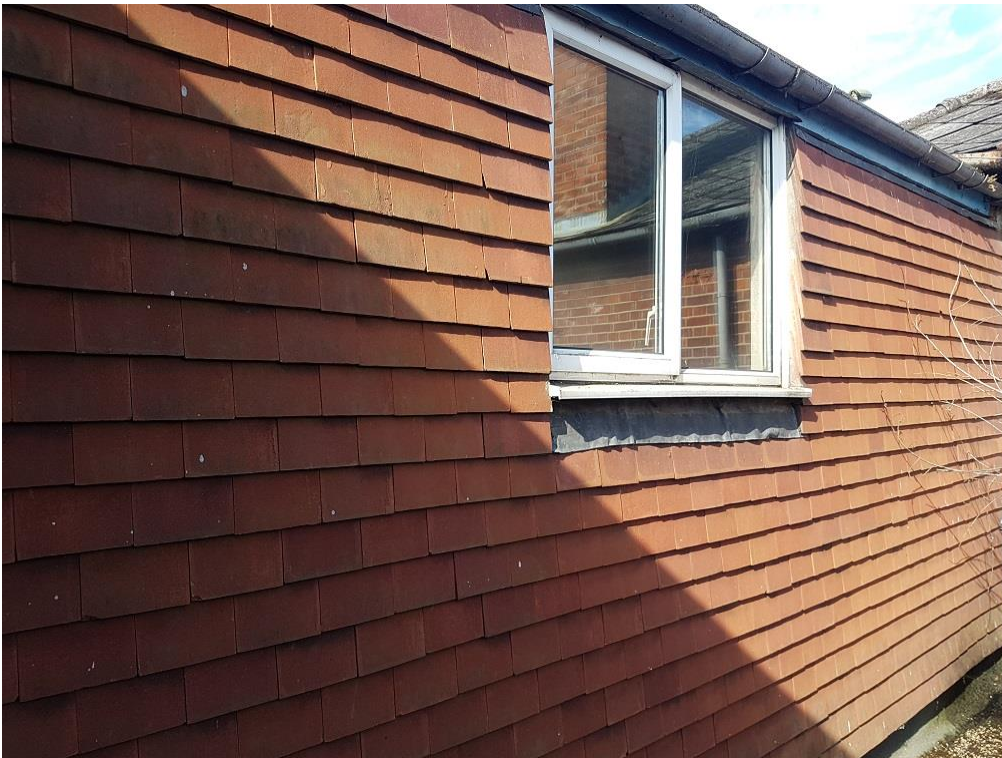
Photo 4

2.2.3 Externally, all of the buildings are generally well sealed and lacking any significant cracks and crevices that might provide a roost location. In particular, the small area of hanging clay tiles was assessed to have negligible roosting potential due to the tiles being flush against each other (see Photo 4). The only significant potential roosting feature, therefore, is where a ridge tile has become dislodged on one of the pitched roofs (see Photo 5), although this is likely to be exposed any inclement weather and is not considered to have more than low roosting potential as a result.

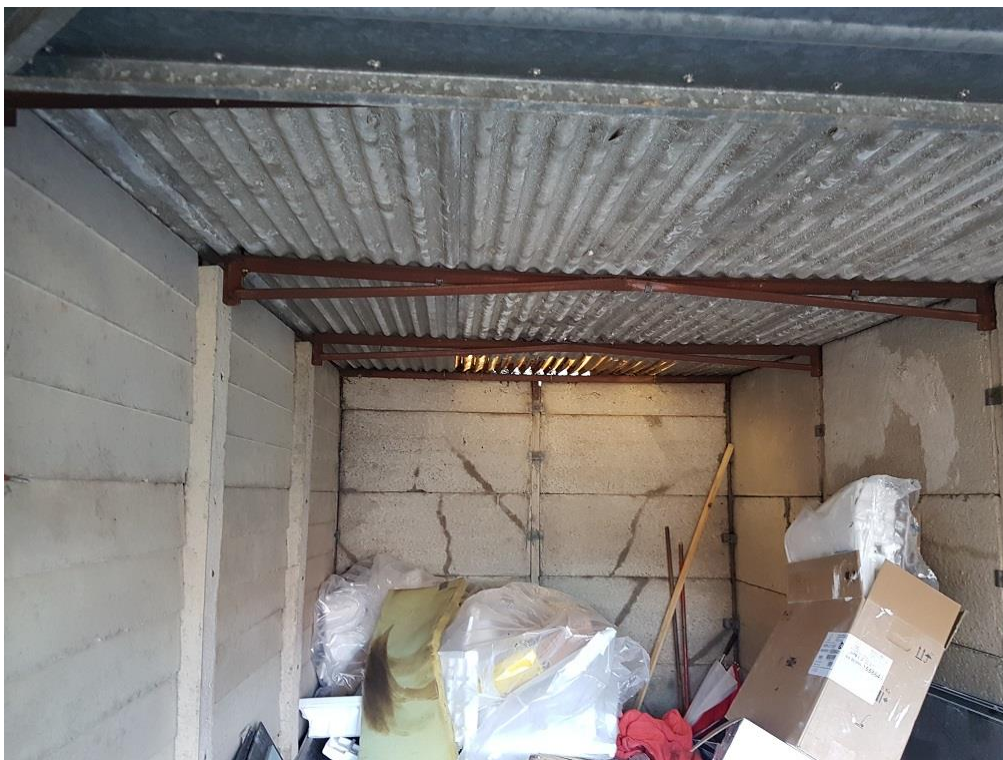
Photo 6

- 2.2.5 The only other building on the site is a group of flat roofed garages, which are constructed from concrete panels with a corrugated roof (see Photo 6). They are assessed to have negligible roosting potential and no evidence of bats was found associated with these.
