## Ground Investigation Report

**Oxford Health  
NHS  
Foundation Trust**

**Warneford Hospital  
Warneford Lane  
Oxford  
Oxfordshire  
OX3 7JX**

**Report No: 18-04-04  
June 2018**

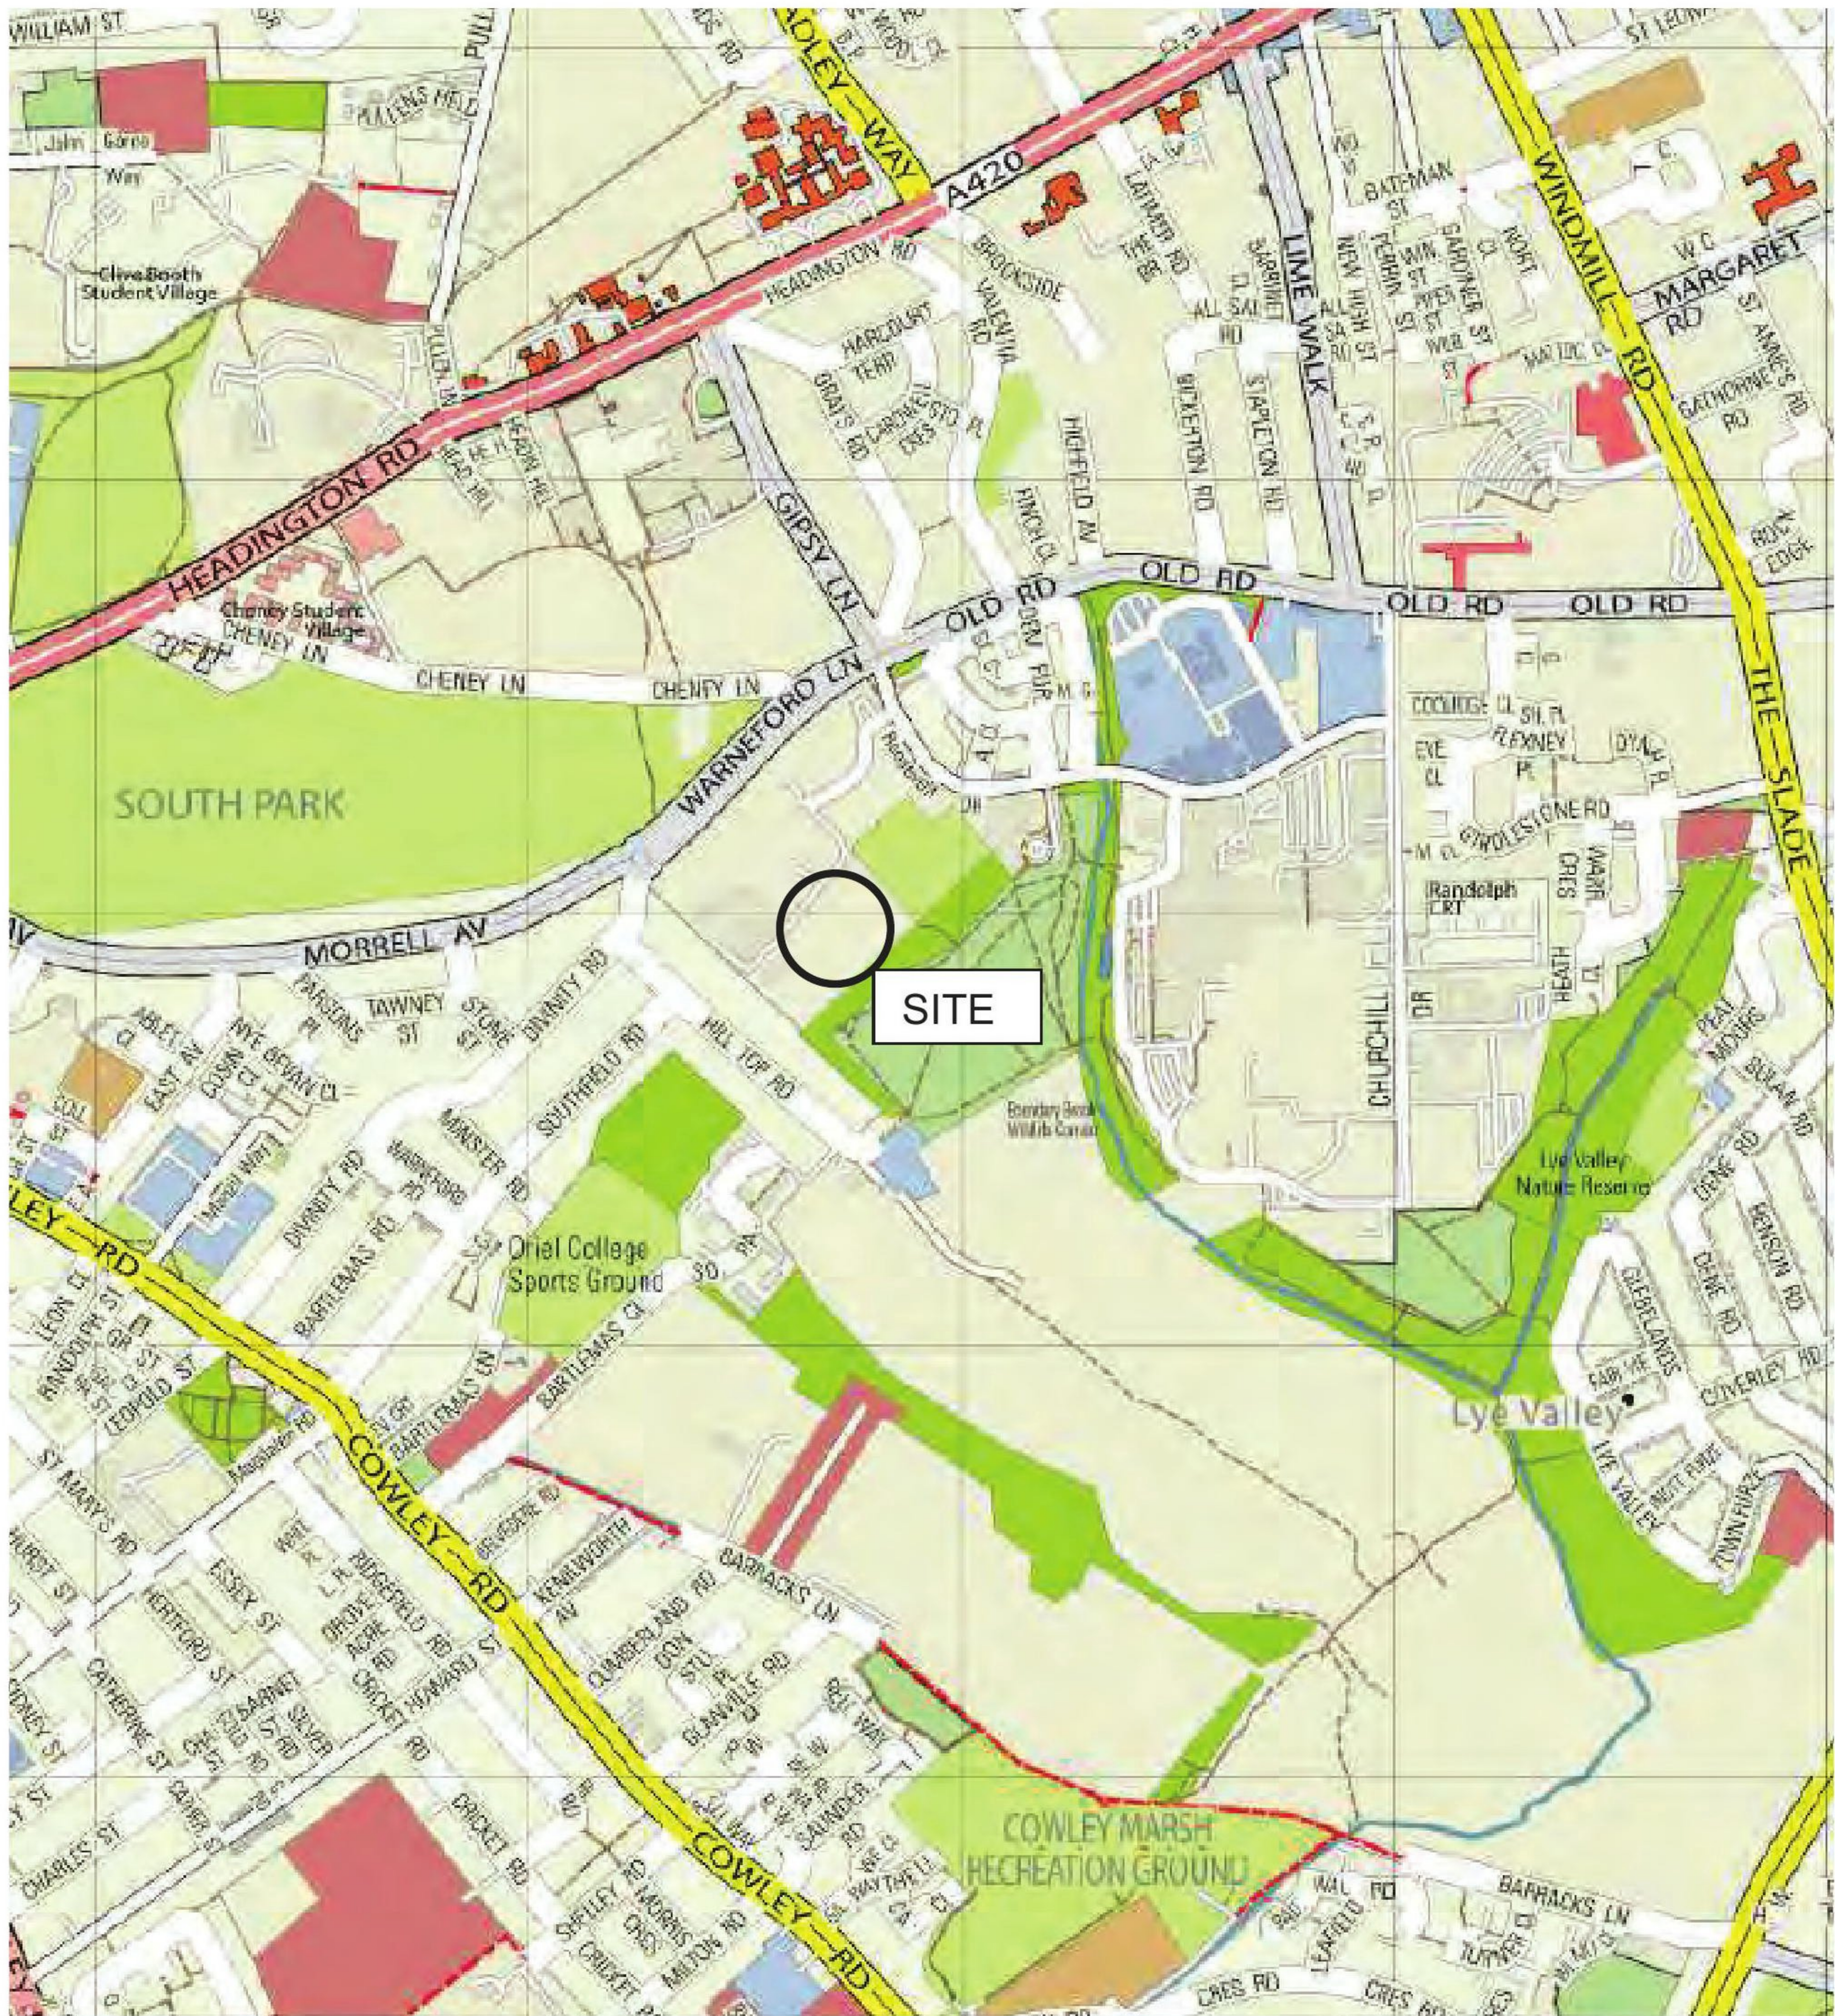
**Key**

Continuous Tube Borehole

CBR test Location

Trial Pit

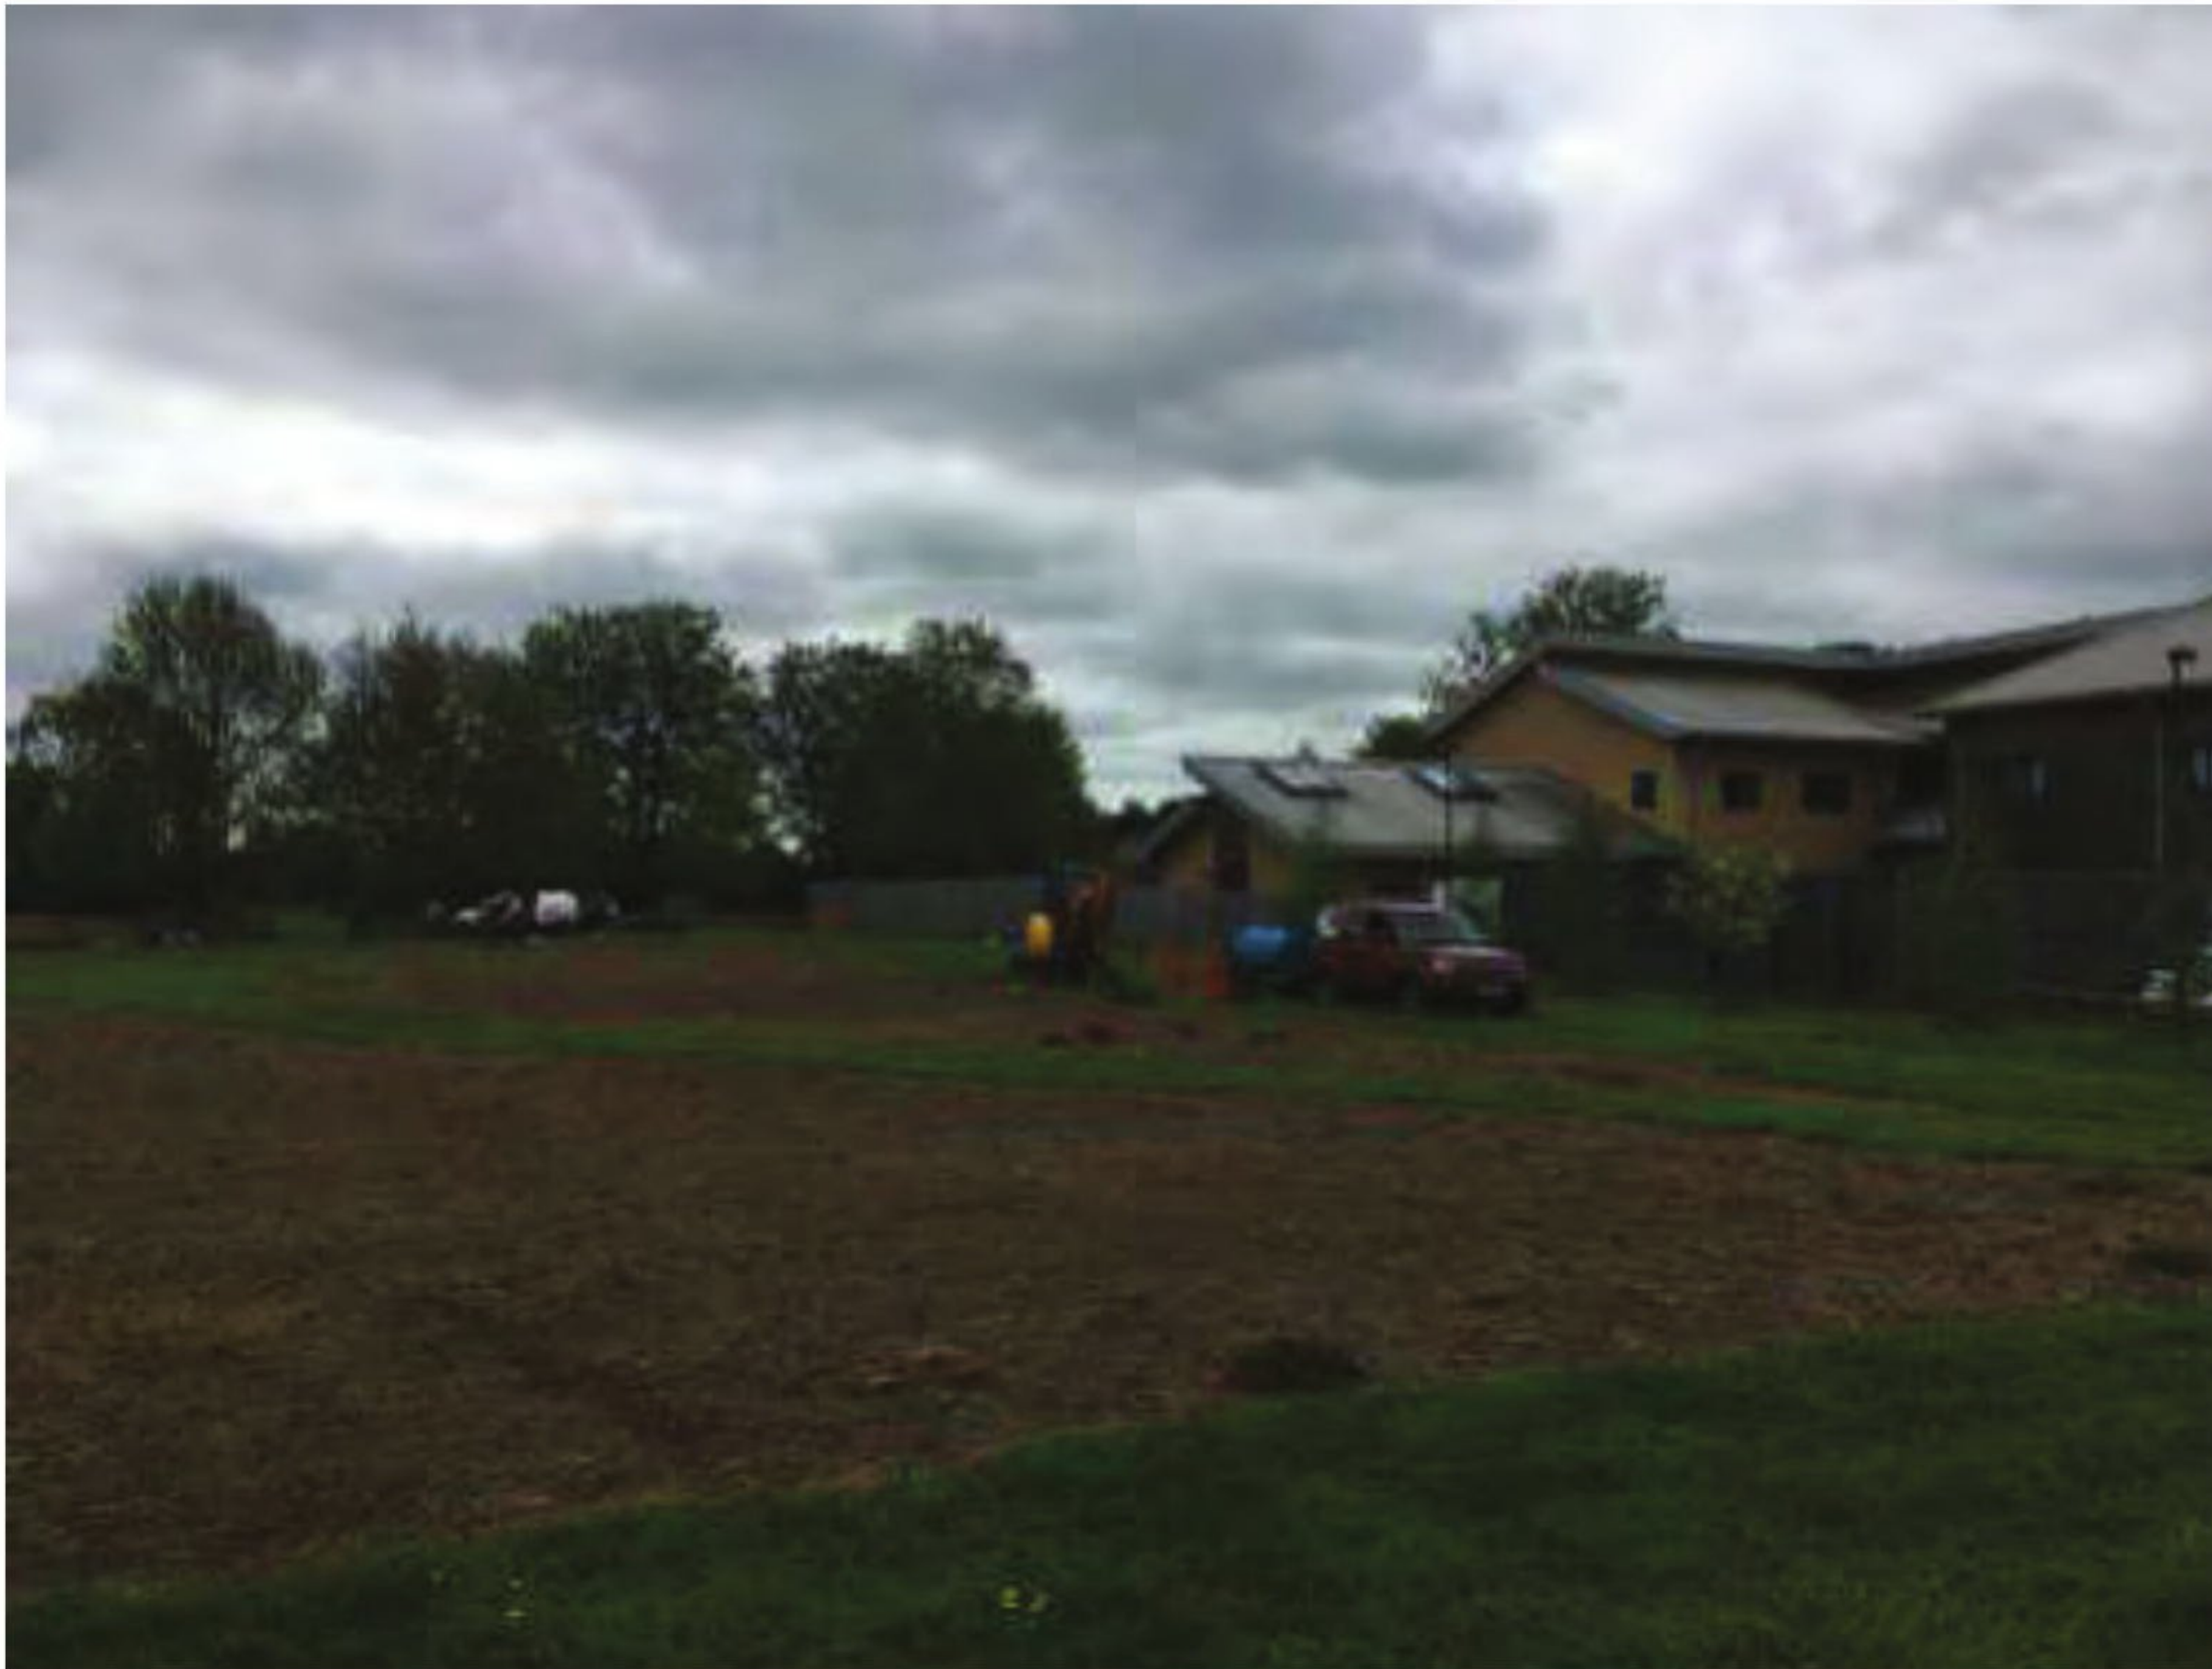
Site location looking southwards

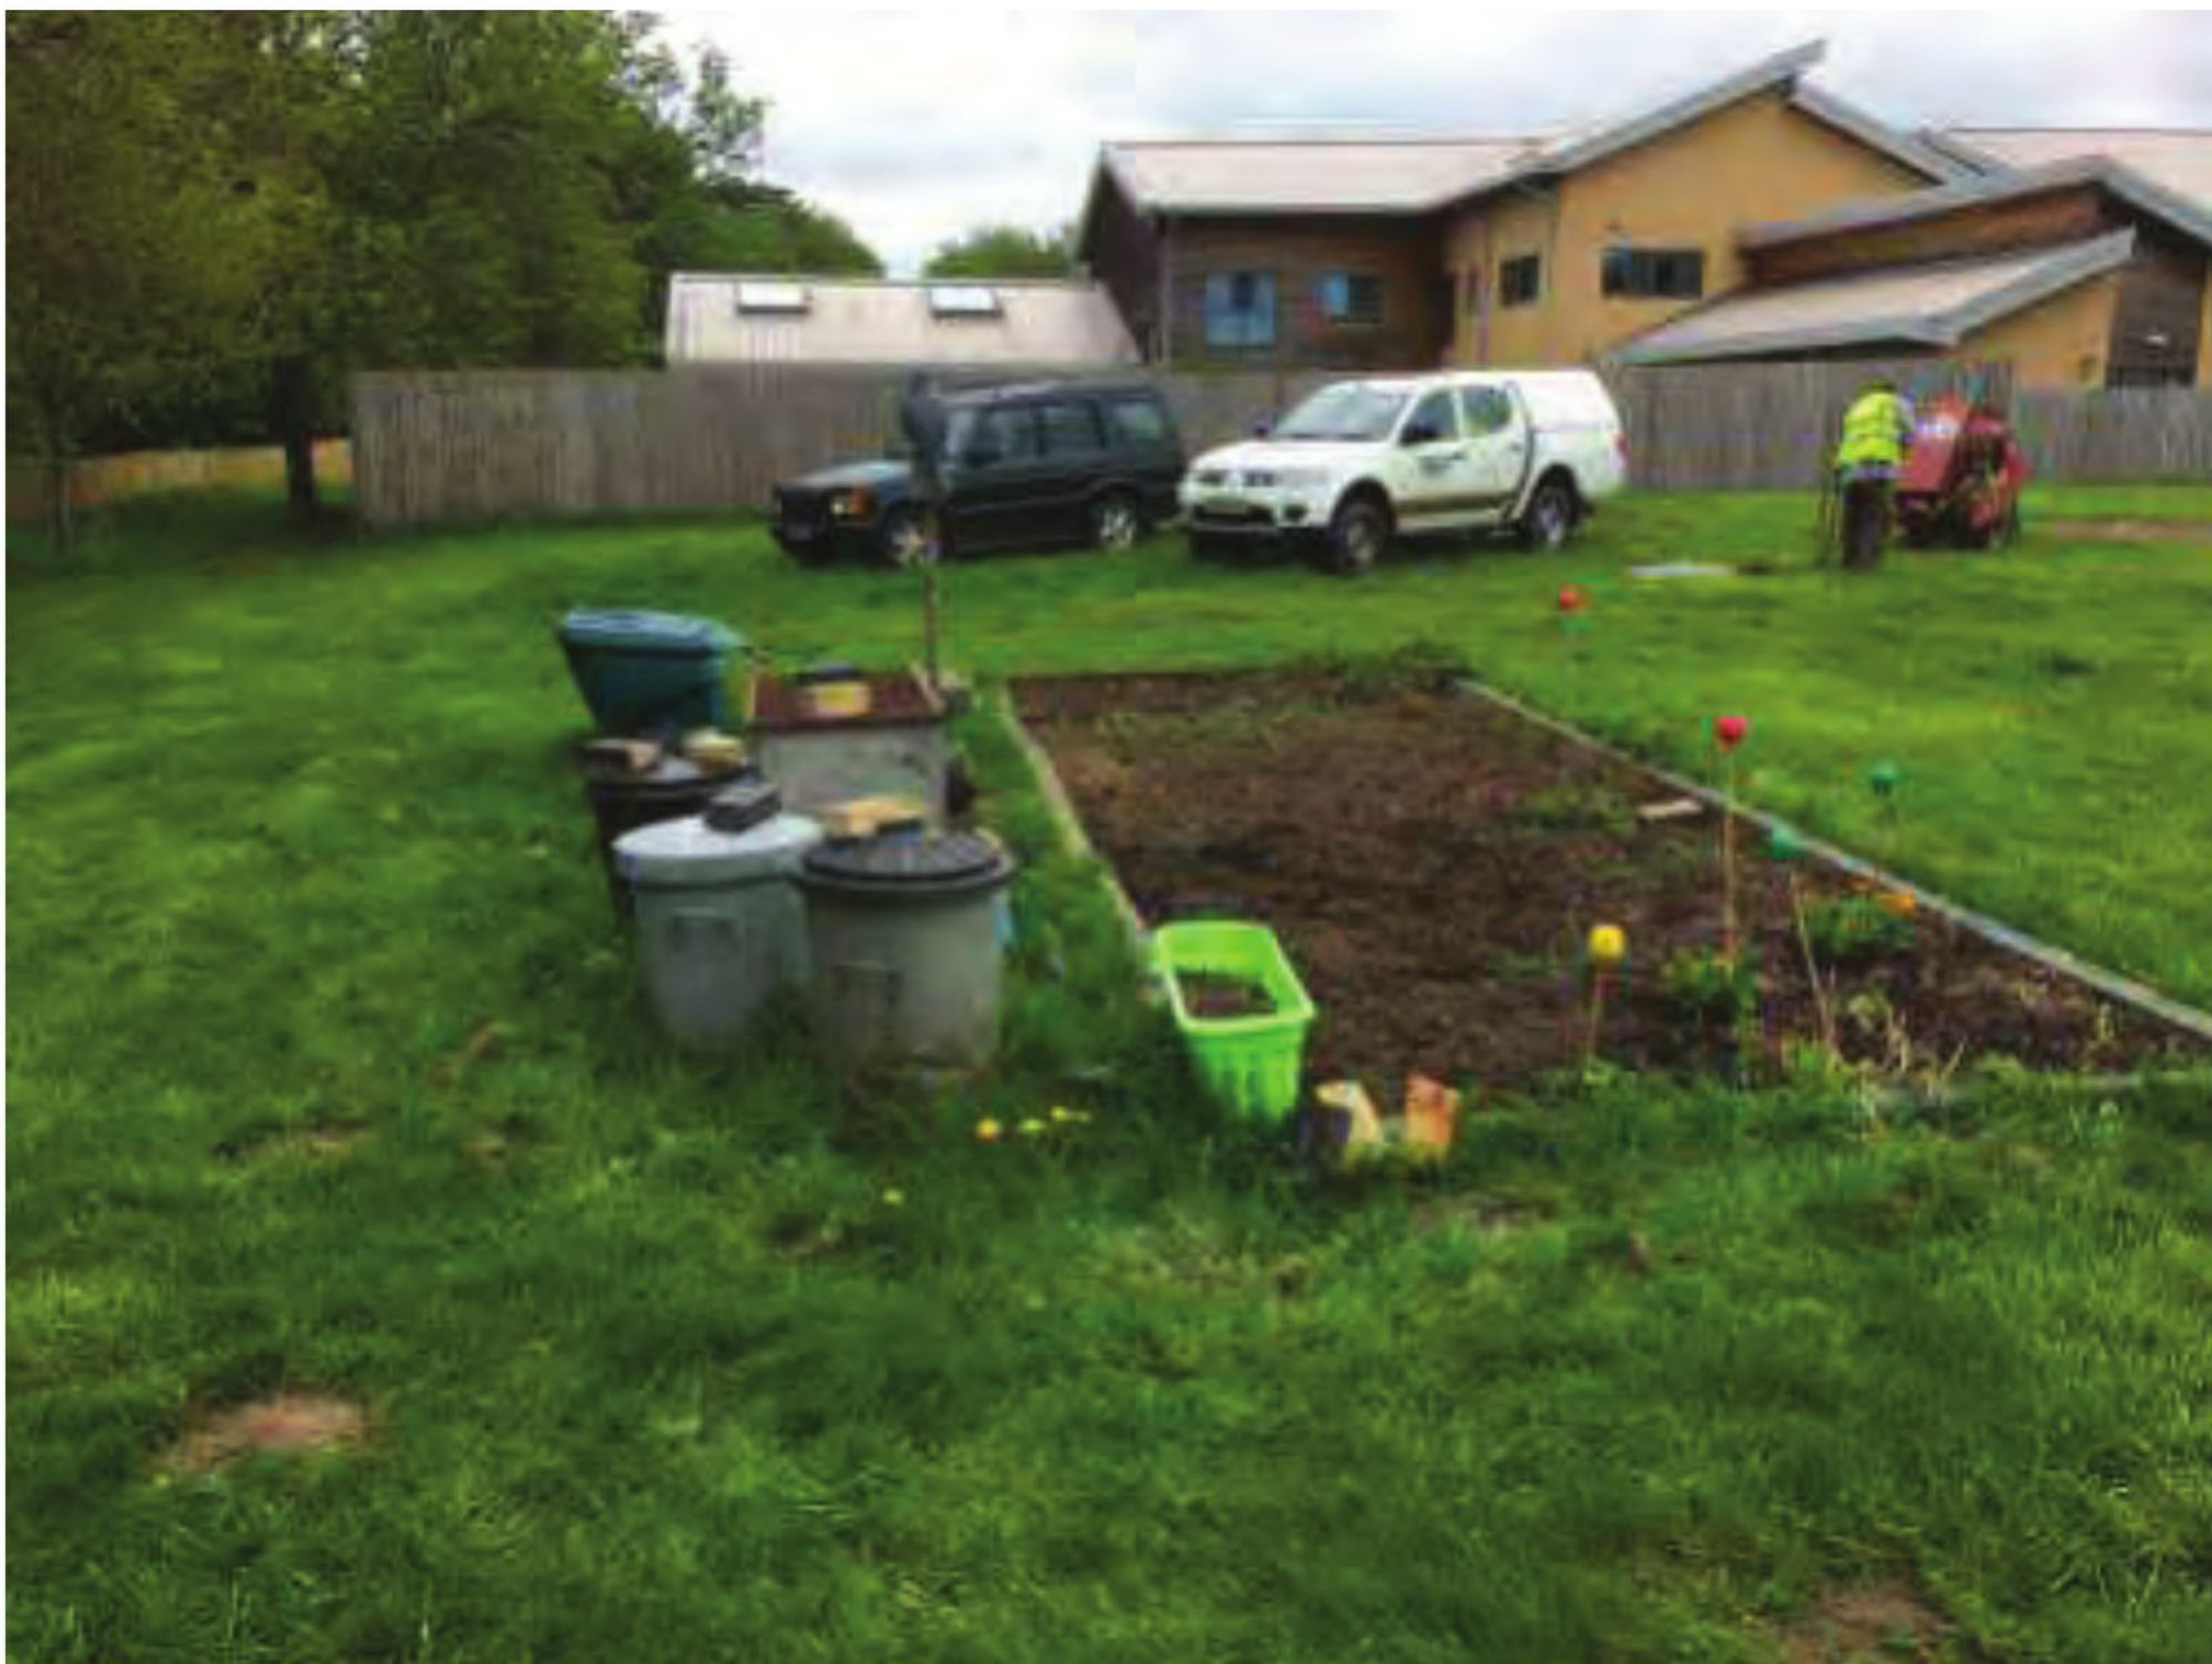
Site area from east

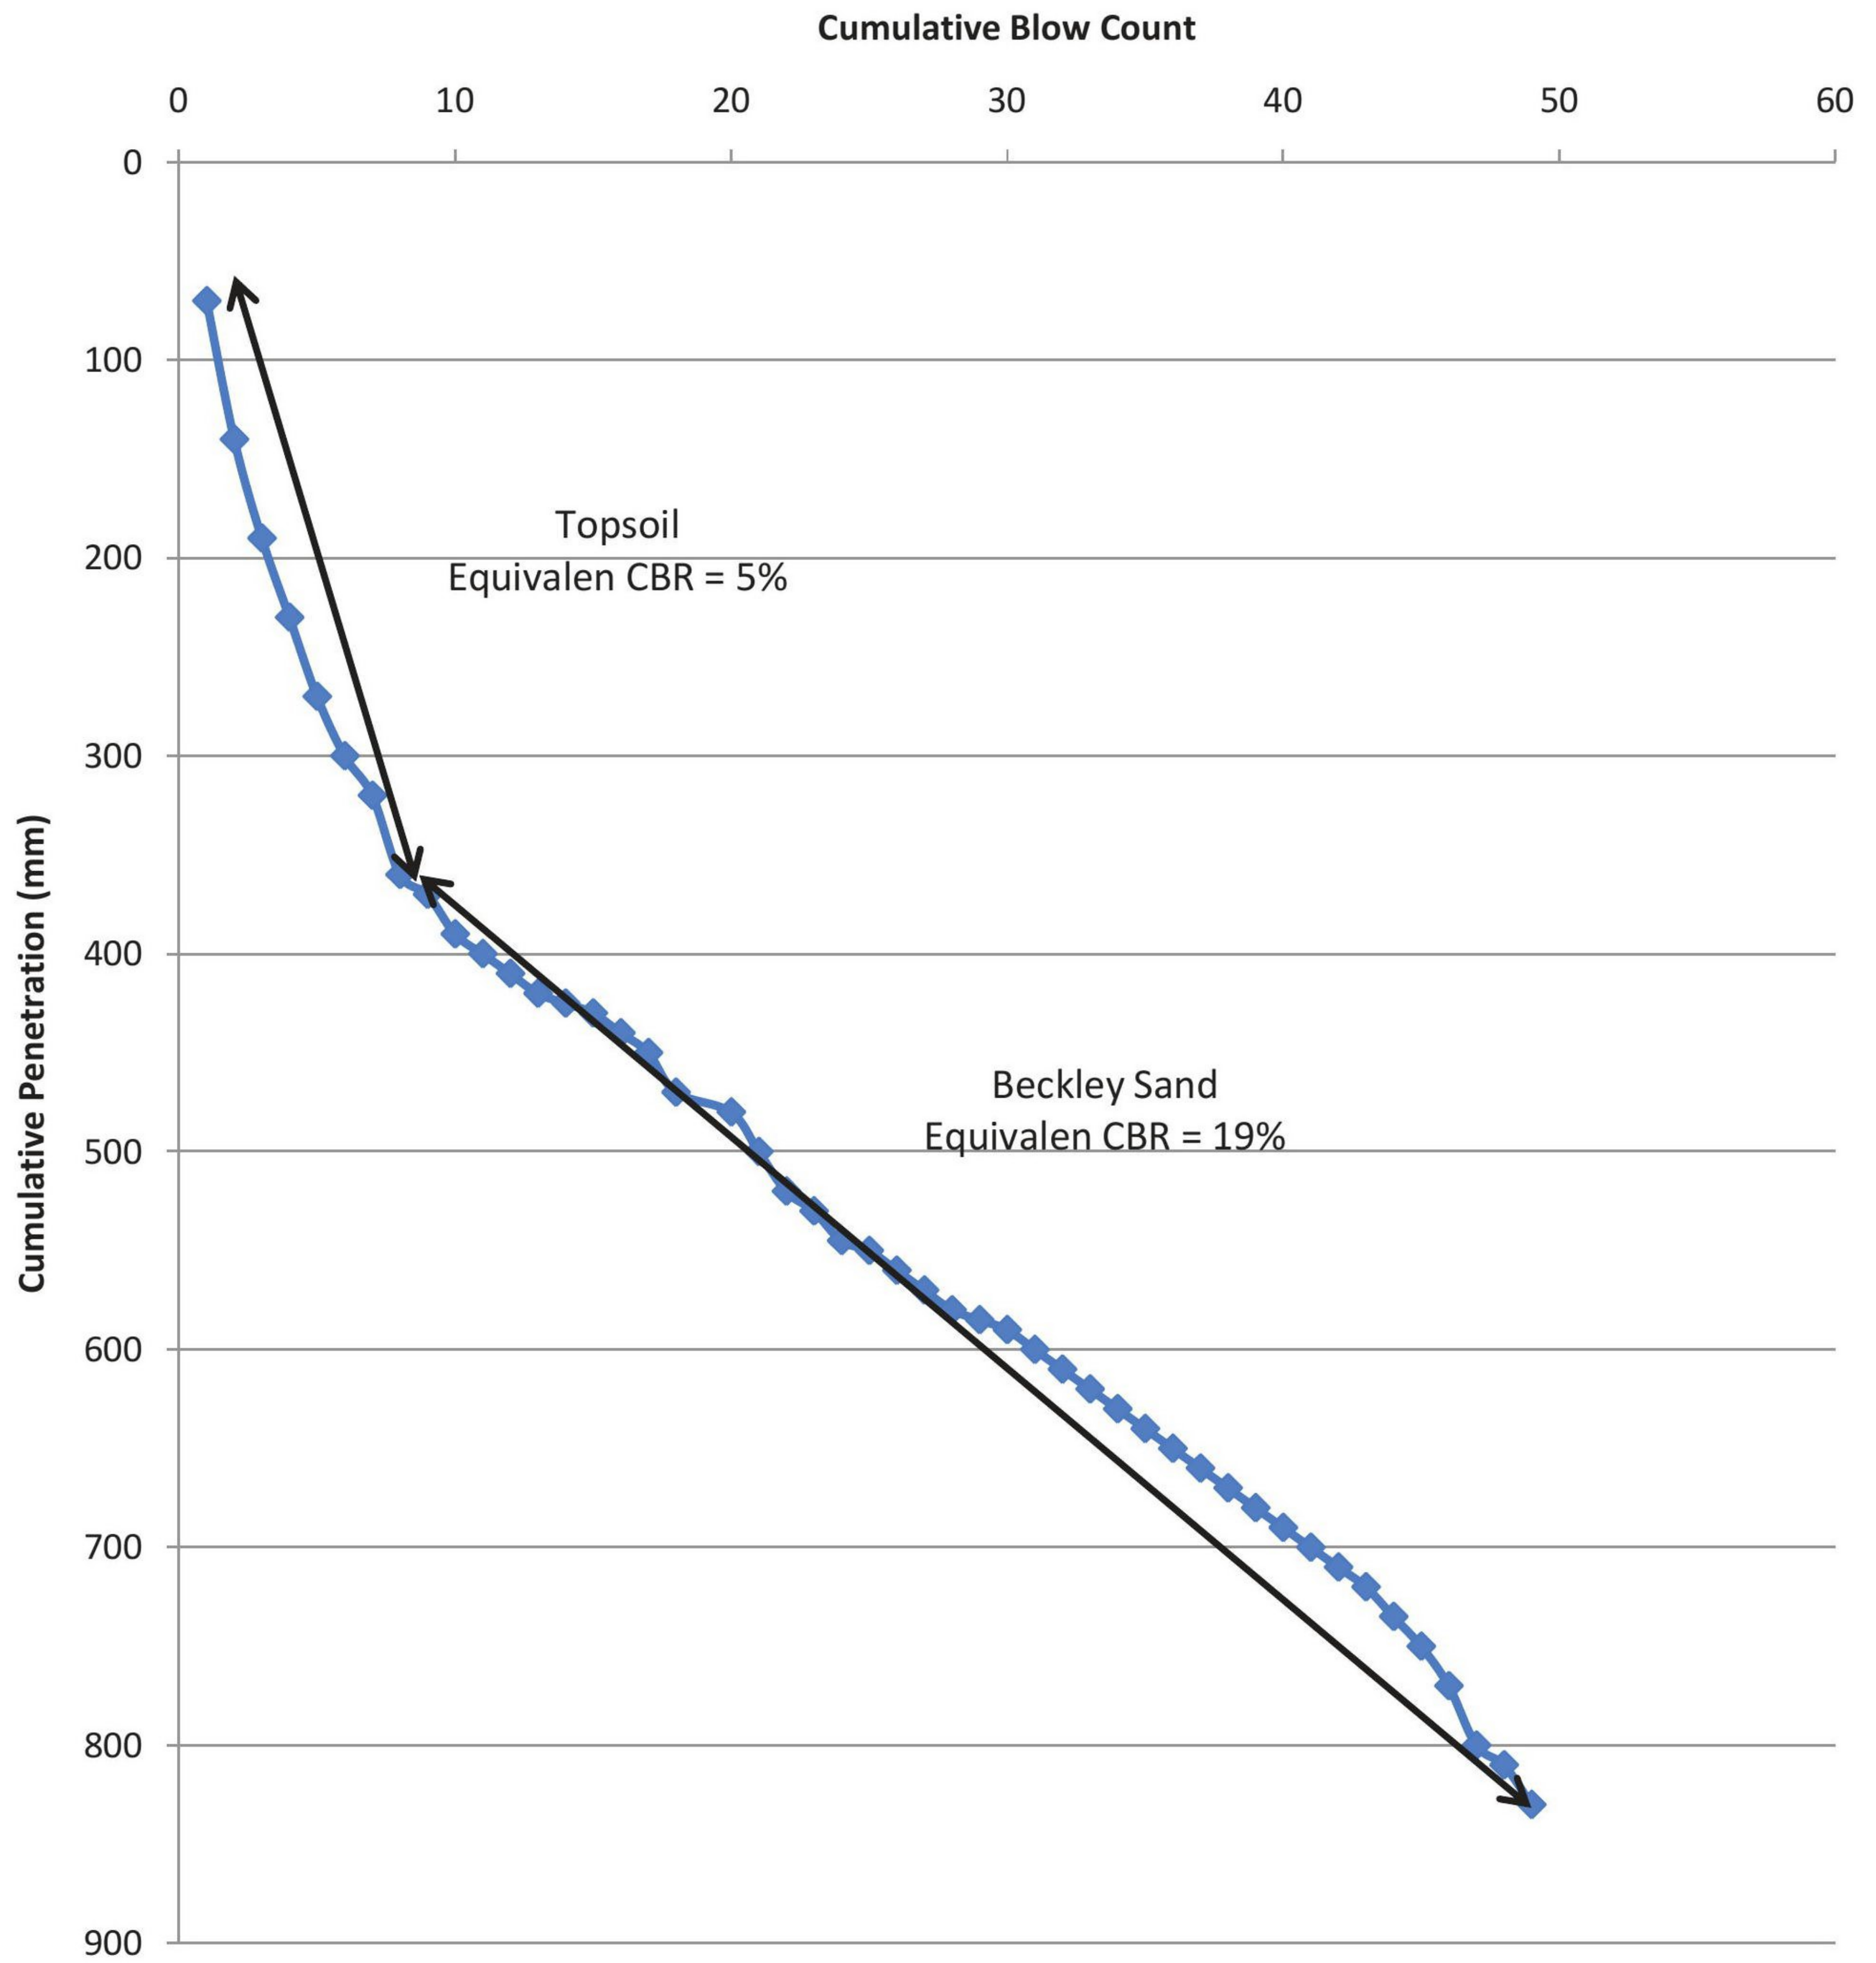
Job No:- 18-04-04  
Job Name:- Warnerford Hospital  
Position:- CBR1

# TRL DYNAMIC CONE PENETROMETER RECORD

## Cumulative Blows Vs Penetration (mm)

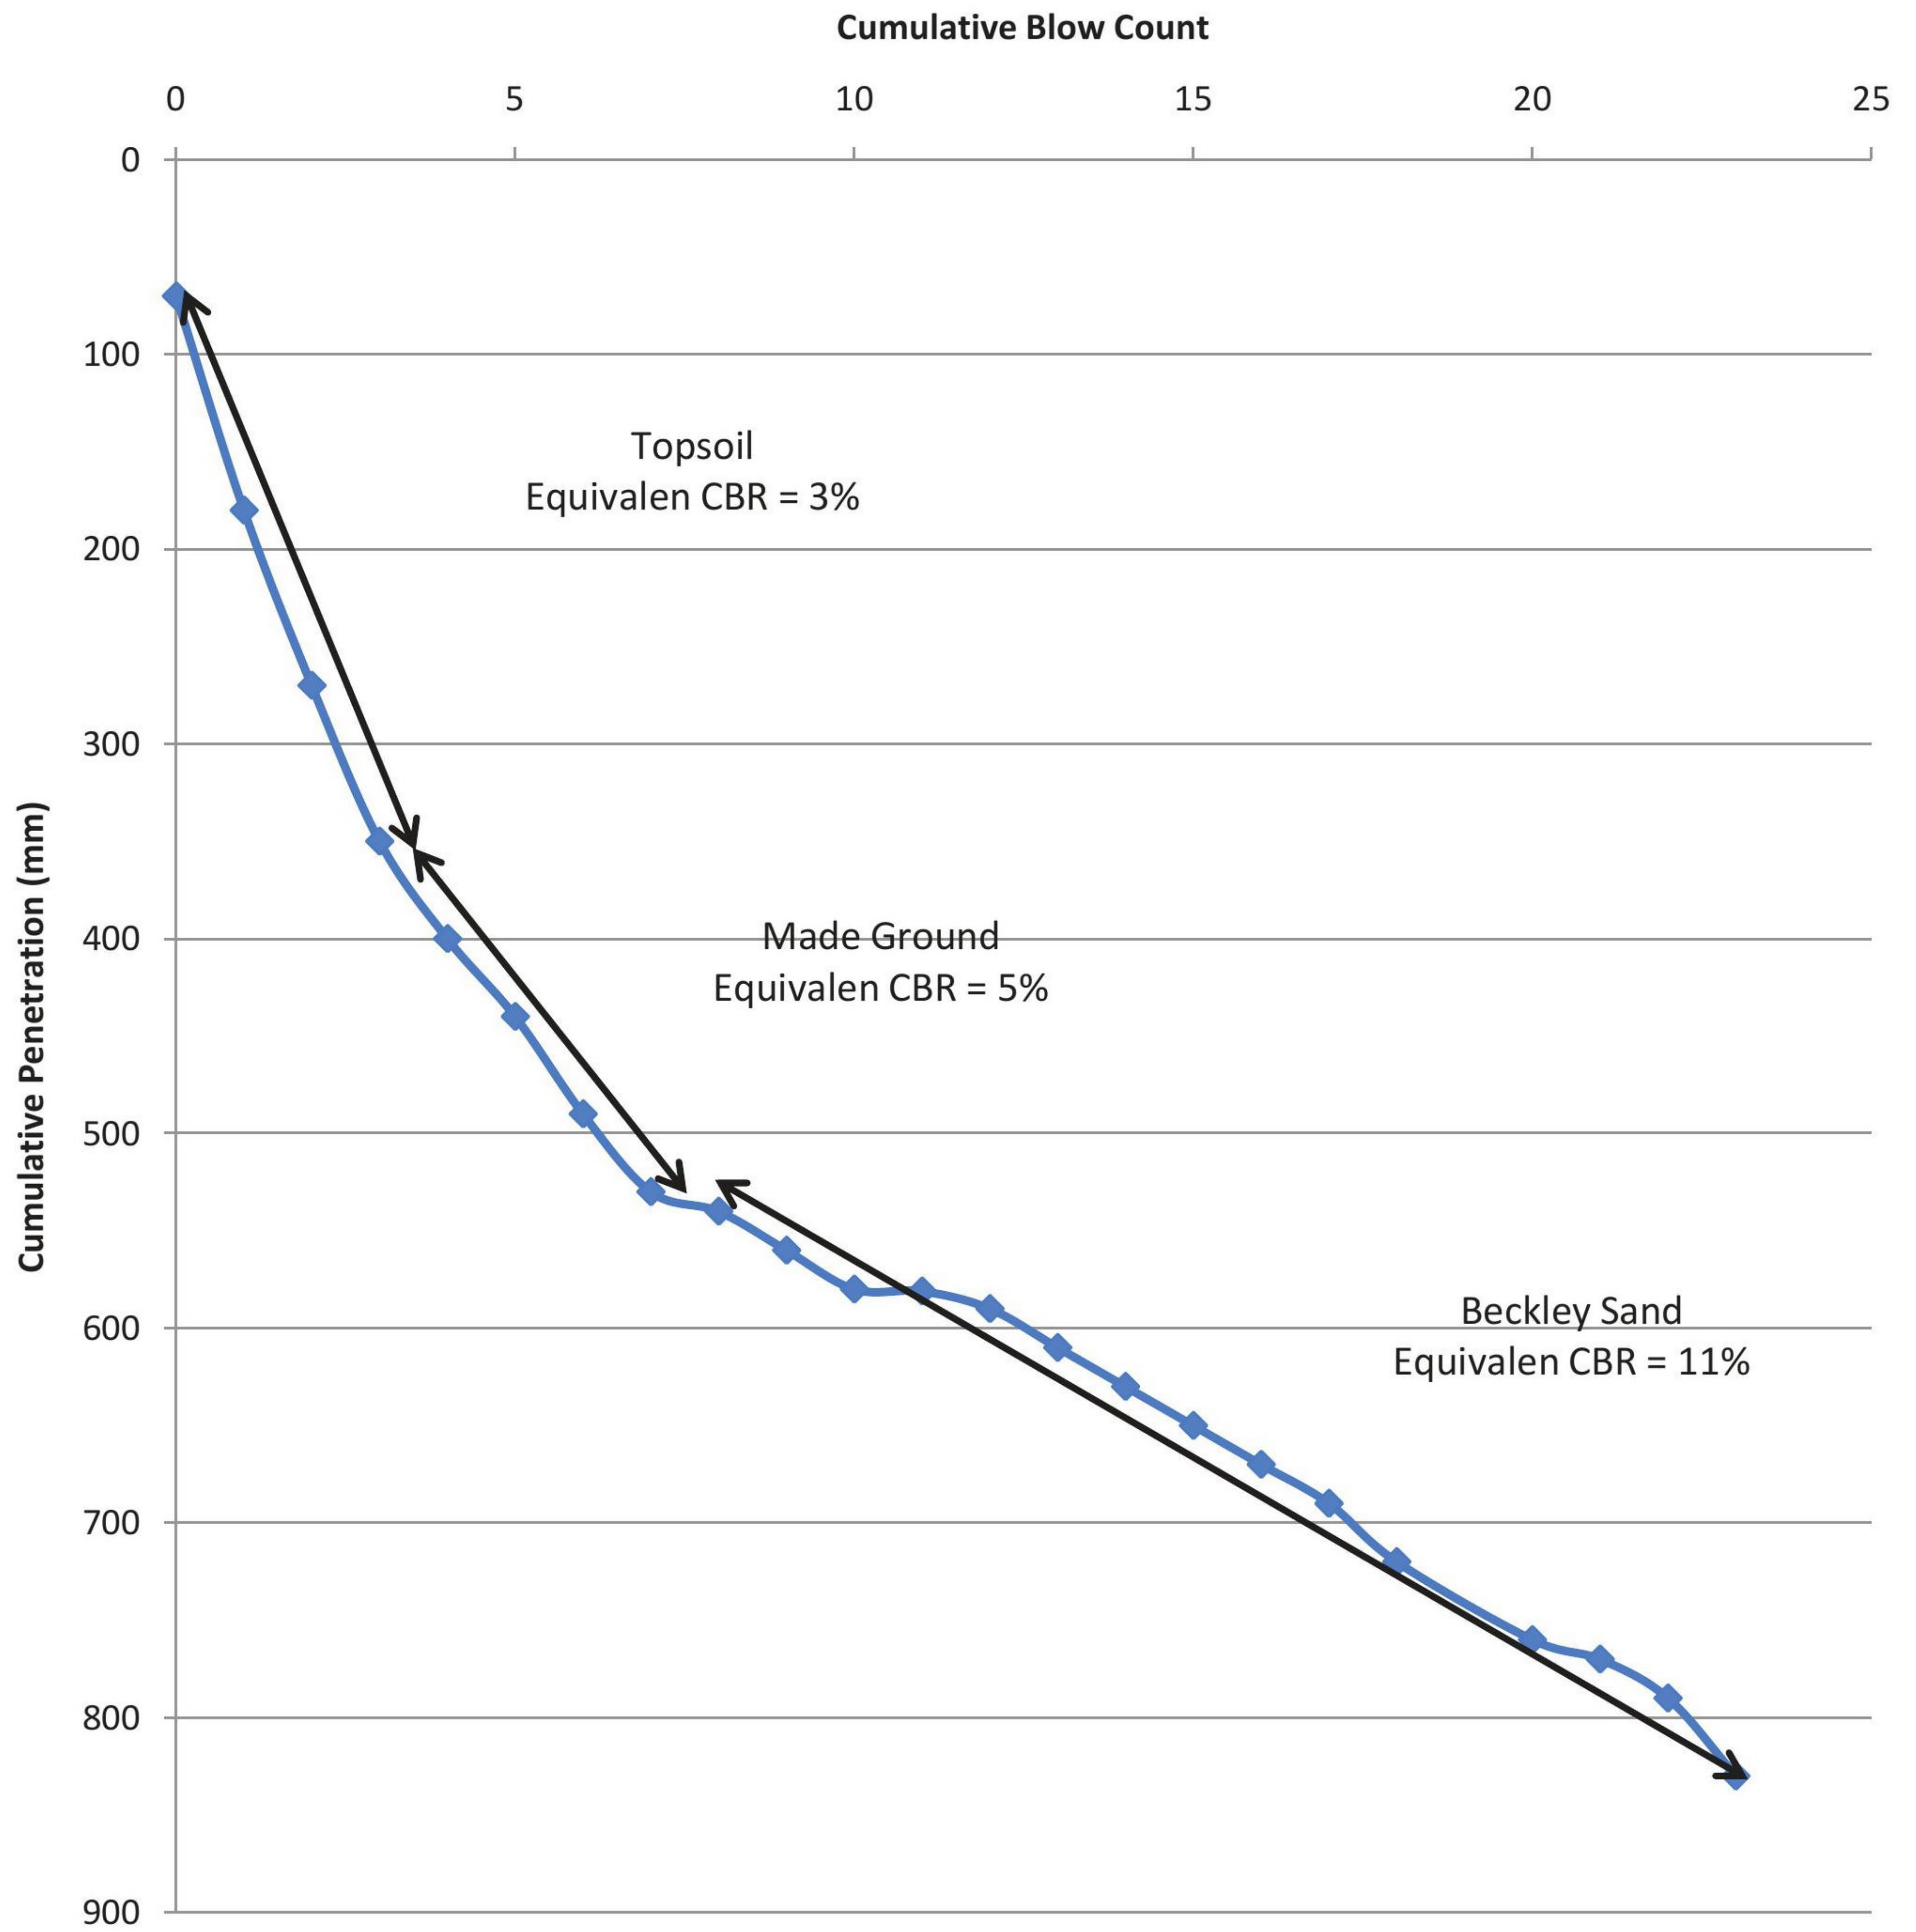
Job No:- 18-04-04  
Job Name:- Warnerford Hospital  
Position:- CBR2

## TRL DYNAMIC CONE PENETROMETER RECORD

### Cumulative Blows Vs Penetration (mm)

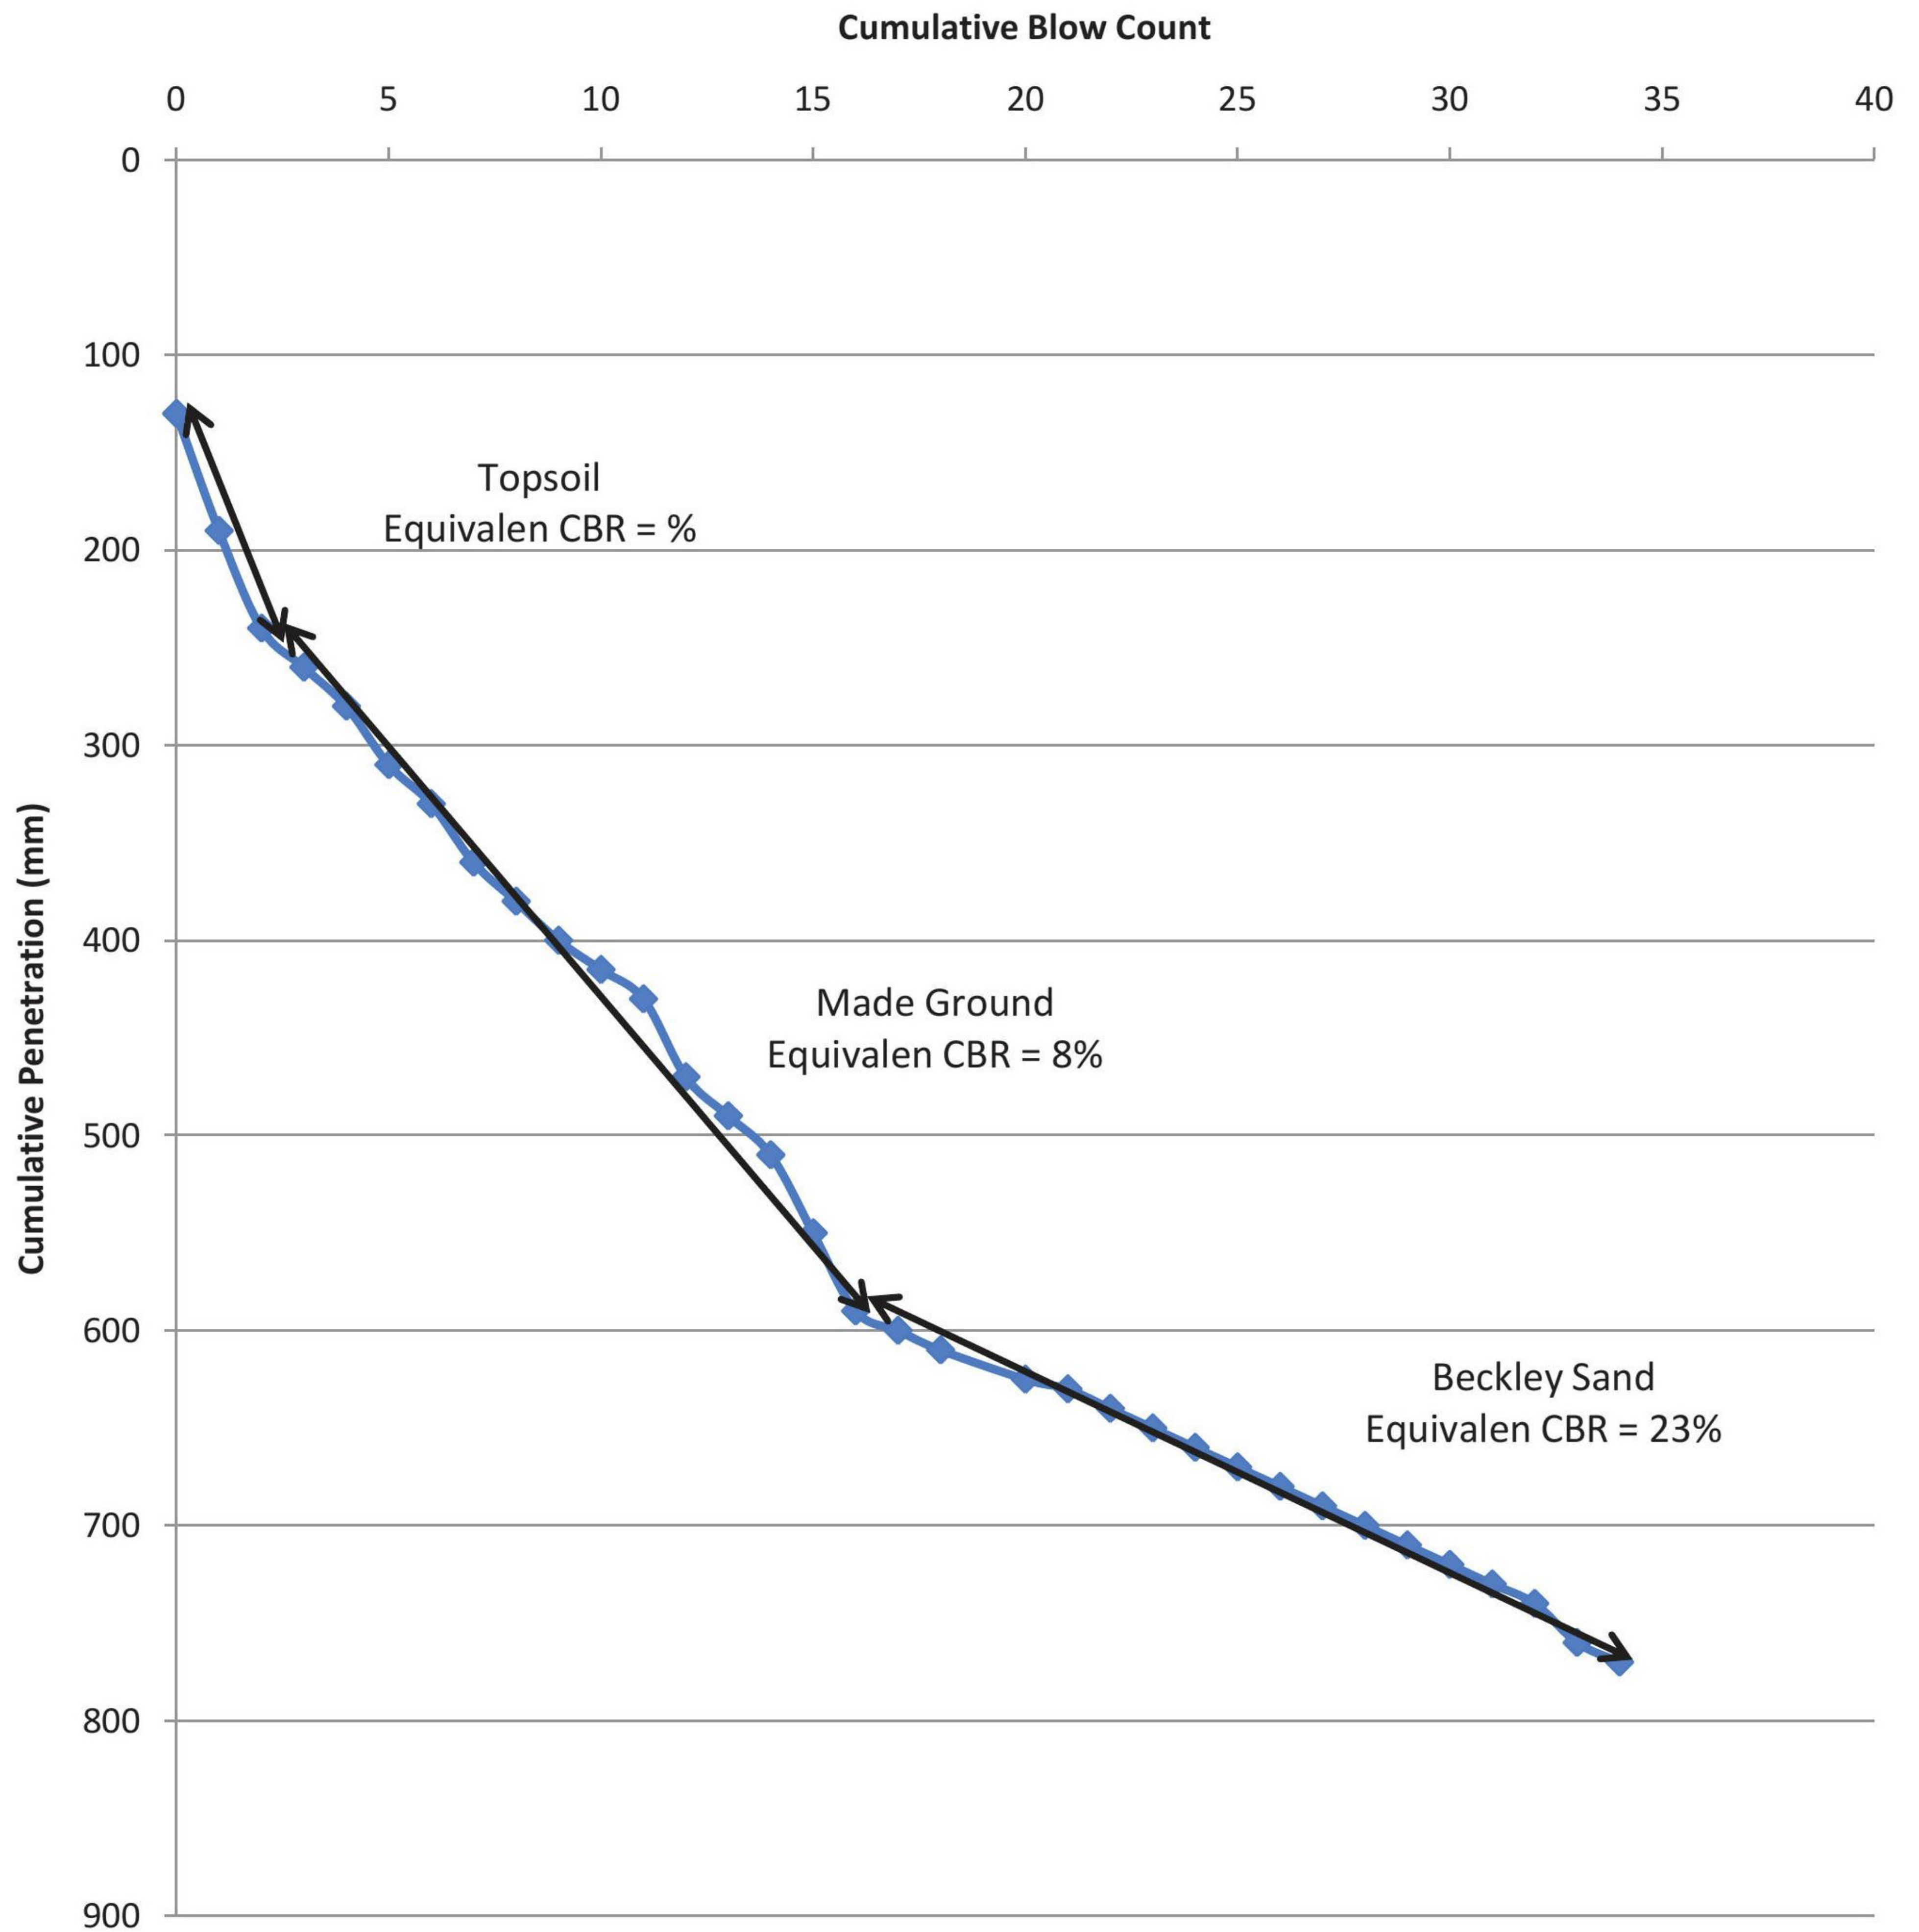
Job No:- 18-04-04  
Job Name:- Warnerford Hospital  
Position:- CBR3

## TRL DYNAMIC CONE PENETROMETER RECORD

### Cumulative Blows Vs Penetration (mm)
