## Ground Investigation Report

**Oxford Health  
NHS  
Foundation Trust**

**Warneford Hospital  
Warneford Lane  
Oxford  
Oxfordshire  
OX3 7JX**

**Report No: 18-04-04  
June 2018**

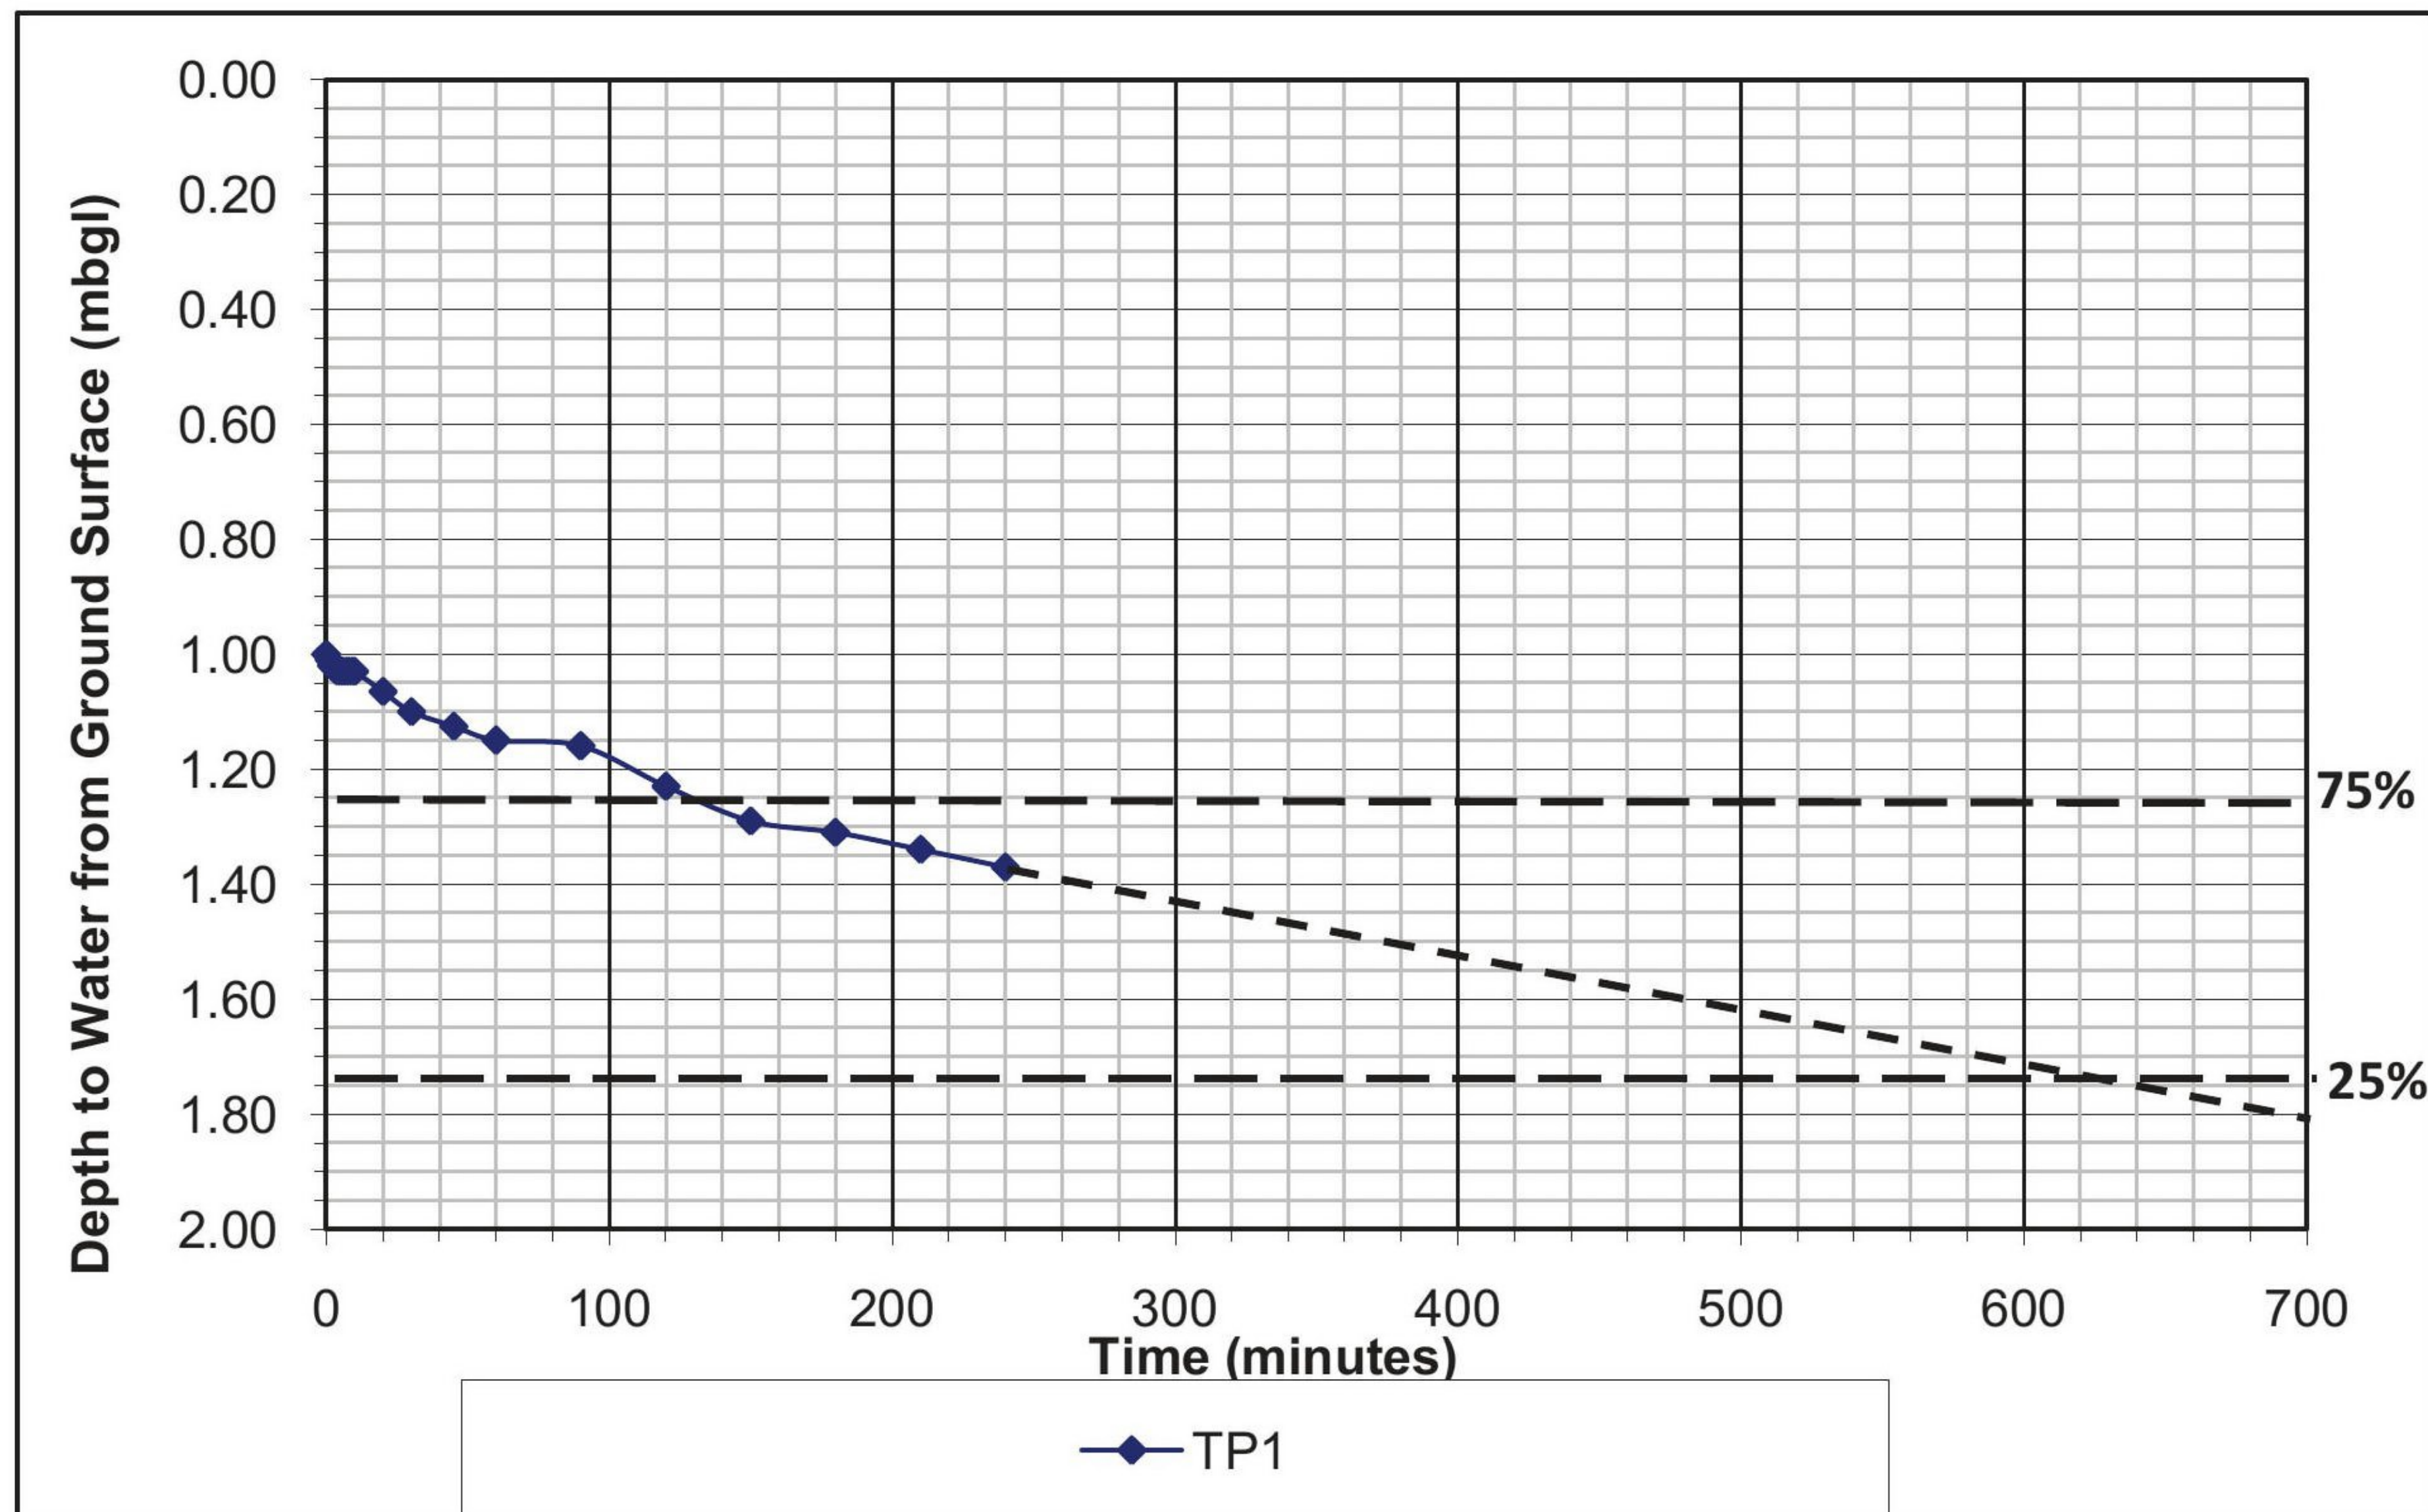
### Trial Pit Infiltration Testing to BRE Digest 365

**Client:** Oxford Health NHS Trust  
**Site:** Warnerford Hospital  
**Dimensions:** 0.30m x 1.50m x 2.00m  
(width x length x depth)

Time	Depth BGL	Time	Depth BGL	Time	Depth BGL
0	1.00	7	1.03	60	1.15
1	1.01	8	1.03	90	1.16
2	1.02	9	1.03	120	1.23
3	1.03	10	1.03	150	1.29
4	1.03	20	1.07	180	1.31
5	1.03	30	1.10	210	1.34
6	1.03	45	1.13	240	1.37

**Average Soil Infiltration Rate =  $3.40 \times 10^{-6}$  m/s**  
**Comments : Caution Results Extrapolated**

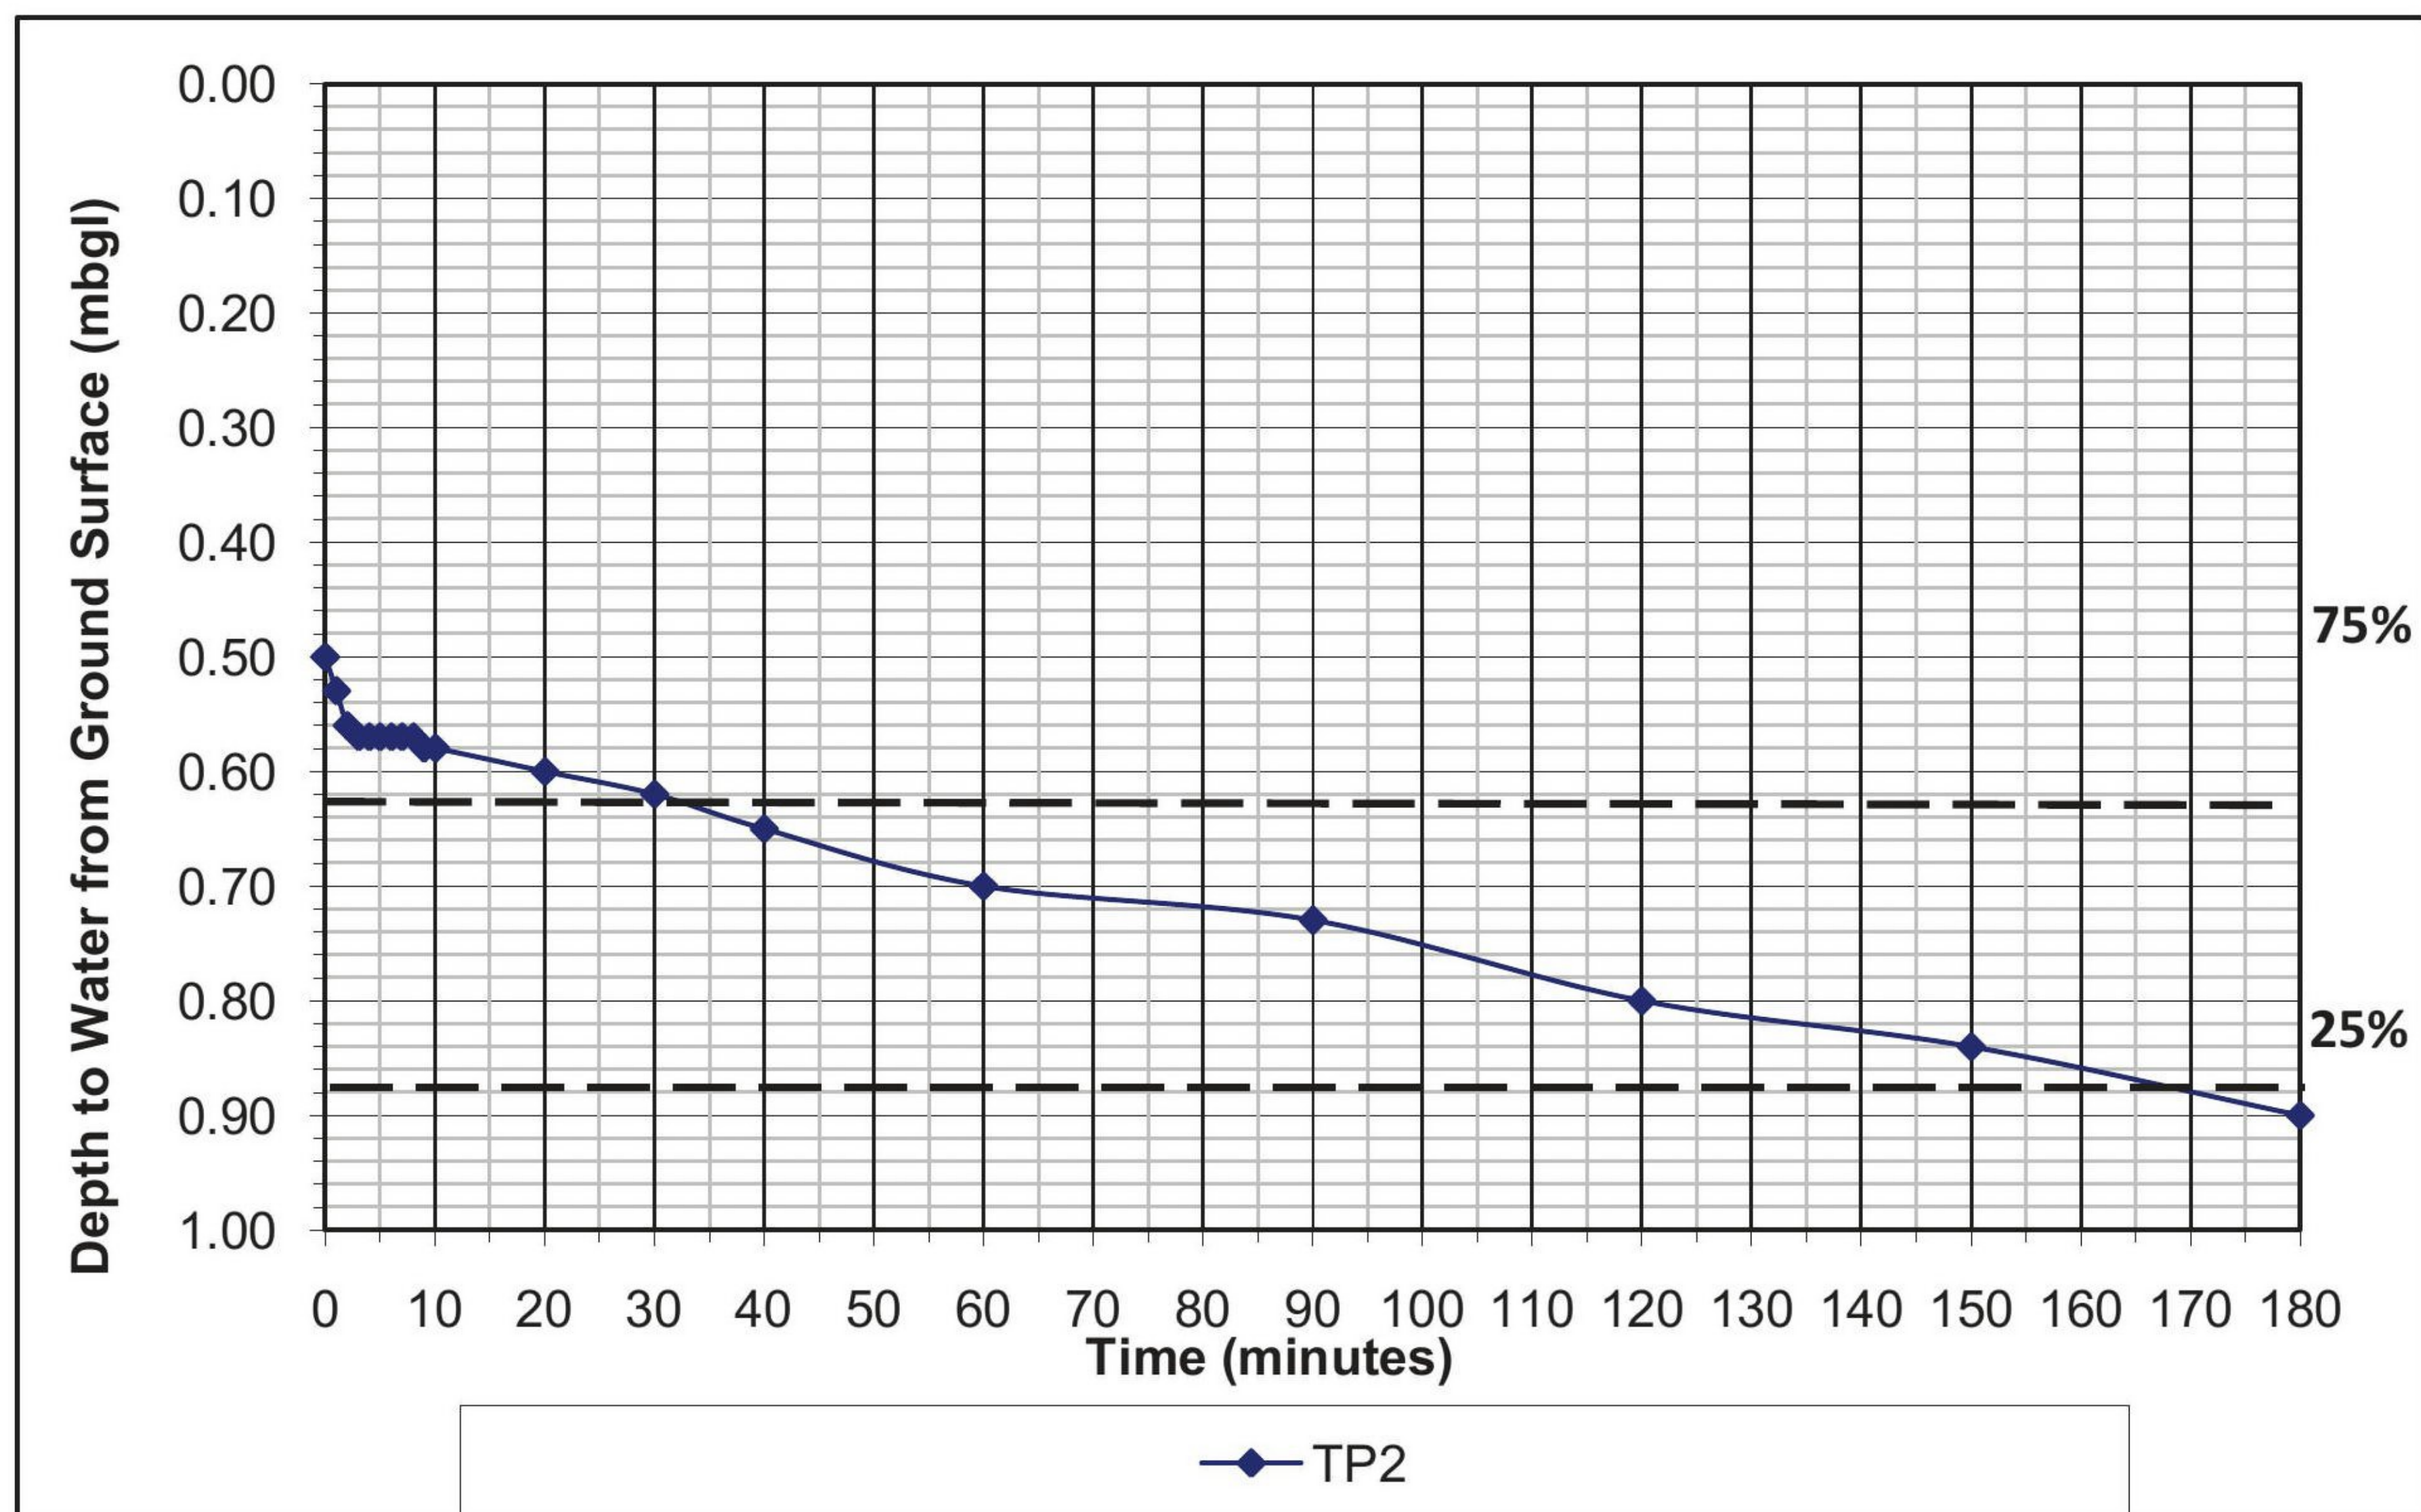
### Trial Pit Infiltration Testing to BRE Digest 365

**Client:** Oxford Health NHS Trust  
**Site:** Warnerford Hospital  
**Dimensions:** 0.30m x 1.30m x 1.00m  
(width x length x depth)

Time	Depth BGL	Time	Depth BGL	Time	Depth BGL
0	0.50	7	7.00	60	0.70
1	0.53	8	8.00	90	0.73
2	0.56	9	9.00	120	0.80
3	0.57	10	10.00	150	0.84
4	0.57	20	20.00	180	0.90
5	0.57	30	30.00		
6	0.57	40	40.00

**Average Soil Infiltration Rate =  $9.9 \times 10^{-6}$  m/s**
