Phase 1 Contaminated Land Desk Study Report

Site address: 127a Crescent Road
Cowley
Oxford
OX4 2NY

Report reference: 62378R1

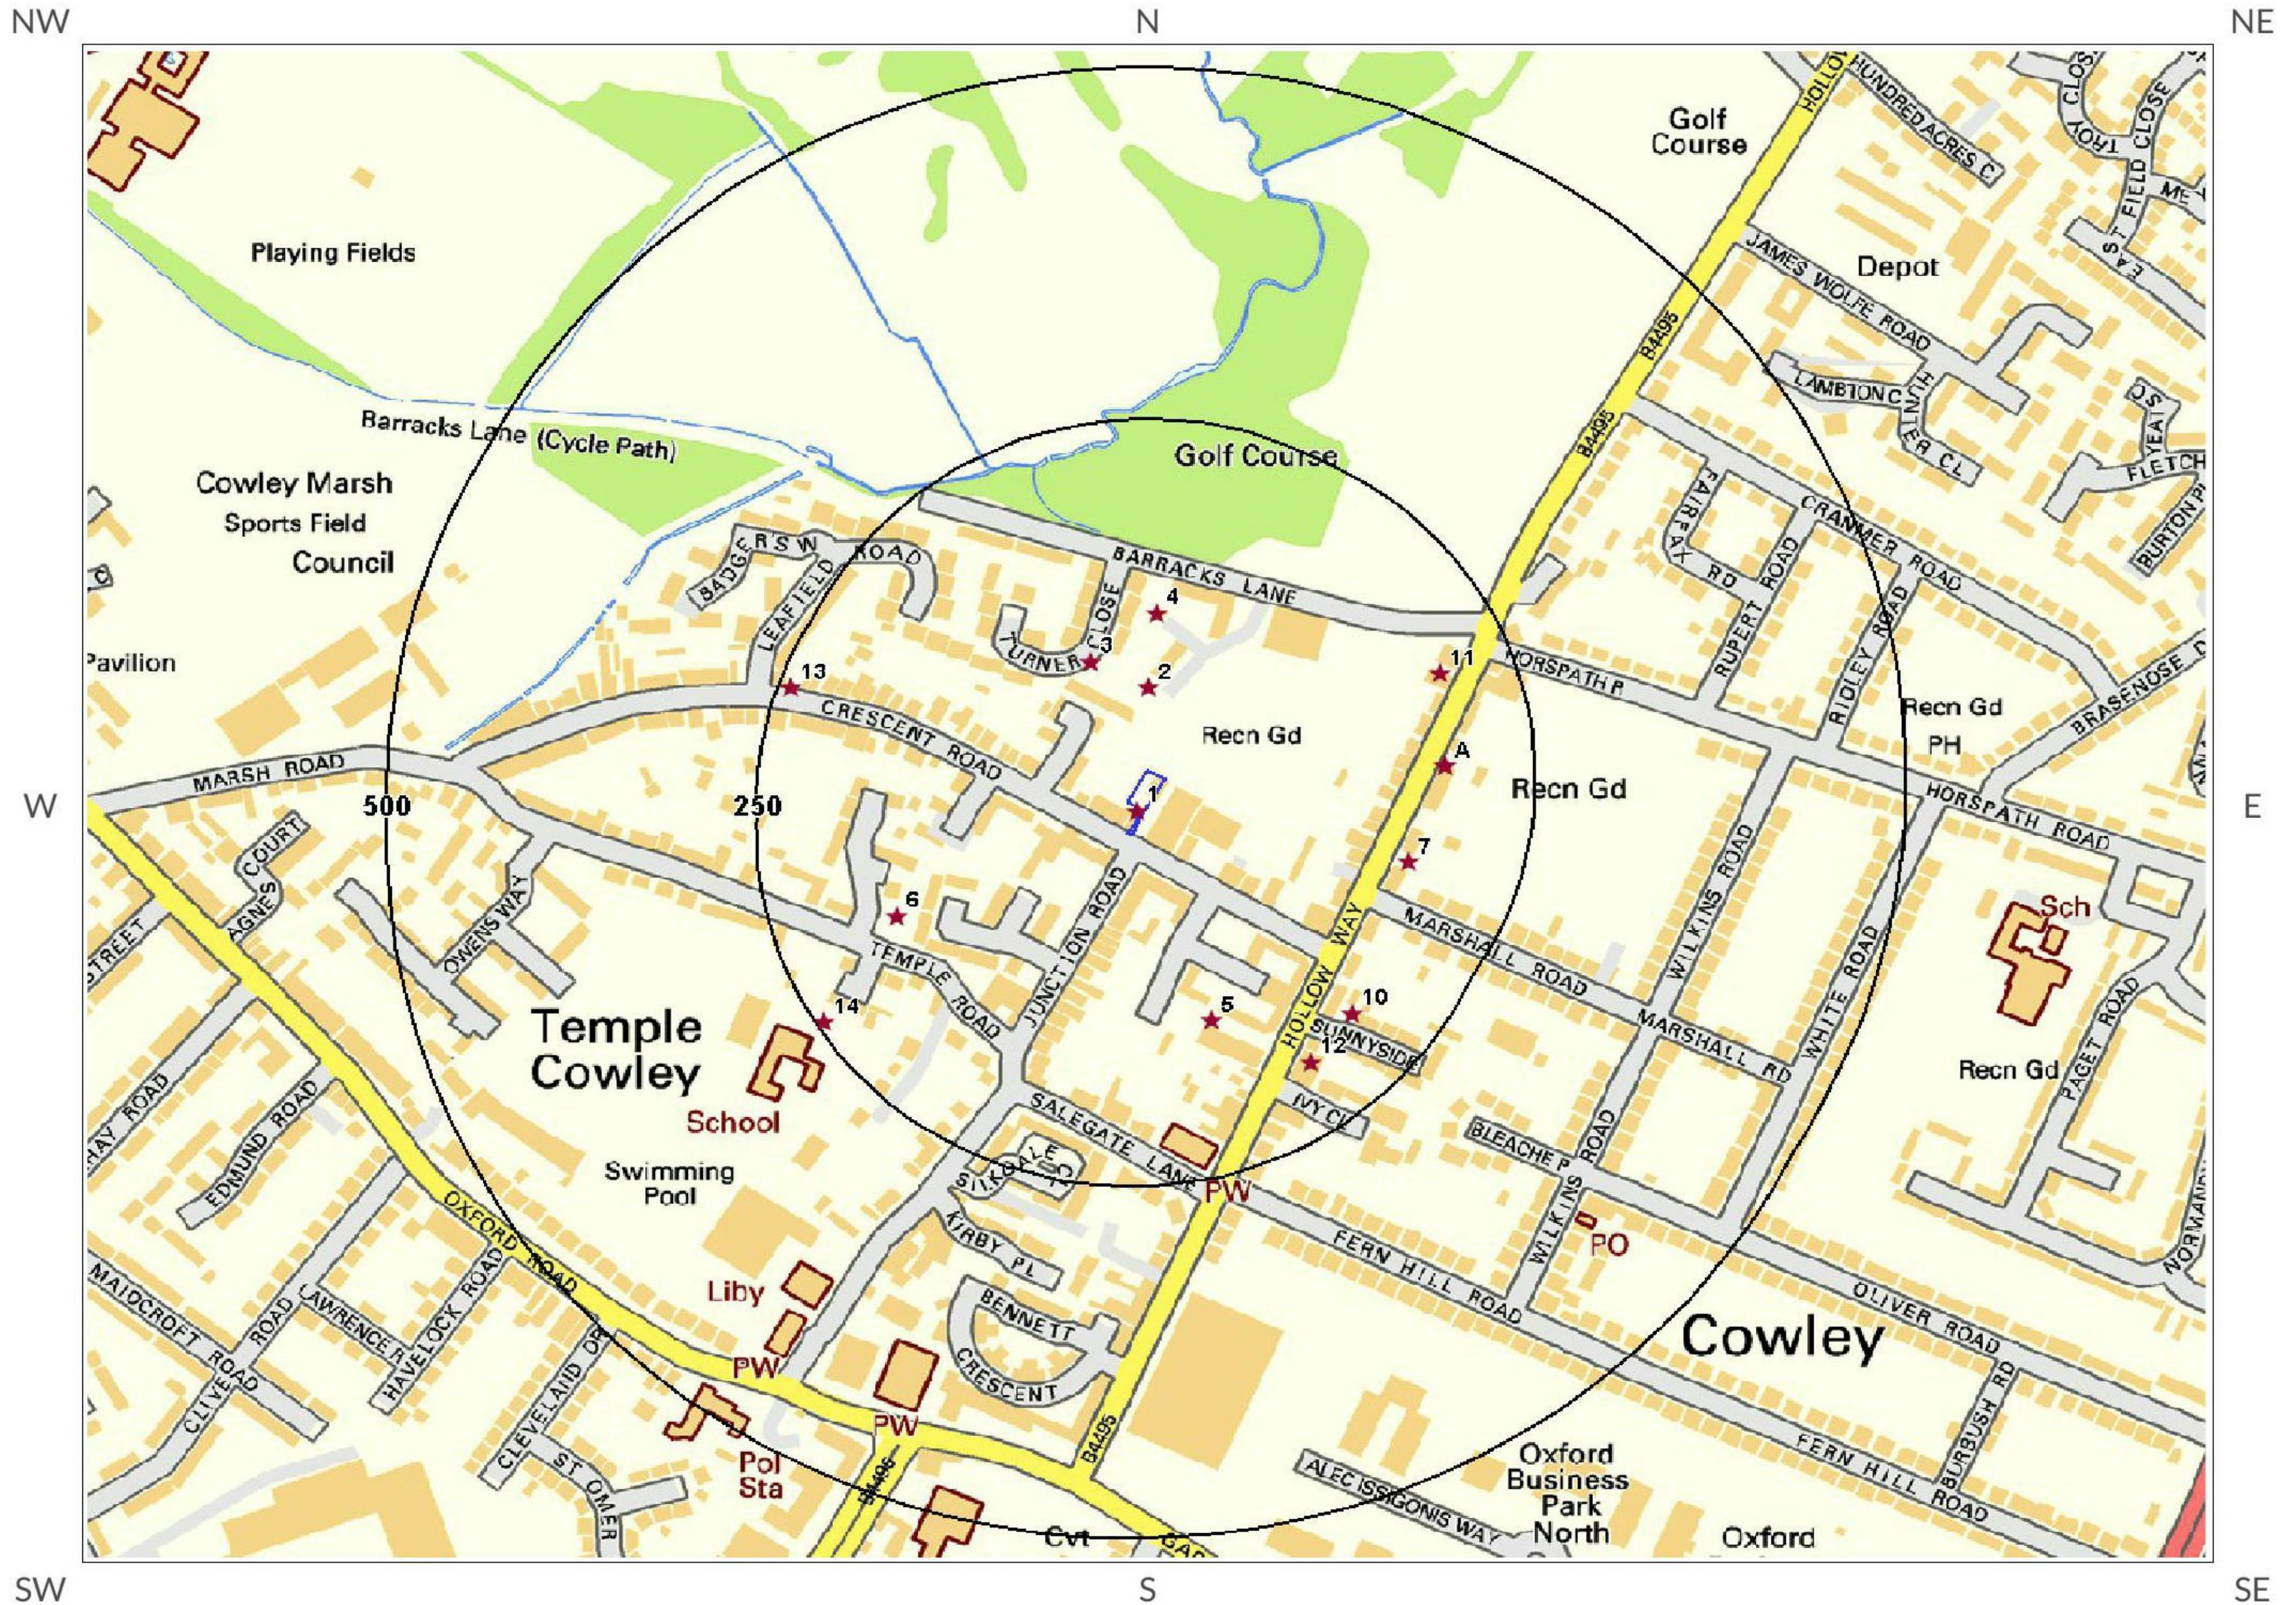
3. Current Land Use Map

Current Land Use Legend

ID	Distance (m)	Direction	Company	NGR	Address	Activity	Category
1	3.0	SW	Crescent Road Garage Ltd	454665 204682	127, Crescent Road, Oxford, OX4 2NY	Vehicle Repair, Testing and Servicing	Repair and Servicing
2	59.0	N	Electricity Sub Station	454674 204770	OX4	Electrical Features	Infrastructure and Facilities
3	86.0	NW	Electricity Sub Station	454635 204788	OX4	Electrical Features	Infrastructure and Facilities
4	112.0	N	Miniature Rifle Range	454679 204823	OX4	Shooting Facilities	Sports Complex
5	142.0	S	Electricity Sub Station	454716 204533	OX4	Electrical Features	Infrastructure and Facilities
6	167.0	W	Electricity Sub Station	454504 204607	OX4	Electrical Features	Infrastructure and Facilities
7	174.0	E	Electricity Sub Station	454849 204646	OX4	Electrical Features	Infrastructure and Facilities
8A	189.0	E	Dunn Car Sales Ltd	454874 204713	138, Hollow Way, Cowley, Oxford, OX4 2NL	Secondhand Vehicles	Motoring
