239945-PUR-00-00-DR-A-3008

PROJECT Reuben College

TITLE Reuben College External Elevations Remedial Works

Temporary Works for Support Scaffolding Above Museum Store

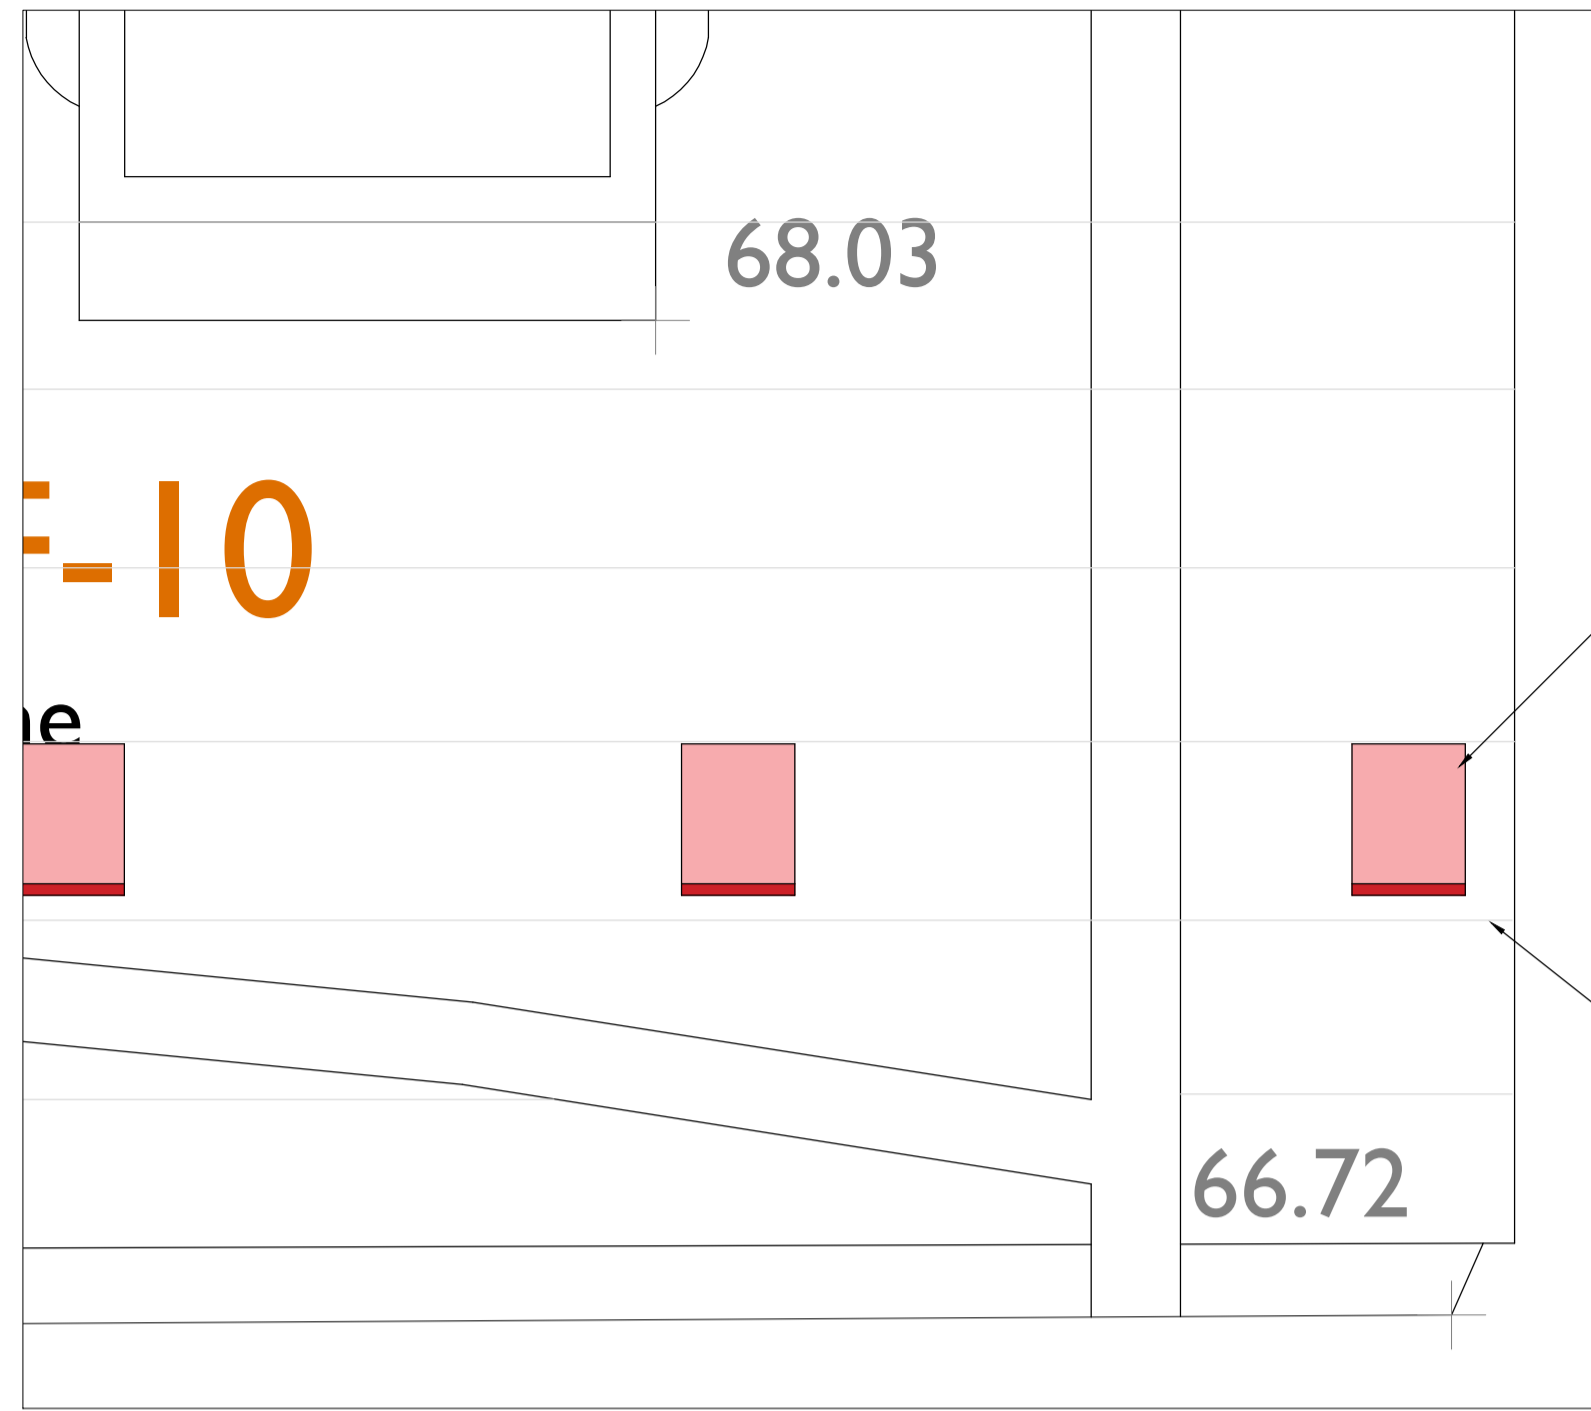
Brackets to be left in place for future use.

Refer to Stantec drawing no 48961-STR-TVV-SK006 for location and details of structural steel. Bracket to be colour RAL 1002 (Sand) in order to more closely match the colour of the existing wall beyond.

Extent of wall penetration to be limited to the extent of the anchor penetrations. Stone to be carefully cut out to limit damage to adjacent stone. Make good any damage around opening. Reinststate matching stone following Purcell specification clause F10.665

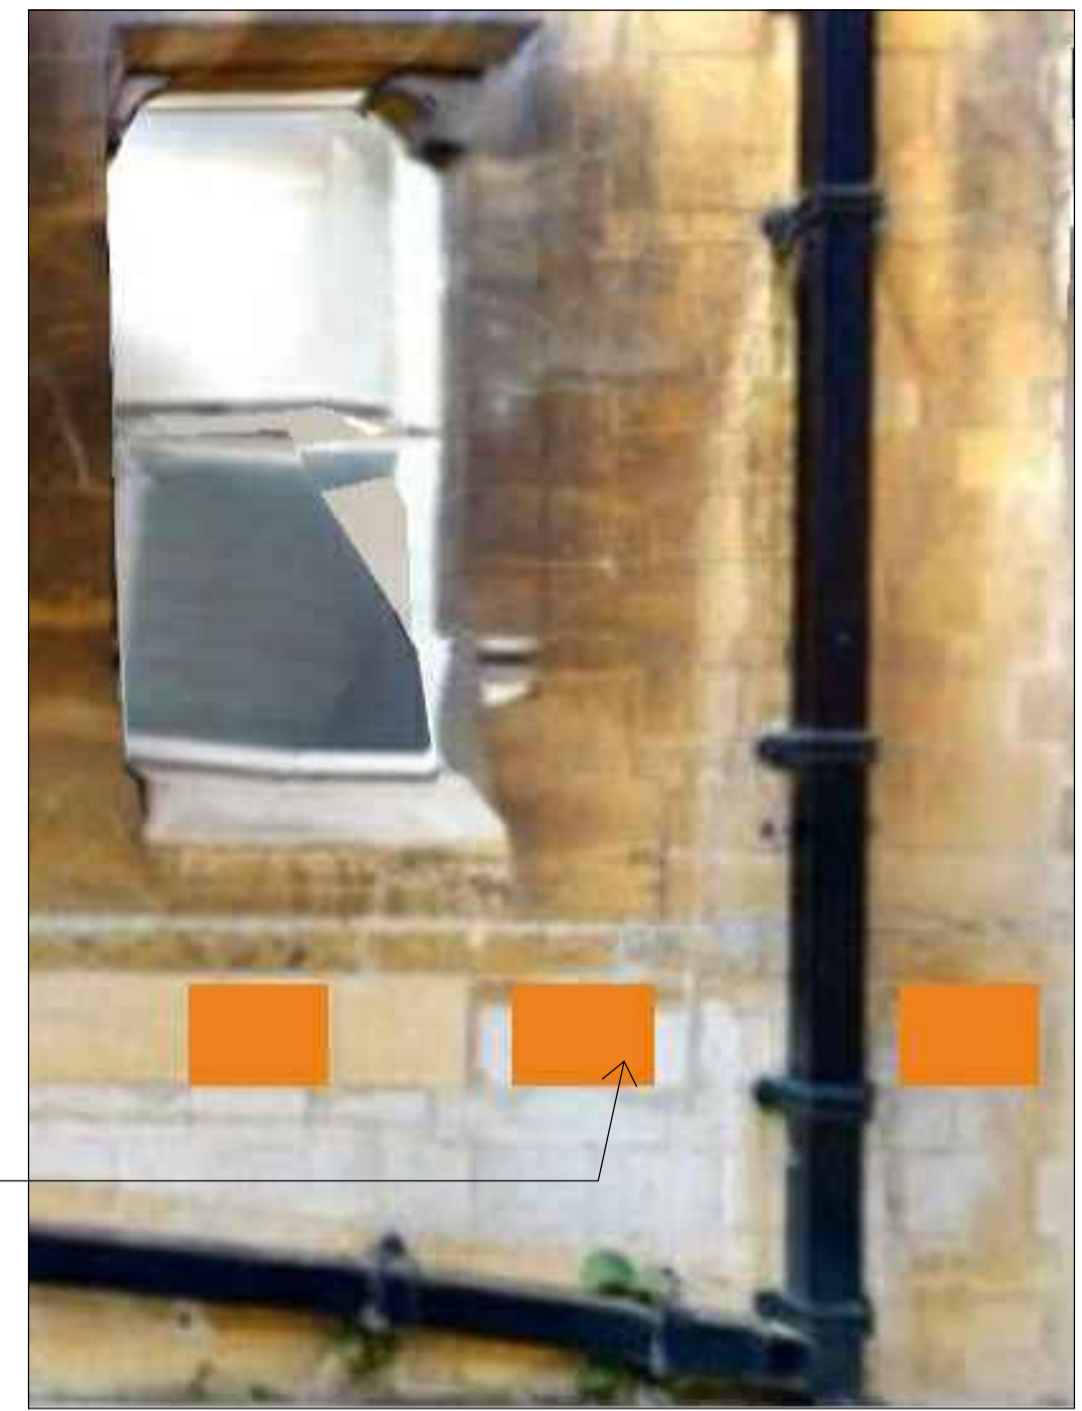
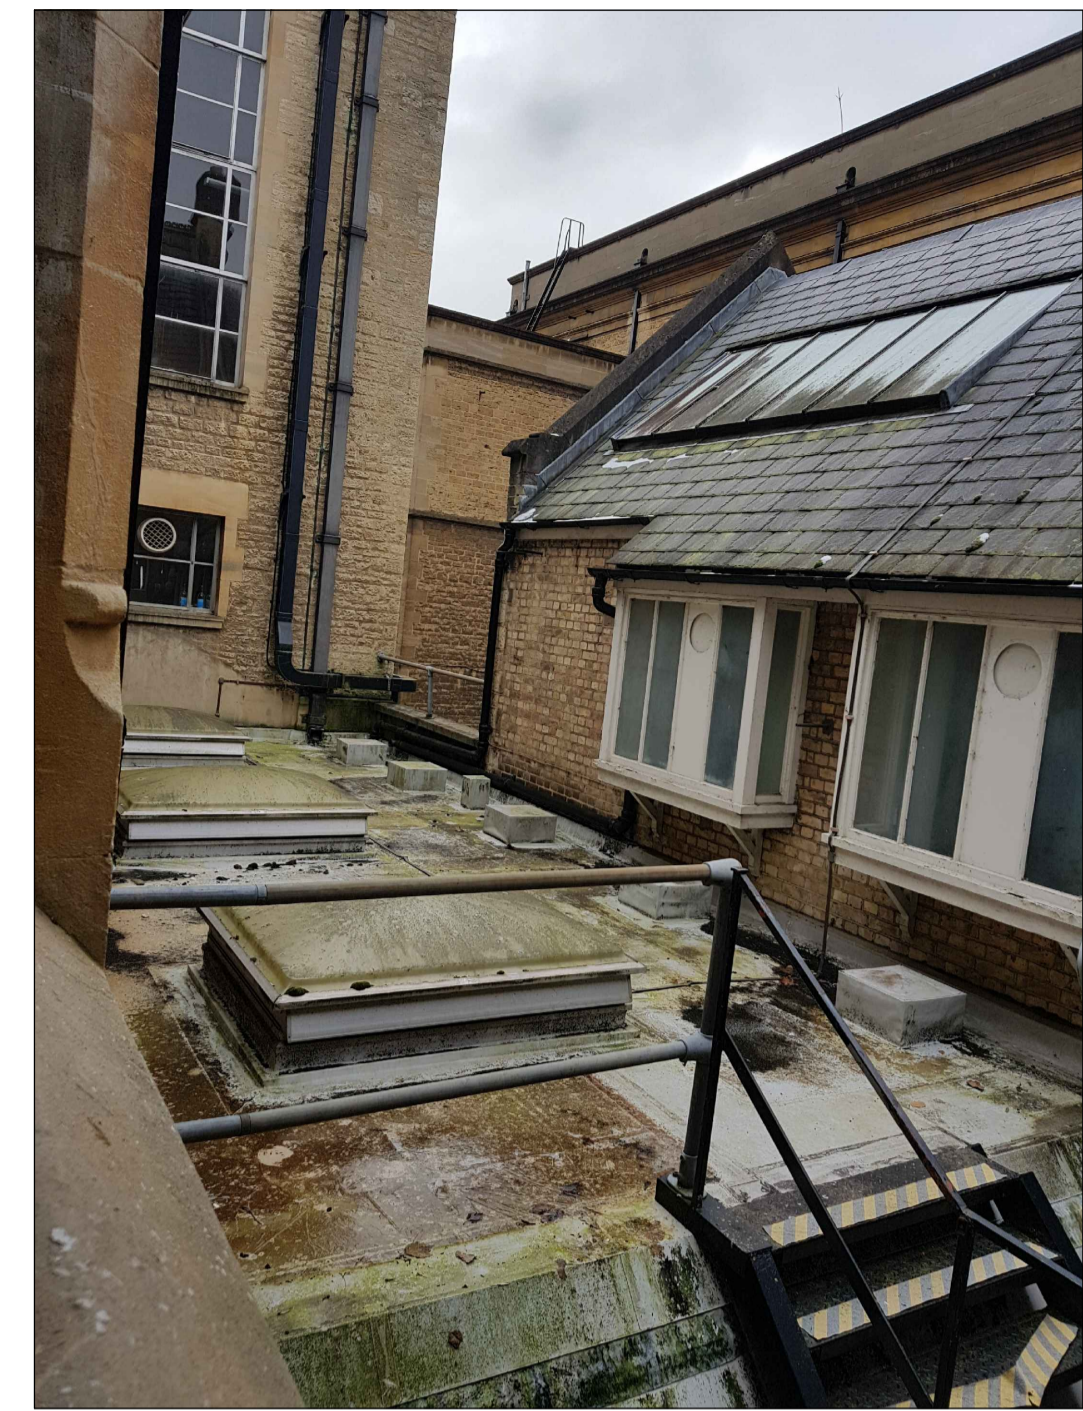
Site photograph of Purcell elevation I2 (viewport no 2/3008 below)
