Marshall Road, Oxford

Preliminary Ecological Appraisal and Bat Survey

May 2020

Bioscan Report No.
E2015r2

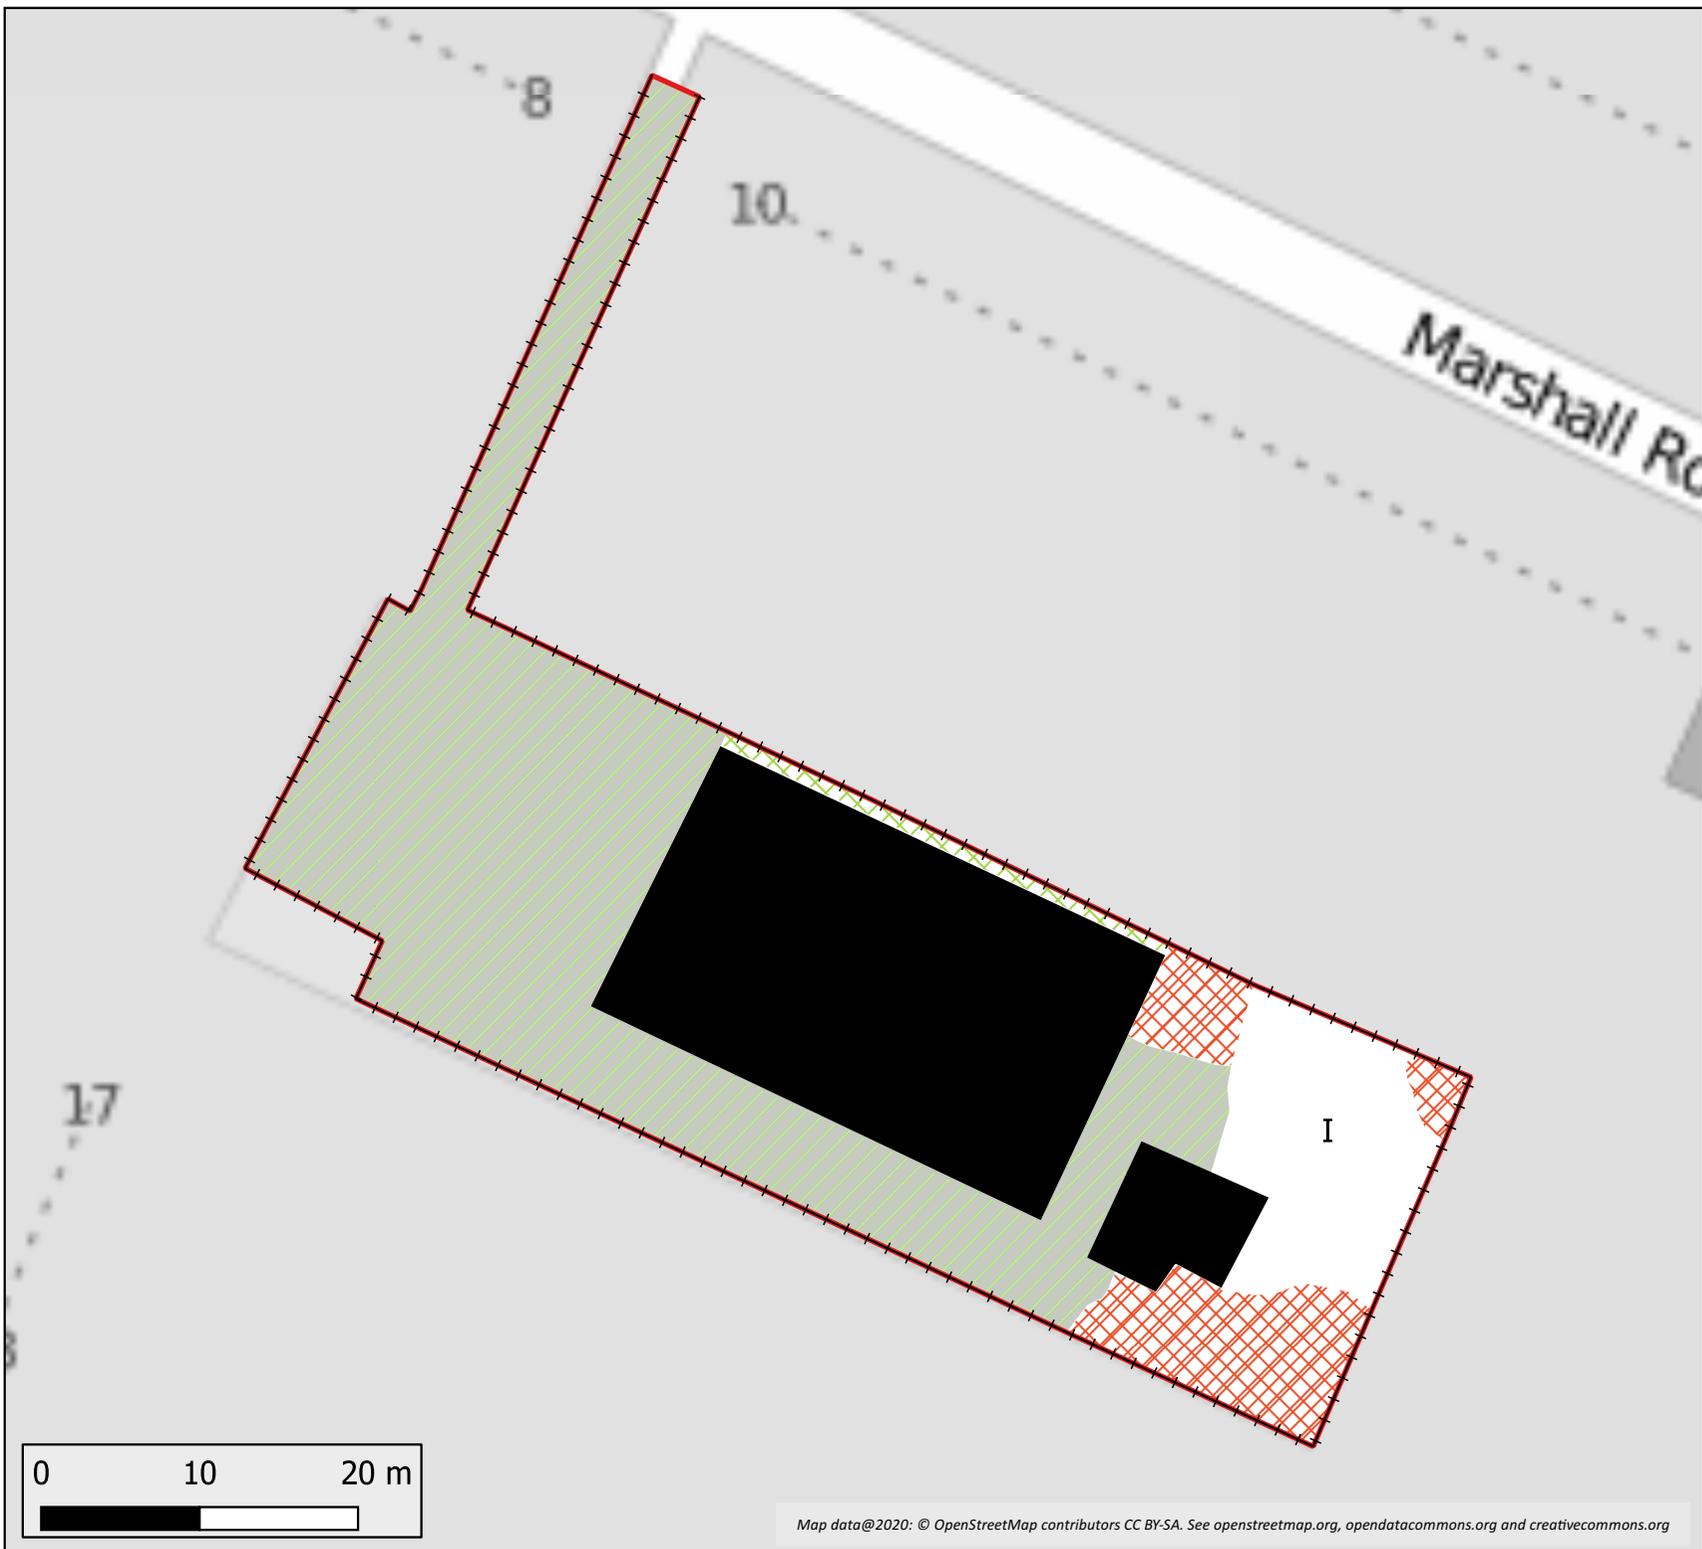
Title
Habitat map

2.2.2 Each habitat is mapped on Figure 1, with the characteristic species described below. See appendix 1 photos 1-5 for images of the habitats found on site.

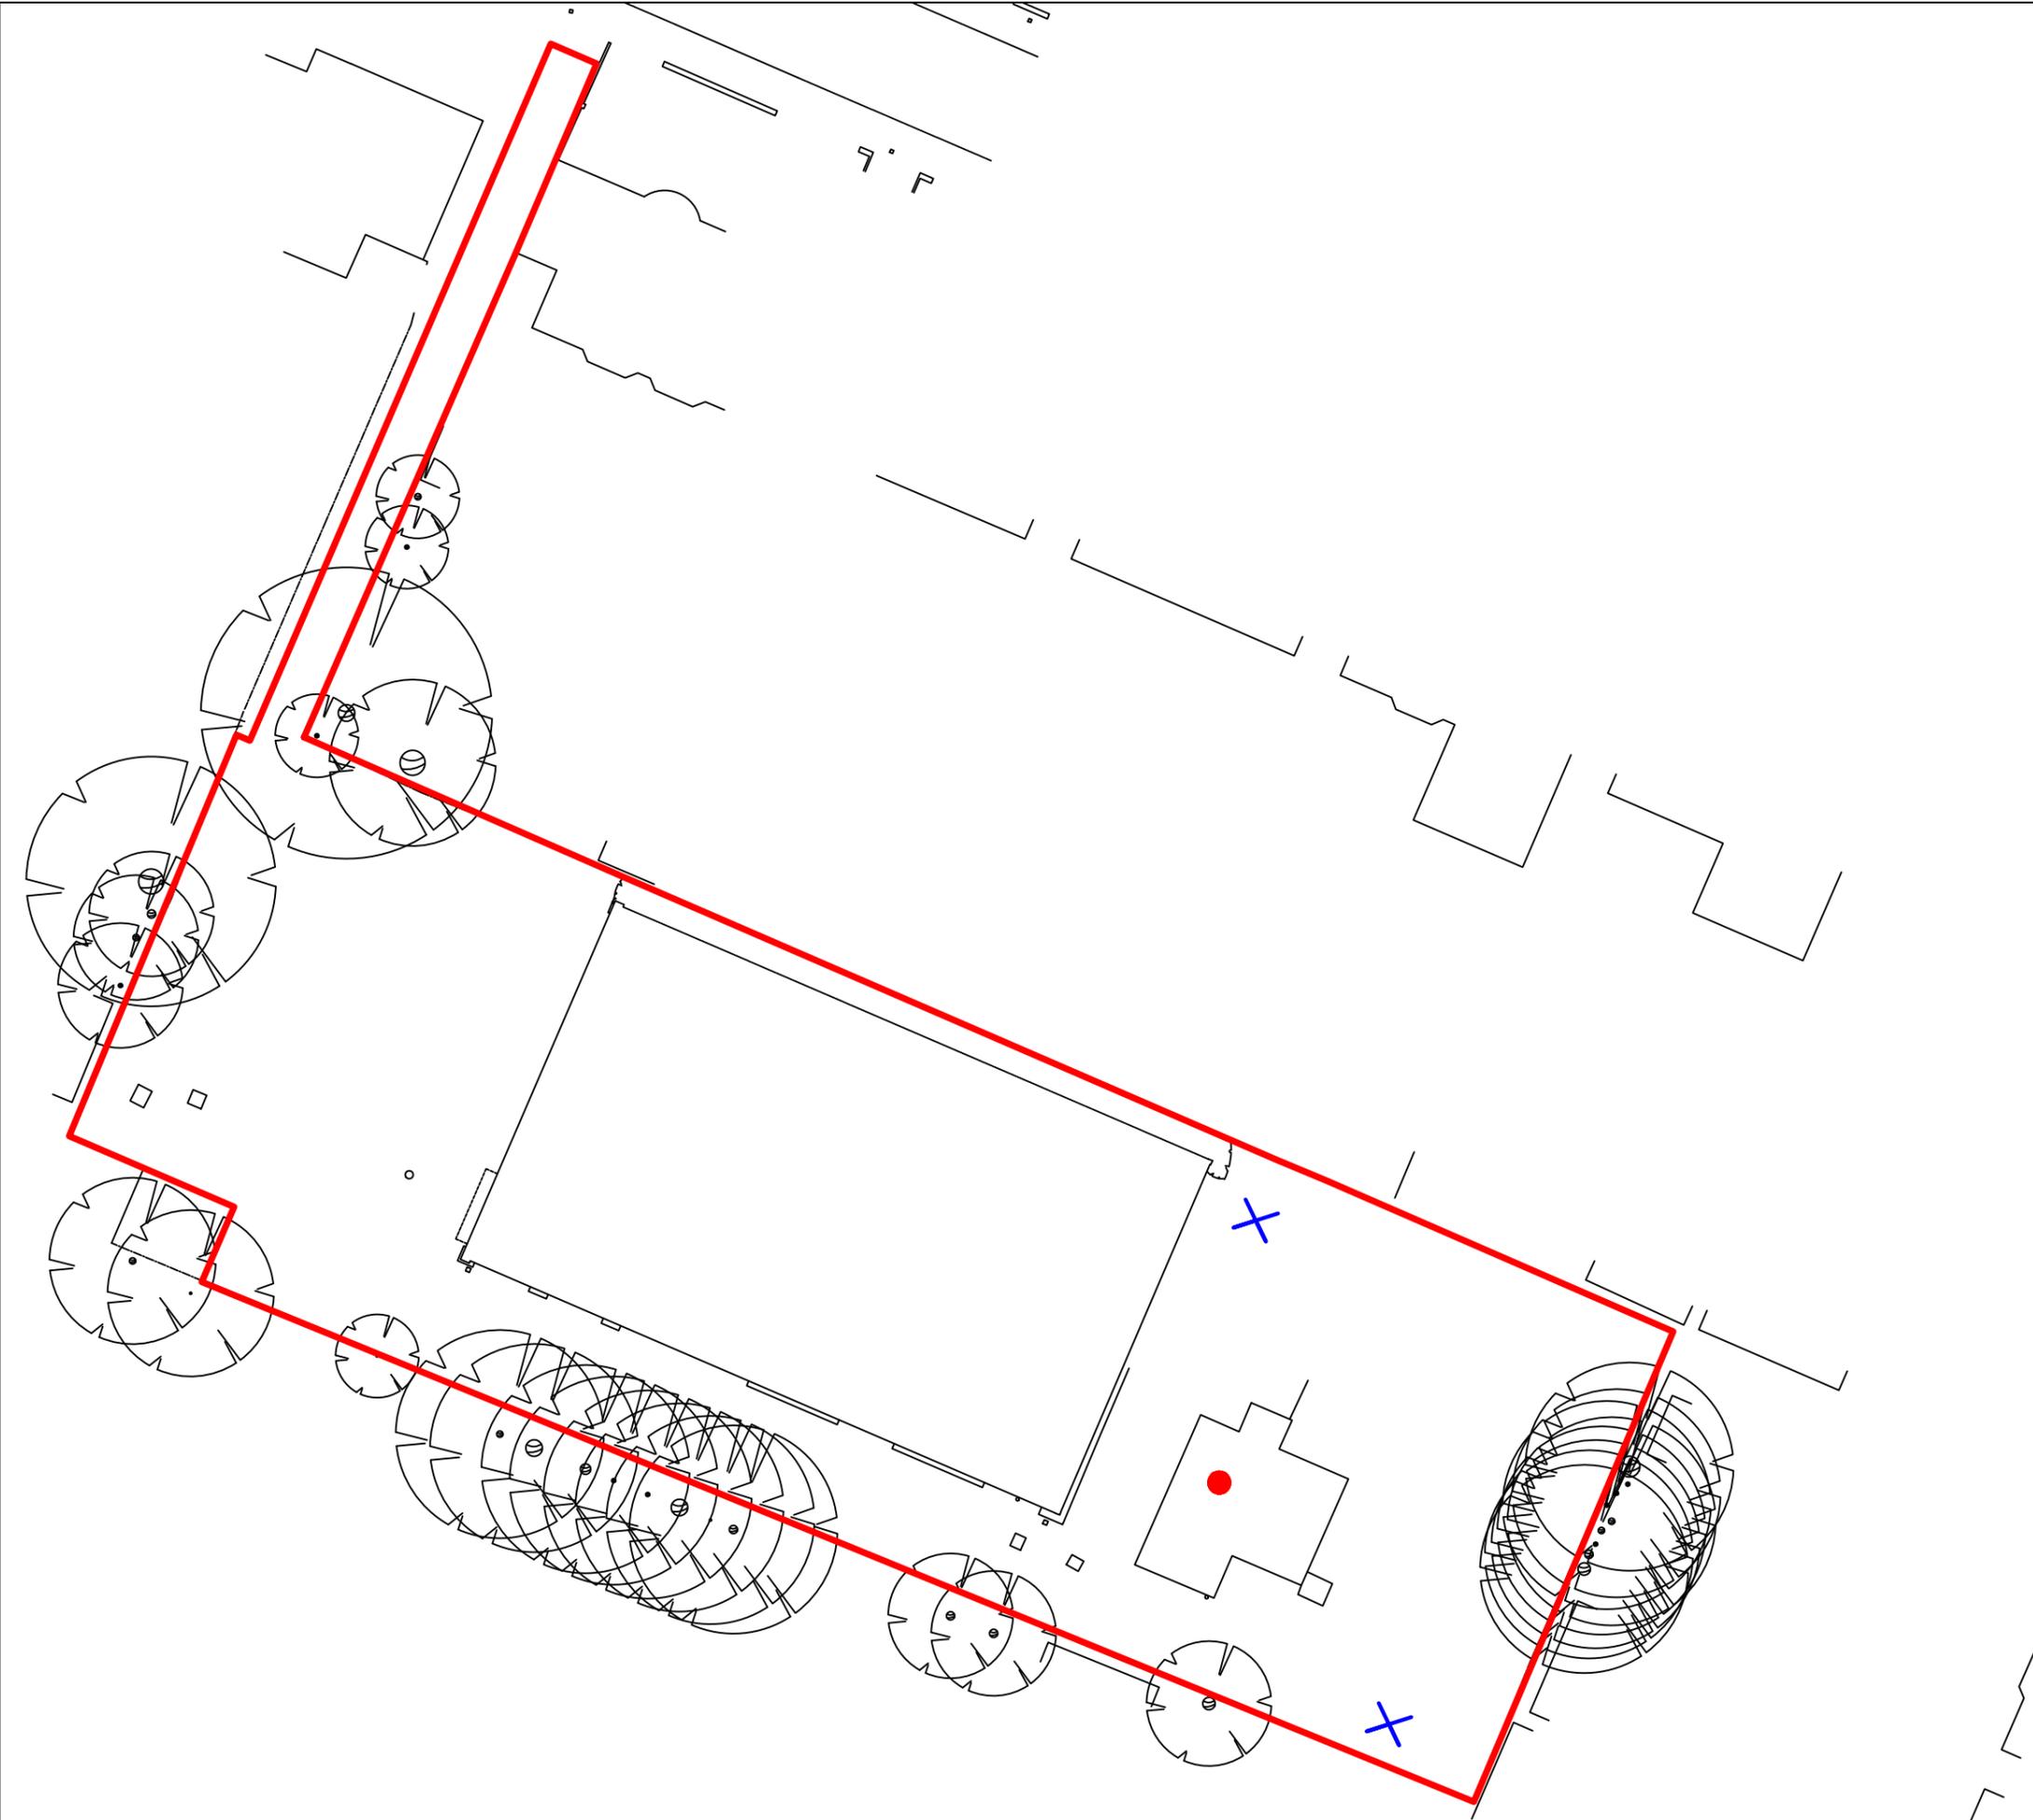
| Bat survey | | |

2.4.1 The emergence surveys were carried out on 27th April and 12th May 2020. The position of the surveyors during each survey is shown on Figure 2. The survey conditions are provided in Table 1 below.

- 2.4.2 A single common pipistrelle bat was recorded emerging from the northern elevation of the building (see Figure 2 and Photo 12) at 20:30 during the first dusk survey. Examination of this location prior to the start of the second survey suggests that the roost location is at the wall top.
- 2.4.3 No other activity was detected during either survey that would indicate a roost at other locations on the building. Other bats detected during the survey include a small number of common pipistrelle passes and a single noctule registration.

- 4.2.2 On the basis that a single bat was detected emerging from the roost, it is assessed to be of low conservation significant and licencing in this instance can be by way of the low impact class licencing system. Mitigation for the loss of this roost is recommended to be in the form of bat brick installed into one of the proposed buildings. This should be installed at eave height and with a south or south-westerly aspect.

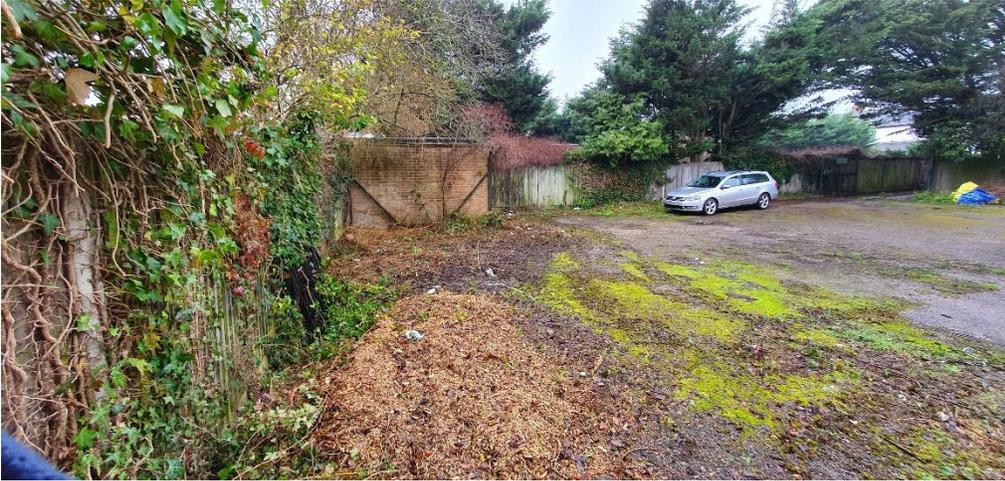
2.2.3 The majority of the site consists of hardstanding, with much of this being covered in a thin layer of mud/soil which has allowed some colonisation by opportunistic species. Grasses recorded include Yorkshire fog (*Holcus lanatus*), common bent (*Agrostis capillaris*), cock's-foot (*Dactylis glomerata*), and smooth meadow grass (*Poa pratensis*).

Photo 1: Hardstanding at western end of the site

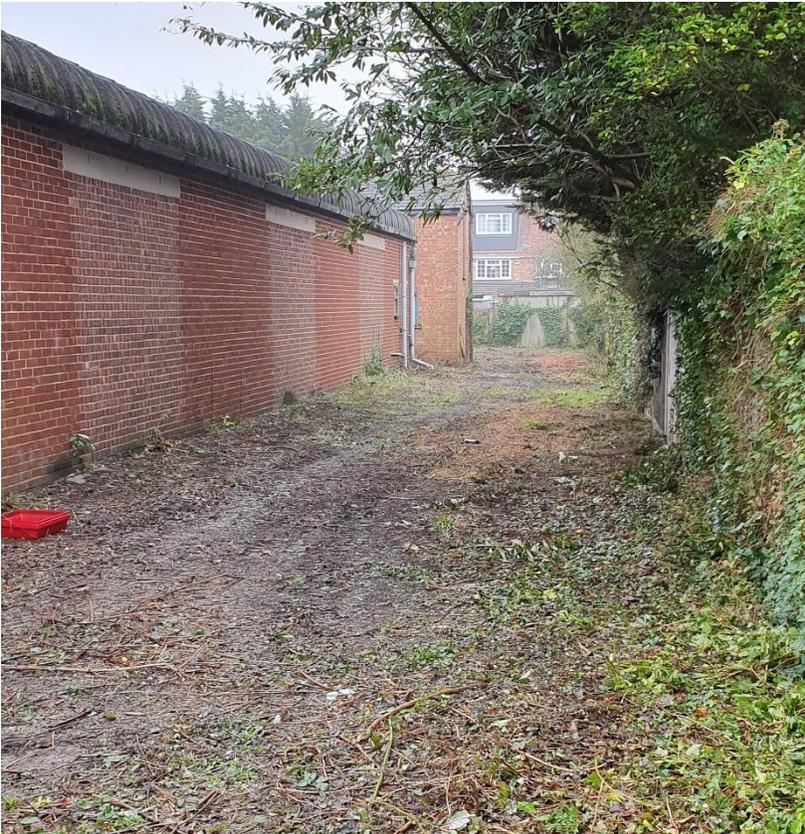
Photo 2: Hardstanding along the southern site boundary

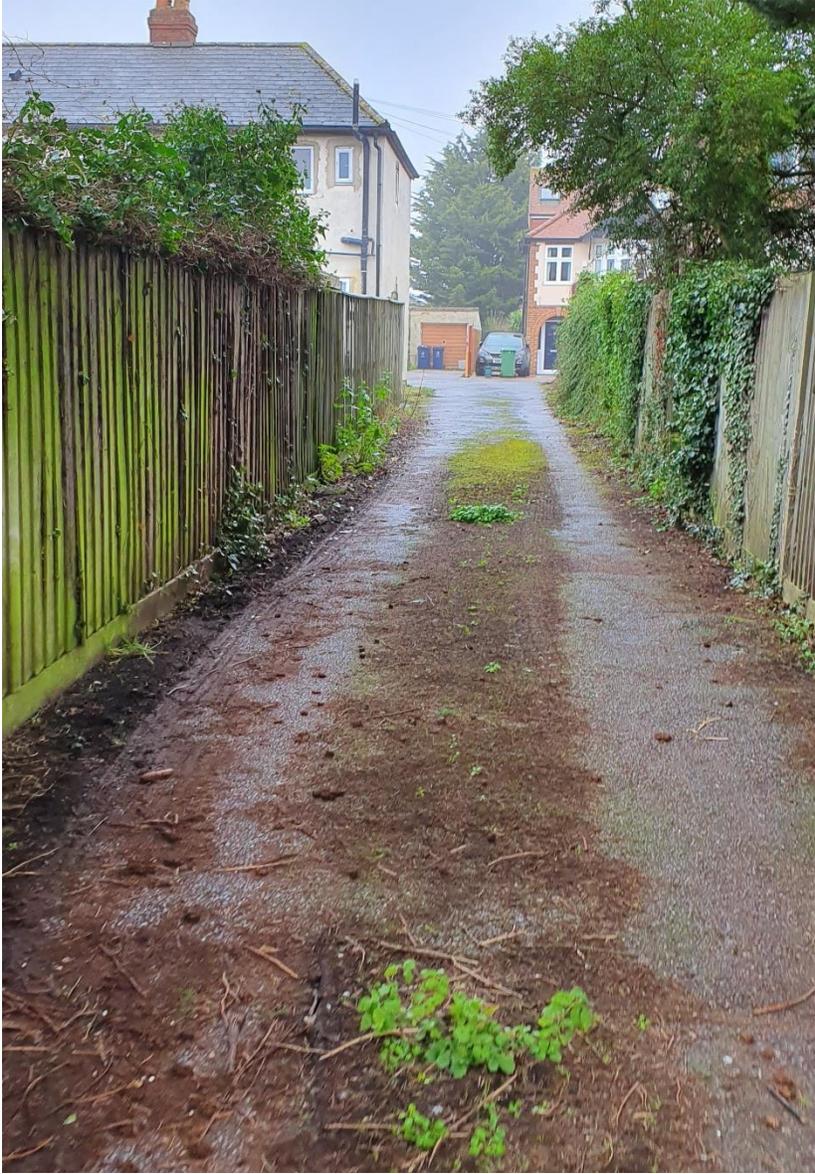
Photo 3: Hardstanding along site access road

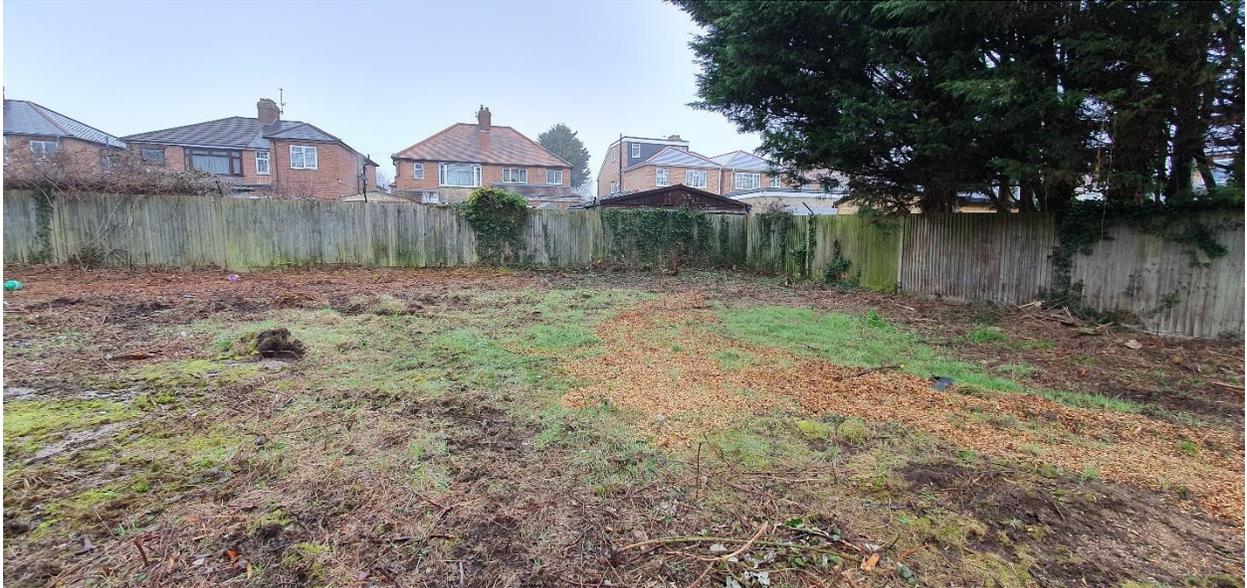
- 2.2.7 At the eastern end of the site there is an area of outgrown, improved grassland that looks to have once been the garden of the now derelict house. The grassland was species poor consisting mostly of common bent, Yorkshire fog and smooth meadow grass. Ribwort plantain, white clover (*Trifolium repens*), dove's foot cranesbill and cleavers were also found throughout, although as a relatively small component of the overall sward.

- 2.2.8 Adjoining the improved grassland to the south, north-east and north-west were areas of disturbed ground. These appear to have been bramble thickets have been recently cut down, with the ivy dominated ground flora now uncovered.

Photo 4: Improved grassland showing areas of disturbed ground

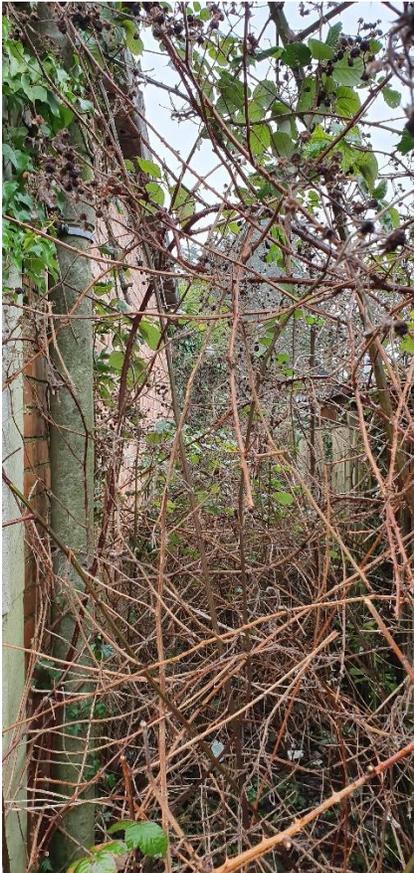
- 2.2.9 At the north of the site, between the warehouse and the northern boundary fence, there is narrow strip of dense bramble. Other species noted to be present here included cleavers and ivy.

Photo 5: Bramble between the warehouse and northern site boundary

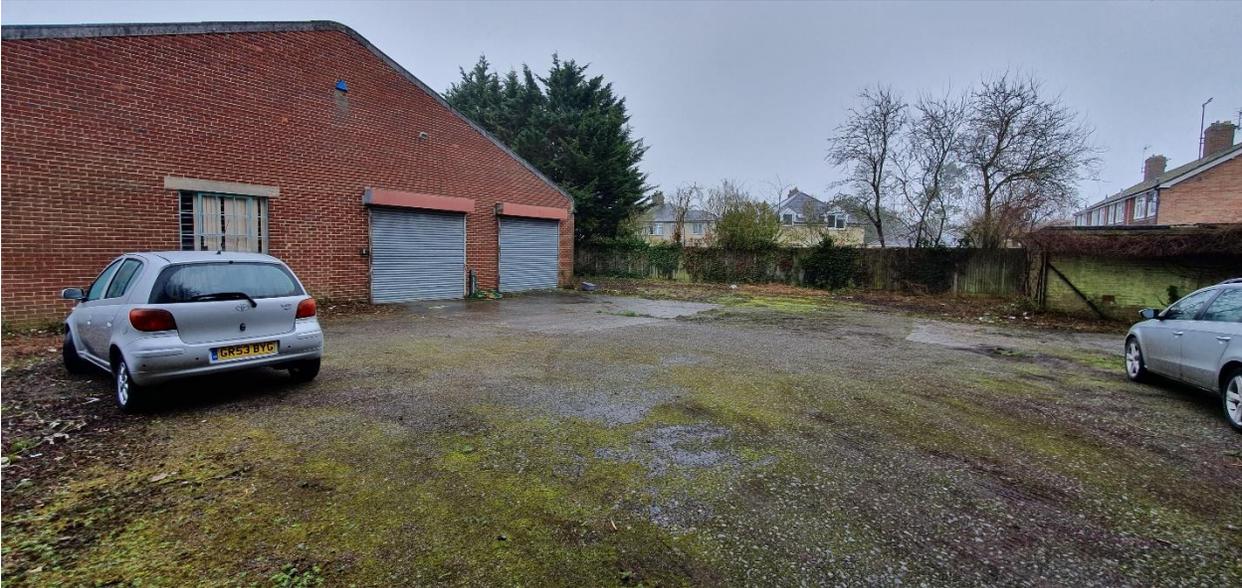
2.3.4 Externally, the brickwork was generally in good condition with no obvious gaps or cracks. The only potential roost location noted was a narrow gap between the fascia and top of the gable on the western end.

Photo 6: Western aspect of the warehouse

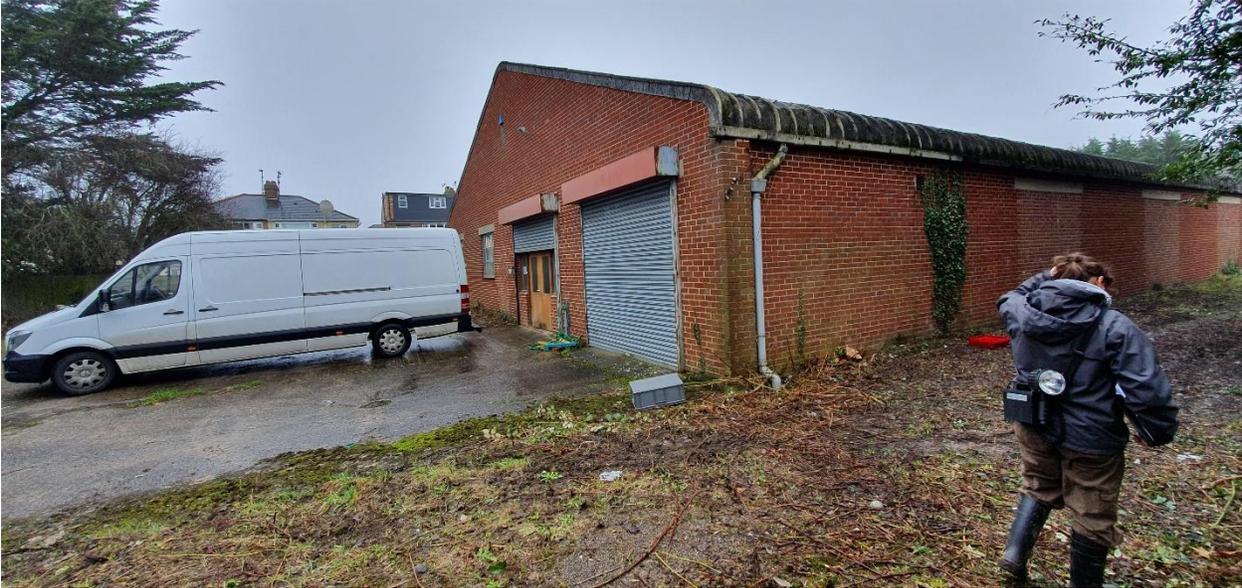
Photo 7: Southwestern aspect of the warehouse

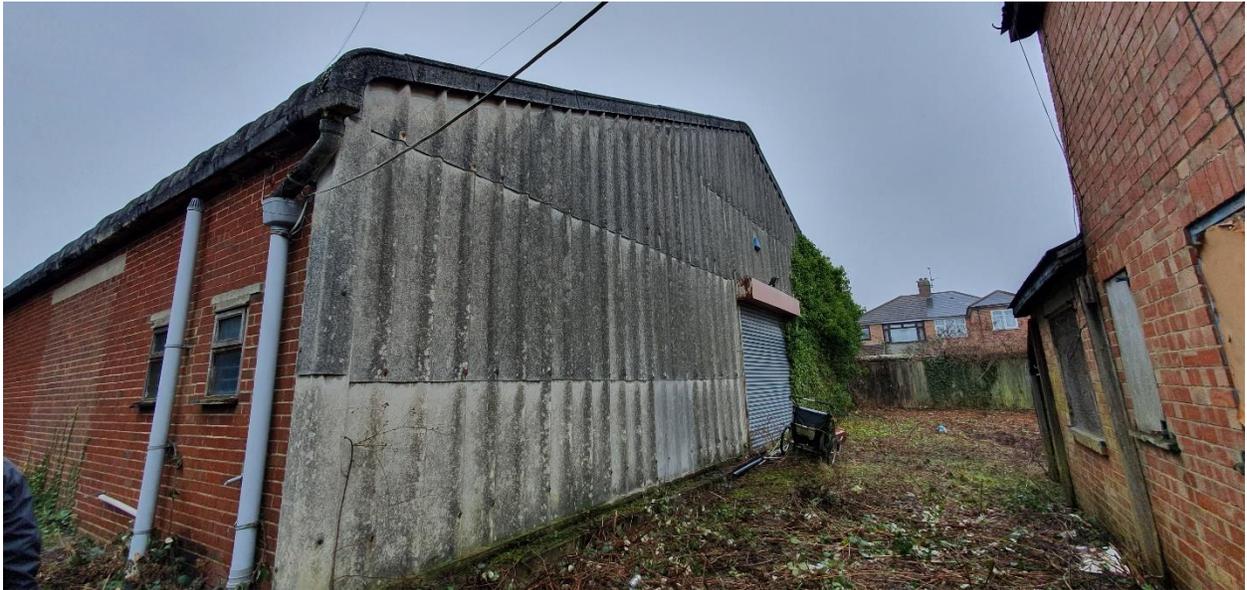
Photo 8: Eastern aspect of the warehouse

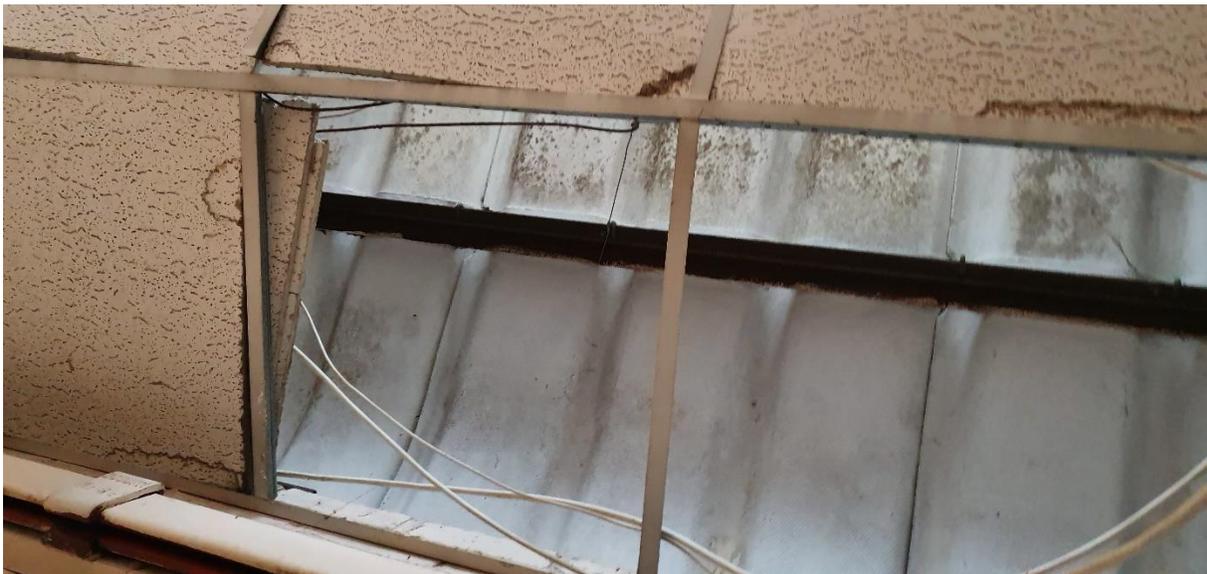
- 2.3.2 The warehouse is a single-story, predominately red brick building with gable ends and a shallow pitched roof. It has a metal profile roof with four strips of sky lights running the length of the roof.
- 2.3.3 Internally, the building lacks a contained roof void, although there is shallow gap between the roof covering and internal false ceiling. This was not accessible for detailed inspection but missing ceiling tiles in places allowed the space to be viewed

confirming that the building has an internal metal frame which is unlikely to provide any significant roosting potential. The rest of the interior of the building was well lit due to the skylights.

Photo 9: Missing ceiling tile showing metal frame and lack of insulation between the metal roof and internal ceiling

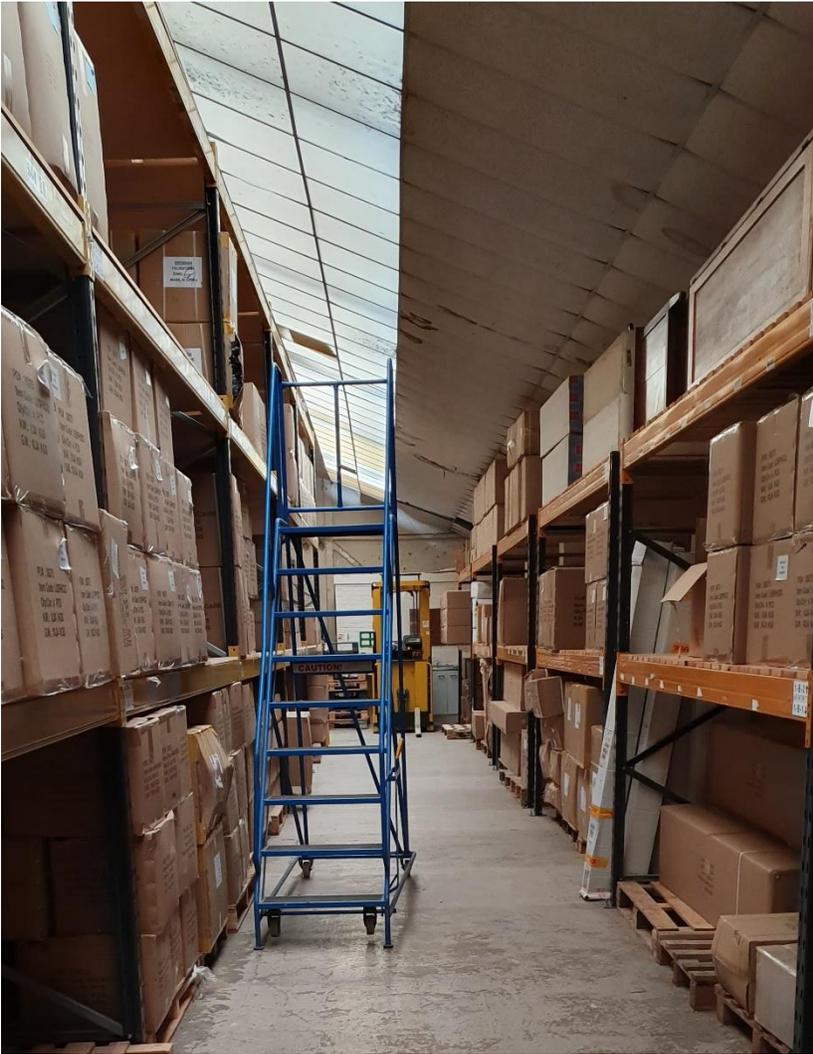
Photo 10: Inside the warehouse illustrating it's use for storage

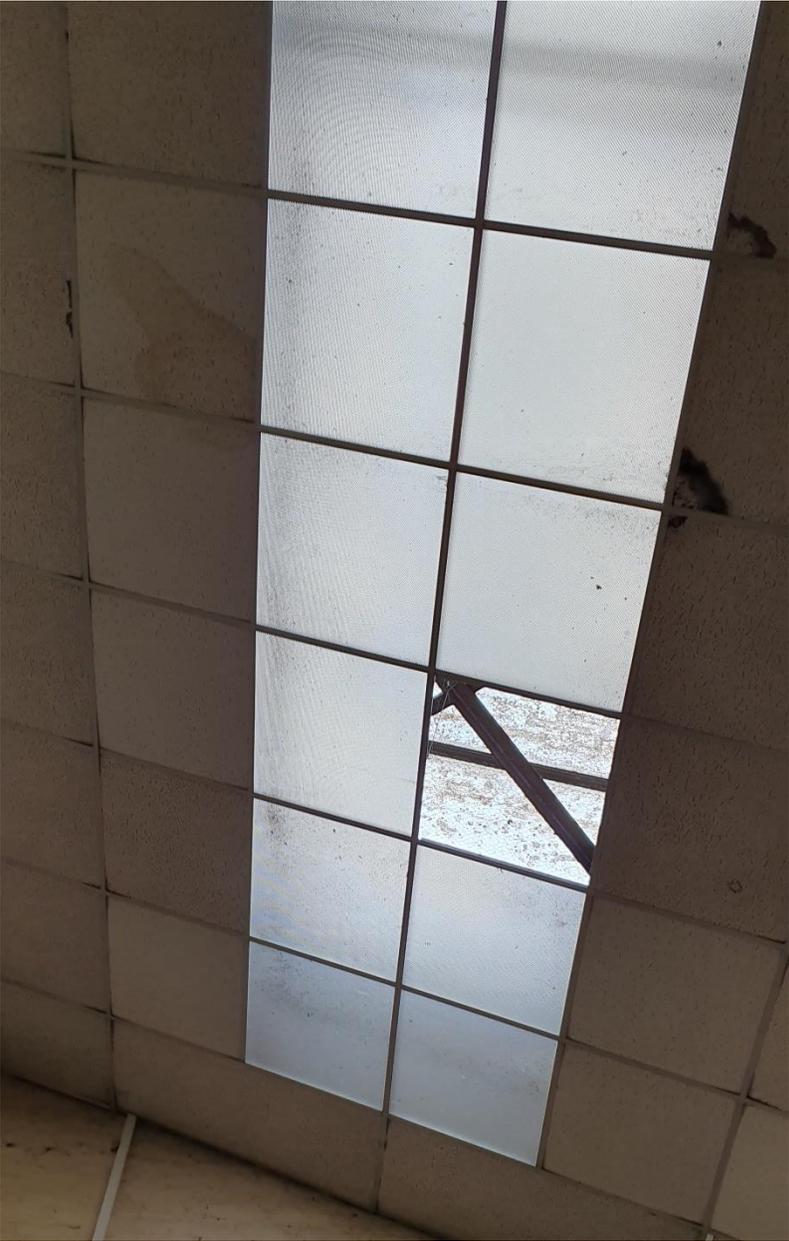
Photo 11: Inside the warehouse showing the sky lights

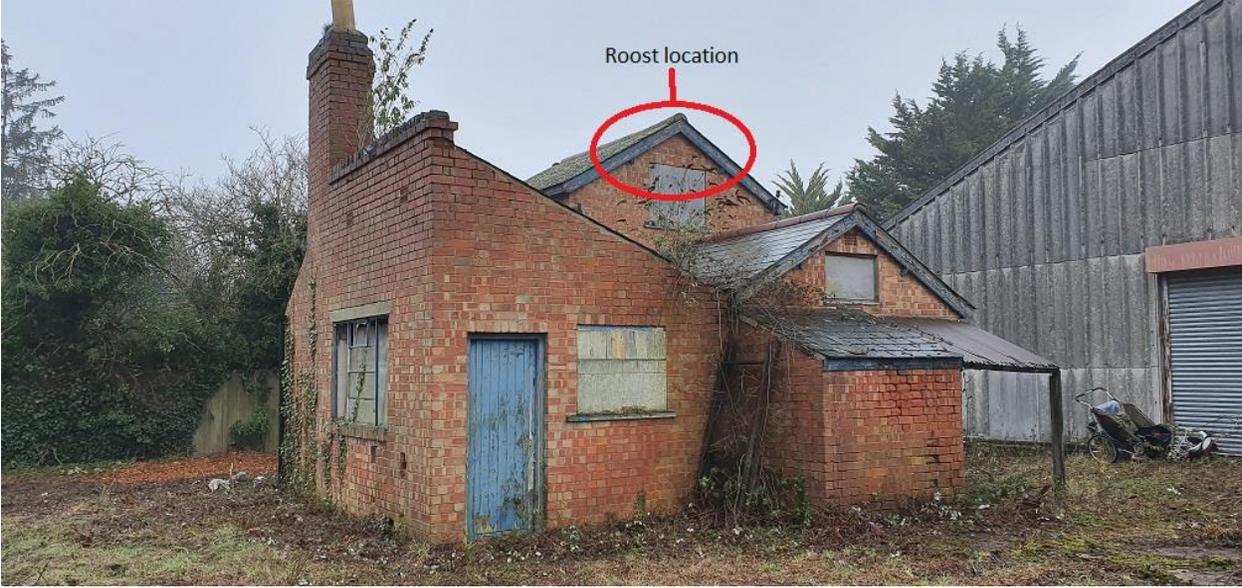
- 3.2.2 The only confirmed evidence of specially protected species being resident on the site was the emergence of a single common pipistrelle bat from a roost that is likely to be at the wall top on the northern elevation of the derelict house during the dusk survey on 27th April. All bat species and their roosts in Britain are afforded full protection under the Conservation of Habitats and Species Regulations 2017 (as amended). Regulation 43 of these sets out that it is an offence to:

Photo 12: Northern aspect of the derelict house

- 3.2.3 Confirmation of the presence of bat roosting in the building means that the above provisions apply and **a derogation licence issued by Natural England will therefore be required before any work can be carried out to this building.**

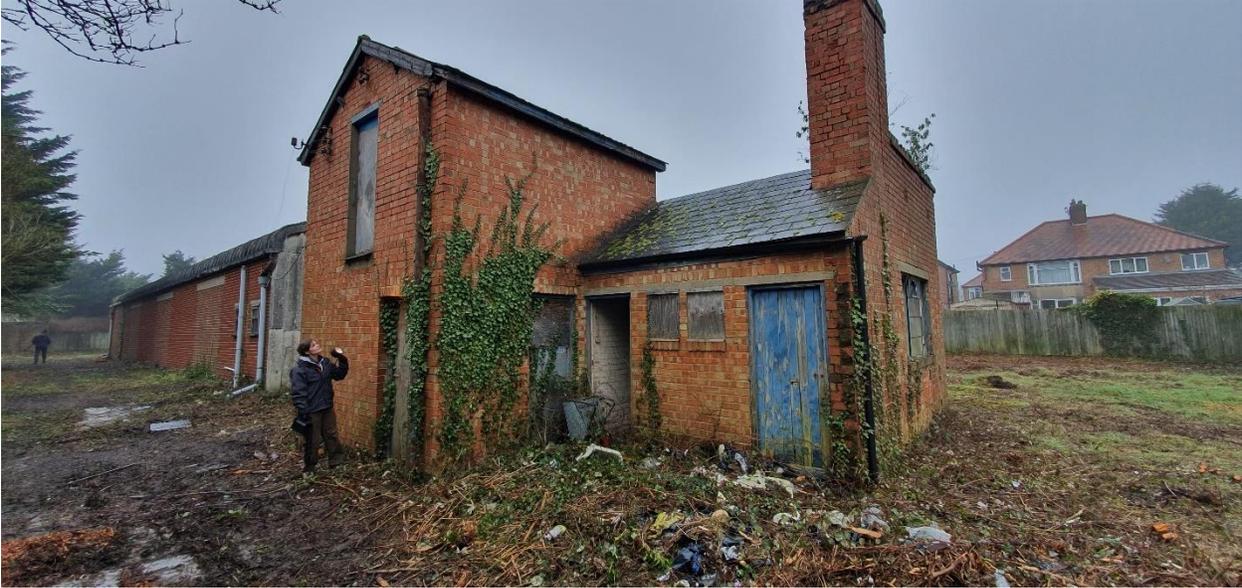
2.3.5 The derelict house is a two-story gable ended building with two adjoining single-story outhouses, both with gable ends. The roof is pitched with slate tiles and there is a chimney on the western end. It was not possible to gain entry into the building due to the windows and doors being boarded up and so only an external survey could be carried out at the time of the survey.

2.3.6 Generally, the building is in poor condition and it appears unlikely to have been occupied for some time. Roosting opportunities noted on this building include where the ridge is missing a tile and at under the eaves. It is also possible that the building has an internal roof void.

Photo 13: Southeastern aspect the derelict building

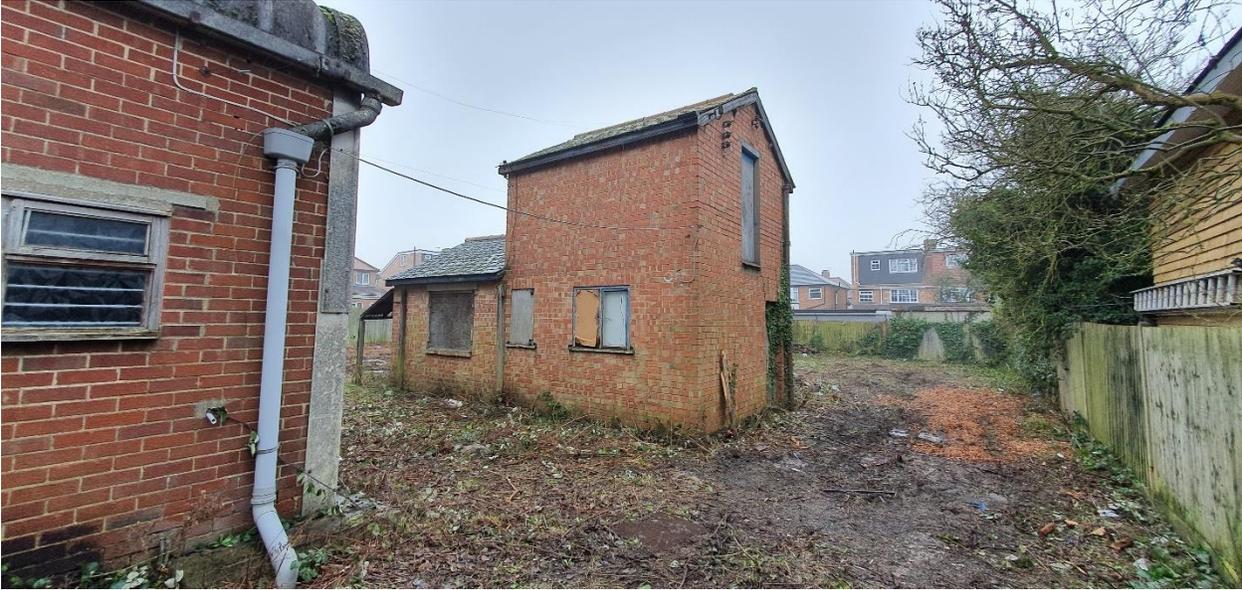
Photo 14: Western aspect of the derelict house
