HERITAGE STATEMENT TO SUPPORT A PLANNING APPLICATION AND LISTED BUILDING CONSENT APPLICATION

CHATHAM MILL,
LOWER ORMOND STREET
MANCHESTER

Appendix A
PHOTOGRAPHIC SCHEDULE

Chatham Mill, Lower Ormond Street. M1 5AY. General images (128758/FO/2020 & 128759/FO/2020

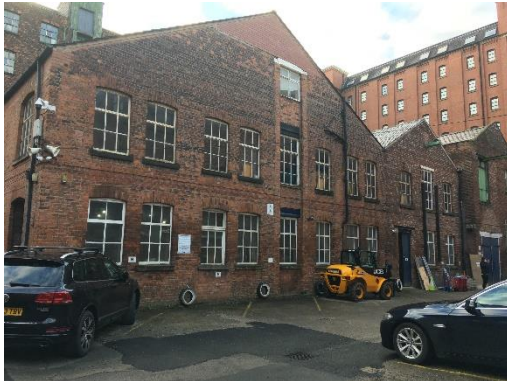
A1

General View of North Elevation of the application subject building. Ground floor windows and doors to be retained and overhauled.

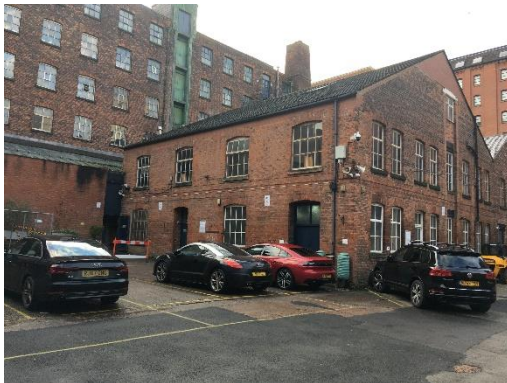
A2

General view of East Elevation of the application subject building. Ground floor windows and doors to be retained and overhauled.

Note the application relates to ground floor alterations only. The roof is unaffected by the proposed works and is not included within this application

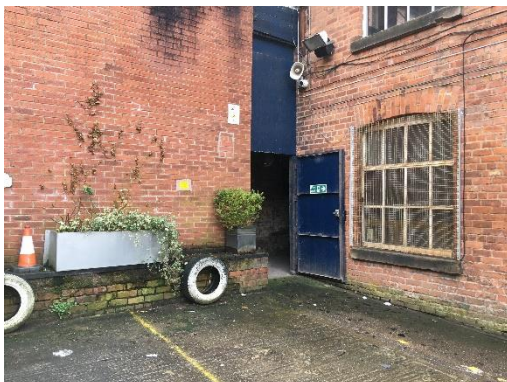
A3

Steel galvanised grid to be carefully removed and discarded.

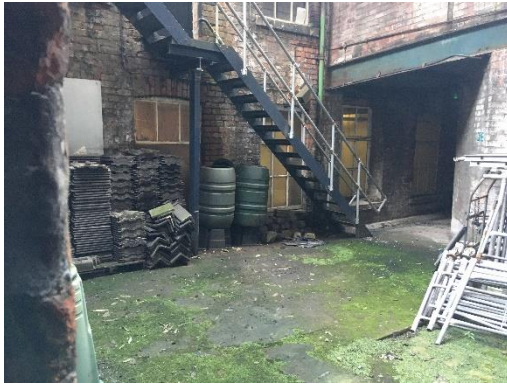
A5

General view of South Elevation of the application subject building. Ground floor windows and doors to be retained and overhauled.

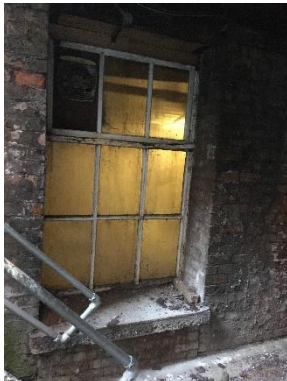
A6

View of typical window to South elevation. To be retained and overhauled.

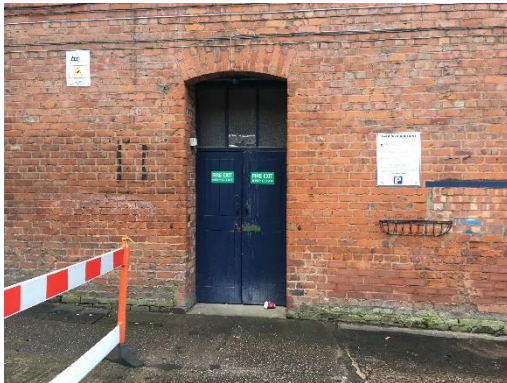
A7

View of Door (D3) level access door to be converted to main entrance to ground floor of the application building only.

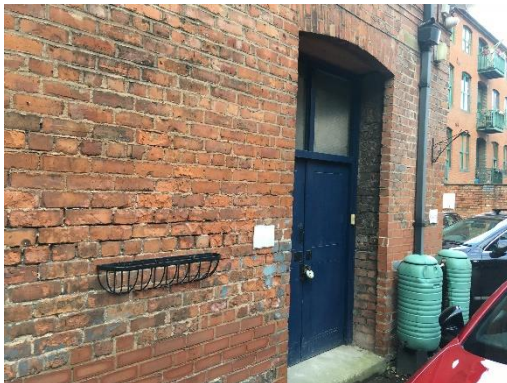
A8

View of Door (D2) to be retained and overhauled

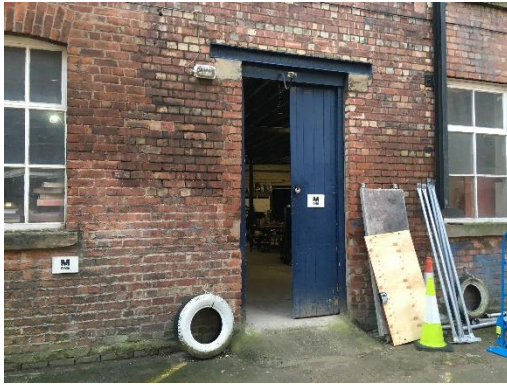
A9

View of Door (D1) to be retained and overhauled

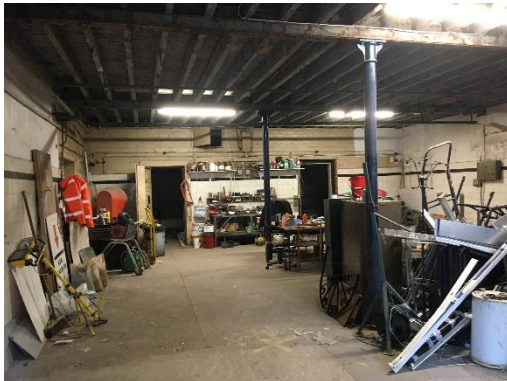
A10

General internal view of the ground floor of application subject building C. Note level concrete floor slab to be retained and patch repaired as necessary.

Original structural columns to be retained and carefully cladded for fire protection.

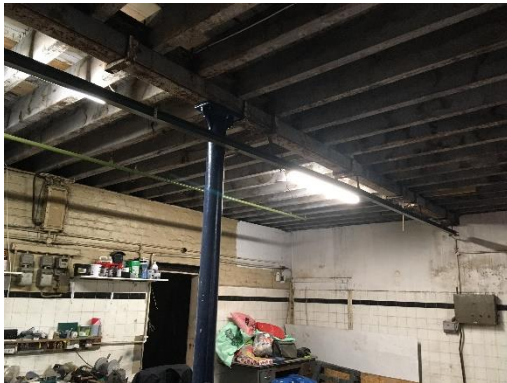
A11

General internal view of structural column arrangement at application subject building C

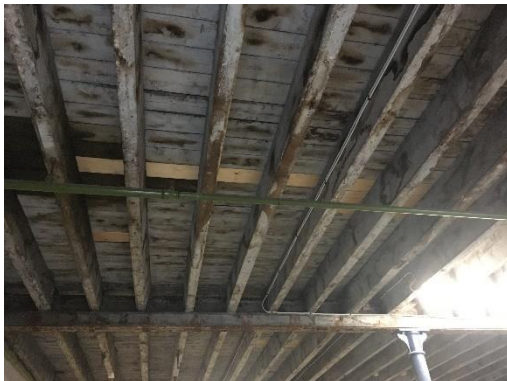
A12

General internal view of underside of first floor(ceiling) to application subject building C. Proposal to install fire rated board to the underside.

Note, existing sprinkler system is to be retained and decorated

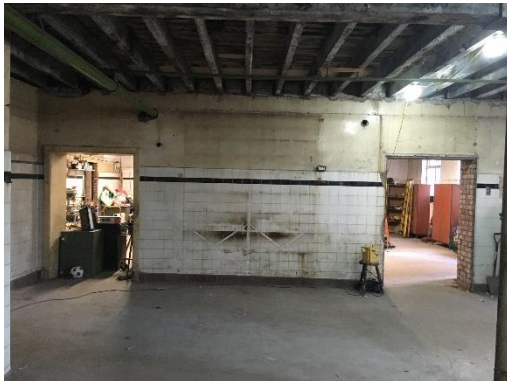
A13 i

General view of dividing structural wall between building B and C. Proposal to enlarge both openings. Retain remaining ceramic tiles and protect with board lining.

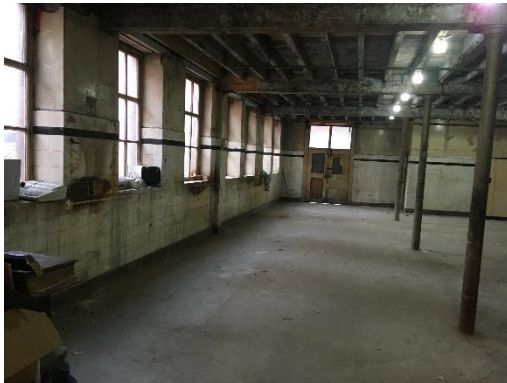
A14

General view of internal North elevation wall (drawing T09 Section A-A). Proposal to strip back non-original plaster above tiles to reveal original brick work. Clean and retain ceramic tiles. Original steel columns to be retained and decorated. Original door (D2) to be retained and overhauled.

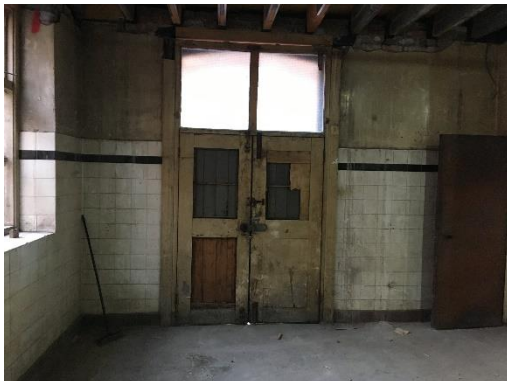
A15

Close up internal view of door D2, to be retained and overhauled.

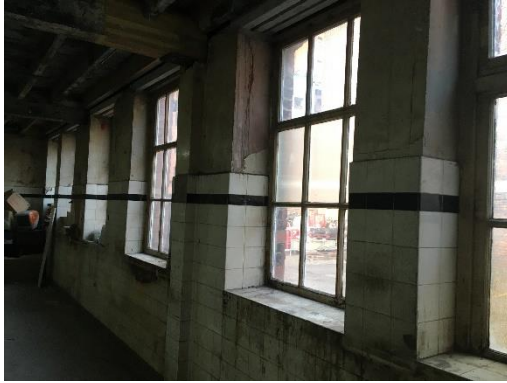
A16

General close-up view of internal North elevation wall (drawing T09 Section A-A). Proposal to strip back non-original plaster above tiles to reveal original brick work. Windows to be retained and overhauled.

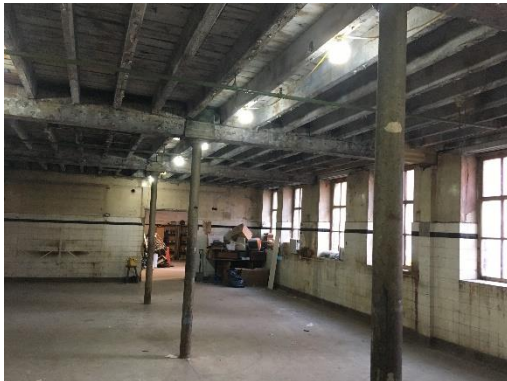
A17

General reverse view of internal North elevation wall (drawing T09 Section A-B). Proposal to strip back non-original plaster above tiles to reveal original brick work. Clean and retain ceramic tiles. Original steel columns to be retained and decorated.

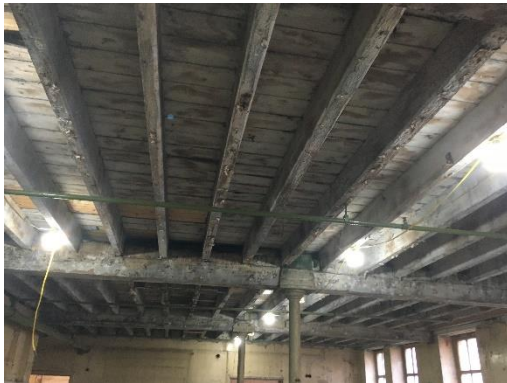
A18

General view of underside of North building B (ceiling) underside of first floor. To be lined with fire rated board.

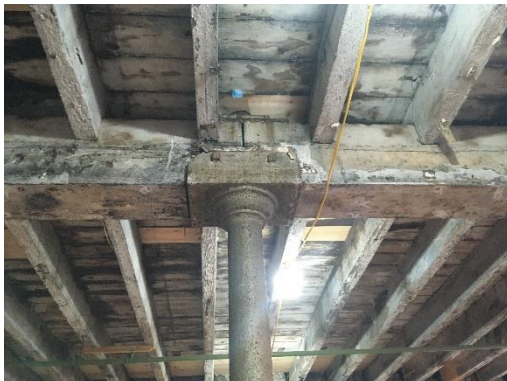
A19

View of typical supporting column arrangement to Building B

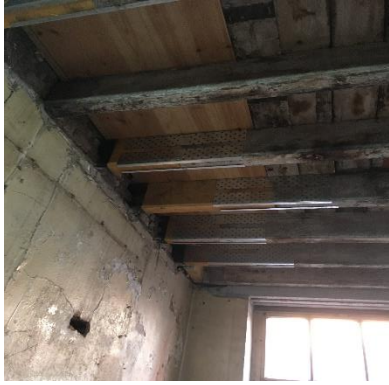
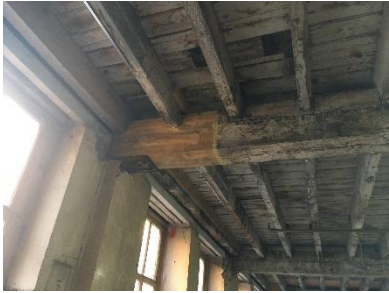
A20i

Typical historic repairs to underside of North building B (ceiling) underside of first floor. To lined with fire rated board.

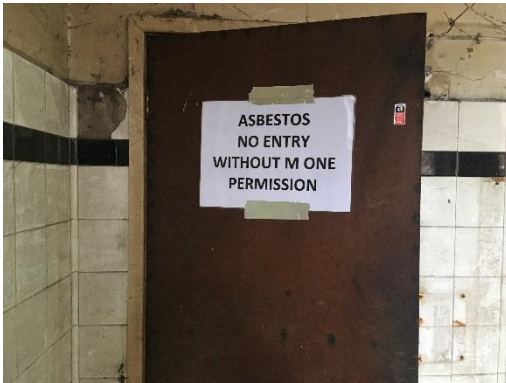
A21i

Asbestos containing material to be removed

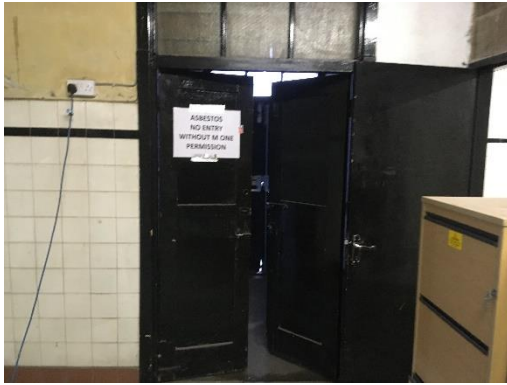
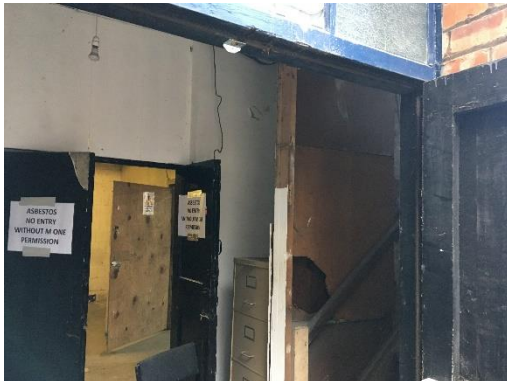
A22i

General views of lobby behind Door D3. Non-original and Asbestos containing material to be removed

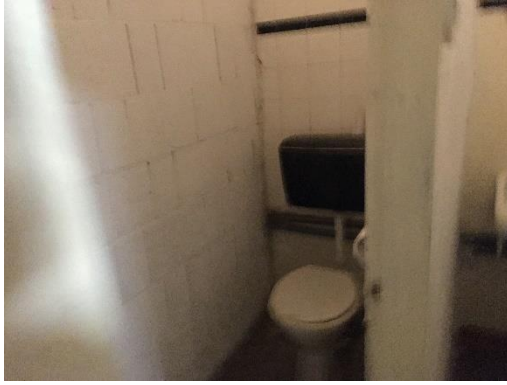
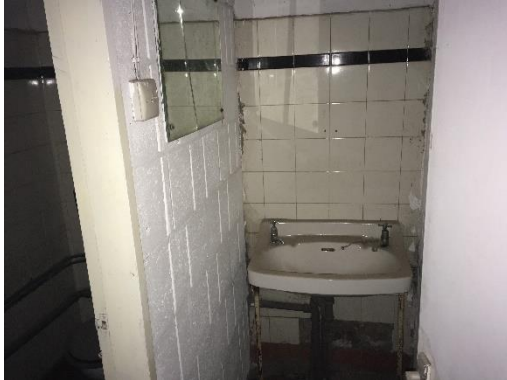
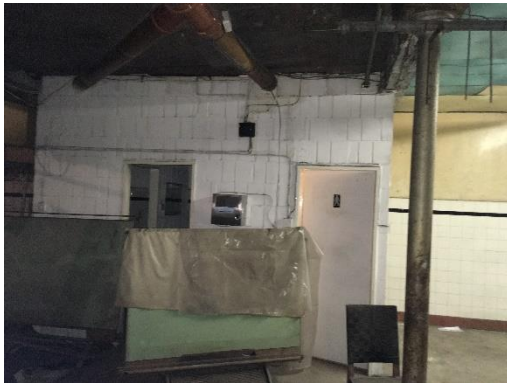
A24i

General view of existing WC block. Non-original block wall and sanitaryware to be removed and existing utilities connections to be re-used.

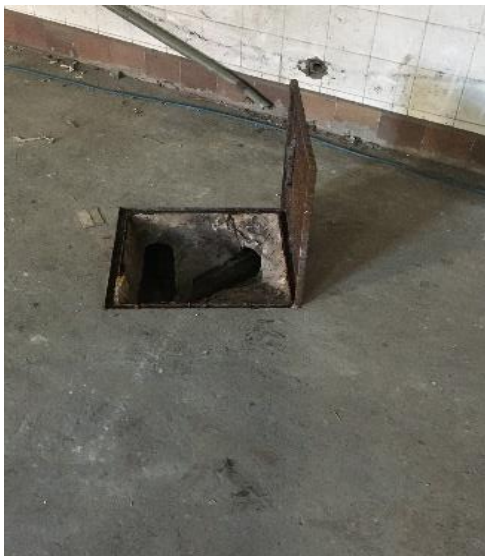
A25

Existing drainage connection to be re-used.

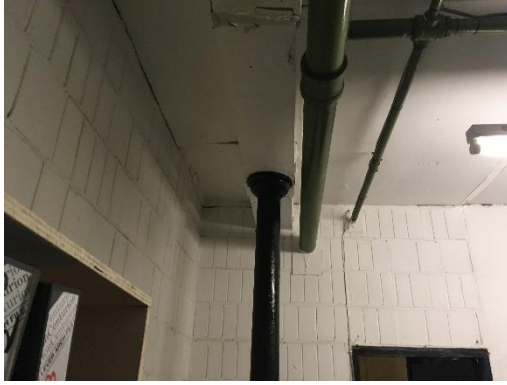
A26

Typical view of existing column non-complaint cladding to be removed and replaced.

Non-original block wall to be removed.

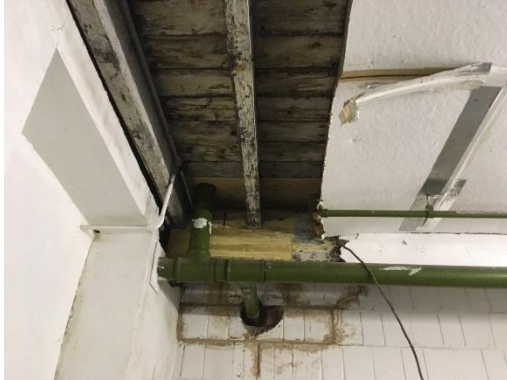
A27

Non-original damaged sheet to be removed and replaced.

Non-original block wall to be removed.
