STRUCTURAL INSPECTION REPORT

REDUNDANT BARN AT

LEE BARTON FARM

MARCH 2021

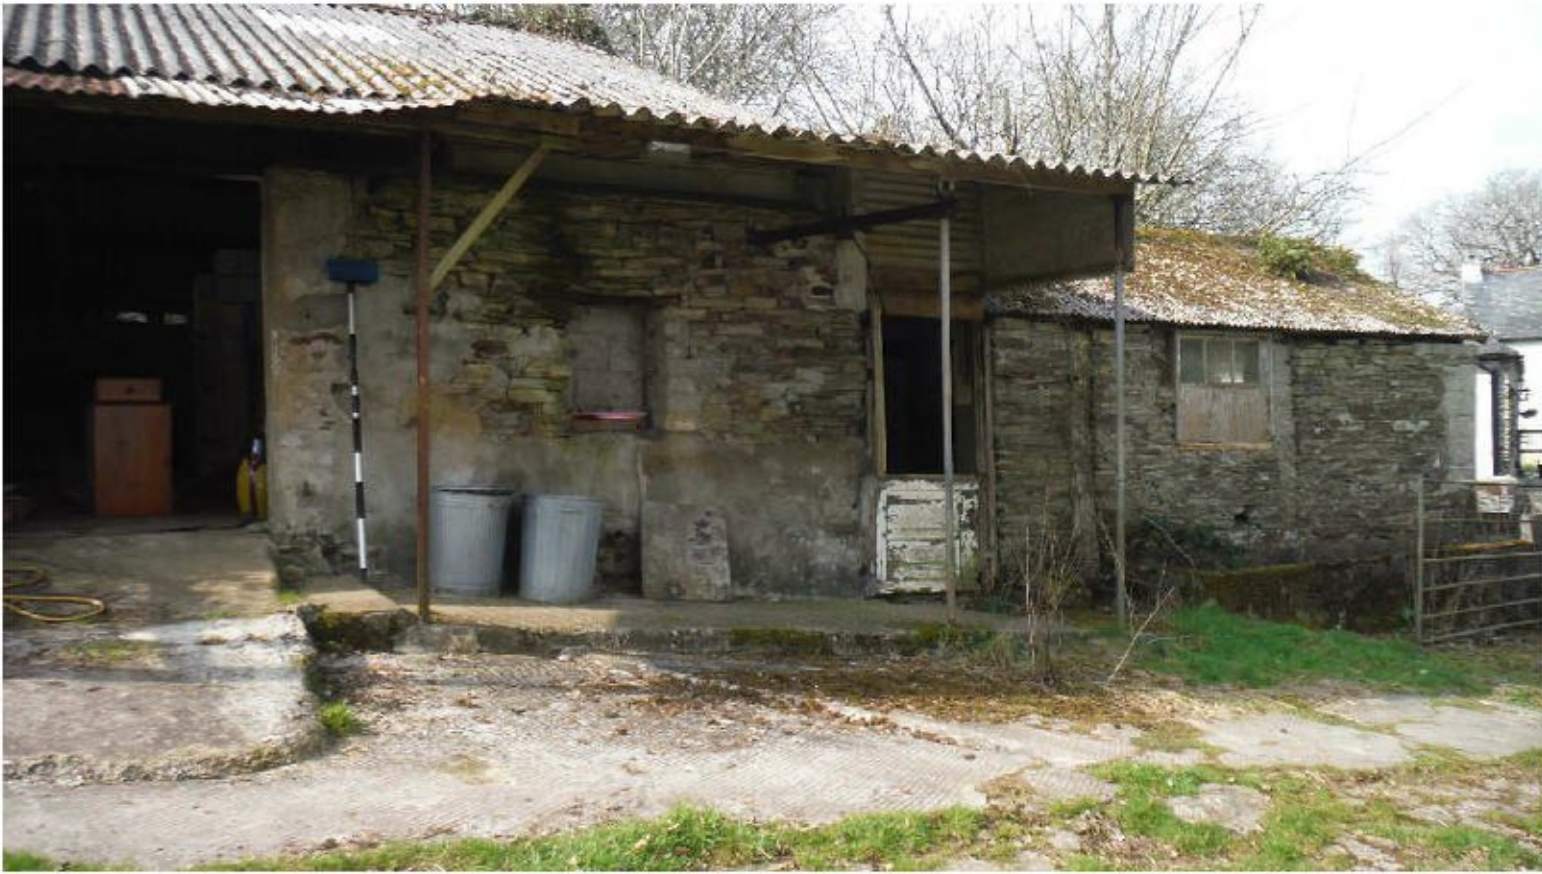
Photograph 1 Stonework walls to the East elevation

For the purposes of this report the property is considered to face east as shown in Photograph 1. A plan of the barn is attached to this report as Drawing SC_799.

3.2 The stonework to the walls are in generally good condition. The flank walls lean out slightly. The masonry to the north end wall has been removed leaving the ends of the flank walls without any lateral bracing

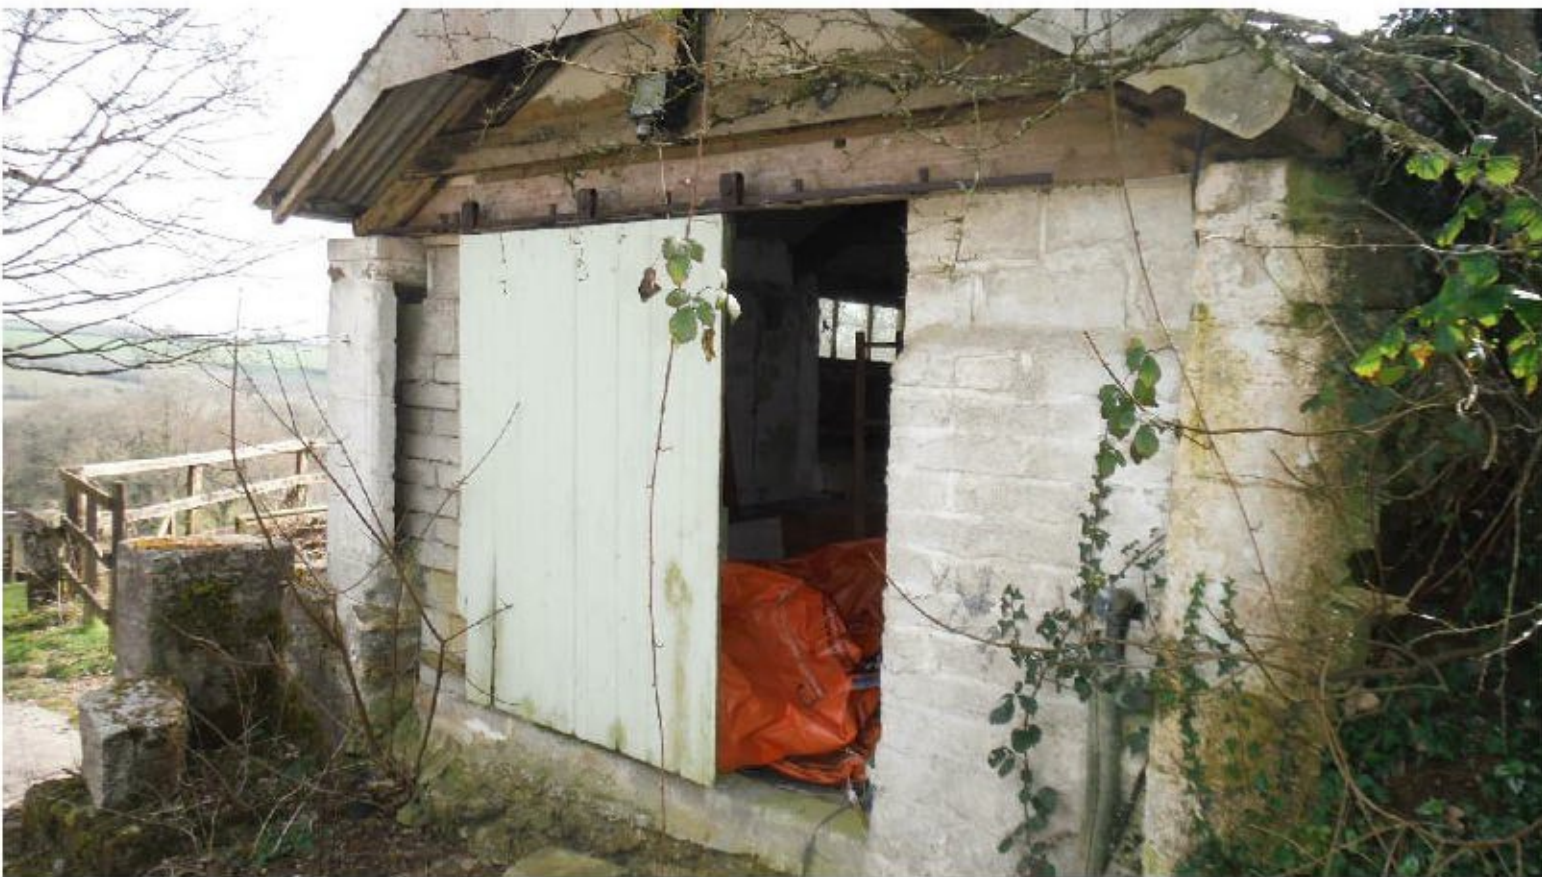
Photograph 2 North gable End

The stonework to the north gable end wall has been removed and replaced with a section of blockwork either side of a sliding door as shown in Photograph 2. The stone base stones are still in place as shown in Photograph 5.

Due to these discontinuities in the existing walls it is recommended that the external stone walls be stabilized at eaves level with a insitu concrete capping beam. The details of an appropriate capping beam is shown in the drawing SC_799. This will also provide a level platform for the construction of a new roof structure.

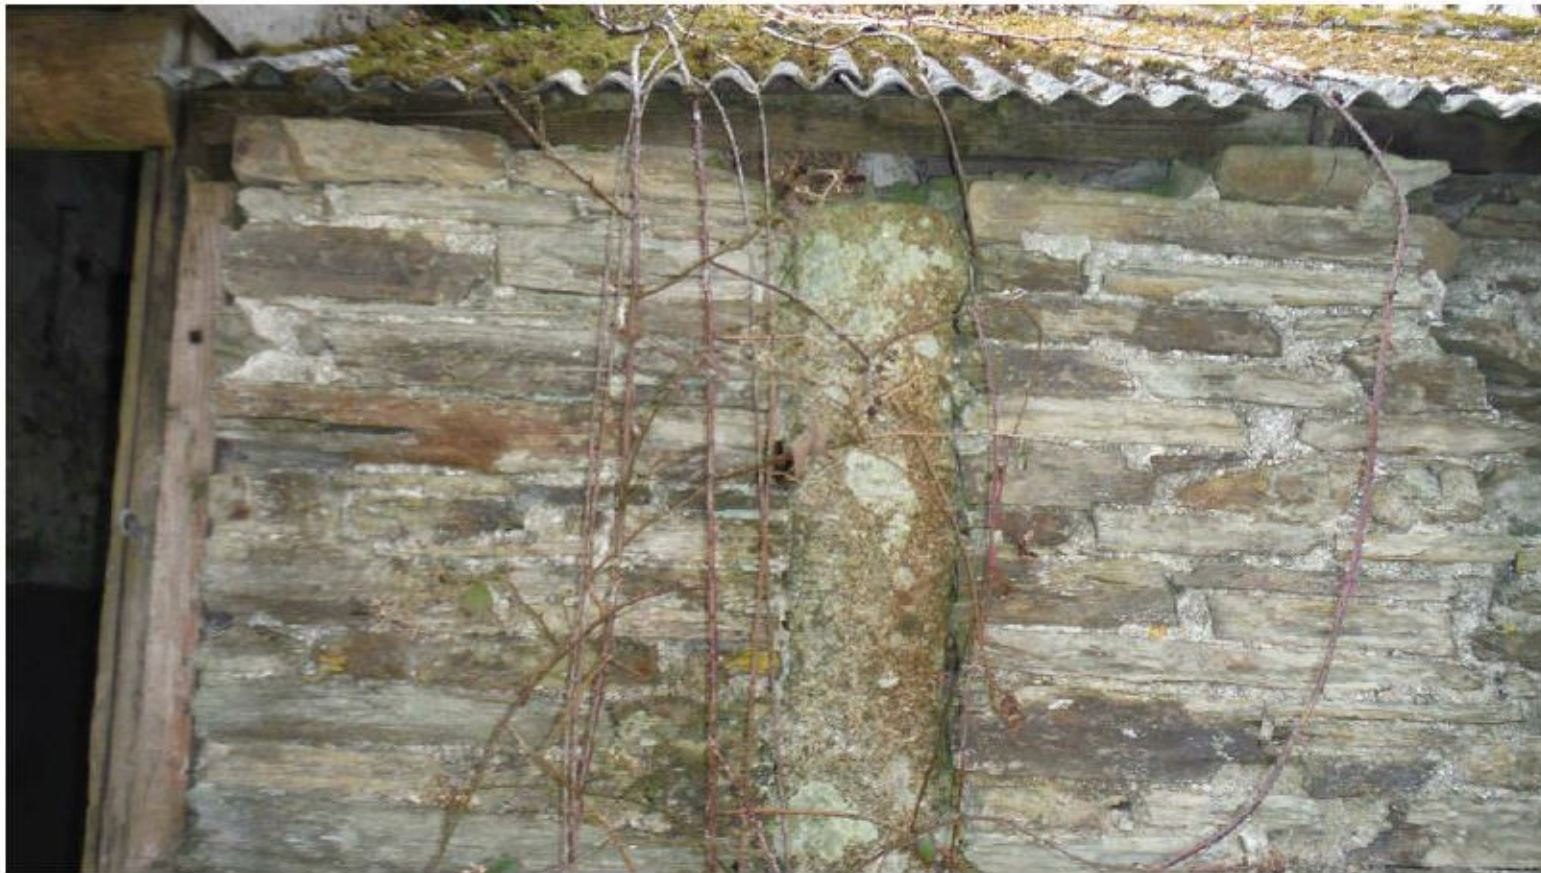
Photograph 3 Granite post with the stonework butted up to it within the east elevation wall

The east wall incorporates two granite posts with the stonework butted up to them as shown in Photograph 3.

In addition the stonework to the east wall is an infill between the granite posts shown in Photograph 3.

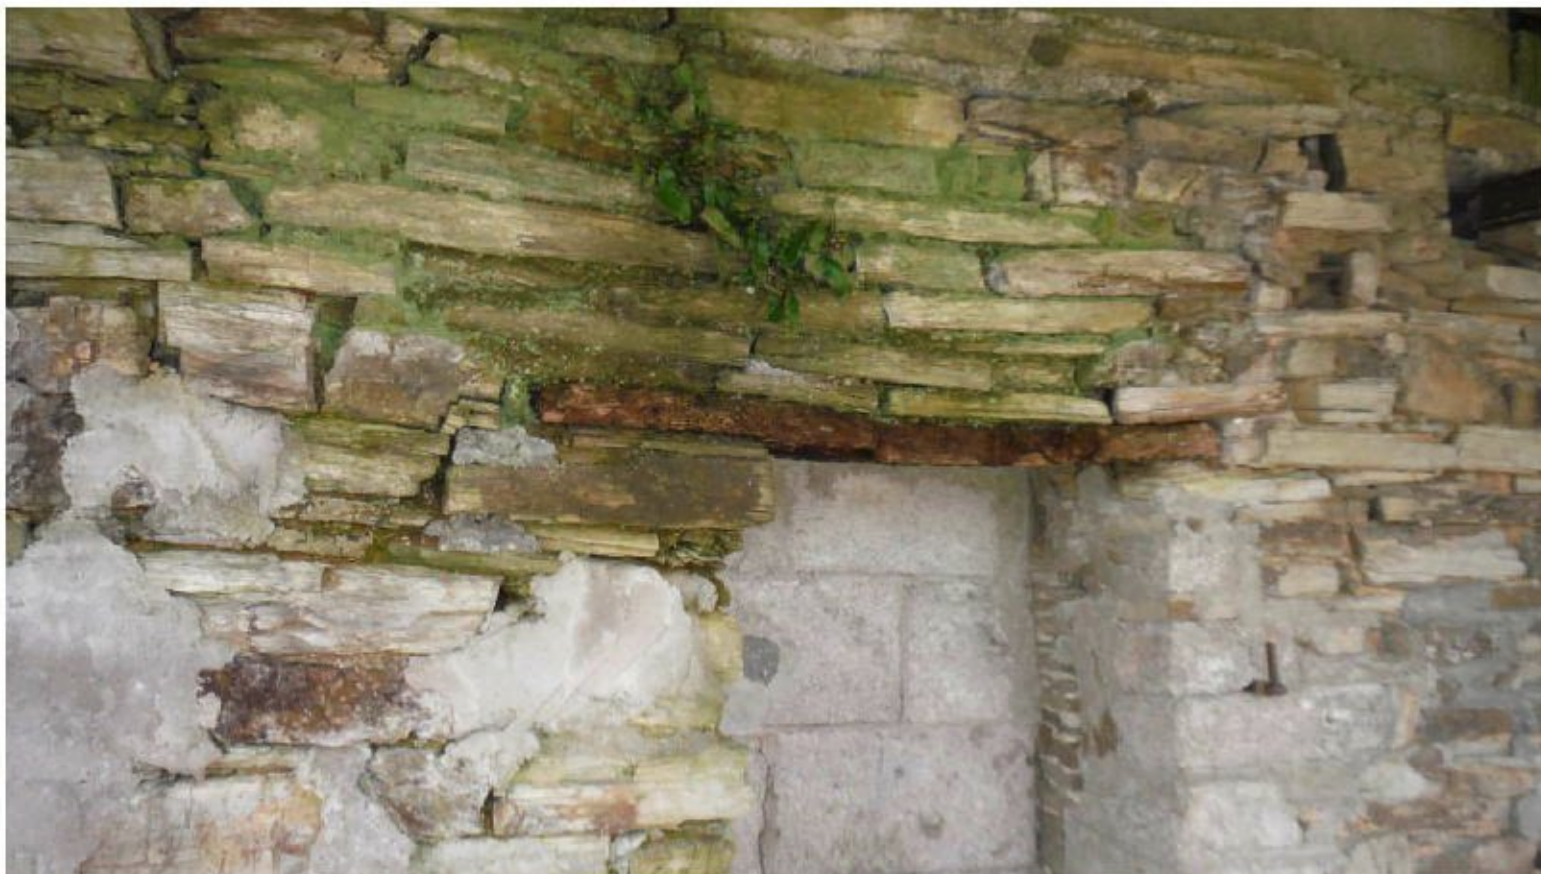
Photograph 4 Bow in the lintel over the window opening to the East Elevation

2.4 The lintels over the door and window openings in the front elevation are formed from rough hewn timber beams. One of the timbers over the window in the east elevation is shown in Photograph 4.

3.3 It is recommended that the existing lintels be replaced with a 100mm dp concrete or oak lintels due to the additional loads imposed by the renovated roof structure.

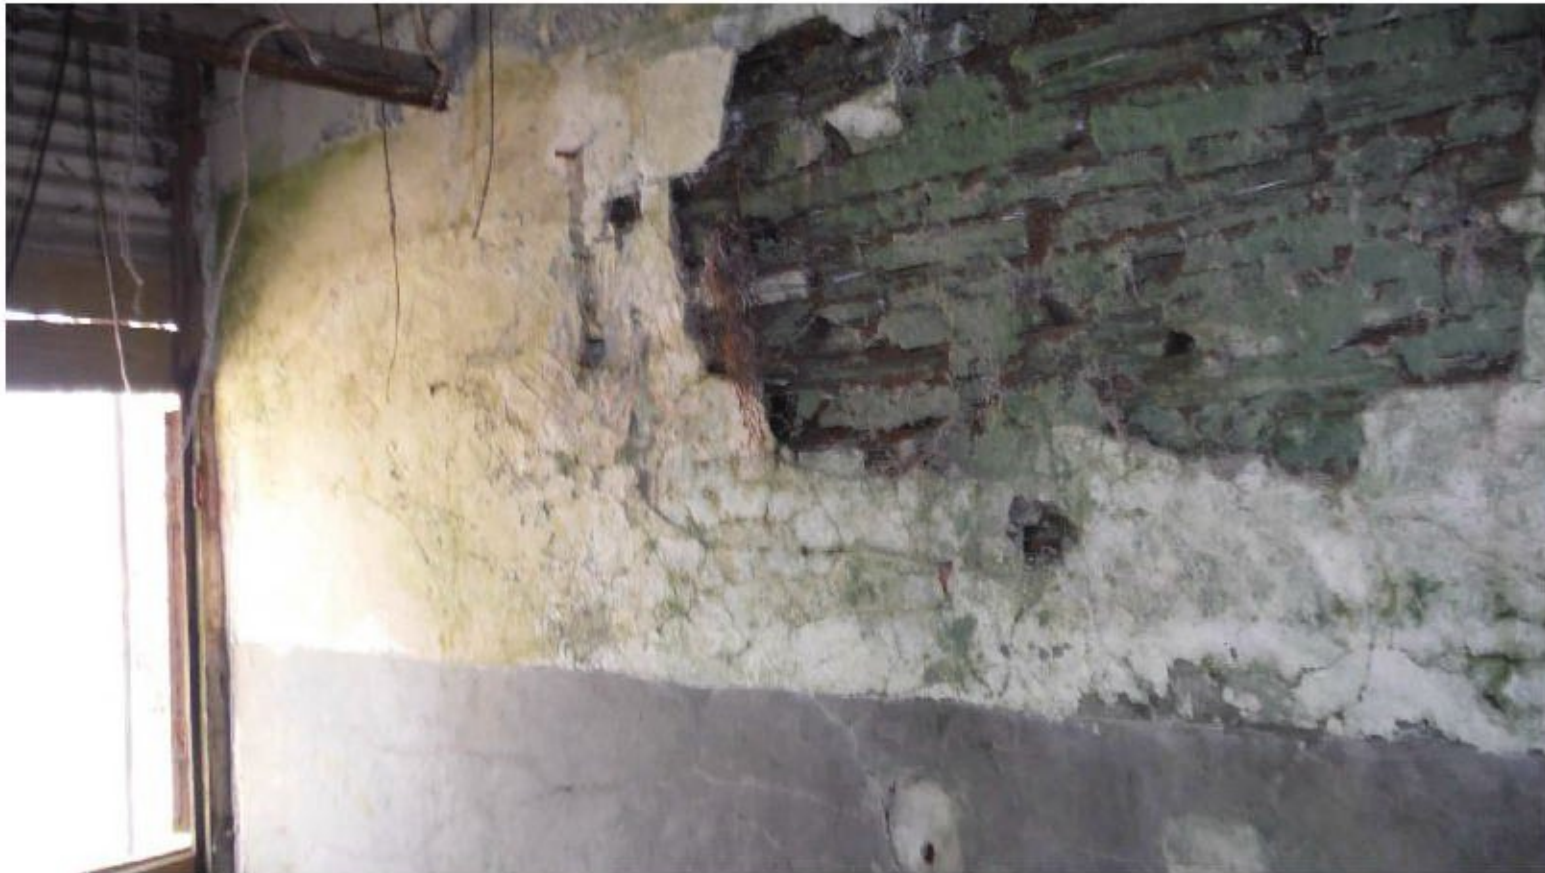
Photograph 6 Internal stone wall

2.3 The walls of the barn are constructed from mass locally quarried with some semi worked granite blocks to the quoins. The stonework is pointed with a lime rich mortar. Internally some walls are plastered as shown in Photograph 6.

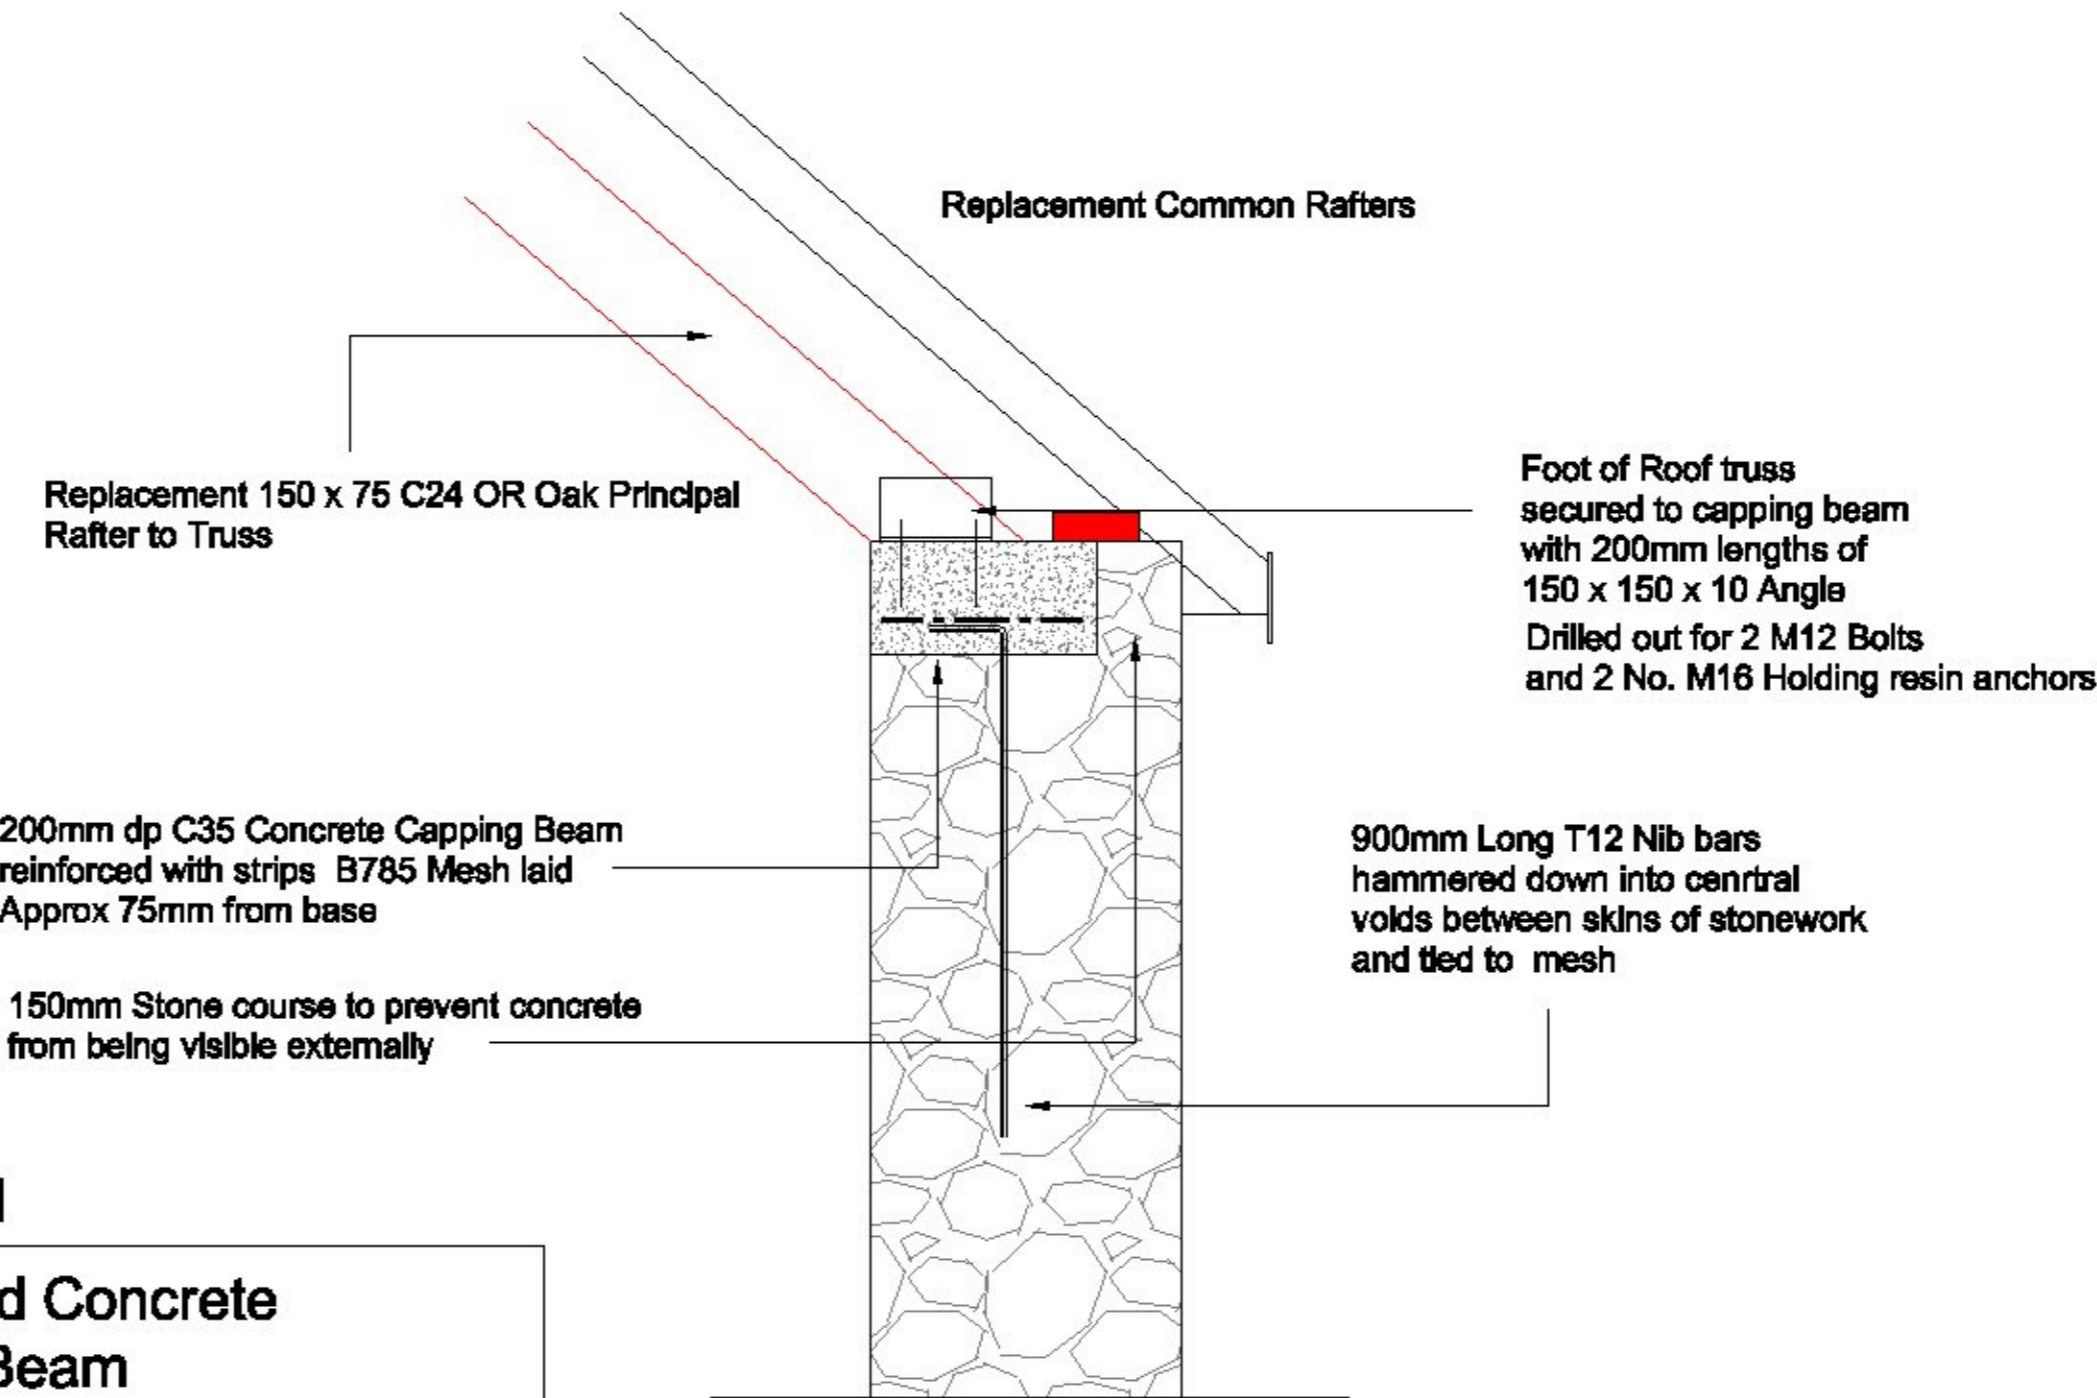
DETAIL 1

Section on Proposed Concrete Capping Beam
