Our Ref: GM/RH/280954.RIR

Remediation Inspection Report

Land Adjacent to 1 Carn Brea Lane, Pool, Redruth, Cornwall
TR15 3DS

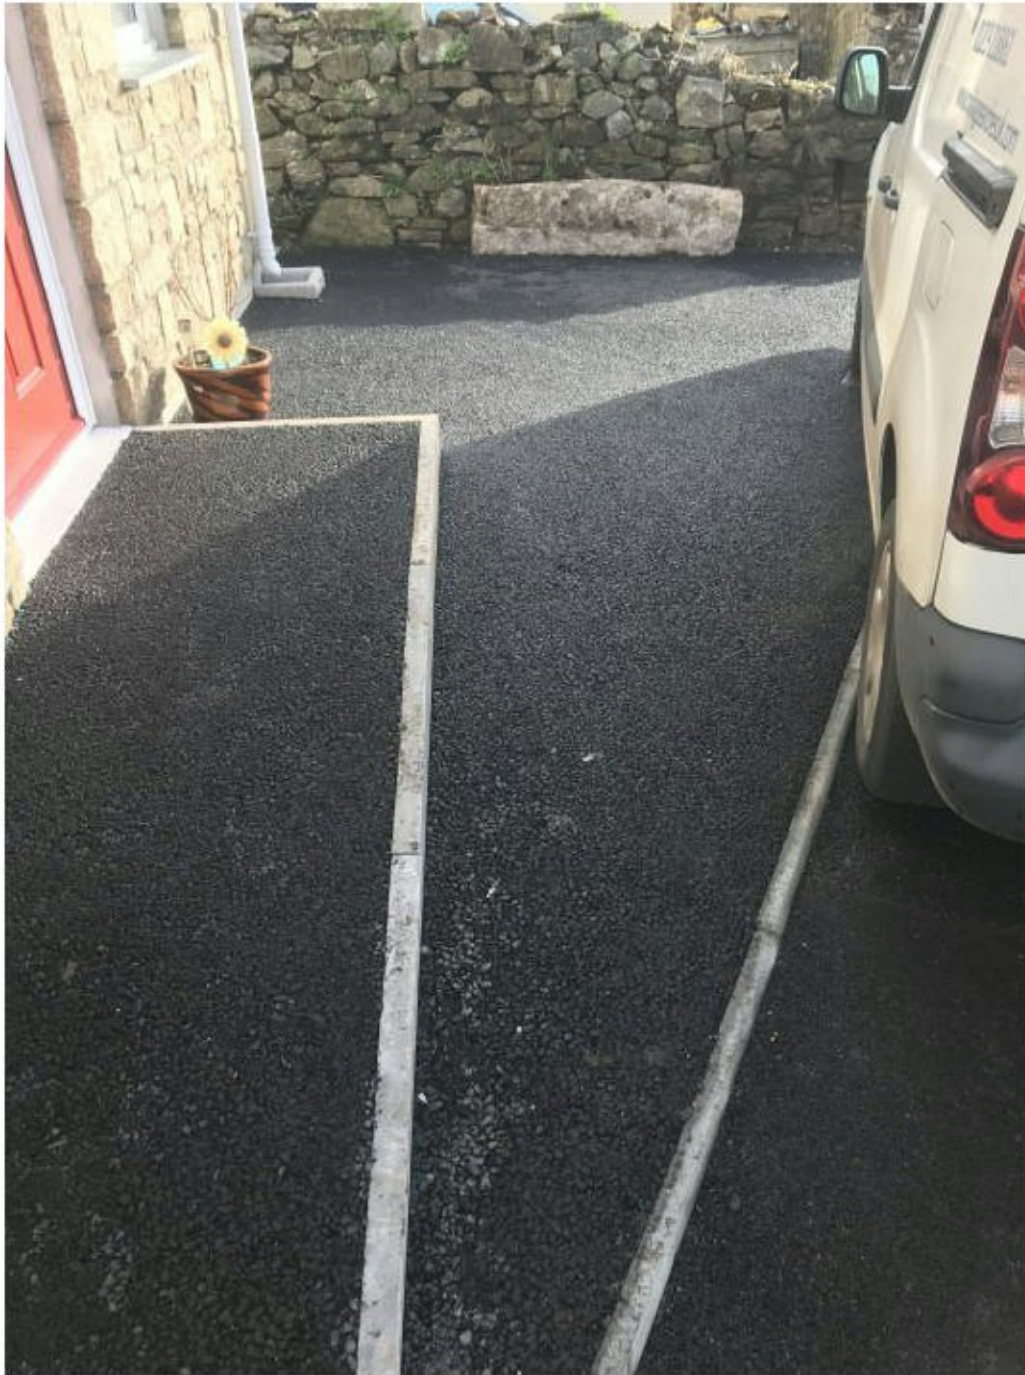
Plate 1— The front of the property was finished with asphalt creating a small parking space. The asphalt was well laid and was considered suitable in breaking the contamination pathway.

The driveway at the front of the building the house were covered by asphalt which is considered suitable in breaking the contamination pathway. The asphalt was observed to have been well installed.

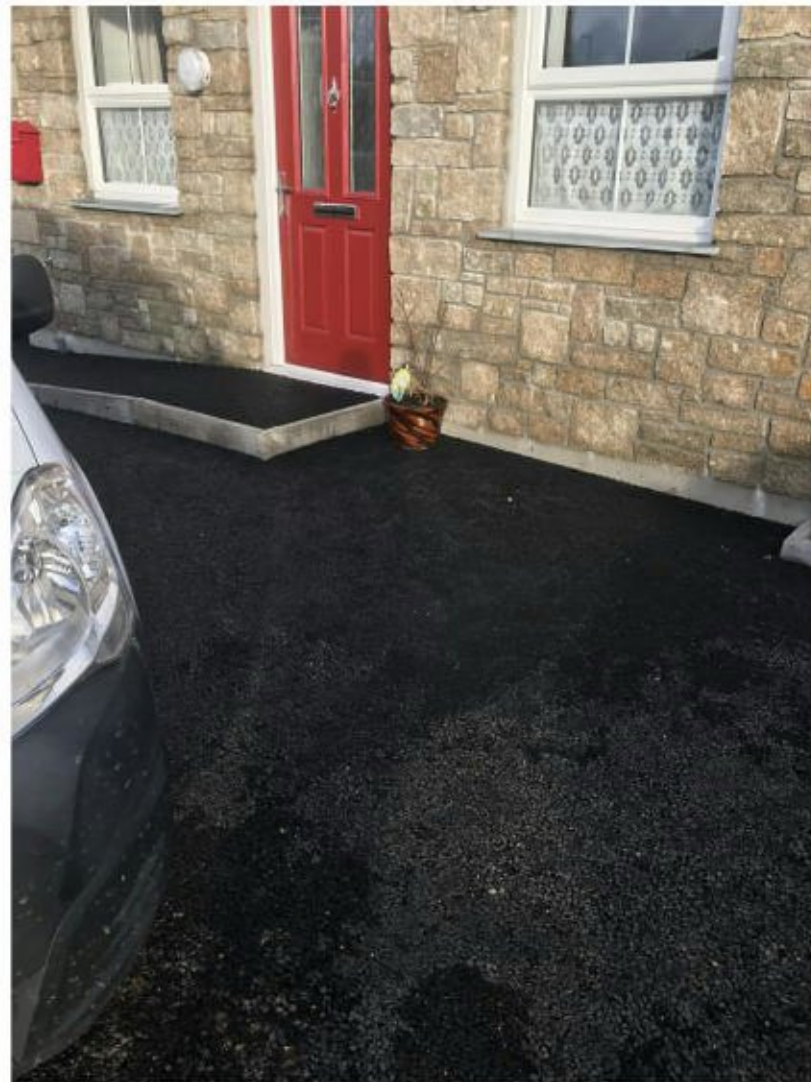
Plate 2 — Another view of the asphalt parking area to the front of the property

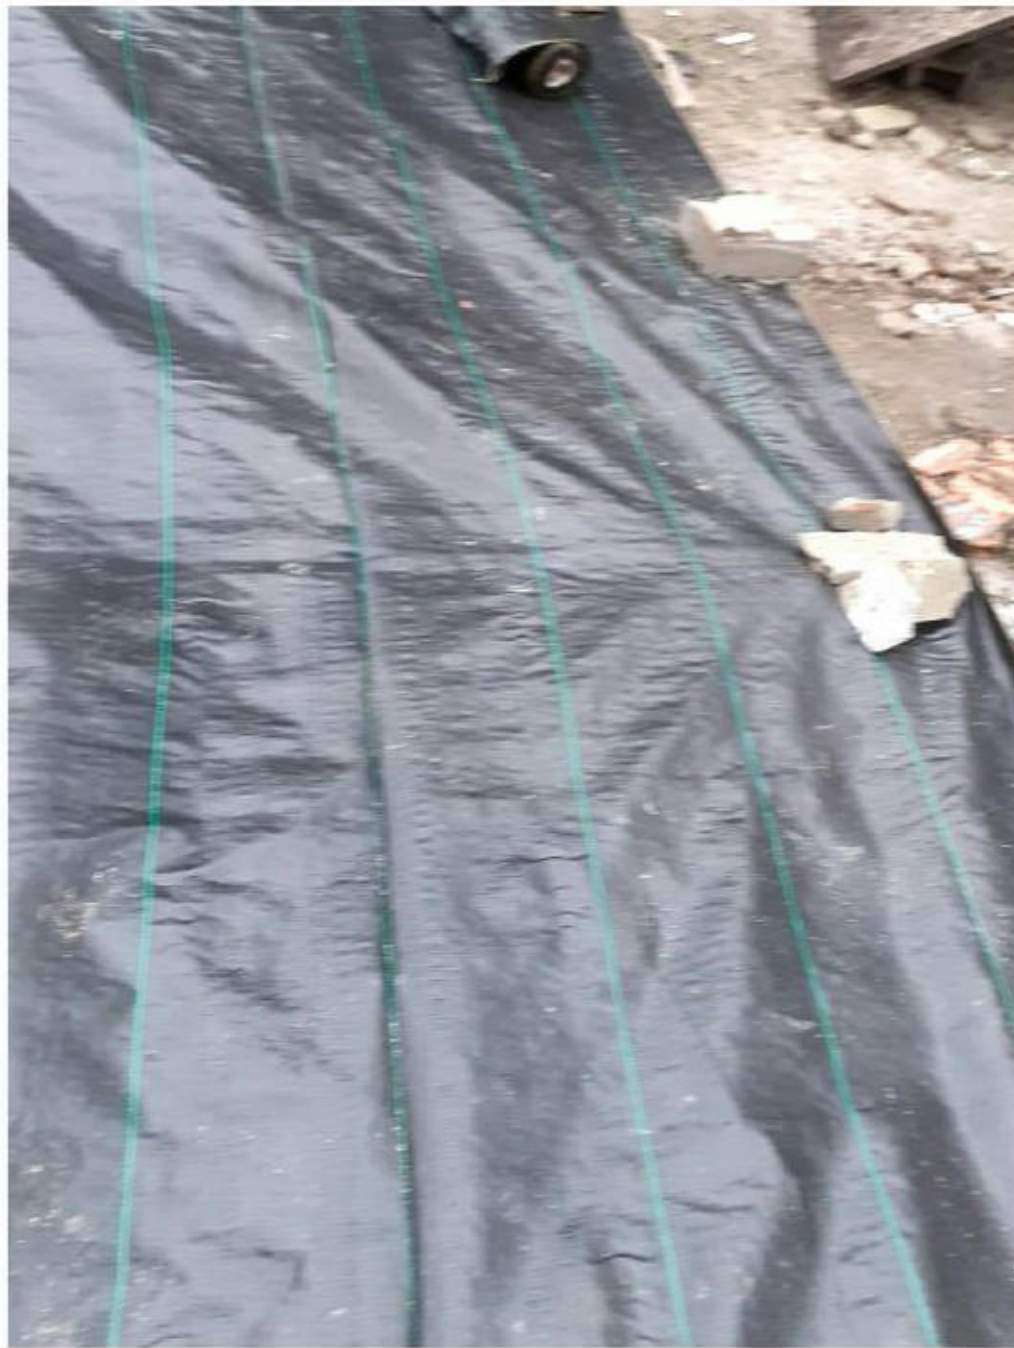
Plate 3— Photographic evidence of the geotextile being laid down throughout the rear garden

We can confirm that a layer of suitable geotextile was satisfactorily laid within the rear garden area of the site.

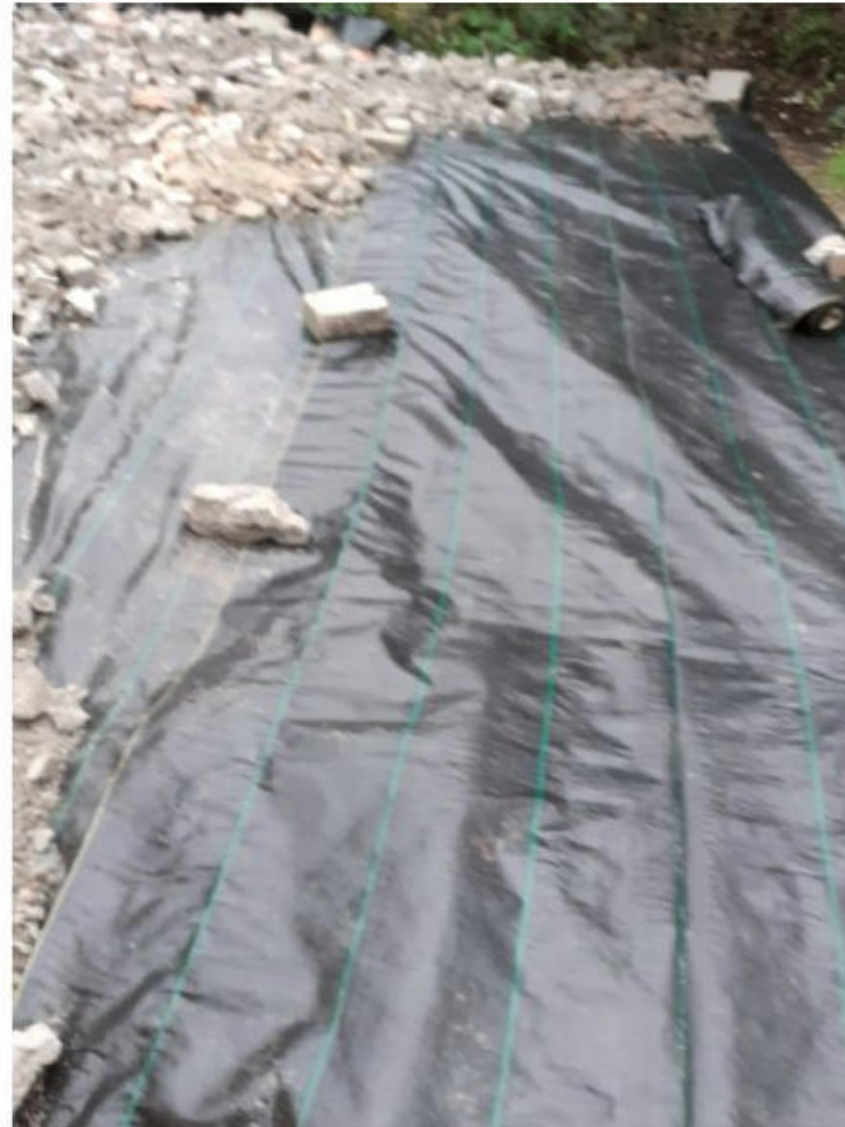
Plate 4 — Further evidence of the geotextile being laid down in the rear garden, before a layer of clean aggregate to build up the correct depth of cover before the decorative chippings were applied.

The geotextile had been laid over an area of reduced ground, sufficient to gain an adequate thickness of soil/gravel cover.

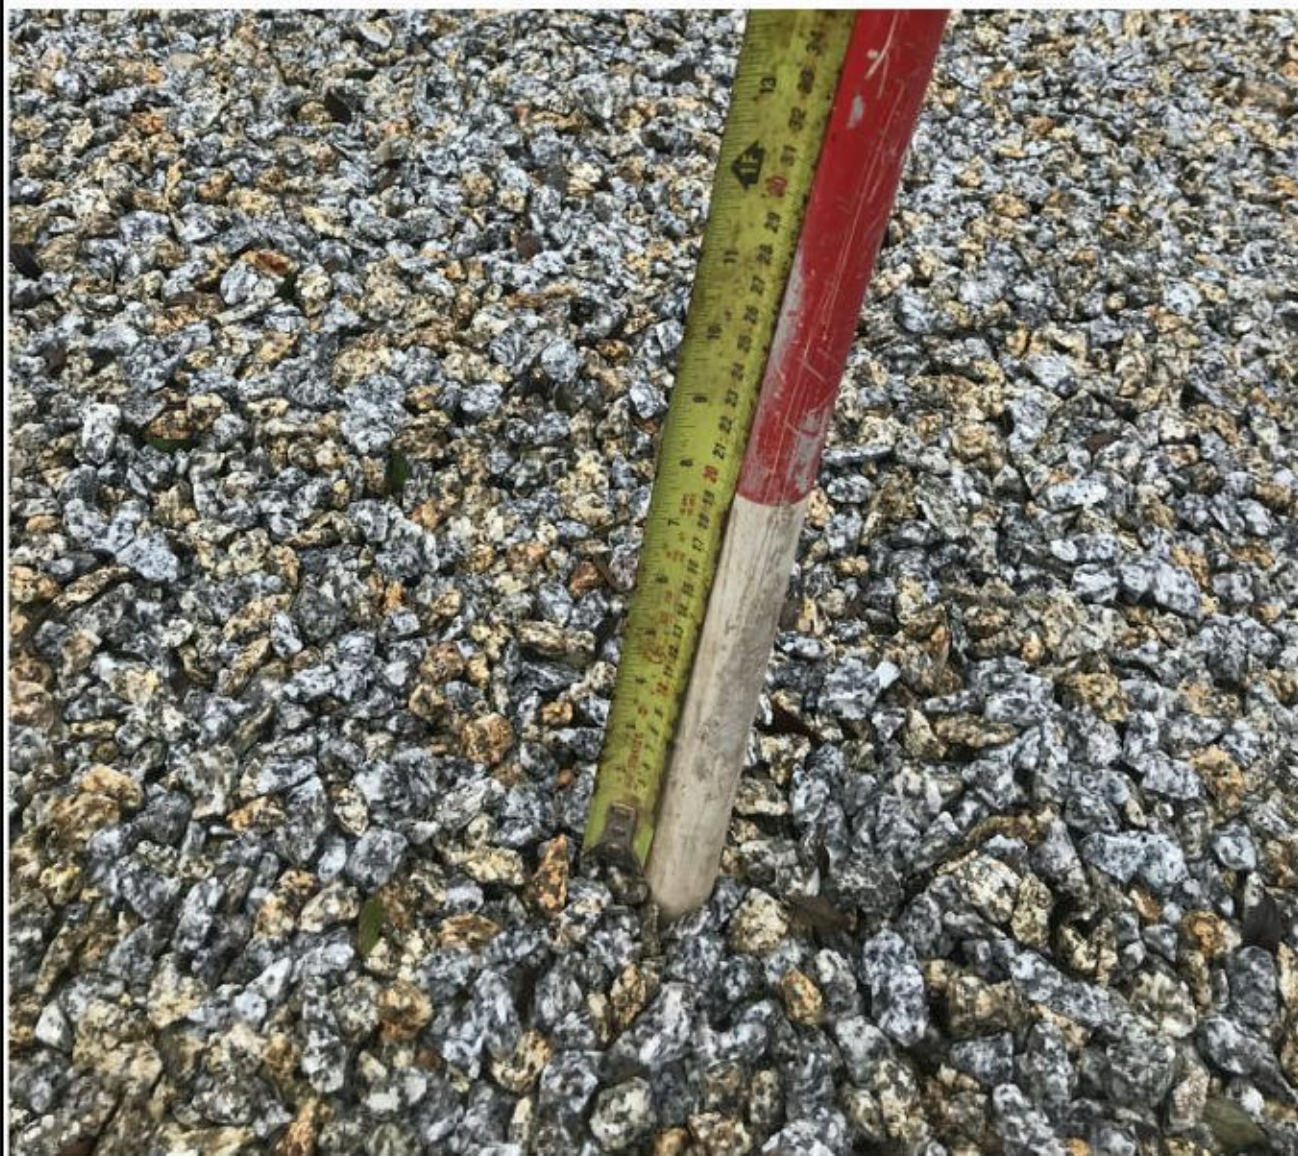
Plate 5 — Numerous depth probes were taken throughout the gravelled garden all indicating a depth of at least 300mm cover system which is considered suitable in breaking the contamination pathway.

The rear garden and side paths were covered by gravel landscaping. Above the layer of continuous geotextile the gravel was observed to be at least 300mm in thickness and has been confirmed by a number of depth probes.

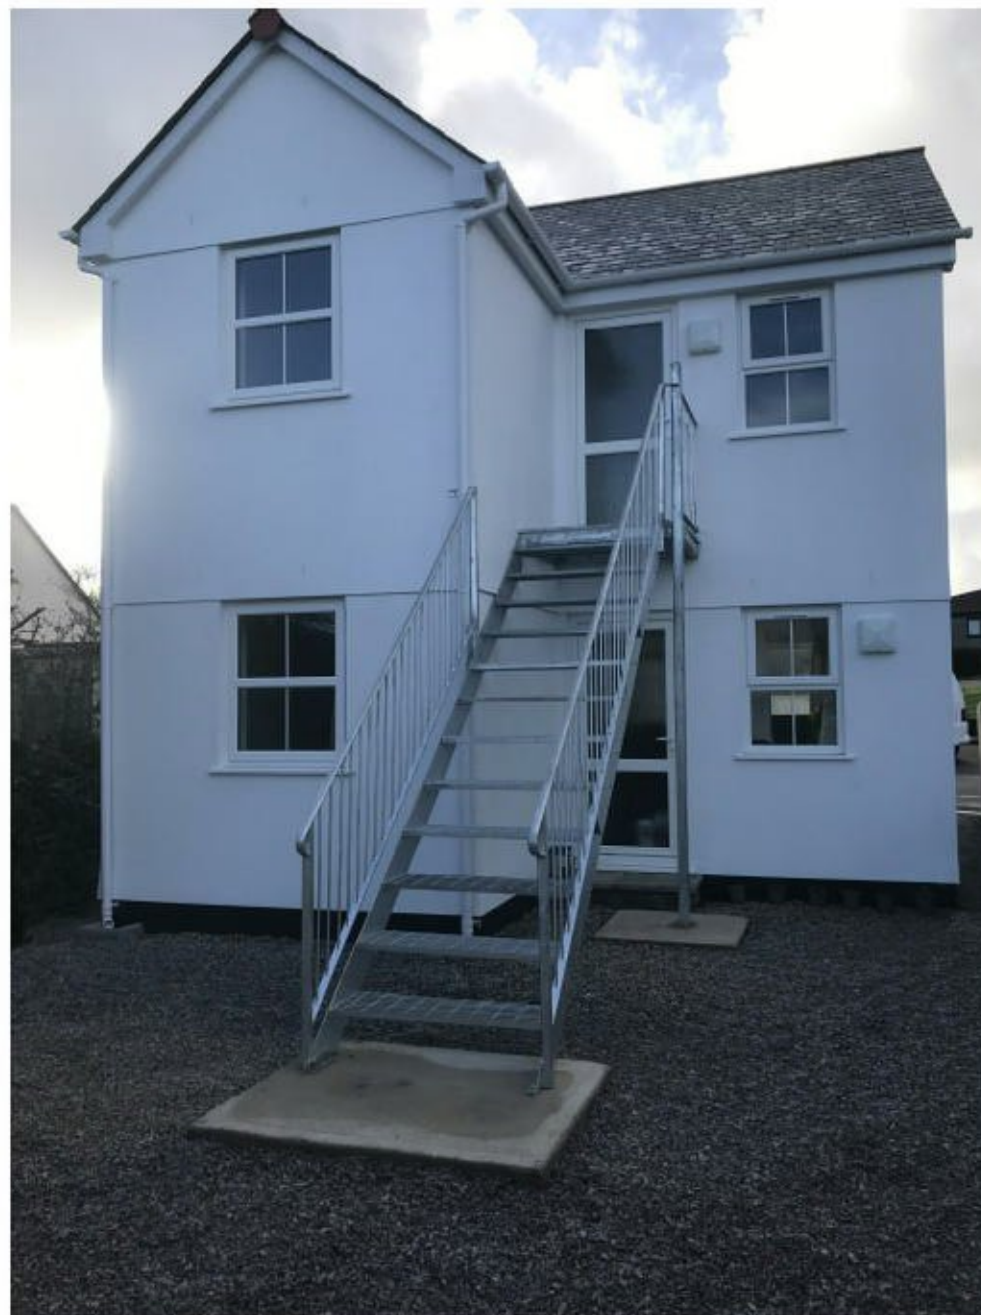
Plate 6 — A view of the rear of the property. The entire rear garden was covered by a gravel cover system of at least 300mm which was considered suitable for breaking the contamination pathway.
