**Former Piggery Site  
Hill House Lane  
Needham Market  
IP6 8EA**

## **STAGE I – Contaminated Land Assessment**

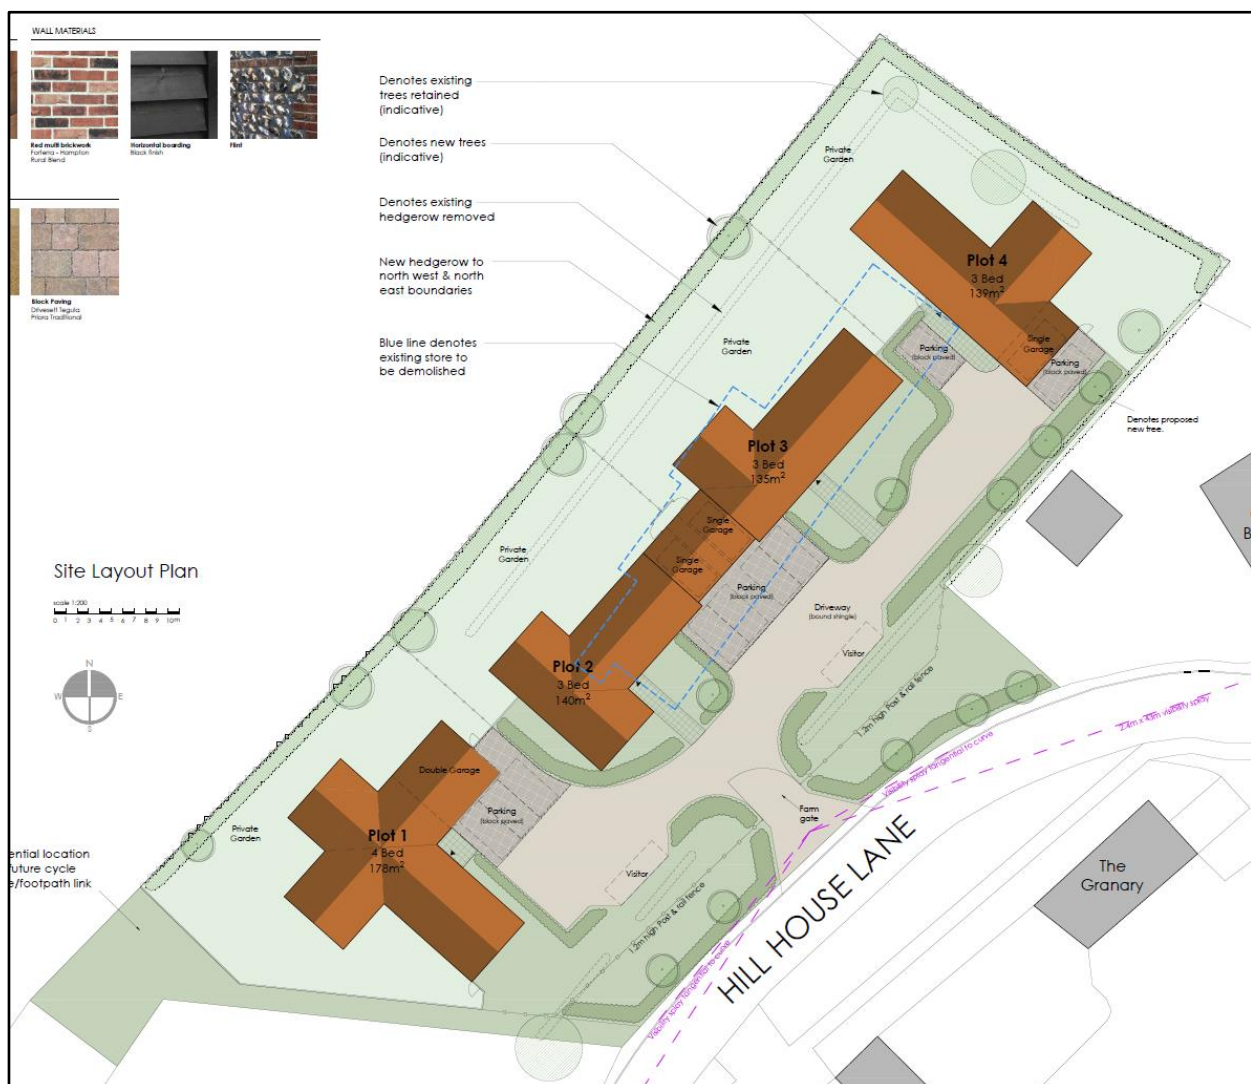
Figure 1 – Architect's Proposed Layout (extract)

- 1.04.1 We understand that the intention is to demolish the former piggery building and to construct 4 No. residential dwellings, with associated gardens and access road.
- 1.04.2 An extract of the architect's site plan is shown below. A full-scale copy of the architect's drawing is presented within the appendices.

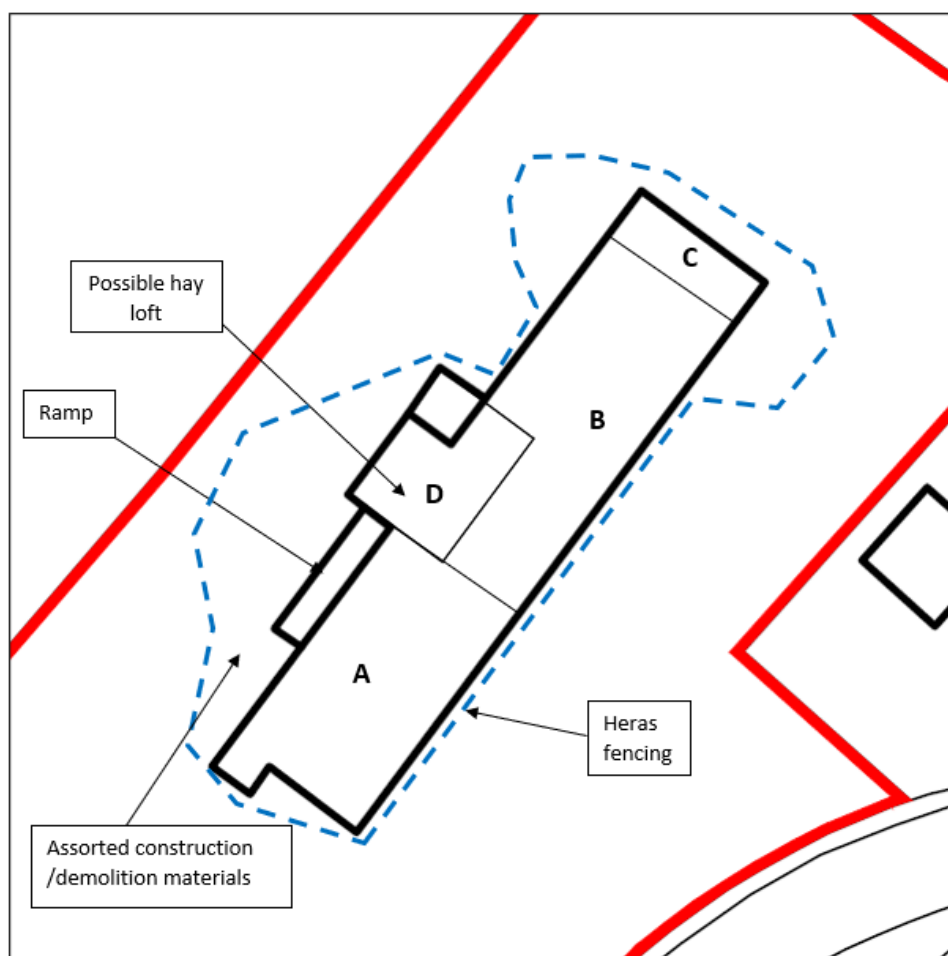
Figure 2 - Architect's Existing Layout Plan (extract)

2.02.5 The larger north-eastern aspect is currently occupied by what appears on aerial photographs to be a single structure, but in reality is a collection of single and part two-storey buildings. This conjoined collection of buildings sits centrally within the developed side of the site but is surrounded by further grass rather than hard standing. The sketch below shows an artificial division of the building, which has been used to aid description.

- 2.02.6 The collection of buildings is currently enclosed by well secured Heras security fencing, which limits physical access into the structure, however most of the building footprint is laid out as a series of open fronted bays. The exception to this is a triple bay width at the southern end (Section A), where the frontage has been enclosed with timber cladding and wooden doors. Sections B & C are all entirely open fronted, opening towards Hill House Lane to the south east. While Sections A & B are of long-established construction, with blockwork walls to approximately 1.2m, and a timber framed construction over, Section C at the northern end is a modern addition formed out of galvanised metal sheeting.

- 2.02.7 Section D appears to be either one and a half or two storeys in height, and is heavily overgrown with ivy, which obscures the majority of this element from view. There is, however, a high-level door on the south west elevation, which is accessed via a masonry ramp which runs part way along the rear of Section A.
