**INTERPRATIVE REPORT**  
**on**  
**GROUND INVESTIGATION**  
**at**  
**84 ST. ALDATE'S**  
**OXFORD**

**JUNE 2014**

**REPORT NO: 729180**

Document: Interpretive Report on Ground Investigation

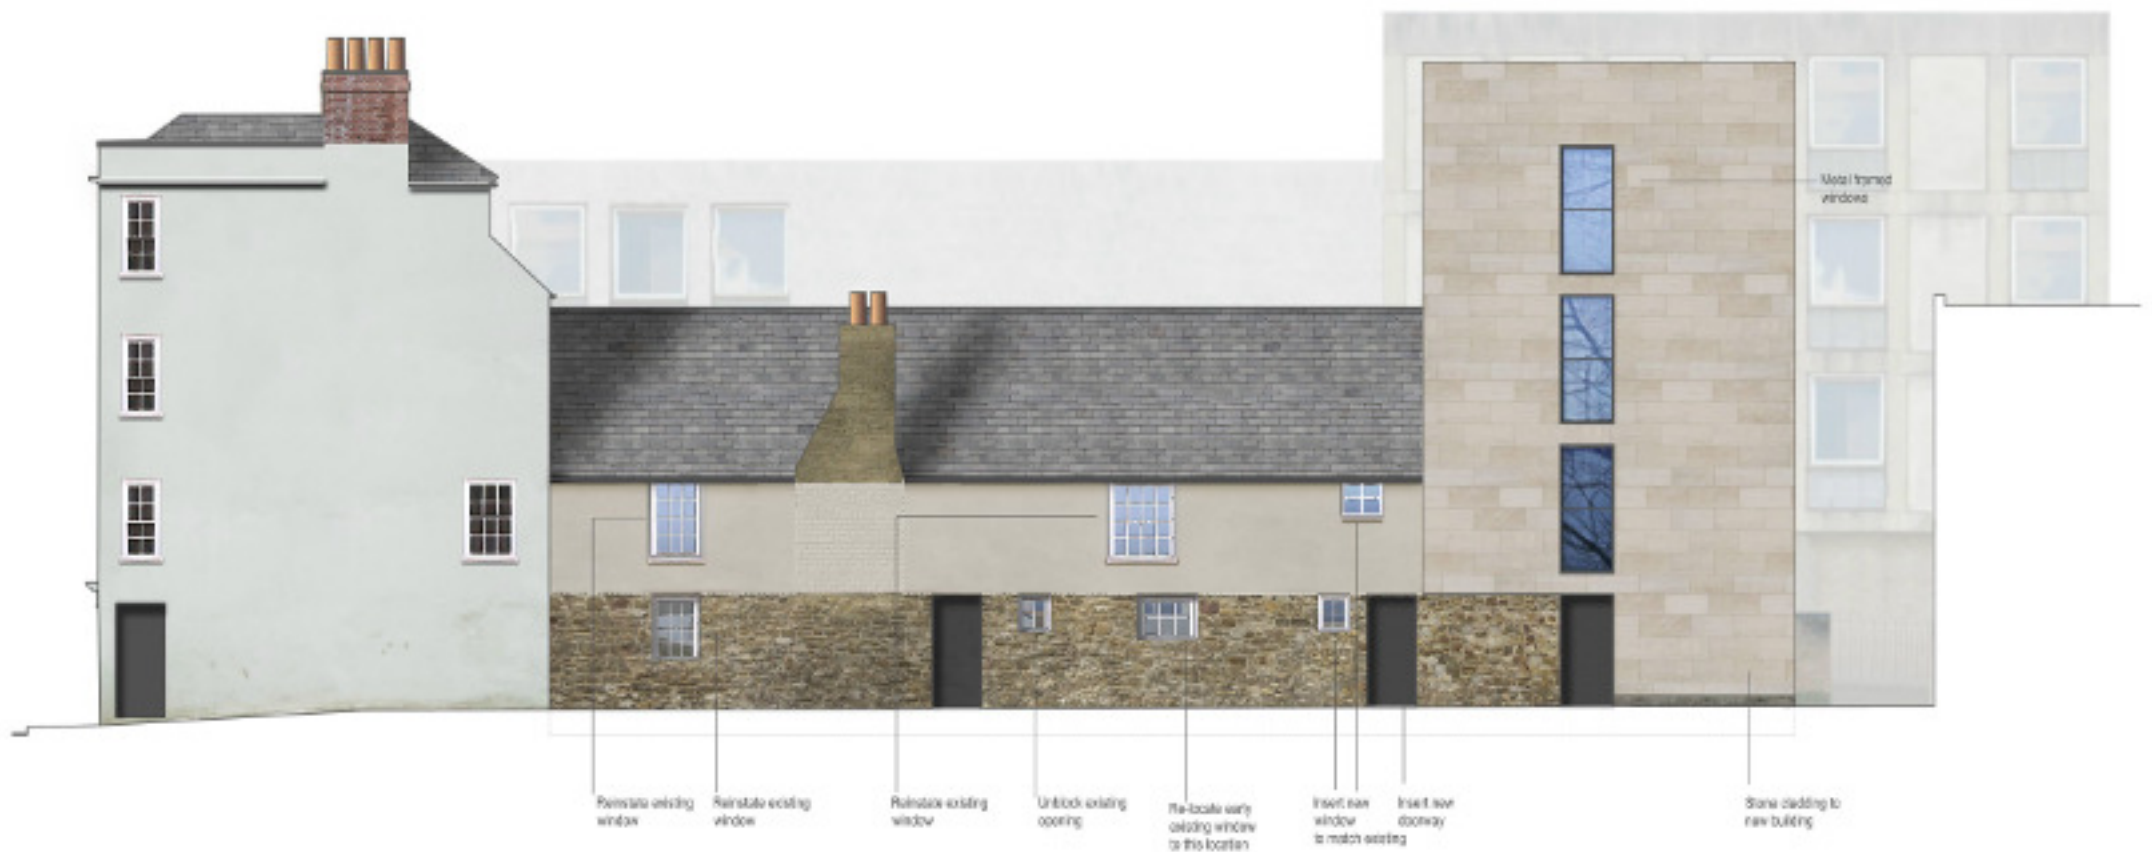
## Proposed North Elevation

84 St Aldanos, Oxford  
1:100 @ A3  
North Elevation  
July 2013

The proposed development is to reinstate the historic two storey timber framed building, in its original position, with new foundations. The current proposal is to rebuild the timber frame on a new raft foundation, in order to minimize disturbance to any underlying archaeology.

At the rear of the site, a new four storey residential structure is proposed. The higher and more concentrated loads from this structure mean that a raft may not be adequate, and the current proposal is for a raft foundations supported by mini piles.

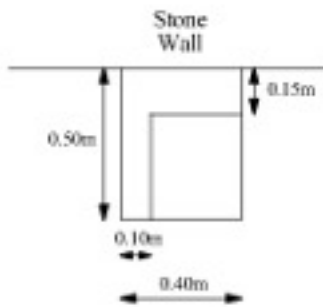
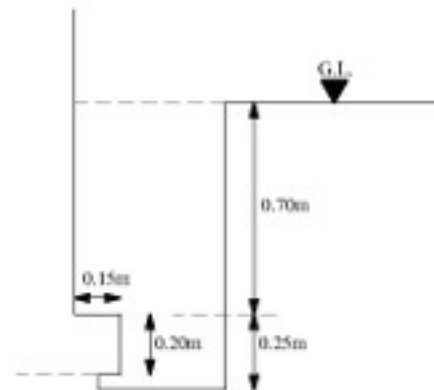
Plan (Not to Scale)

Trial pit terminated at 0.95m depth, when foundations had been proven.

Within TP2, as shown on the diagram in the log, a step out to a corner foundation was encountered at 0.70m depth. This had a step out of 0.15m from the exterior wall and 0.10m from a demolished interior wall and had a thickness of 0.20m. The foundations were overlying made ground of sandy gravelly clay.

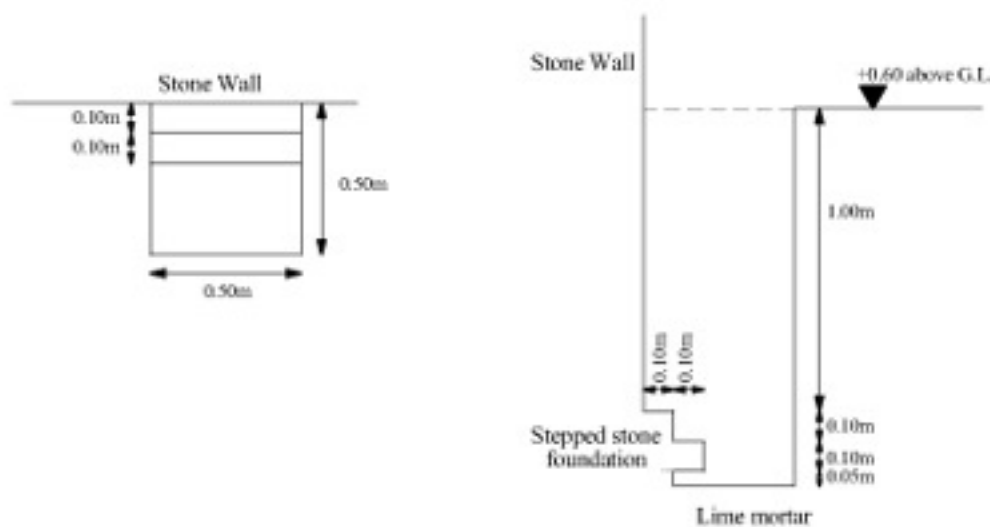
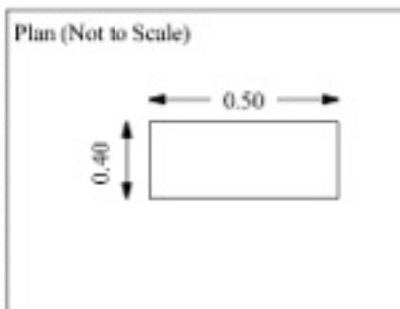
Trial pit terminated at 1.25m depth when foundations had been proven.

1. Location CAT scanned prior to excavation.
2. Hand dug inspection pit to 1.25m depth.
3. No groundwater encountered.

Within TP4, as shown on the diagram in the log, a stepped, stone foundation was encountered at 1.00m depth. It stepped out by 0.20m and was 0.20m thick. At the base of the foundations was what appeared to be lime mortar, as well as the foundations overlying made ground of clayey sandy gravel.

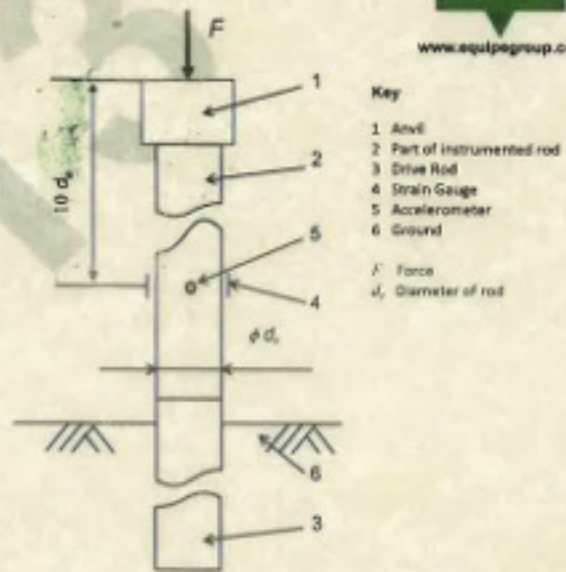
Fig B.1 and B.2 BS EN ISO 22476-3 : 2005 + A1 : 2011

Mass of the hammer  $m = 63.5\text{kg}$   
 Falling height  $h = 0.76\text{m}$   
 $E_{theor} = m \times g \times h = 249\text{J}$

Characteristics of the instrumented rod  
 Diameter  $d_r = 0.052\text{ m}$   
 Length of the instrumented rod  $0.558\text{ m}$   
 Area  $A = 11.61\text{ cm}^2$   
 Modulus  $E_s = 206843\text{ MPa}$

- Key**
- 1 Anvil
  - 2 Part of instrumented rod
  - 3 Drive Rod
  - 4 Strain Gauge
  - 5 Accelerometer
  - 6 Ground
- $F$  Force  
 $d_r$  Diameter of rod

Standard Penetration Tests (SPT) were carried out in the exploratory holes, where noted in the preceding sections, in accordance with BS EN ISO 22476-3 using a hammer which had been calibrated for efficiency. The calibration certificate is included in Appendix C. Seating drives have been recorded in increments of 75mm in accordance with recommended UK practice.

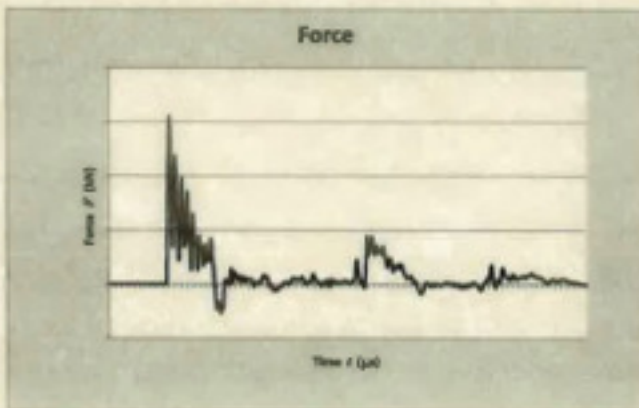
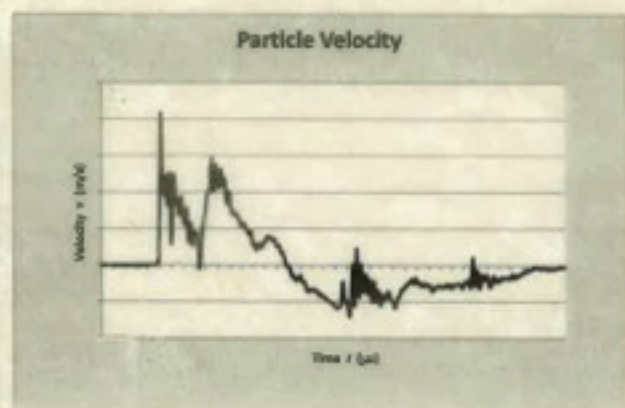
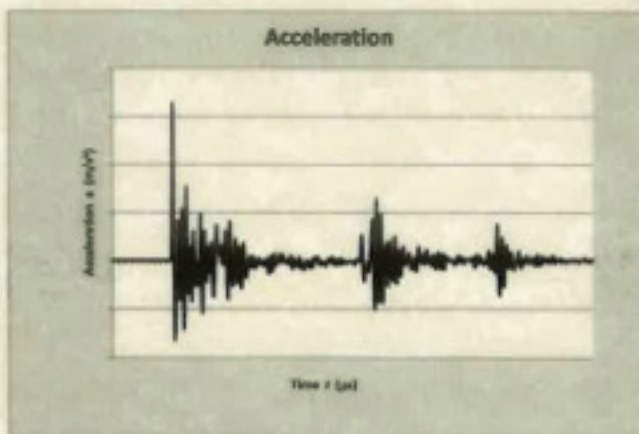
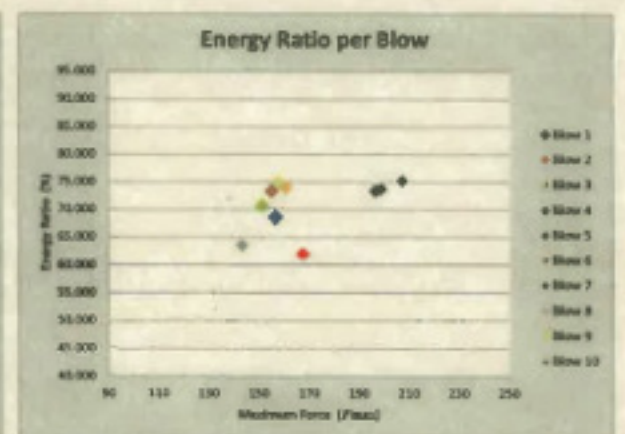
$E_{meas} = 0.334\text{ kN-m}$   
 $E_{theor} = 0.473\text{ kN-m}$

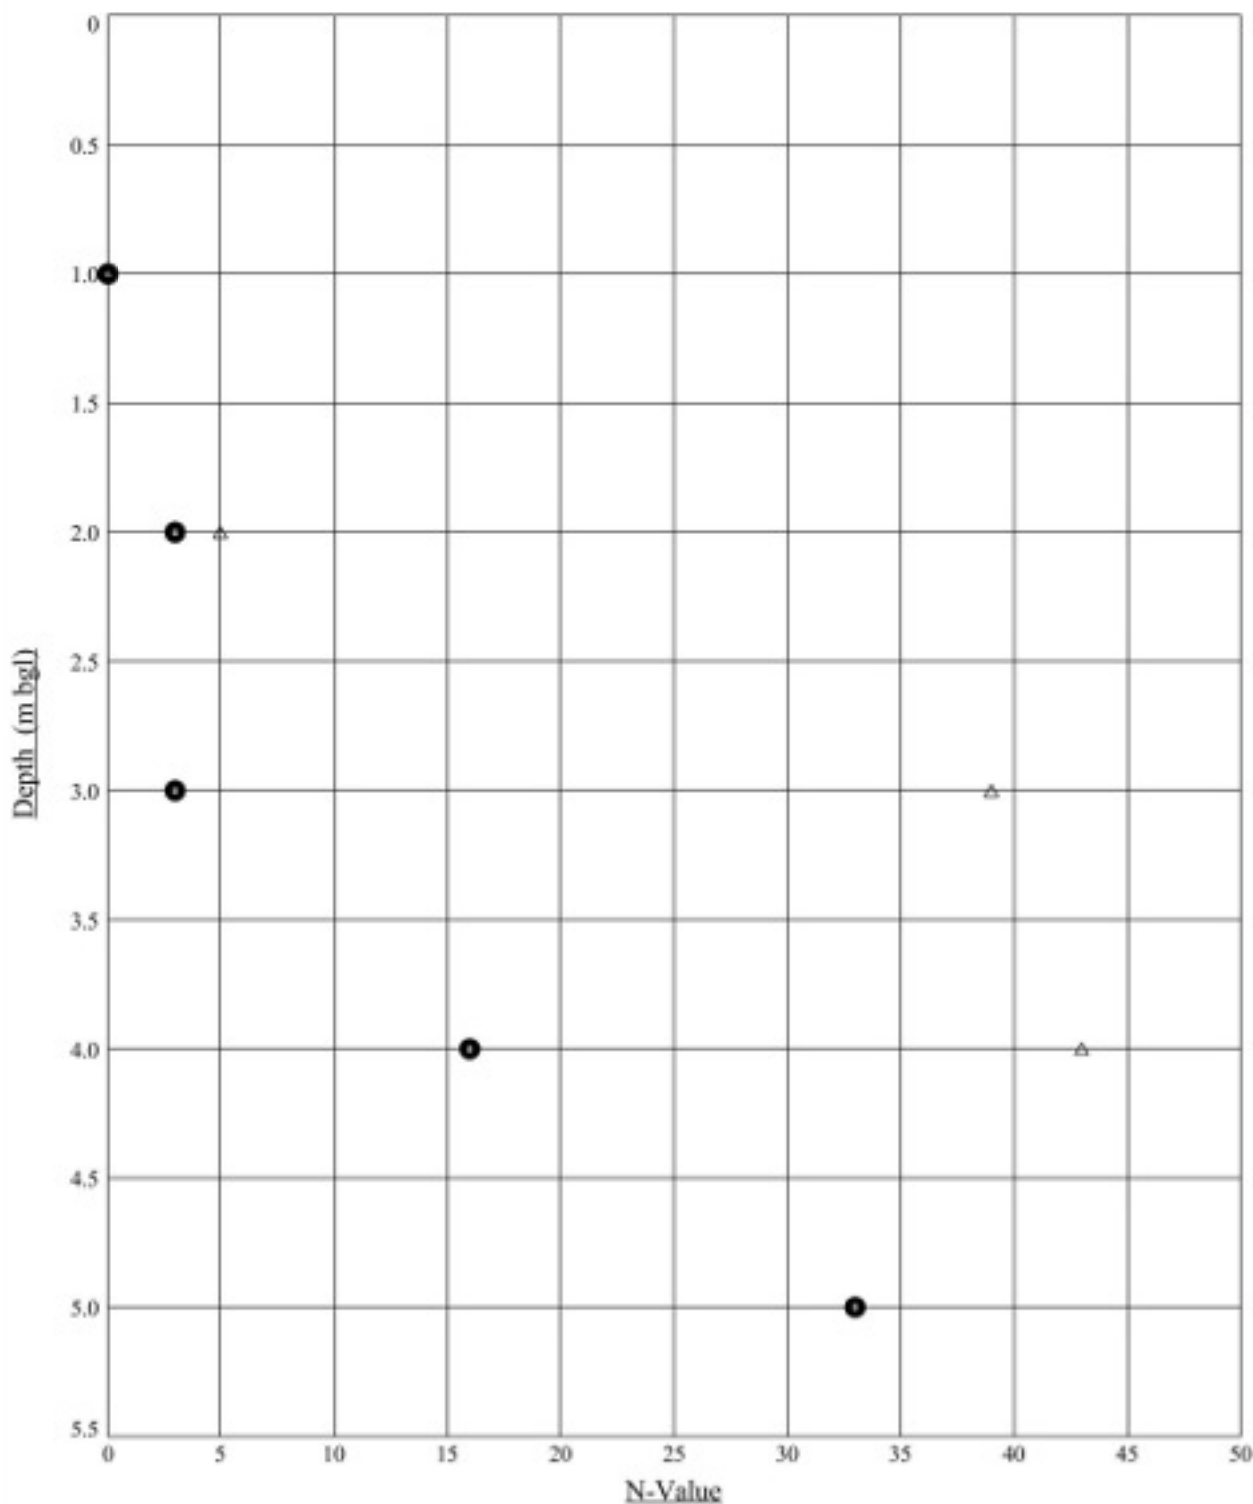
# STANDARD PENETRATION TEST (SPT N-Value) vs DEPTH

Key: ● = WS1, △ = WS2

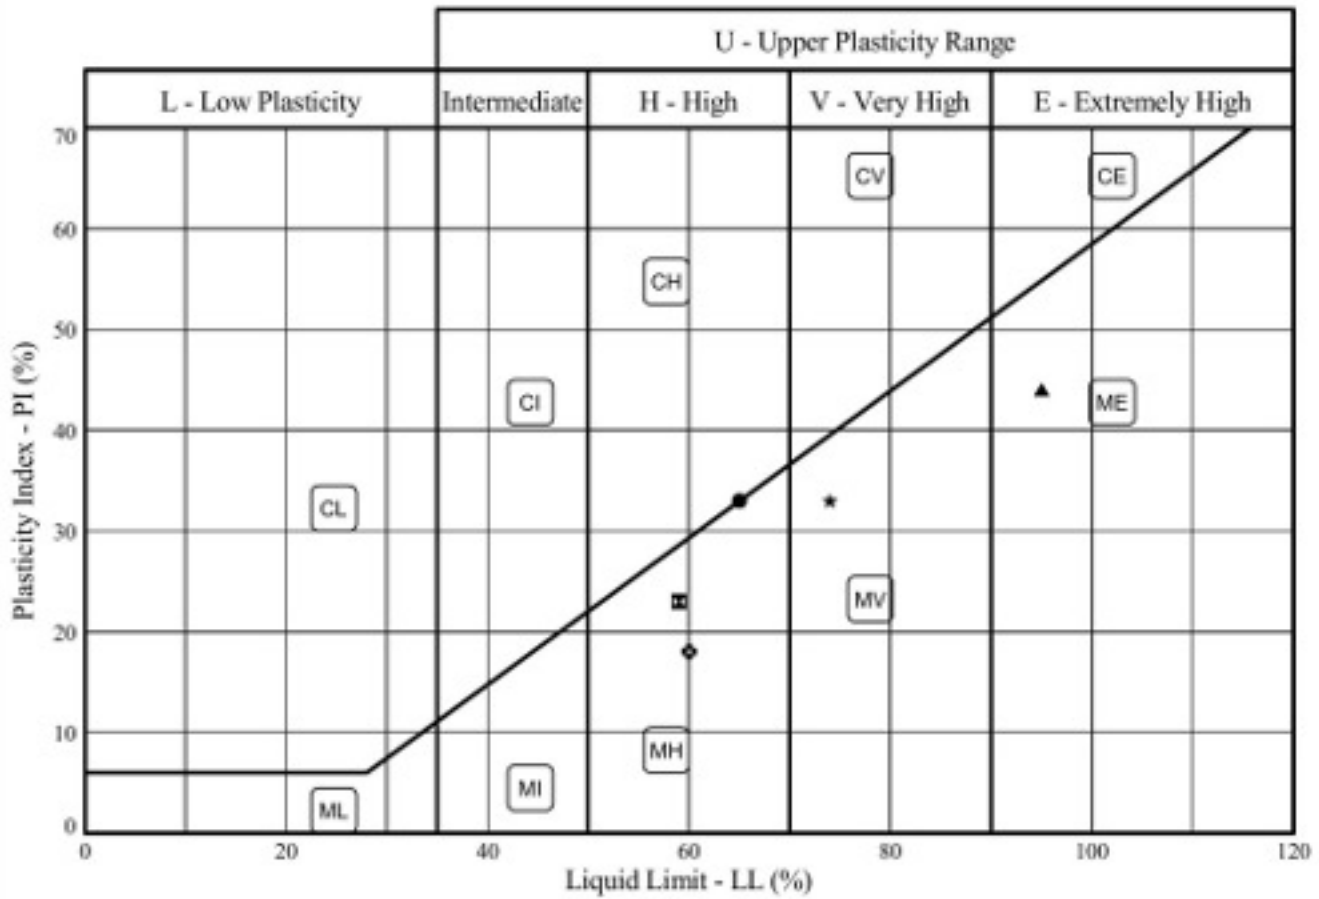
# PLASTICITY CHART - PI Vs LL

In accordance with clause 42.3 of BS5930:1999  
Testing in accordance with BS1377-2:1990

Sample Identification			BS Test Method #	Preparation Method +	MC %	LL %	PL %	PI %	<425um %	
Exploratory Position ID	Sample	Depth (m)								
●	WS1	9D	2.60	3.2/4.4/5.3/5.4	4.2.4	38	65	32	33	80
■	WS1	11DSPT	3.00	3.2/4.4/5.3/5.4	4.2.4	48	59	36	23	63 *
▲	WS1	12D	3.40	3.2/4.4/5.3/5.4	4.2.4	66	95	51	44	77
★	WS2	6D	1.35	3.2/4.4/5.3/5.4	4.2.4	45	74	41	33	66
	WS2	10D	2.35	3.2/4.4/5.3/5.4	4.2.3	113	197	104	93	83
◆	WS2	12D	3.00	3.2/4.4/5.3/5.4	4.2.4	77	60	42	18	73
