HERITAGE ASSESSMENT

EAST GABLE SOUTH RANGE

MANOR FARMHOUSE, NETHER WINCHENDON

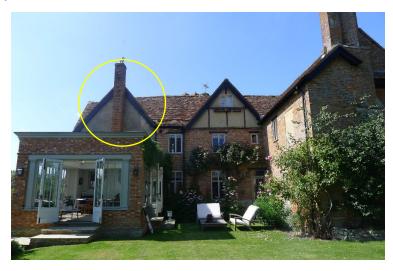
Fig 1: View of the east facing elevation

The east gable of the south range is on the left [highlighted] behind the 21st century single storey orangery style conservatory extension.

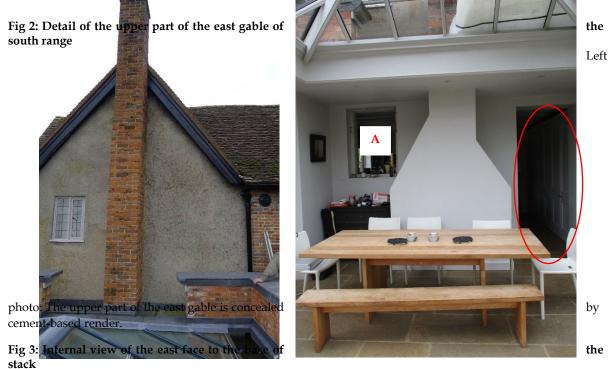
Right photo: View from within the extension looking towards the south range. The stack and ground floor of the east wall are concealed by modern linings. The window opening [A] was introduced at the same time as the extension. Openings between the 21^{st} century extension and the historic south range of the building have been made or adapted when the extension was built. The door opening created in association with the extension works is highlighted [refer to Figs 4 & 5].

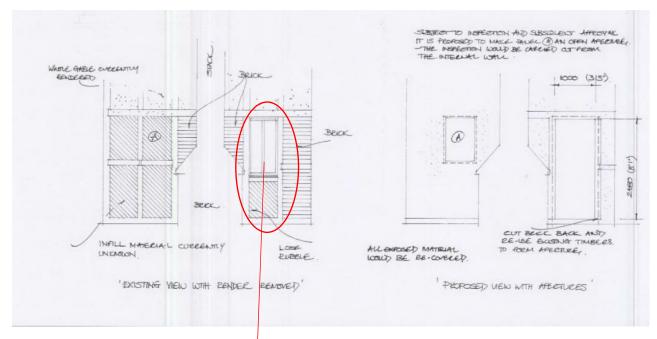
Fig 4: Extract of drawing dated 4th February 2011 submitted as minor amended plans
This drawing is stamp dated 7th February by Building Control for App No 10/02323. The drawing illustrates the exposed fabric and the proposed alterations to the ground floor of the east gable of the south range in 2011.

The window and the infill panel below the window to the north [right] of the stack [highlighted] now form the door opening [Fig 3] where the drawing described the works to "Cut brick back and re-use existing timbers to form aperture". A window opening [A] was created with the removal of an infill panel [Fig 4].

The width of the infill panel [Fig 5] where the door opening is now located [Fig 3] would have been too narrow to accommodate this opening. The opening has been enlarged to provide the existing door opening. This follows the proposed alterations of cutting brickwork back and reusing the timbers to form the door opening [Fig 4]. It is

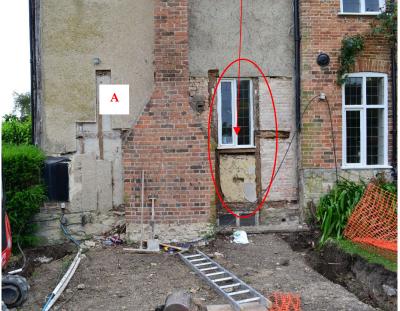
Fig 5: View of the ground floor of the east gable in 2011
Left photo

The removal of the render reveals a surviving timber frame with brick and/or rendered infill panels.

An infill panel [A] was removed [Figs 3-6] to create an internal window opening in the east gable between the south range and the extension. The historic timber frame and some infill panels were altered to accommodate the extension and associated works.

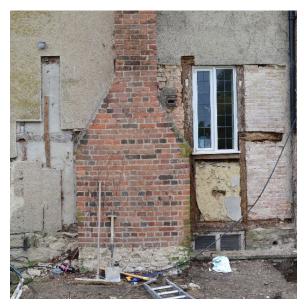
Fig 7: Detail of the base of the chimney stack to the east gable in 2011

Fig 7 shows the currently concealed base of the chimney stack. The stack has asymmetrical shoulders.

The base of the stack is built off a small coursed rubble stone plinth and in English bond [alternate stretchers and headers] brickwork that is bedded or repointed in cement mortar. The size of the bricks, smaller than those to the flue, and the bond are indicative of a stack earlier than the late 19th or early 20th century flue.

It is possible the base of the stack has been adapted or comprises of reused bricks, it is anticipated that the base of the stack has early to mid-19th century origins.

The base of the stack is too slender and narrow for an earlier stack, as its size is appropriate for smaller coal burning fire places.

The age and nature of the construction would need to be determined from a closer examination.

If the base of the stack predates the mid-19th century it would be considered to be of medium significance.

- A. Removal of the 21stcentury linings to expose the historic elements of the wall will enhance the significance, of the house.
- B. The removal of the chimney stack will address structural issues [refer to the separate report produced by SFK Consulting] and remove an ongoing threat to the historic timber frame which is of high significance.

The upper slender shaft is late 19th century or early 20th century and considered to be low significance. The removal of the stack will remove the risks of damage to the timber frame and infill panels caused by continued movement.

The base of the stack predates the upper shaft and is considered to be of low/medium significance in relation to the elements of high significance, such as the medieval timber frame and the massive stacks.
