Remediation and Enabling Works Strategy  
Former Bridgewater Paper Mill

Reference: 14-035-R2-0  
Date: February 2021

Former Bridgewater Paper Mill  
North Road  
Ellesmere Port

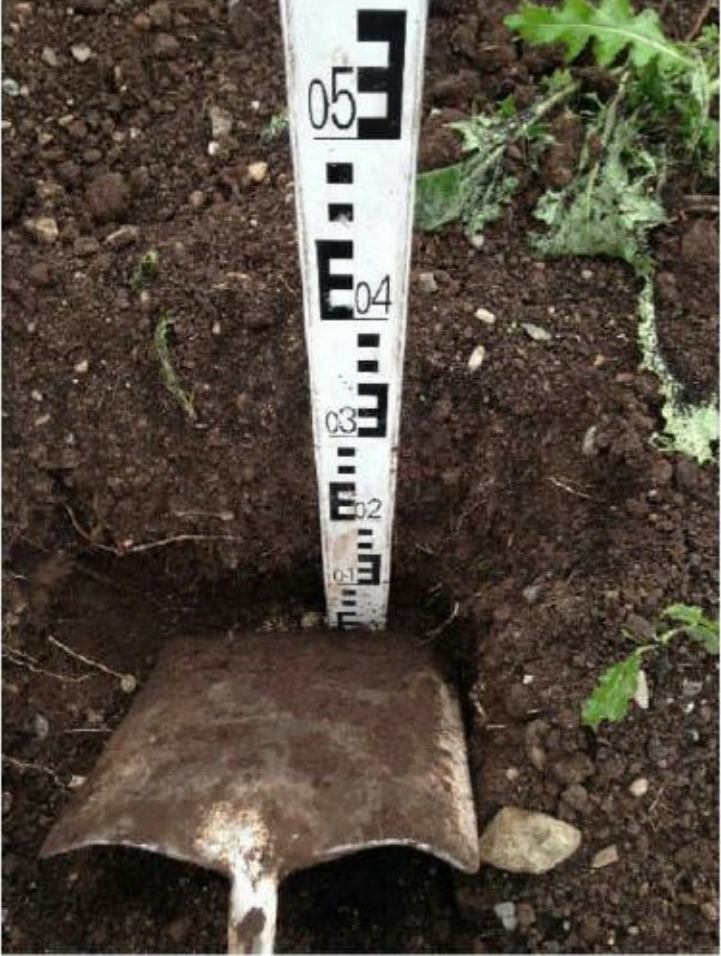
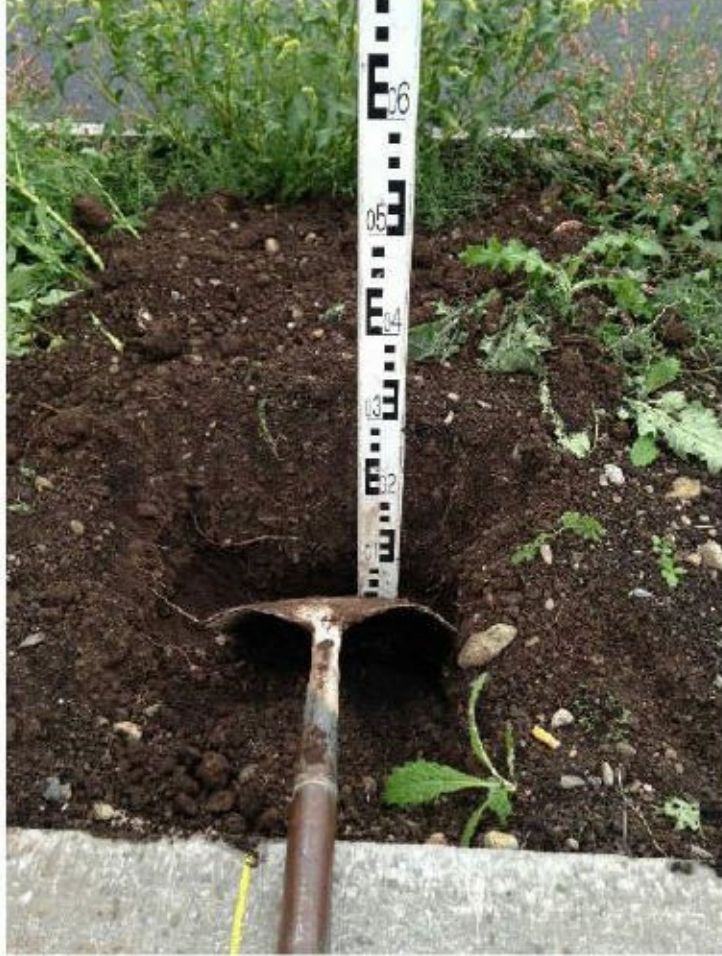
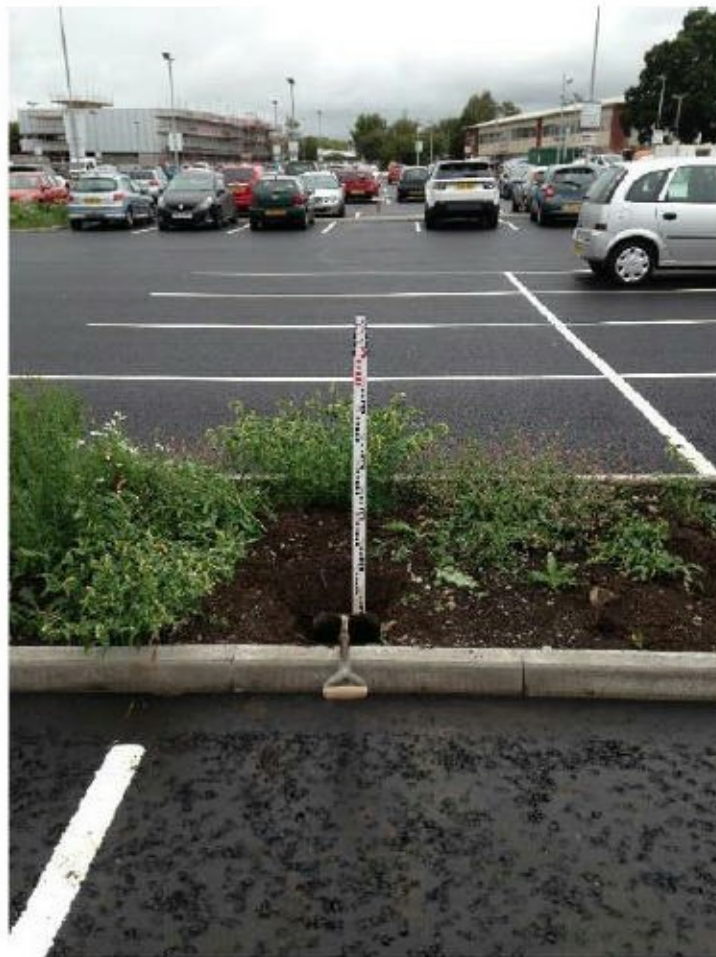
Depth of Strata (m bgl)	0.00-0.30	Validated TOPSOIL
<i>Depth of Cover System Materials</i>		<i>Depth of Cover System Materials</i>

*Depth of Cover System at Ground Level and in Relation to Unit / Structure*

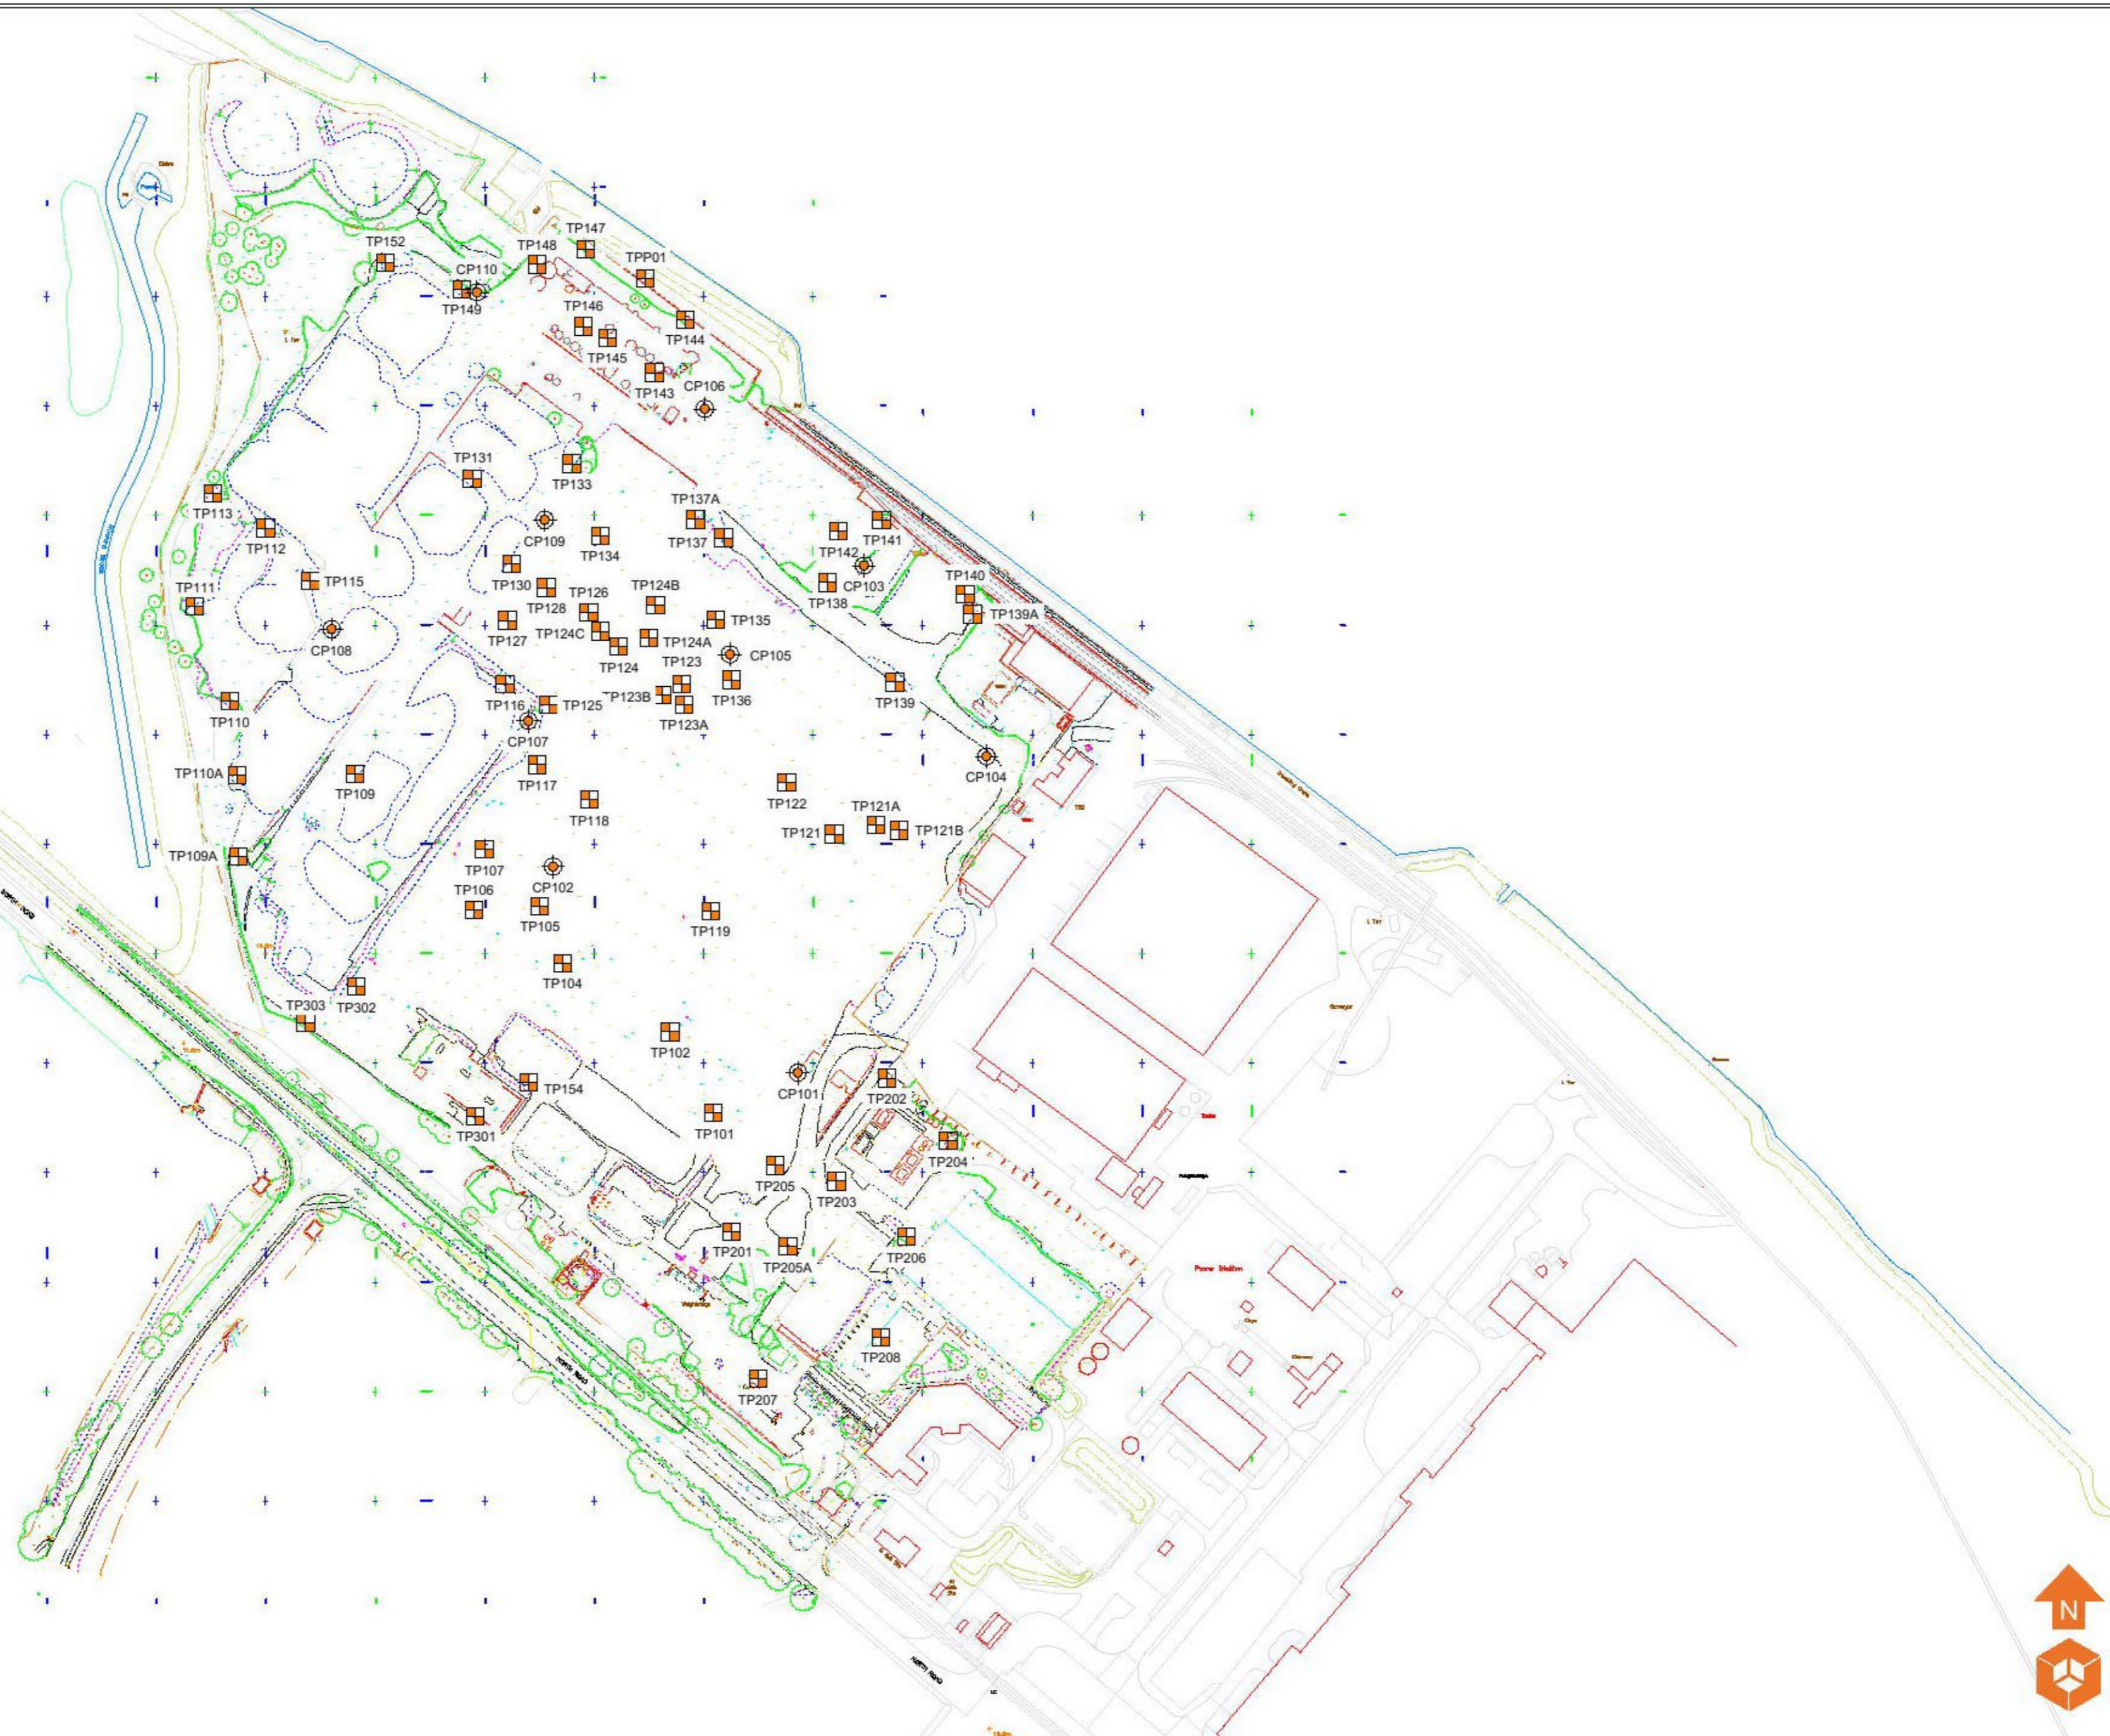
<b>Location Symbols</b>   Approximate Trial Pit Location   Approximate Cable Percussive Borehole Location				
Notes:				
Client:	SGI			
Job No:	14-035			
Date:	04.02.2021			
Drawing No:	004			
Scale:	NTS			
Job Title:	Bridgewater Paper Mill			
Drawing Title:	Exploratory Hole Location Plan			
Phase	Issue	Date	Drawn	Checked
P1	REVC	04.02.2021	HM	AE
P1	REVB	29.01.2021	HM	AE
P1	REVA	16.11.2020	HM	AE

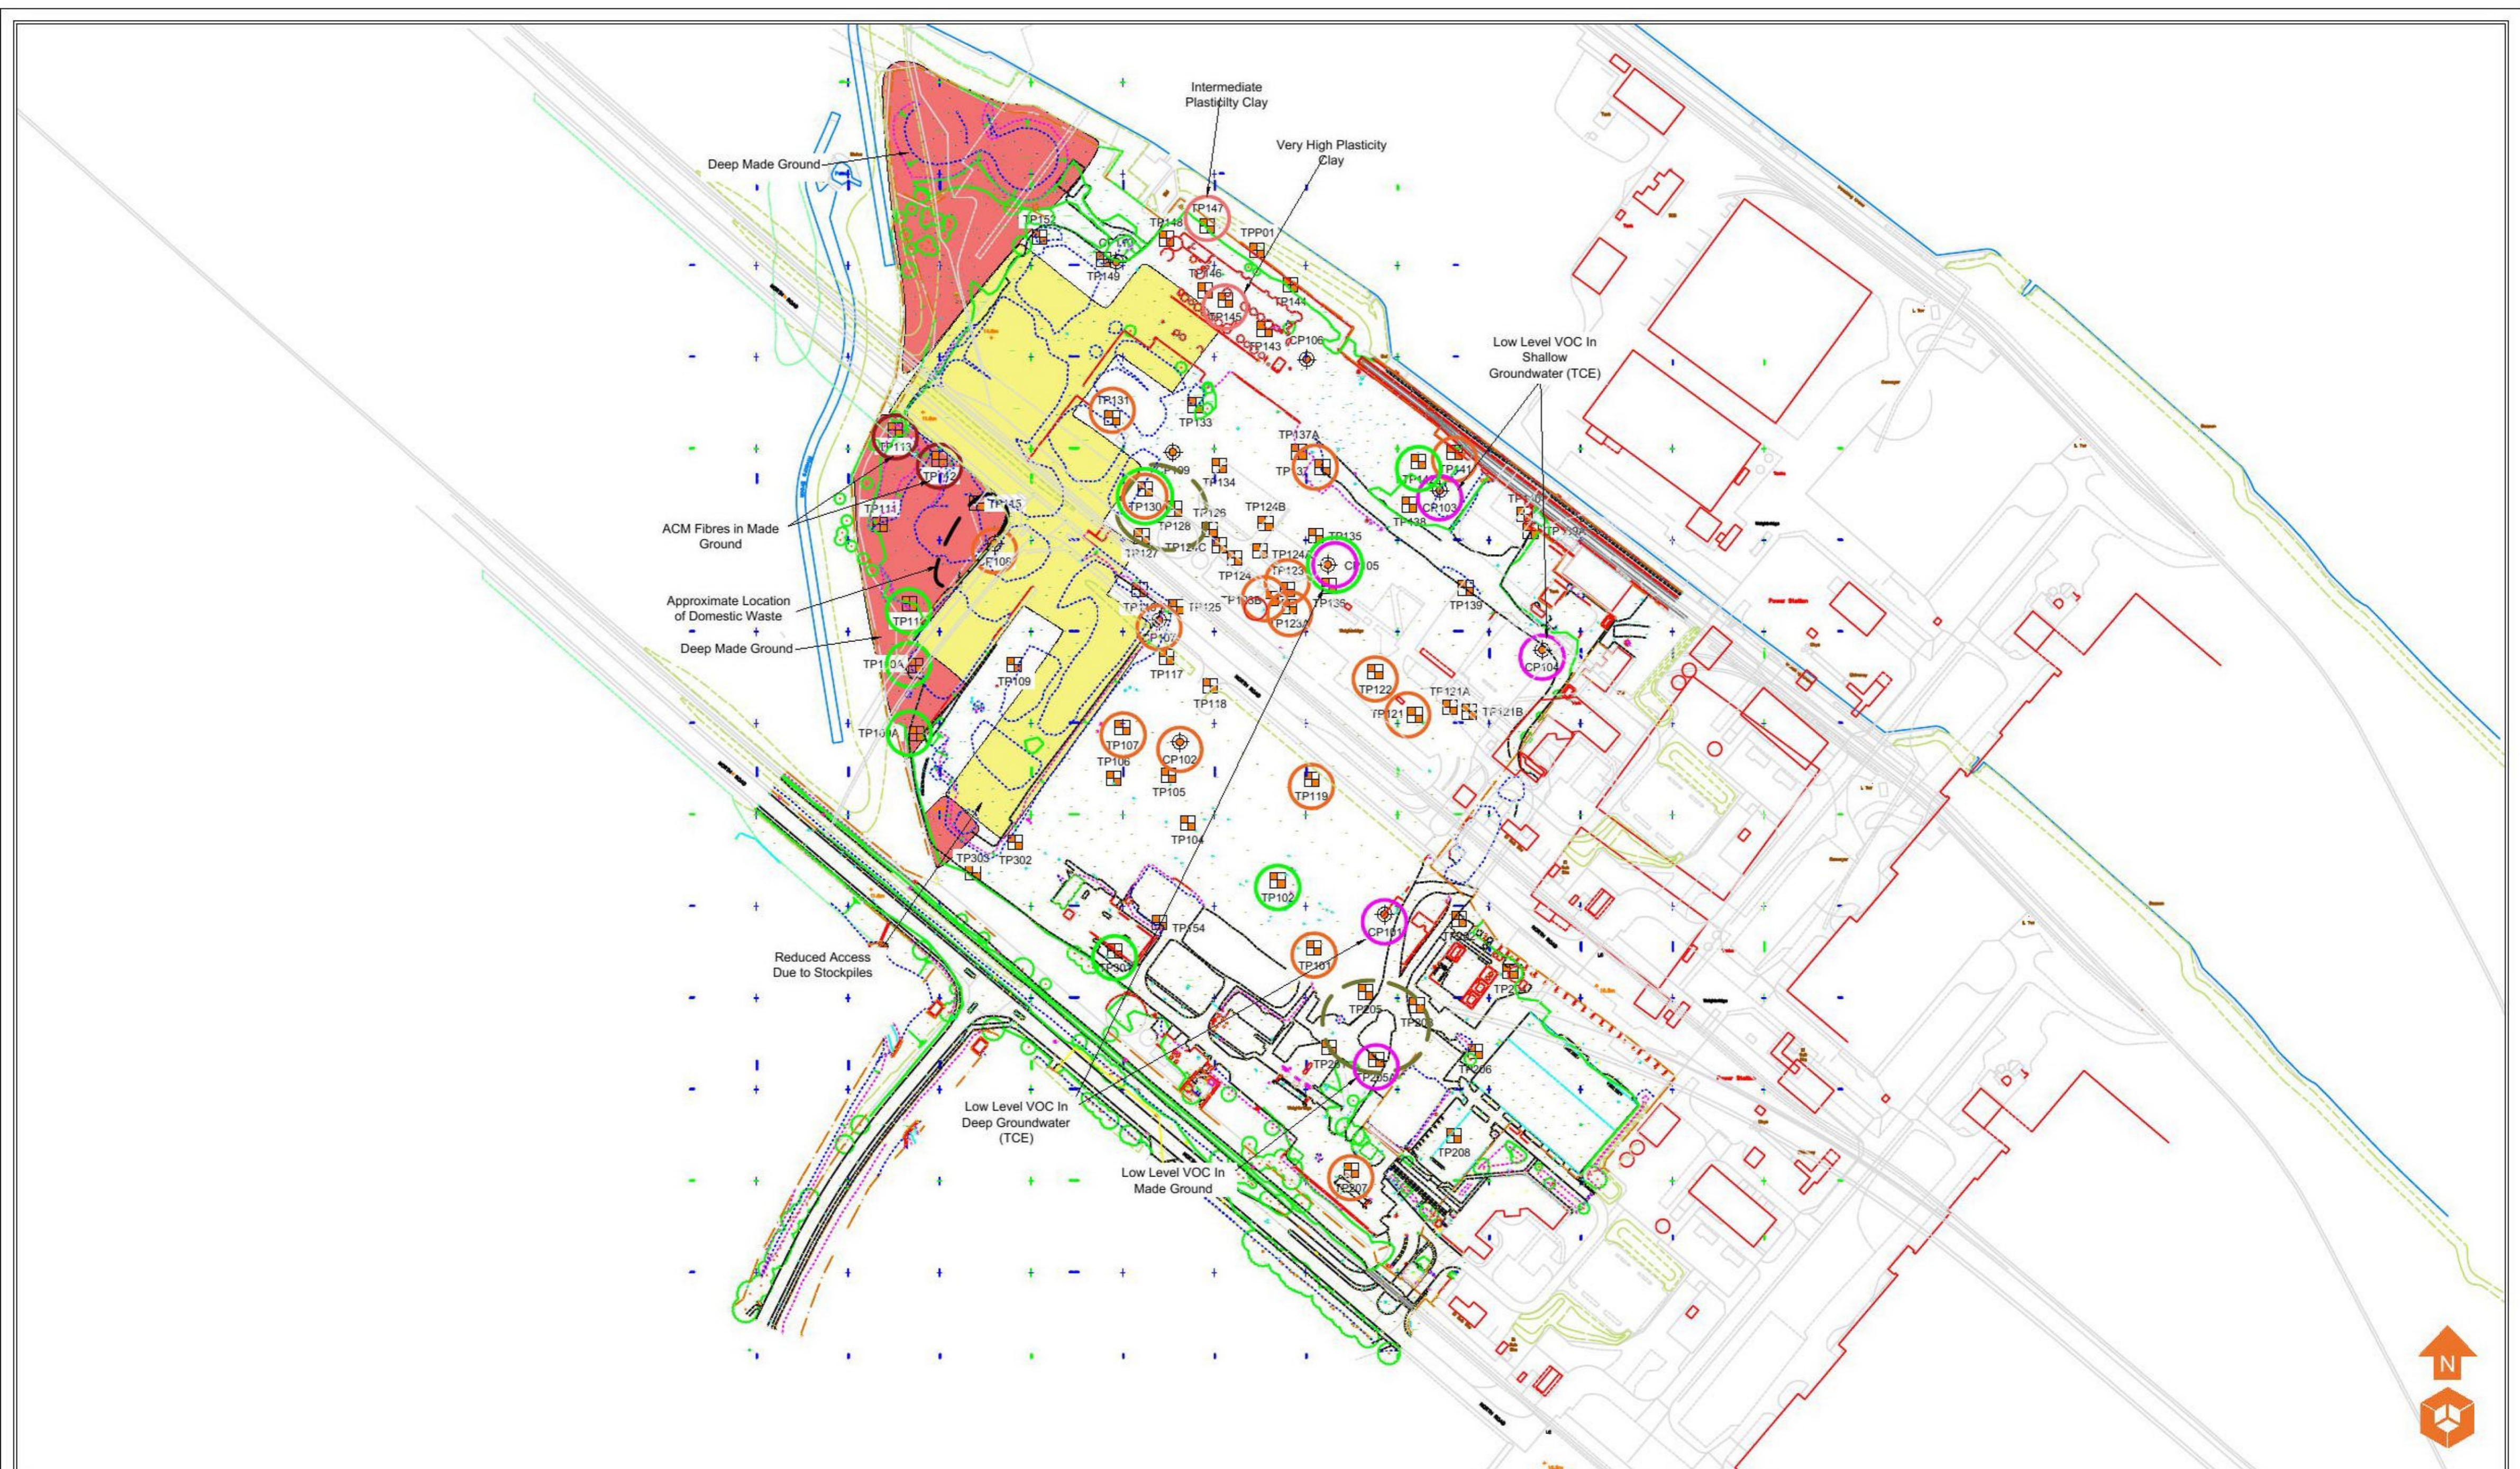
Drawing Title:  
**Development Constraints Plan**

Location Symbols		Development Constraints	
	Approximate Trial Pit Location		Visual Olfactory Evidence of Contamination
	Approximate Cable Percussive Borehole Location		Substructure
			ACM Fibres in Made Ground
			Approximate Area of Historical Ponds
			Low Level VOC
			Existing Stockpiles
			Deep Made Ground

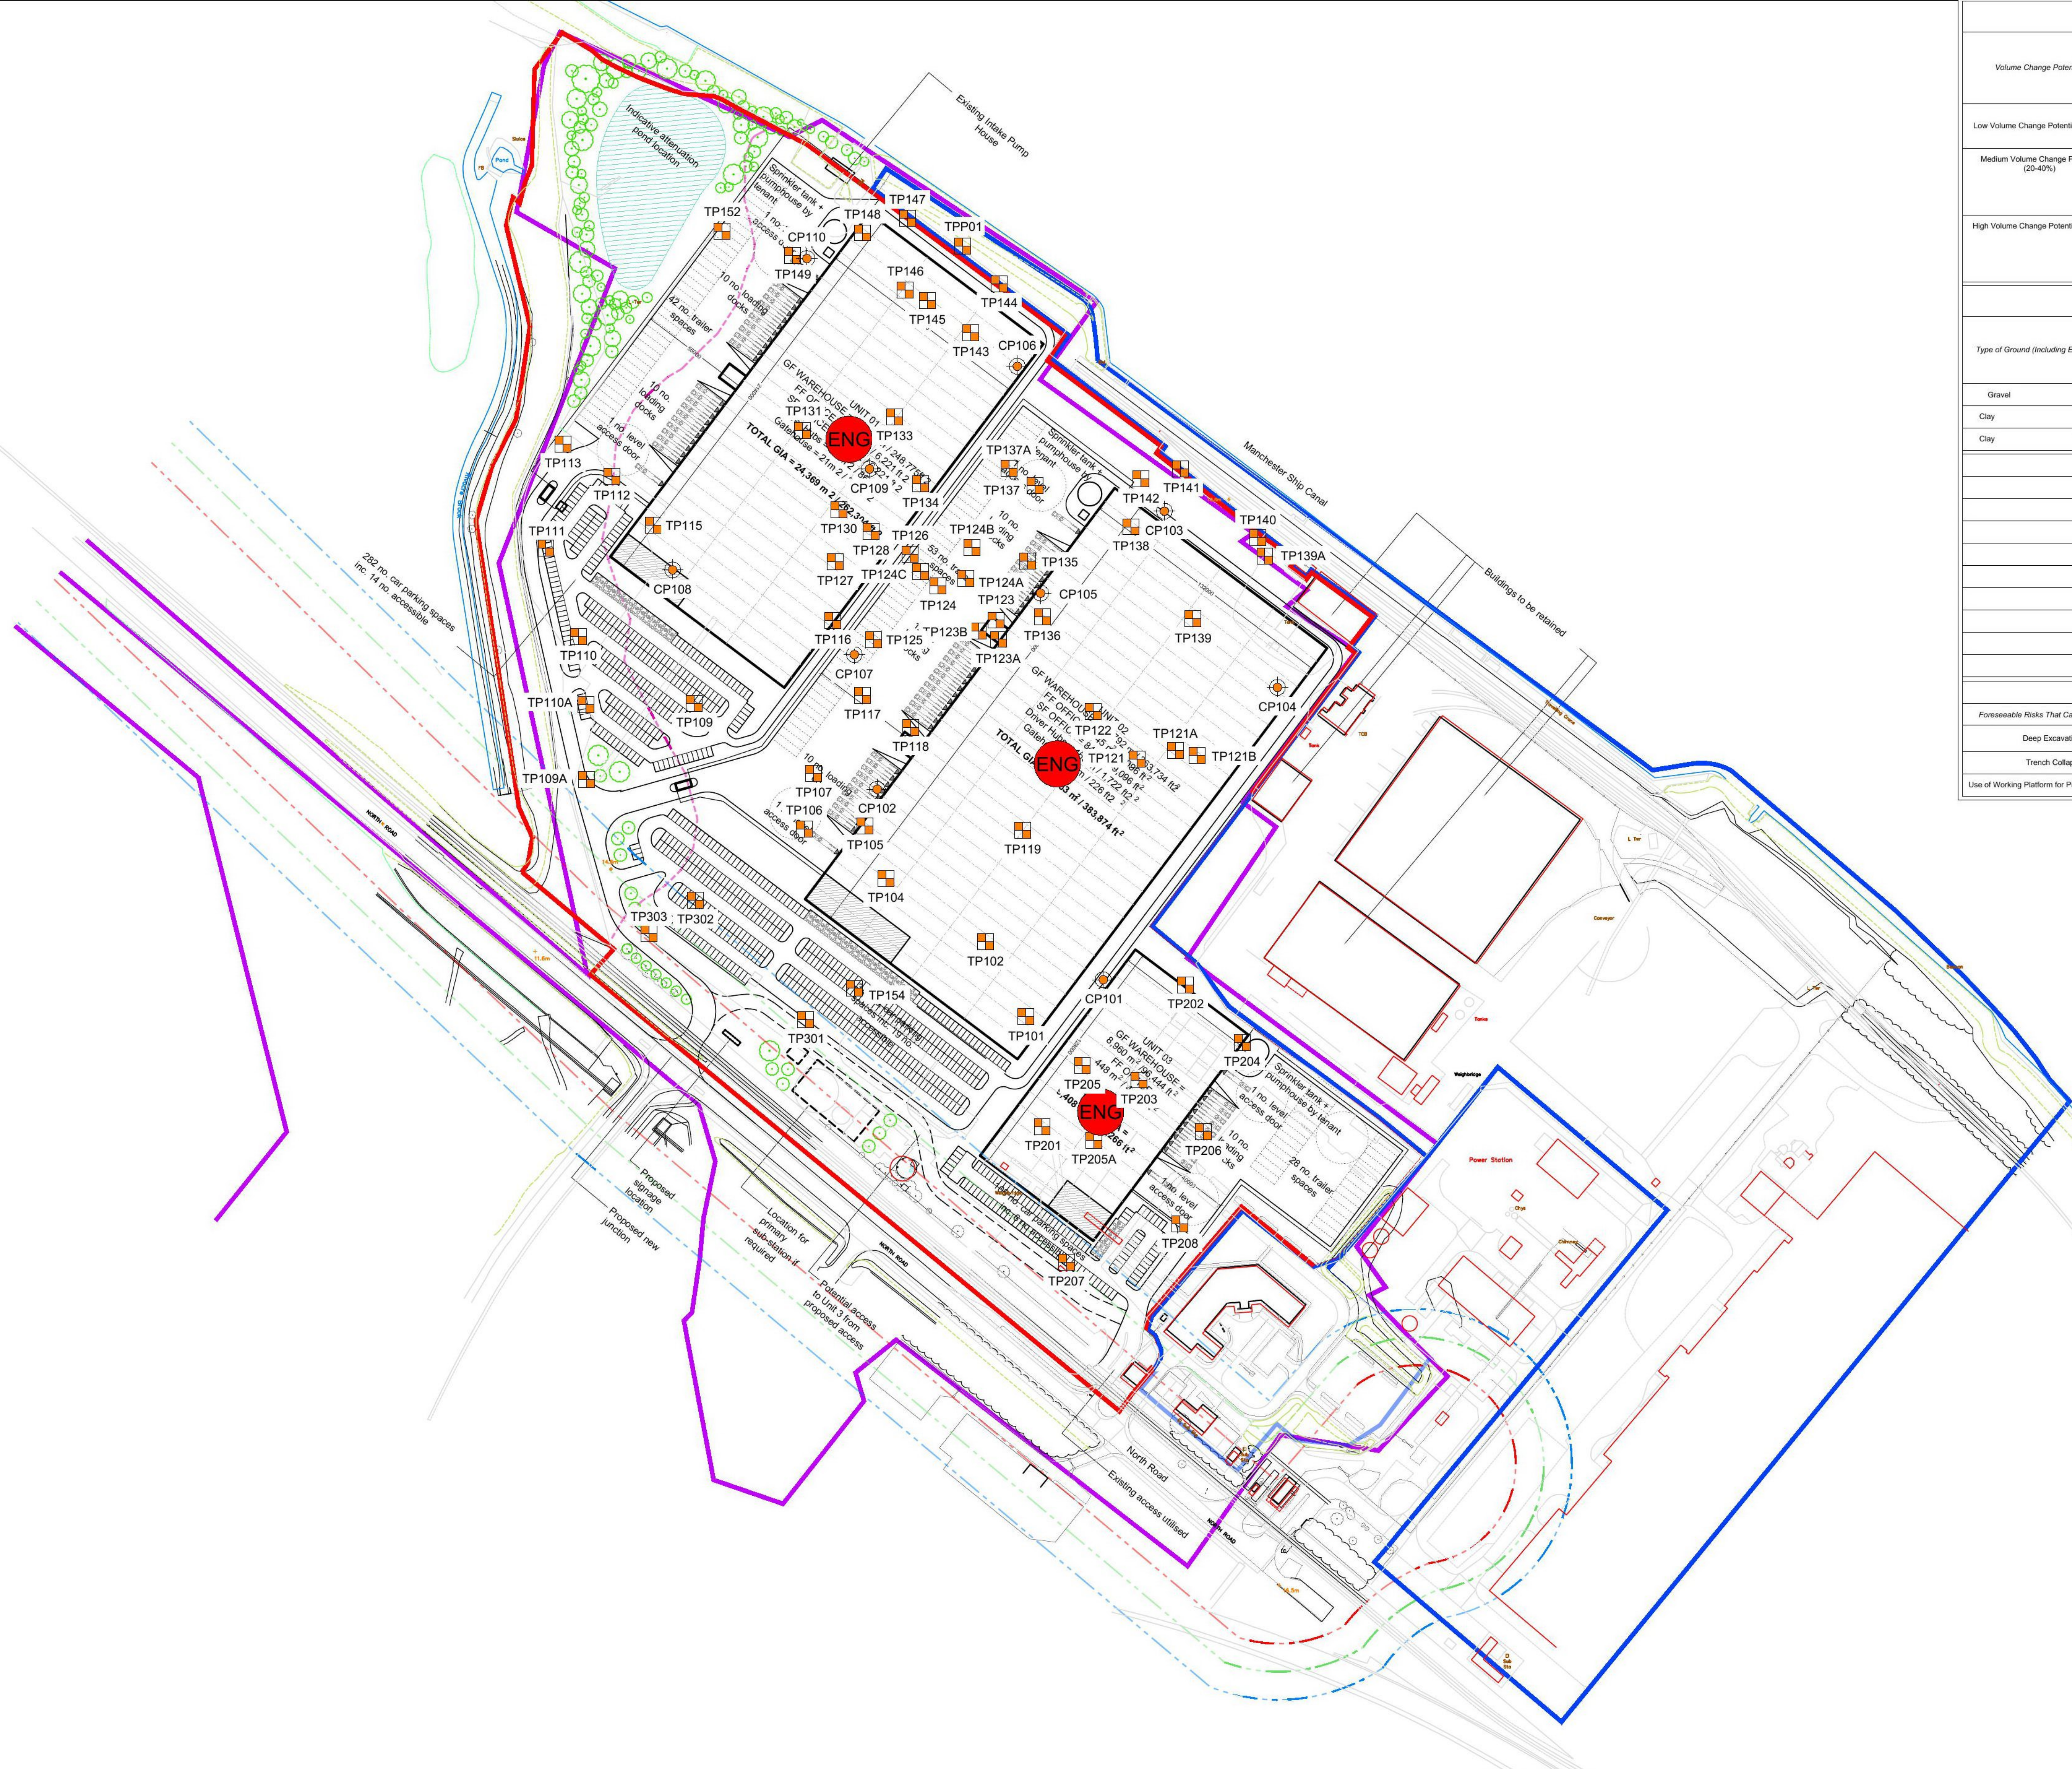
**Drawing Title:** Concept Foundation Zoning Plan

Summary of Heave Precaution Requirements				
Volume Change Potential	Required Foundation Depth (m)	Minimum Void Dimensions for Foundations, Ground Beams & Suspended In-Situ Concrete Ground Floors		Minimum Void Dimensions Under Pre-Cast Concrete & Suspended Timber Floors
		Thickness of Void Former Against Side of Foundation or Underneath of Edge Beam & Floor Slab (mm)	Thickness of Void Former on Underside of Edge Beam & Floor Slab (mm)	Void Dimension (mm)
Low Volume Change Potential (<20%)	>2.00	No Special Precautions		200
	2.00-2.50	-	50	250
Medium Volume Change Potential (20-40%)	1.50-2.00	25	50	250
	2.00-2.50	25	100	300
	>2.50	Engineer Design		Engineer Design
High Volume Change Potential (>40%)	1.50-2.00	25	75	300
	2.00-2.50	35	150	350
	>2.50	Engineer Design		Engineer Design

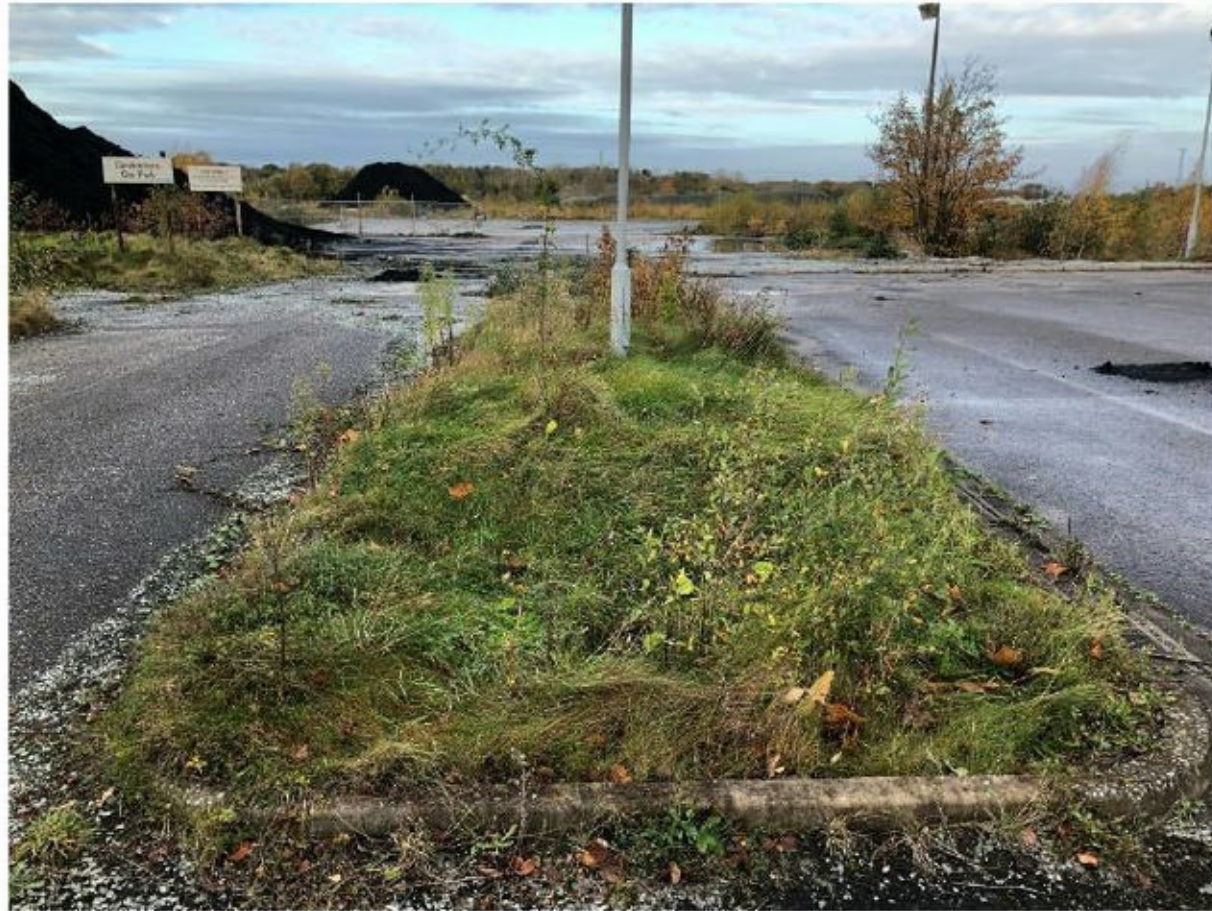
PLATE 2      SHOWING NEUTRAL SEMI-IMPROVED GRASSLAND

Small strips of neutral semi-improved grassland were present in the south-eastern area of the site, located around the former car parking areas. Areas of grassland looked to be previously present in the northern area of the site, however, it has since transitioned into scattered scrub in these areas. The flora in these grassland areas comprised Yorkshire fog (*Holcus lanatus*), Canadian fleabane, broad-leaved dock, butterfly bush, ox-eye daisy (*Leucanthemum vulgare*), bristly oxtongue, rosebay willowherb, bramble, dog-rose (*Rosa canina*), common knapweed (*Centaurea nigra*), ribwort plantain (*Plantago lanceolata*), hawthorn (*Crateagus monogyna*), spear thistle (*Cirsium vulgare*), dogwood (*Cornus sanguinea*), teasel (*Dipsacus fullonum*) and bush vetch (*Vicia sepium*).

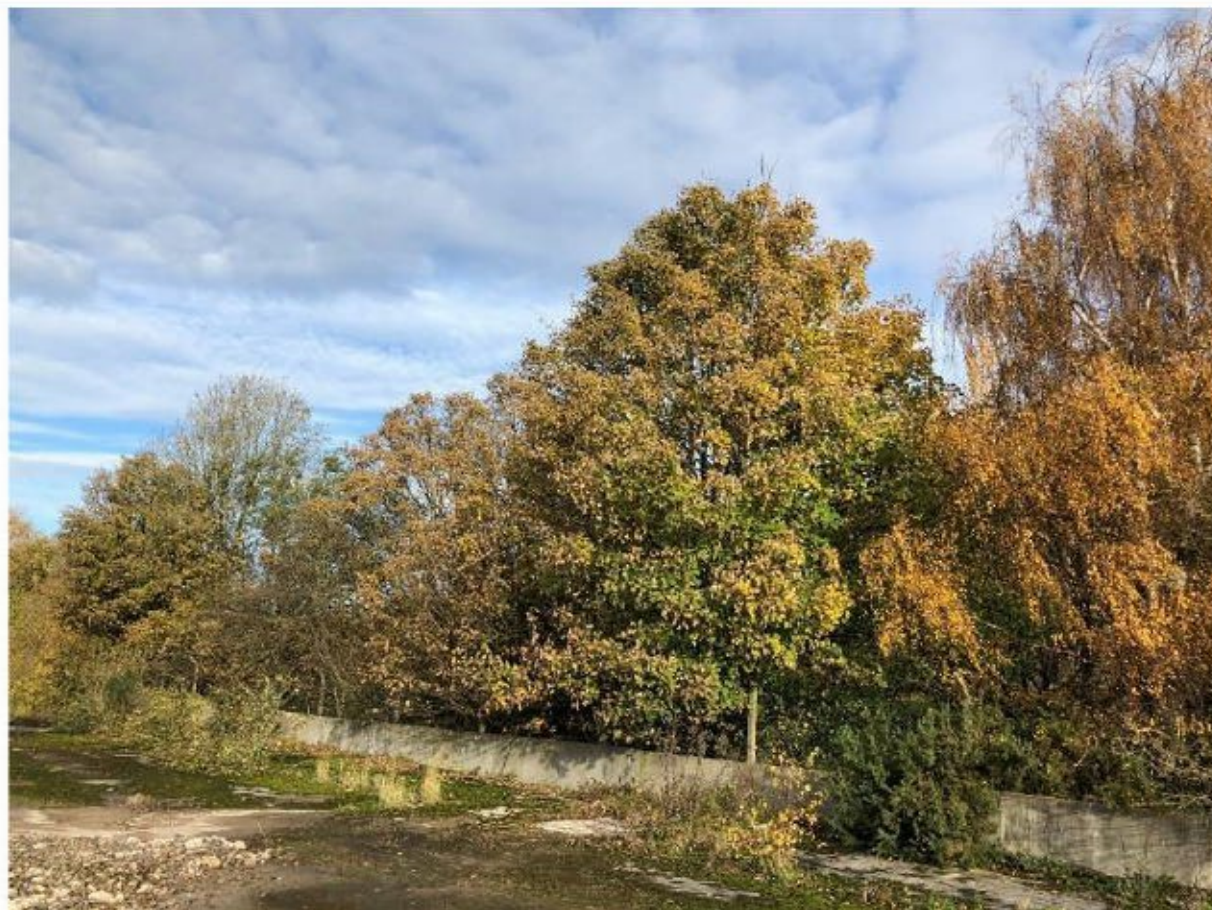
PLATE 3      SHOWING AN AREA OF BROADLEAVED WOODLAND

Areas of broadleaved woodland were present across the site with young self-seeded woodland located in the north-western and south-eastern areas of the site. Small areas semi-mature woodland run along the northern boundary and southern boundaries of the site and a large semi-natural broadleaved woodland associated with Booston Wood lies adjacent to the western boundary of the site. Tree species present comprised silver birch, grey willow, goat willow, crack willow (*Salix fragilis*), hawthorn, sycamore (*Acer pseudoplatanus*), dog-rose, gorse (*Ulex europaeus*), ash (*Fraxinus excelsior*), oak (*Quercus robur*), alder (*Alnus glutinosa*) and Italian alder (*Alnus cordata*).

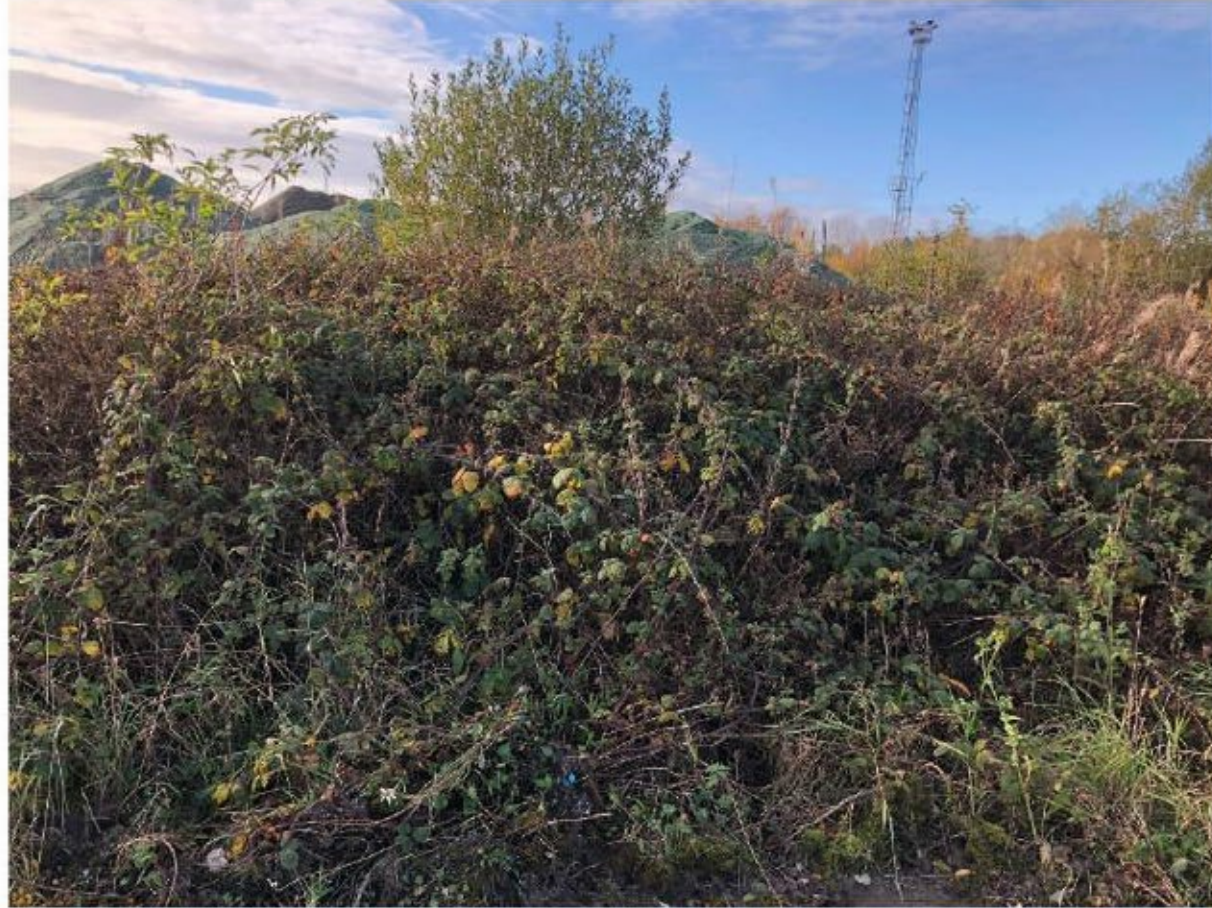
PLATE 4      SHOWING DENSE SCRUB

Small areas of dense scrub were present in the northern area of the site and along the south-western boundary of the site and were associated with the scattered scrub and broadleaved woodland. The species present comprised bramble, dog-rose, rosebay willowherb and grey willow.

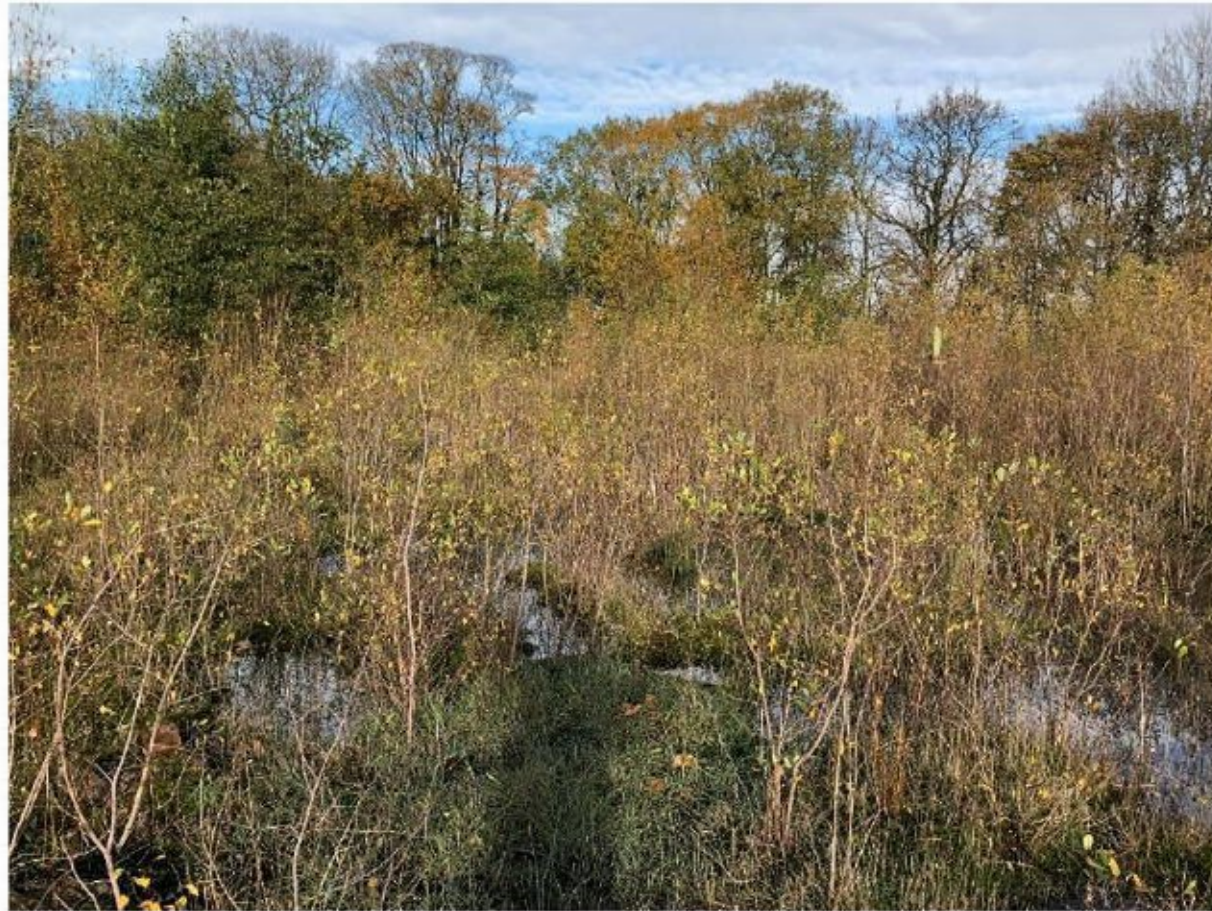
PLATE 5      SHOWING SCATTERED SCRUB

Areas of scattered scrub were present in the northern area of the site, along the south-western boundary of the site and across areas of hardstanding. The scattered scrub appeared to be growing in areas of former semi-improved grassland which has transitioned into scattered scrub due being unmanaged. Large areas of the scattered scrub were waterlogged due to recent heavy rainfall. The scrub species present comprised grey willow, goat willow, crack willow, alder, silver birch, gorse, butterfly bush and bramble with an understorey of grassland species comprising Yorkshire fog, cock's foot (*Dactylus glomerata*), ribwort plantain, red clover (*Trifolium pratense*) and field horsetail (*Equisetum arvense*).

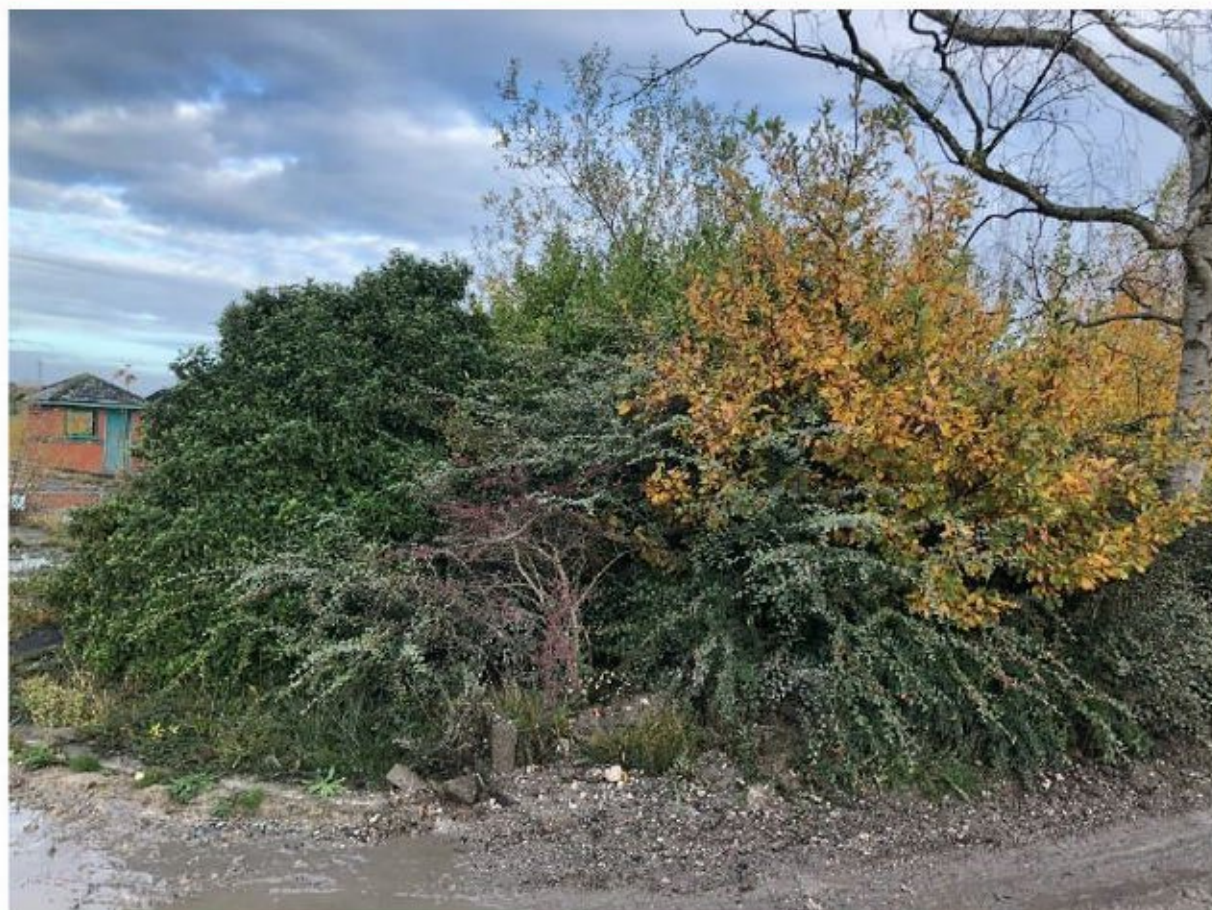
PLATE 6      SHOWING INTRODUCED SHRUB

Small stands of introduced shrub were present in the southern area of the site associated with the former car parking areas. The introduced shrub was likely planted for decorative purposes for the previous buildings on-site. The shrub species present comprised small-leaved cotoneaster (*Cotoneaster microphyllus*), wall cotoneaster (*Cotoneaster horizontalis*), Franchet's cotoneaster (*Cotoneaster franchetii*), daisy bush (*Brachyglottis greyi*), yucca sp. (*Yucca sp.*), evergreen spindle (*Euonymus japonicus*), red-barked dogwood (*Cornus alba sibirica*), laurustinus (*Viburnum tinus*), spotted laurel (*Aucuba japonica*) and barberry species (*Berberis sp.*).

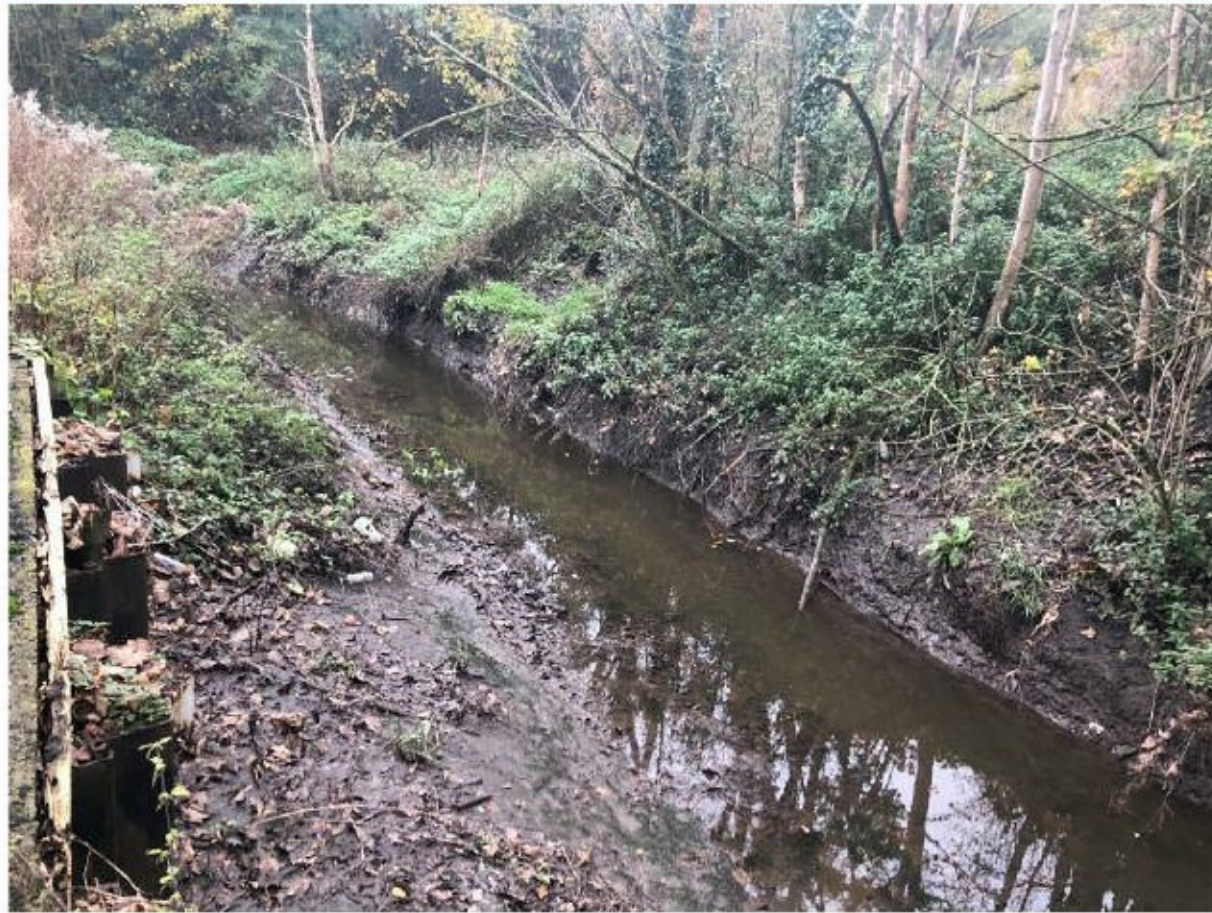
PLATE 7      SHOWING RUNNING WATER

Rivacre Brook runs along the western site boundary running from south to north before culverting under the Manchester Ship Canal and entering the Mersey Estuary. The brook runs through Booston Wood and is heavily shaded with sloping muddy banks. The bankside vegetation is limited and is largely comprised of bramble, common nettle and rosebay willowherb. The brook appears to be susceptible to flooding and periods of fast flow with debris and flattened vegetation noted around the banksides.

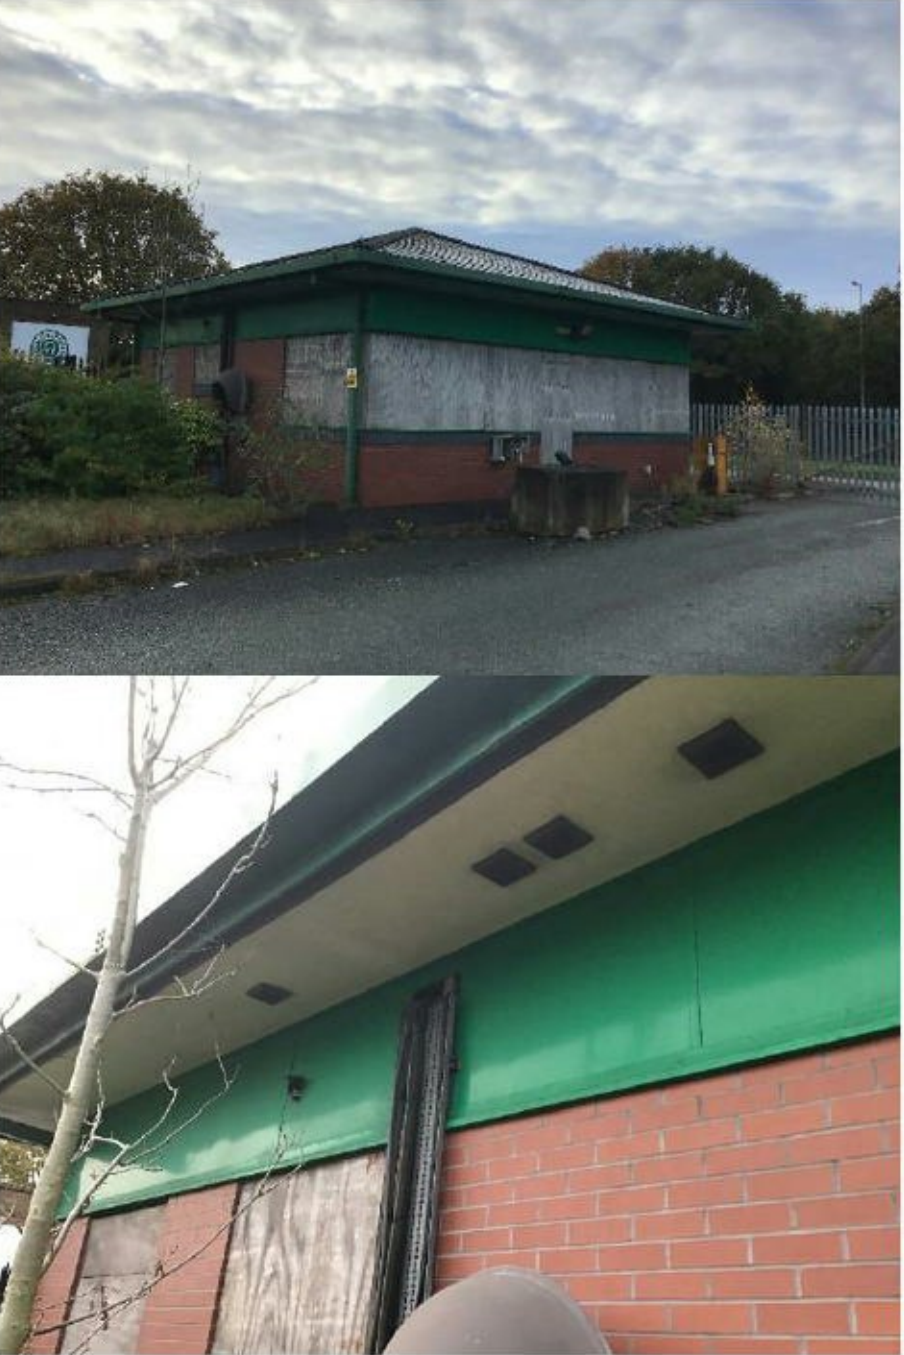
REF.	DESCRIPTION	PHOTOGRAPH
<p><b>B1</b></p>	<p>B1 was a single storey red brick building with a pitched tiled roof, located at the site entrance. The roofing tiles and brickwork were found to be in good condition, apart from an opening in the brickwork on the northern aspect of B1, that may provide roosting opportunities for crevice dwelling bats, such as pipistrelle species on an occasional basis. The windows were boarded. The boards were found to be lifted in places, which may provide roosting opportunities for crevice dwelling bats on an occasional basis.</p> <p>B1 was assessed as having <b>Low</b> bat roosting potential.</p>
