Remediation and Enabling Works Strategy  
Former Bridgewater Paper Mill

Reference: 14-035-R2-0  
Date: February 2021

Former Bridgewater Paper Mill  
North Road  
Ellesmere Port

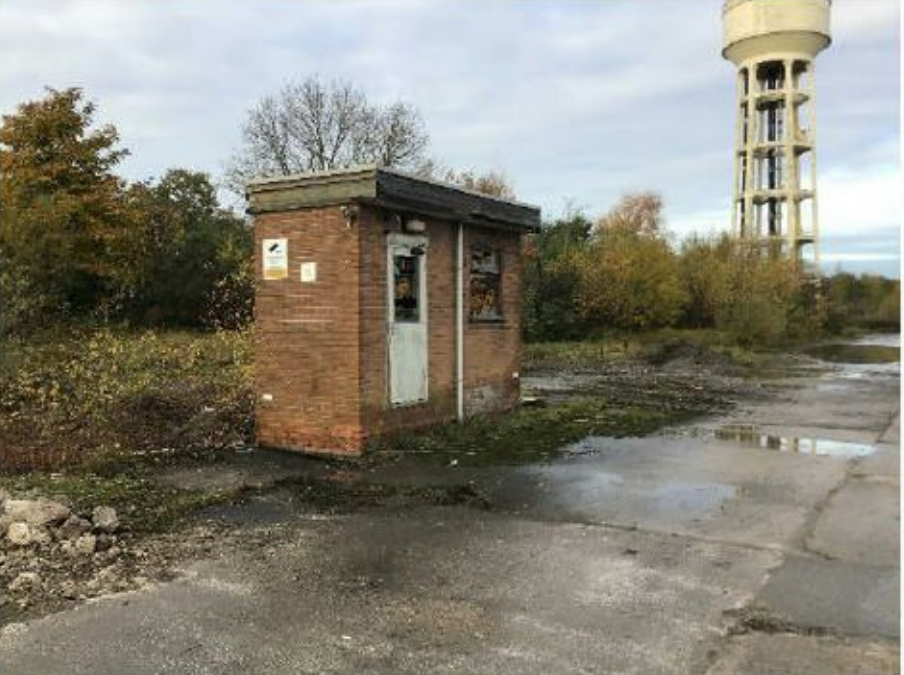
<p><b>B2</b></p>	<p>B2 was a single room brick building with wooden barge board and a flat roof. The roof and windows were broken and damaged, allowing light and weather conditions into the internal structure of the building, reducing its suitability for roosting bats. The brickwork was found to be in good condition, with no potential roosting features present.</p> <p>B2 was assessed as having <b>Negligible</b> bat roosting potential.</p>

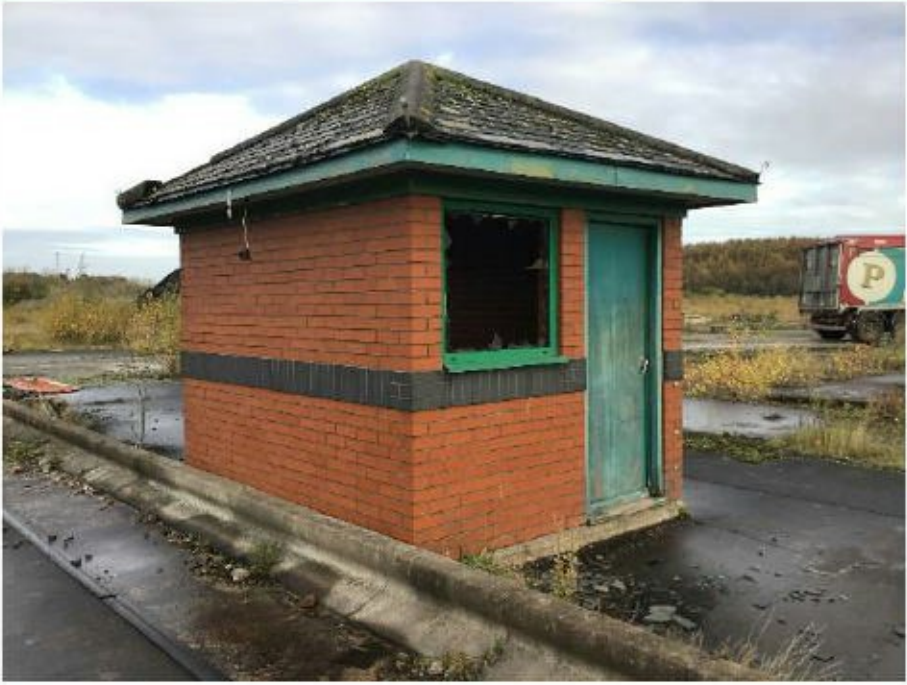
<p><b>B3</b></p>	<p>B3 was a single room red brick building with pitched tiled roof. The windows were smashed, allowing light and weather conditions into the internal structure of the building, reducing its suitability for roosting bats. The brickwork was found to be in good condition, with no potential roosting features present.</p> <p>B3 was assessed as having <b>Negligible</b> bat roosting potential.</p>

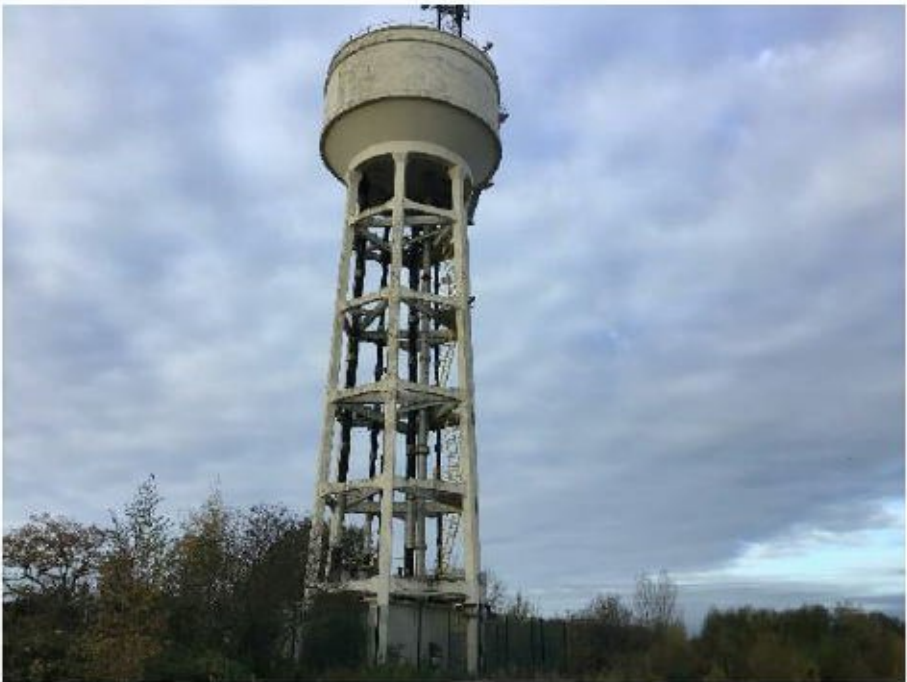
<p><b>B4</b></p>	<p>B4 was a large water tower, constructed of concrete and metal. No potential roosting features were present within B4.</p> <p>B4 was assessed as having <b>Negligible</b> bat roosting potential.</p>

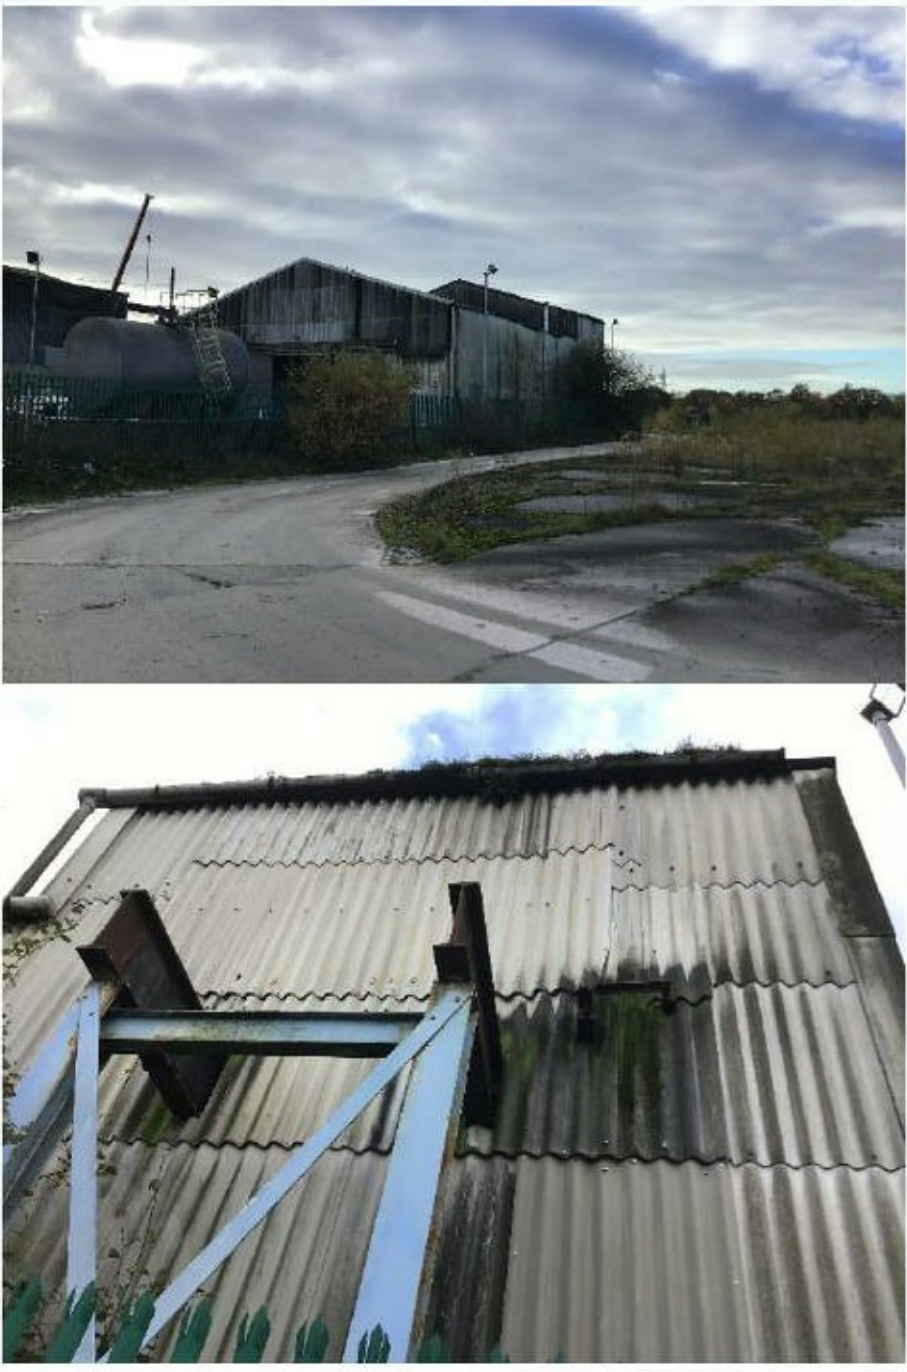
<p><b>B6</b></p>	<p>B6 was located adjacent to the eastern site boundary and is to be retained throughout development. B6 was a warehouse with asbestos sheeting walls and roof, with an asbestos sheeting barge board present. The crevices formed between the overlapping sheeting and beneath the barge board may provide roosting opportunities for crevice dwelling bats on an occasional basis.</p> <p>B6 was assessed as having <b>Low</b> bat roosting potential but will not be affected by development.</p>

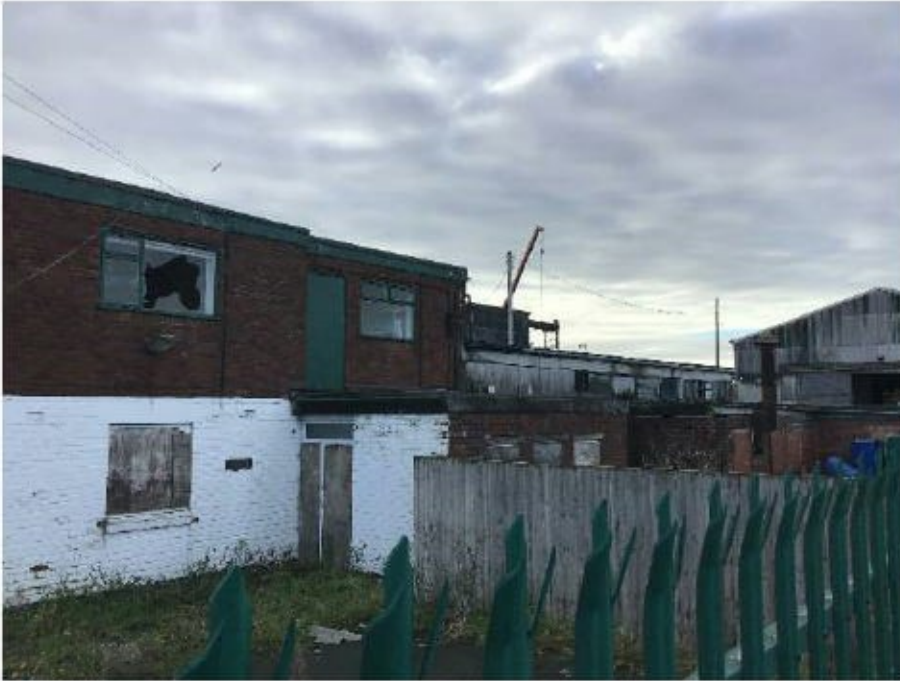
<p><b>B8</b></p>	<p>B8 was located adjacent to the eastern site boundary and is to be retained throughout development. B8 was a red brick two storey building with flat roofing felt roof. There were some broken windows allowing access for bats into the internal structure of the building, however a hung ceiling was visible and the structure was open to light and weather, reducing its suitability for roosting bats. Some of the windows were boarded and a barge board was present, forming crevices beneath the boarding and the barge board, which may provide roosting opportunities for crevice dwelling bats on an occasional basis.</p> <p>B8 was assessed as having <b>Low</b> bat roosting potential but will not be affected by development.</p>

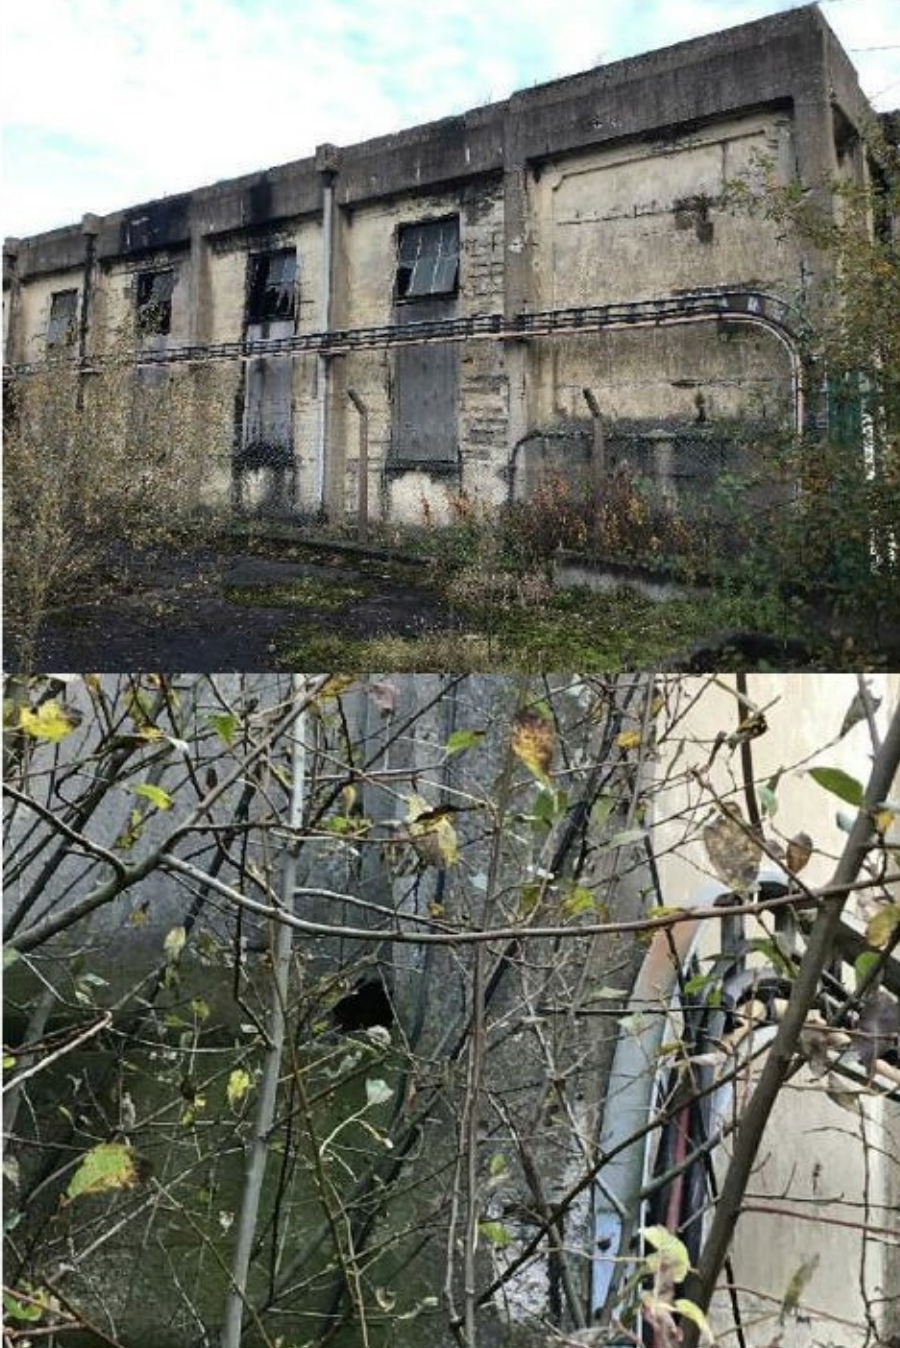
<p><b>B9</b></p>	<p>B9 was a concrete two storey structure with a flat roof. The windows were broken allowing access into the internal structure, where potential roosting features may be present. Some windows were boarded, providing crevices beneath the boards which may provide roosting opportunities for crevice dwelling bats on an occasional basis. In addition, a whole in the concrete wall was located on the western aspect, which may provide access into the internal wall structure for bats.</p> <p>B9 was assessed as having <b>Low</b> bat roosting potential.</p>

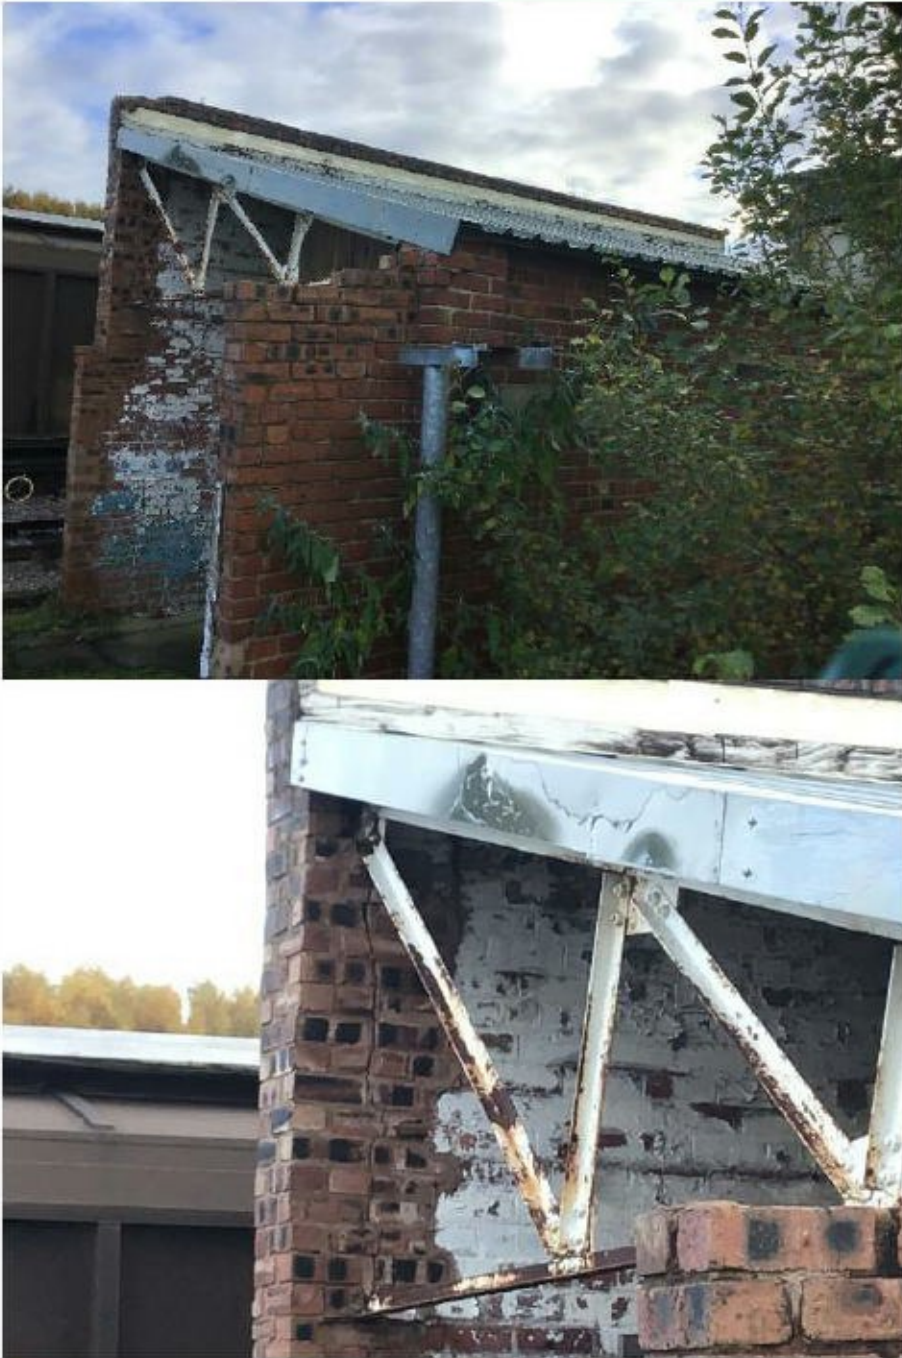
<p><b>B10</b></p>	<p>B10 was a red brick structure, with a mono-pitched corrugated metal roof, connected to the disused railway. A crack in the brickwork was visible, which may provide roosting opportunities for crevice dwelling bats on an occasional basis.</p> <p>B10 was assessed as having <b>Low</b> bat roosting potential.</p>

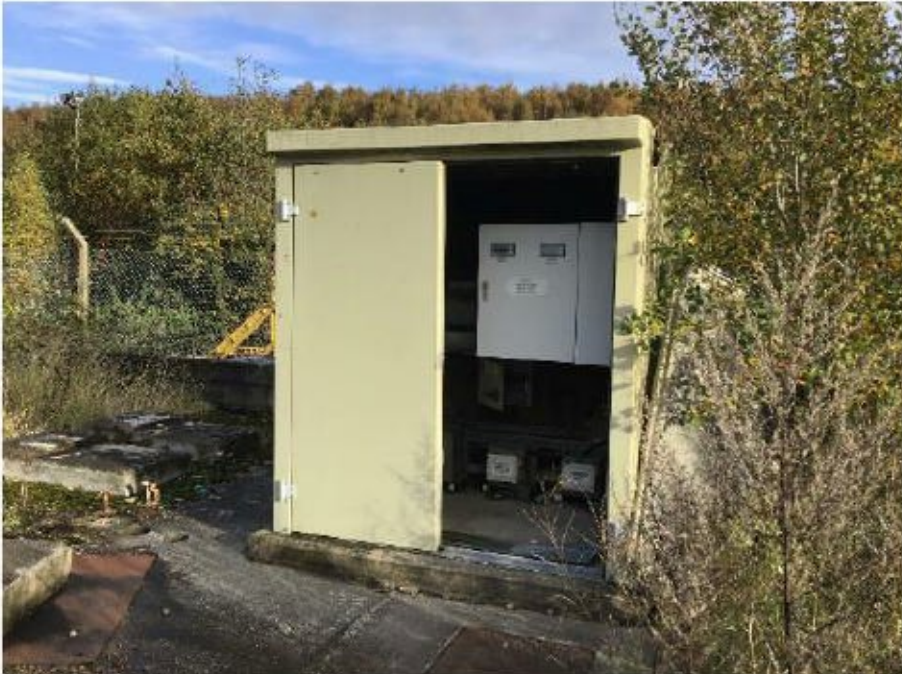
<p><b>B11</b></p>	<p>B11 was a single room electricity substation constructed of fibre board walls and roof, with no potential roosting features present.</p> <p>B11 was assessed as having <b>Negligible</b> bat roosting potential.</p>

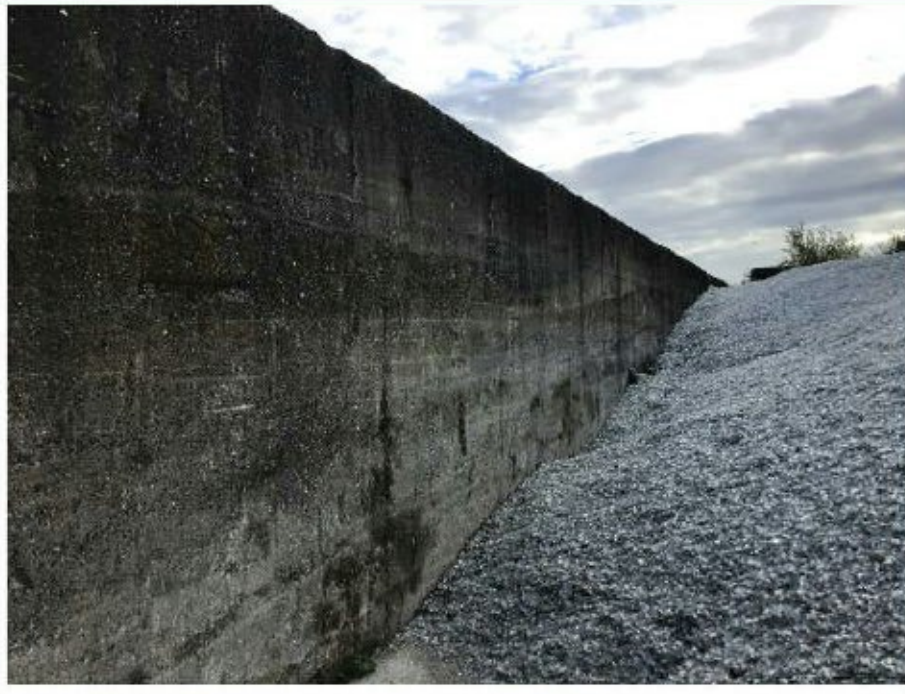
<p><b>W1</b></p>	<p>W1 was present along part of the northern site boundary. It was constructed of concrete and was 3 m high with no potential roosting features present.</p> <p>W1 was assessed as having <b>Negligible</b> bat roosting potential.</p>

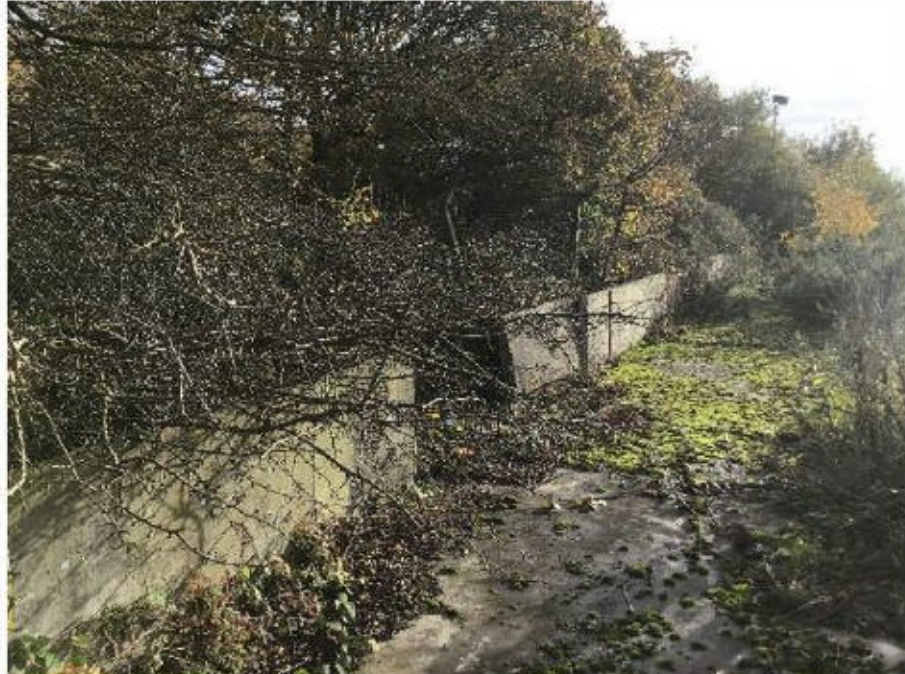
<p><b>W2</b></p>	<p>W2 was present along part of the northern site boundary. It was constructed of concrete and was 1 m high with no potential roosting features present.</p> <p>W2 was assessed as having <b>Negligible</b> bat roosting potential.</p>

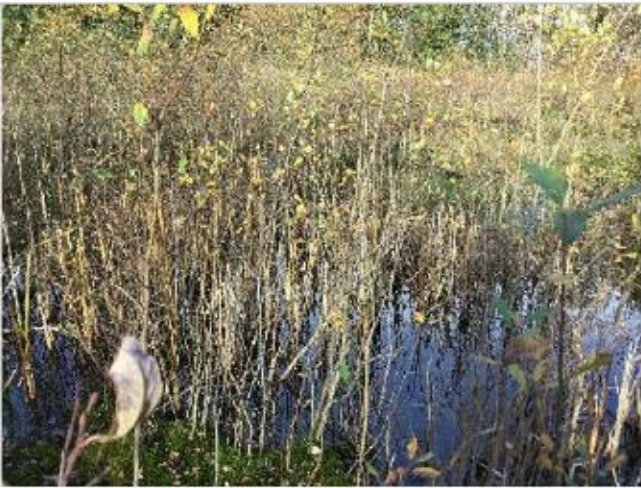
DISTANCE FROM SITE	DESCRIPTION	HSI CALCULATION											PHOTOGRAPH
		SI1	SI2	SI3	SI4	SI5	SI6	SI7	SI8	SI9	SI10	S	
<b>Pond 1</b>													
<b>Located on-site within scattered scrub</b>	<p>The pond was located within an area of scattered scrub within the north western corner of the site.</p> <p>The waterbody was boggy with moss and grass present under parts of the waterbody. Numerous young willow trees were growing within the waterbody and bull rush (<i>Scirpoides holoschoenus</i>) was present. The surrounding habitat comprised scattered scrub and grassland.</p> <p>HSI score=GOOD</p>	1	1	0.5	0.67	0.4	0.67	1	1	1	0.4	0.72

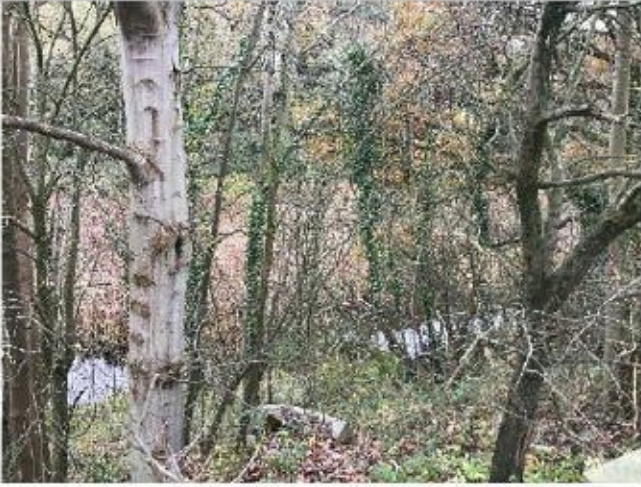
<b>Pond 2</b>													
<b>Located approximately 55 m south west of the site</b>	<p>The pond was located adjacent to North Road and is assumed to be for drainage of the road.</p> <p>The waterbody was vast and had a large amount of vegetation growing within the centre of the waterbody.</p> <p>Mallards (<i>Anas platyrhynchos</i>) were seen using the waterbody and a large woodland margin was present around the waterbody.</p> <p>HSI score=GOOD</p>	1	0.8	0.9	0.67	0.3	0.67	0.67	1	1	0.9	0.75

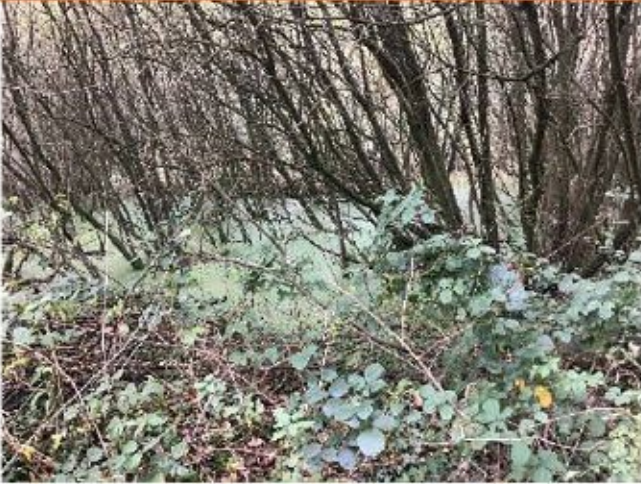
<b>Pond 3</b>

<p><b>Located approximately 220 m west of the site.</b></p>	<p>The waterbody was found to be present with Booston Wood, with duckweed (<i>Lemnoideae sp.</i>) present over the water surface. Willow were growing throughout the waterbody, with little aquatic vegetation present.</p> <p>HSI score=AVERAGE</p>	1	1	0.5	0.67	0.2	0.67	1	1	1	0.35	0.66

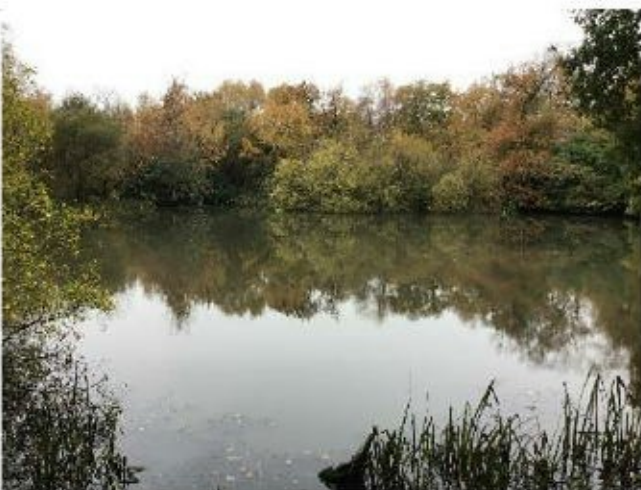
<p><b>Pond 4</b></p>													
<p><b>Located approximately 216 m west of the site.</b></p>	<p>From OS mapping Pond 4 appeared to be multiple ponds, however were found to be joined at the time of survey, forming one large waterbody.</p> <p>The waterbody was surrounded by woodland and waterfowl were present. Fish were also seen to be present within the northern aspect of the pond.</p> <p>The northern aspect of the pond was found to be open with some bull rush stands on the edges of the waterbody but little other aquatic vegetation. southern aspect of the pond was found to be smaller and present within an area of trees, with more aquatic vegetation present.</p> <p>HSI score=AVERAGE</p>	1	0.8	0.9	0.67	0.3	0.67	0.33	1	1	0.4	0.65
