The Bent Farmhouse, Warburton Heritage Appraisal

February 2021

**The Bent Farmhouse, Warburton
Heritage Statement**

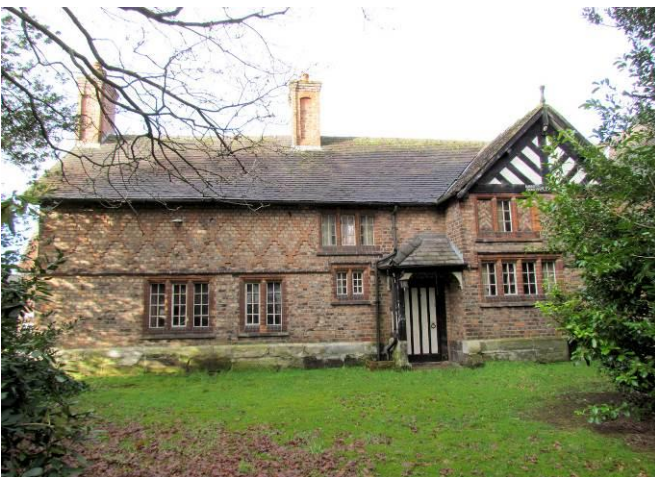
The east front elevation retains a continuous hoodmould, lozenge-shaped decorative brickwork to the first floor and overhanging eaves. There are five 2-light, one 3-light and two 4-light windows to the ground floor and one 1-light, three 3-light and one 4-light windows to the first floor. All the windows on this side have ovolo-moulded terracotta mullions and cast-iron casements with glazing bars. There are also two small openings at basement level in the stone plinth at bay 3. The elevation retains a 19th century porch in bay 2 with a slate canopy, supported by a timber post on a sandstone plinth and with red and black tiling in front of the timber panelled door, gables over bays 3 and 4, the former with a decorative timber herringbone pattern with a finial and barge boards and the latter with straight timber beams shown in the historic drawing, in Section 3.1 above, to have contained a two-light window and diagonal braces, a simply-moulded tie-beam, barge boards and a finial to match the previous gable. Inscribed on the tie-beam in bay 3 is 'Built R.D. A.D:1600 R.E.E.W Restored A.D:1880 (Richard Drinkwater and Roland Eyles Egerton- Warburton). Both gables retain an ornamental face sculpture below the eaves. At the north end, the north wing retains two windows with a decorative dentilled course above the hood mould. The whole of this elevation is understood to have been re-built or built by Douglas, as evidenced by the terracotta window surrounds; the gable in the cross-wing may date from the late 17th or early 18th century.

East Front Elevation

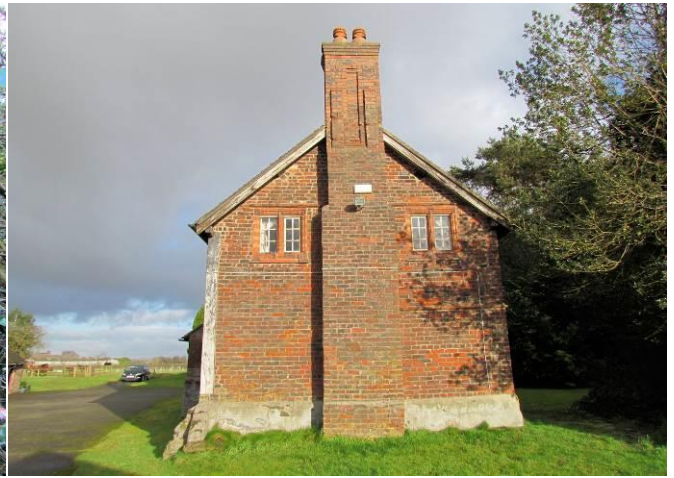
South Elevation

The south elevation is constructed in English Garden Wall bond and is largely blind, save for two 2-light mullioned windows with similar terracotta surrounds and an external chimney. The plinth has been covered with a cementitious surface. GMAU report that

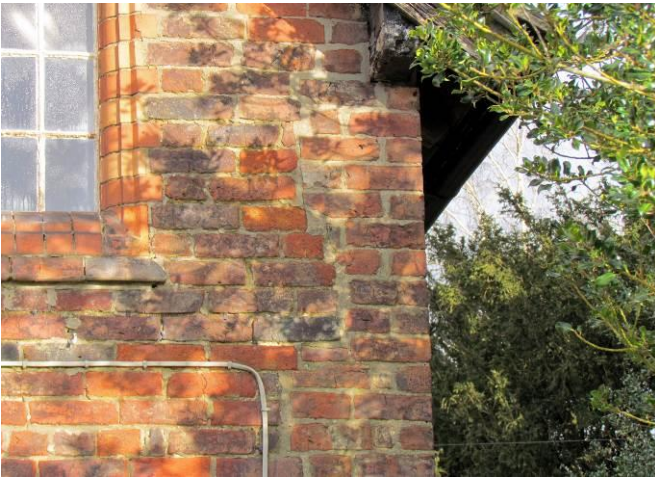
Line in Brickwork, South Elevation

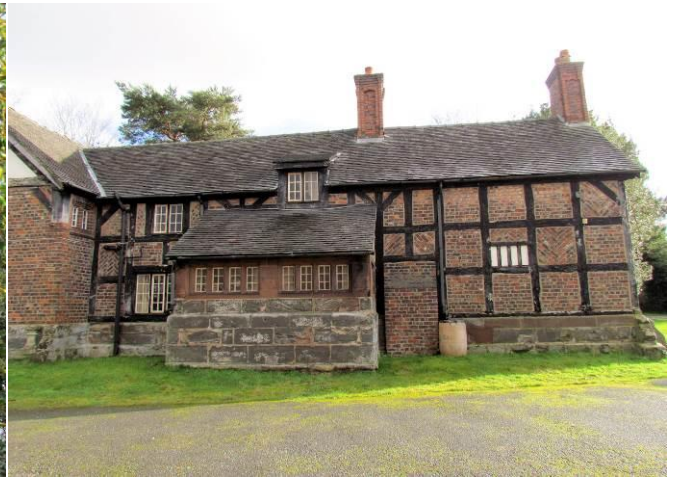
Rear West Elevation

The rear, west elevation retains three structural bays of box framing with well-preserved remnants including a blocked 3-light ovolo-moulded timber mullion window and diagonal braces. The upper level of stone on the plinth at the south end is of a different colour than those underneath and may be a 19th century replacement. Some of the brick infill panels at the north end are laid in a herringbone pattern and a 4-light ground-floor window with timber mullions and metal casements which interrupts the lower rail was probably inserted in the 19th century. In the centre of the framing is an added, projecting stone bay with chamfered stone-mullioned windows and a 2-light eaves dormer above with a timber frame. Next to the stone bay is a brick buttress

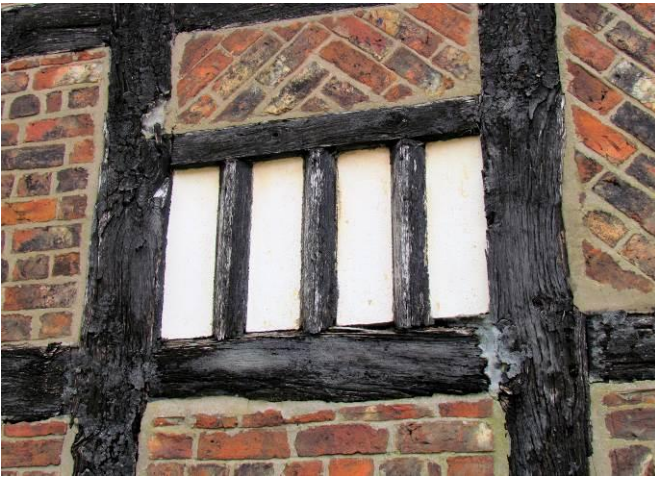
Detail of Timber-mullioned Window

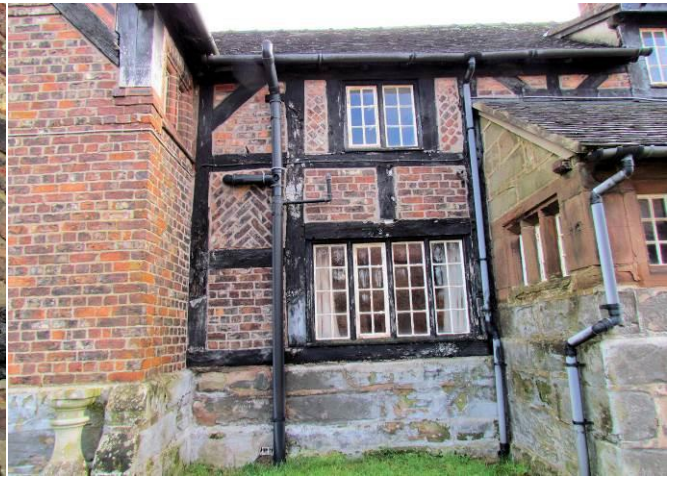
4-light Window at North End

Near the north end of the elevation is the end gable of the cross-wing, built in English Garden Wall brick bond by Douglas on a sandstone plinth. This retains a 4-light ground floor window, a 3-light first floor window and a small 2-light window on the return, with similar terracotta surrounds to those on the east elevation. The gable is supported on replaced truncated posts resting on the corner brickwork, with braces supporting the tie-beam, parts of which have also been replaced. The roof structure is a queen post truss with brace struts to the rafters, barge boards and a finial. At the north end is a 19th century lean-to by Douglas with a historic timber plank door obscured by 20th century brick and timber porch with a corrugated roof.

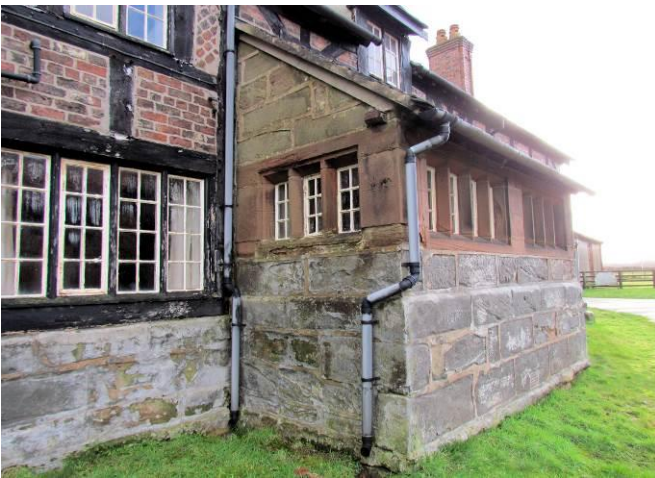
Projecting Stone Bay

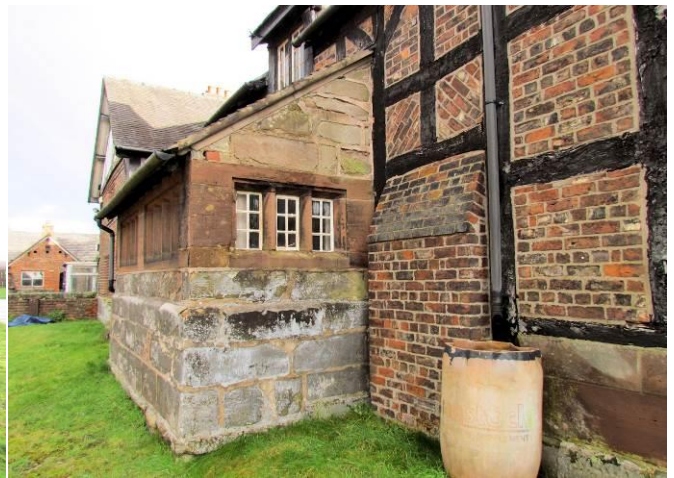
Detail of Buttress

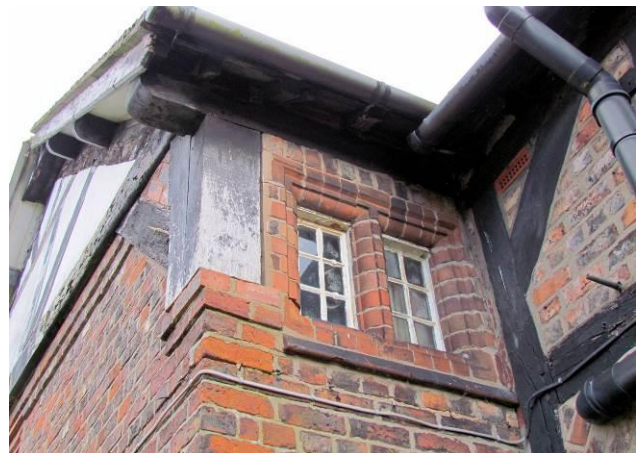
Detail of Replaced Post

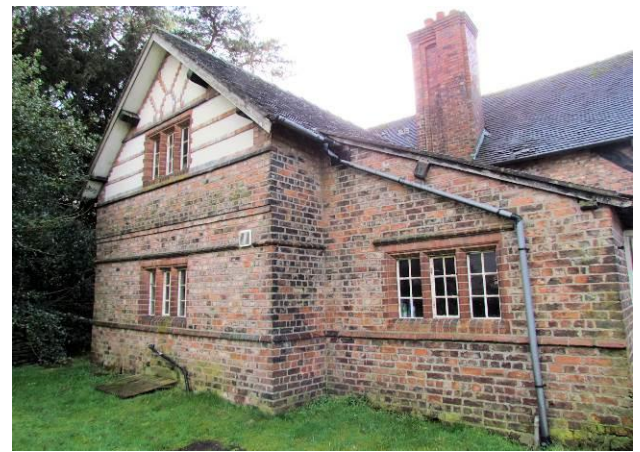
North Elevation

The north elevation consists of a two-storey service wing with a lean-to constructed at the same time, as the brick courses match up. These retain two 3-light windows with terracotta surrounds on the ground floor and a further similar window at first-floor level in the gable. The projecting hood mould is continued from the front elevation, although not continuously; there is a sill-band across the elevation at ground-floor level and a further sill-band at eaves level. The gable retains a decorative design of brickwork on a white plaster background.

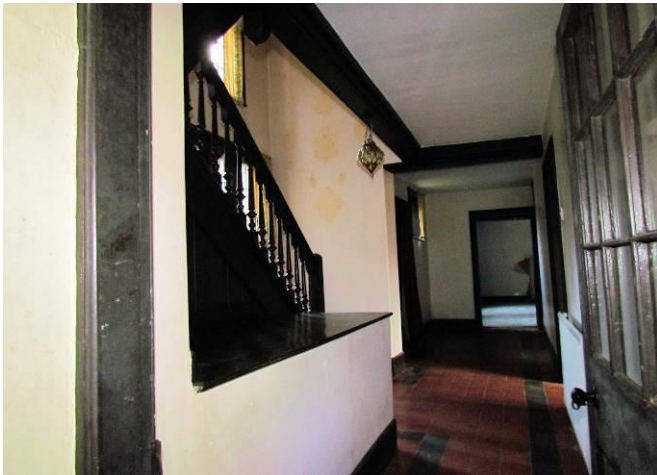
Stair Hall

The front entrance gives onto a stair hall, which GMAU believe to have been added with the cross-wing¹³, and a solid-wall partition inserted to the room to the west. Certainly, a beam extends either side of the partition. The floor is tiled with red tiles and black bordering; walls and ceiling are plain plastered. The timber dog-leg staircase retains turned balusters and hand rail and a plain, chamfered square newel post. Four-panel doors give onto the rooms to the west and south. The stair hall is lit by a painted mullioned window which retains metal casements with distinctive loop handles and a bar over the opening light. A cupboard is fitted into the wall at the south end, with panelled doors.

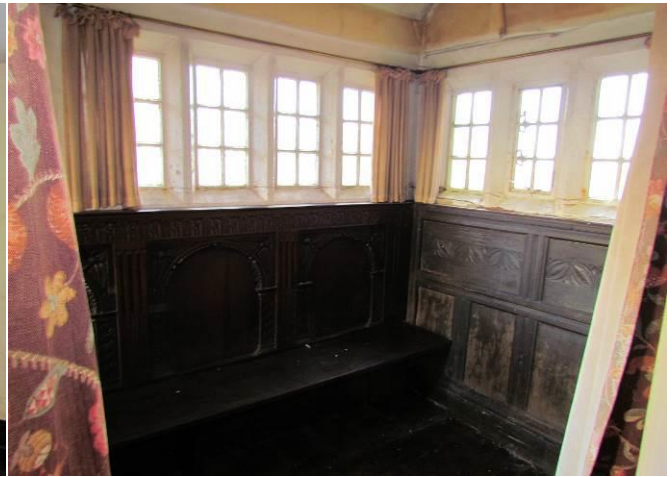
Bay

The central room retains a timber boarded floor with plain plastered walls and ceiling which is supported by three beams, two of which are aligned west – east with one fixed at right angles. The adjoining beams have ovolo moulding on both sides, that nearest the hearth has moulding on one side and simple chamfering on the other; GMAU postulate that the moulding would indicate a 17th century date. The room has a tiled fireplace with a heavy timber surround, dating from the late 20th century. The insertion of the bay on the west side has resulted in posts which may be encased timber posts or a more modern material. The bay has been fitted with timber panelling which the listed building description dates as original and it may be a genuine element, presumably moved from elsewhere.

Repair is likely to be necessary to the historic timber window surrounds, both external historic doors and to the panelling in the bay.

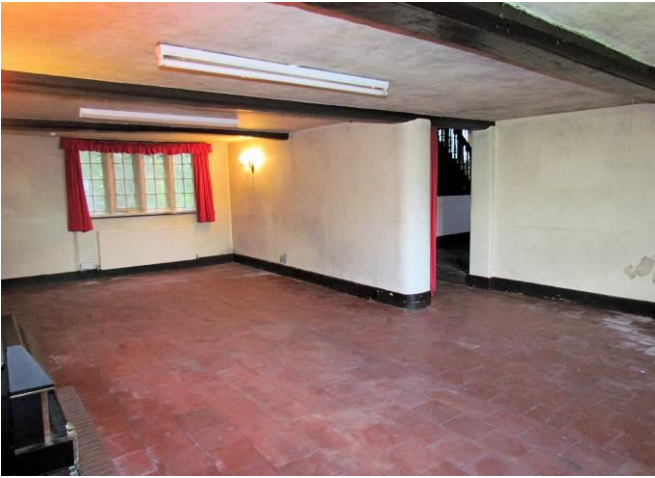
The cross-wing is a large open room running the width of the building with a quarry-tiled floor, plain plastered walls and ceiling supported by three moulded beams. There is a brick late 20th century fireplace with a timber surround but the room retains a timber worktop and two cupboards with panelled doors in the south-west corner and a

View into Cross-wing

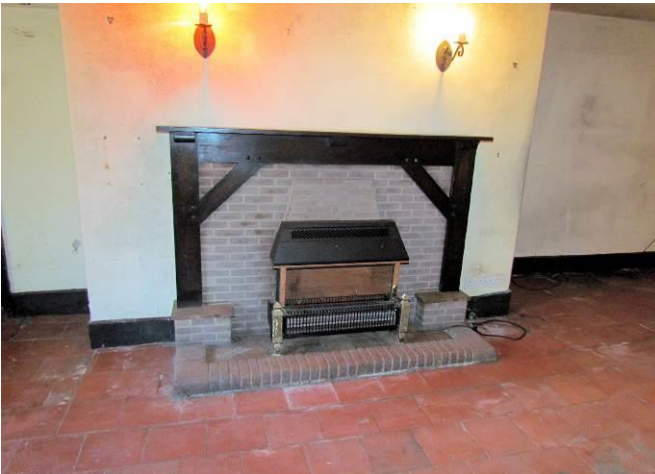
Fireplace

There is also the potential to replace the 20th century fireplaces with others of a 19th century date and style, in keeping with the surviving fireplaces or with very simple contemporary fireplaces in natural materials, although this would also require Listed Building Consent.

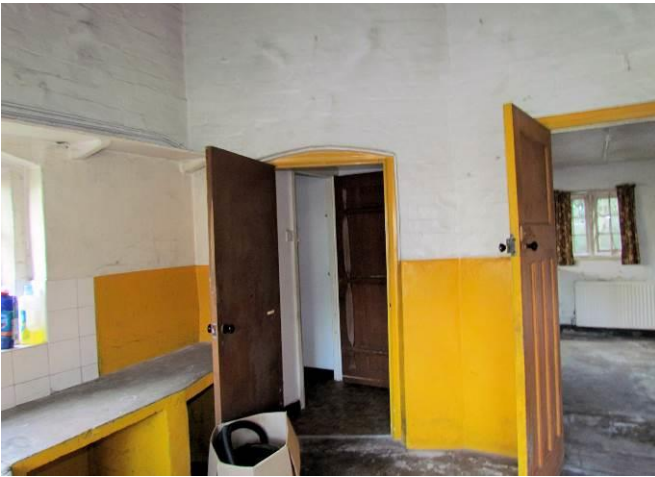
Scullery

The northern service wing consists of a scullery and kitchen on the ground floor, with a toilet between. The floors in both areas are concrete and doors are 20th century timber. Walls in the scullery are of painted brick with a concrete dado and the ceiling plain plastered, fitted with a frame for a laundry drying rack which also has large drying hooks. The space also retains a shallow stone sink and worktop. The doorways here are different, with that into the toilet with a segmental-arched head and the other with a flat head, possibly inserted. The kitchen has been altered with the removal of

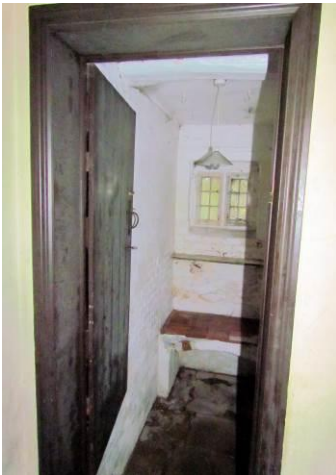
The small basement lies beneath the south-east corner of the cross-wing and stair hall and is accessed via the cross-wing and a timber plank door. The walls are painted brick and the floor is stone-flagged. At the junction of the cross-wing and the north wall of the earliest part of the building, this area retains historic timber framing at ground level and a moulded beam above. Within the basement are arched openings with timber shelves.

Access to Basement

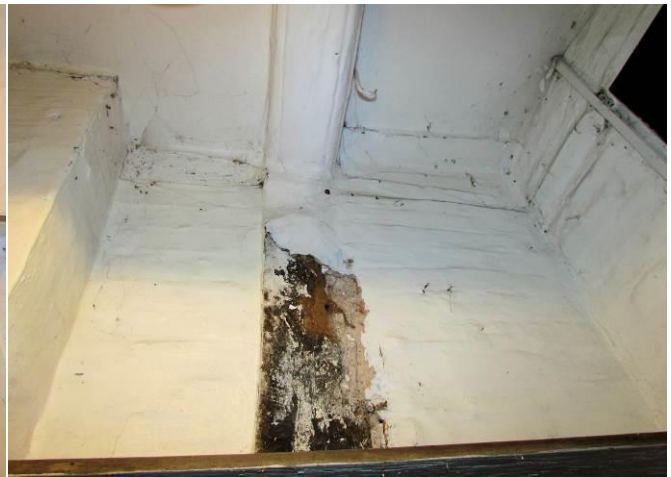
Timber Framing

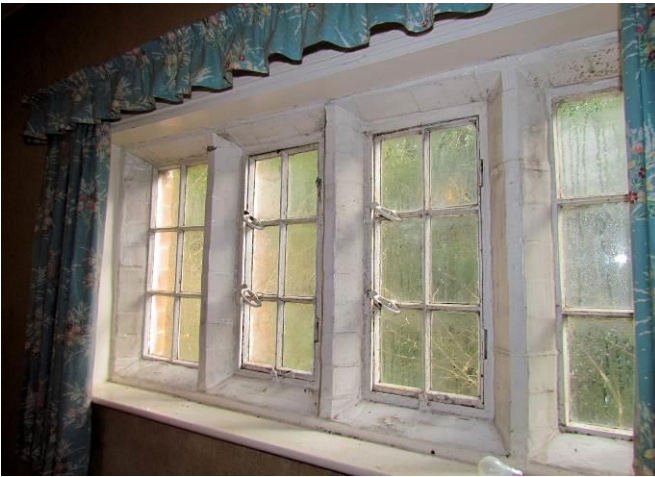
Window

The eastern room is largely plain with plastered ceiling and papered walls but retains a small 19th century cast-iron fireplace in the north-west corner. There are also two projections on the west wall which may indicate the existence of historic timber posts. The room is lit by a painted terracotta mullioned window with loop handles.

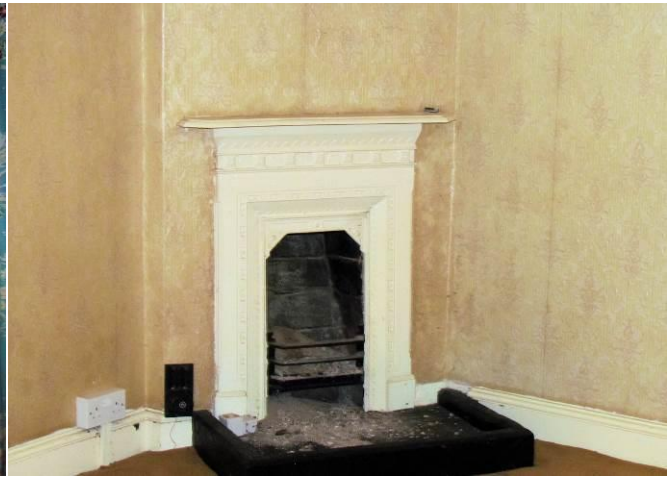
Fireplace

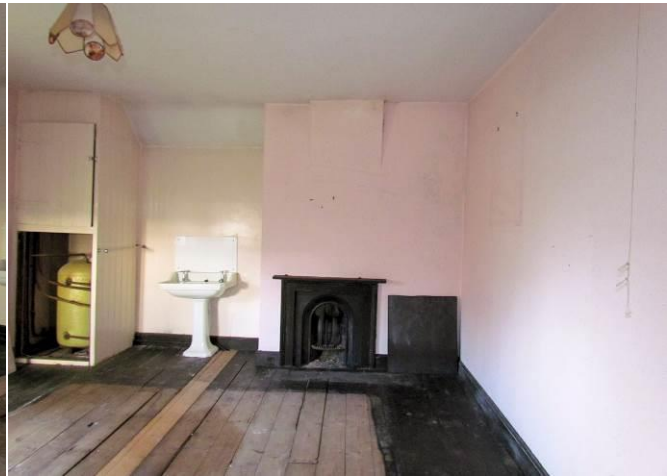
Fireplace

The western room is similarly plain but retains a 19th century cast-iron fireplace on the north wall and is lit by two similar terracotta windows.

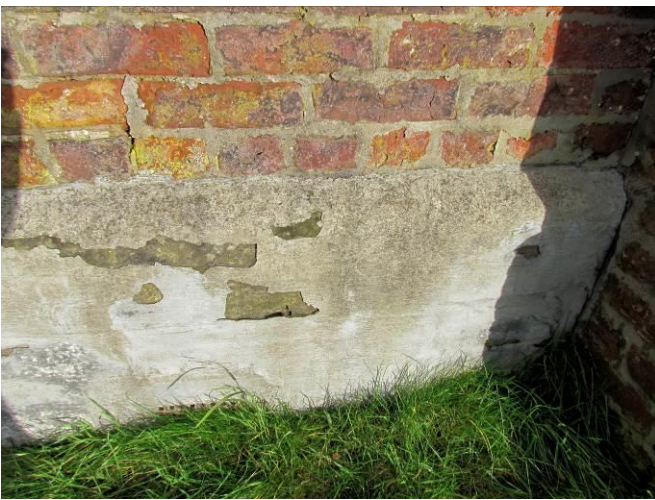
The building is in a generally fair condition, although many parts have been re-pointed in cement-based mortar and a cement-based surfacing applied to parts of the stone plinth, there is a crack in the base of the southern chimney and parts of the timber frame have been filled with a cement-based mortar. Internally, there is evidence of damp penetration, including peeling paint on the ceiling of the east side of the cross-wing and walls of the central room.

Surfacing on Plinth

Repair and conservation work are needed to ensure the retention of the special character of the listed building.

During the survey for this report, evidence was found of damp penetration and possibly also of structural movement. Many parts have been re-pointed in cement-based mortar and a cement-based plaster used at the south end. It is strongly recommended that a full condition survey is carried out by a building surveyor experienced with historic buildings, including the timber frame in the basement and the roof. It may also be advisable to have a structural survey carried out, preferably by a conservation accredited engineer (CARE); further details are available at <https://www.ice.org.uk/careers-and-training/careers-advice-for-civil-engineers/specialist-professional-registers#Conservation>. Otherwise, an engineer suitably experienced with historic buildings.

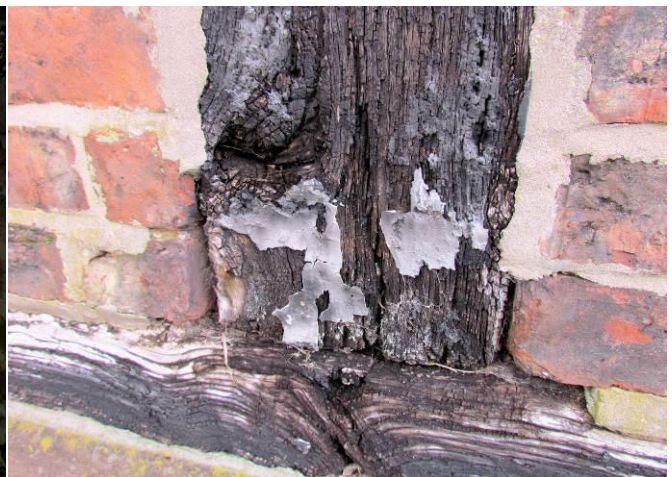
Cement Mortar in Timber-Frame

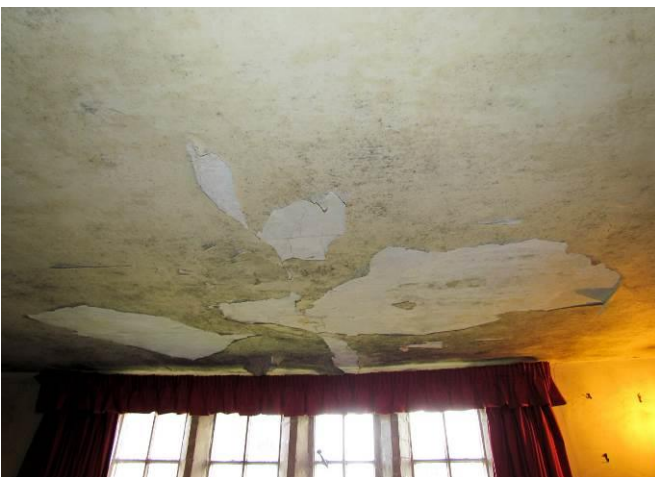
Mould and Peeling Paint in Cross-wing

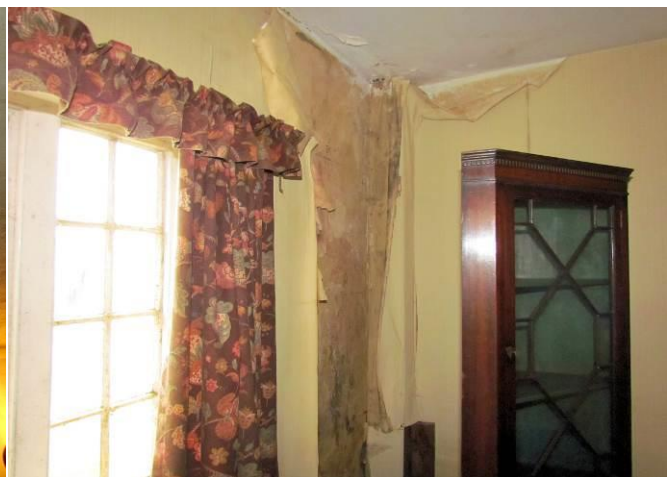
Peeling Wallpaper in Central Room

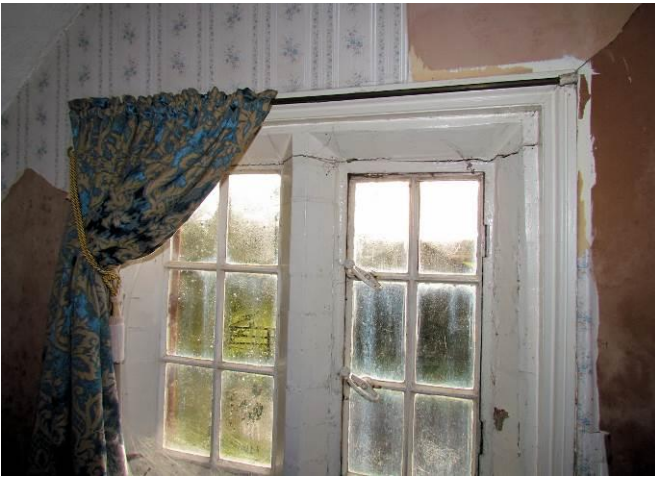
Crack Across Terracotta Window Surround at South End, First Floor

Repair is likely to be necessary to the historic timber window surrounds, both external historic doors and to the panelling in the bay. Local companies which undertake this work include Touchstone Glazing <http://www.touchstoneglazing.co.uk/home/> and Joinery Workshop <https://joineryworkshop.com/>.

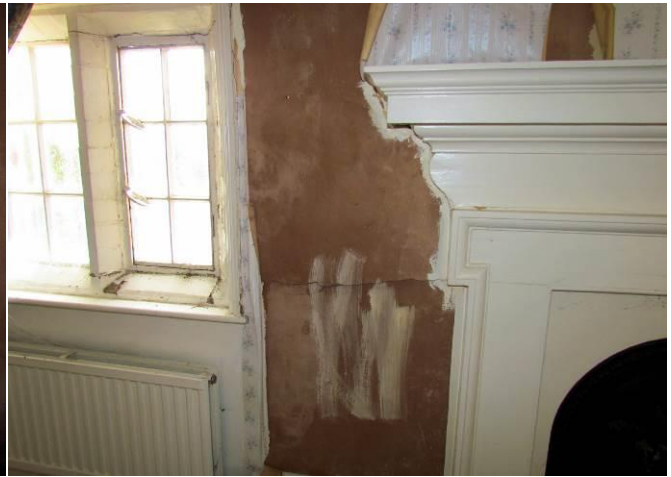
Crack in Plaster at South End

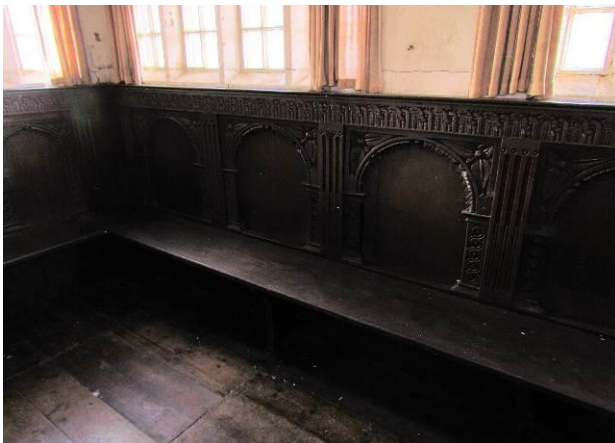
Timber Panelling

The farmhouse retains some decorative elements of artistic value by craftsmen, including the timber panelling in the bay and the moulding on the tie-beam of the east gable of the cross-wing.

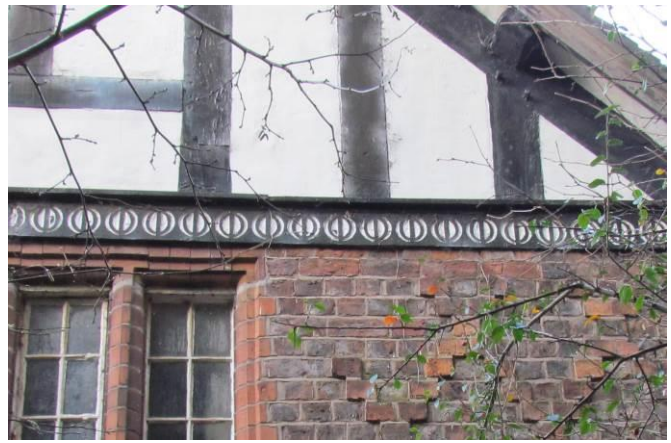
Moulding on Tie-beam

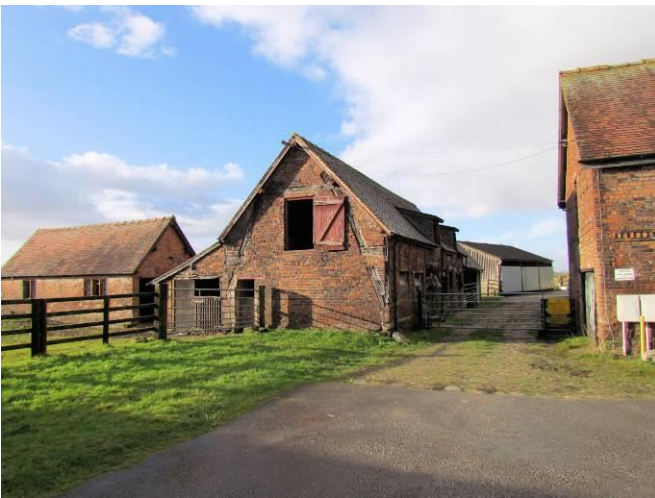
Cruck Barn

terracotta window surrounds and dentilled brickwork, although it is in poor condition. To the south-west lies a cruck-framed, three-bay building dating from the 16th century, constructed as a one-and-a-half-storey precursor to The Bent farmhouse and now used as a barn¹⁸. This building is now listed at Grade II. Although the yard is now largely surfaced in asphalt, further historic cobblestones survive by the cattle shed. To the south of the farmhouse are stone remains of an early barn, shown on the 1839 tithe map and demolished by 1967-8.

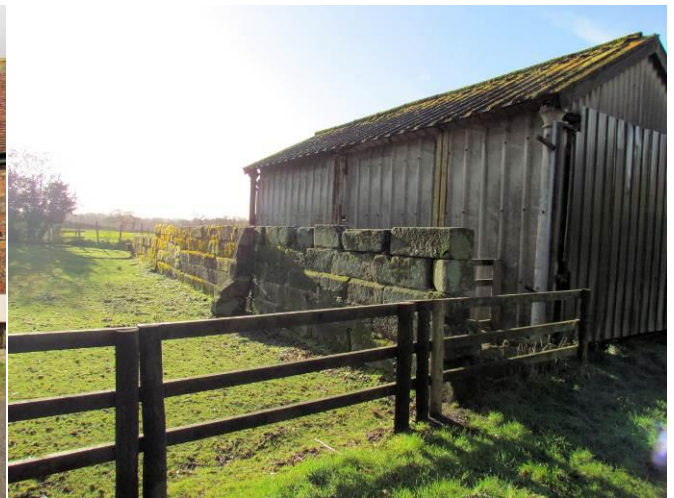
Remains of Early Barn

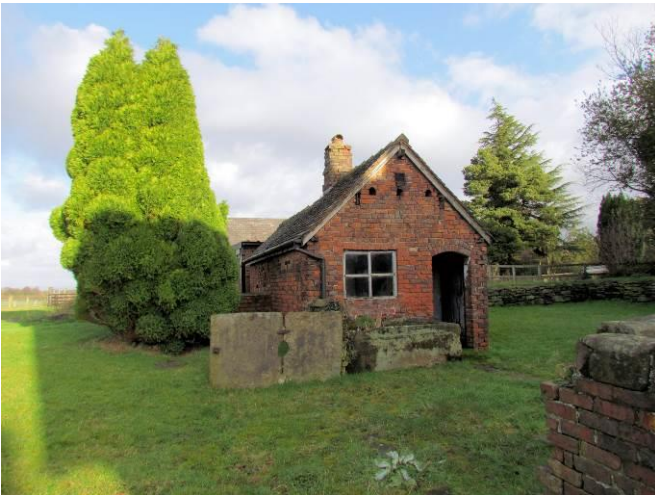
Building Formerly by Pigsty

To the north of the farmhouse lies a small rectangular brick building with a clay tile roof, which historically had a small lean-to pigsty, constructed out of stone slab walls with a tiled canopy. The canopy has since gone but the slabs are still upright. The building is shown on the 1839 tithe map and retains a timber door and window on the front elevation, with a small dovecot in the gable and a chimney at the rear. Internally, it retains a cracked brick and stone pig-rendering bench with an iron fire door, although the floor has been surfaced in concrete. At the rear is a small, brick-built toilet with a tiled floor and two earth closets. North of the large cattle shed is a small brick-built shippon with a slate roof shown on the 1910 map and now used as a garage. The timber roofing structure is still visible but, otherwise, there is little of historic interest and the floor has been covered with concrete.
