Garden Wall to East Side of Pond & Podium Western Garden Wall

In millimetres	
Garden Wall Repairs St Catherine's College , Oxford. OX1 3UJ	Pendery Architecture & Heritage Ltd 23 Orchard Road Hook Norton Banbury Oxon OX15 5LX d.pendery@btinternet.com 07482 557577
CLIENT St Catherine's College	ALL DIMENSIONS IN MILLIMETRES UNLESS STATED OTHERWISE. DO NOT SCALE FROM THE DRAWING USE GIVEN DIMENSIONS ONLY. ALL DIMENSIONS TO BE CHECKED ON SITE. LATEST REVISION:
Wall Sections - As Proposed	SCALE @ A1 DATE DWG NO. REV As Shown Dec'20 2013/04 © Pendery Architecture & Heritage Ltd DWG NO. REV

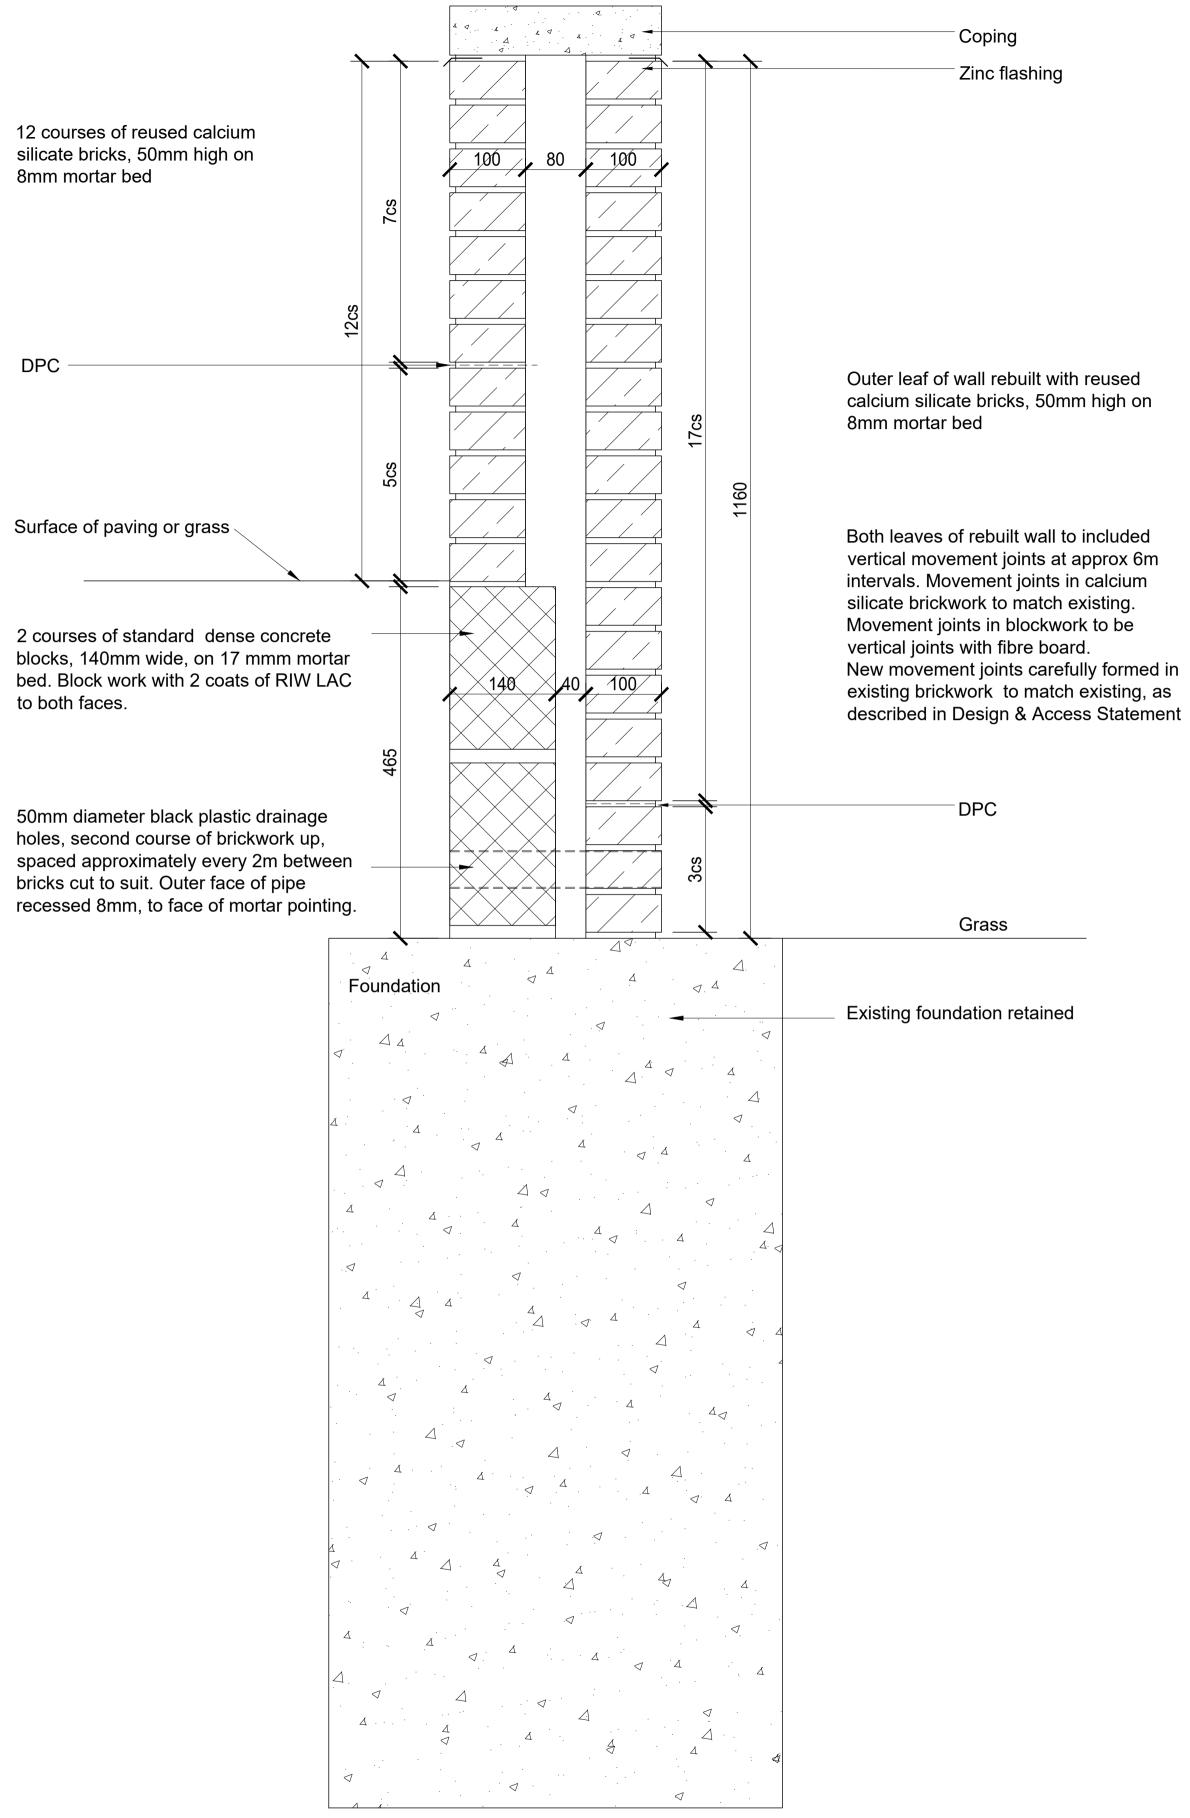
Podium Eastern Garden Wall - As Proposed 1:5 for rebuilt section

Garden wall to east side of pond & podium western wall both repaired in damaged area. Damaged area carefully taken down, bricks cleaned of mortar & wall rebuild, reusing same bricks, zinc flashings & concrete copings, with new movement joints to match existing one in podium eastern garden wall, as described in Design & Access Statement
