# BRACKNELL DATA CENTRE

TREE SURVEY & ARBORICULTURAL IMPACT ASSESSMENT  
20305B-RPS-XX-XX-RP-P-9733

20305S-RPS-XX-XX-RP-P-  
9733  
Tree Survey and  
Arboricultural Impact  
Assessment  
Final  
01 March 2021

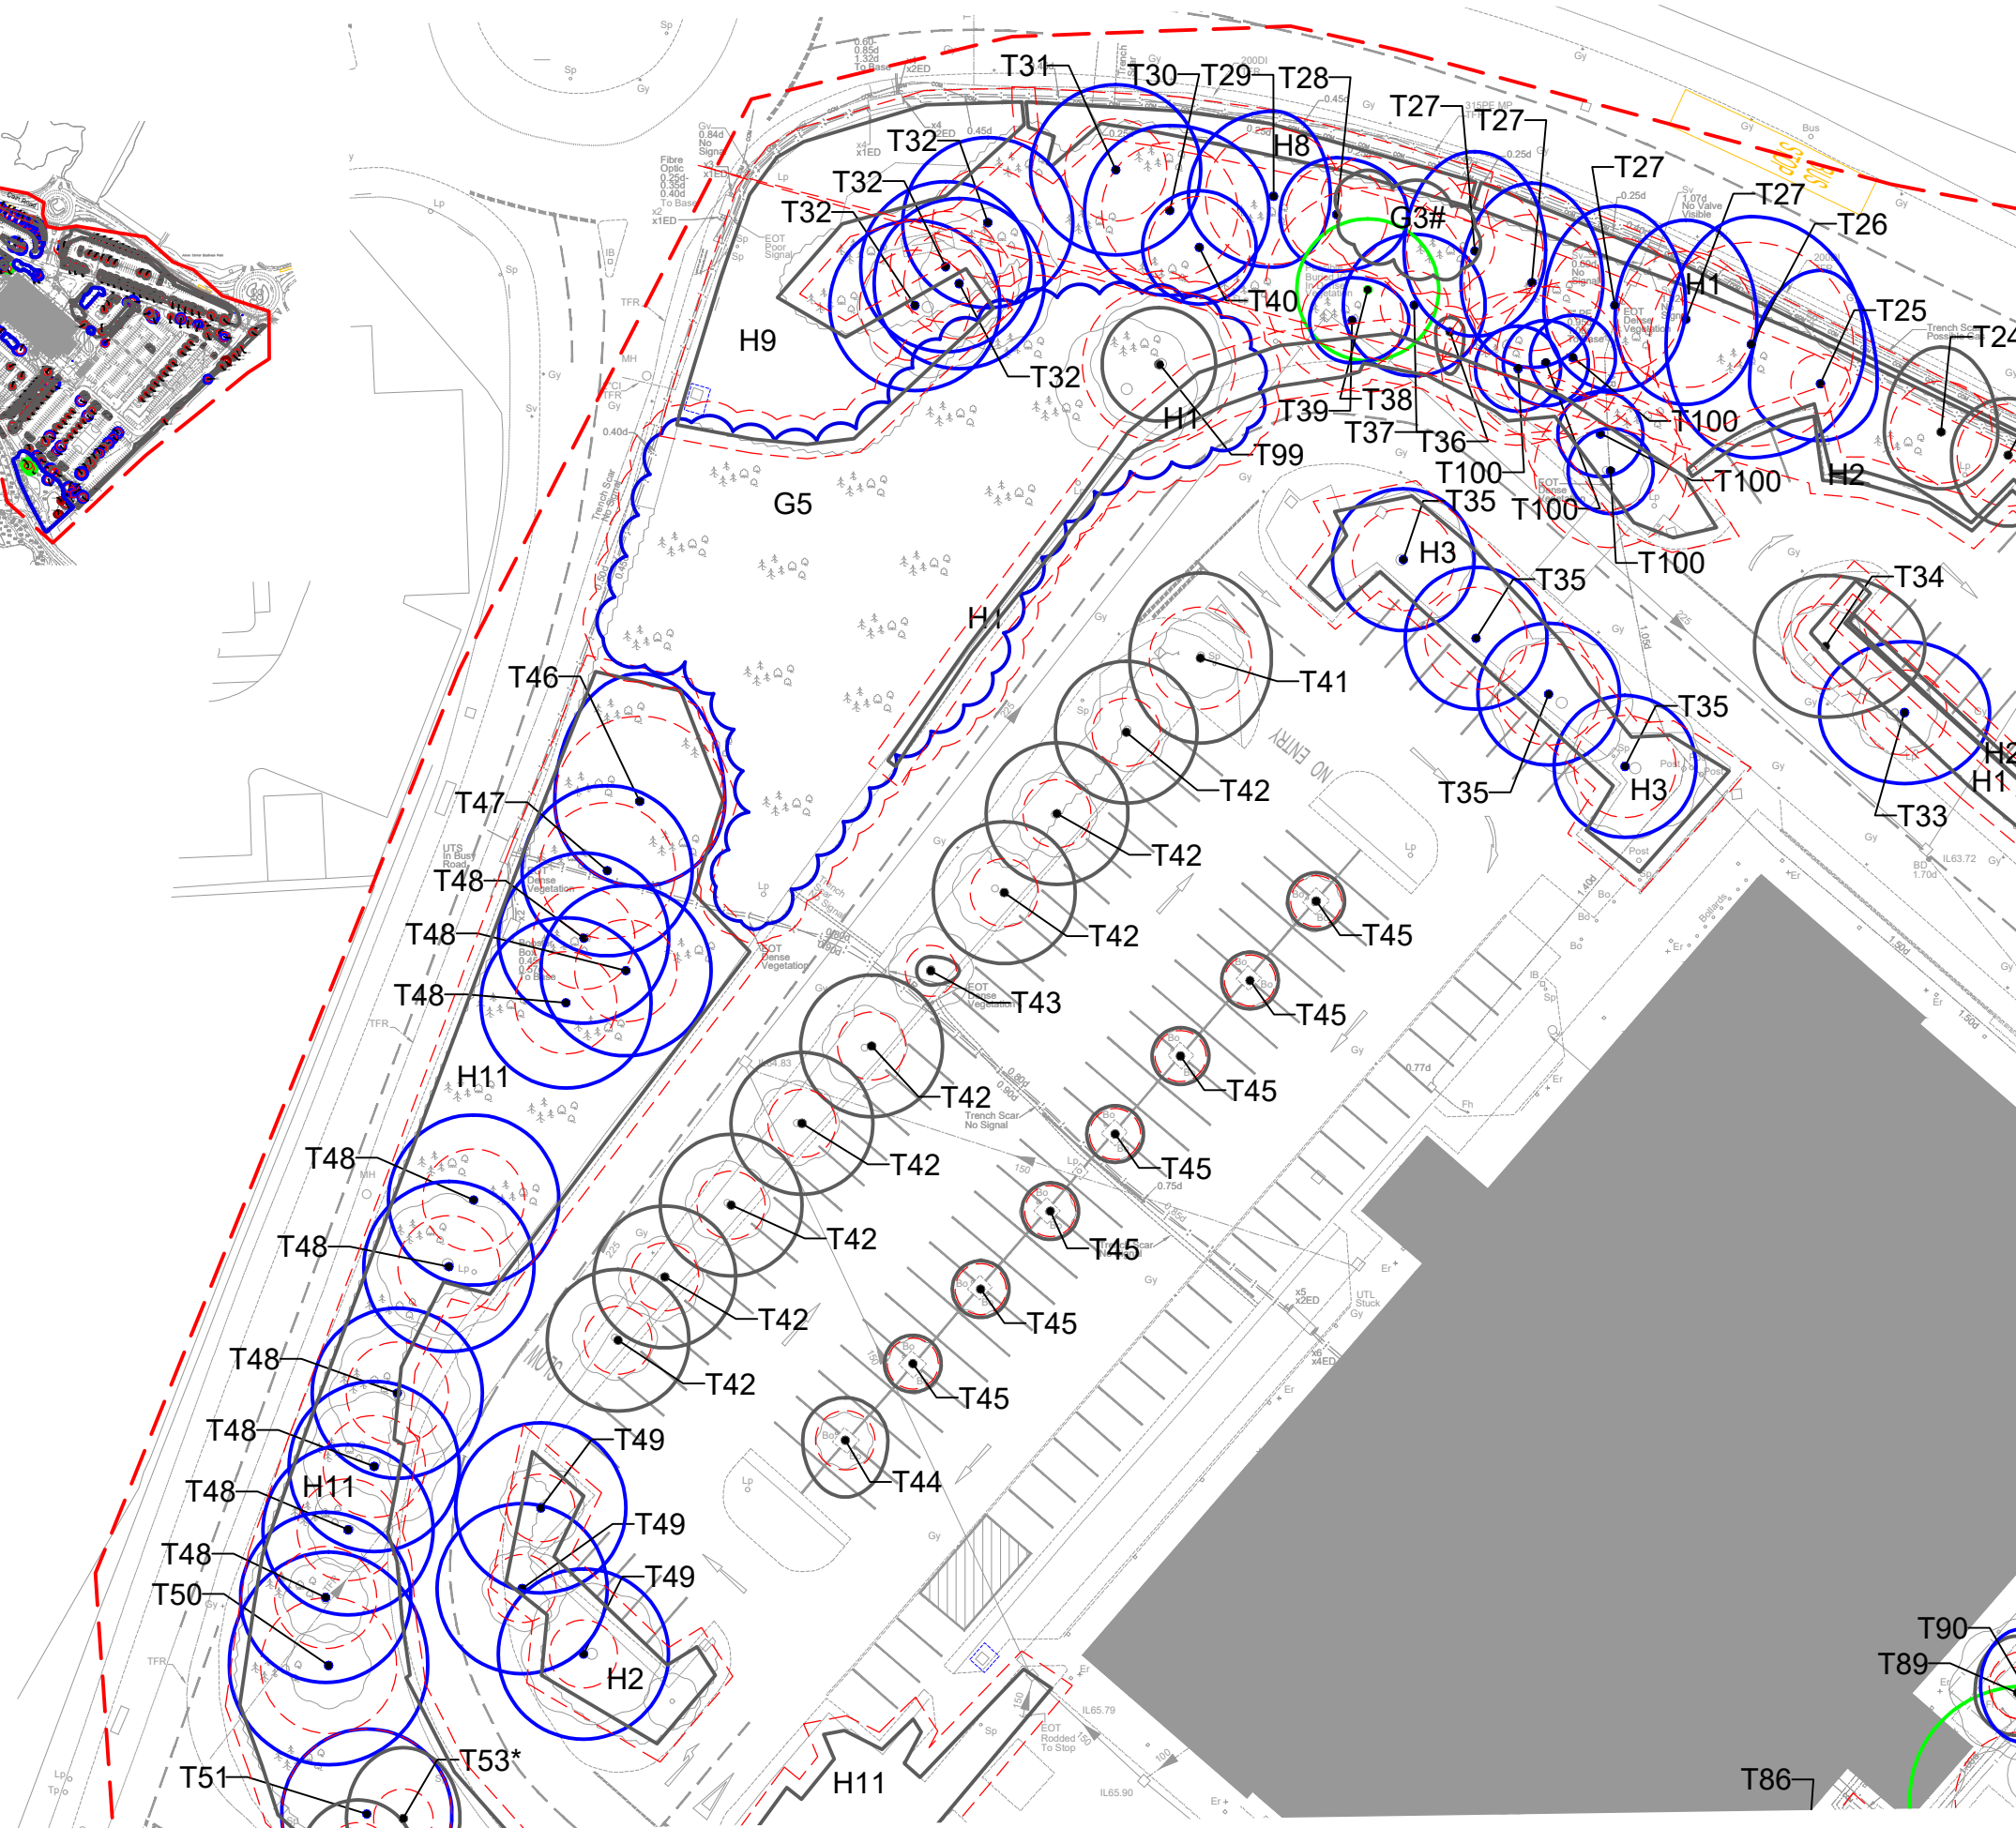
RPS Drawing / Figure Number  
**20305B-RPS-00-XX-DR-A-9561**

- Refer to RPS Tree Survey Report & Schedule for further details.
- Survey based on a visual inspection from the ground and is not intended as a full arboricultural inspection.
- Plan produced in accordance with recommendations set out in BS 5837:2012 - 'Trees in Relation to design, demolition and construction'.
- Due to the legal protection afforded to breeding birds vegetation removal should not take place during the bird nesting period, generally, although not restricted to, March - August inclusive.
- Survey based upon topographic survey produced by Greenhatch Group in August 2018.

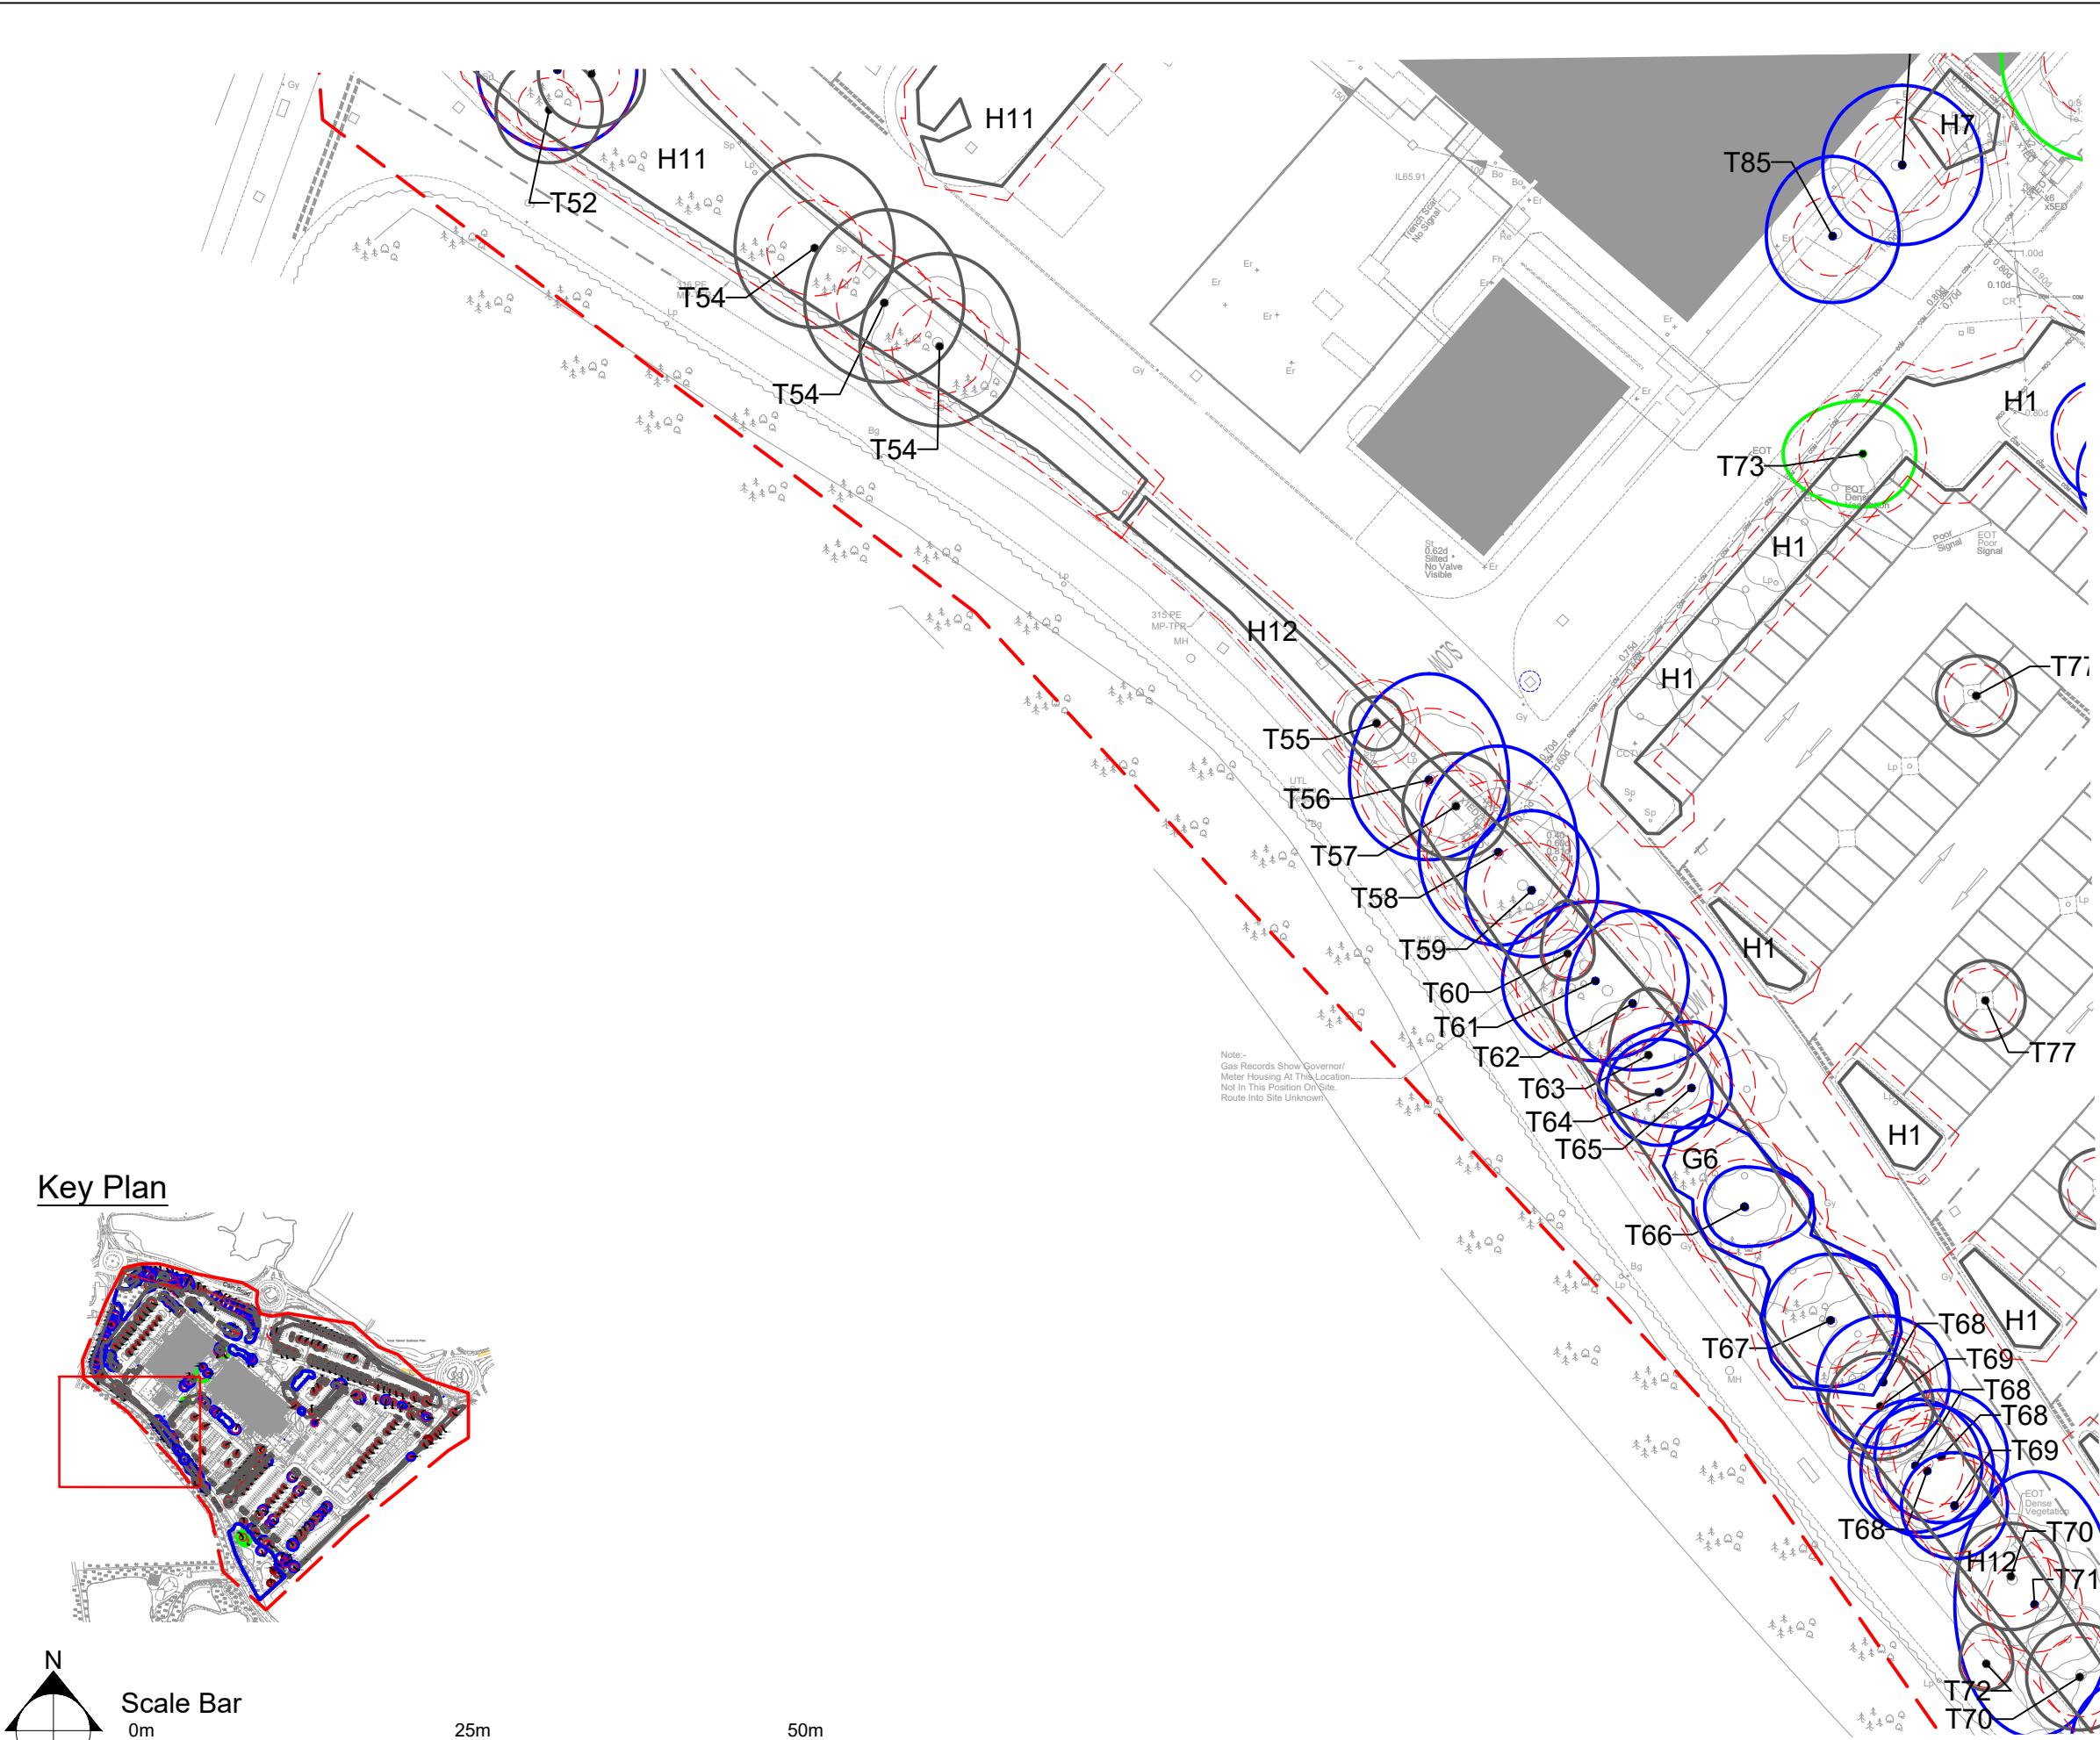
RPS Drawing / Figure Number	Rev
20305B-RPS-00-XX-DR-A-9562

- Refer to RPS Tree Survey Report & Schedule for further details.
- Survey based on a visual inspection from the ground and is not intended as a full arboricultural inspection.
- Plan produced in accordance with recommendations set out in BS 5837:2012 - 'Trees in Relation to design, demolition and construction'.
- Due to the legal protection afforded to breeding birds vegetation removal should not take place during the bird nesting period; generally, although not restricted to, March - August inclusive.
- Survey based upon topographic survey produced by Greenhatch Group in August 2016.

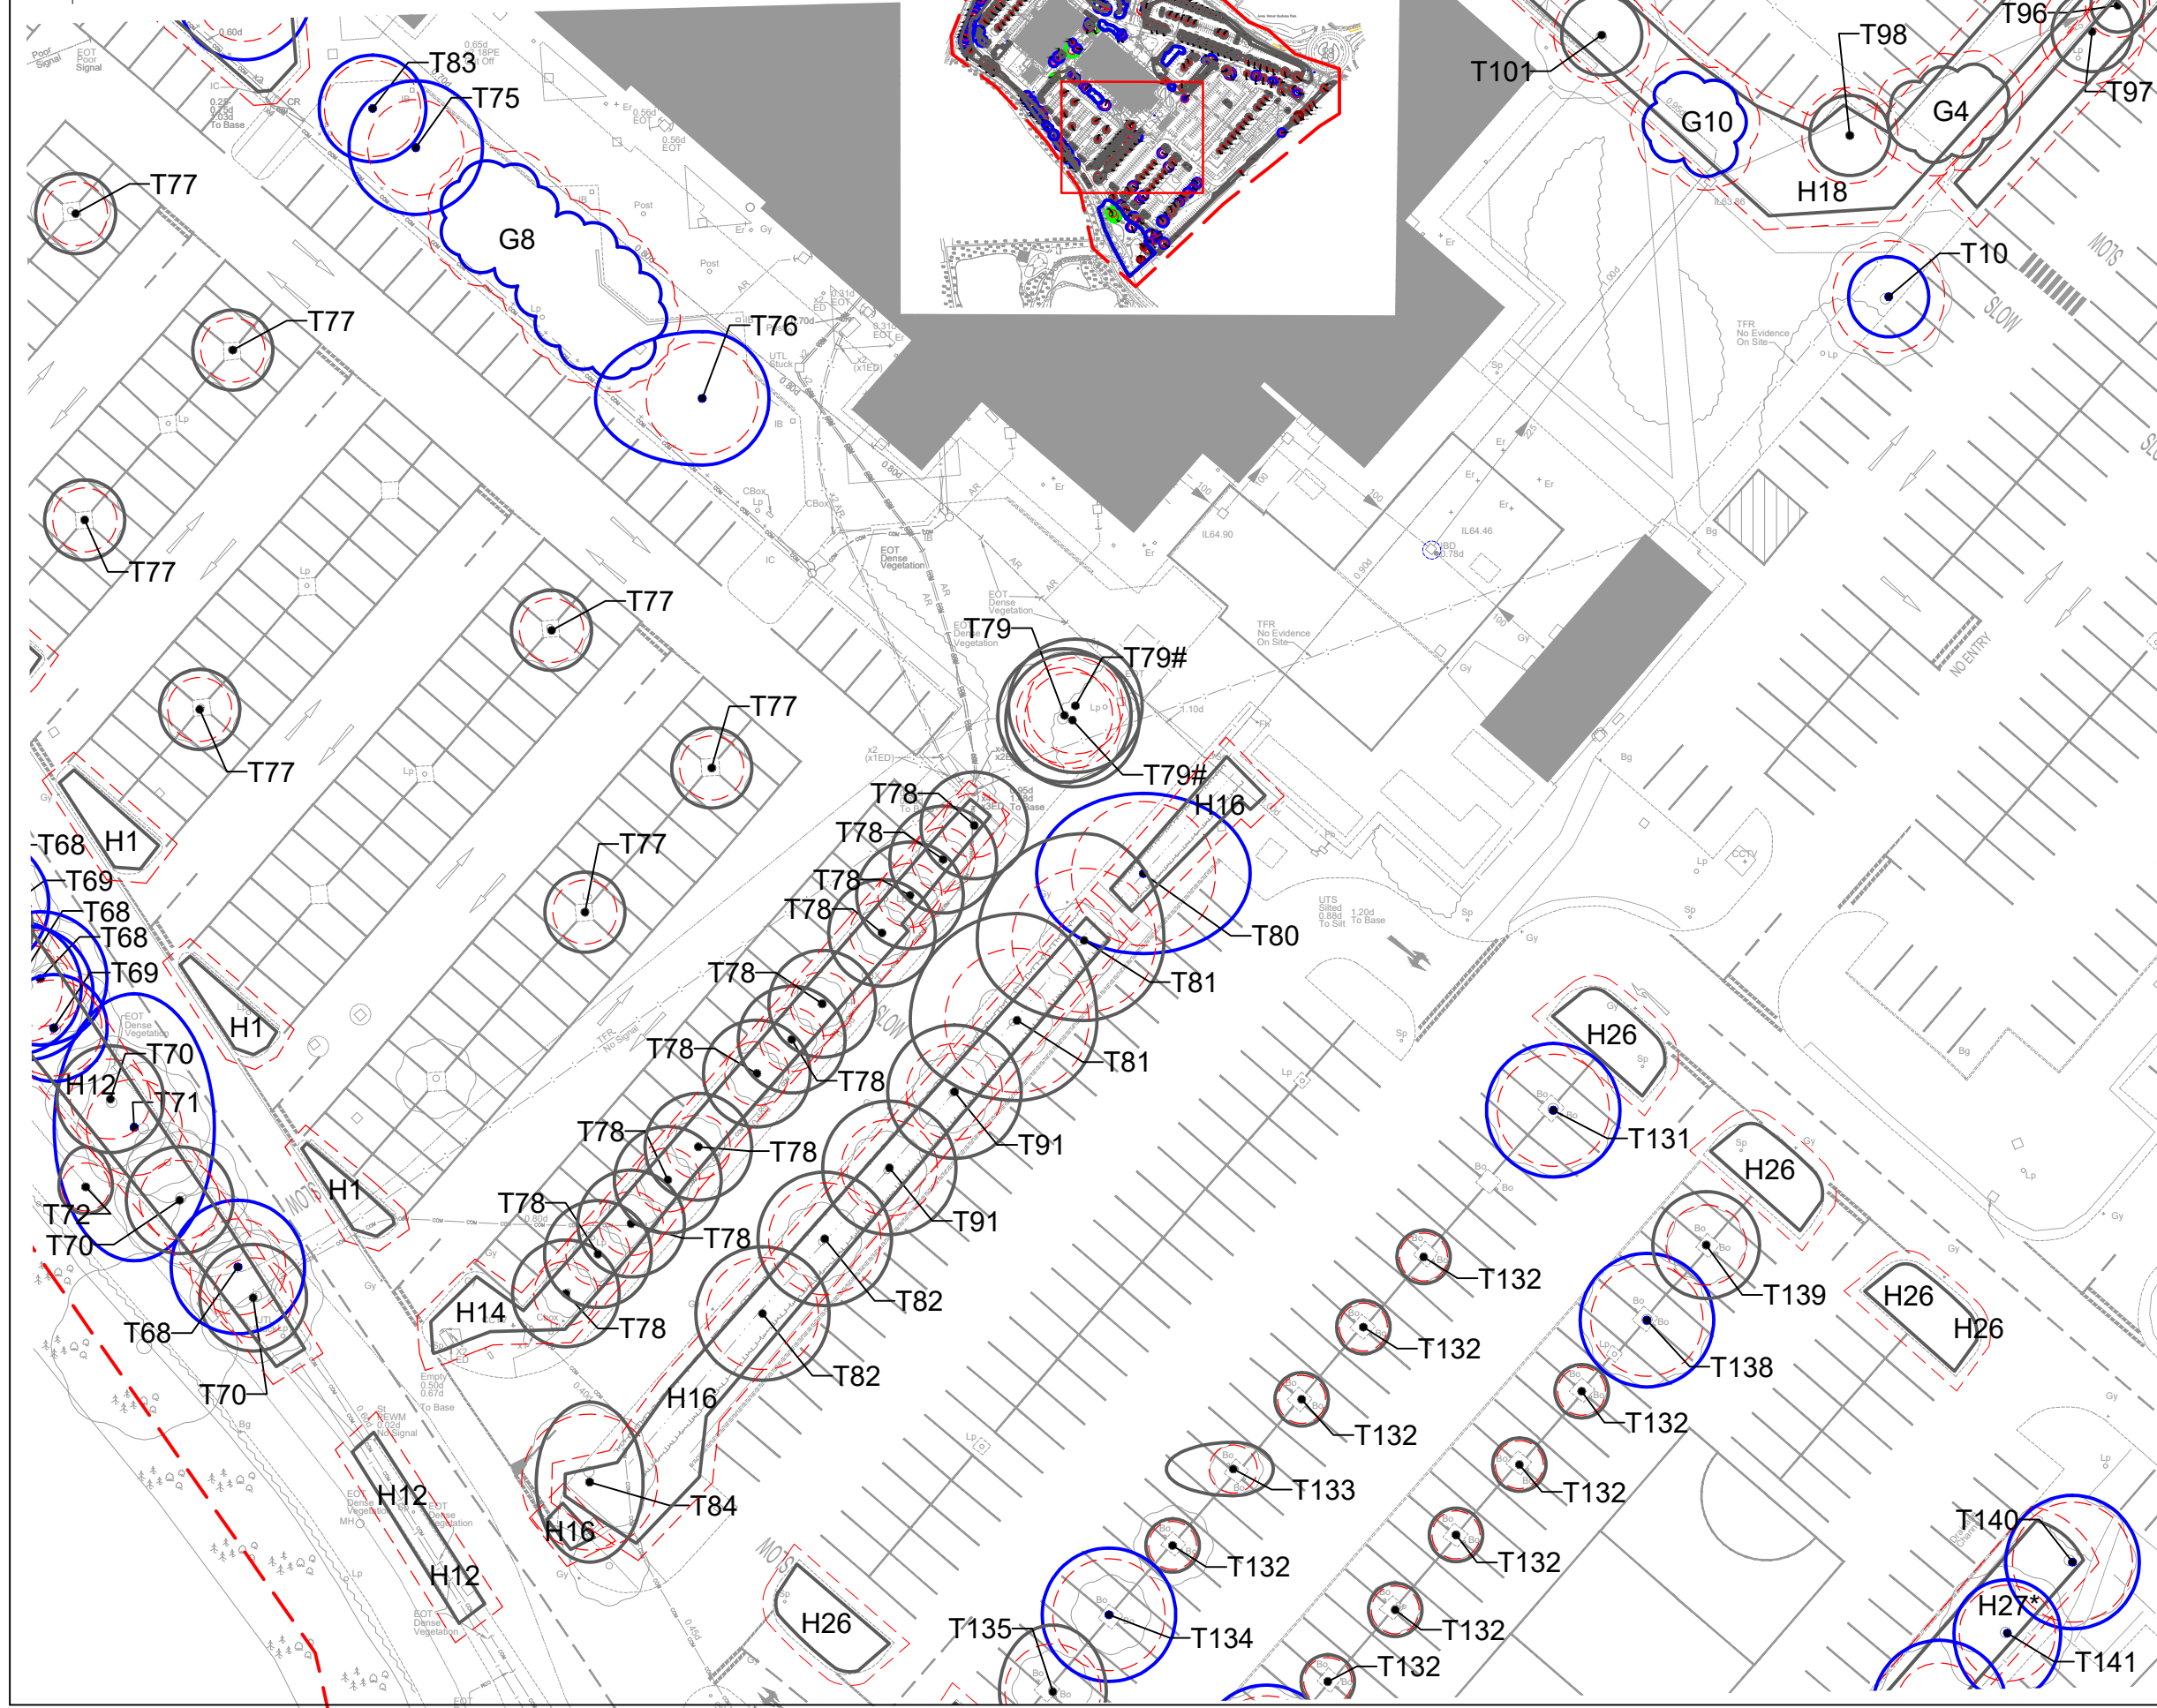
RPS Drawing / Figure Number  
20305B-RPS-00-XX-DR-A-9564

- Refer to RPS Tree Survey Report & Schedule for further details.
- Survey based on a visual inspection from the ground and is not intended as a full arboricultural inspection.
- Plan produced in accordance with recommendations set out in BS 5837:2012 - 'Trees in Relation to design, demolition and construction'.
- Due to the legal protection afforded to breeding birds, nest removal should not take place during the bird nesting period; generally, although not restricted to, March - August inclusive.
- Survey based upon topographic survey produced by Greenhatch Group in August 2018.

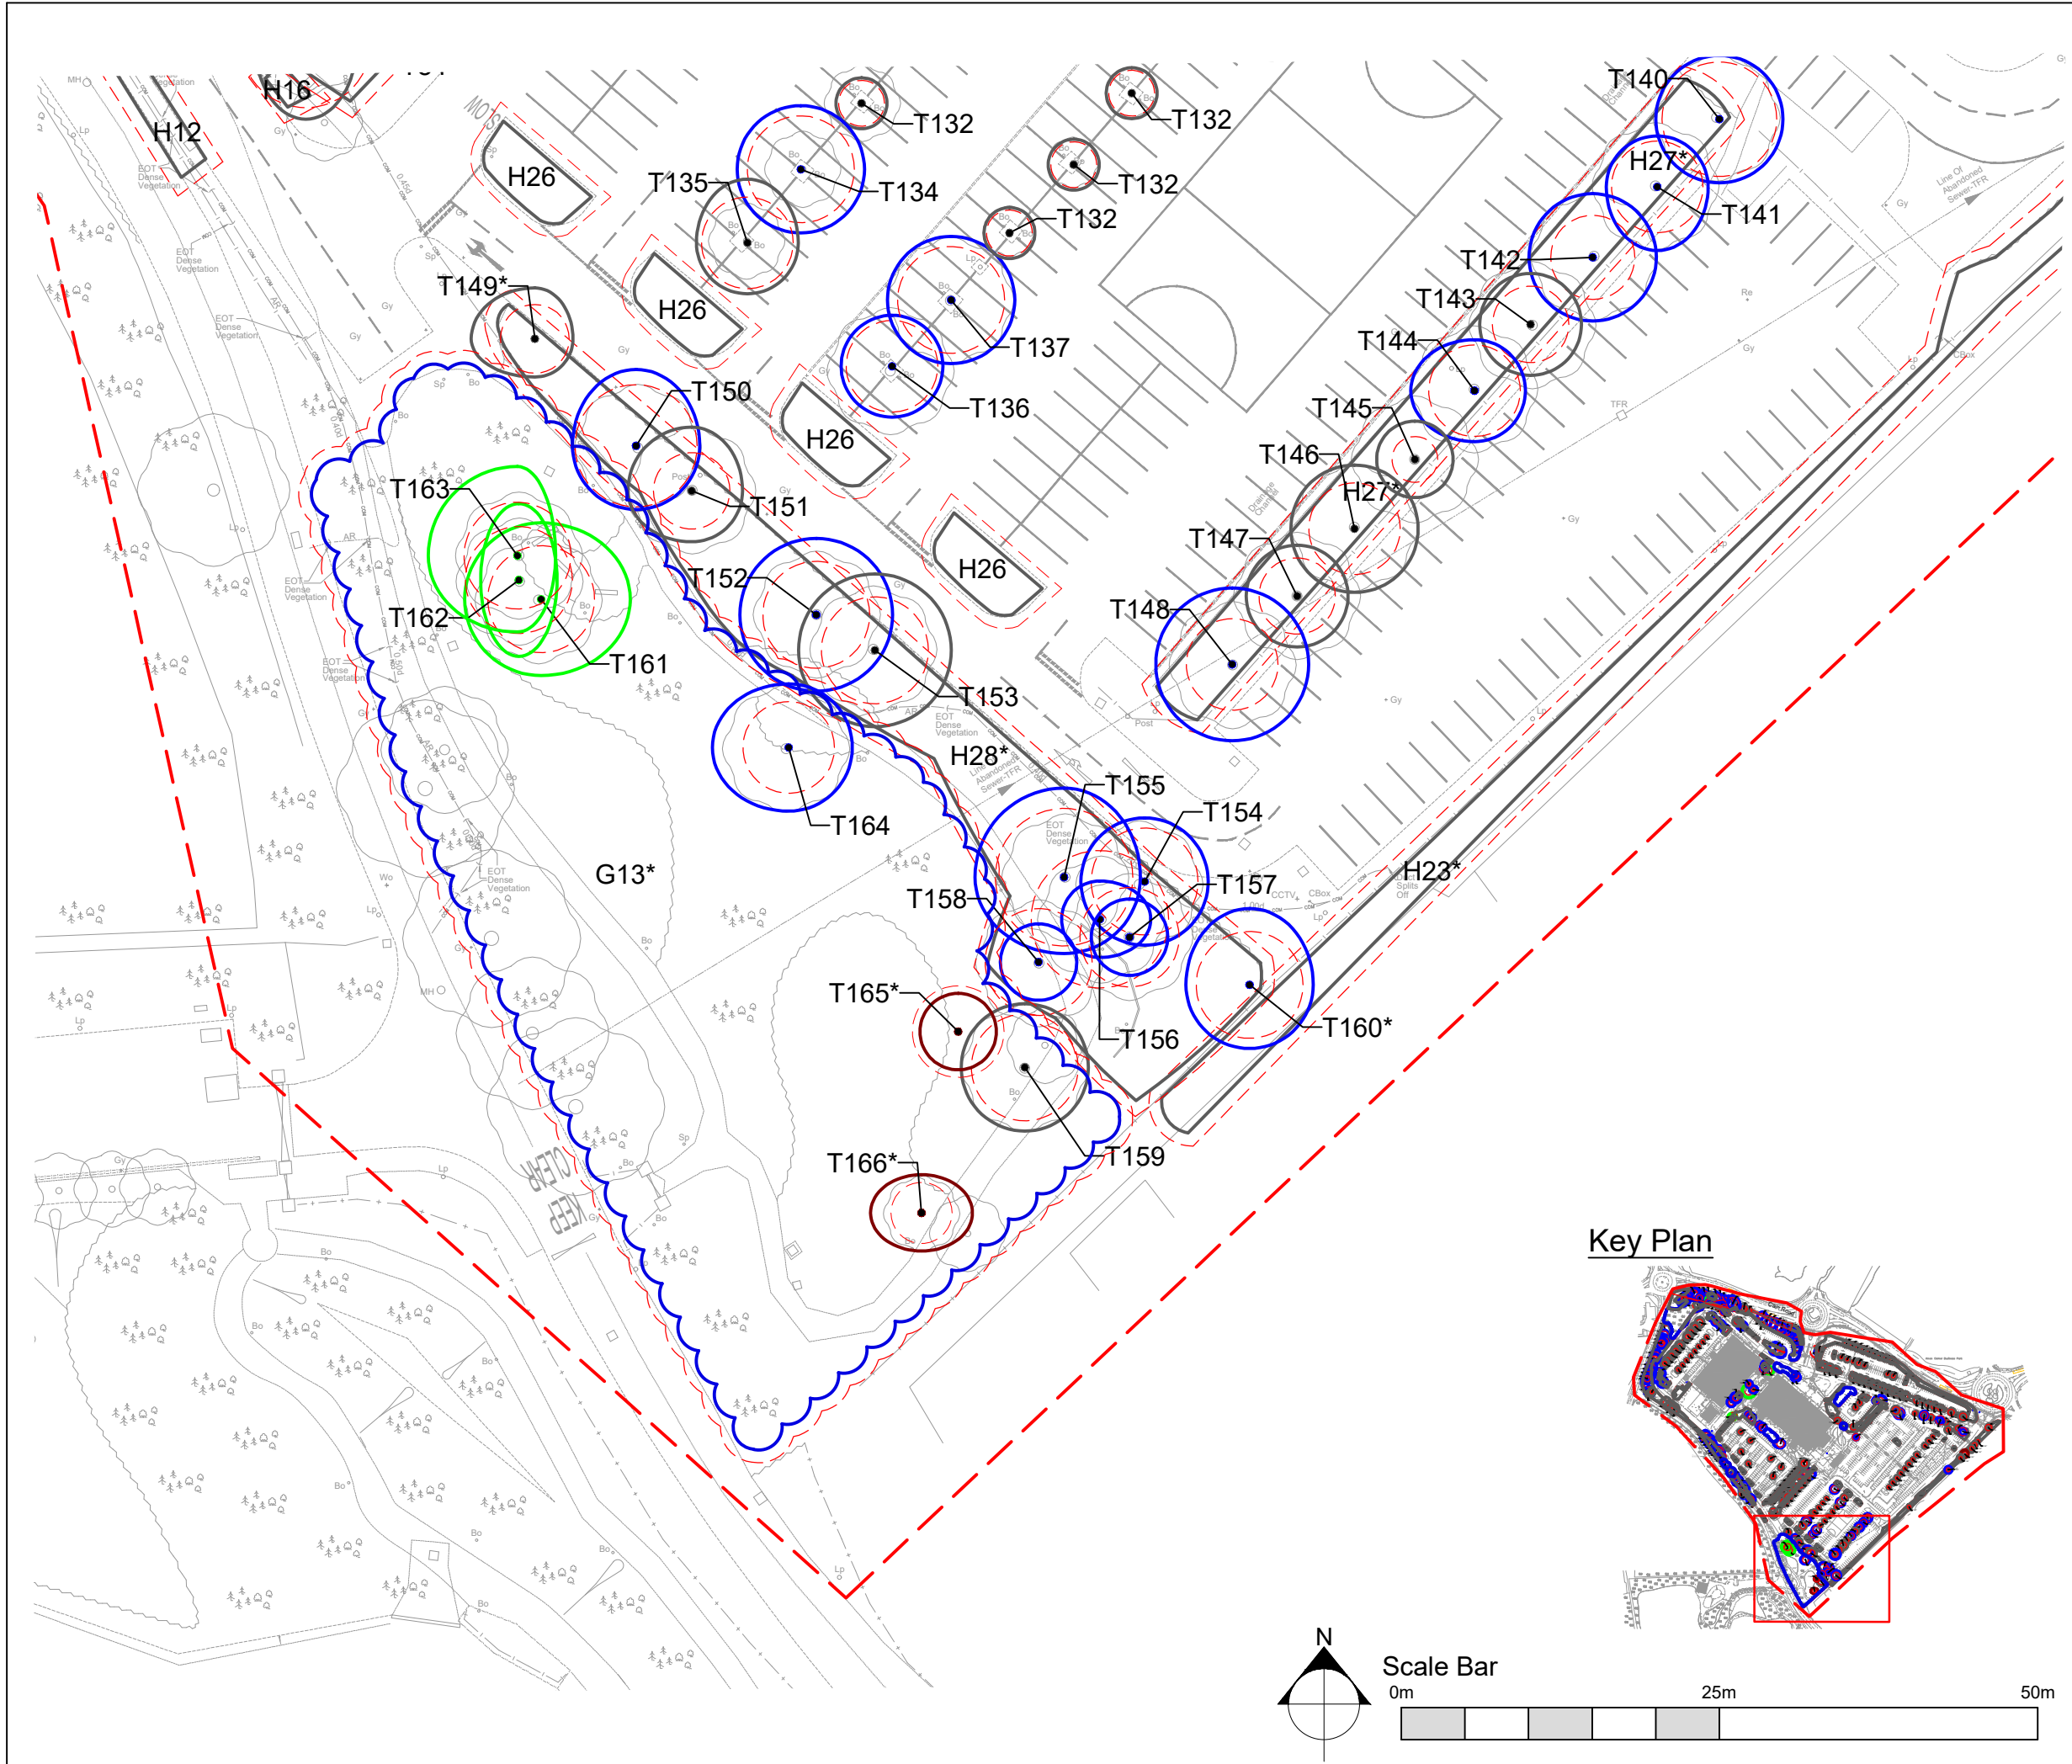
RPS Drawing / Figure Number  
**20305B-RPS-00-XX-DR-A-9565**

- Refer to RPS Tree Survey Report & Schedule for further details.
- Survey based on a visual inspection from the ground and is not intended as a full arboricultural inspection.
- Plan produced in accordance with recommendations set out in BS 5837:2012 - 'Trees in Relation to design, demolition and construction'.
- Due to the legal protection afforded to breeding birds vegetation removal should not take place during the bird nesting period, generally, although not restricted to, March - August inclusive.
- Survey based upon topographic survey produced by Greenhatch Group in August 2018.

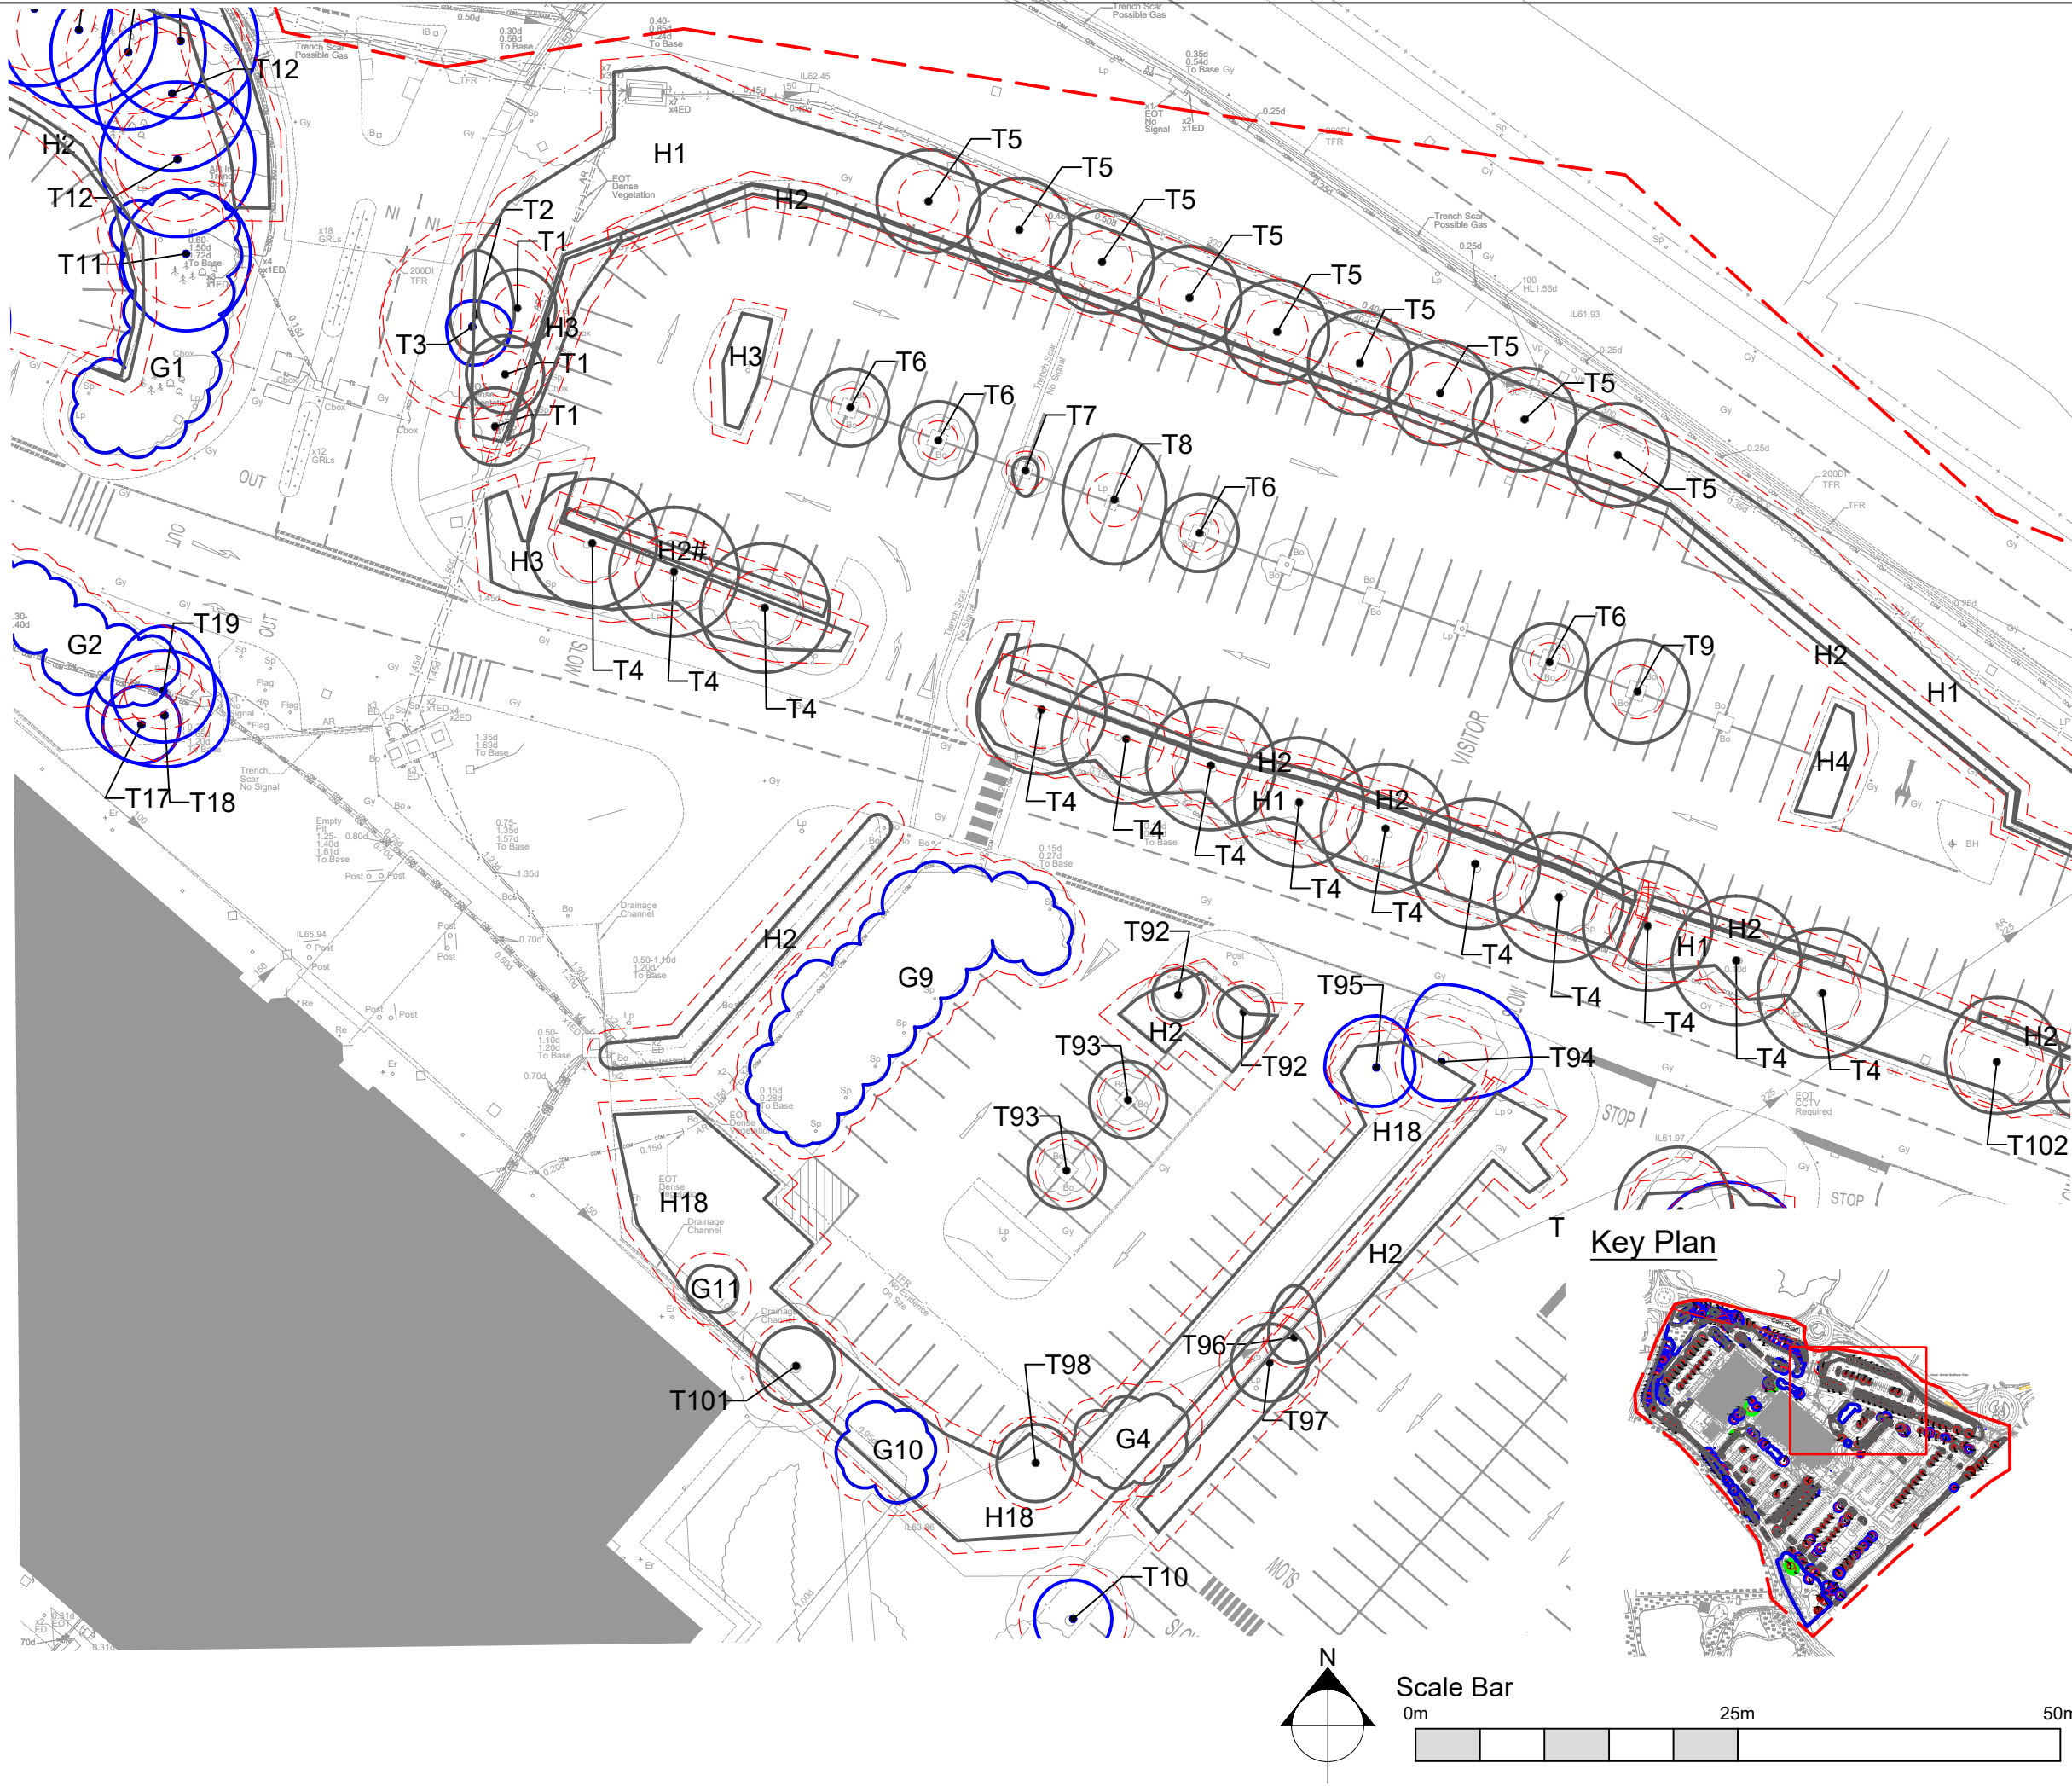
RPS Drawing / Figure Number **20305B-RPS-00-XX-DR-A-9566** Rev

- Refer to RPS Tree Survey Report & Schedule for further details.
- Survey based on a visual inspection from the ground and is not intended as a full arboricultural inspection.
- Plan produced in accordance with recommendations set out in BS 5837:2012 - 'Trees in Relation to design, demolition and construction'.
- Due to the legal protection afforded to breeding birds vegetation removal should not take place during the bird nesting period, generally, although not restricted to, March - August inclusive.
- Survey based upon topographic survey produced by Greenhatch Group in August 2018.
