# BRACKNELL DATA CENTRE

TREE SURVEY & ARBORICULTURAL IMPACT ASSESSMENT  
20305B-RPS-XX-XX-RP-P-9733

20305S-RPS-XX-XX-RP-P-  
9733  
Tree Survey and  
Arboricultural Impact  
Assessment  
Final  
01 March 2021

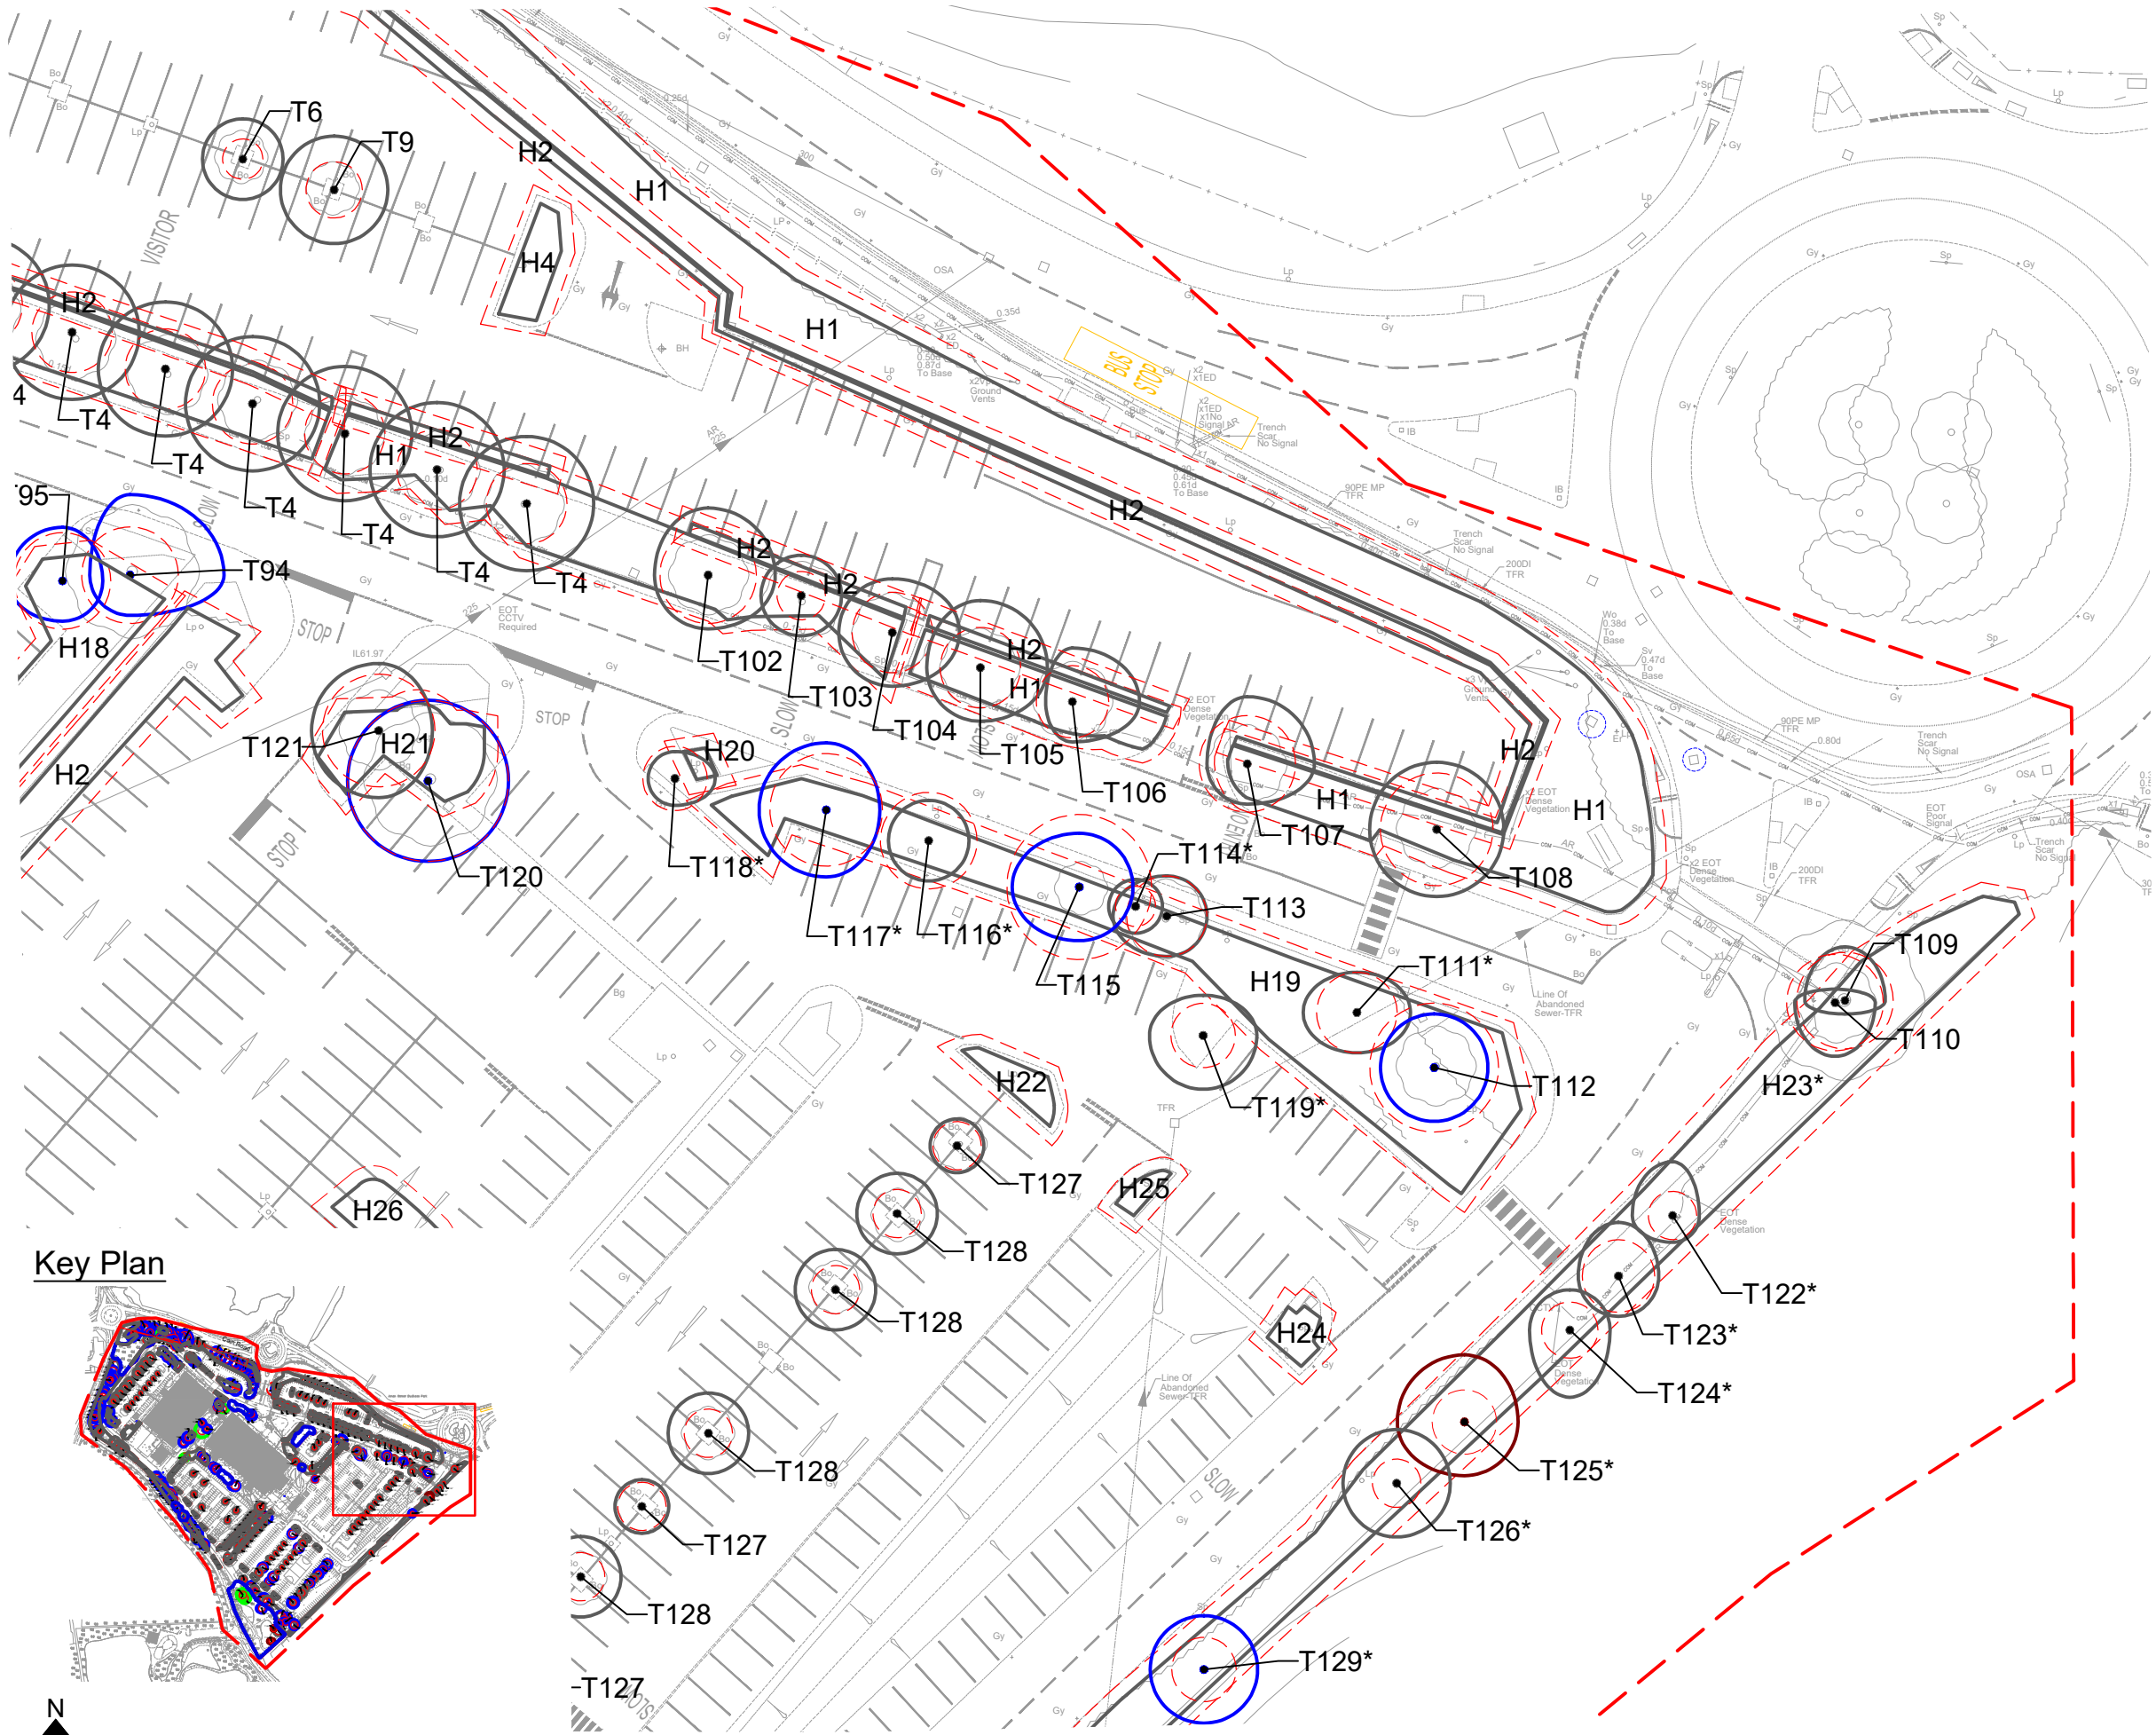
RPS Drawing / Figure Number  
**20305B-RPS-00-XX-DR-A-9567**

- Refer to RPS Tree Survey Report & Schedule for further details.
- Survey based on a visual inspection from the ground and is not intended as a full arboricultural inspection.
- Plan produced in accordance with recommendations set out in BS 5837:2012 - 'Trees in Relation to design, demolition and construction'.
- Due to the legal protection afforded to breeding birds vegetation removal should not take place during the bird nesting period, generally, although not restricted to, March - August inclusive.
- Survey based upon topographic survey produced by Greenhatch Group in August 2018.

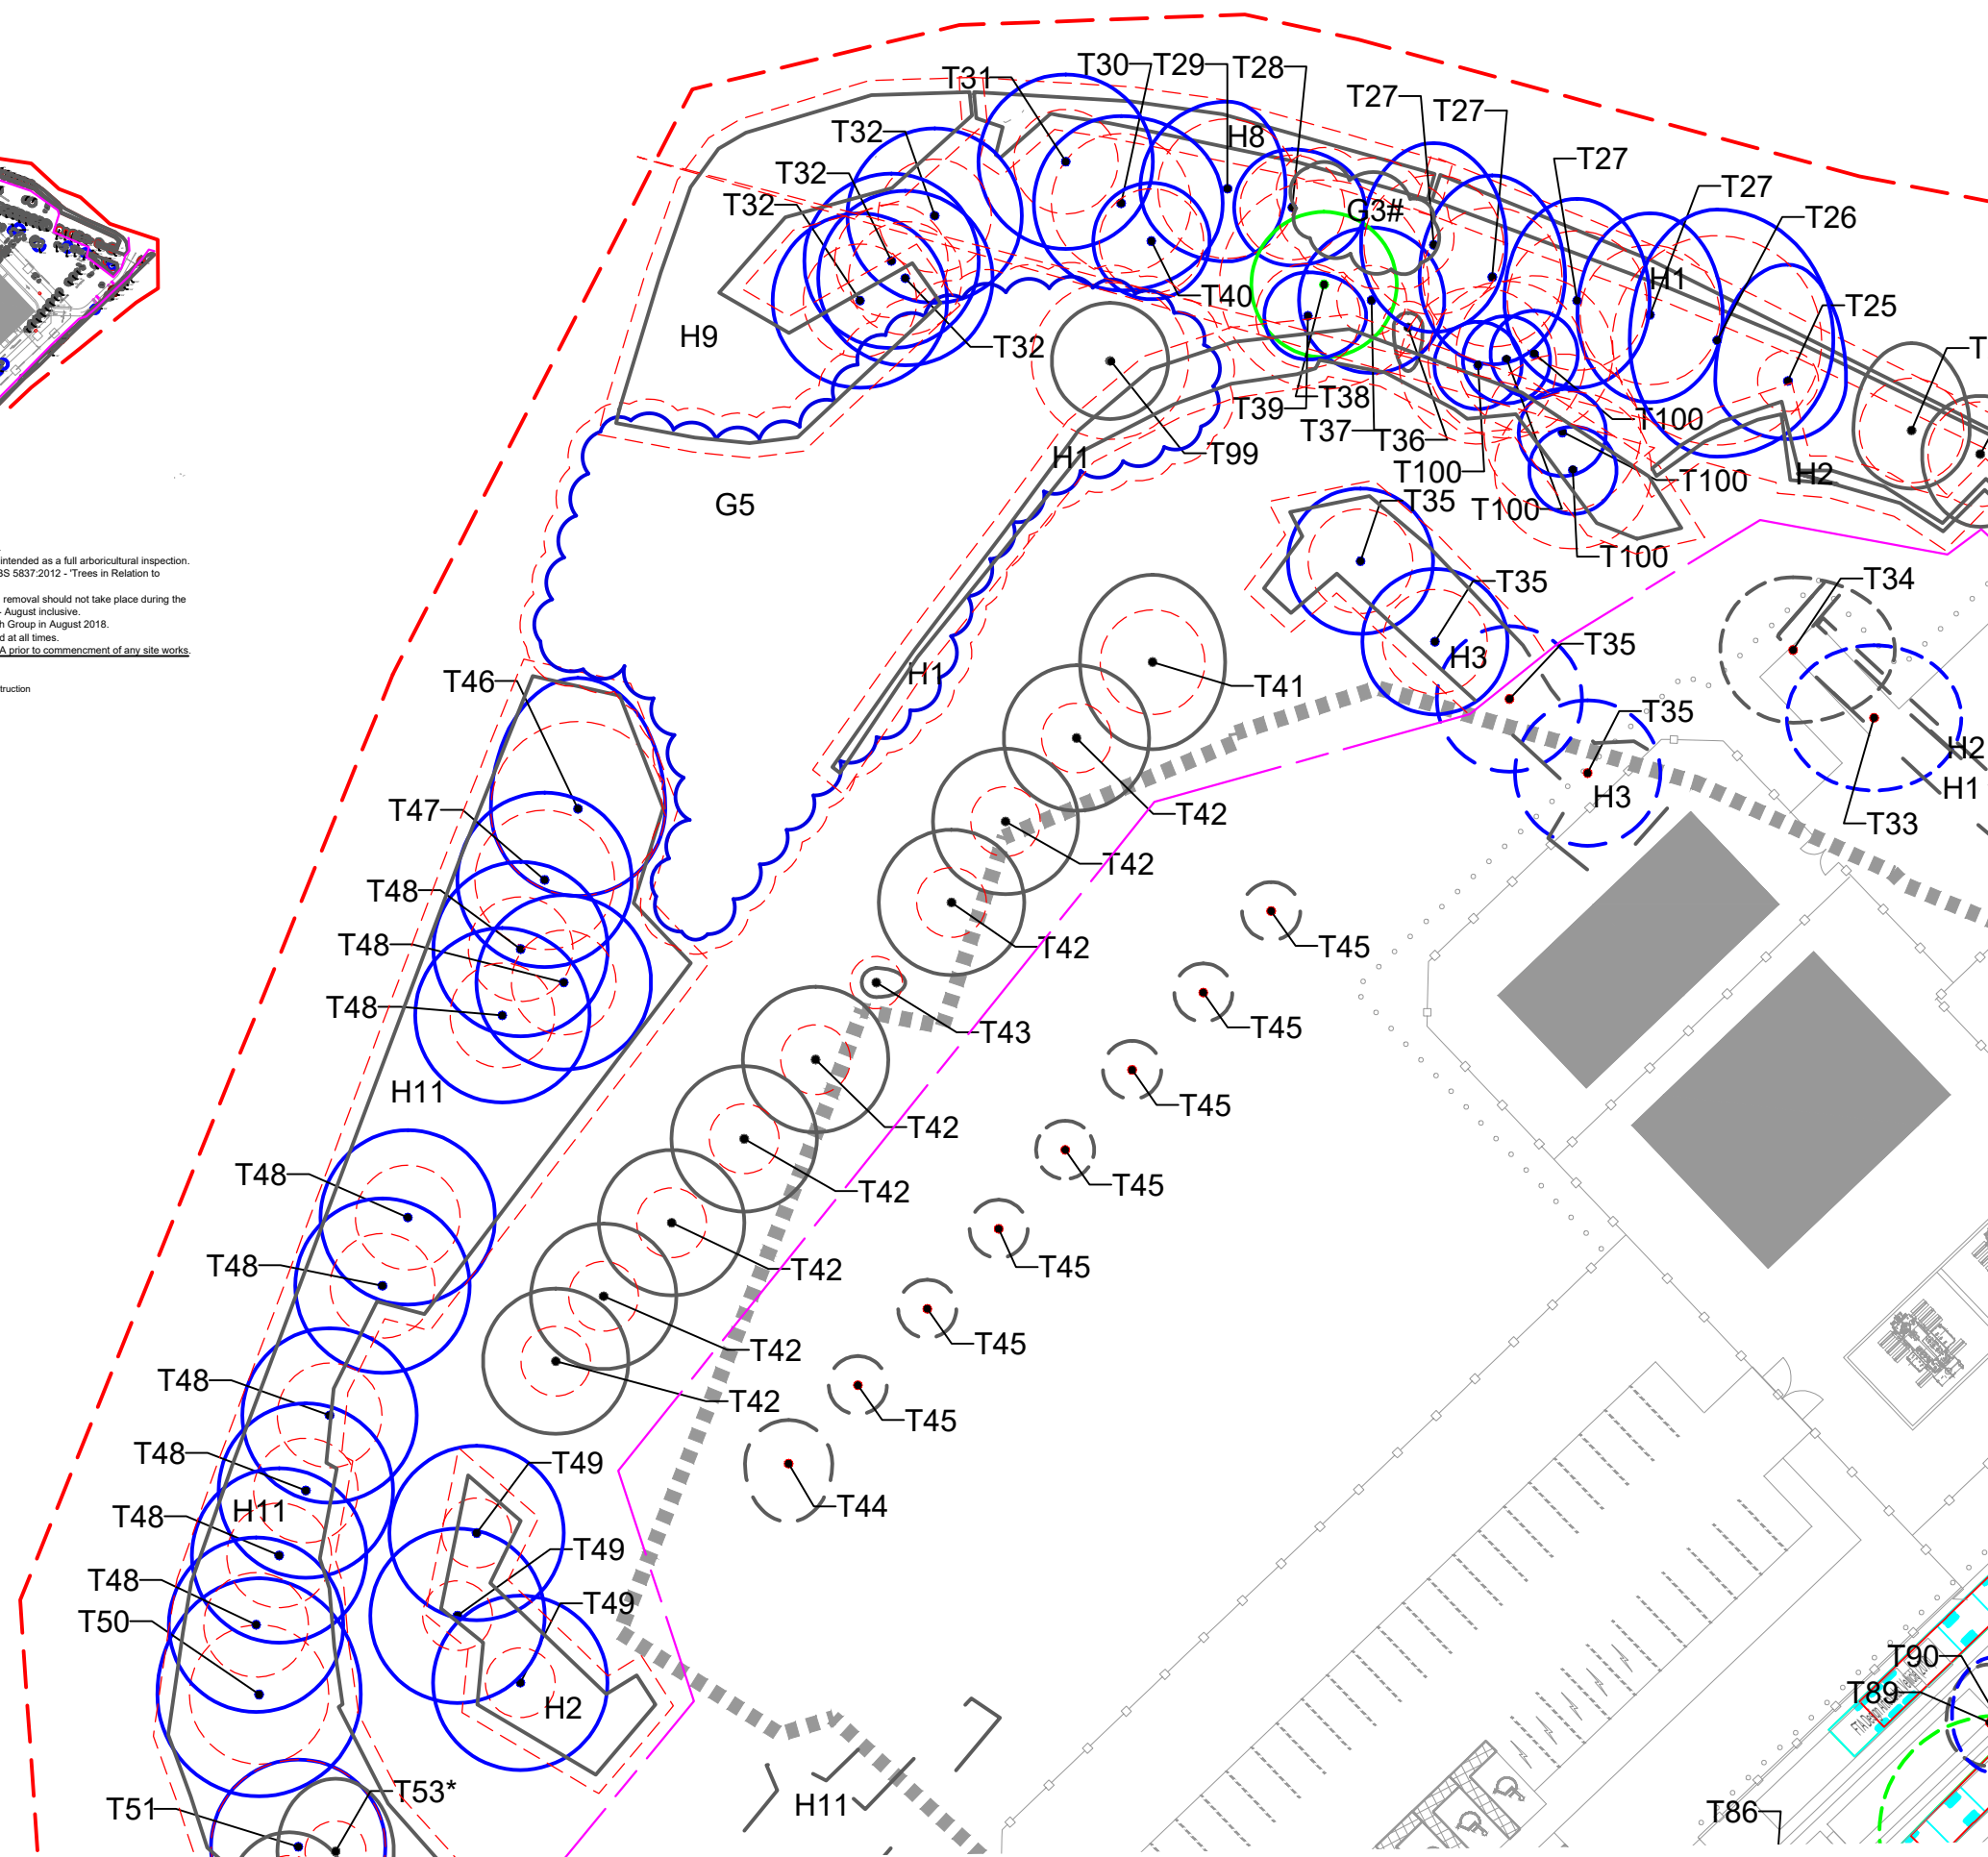
RPS Drawing / Figure Number      Rev  
20305B-RPS-00-XX-DR-A-9569

- Refer to RPS Tree Survey Report & Schedule for further details.
- Survey based on a visual inspection from the ground and is not intended as a full arboricultural inspection

- Plan produced in accordance with recommendations set out in BS 5837:2012 - 'Trees in Relation to design, demolition and construction'.
- Due to the legal protection afforded to breeding birds vegetation removal should not take place during the nesting period; generally, unless not restricted to, March - August inclusive.

- All protective fencing to be completed and approved by LPA/CAC prior to commencement of any site works
- All works to conform with requirements of:
  - BS 3998:2010 - Tree Works

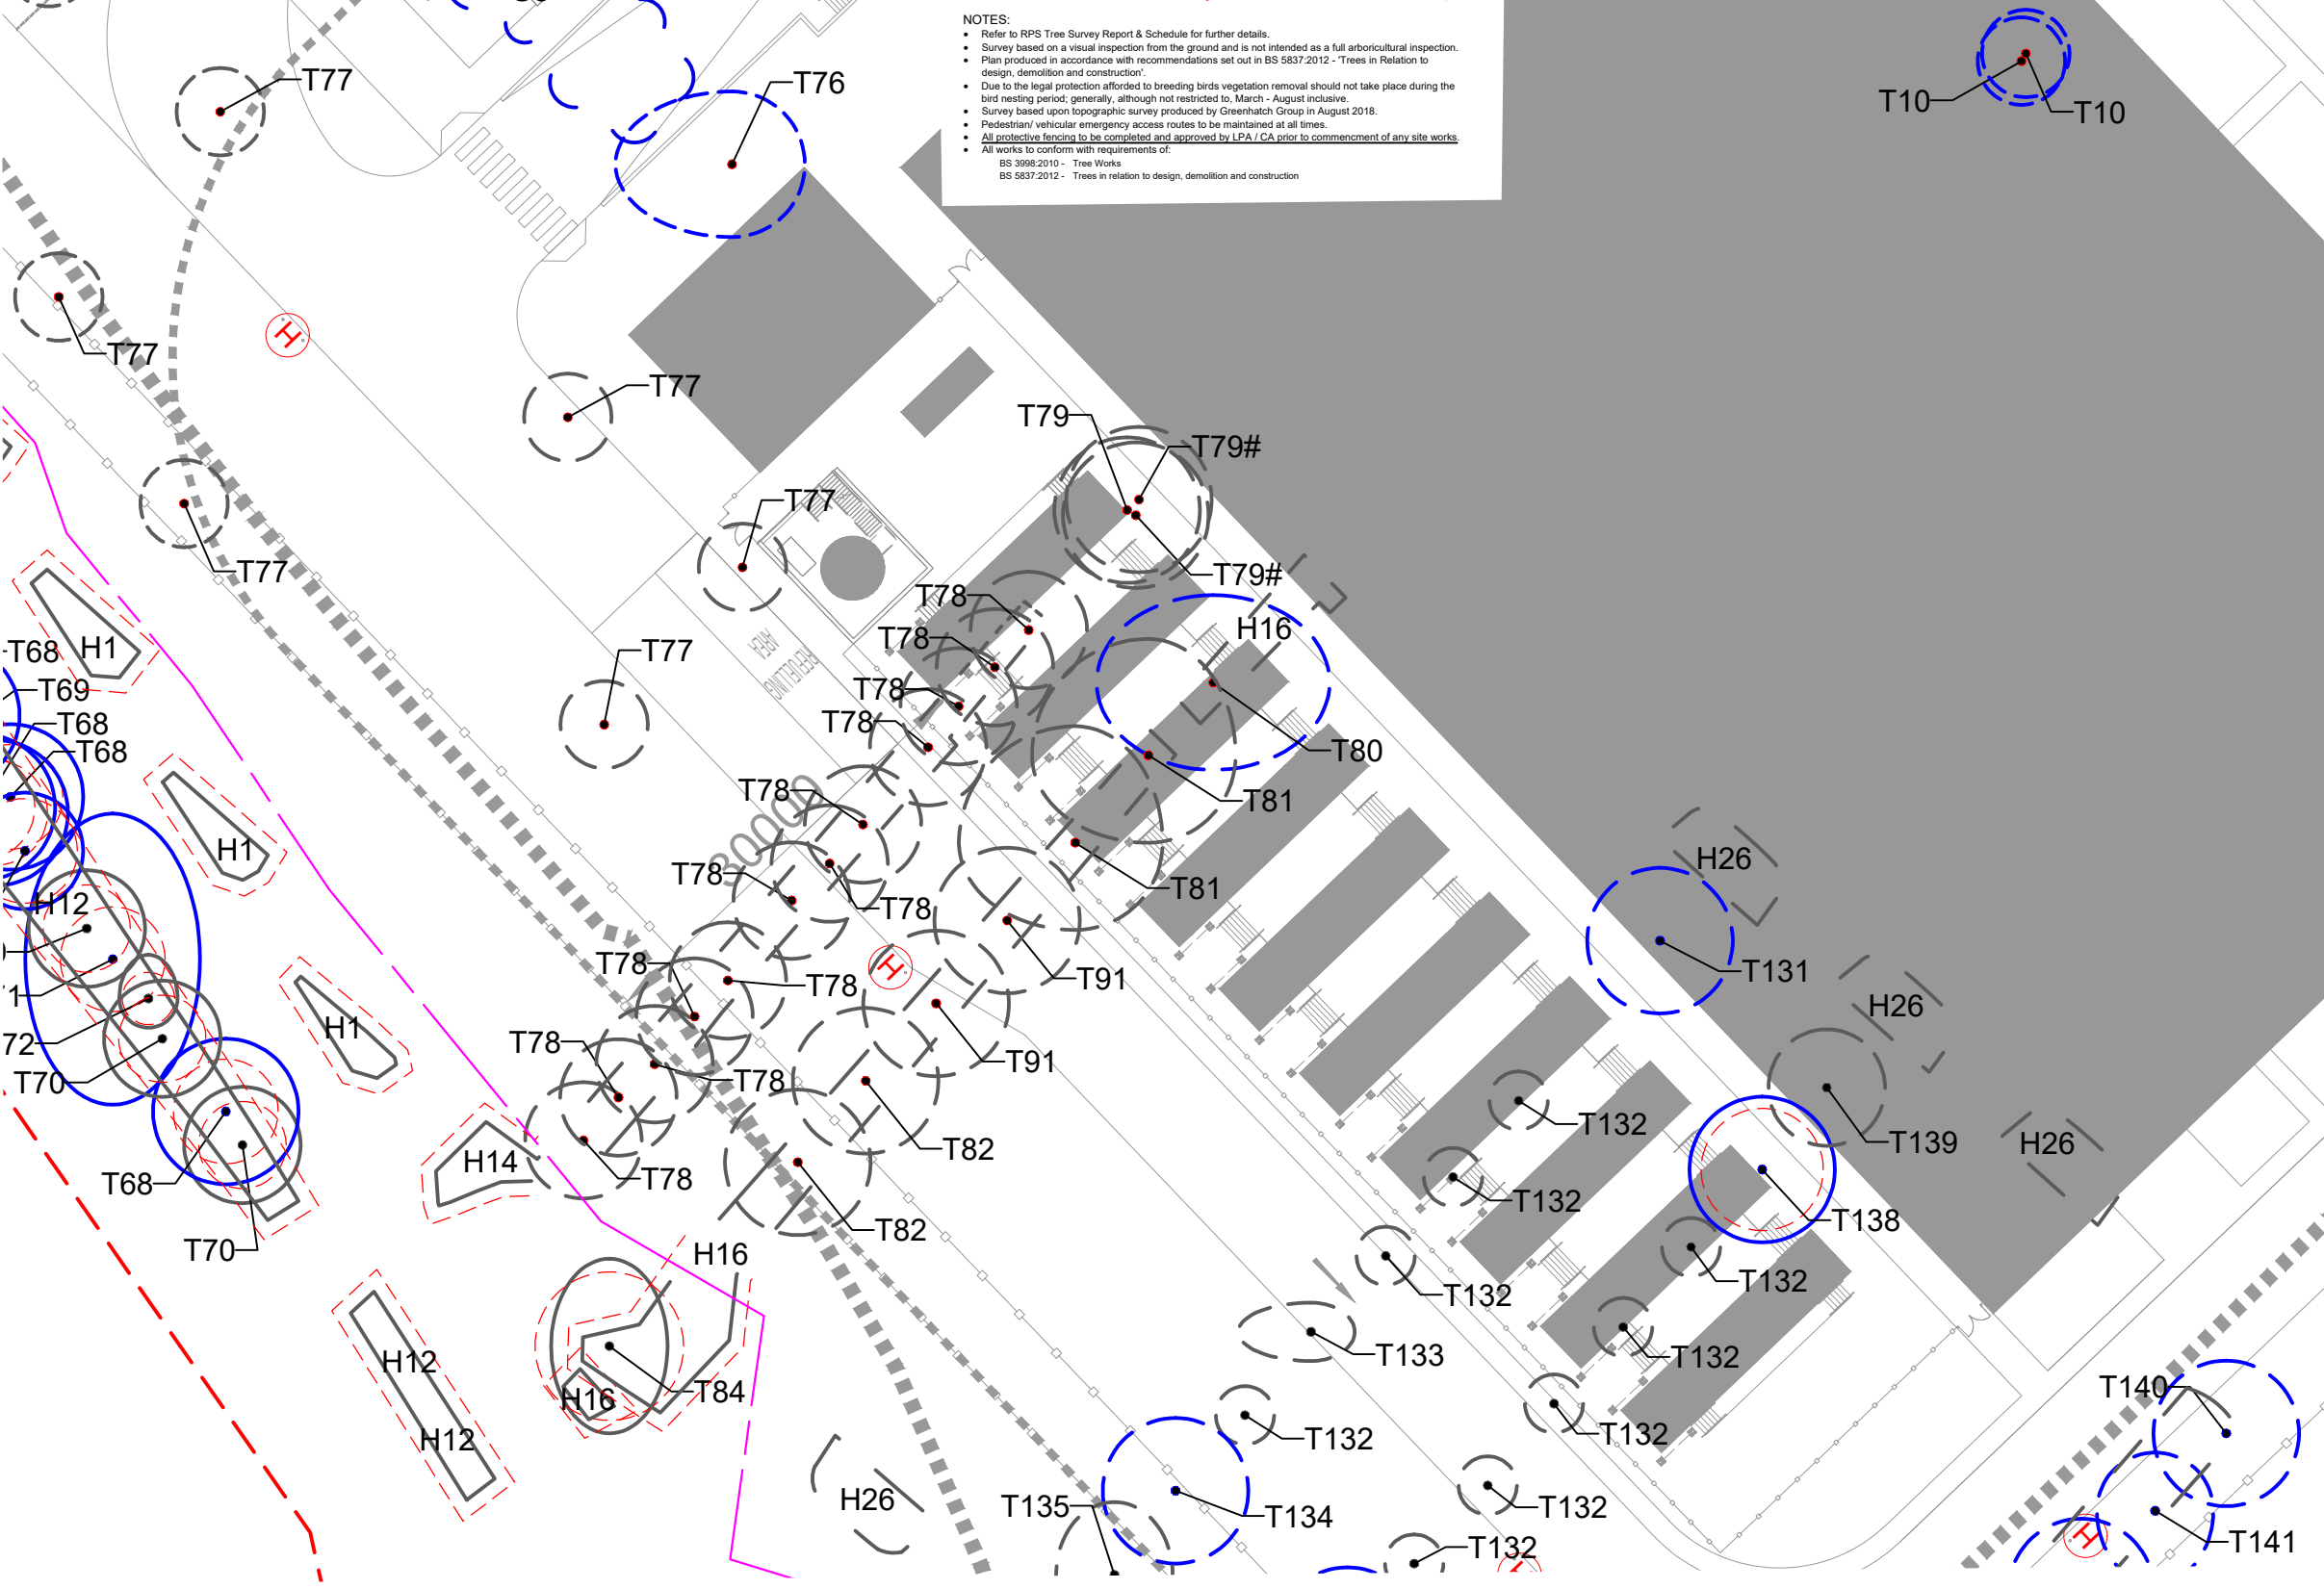
RPS Drawing / Figure Number **20305B-RPS-00-XX-DR-A-9572** Rev

- NOTES:
- Refer to RPS Tree Survey Report & Schedule for further details.
  - Survey based on a visual inspection from the ground and is not intended as a full arboricultural inspection.

- Plan produced in accordance with recommendations set out in BS 5837:2012 - 'Trees in Relation to design, demolition and construction'.
  - Due to the legal protection afforded to breeding birds vegetation removal should not take place during the bird nesting period; generally, although not restricted to, March - August inclusive.

- Temporary protective fencing in accordance with Section 6.2 - BS5837:2012. See inset details for example barriers.
  - All works to conform with requirements of:

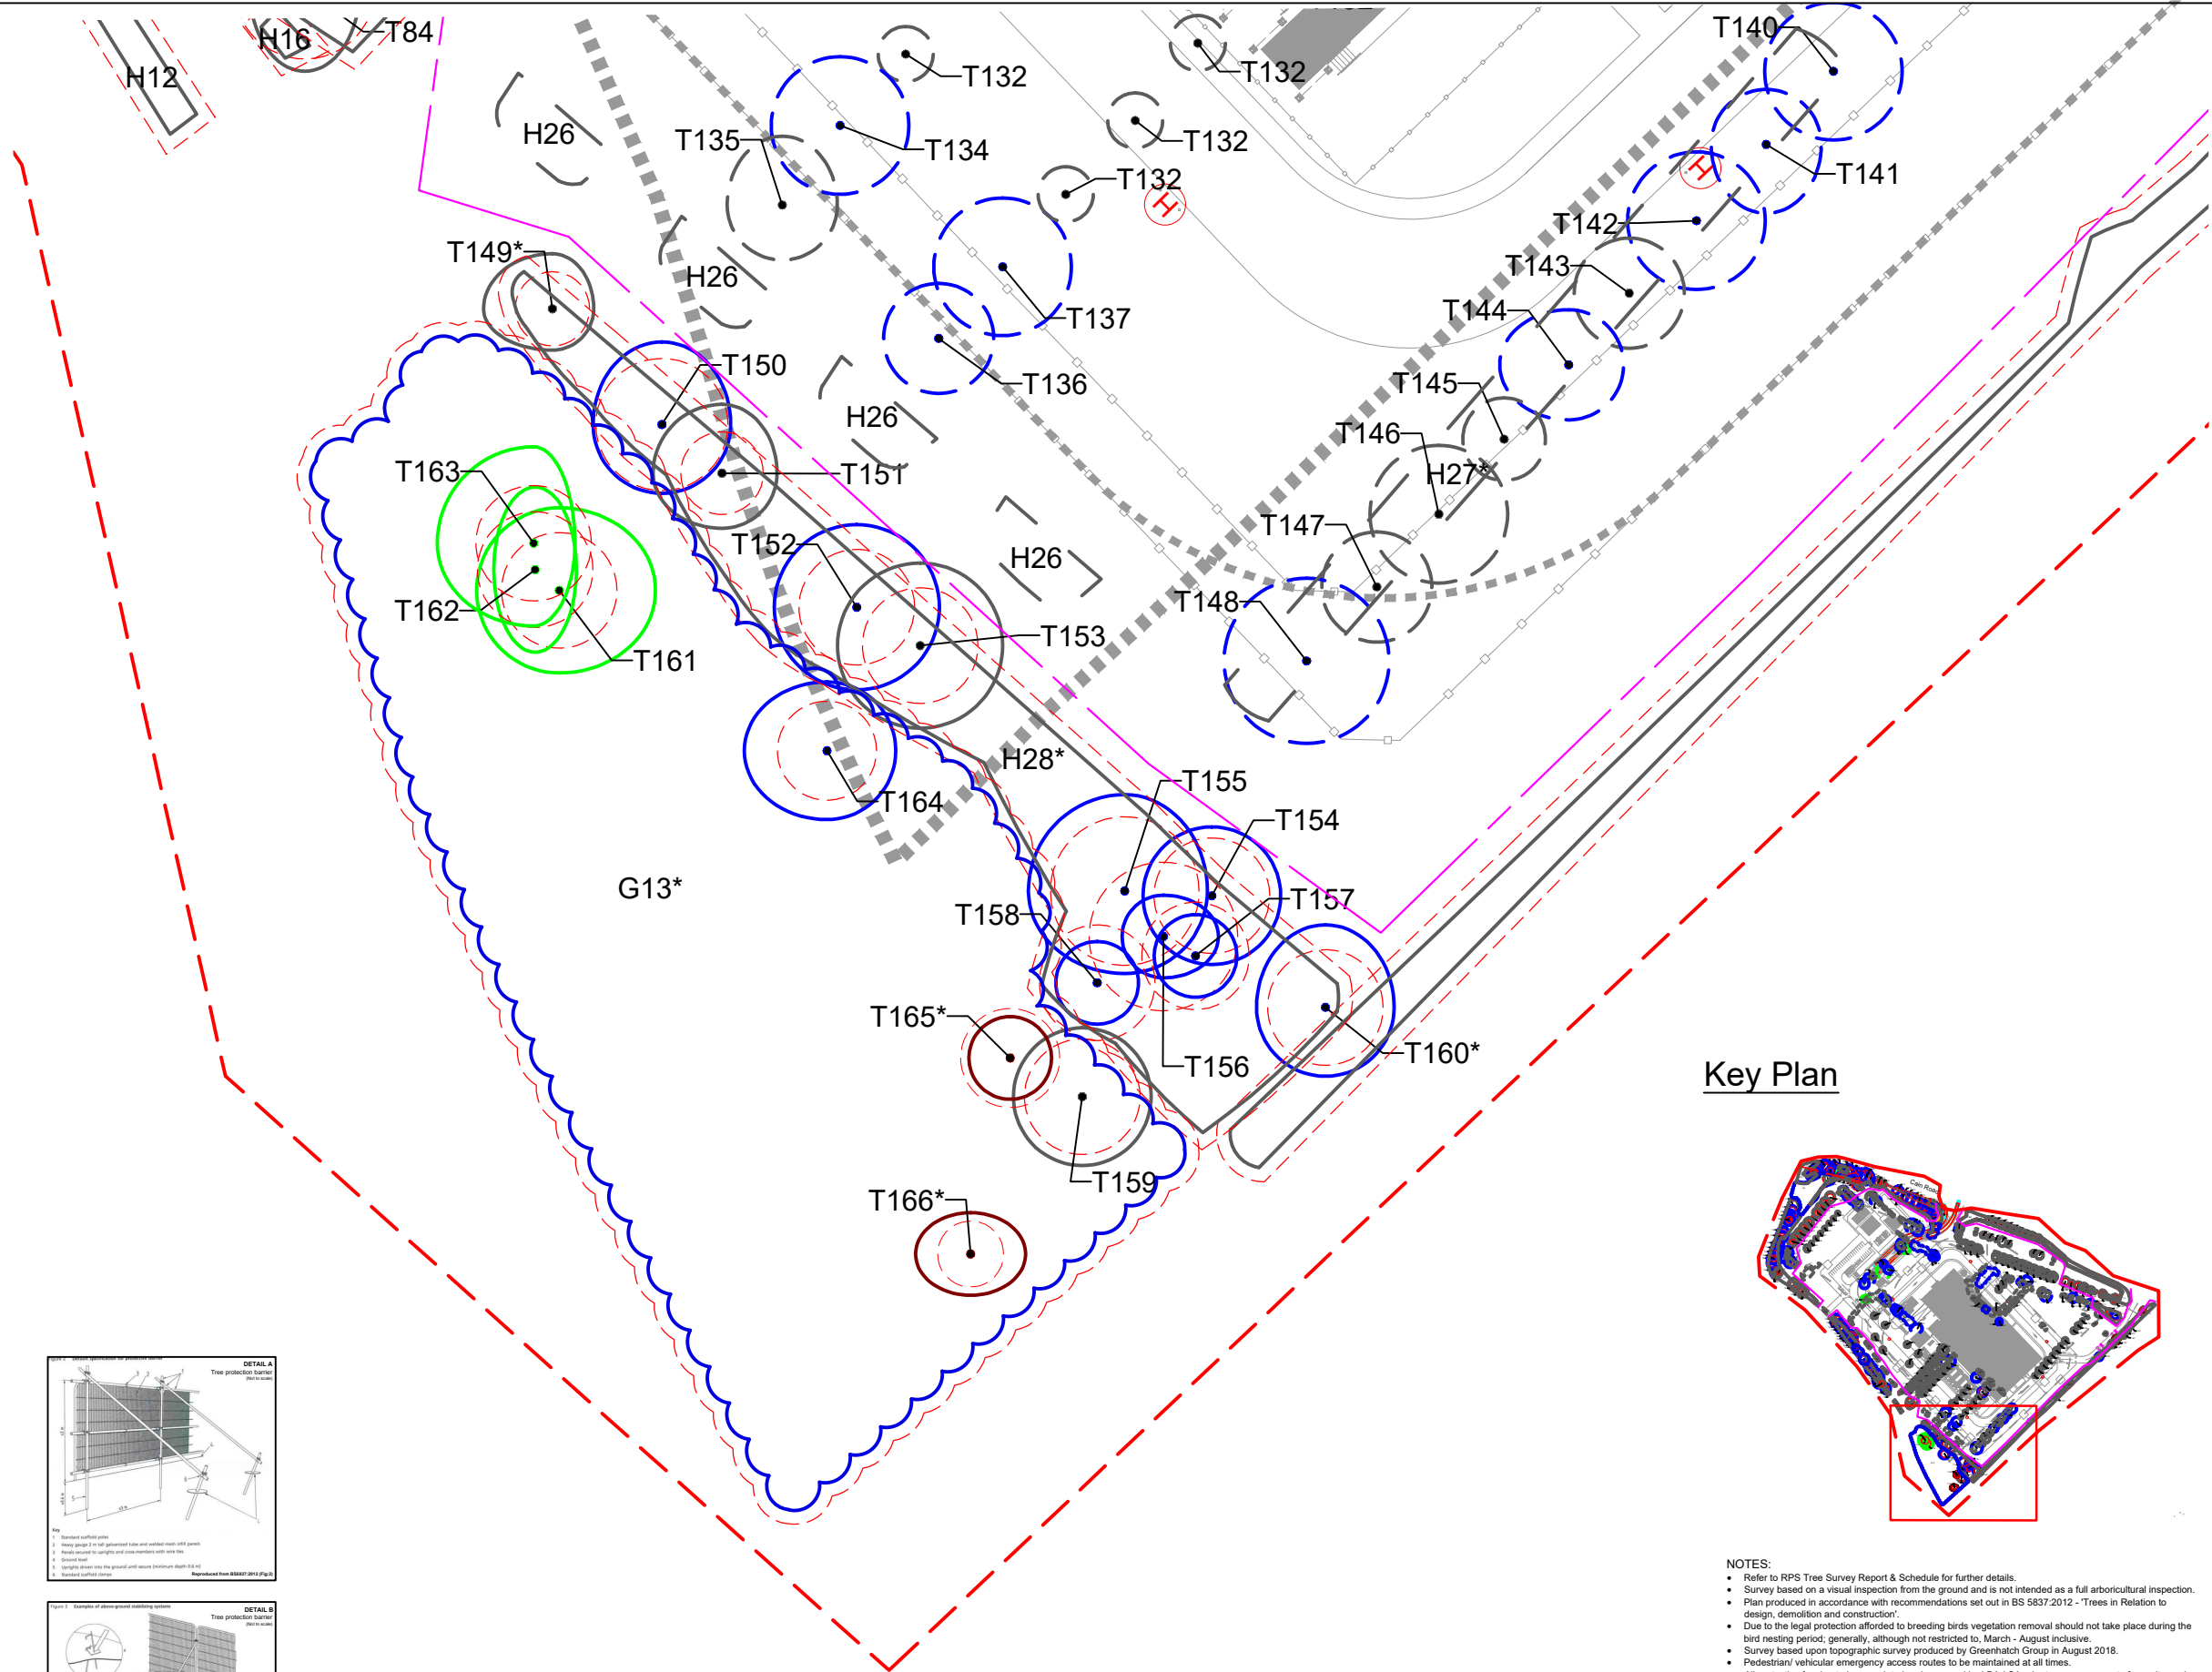
RPS Drawing / Figure Number **20305B-RPS-00-XX-DR-A-9573** Rev

- NOTES:
- Refer to RPS Tree Survey Report & Schedule for further details.
  - Survey based on a visual inspection from the ground and is not intended as a full arboricultural inspection.

- Plan produced in accordance with recommendations set out in BS 5837:2012 - 'Trees in Relation to design, demolition and construction'.
  - Due to the legal protection afforded to breeding birds vegetation removal should not take place during the bird nesting period; generally, although not restricted to, March - August inclusive.

- Survey based upon topographic survey produced by Greenhatch Group in August 2018.
  - Pedestrian/ vehicular emergency access routes to be maintained at all times.

- All protective fencing to be completed and approved by LPA / CA prior to commencement of any site works.
  - All works to conform with requirements of:  
BS 3998:2010 - Tree Works  
BS 5837:2012 - Trees in relation to design, demolition and construction

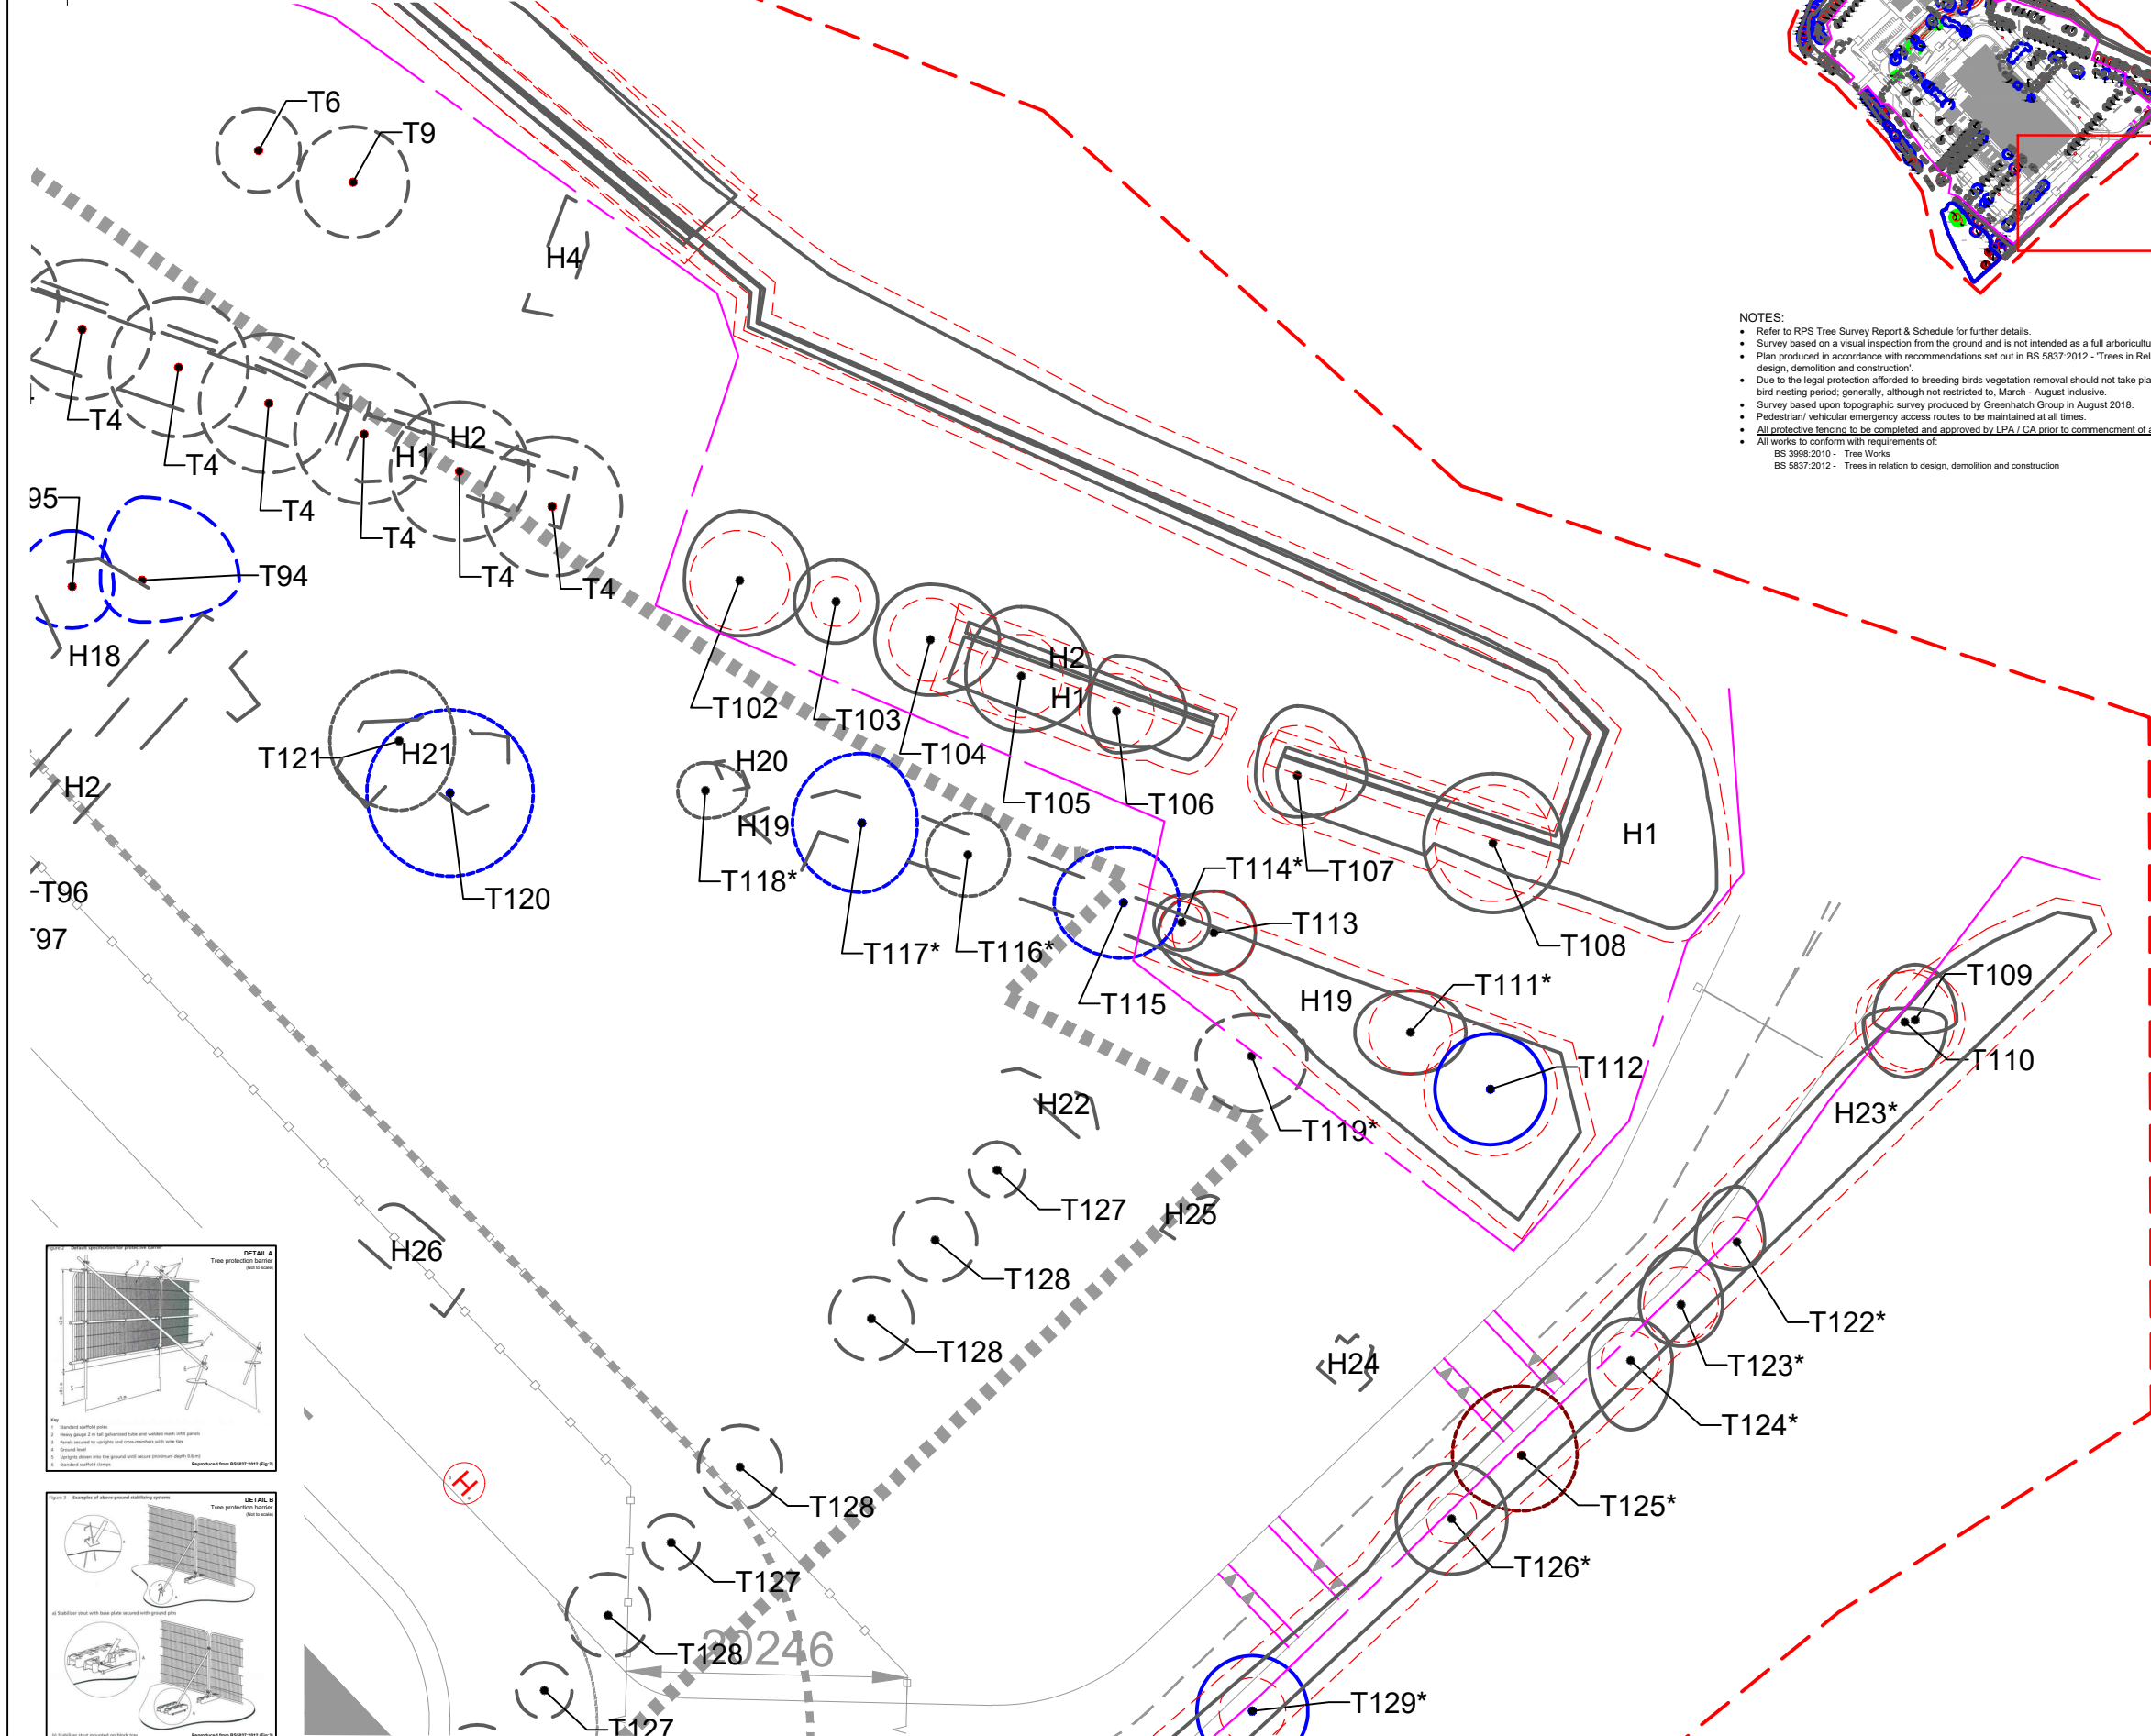
RPS Drawing / Figure Number      Rev  
20305B-RPS-00-XX-DR-A-9575

- **NOTES:**
- Refer to RPS Tree Survey Report & Schedule for further details.
- Survey based on a visual inspection from the ground and is not intended as a full arboricultural inspection

- Plan produced in accordance with recommendations set out in BS 5837:2012 - 'Trees in Relation to design, demolition and construction'
- Due to the legal protection afforded to breeding birds vegetation removal should not take place during the bird nesting period; generally, although not restricted to, March - August inclusive.
