Appendix 7P

Soil Sampling Technical Note

28th April 2020

TECHNICAL NOTE – Nant Helen - Investigation of Soils within Planted Ancient Woodland Site.

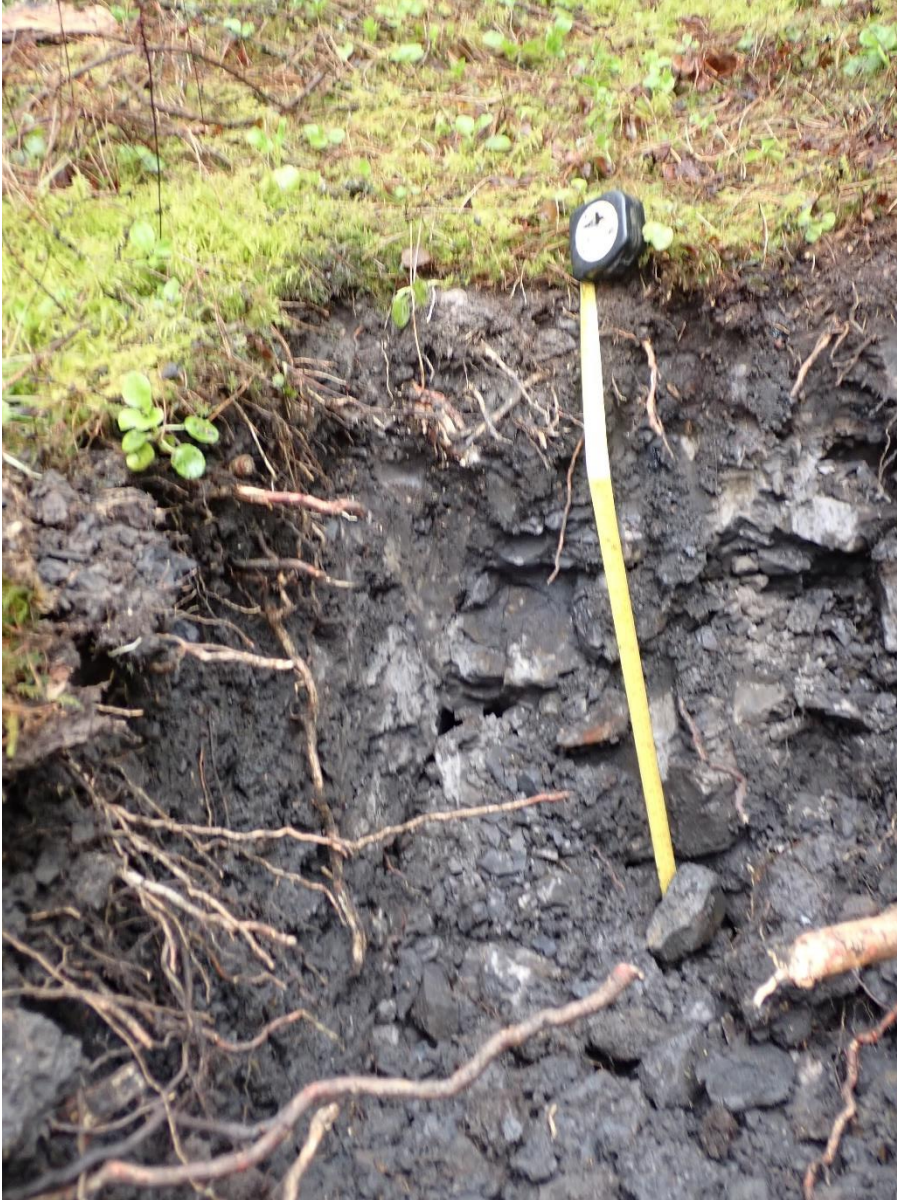
All four soil pits comprised backfilled Carboniferous Shale material. Soil Pits 1 and 2, and particularly Pit 2, had burnt colliery shale indicating an origin as ‘above ground’ deposited colliery waste. The predominantly clay profiles of Pits 3 and 4 were likely to be surfaced mined overburden.

Soil Pit 1 – 281872 E 211931 N

Depth cm	Description	Horizon
0-1	Moss/Litter	L
1-3	Dark Brown Humic / Stone Free	H
3-10	Clay Loam / 90% Grit / Grey Shale	Ah
10-70	80% Boulders & 20% Small Stones / Grey Shale	C

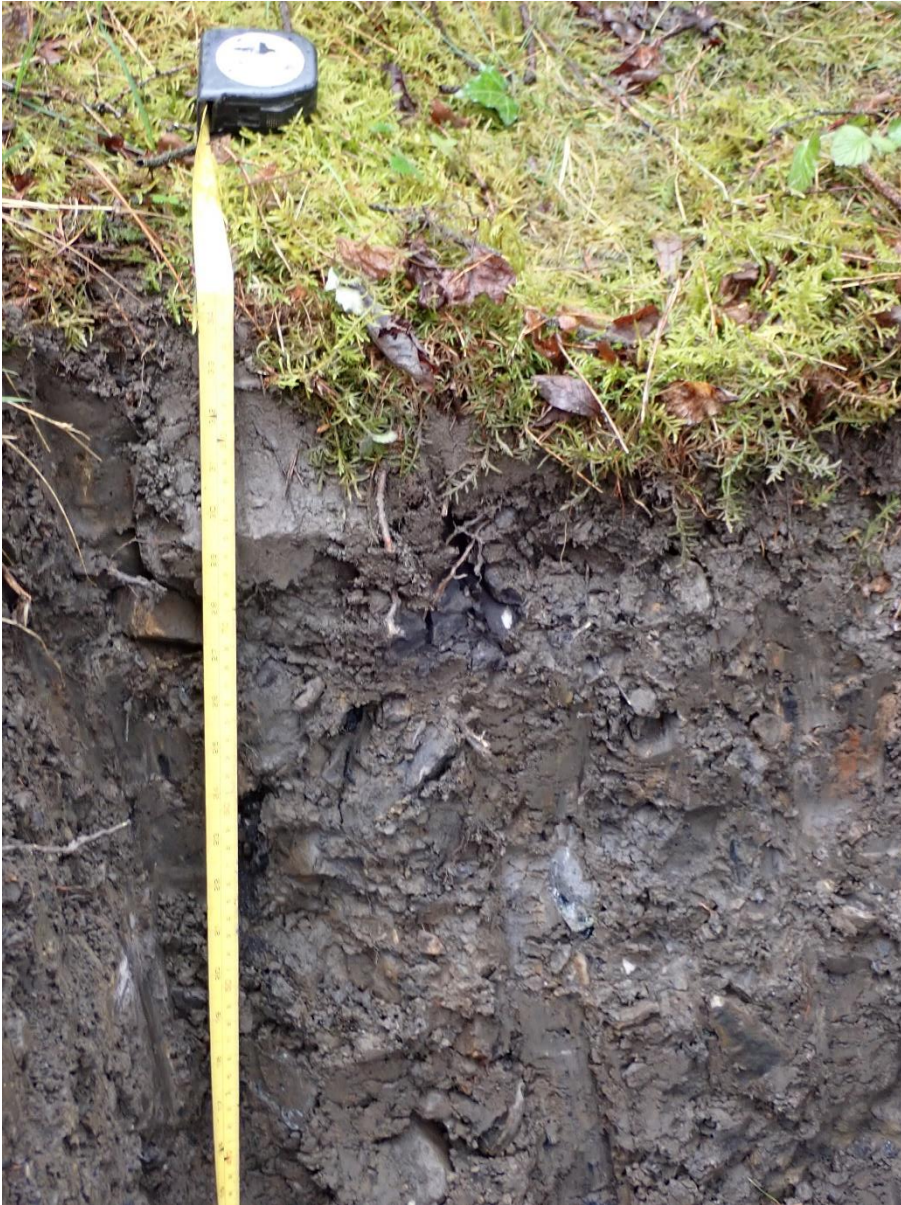
Soil Pit 2 – 281870 E 211889 N

Depth cm	Description	Horizon
0-1	Moss/Litter	L
1-3	Dark Brown Humic / Stone Free	H
3-10	Heavy Clay Loam / Stone Free / Grey Shale	Ah
10-90	Heavy Clay Loam/Clay / 40% Large Stones / Grey Shale	C

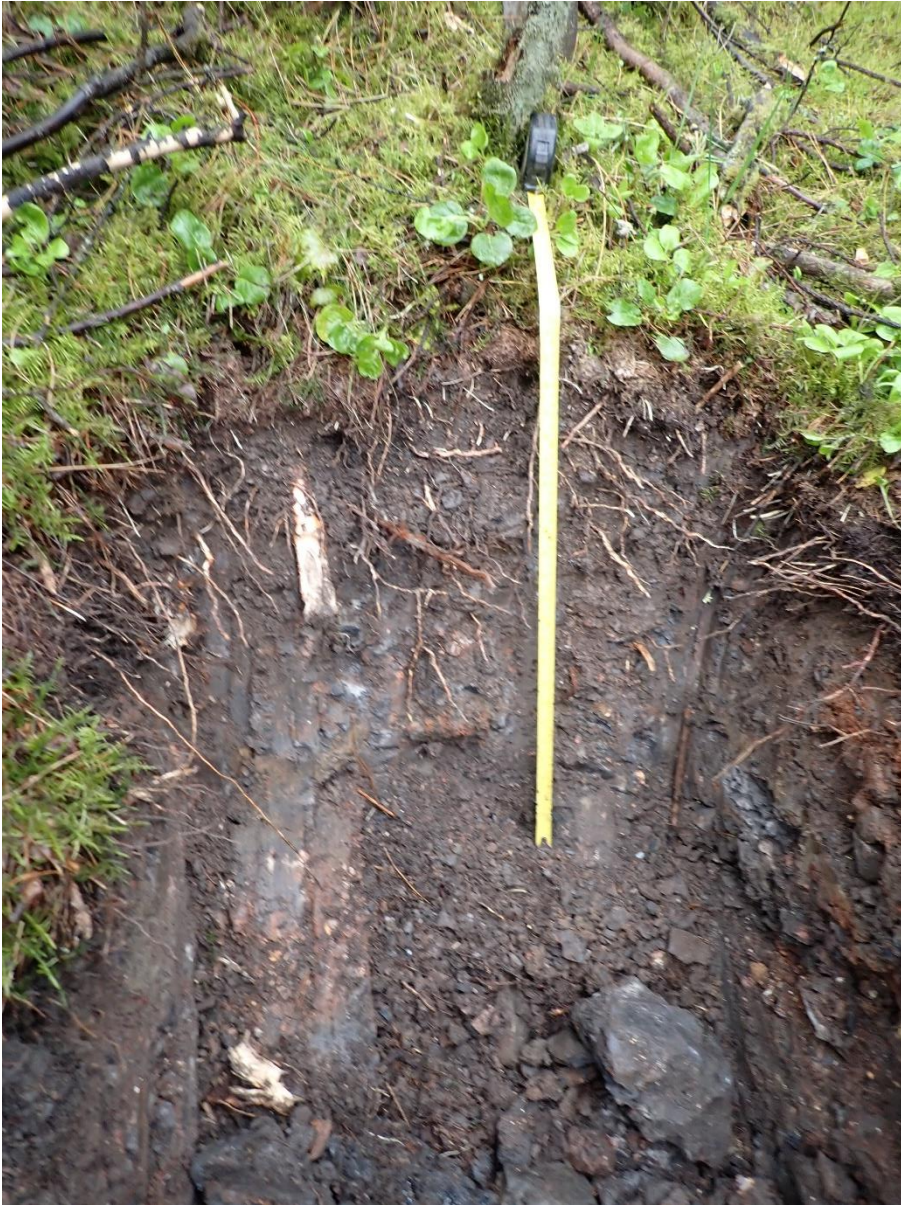
Soil Pit 3 – 281908 E 211935 N

Depth cm	Description	Horizon
0-1	Moss/Litter	L
1-3	Dark Brown Humic / Stone Free	H
3-10	Sandy Clay Loam / Stone Free / Grey Shale	Ah
10-70	Clay Loam / 20% Large Stones / Grey Shale + 30% Red Burnt Shale	C

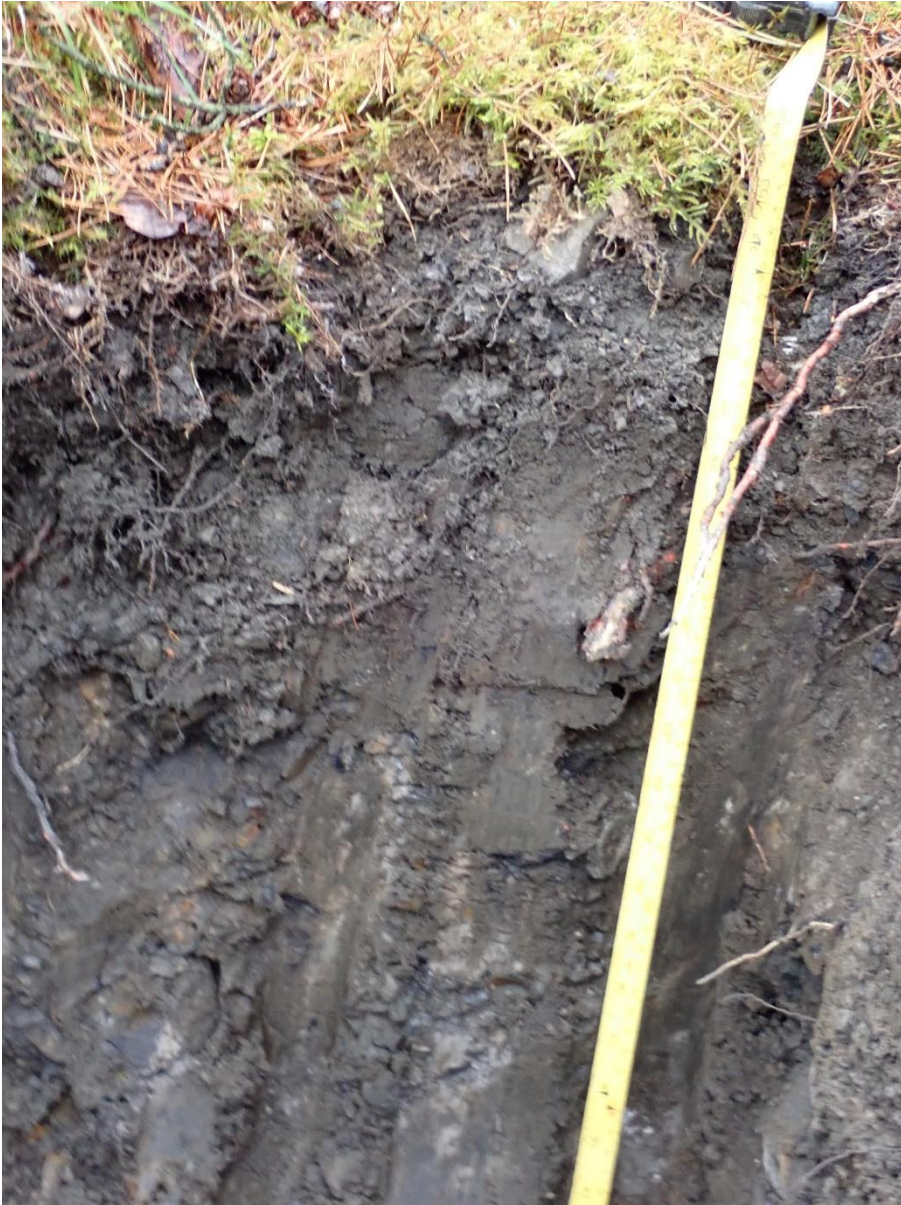
Soil Pit 4 281891 E 211897 N

Depth cm	Description	Horizon
0-1	Moss/Litter	L
1-3	Dark Brown Humic / Stone Free	H
3-20	Heavy Clay Loam / Stone Free / Grey Shale	Ah
20-90	Heavy Clay Loam/Clay / 50% Large Stones / Grey Shale	C
