Norman Shaw North Standalone Heritage Impact Assessment

# **3** Site Survey Descriptions

# 3.2 The Building Externally

# 3.4 The Building Internally

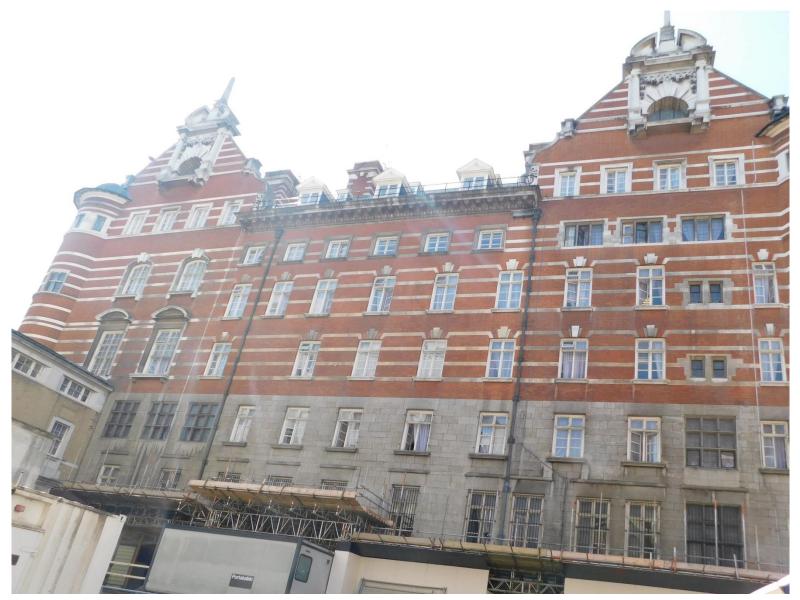
37. North Exterior Elevation

- 3.2.4 The fenestration to the red-brick and Portland-stone upper storeys largely comprises original four-by-two regularly-spaced timber casements, with large Portland-stone keystones. The top floor has architraved three-by-two squat casements. The two original windows closer to the east tourelle are more in keeping with the grander windows of the east elevation as they are pedimented at second-floor level and have segmental arch topped shouldered architraves on the third floor. Between the two gabled ends, there are three original dormers at fifth floor level, to the centre of the tiled roof. They have original painted timber casements with leaded lights. Smaller and simpler dormers are positioned above them at sixth-floor level.

- 3.2.5 The original corner tourelles, also in banded red brick and Portland stone, have original stone framed windows (mullioned at second- and fifth-floor level, and mullioned and transomed at fourth floor) that are fitted with leaded lights. The tourelles are surmounted by original cupola domed roofs with finials and wide projecting eaves over a simple cornice. The bases of the tourelles are deeply corbelled and decorated with mouldings of various profiles, including egg and dart. There is an original single-storey blind wing projecting to the east and facing the Thames, built of granite with a simple cornice.

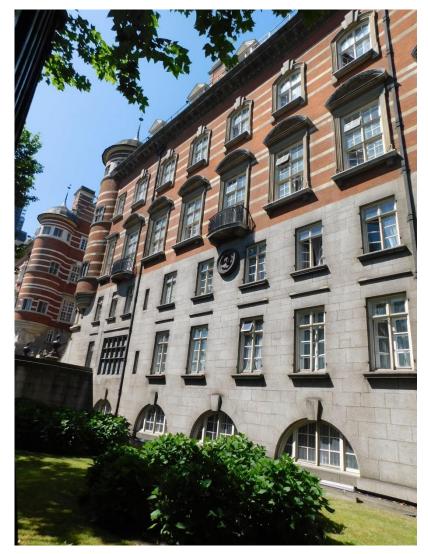
38. East Exterior Elevation

- 3.2.13 The safety railing over the cornice at parapet level are original, but the railings to the cornices over the lower projection blocks are modern, as are the grilles to some of the windows.

- 3.2.14 The gates and piers between Norman Shaw North and Norman Shaw South buildings, erected to the south of the building in 1904 in association with the new building, are also original. The heavily corniced and rusticated granite piers and granite gates are by Norman Shaw, but the central gates in wrought iron are by Reginald Blomfield. Each pier is surmounted by a cast-iron globe lantern. The gate and brick piers to the north of the building along the Embankment belong to the 1940 Curtis Green building.

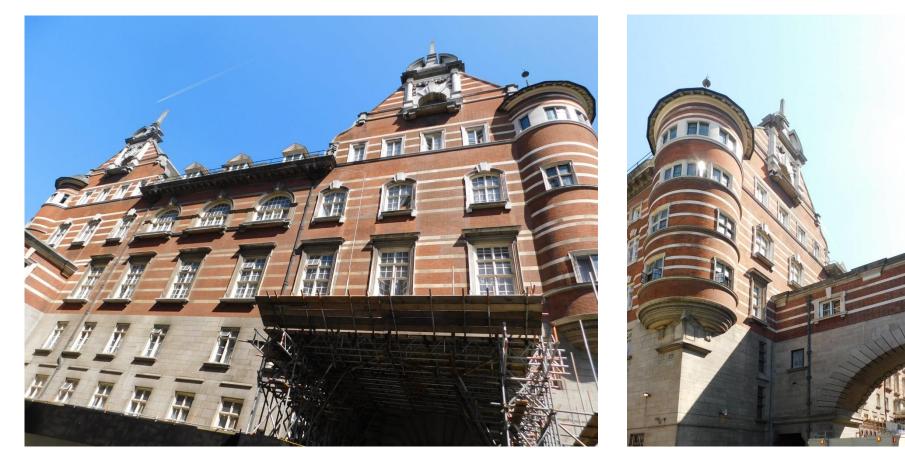
40. South Exterior Elevation

- 3.2.16 The main entrance has an original storey-high flight of granite steps, reached through a large semi-circular arched portal with a rusticated surround and engaged rusticated columns supporting a large broken segmental pediment housing an original decorative cast-iron railing to the first-floor balcony [plate 40]. The entire entrance is carved in granite matching the three-storey base. The upper storeys are of red brick with Portland-stone banding, surmounted by a modillioned composite cornice in Portland stone, spanning between the two gables.

3.2.21 The corner tourelles are consistent in their architecture, as described in the north elevation [plate 41]. There are two original lead downpipes on the façade with original hopper heads with the date '1889' inscribed on them.

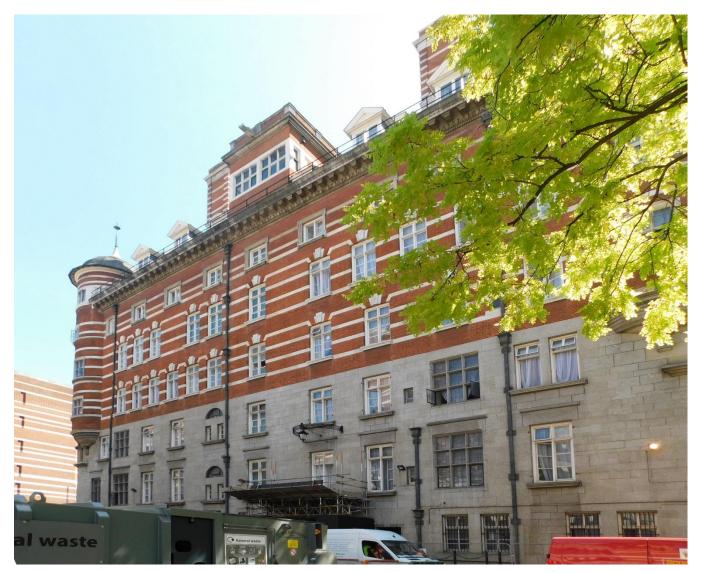
42. West Exterior Elevation

- 3.2.25 The corner turrets are as described previously. The tall roof is articulated with two pedimented dormers flanking a central flat topped tower with stone mounted leaded light casements, which although a departure from the original design, appears to be original.
- 3.2.26 Two further levels of diminishing dormers are higher up and two chimney stacks as on the east elevation finish off the roof. There are three main original downpipes complete with dated hopper heads. To the northwest corner there is a modern, giant stepped granite pedestal, likely contemporary to and facilitating level changes to the adjacent Richmond House, completed in 1987.

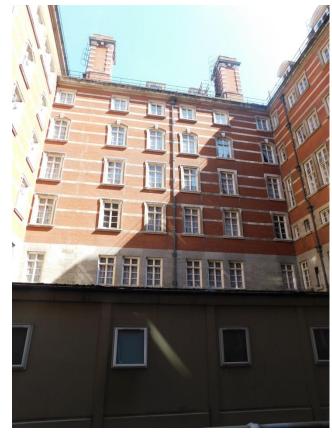
43. North Courtyard Elevation

- 3.3.1 This original elevation of seven storeys has retained its original fenestration above the lower ground floor [plate 43]. It is built in granite up to the first-floor level and red brick and Portland-stone bands above. At the lower-ground-floor level, the original large segmental headed door openings had been fitted with modern slatted doors and screens [plate 44]. The extreme western door is also a modern replacement, but the eastern one is an original panelled door, with later alterations, including wired glass and a kick panel. Modern bike racks to the centre and modern rails to the eastern corner. Railings to the western corner, surrounding a glazed brick stairwell appear to be original.

- The windows at ground and first floor sit within the granite base 3.3.2 and are original painted timber casements wither operable lights above and granite sills. Within the red brick from second to fifth floor, the original painted timber casements are consistent in size, with Portland-stone cills and shouldered architraves, but the windows to the fourth floor have the addition of an arched head and keystone. There is a single central window to the fifth floor, the arrangement breaking with the symmetry to the three floors below, with a pair either side. Some windows have had modern vents fitted to the glass. There are two original dormers to the pitched roof, above an original simple stone cornice. Modern security lights and services fixes at lower level. Modern paving and cast-concrete step to perimeter, in addition to a ramp at the eastern end. There is a modern concrete ramp to the eastern corner with modern metal railings. Metal grills to perimeter serving basement lightwells appear to be original.

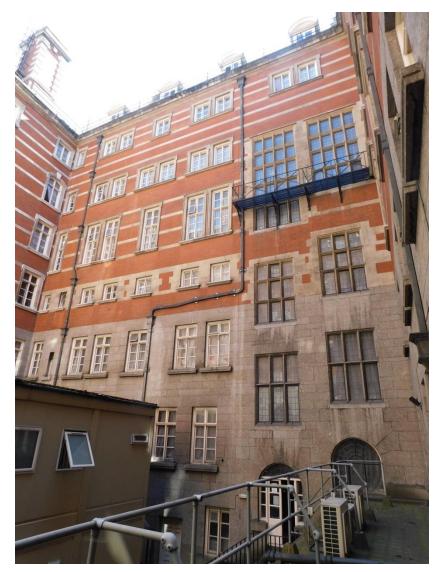
45. East Courtyard Elevation

- 3.3.6 The windows at ground and first floor sit within the granite base and are original painted timber casements wither operable lights above and granite cills. Within the red brick at second floor, there is a run of smaller original timber casement windows within Portland-stone ashlar, creating a band across the elevation. The windows to the third, fourth and fifth floor vary in size but are consistent with their details; original timber casements, those to the third with operable lights above with Portland-stone cills shouldered architraves. The windows to the fourth floor have the addition of an arched head and keystone. Some windows have had modern vents fitted to the glass.

- 3.3.7 There is an original simple stone cornice to the brick parapet and a railing over. The tall slate roof has four original dormers with arched pediments and leaded lights fitted to timber casements. There are two original downpipes from cornice to ground, with hoppers on the front bearing the date '1889'.

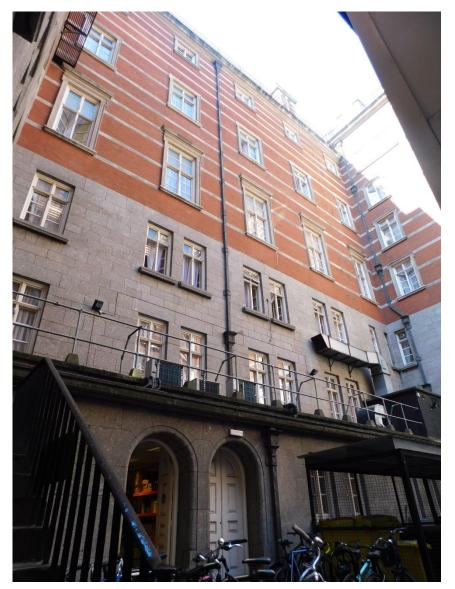
46. South Courtyard Elevation

- 3.3.9 To the projecting single-storey structure at lower-ground level, there are modern glass pavement lights to the flat roof of the single-storey projection, set into concrete, with modern railings and plant and an asphalt ledge to the original stone cornice. There is a large modern plant enclosure to the western end of the flat roof. At ground level, the opening to the west of the singlestorey structure is original, with an original door and architrave. To the east the two openings appear to be original but deviate from the arrangement shown on the original archive drawings, with modern architrave and door matching the door to the west. The window joinery at courtyard level, although of some age, does not appear to be original. As seen elsewhere to the base of the courtyard elevations, the metal perimeter grills appear to be original set in original York paving with modern concrete infill.

3.3.10 At the top of the main elevation, there is a simple stone cornice and a tall pitched slated roof with two original dormers, one of which includes a modern timber access ladder. Two brick chimney stacks spring on either side of the dormers. In brick and stone, they are original with modern access ladders. Modern access hatches have also been inserted near the ridge.

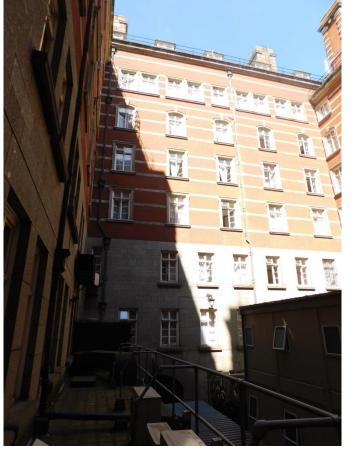
47. West Courtyard Elevation

3.3.11 The parapet line of this elevation rises higher than the other three courtyard elevations. Seven storeys high plus two attic storeys in the roof, this elevation is built in granite up to the first-floor level and red brick and Portland stone bands above [plate 47]. The original windows in the granite base are all plain timber casements with giant granite lintels throughout and giant projecting granite sills. The access passage opening at the southern end is a segmental arch with a projecting keystone [plate 48]. The ground- and first-floor sills are moulded. The original windows in the brick and stone section all have moulded shouldered stone architraves. The original fourth-floor windows have segmental arched heads with giant keystones. There is a single central window to the fifth floor, the arrangement breaking with the symmetry to the three floors below, with a pair either side matching the adjacent north elevation. The original windows have timber casements with Portland-stone cills and shouldered architraves. Some windows have had modern vents fitted to the glass. A simple cornice sits at the base of the roof, which is in green slate as elsewhere and has five original lead clad and corniced dormers. The lower-ground-floor windows have iron grilles of an uncertain date. Two original downpipes bear the date '1889' on hopper heads.

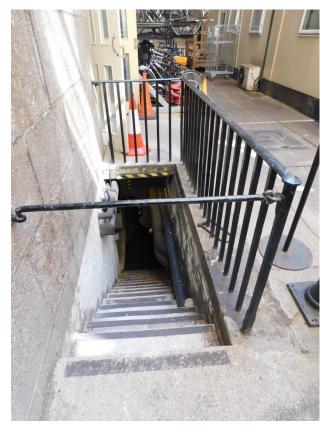
50. Original steps and railings to basement

3.3.13 An original external space with later alterations to the original external paving, although areas of original granite paving, verge stone and grills to the basement are still visible. The courtyard space is much compromised with modern porta cabins and storage cages. Extractor units, modern bollards, bike storage and general waste clutters the space. There are original steps in the northeast corner leading to the basement with original railings [plate 50].

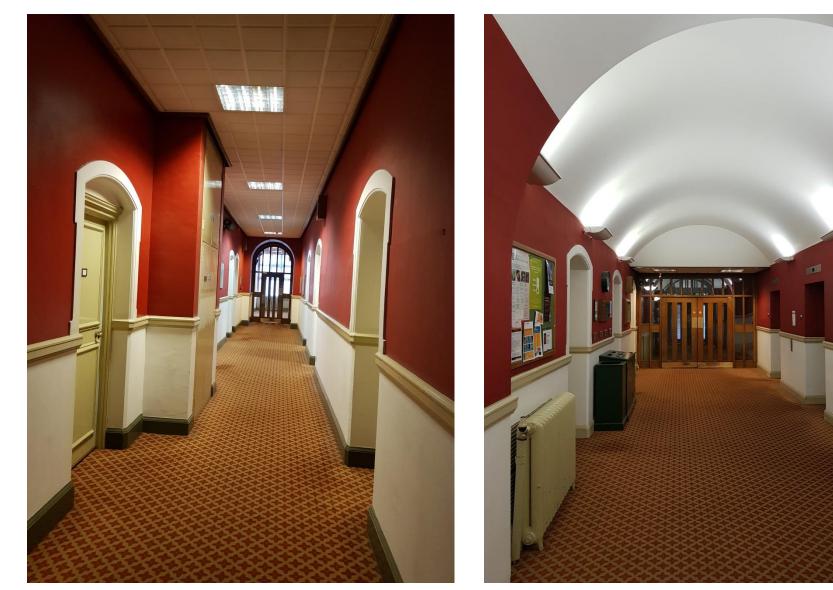
57. Corridor GC3 looking south

3.4.36 Corridor with original barrel vault the length of the corridor and modern carpet throughout. Generally original plaster to walls, painted. Corridor flanked by two sets of c.1970 timber glazed doors with glazed overlights and bulk heads to original barrel vault [plate 57].

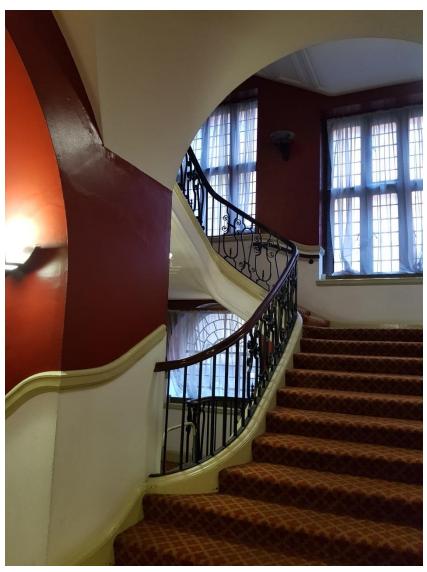
61. Principal staircase GST4

3.4.48 Original principal staircase to the southeast corner of the building. The staircase has original painted decorative metal balusters and a timber handrail. Original painted skirting and dado in the lobby continues up the stair flights, with a modern timber handrail to the perimeter of stairwell. The soffits to the flights above are decorated with original moulded panels. To the west, where the staircase rises, there are two original stone mullioned windows with original metal casements and painted sills [plate 61].

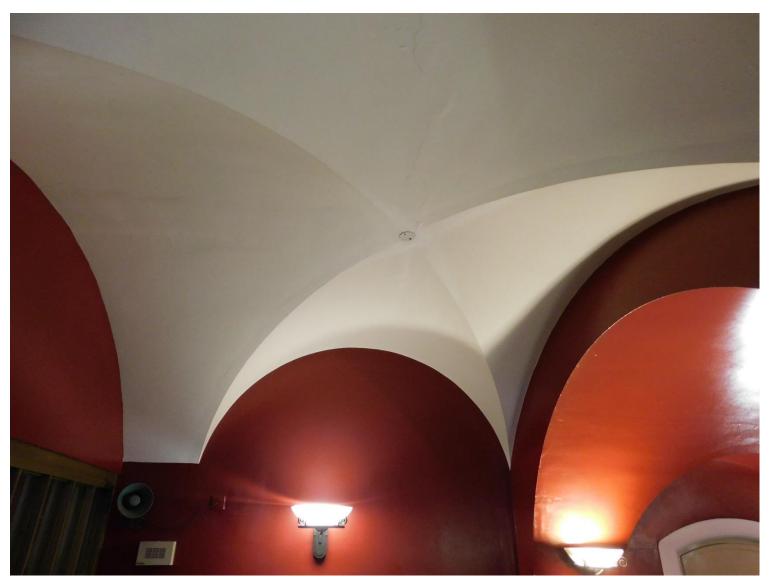
66. Cross vault to lobby of 1ST3

- 3.4.73 The lobby to the east of staircase has an original painted cross vault ceiling, with a barrel vault to the south [plate 66]. To the north and south there are c. 1970s timber glazed doors, with overlights and glazed panels. To the east elevation there is an original bolection double-panelled timber door with plaster architrave and plaster bead and chamfer, with an original arched recess above. Where the staircase leads to the ground floor, there are two original openings to the south elevation with c. 1970s timber windows. There is modern carpet throughout.

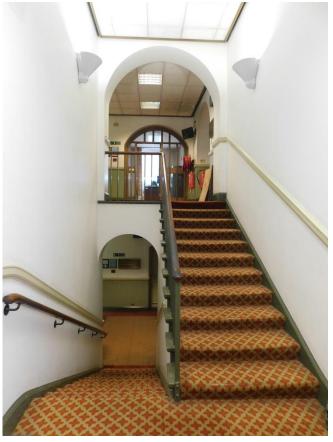
74. Staircase 4ST4

3.4.133 Original staircase to the east of the landing of 4ST1, accounting for a change in level and just serving the third and fourth floors. Original painted metal balusters and handrail that is consistent with those of 4ST1. The original string and dado continues from the landing above along the north elevation, wrapping around the landing and continuing down to the third floor. There is a modern handrail to the south elevation. There is a modern suspended ceiling and modern carpet throughout [plate 74].
