# TOWER BRIDGE

WALKWAY COVER SLAB REPLACEMENT

TRIAL WORKS WED 24<sup>th</sup> FEBRUARY 2021

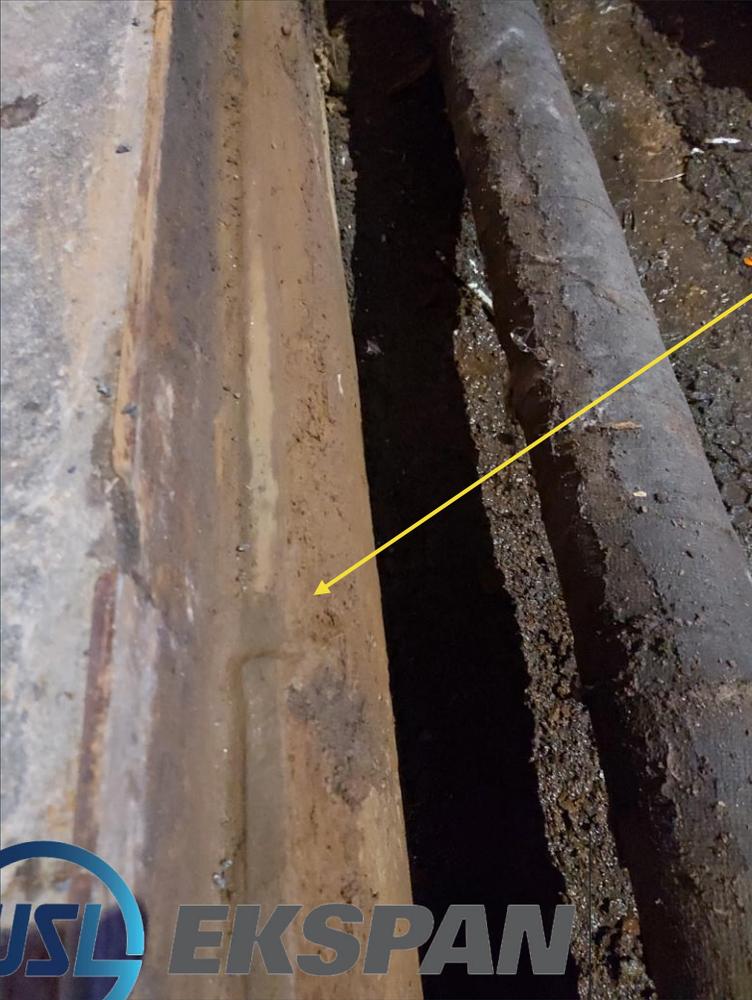
Slight high spots noted where existing bearing frame Sections meet each other

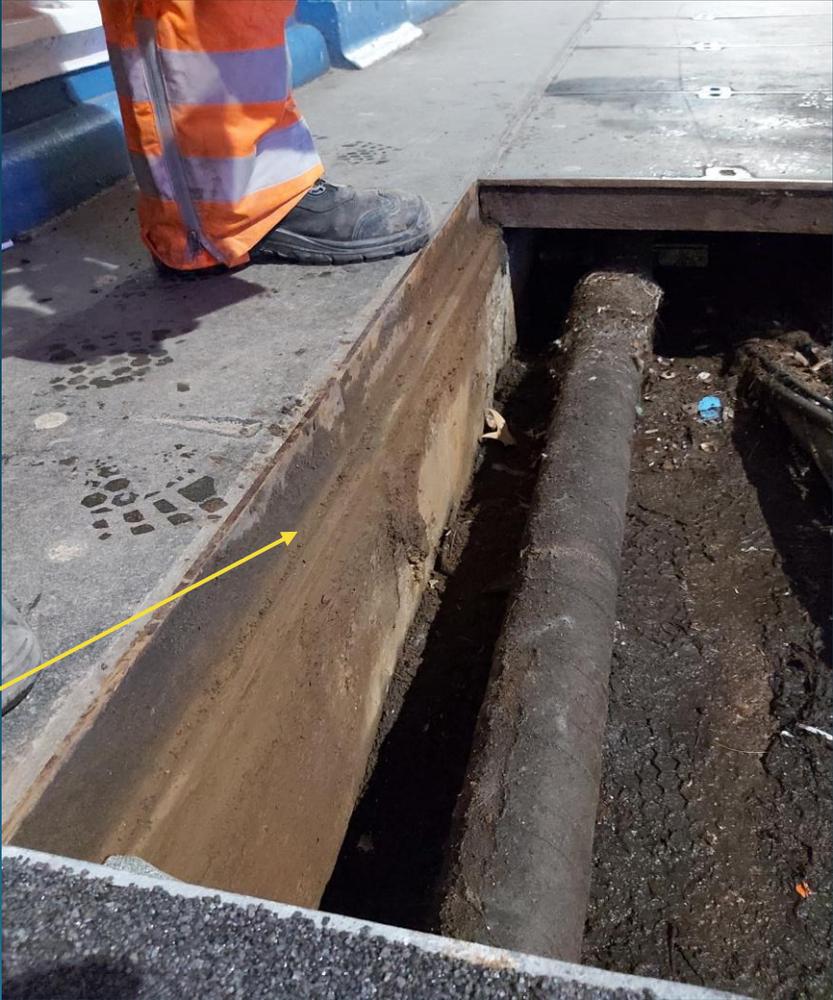
Bearing frame cleaned and prepared for new covers

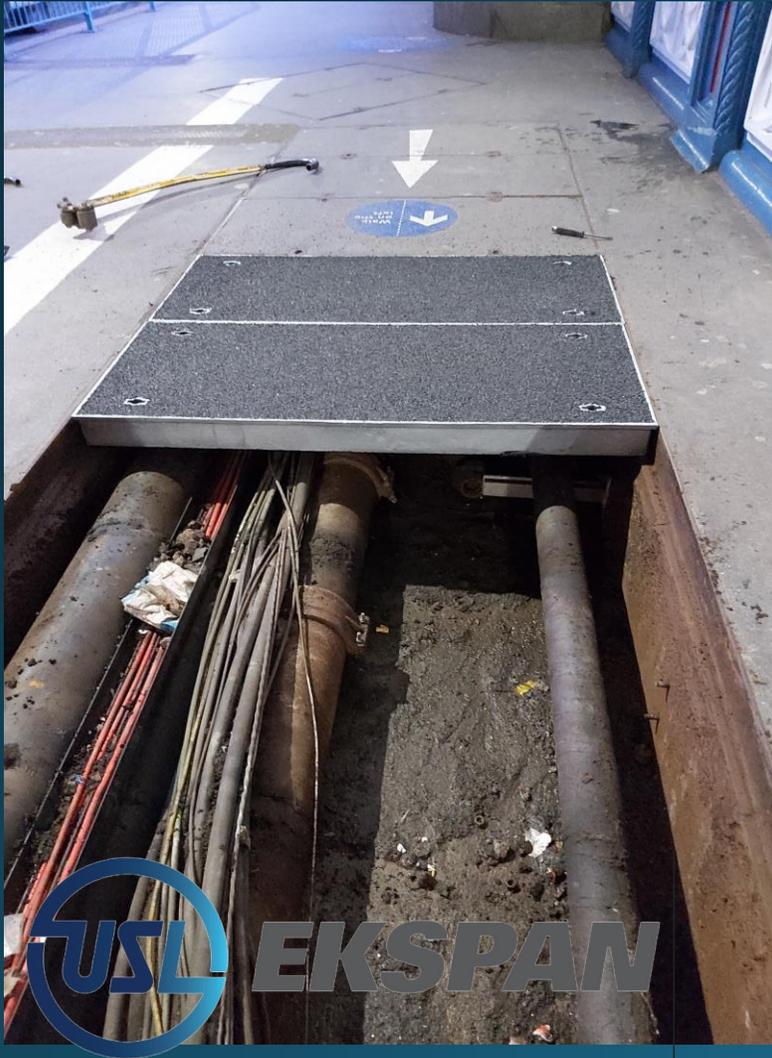
1275mm Dimension of new covers a good fit

80mm Depth dimension good fit into existing frame

Bearing area on frame good

No gaps between each panel

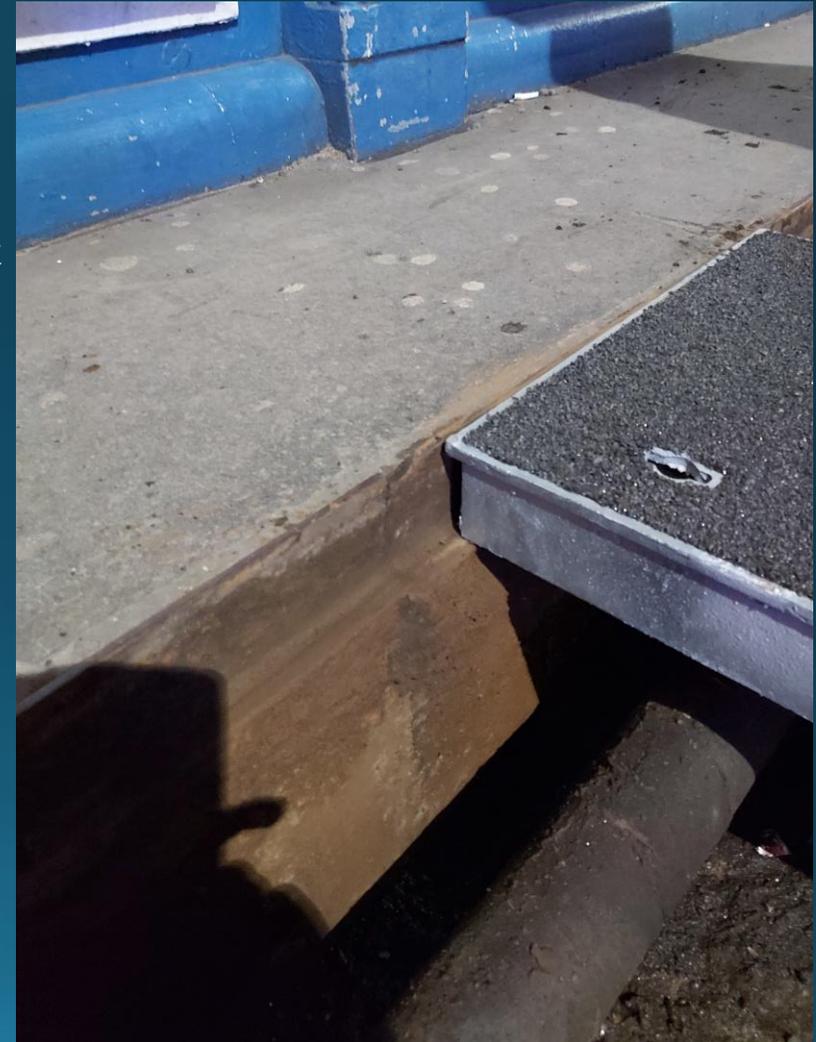
# All 5No New Covers in situ

5No Existing Covers Removed  
5No x 610mm Wide = 3050mm

6No New Lightweight DI covers  
Installed 500mm wide  
(500mm Wide selected to keep  
weight per panel under 50Kg)

6No x 500mm = 3000mm

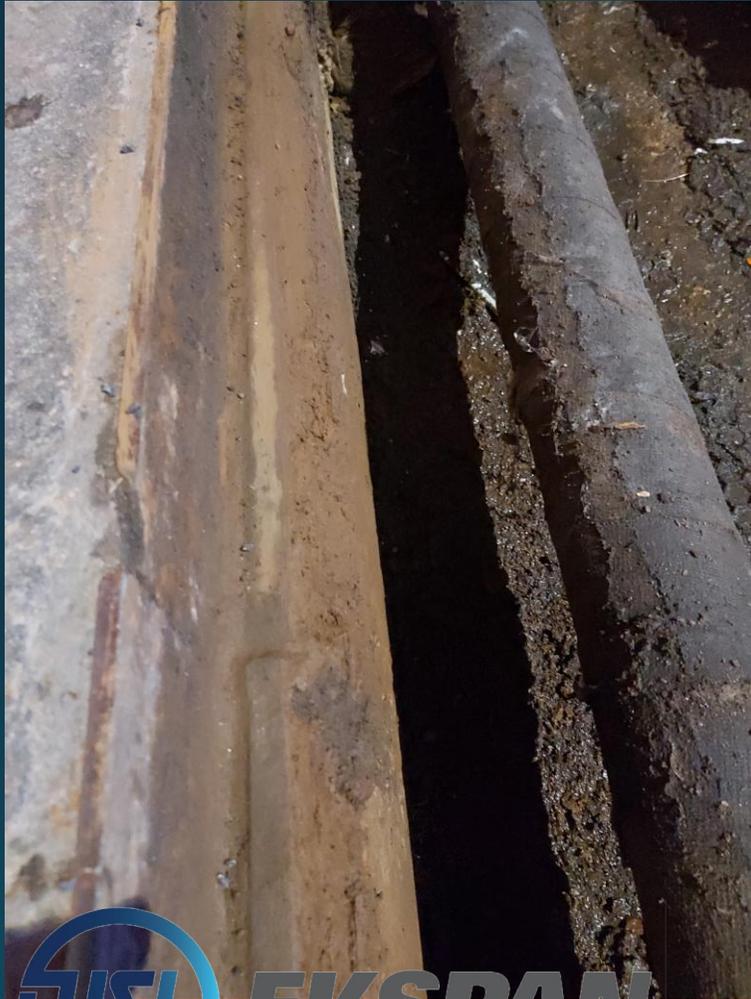
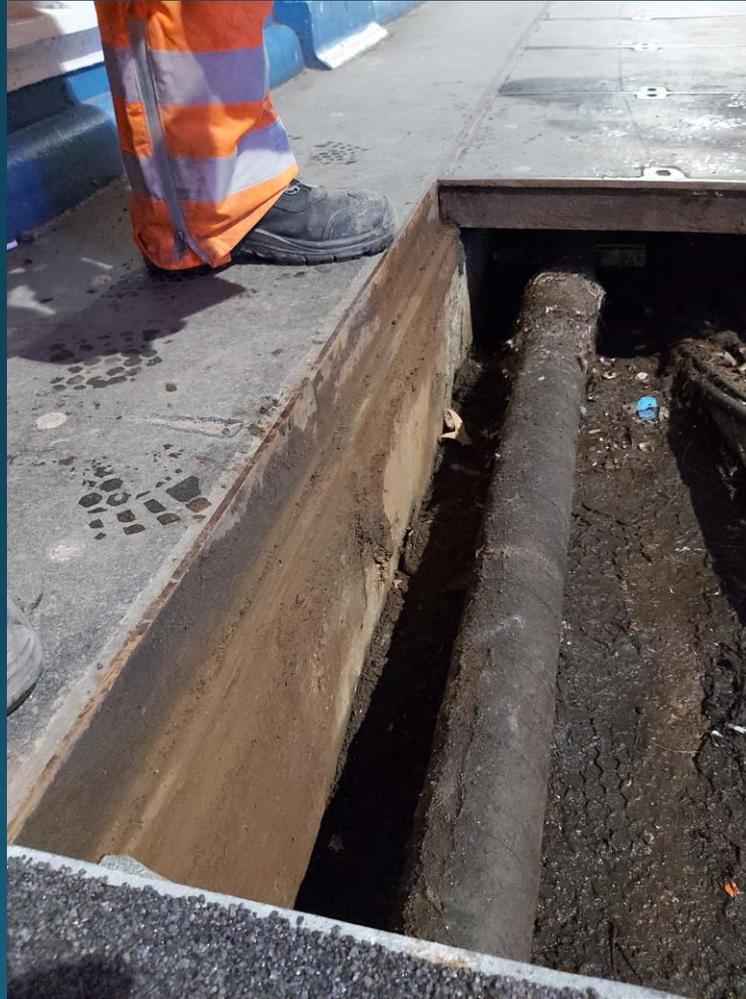
Generally the existing bearing frames are in very good condition.

Not loose nor showing any major signs of corrosion.

They provide an acceptable bearing angle for the new DI lightweight covers

Before installation of the new covers Ekspan cleaned up the bearing areas.

It was noted that slight high spots exist in some places where the 2No sections of frame meet each other

This explains why some of the existing covers do rock slightly

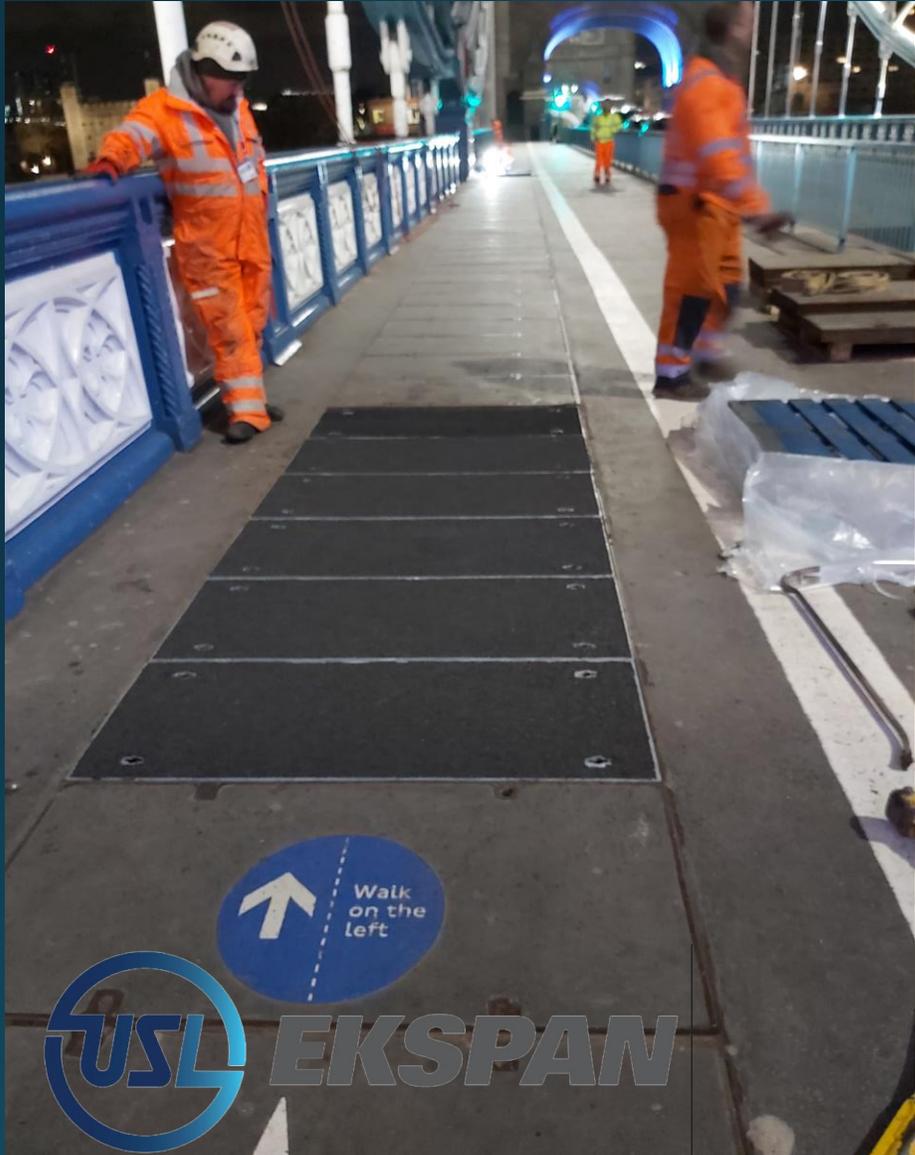
The length of the covers at 1275mm proved a good fit

The 80mm depth mirrored very well the depth of the existing covers

The 3/4mm recess also looked a good spec to accept the instagrip Anti skid surfacing material Ekspan had applied.

The trial over the coming weeks will no doubt prove whether the material can withstand the foot traffic on the bridge

We originally thought our lifting keyholes were a bit big but actually they seemed to be almost the same size as the ones on the existing covers.

At less than 50Kg each, we could reduce the lifting keys from 4No to 2No Removal of the covers will likely always be a 2-man lift and the client may consider that to keep the 4No lifting points better ensures a more balanced and safer lift for their maintenance crews

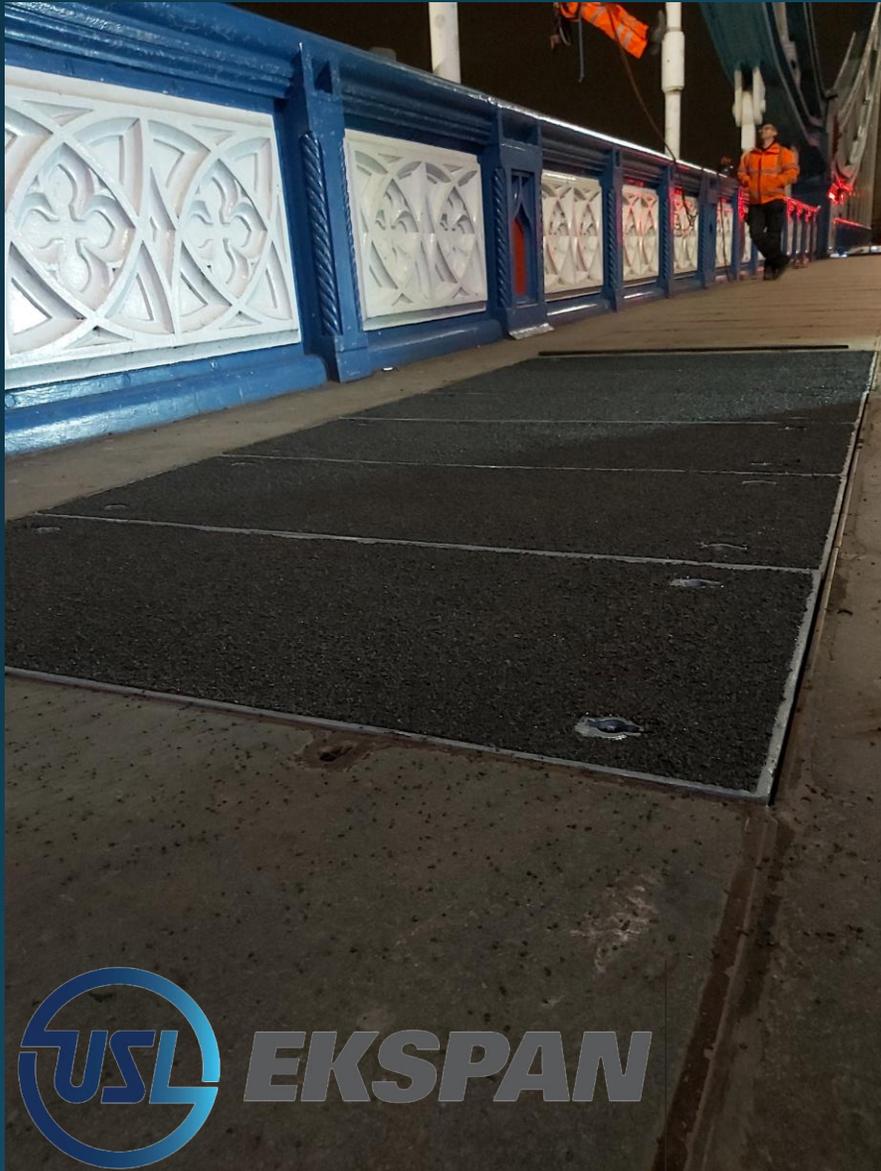
During the design period a request was made for the new covers to be Hot dip galvanised, this was carried out for the trial covers.

Hot Dip Galvanising on average provides between a 10 and 20 year protection to metallic materials (depending on location etc etc)

The new covers are made from Spheroidal Graphite Iron so will not actually corrode excessively, however any exposed surfaces once any transit coating (such as bitumen) has worn off will oxidize to a rust/orange type of colour.

The client can see the finish that galvanising the units will give to the walkway so it remains their choice what finish they would prefer should a decision and contact be awarded for the replacement of all the covers

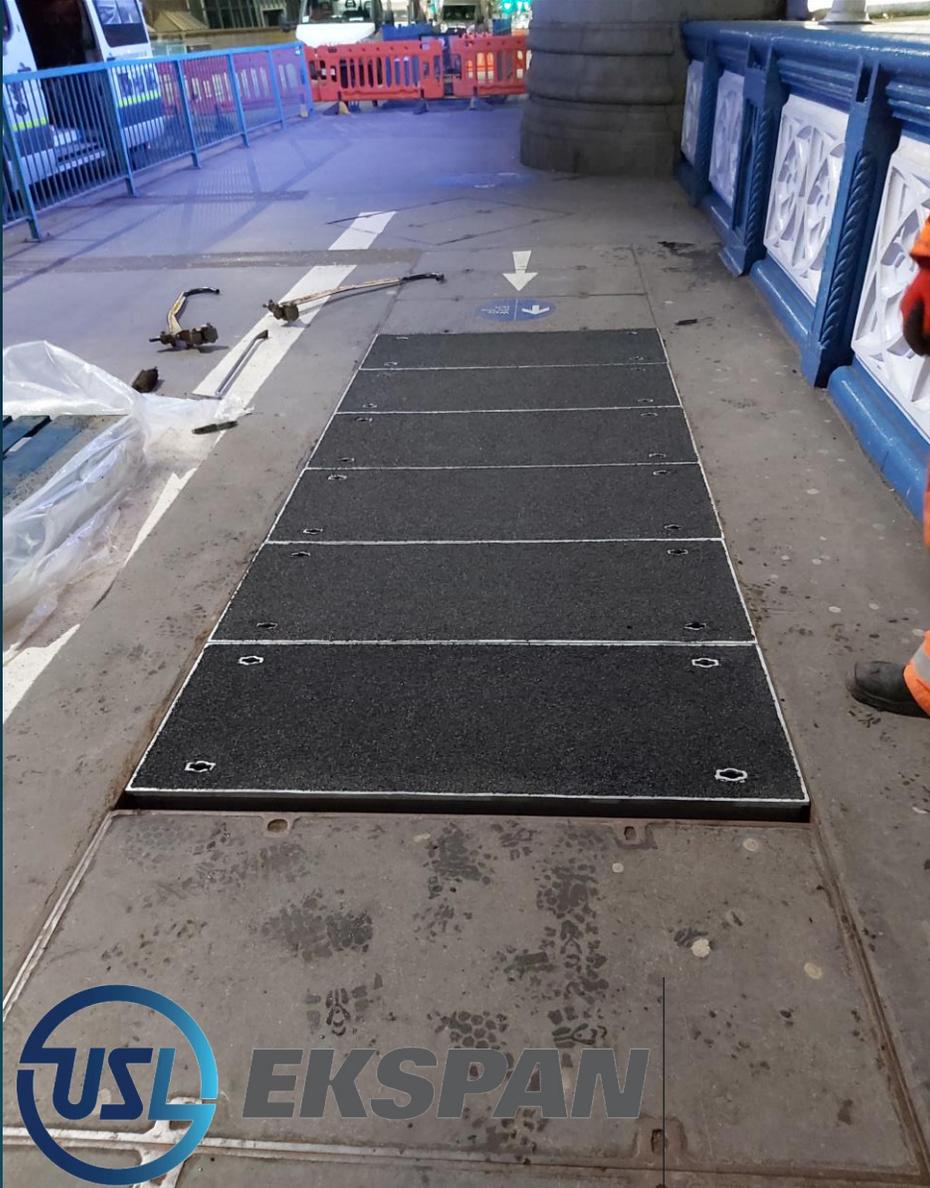
Consideration and thought needs to be given to the overall length of the existing covers installation and the new covers.

The existing covers are 610mm wide – The new covers were designed and manufactured to be 500mm to ensure a safe 2 man lift under 50Kg.

The existing covers are located in 4No separate runs over the deck  
A quick and approx. count on one of these runs came out at 127No covers  
 $127\text{No} \times 610\text{mm} = 77470\text{mm}$   
 $77470 / 500\text{mm}$  (Width of the new covers) = 154No 500mm wide covers  
Plus 1No make up piece approx. 470mm wide.

If an accurate survey/count could be done on all 4No locations then Eccles could manufacture all the required number of 500mm covers (inc any spares that the client may want) before we adjust one of the tools and manufacture the 4No make up pieces
