Document: Remediation Verification Report

Project: Needham Market Quarry

Reference No.: GN17820_RV22

VERIFICATION REPORT
FOR REMEDIAL ACTIVITY
AT
NEEDHAM MARKET QUARRY

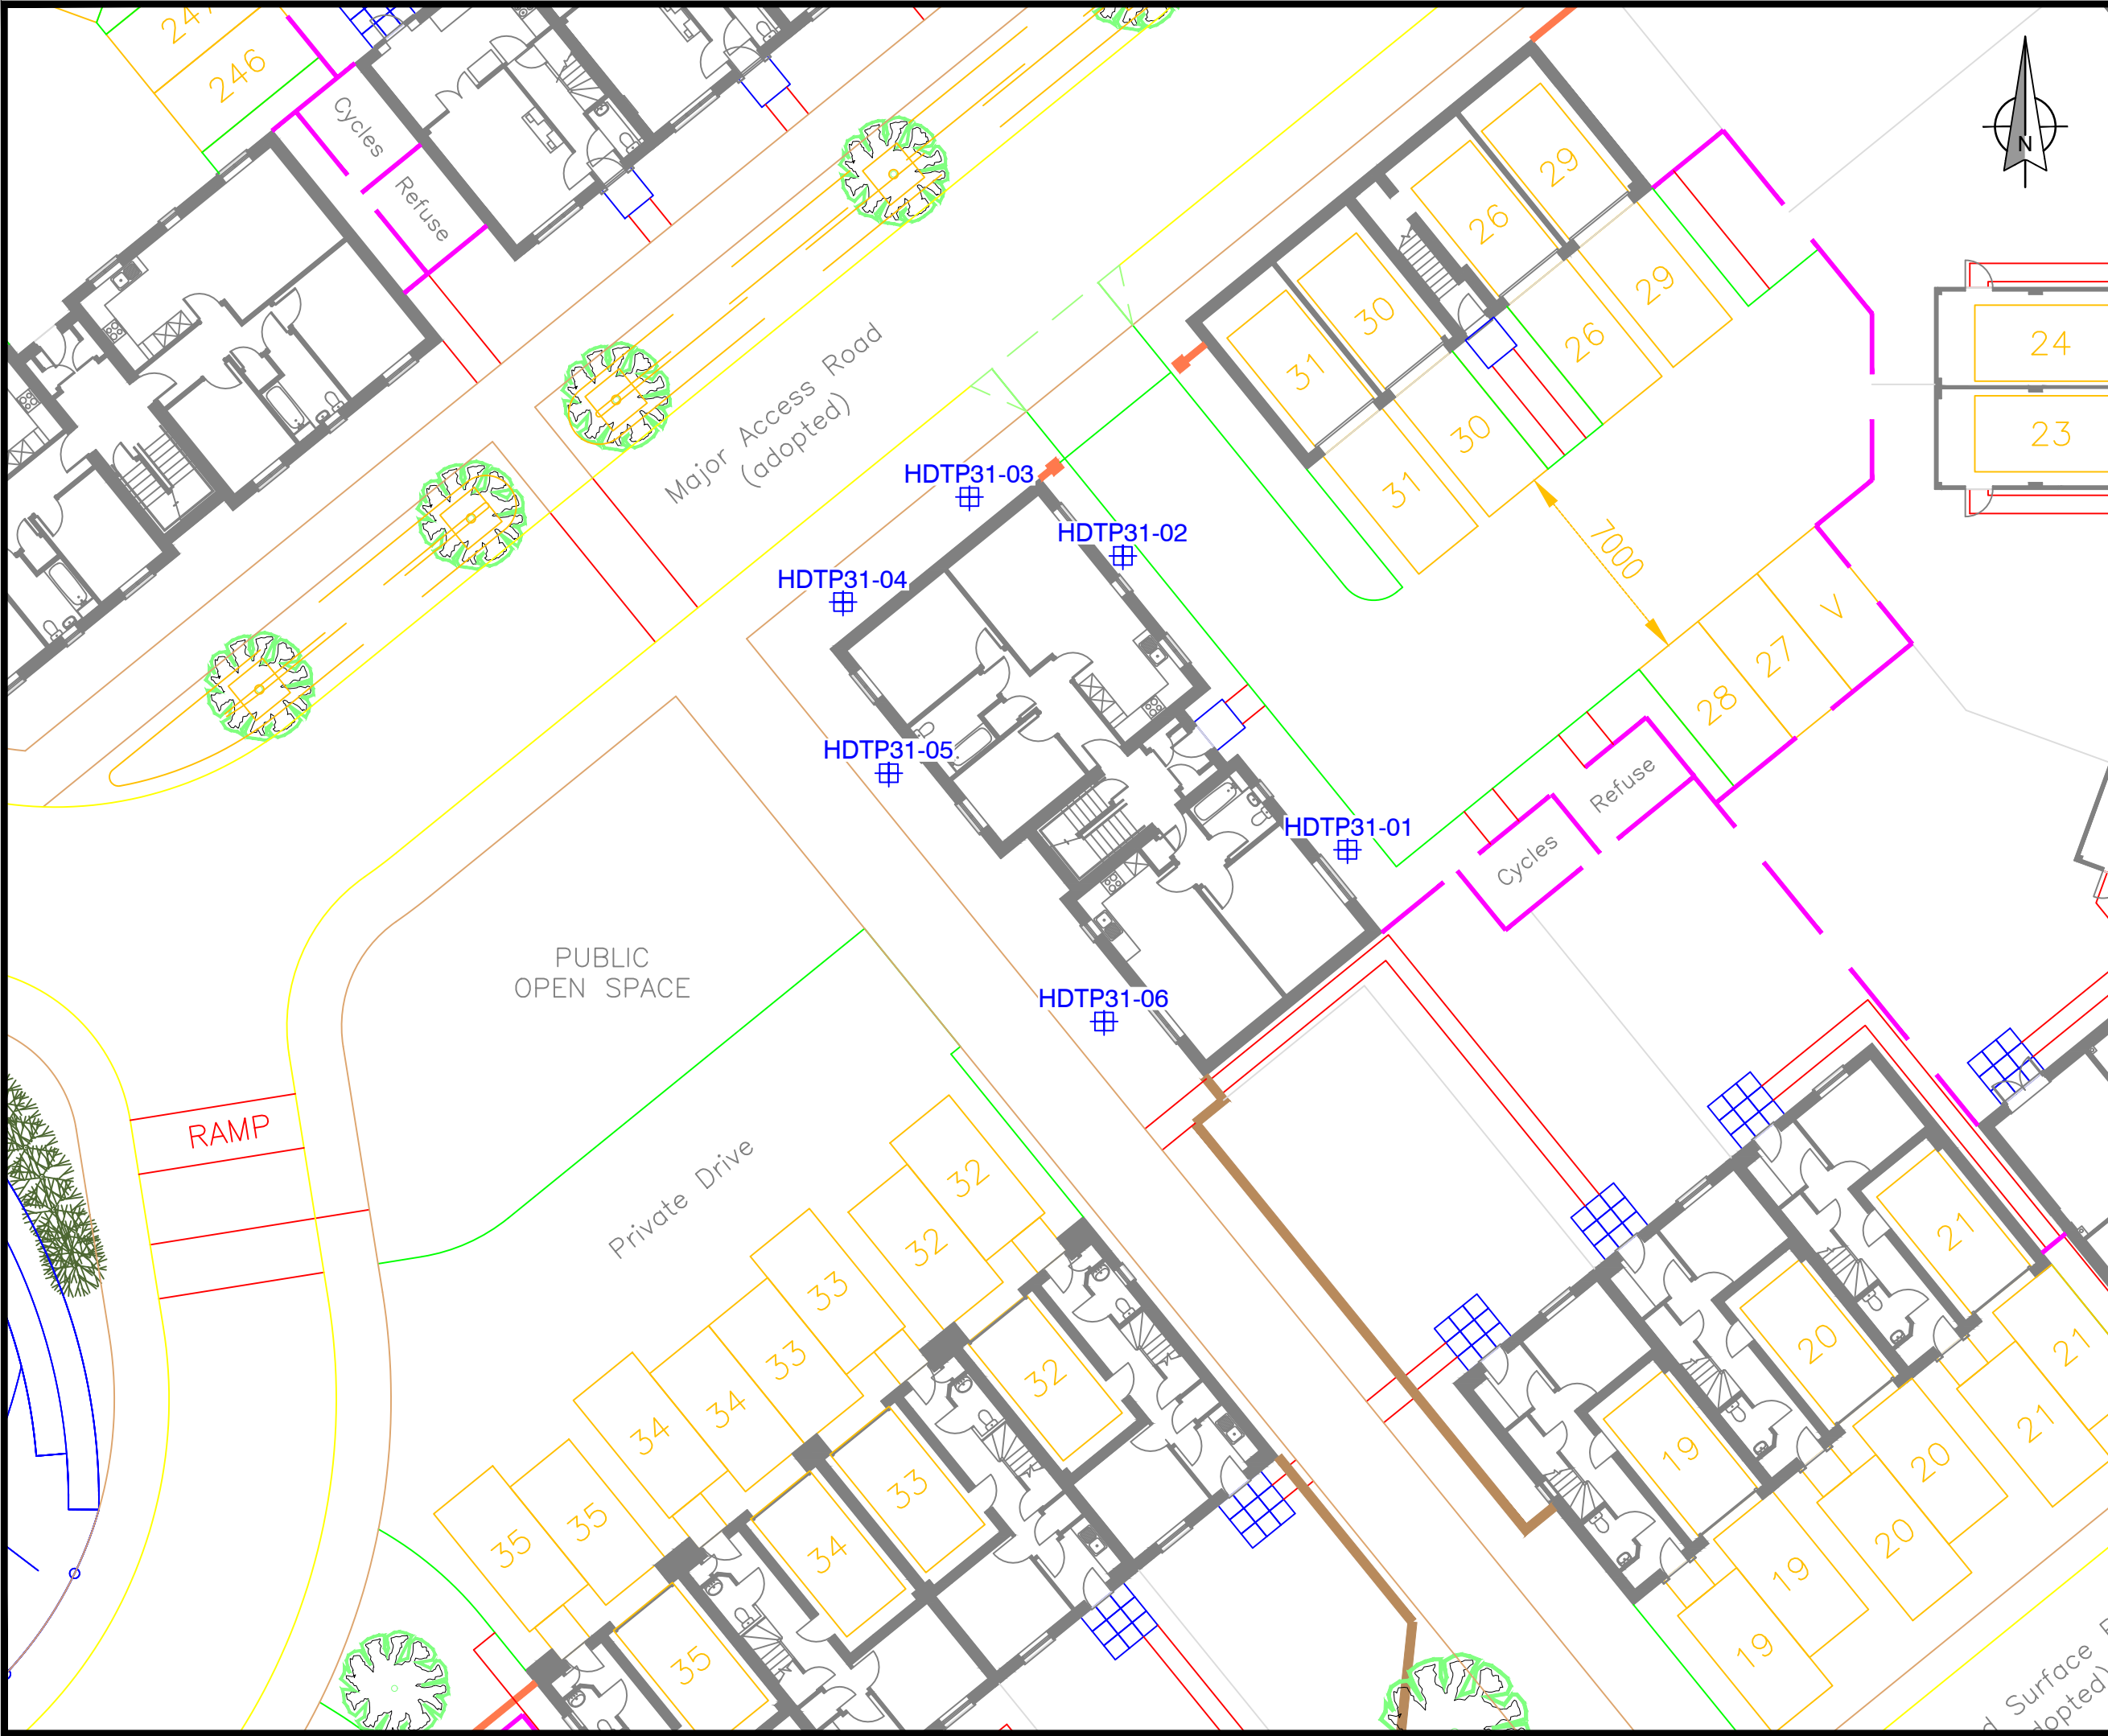
The fieldwork locations are shown on drawing GN17820-DR502ac included within the appendix. The trial pits were undertaken to record the thickness and physical descriptions of the materials present and to confirm material suitability.

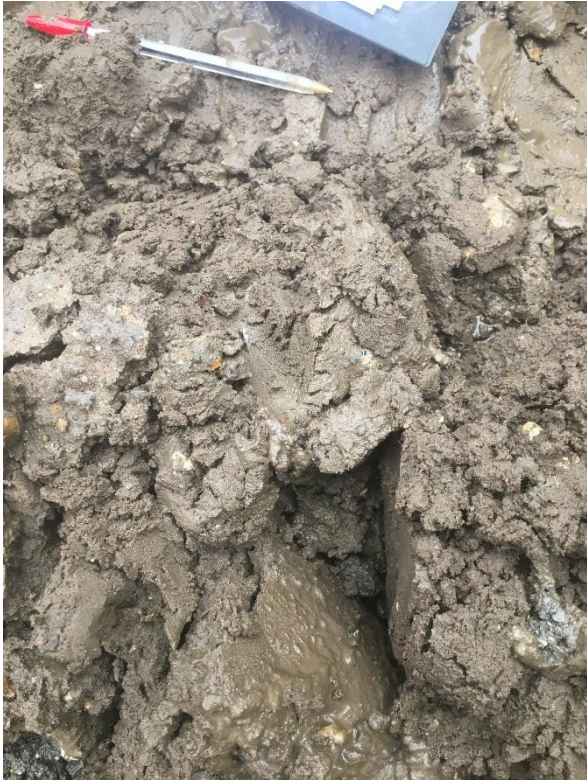
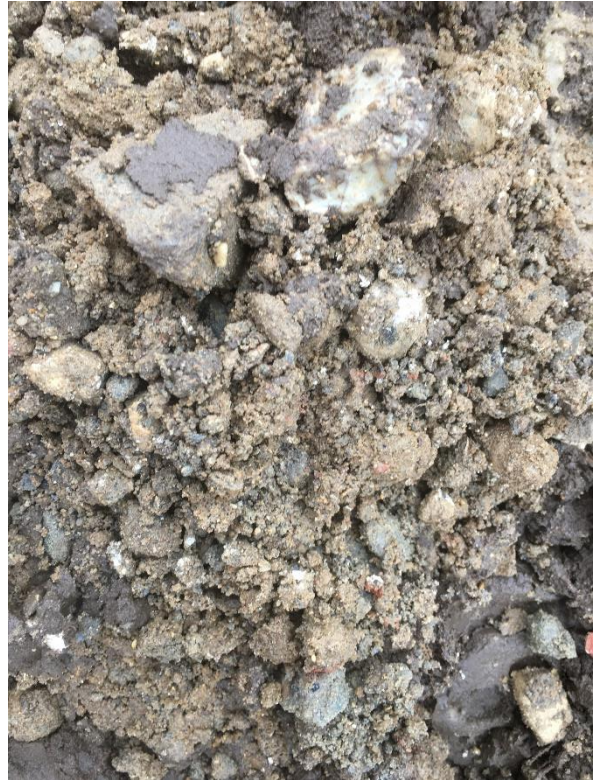
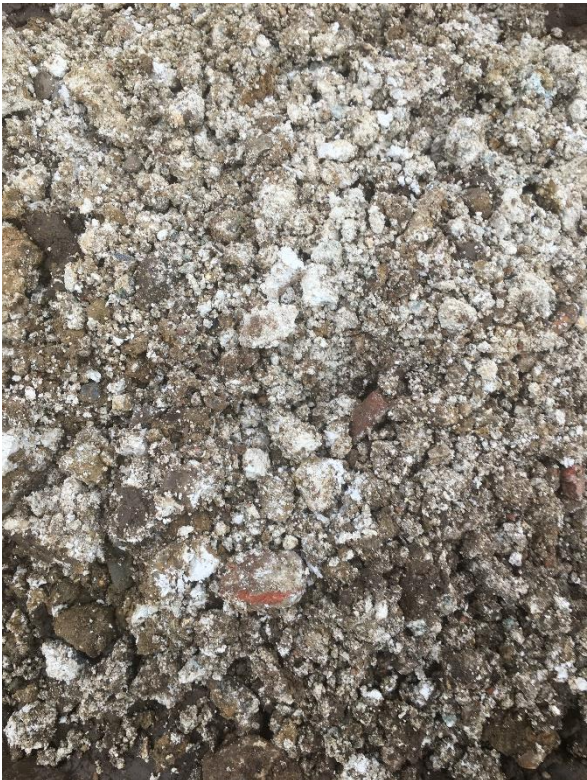
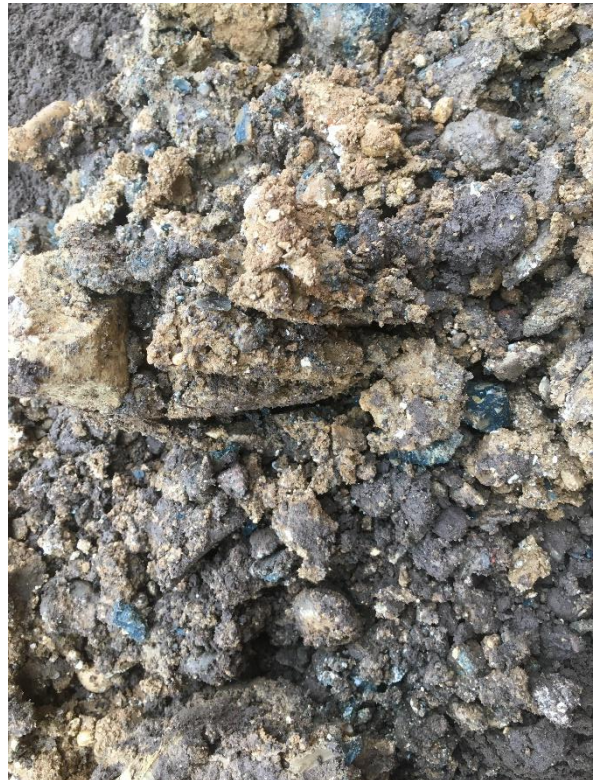
- Made Ground - light brown slightly sandy slightly gravelly silt. Gravel is sub-angular to rounded fine to coarse flint, chalk, and brick.
- Made Ground - yellowish white slightly sandy gravelly silt. Gravel is angular to sub-rounded fine to coarse flint, chalk and brick.
- Made Ground - soft orangish brown slightly sandy slightly gravelly clay. Gravel is sub-angular to sub-rounded fine to coarse flint, chalk, and concrete

During the verification works, the material was described as dark brown slightly gravelly silty fine to medium sand. Gravel is sub-angular to subrounded fine to medium flint. This recent description is generally consistent with the previous description, allowing for some variability, and therefore has been confirmed as the same material.

Photographs 1-4, taken on the 15th February 2021 showing the nature of the subsoil and topsoil within the soft landscaping around flats 27-31.

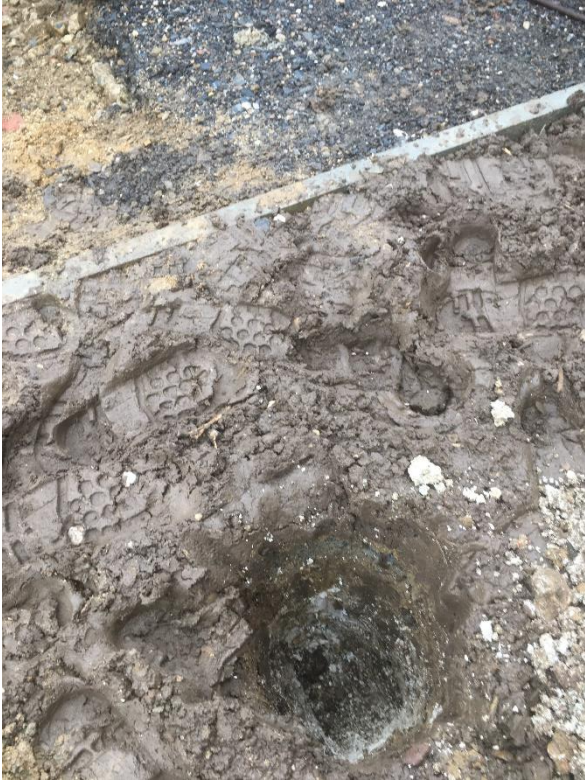
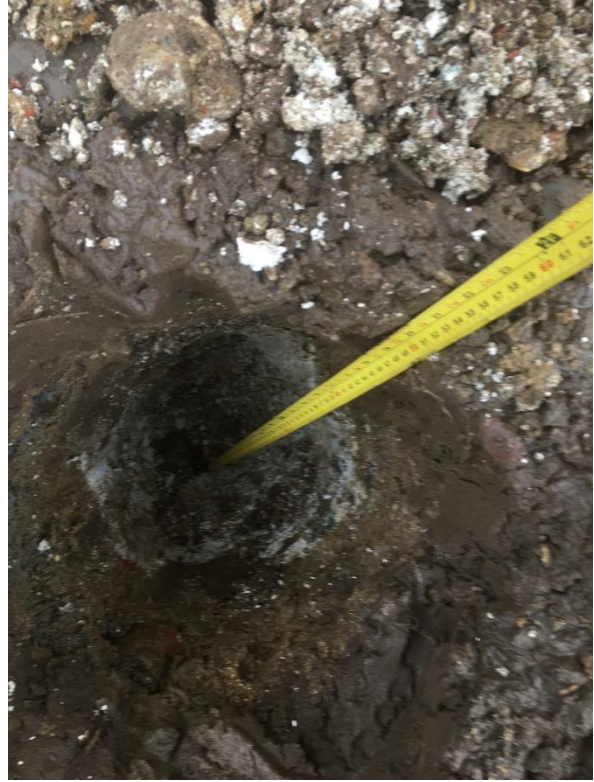
Photographs 5-6, taken on the 15th February 2021 showing an example of the hand dug trial pits undertaken in the soft landscaping surrounding flats 27-31.

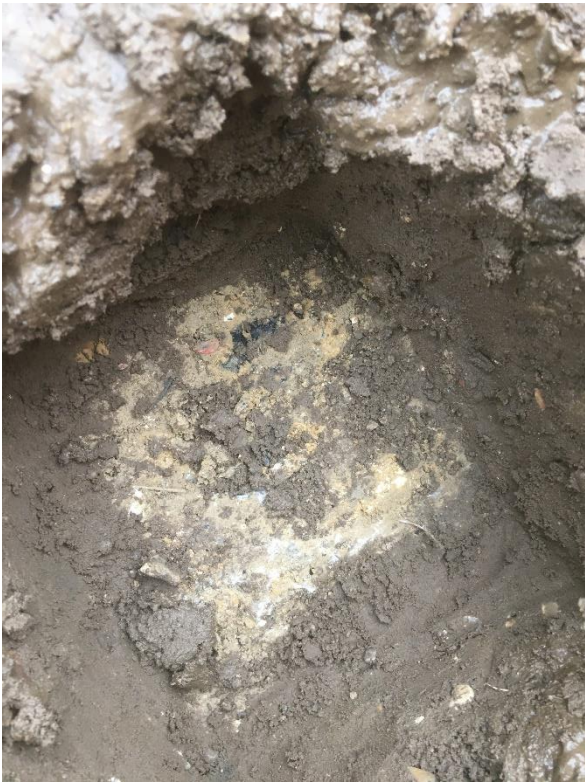
- A layer of concrete was encountered at the base of HDTP31-02 and HDTP31-03 at a depth of 0.35m and 0.15m respectively. This was likely to be associated with the concrete apron of the nearby driveway and paved area.
- Coarse concrete gravel was encountered towards the base of HDTP31-06, this was removed prior to backfilling.

Photograph 7, taken on the 15th February 2021 showing the Concrete apron encountered within HDTP31-03.

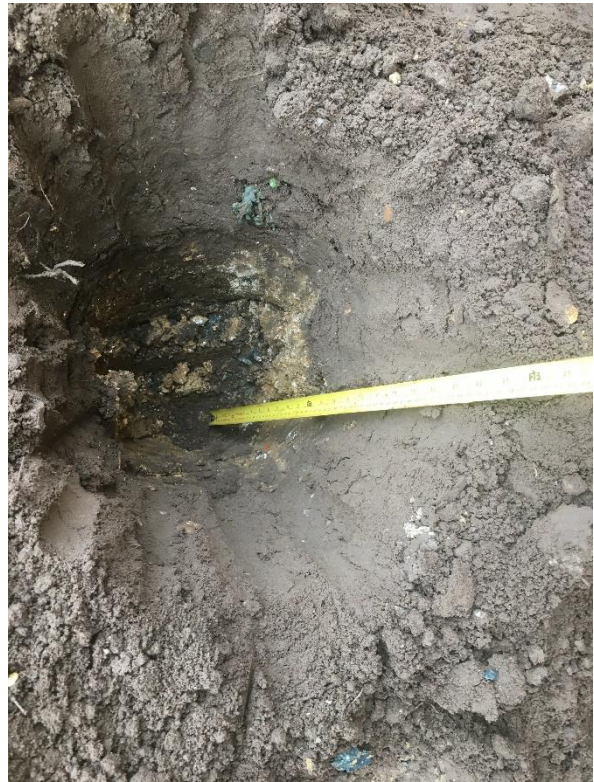
The thickness of suitable soil was recorded to be at least 600mm in three trial pits. Coarse concrete gravel was found within HDTP31-06. Whilst concrete is normally chemically suitable (provided the concrete is not contaminated), it is not physically desirable in a domestic garden, therefore this material was removed from the pit prior to reinstatement. Solid concrete was observed at the base of HDTP31-02 and HDTP 31-03 and is assumed to be part the concrete apron, on which the footpath and/or road is constructed. As this layer is necessary for the structures and appears to present no significant risk it is deemed acceptable to remain.

Photograph 8, taken on the 15th February 2021 showing HDPT31-06 following the removal of the coarse concrete gravel.
