**Document:** Remediation Verification Report

**Project:** Needham Market Quarry

**Reference No.:** GN17820\_RV14

**Date:** September 2019

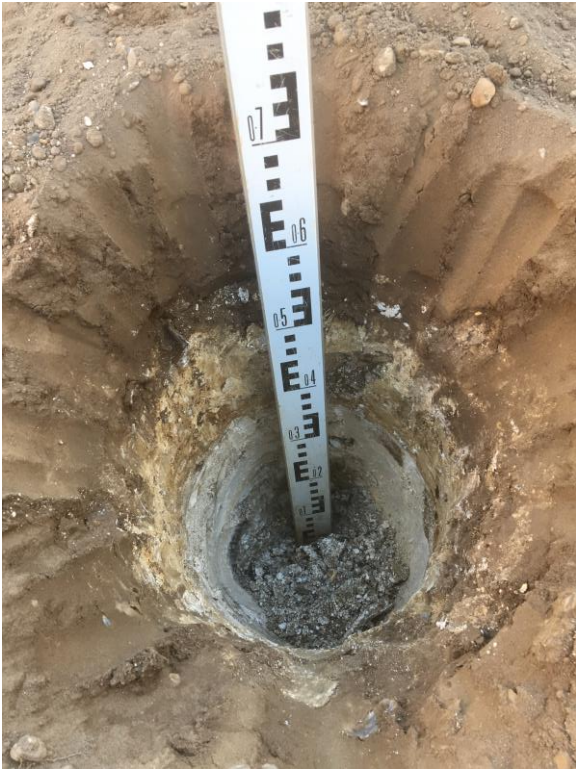
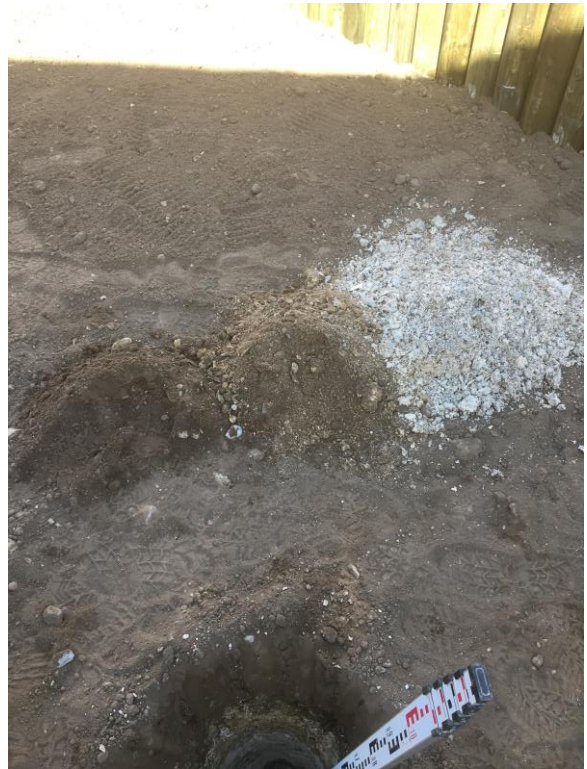
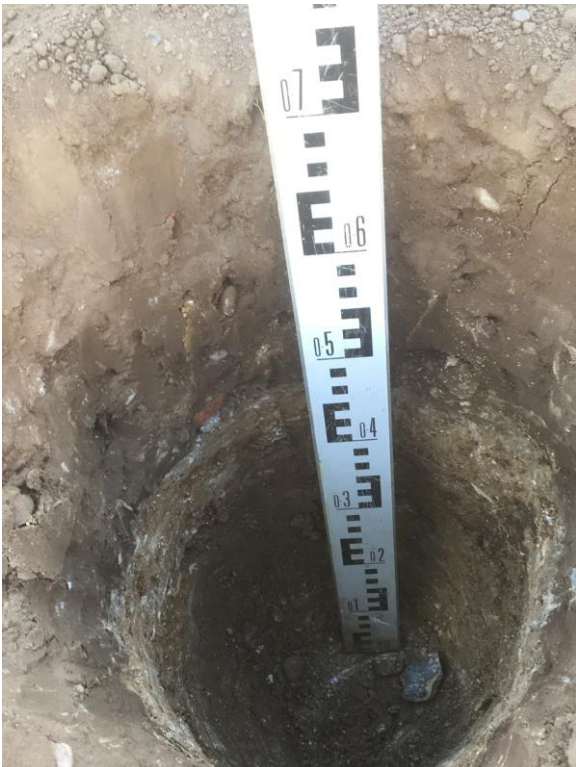
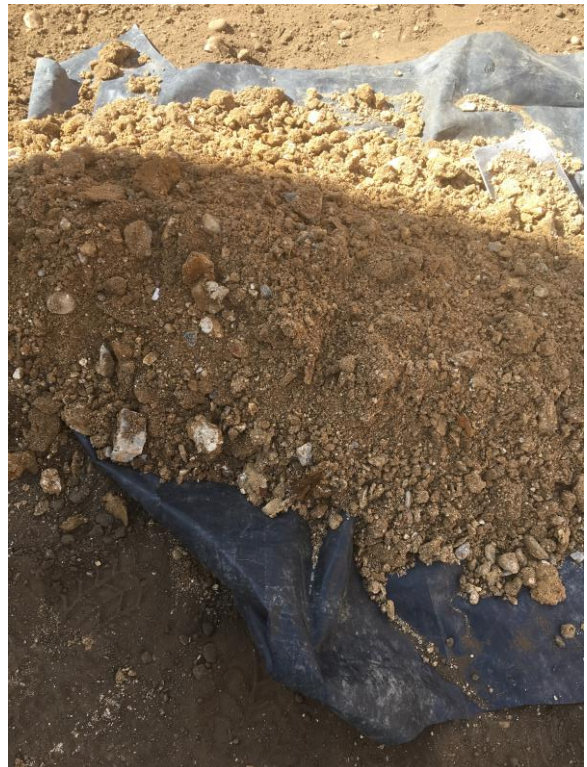
An engineer from HGE visited site on 02/09/19 to undertake hand dug trial pits within the front and rear gardens of plots 167 and 168 to confirm that suitable topsoil and subsoil was present in the gardens. During the visit, two main observations were made –

- Topsoil was yet to be put down in the front gardens of plot 167.
- A darker subsoil, with an appearance like that of previously identified unsuitable material, was logged in the back garden of plot 168. This was described as grey to dark grey slightly gravelly silty fine to

**Photographs 1 - 4**, taken on the 2<sup>nd</sup> September 2019, showing the depth and nature of subsoil and topsoil within the garden areas of plot 167 (HOTP167-01 and HOTP167-02) and the arisings generated.

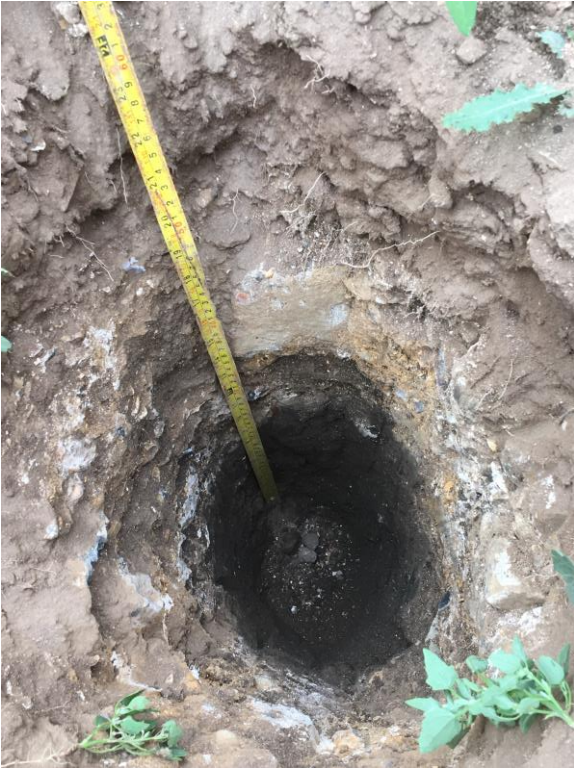
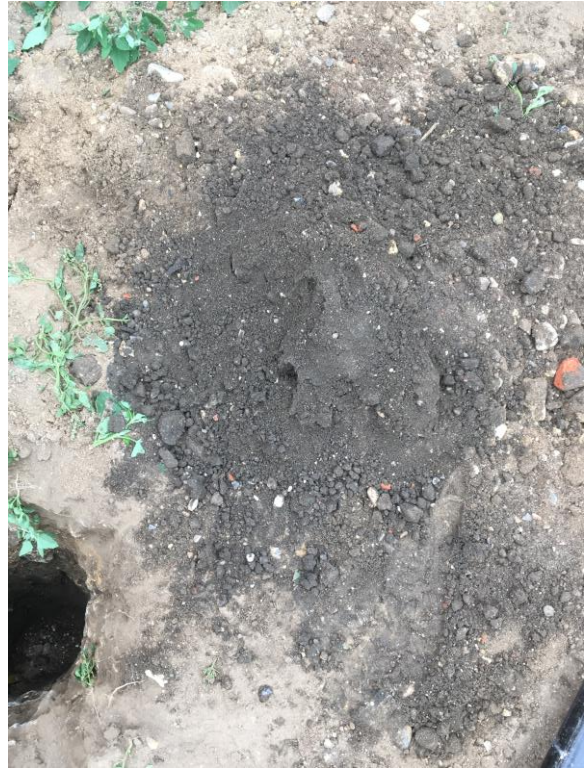
A return visit to site was completed on the 20/09/19 to delineate the extent of the darker subsoil identified in the rear garden of plot 168, to obtain samples of this material to submit for chemical testing and to complete verification of the front gardens of plot 167. Six hand dug trial pits were excavated in the area immediately surrounding where the potentially unsuitable material was identified, with two additional pits in the back garden of plot 168, to provide good coverage. The darker subsoil was identified in two trial pits (HDTP168-02b and DTP168-02c) and the extent of this material was successfully delineated.

**Photographs 5 and 6**, taken on the 20<sup>th</sup> September 2019, showing the depth of the darker subsoil materials within the rear garden of plot 168 (HDTP168-02b). Chemical testing confirmed the suitability of these soils.

The table shows that the detected concentrations of each contaminant were below the generic assessment criteria (C4SL and S4UL), and were therefore considered suitable for use. No asbestos was detected within any of the samples, the darker subsoil material was therefore considered suitable for use.

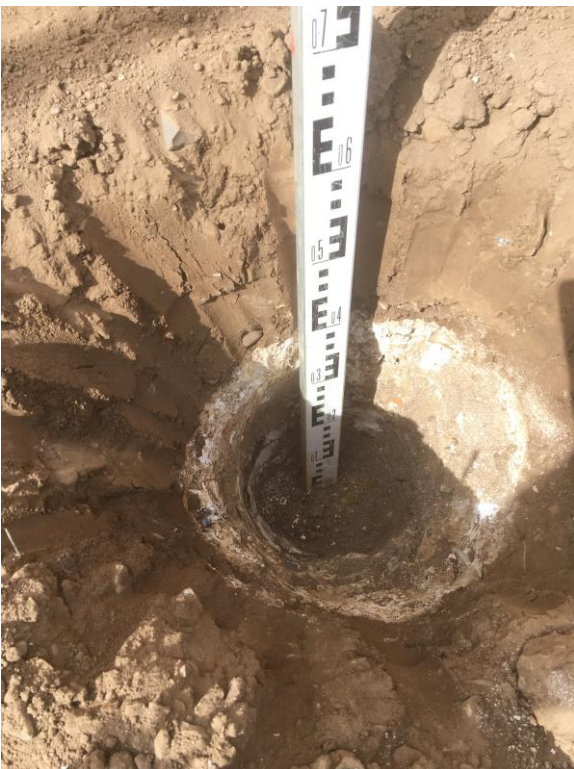
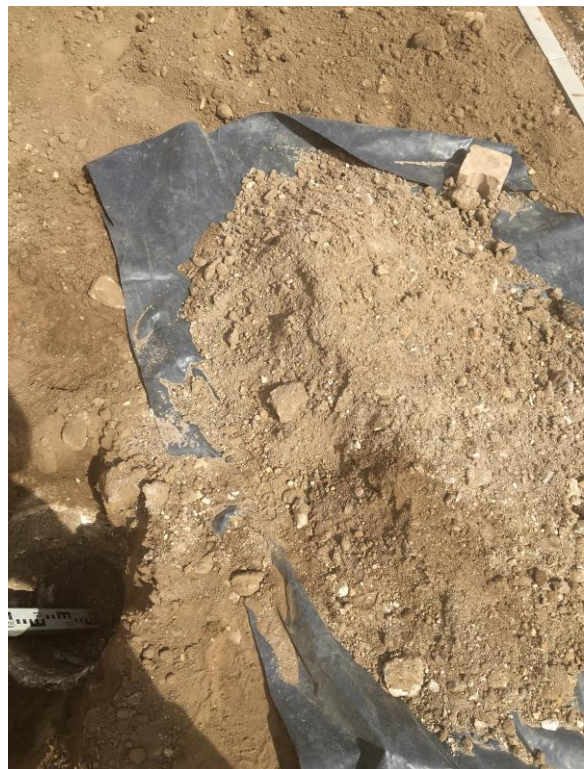
**Photographs 7 and 8**, taken on the 2<sup>nd</sup> September 2019, showing the depth and nature of subsoil and topsoil within the garden areas of plot 168 (HDTP168-03) and the arisings generated.

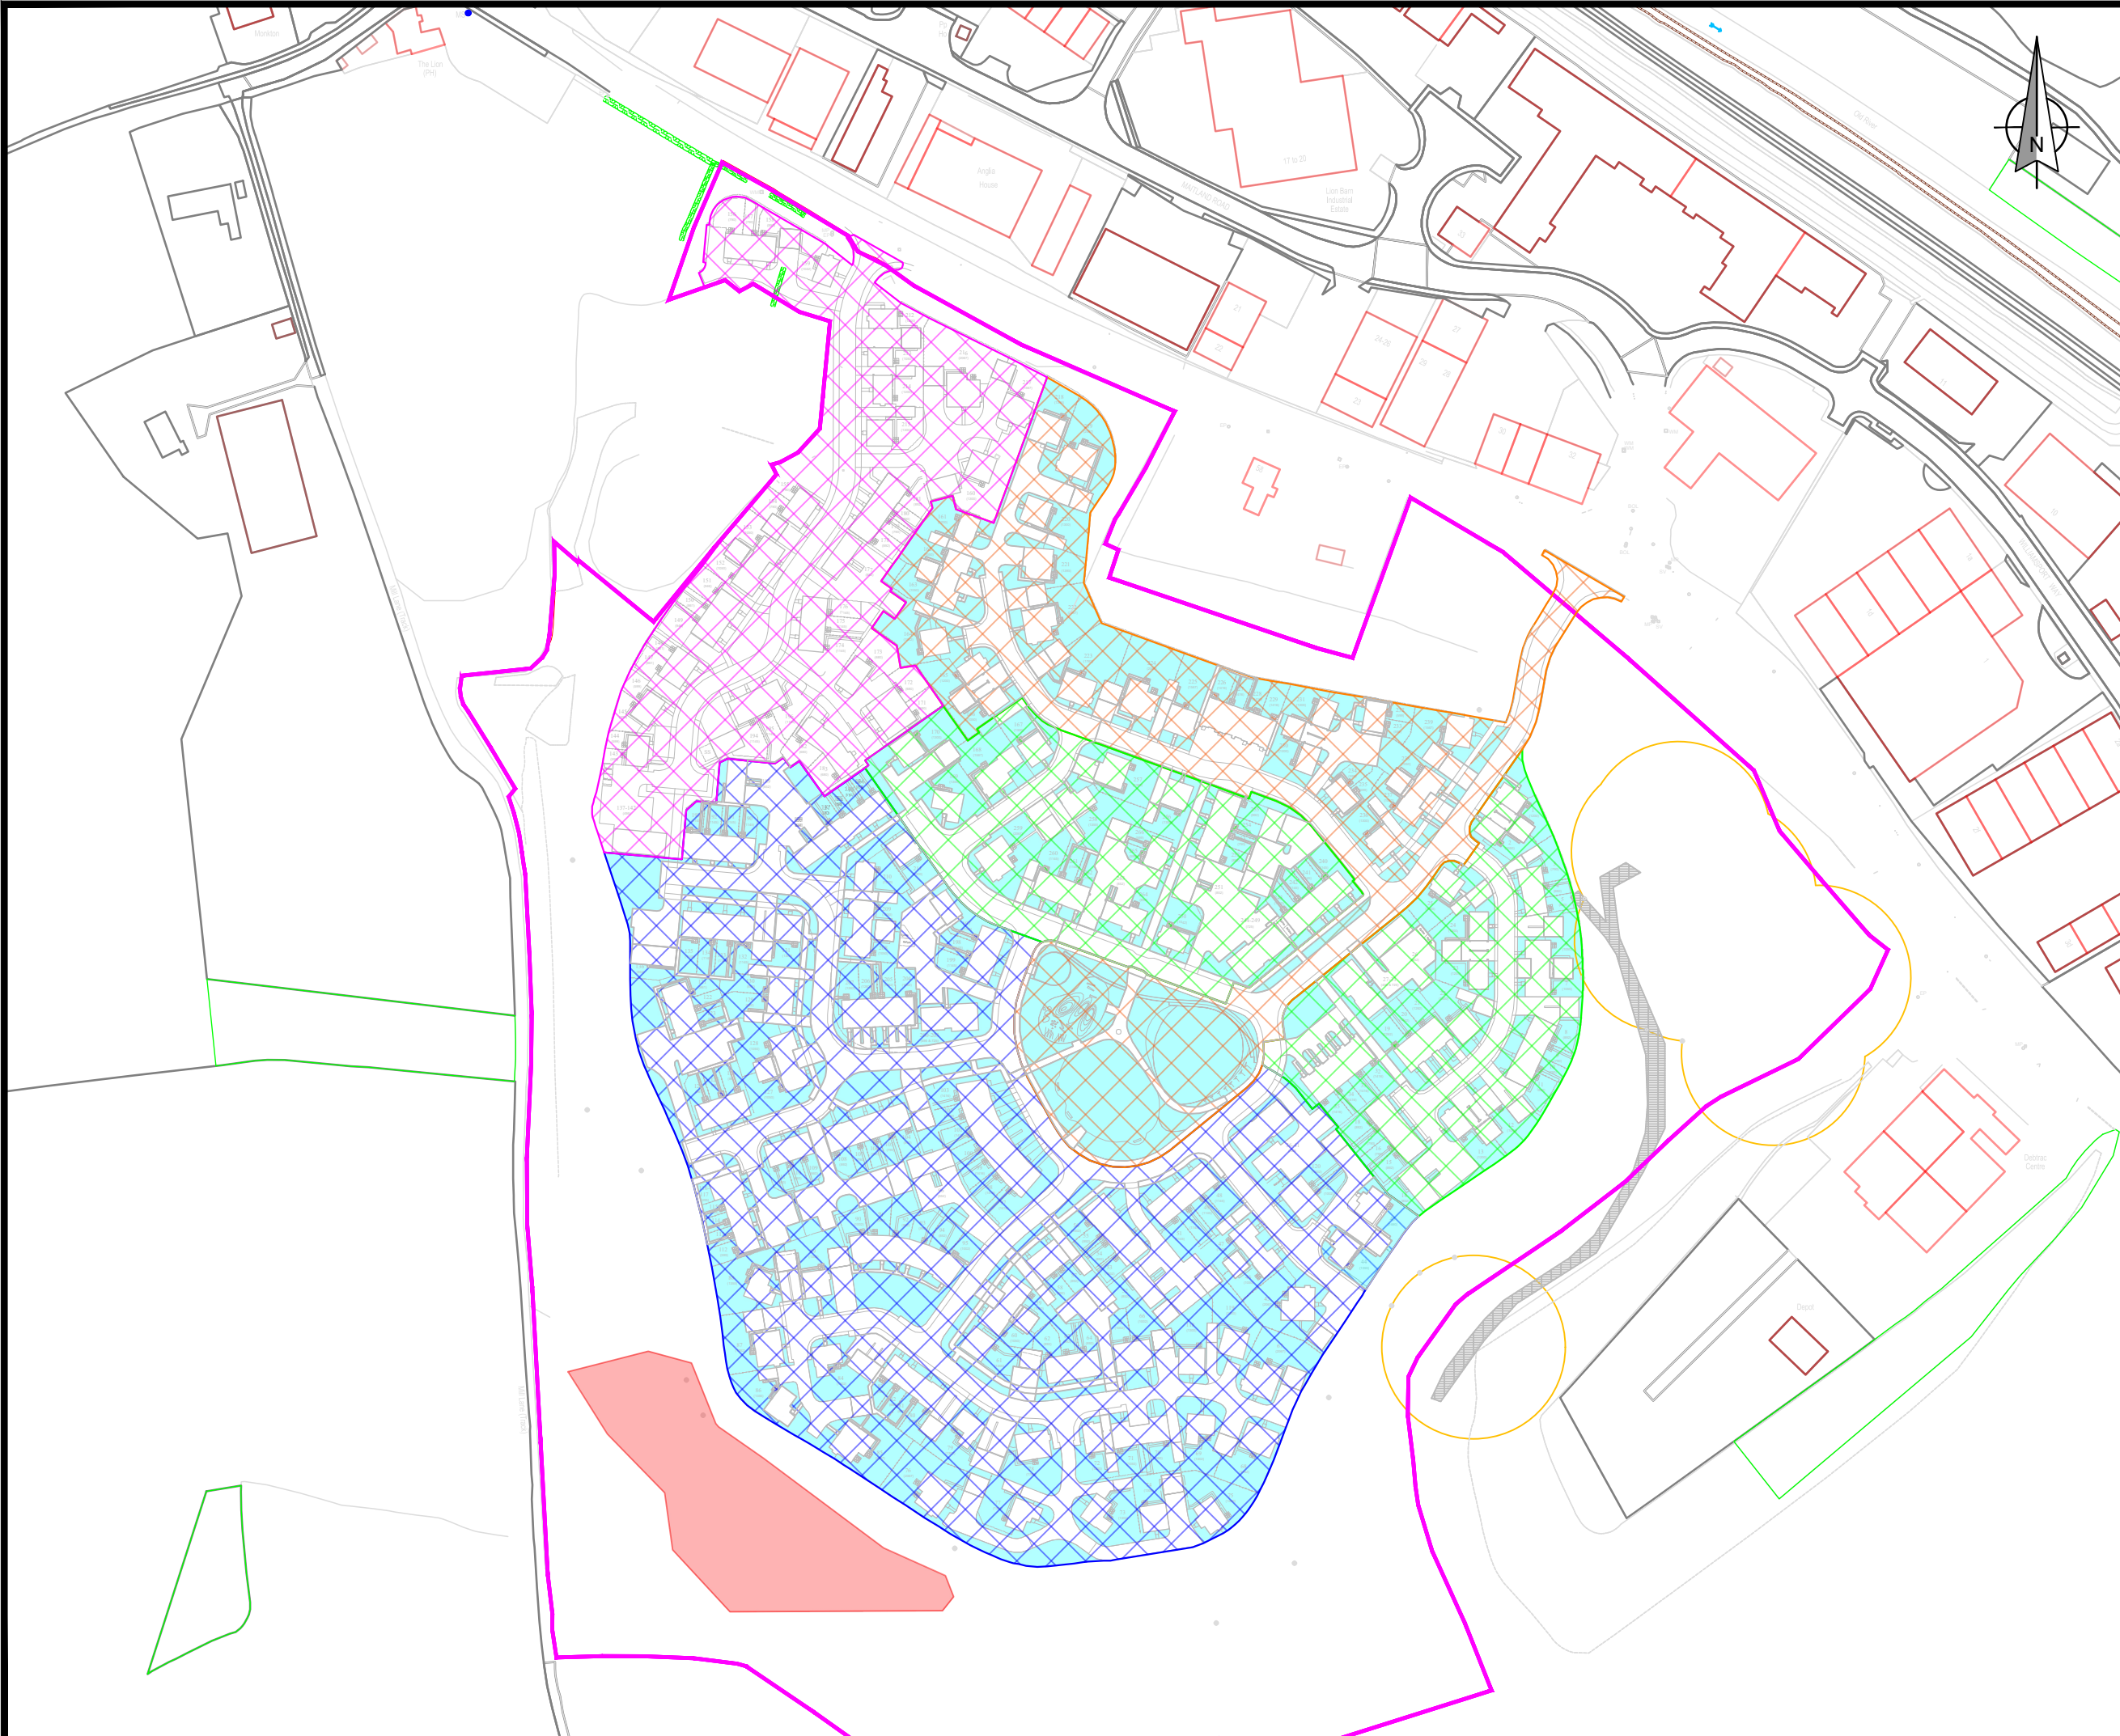
PL-HI-D-101 Rev B N:\work\p\projects\Jobs 17000s\Jobs 17800\GN17820 Needham Market Quarry\Renovation\Drawings\CAD Files\GN17820 - DR402.dwg

The plots which require validation of the suitability of the soils in gardens and soft landscaping can be identified in drawing GN17820\_DR402 (appended to this VR), which highlights the development phasing plan (phases 1A, 1B, 2 and 3). Specifically, plots which require confirmation of the suitability of the near-surface soils, and the need for a soil cover, includes plot numbers 1-136, 161-170, 184-193, 197-211, 218-266 and soft landscaping areas in these development phases.

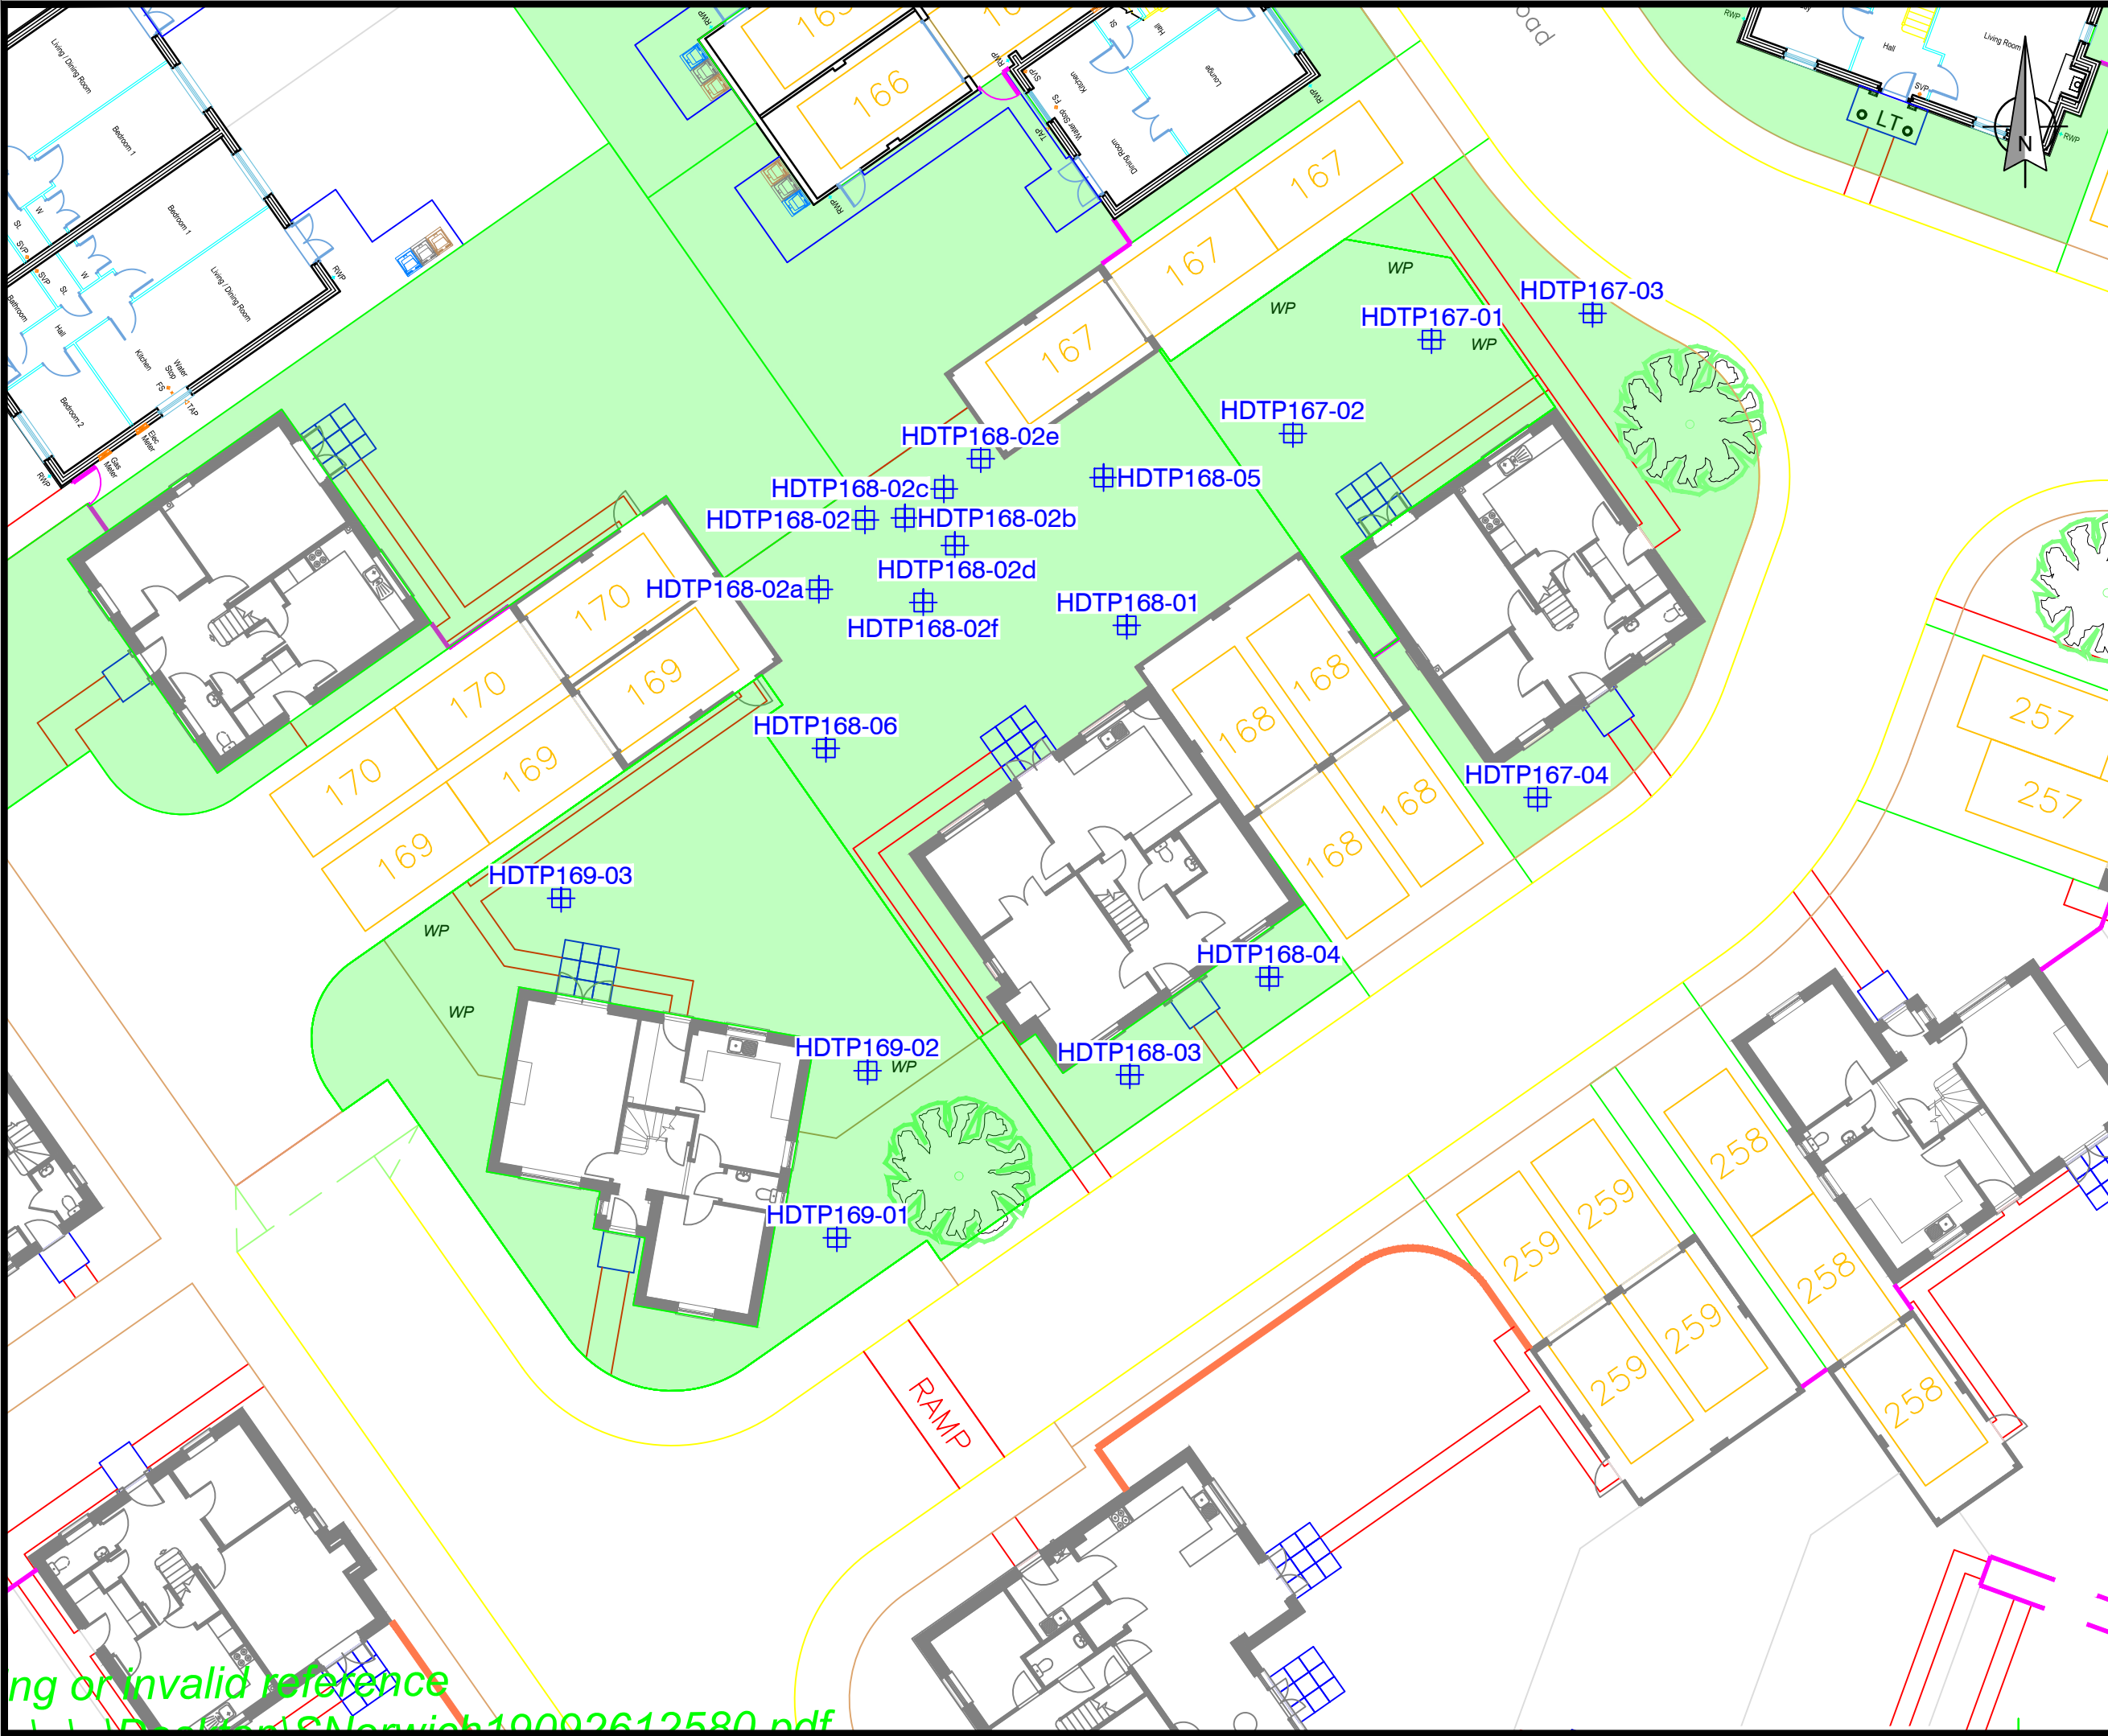
PL-HI-D-101 Rev B N:\Work\Projects\Jobs 17000s\Jobs 17820\GN17820 Needham Market Quarry Remediation Drawings\CAD Files\GN17820 - DR502.dwg

The fieldwork locations are shown on drawing GN17820-DR502u included within the appendix. These were undertaken to record the thickness and physical descriptions of the materials present and to confirm their suitability.

- HOTP167-01 Hand Dug Trial Pit
- Acceptable Cover System
