**Document:** Remediation Verification Report

**Project:** Needham Market Quarry

**Reference No.:** GN17820\_RV19

**Prepared for:** Hopkins Homes Limited

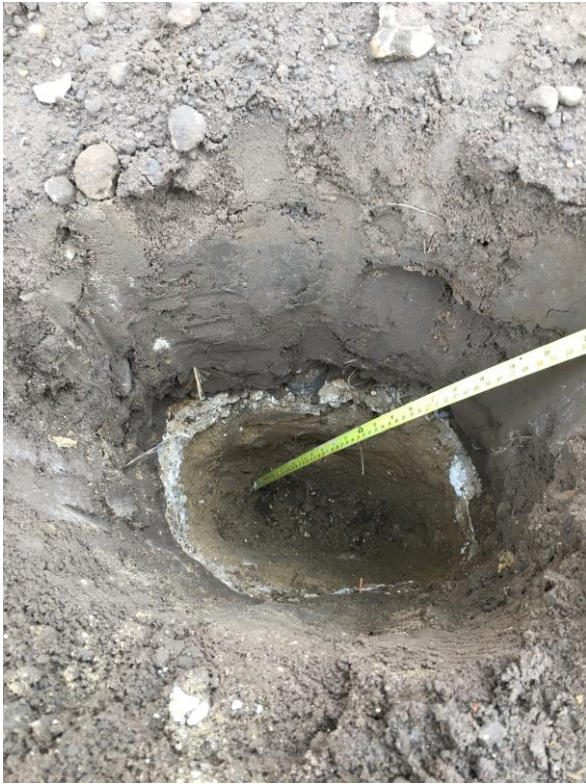
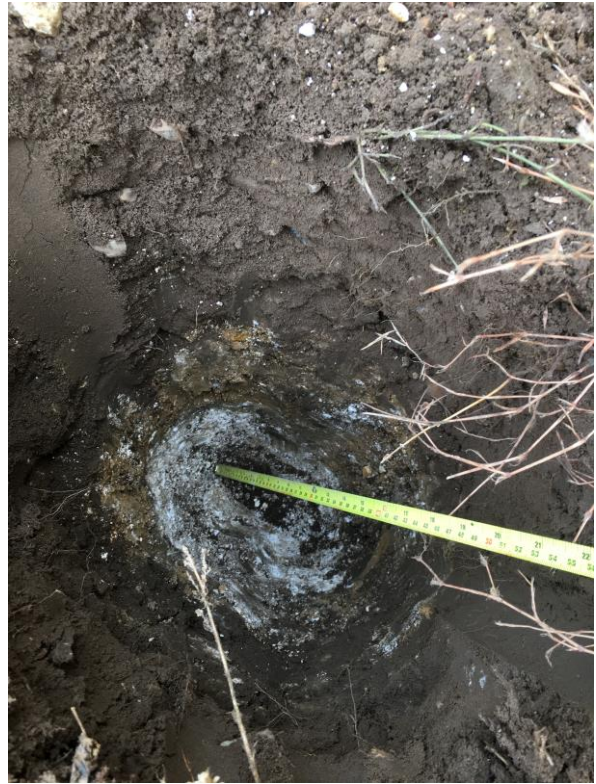
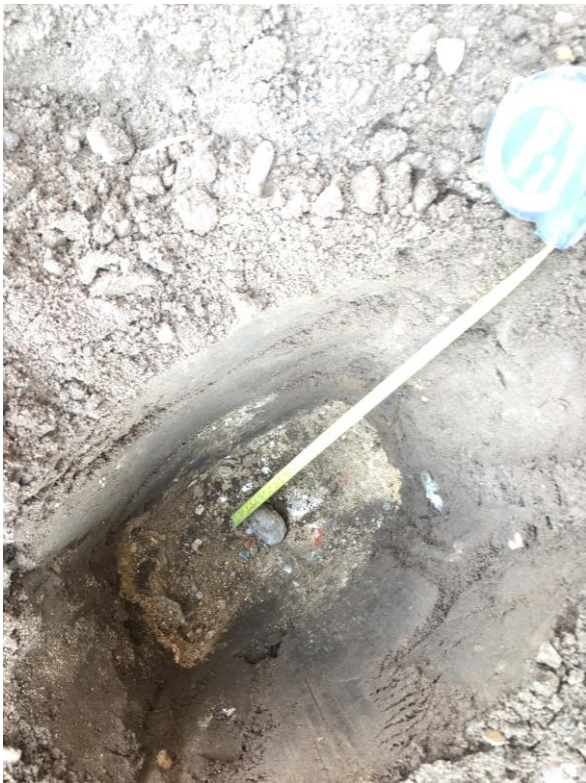
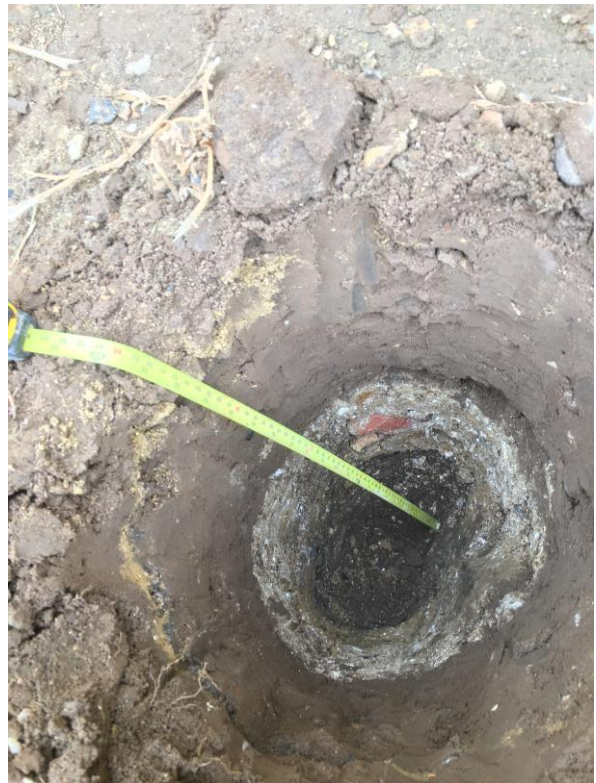
**GN17820 – Needham Market Quarry**  
**Verification Report 19 - Photo Sheet 1**

This material was used for the topsoil (ground level up to 330mm depth) within the all pits excavated in plots 240-243 and soft landscaping area surrounding flats 244-249. The minimum thickness of 150mm of topsoil was encountered in all of the trial pits during the verification exercise.

**Photographs 1 - 4**, taken on the 27<sup>th</sup> July 2020 showing the depth and nature of the subsoil and topsoil within the cover systems for plots 240 to 243 and flats 244 to 249.
