Document: Remediation Verification Report

Project: Needham Market Quarry

Reference No.: GN17820_RV16

Date: December 2019

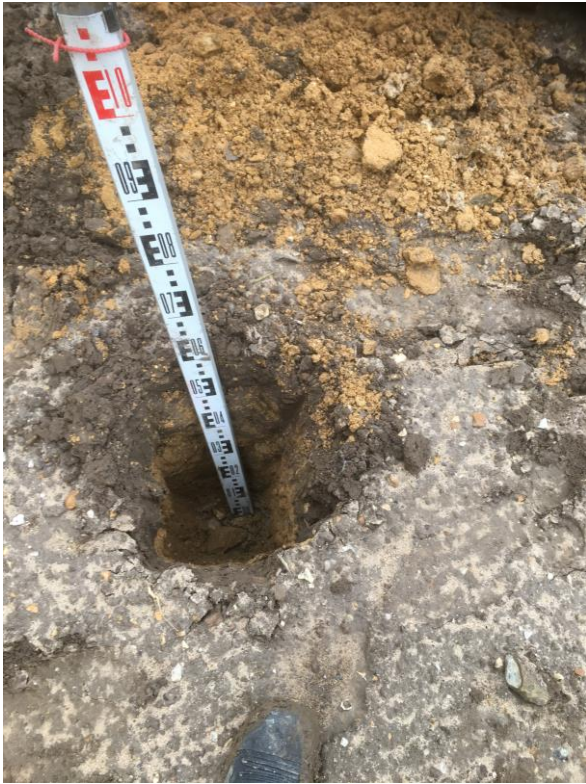
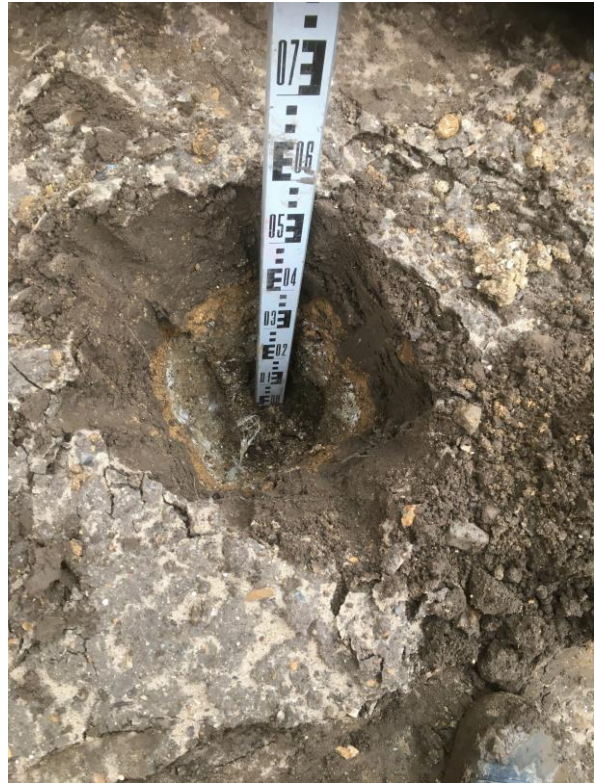
Photographs 1 - 2, taken on the 10th December 2019, showing the depth and nature of subsoil and topsoil within the rear garden area of plot 256 (HDTP256-02 and HDTP256-04).

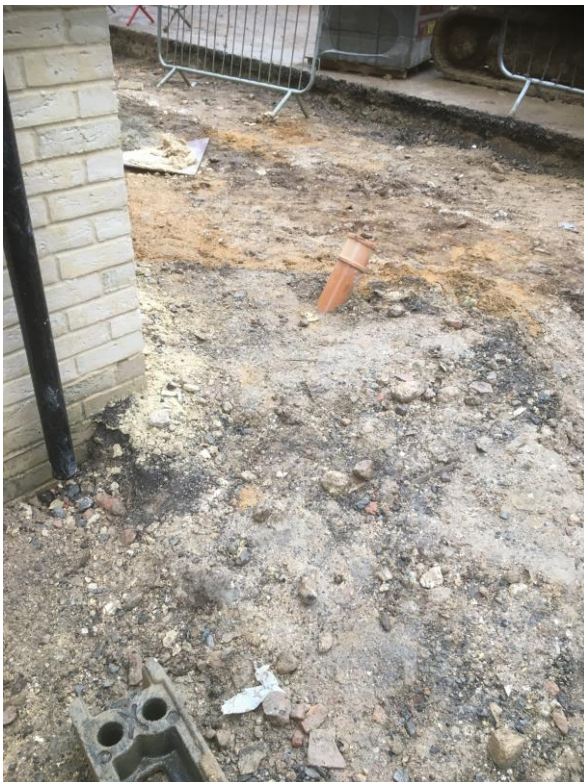
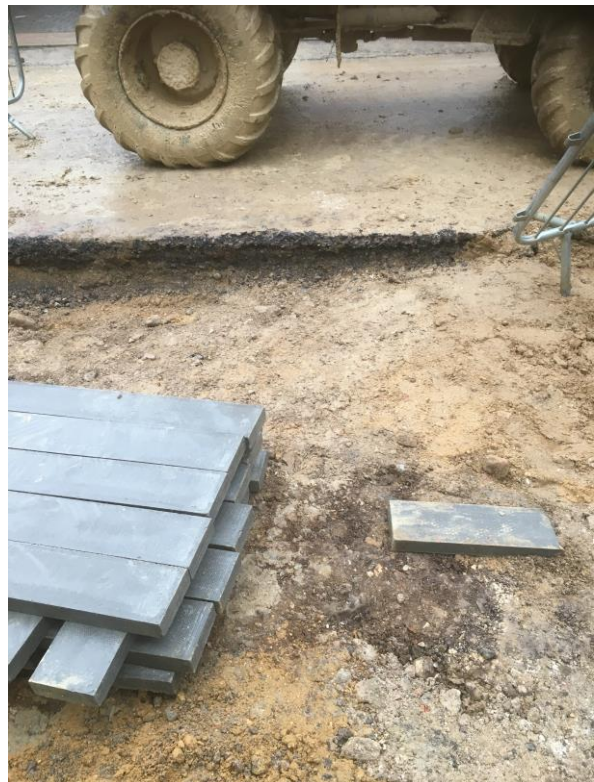
Photographs 2 - 4, taken on the 10th December 2019, showing the area of the front garden prior to placement of the topsoil.

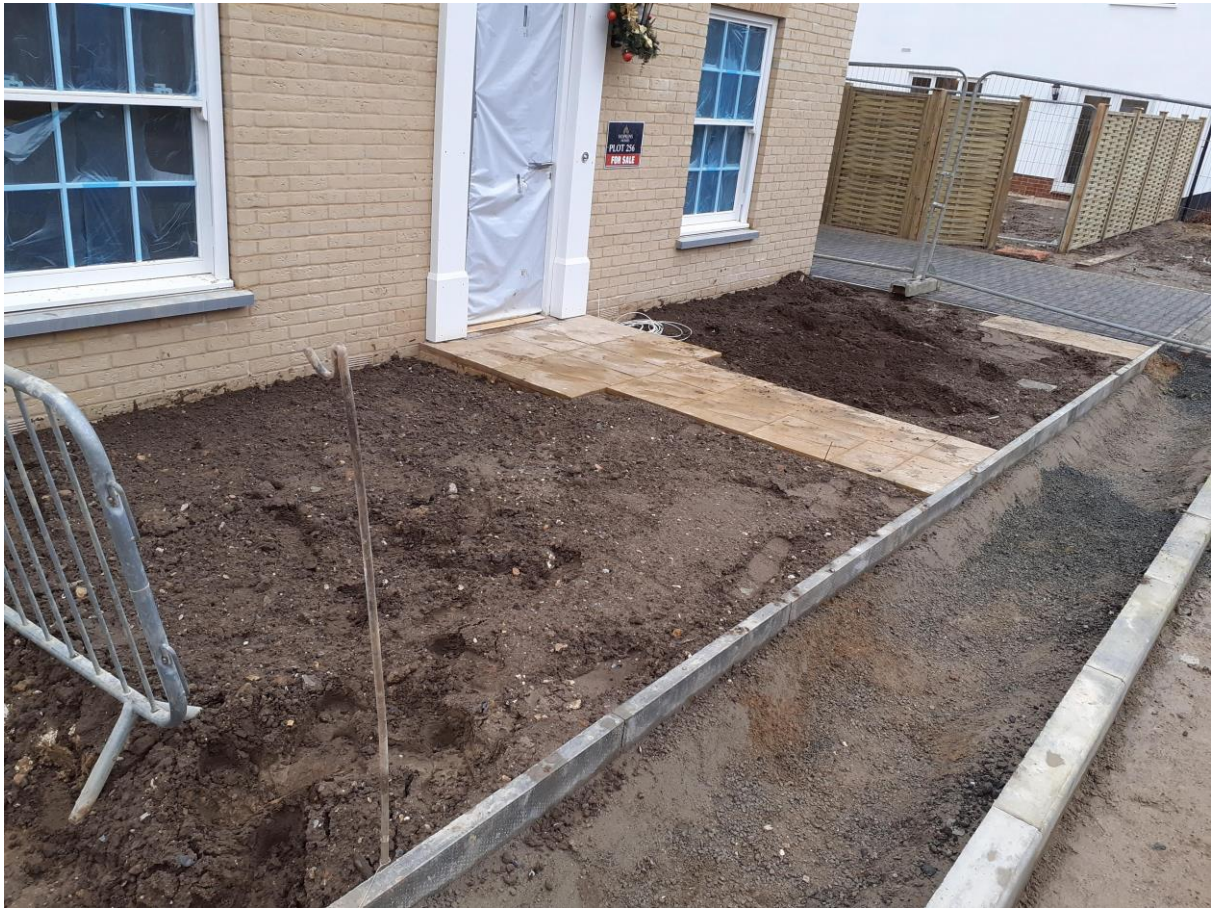
Photograph 5, taken on the 19th December 2019 by the client, showing completed cover system in the front garden of plot 256.

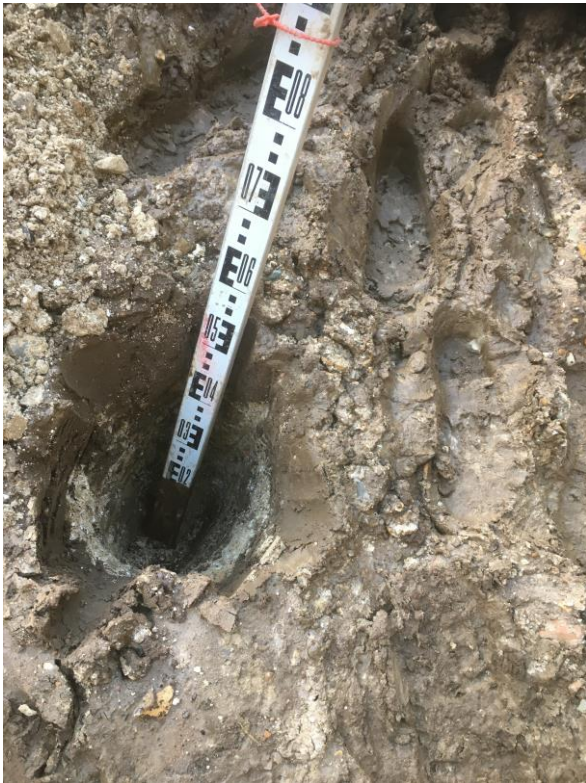
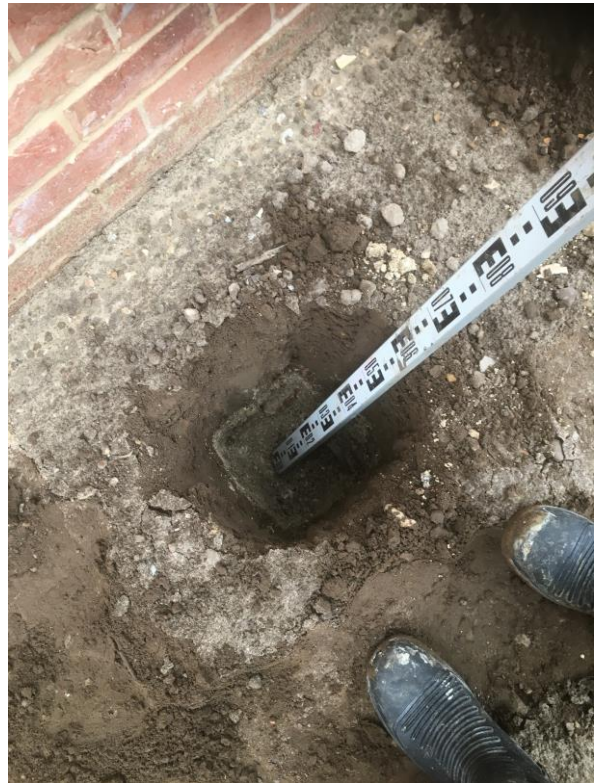
Photographs 6 and 7, taken on the 3rd and 10th December 2019, showing the depth and nature of subsoil and topsoil within the garden areas of plots 260, 261 and 262 (HOTP260-01 and HOTP261-03).

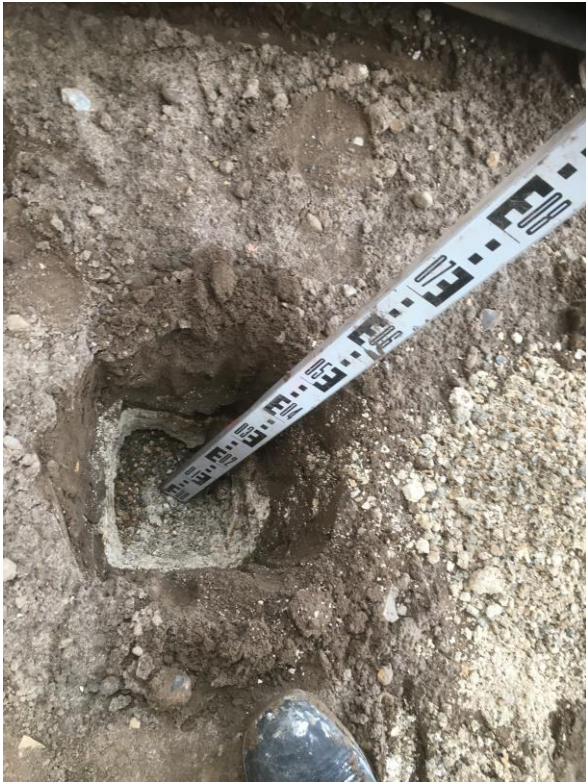
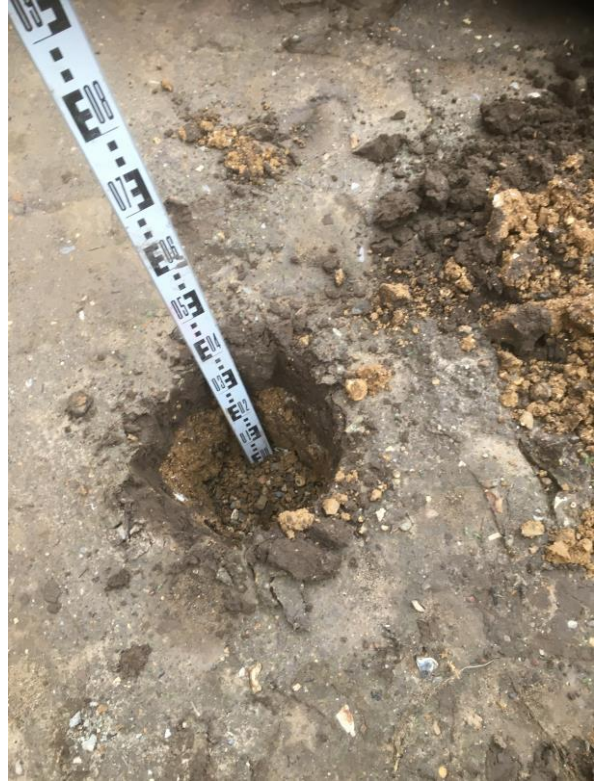
- Made Ground - Brownish orange slightly gravelly slightly silty sand with pockets of grey clay. Gravel is sub-angular to sub-rounded fine to coarse flint and chalk.
- Made Ground (reworked chalk) - Grey/white mottled cream slightly sandy slightly gravelly/gravelly SILT. Gravel is fine to coarse sub-angular to sub-rounded chalk, flint with rare concrete and brick.
- Made Ground - Light greyish brown/light brown slightly gravelly silty fine to coarse sand. Gravel is sub-angular to sub-rounded fine to coarse flint and chalk.
- Made Ground - Greyish brown slightly sandy gravelly silt. Gravel is sub-angular to sub-rounded fine to medium flint, brick and chalk.
- Pea shingle and coarse flint gravel used as a marker layer above presumed services.

Photographs 8 and 9, taken on the 10th December 2019 showing where pea shingle and coarse gravel were encountered within hand dug trial pits (HDT262-03 and HDT266-01) and presumed to indicate the presence of services.

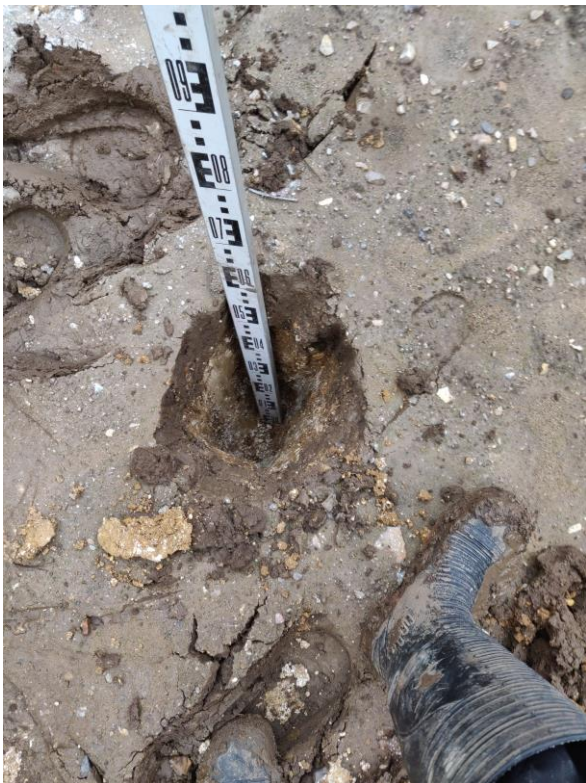
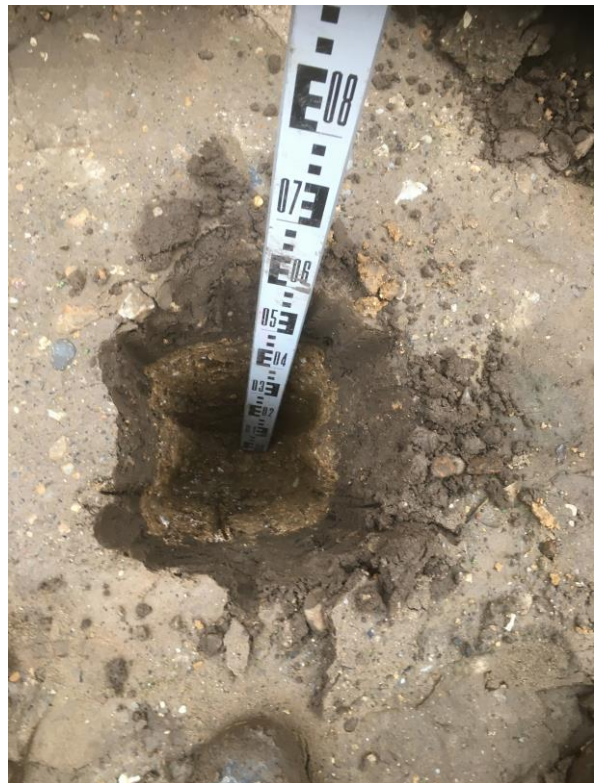
Photographs 10 and 11, taken on the 10th December 2019, showing the depth and nature of subsoil and topsoil within the garden areas of plots 265 and 266 (HDT265-03 and HDT266-02).

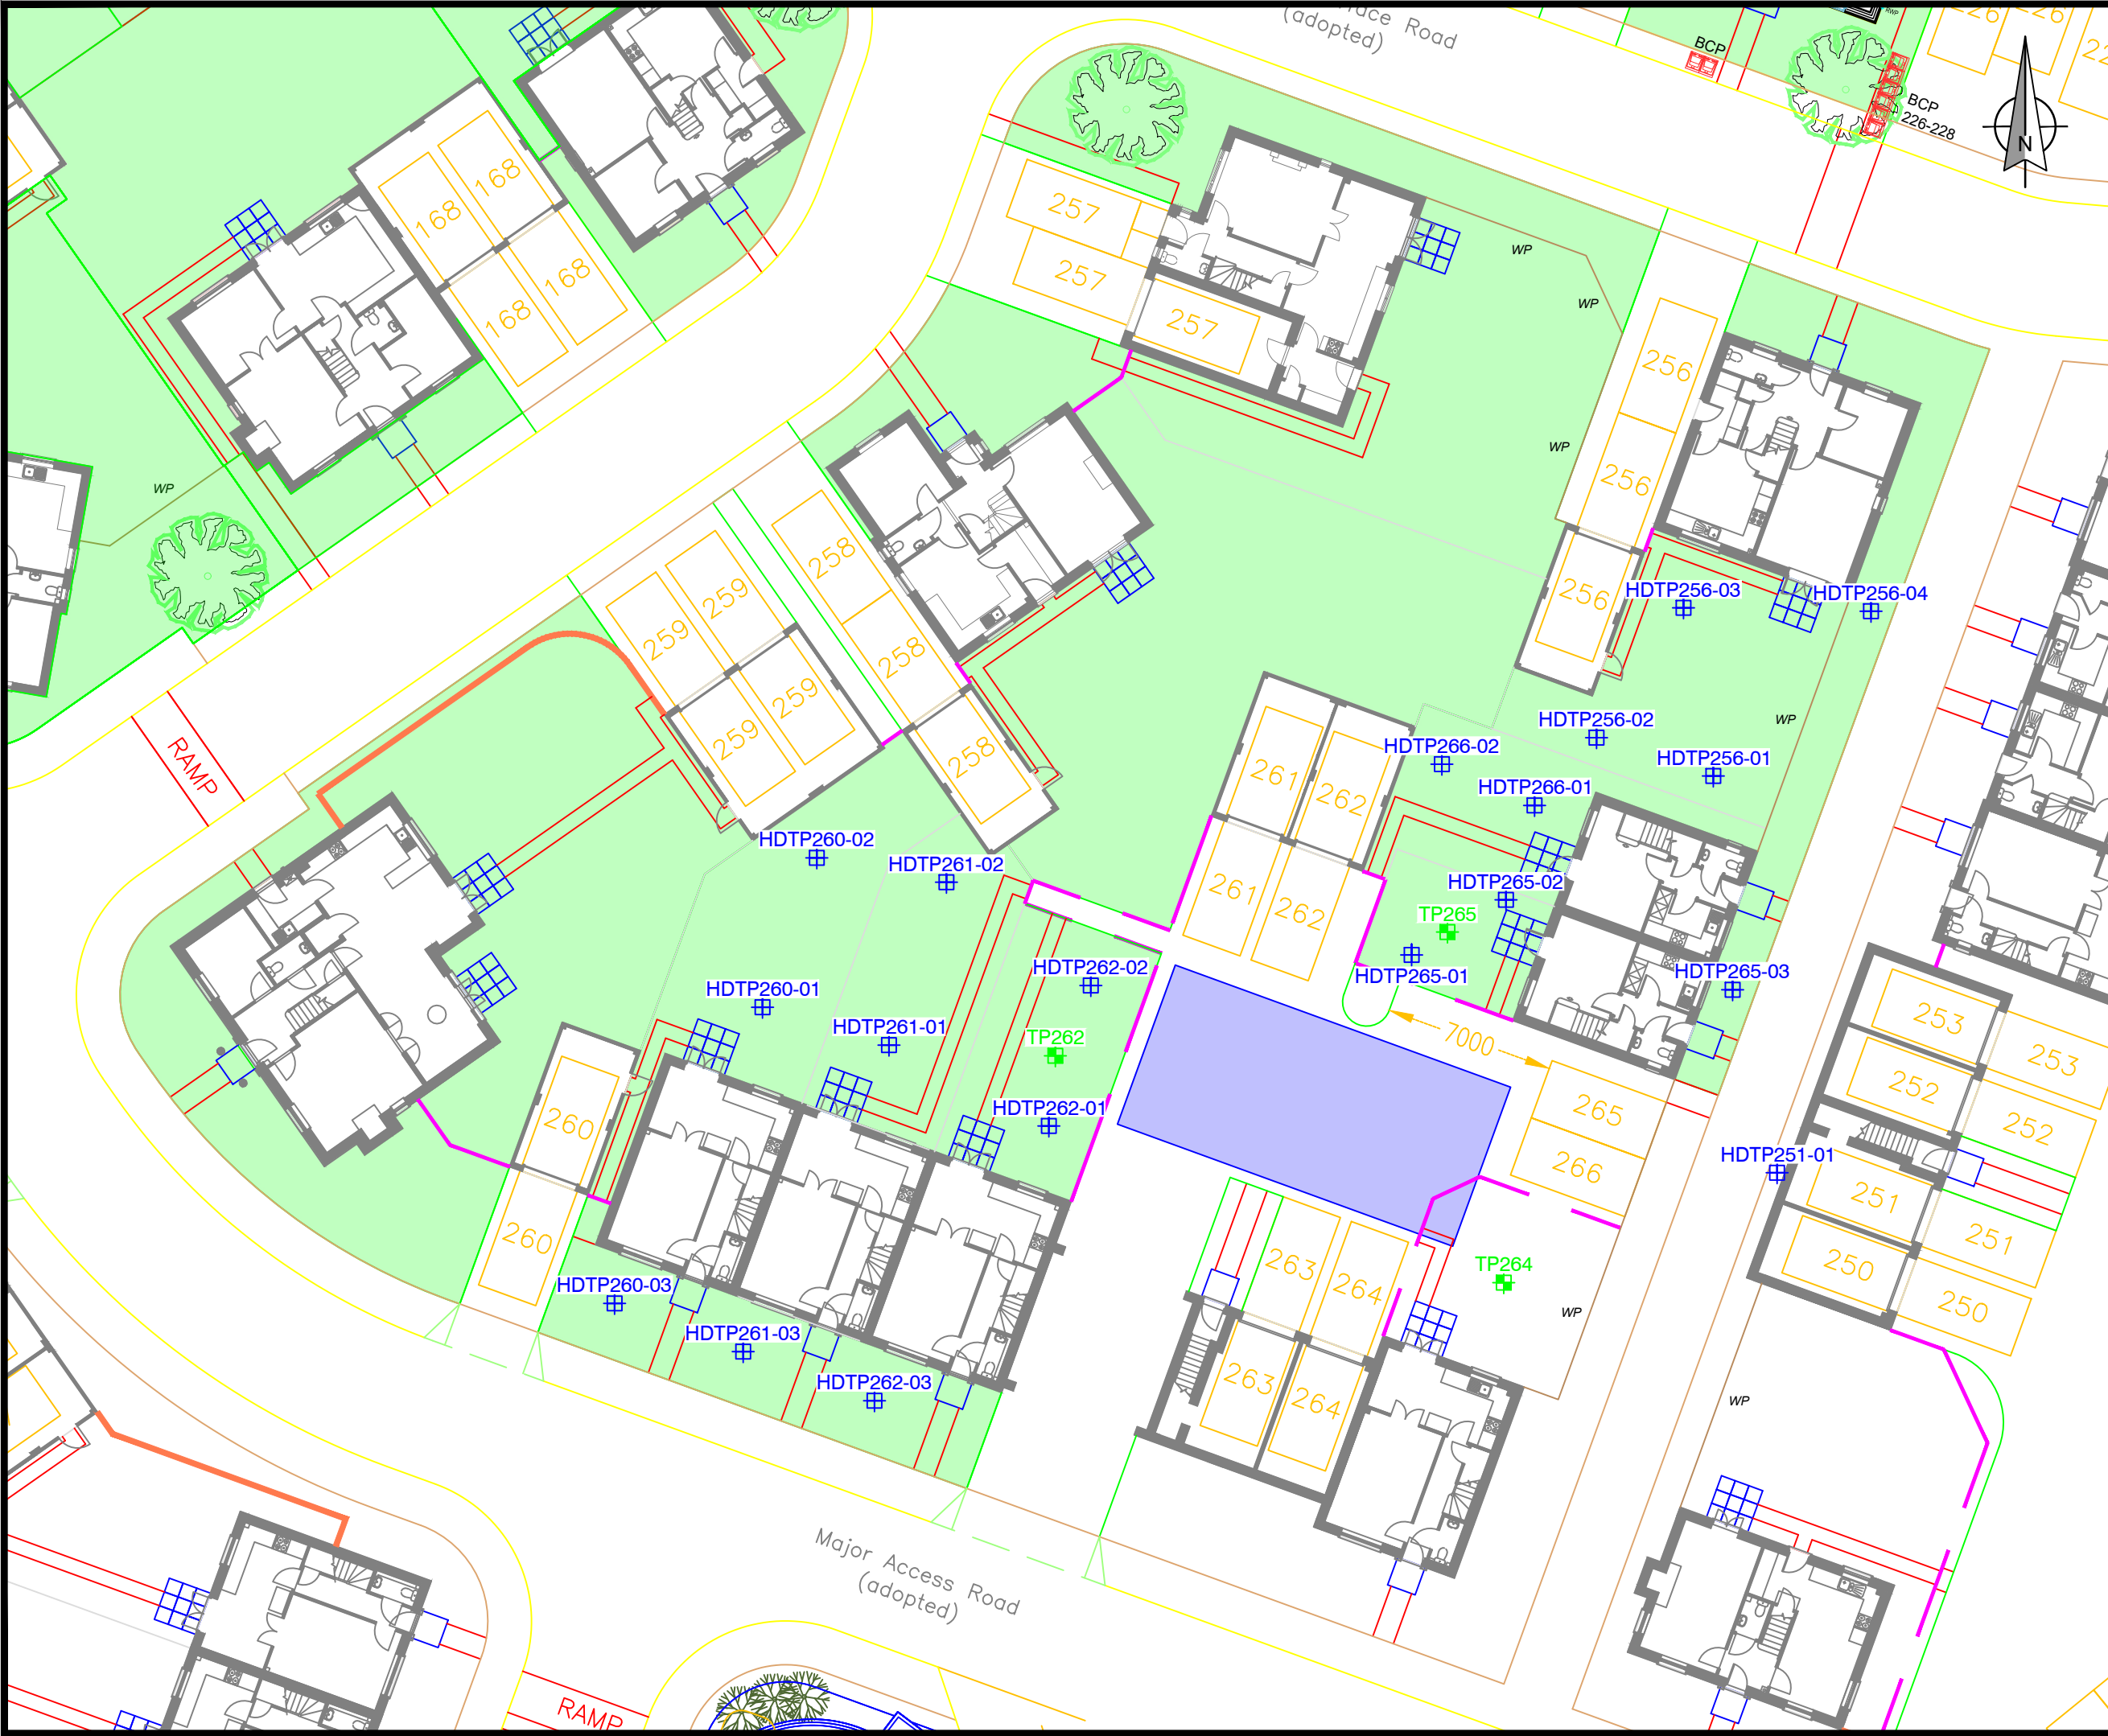
PL-HI-D-101 Rev B N:\work\projects\jobs 17000\jobs 17820\GN17820 Needham Market Quarry Remediation Drawings\CAD files\GN17820 - DR502.dwg

The fieldwork locations are shown on drawing GN17820-DR502w included within the appendix. These were undertaken to record the thickness and physical descriptions of the materials present and to confirm their suitability.

- HOTP256-01 Hand Dug Trial Pit
- TP262 Machine Excavated Trial Pit - April 2019
- Excavation 102
- Acceptable Cover System
