Document: Remediation Verification Report

Project: Needham Market Quarry

Reference No.: GN17820_RV20

VERIFICATION REPORT
FOR REMEDIAL ACTIVITY
AT
NEEDHAM MARKET QUARRY

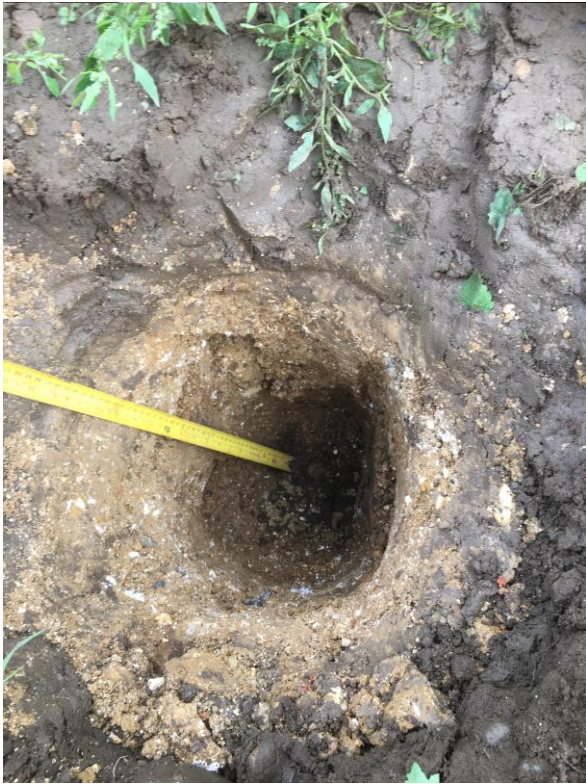
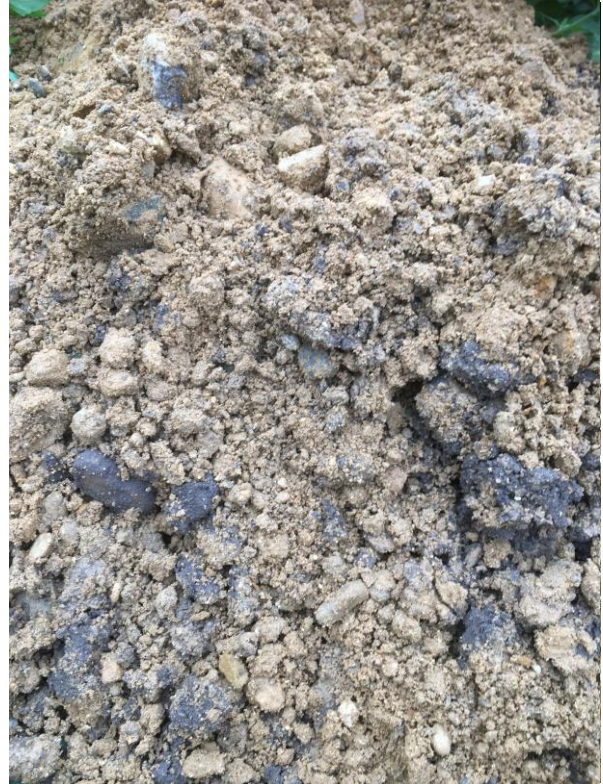
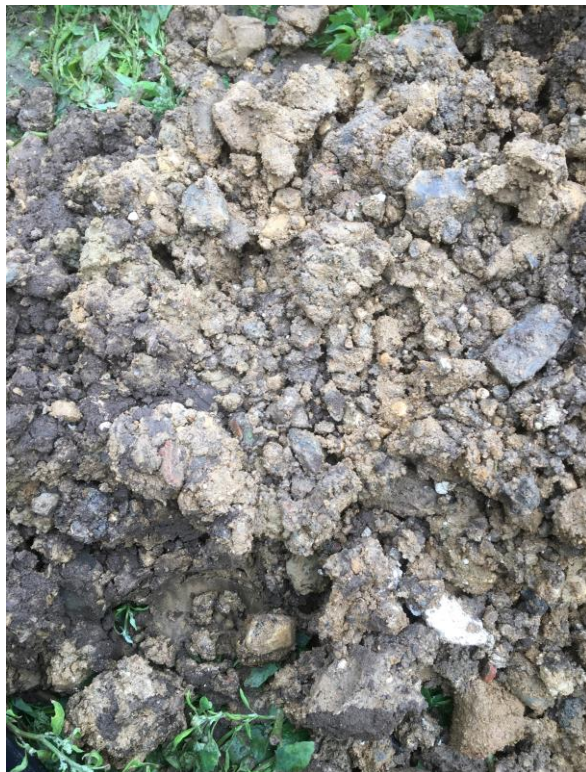
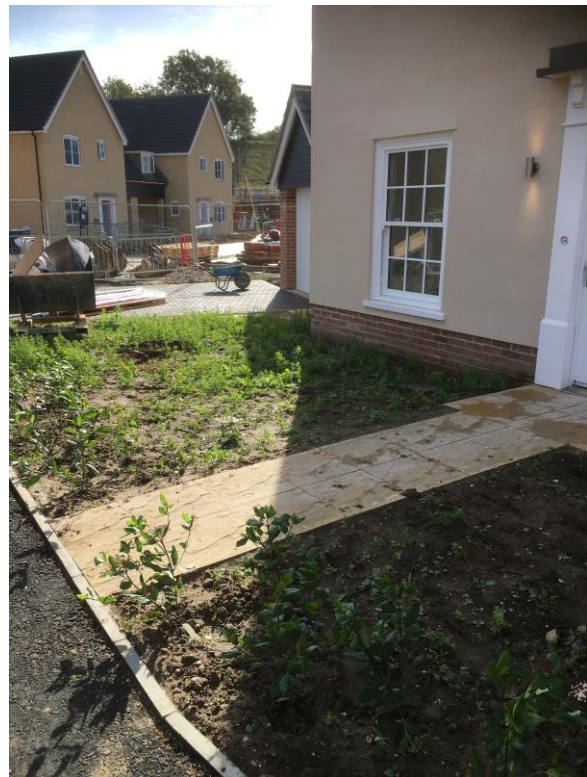
Photographs 1-4, taken on the 15th October 2020 showing the general area of plot 25, along with the range of topsoil and subsoil encountered.

This material was used for the topsoil (ground level up to 330mm depth) within all of the pits excavated in plots 25 and 26. The minimum thickness of 150mm of topsoil was encountered in all of the trial pits during the verification exercise.

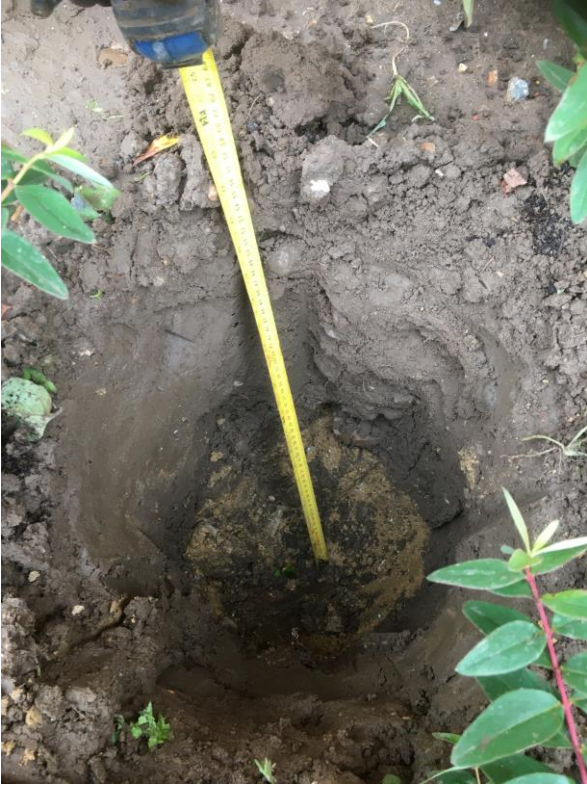
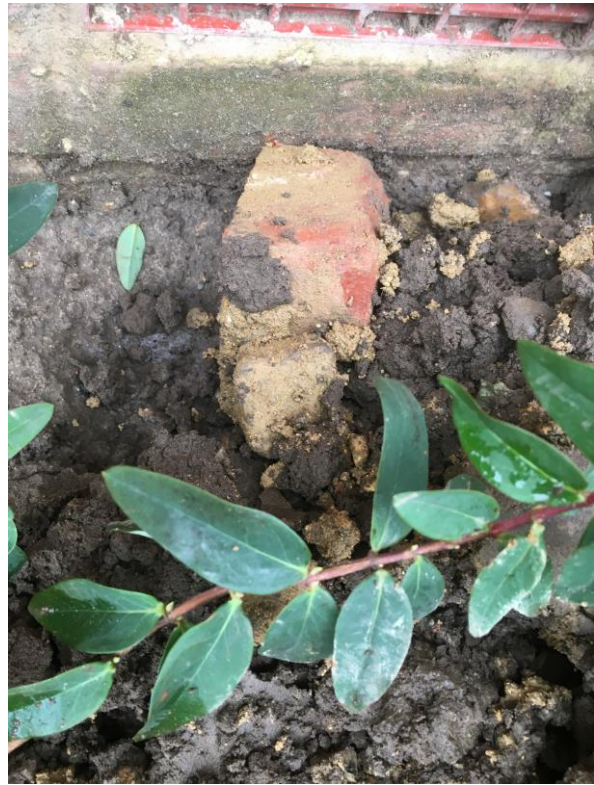
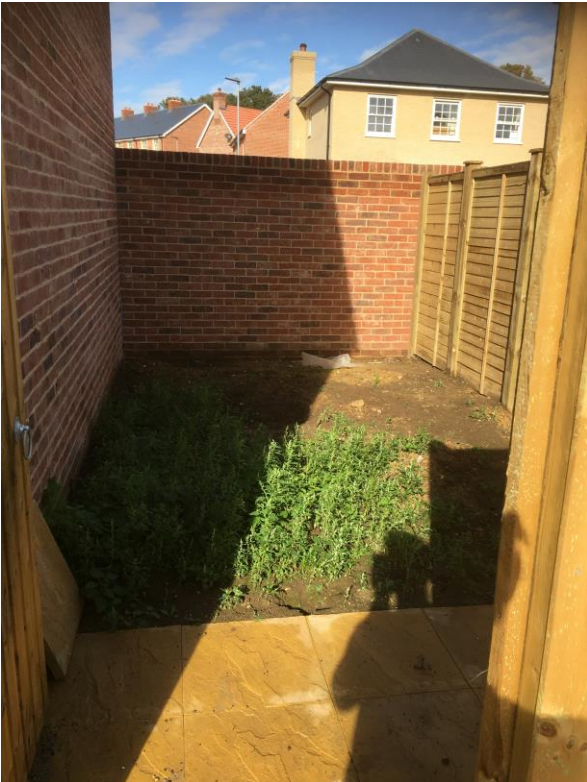
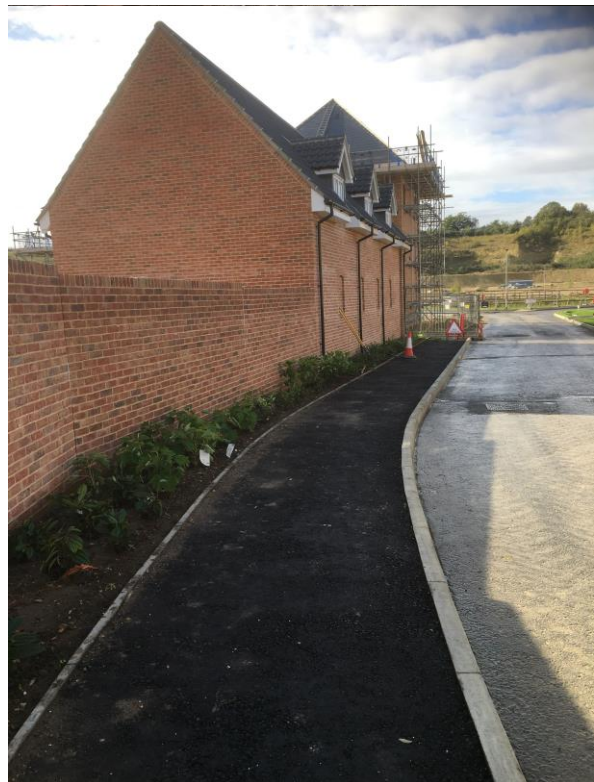
- A partial brick was present at 0.45m within HDTP26-01. This was removed prior to backfilling.
- Concrete gravel was encountered within the subsoil in HDTP26-02, effort was made to remove this material before backfilling.

Photographs 5 - 8, taken on the 15th October 2020 showing the general area of plot 26, along with the range of topsoil and subsoil encountered.
