Document: Remediation Verification Report

Project: Needham Market Quarry

Reference No.: GN17820_RV15

VERIFICATION REPORT
FOR REMEDIAL ACTIVITY
AT
NEEDHAM MARKET QUARRY

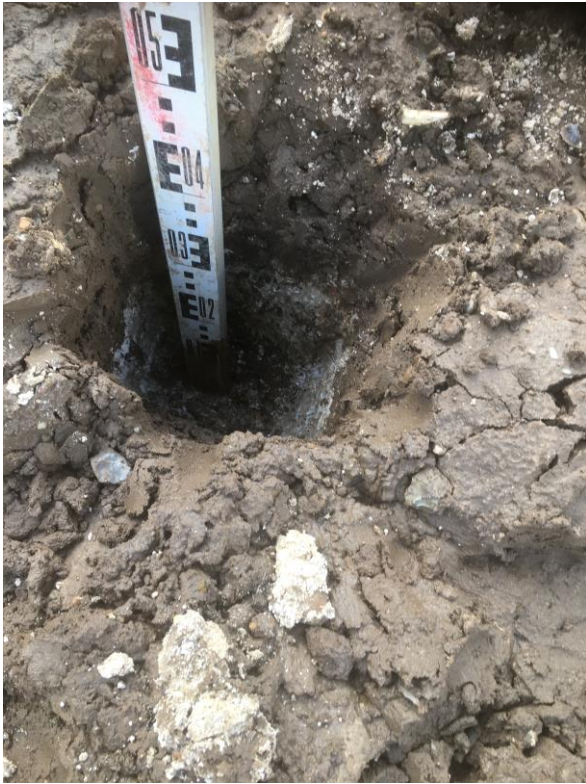
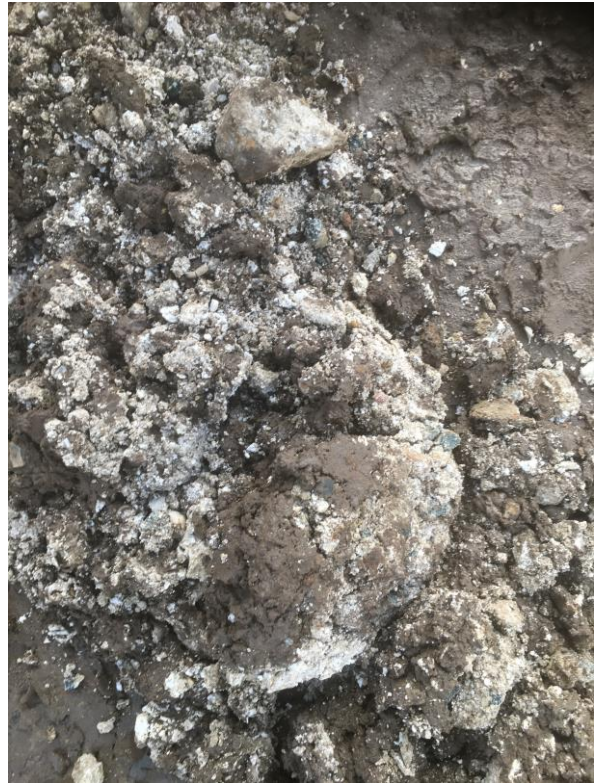
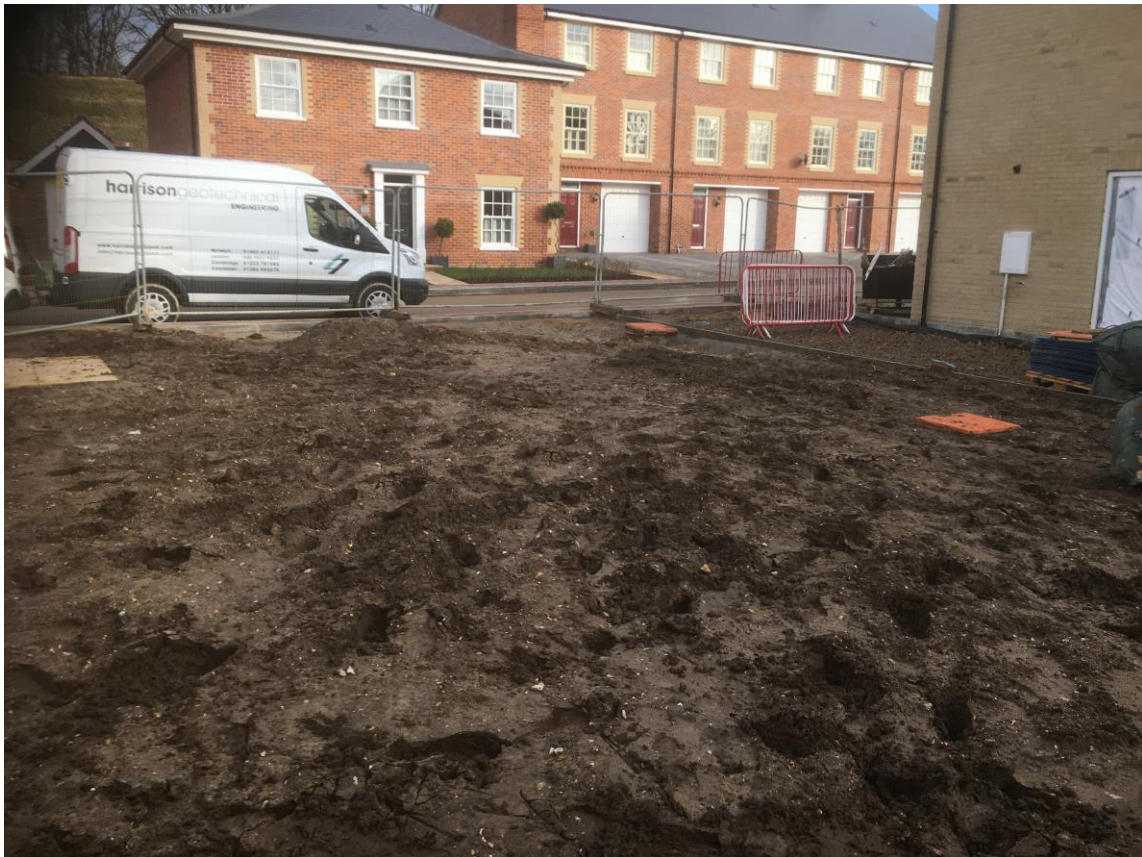
Photographs 1 - 3, taken on the 3rd December 2019, showing the depth and nature of subsoil and topsoil within the garden area of plot 259 (HDTP259-02) and the arisings generated.

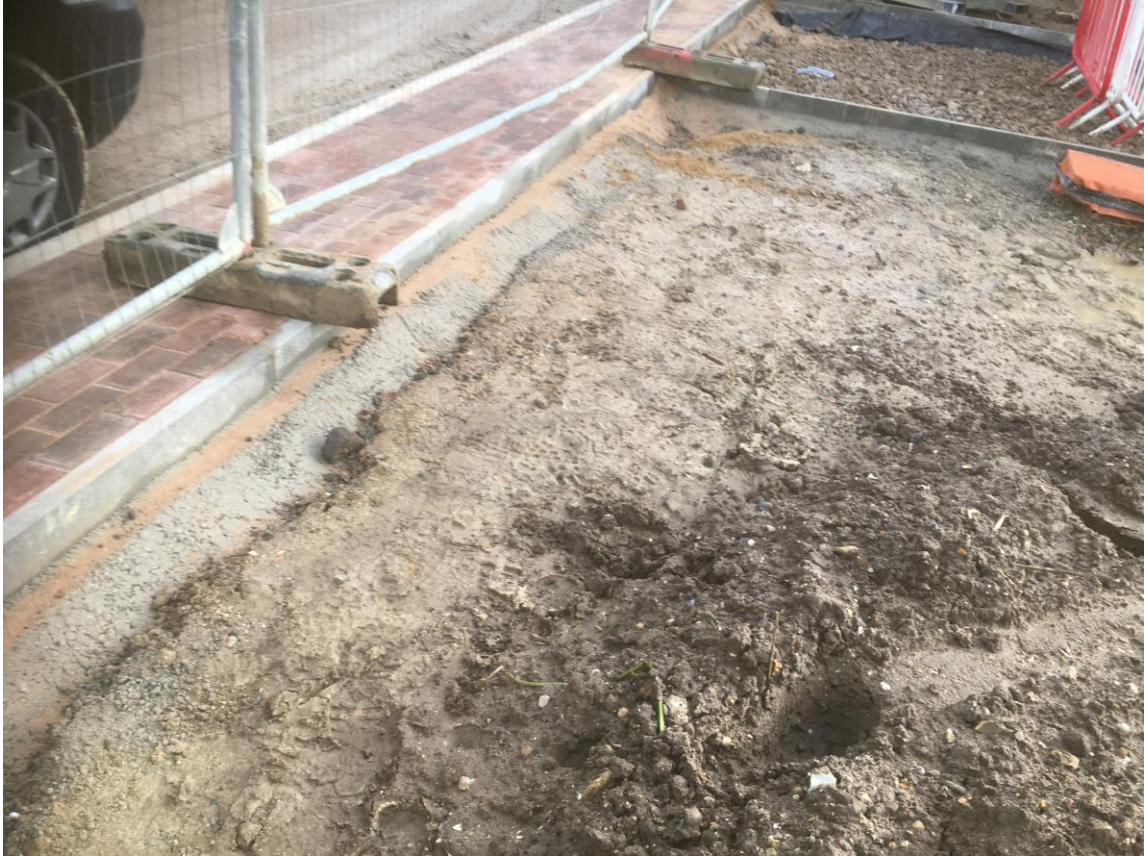
Photograph 4, taken on the 3rd December 2019, showing where the cover system was not present adjacent to footpaths and paving in plot 257.

- A large concrete obstruction in one location in the back garden of plot 258 (HDTP258-02). This was later removed by ground workers on site and backfilled with suitable topsoil.
- In the rear garden of plot 259 was a stockpile of excavated subsoil from the construction of the adjacent garage. All the material was considered to satisfactory form visual inspection. A trial pit log has been generated showing the soil profile of the exposed excavation (HDTP259-02) where topsoil was absent.
- The full depth of cover was not achieved adjacent to footpaths and paving slabs at approximately 45° angle.

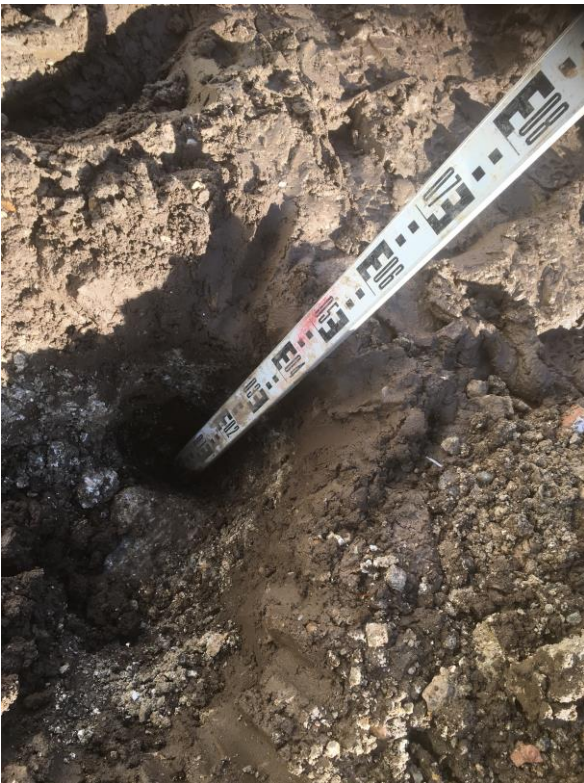
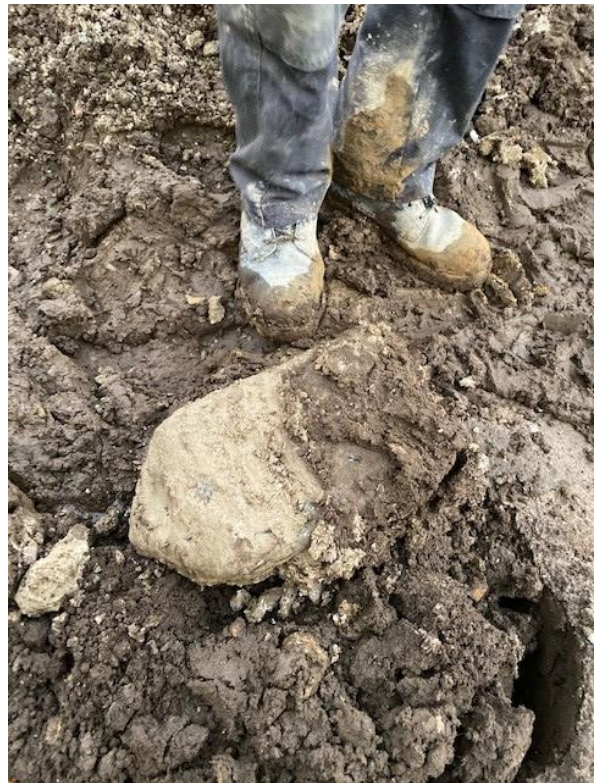
Photographs 5 and 6, taken on the 3rd and 4th December 2019 showing the concrete obstruction in the rear garden of plot 258 (HDTP258-02) and subsequent removal by ground workers.

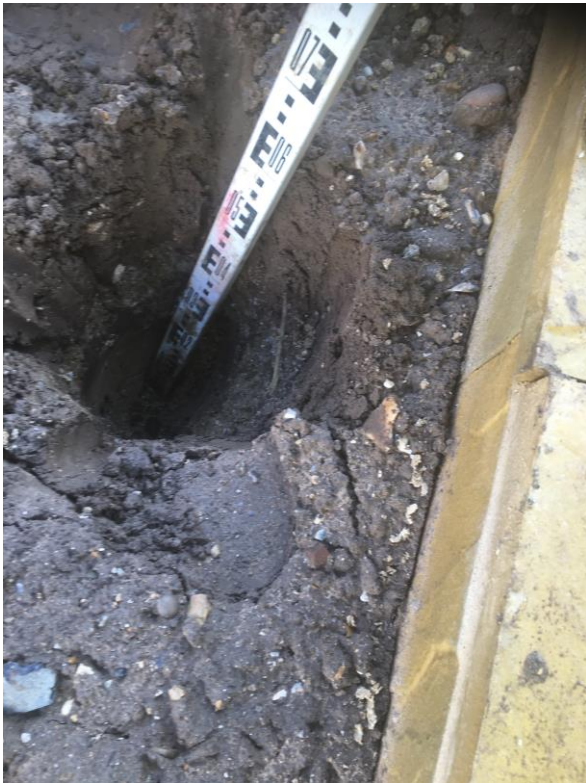
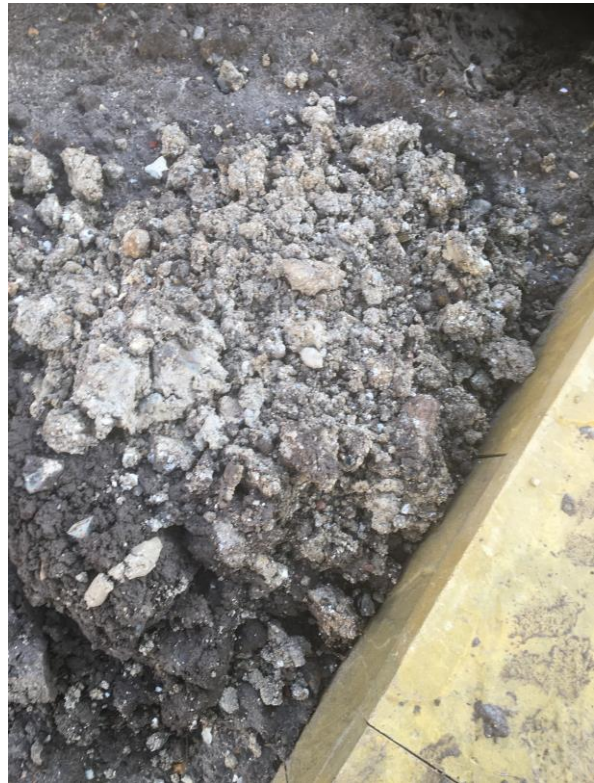
Photographs 7 and 8, taken on the 3rd December 2019, showing the depth and nature of subsoil and topsoil within the garden area of plot 258 (HDTP258-01) and the arisings generated.

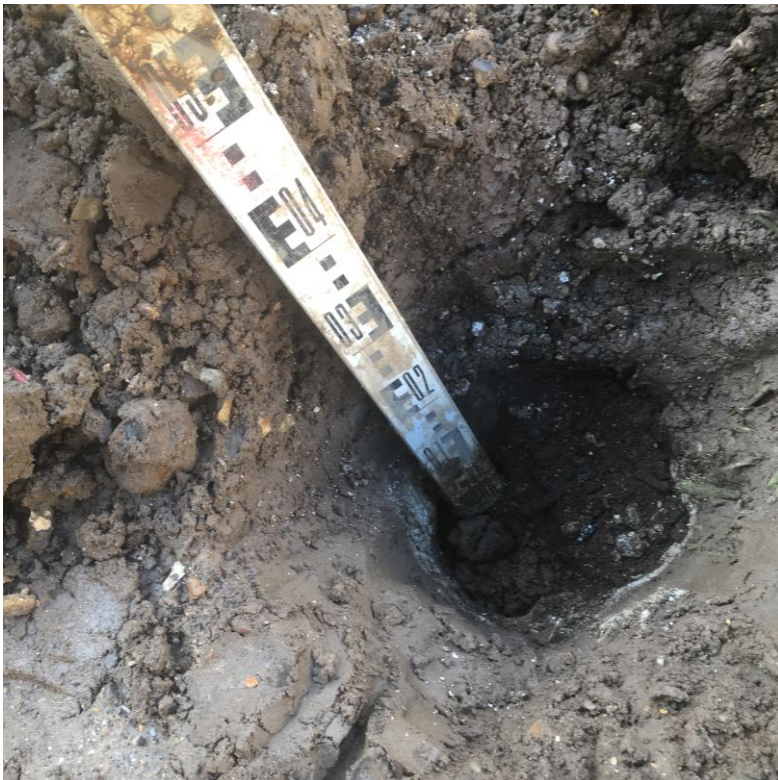
- Topsoil was yet to be put down in the front gardens of plot 259.
- A darker subsoil, with an appearance like that of previously identified unsuitable material, was logged in one location in the back garden of plot 258 (HDTP258-05). This was described as black slightly gravelly silty fine to medium sand. The gravel was sub-angular to sub-rounded fine to medium flint,

concrete and asphalt. This material was considered to be potentially unsuitable for use in the cover system. A sample of this material was scheduled for chemical testing which is discussed further in section 3.2.

Photograph 9, taken on the 3rd December 2019, showing the depth and nature of the darker subsoil encountered in plot 258 (HDTP258-05) that was proven to be chemically suitable to remain as part of the cover system.

As defined by the RMS the detected concentrations have been compared to soil screening values (S4UL and C4SL) for a residential land use with home grown produce. The results show that the detected concentrations of each contaminant were below the generic assessment criteria (C4SL and S4UL), and were therefore the darker subsoil material was considered suitable for use in this instance.

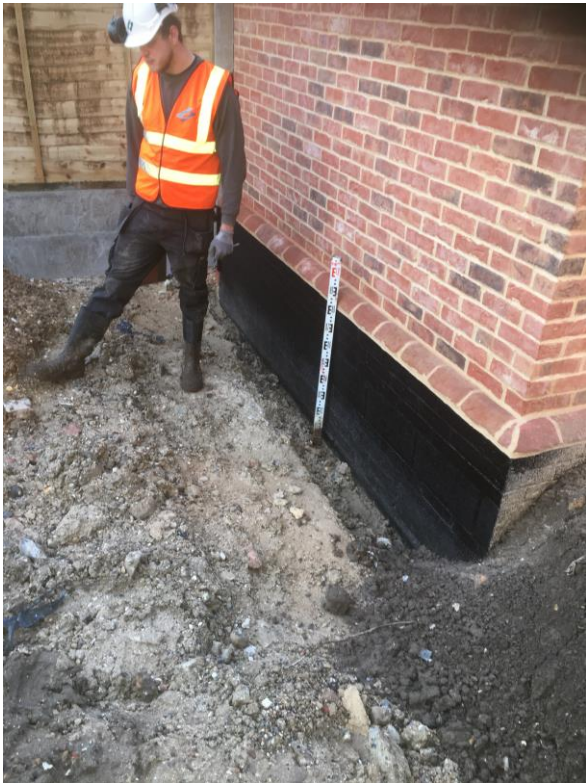
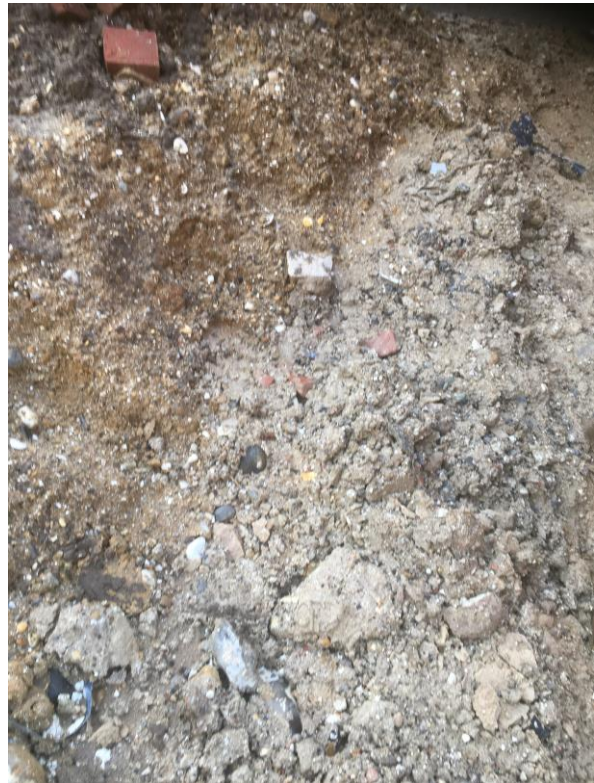
Photographs 10 and 11, taken on the 3rd December 2019, showing the excavation adjacent to the garage in plot 259 and the exposed subsoils.
