Document: Remediation Verification Report

Project: Needham Market Quarry

Reference No.: GN17820_RV7

Date: April 2019

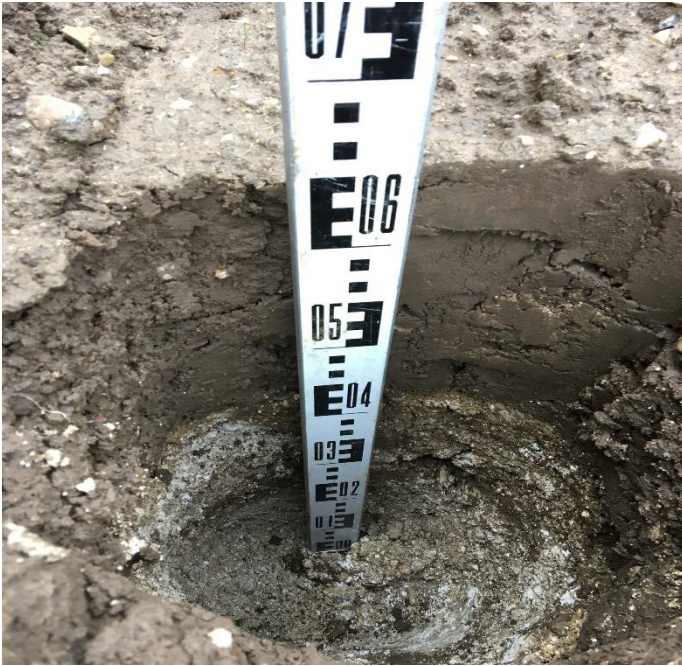
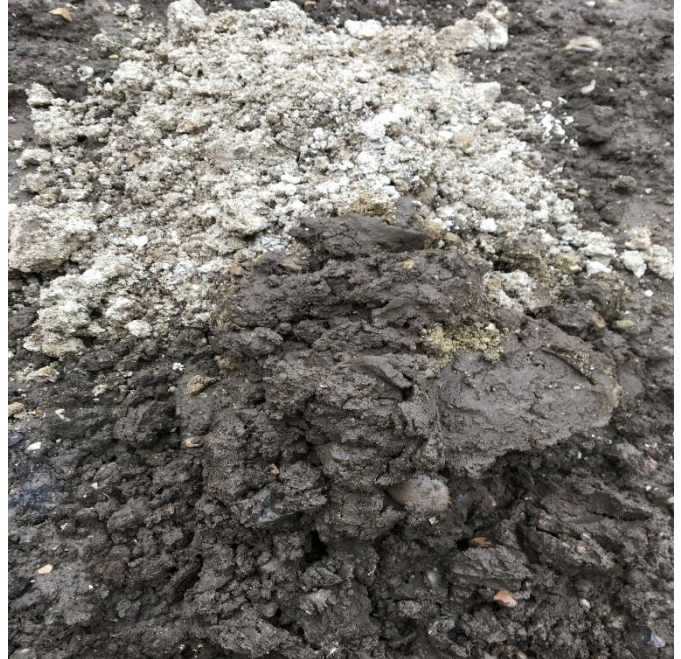
Photographs 1 - 2, taken on the 9th April 2019, showing the depth and nature of subsoil and topsoil within the front garden of plot 170 (HDTP170-05) and the arisings from the excavation.

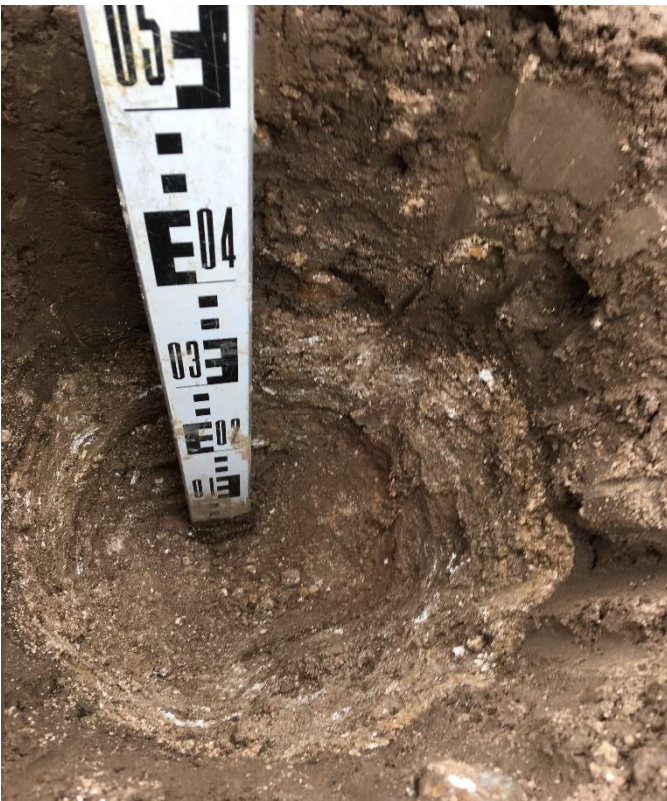
Photograph 3 - 4, taken on the 15th March 2019, showing the depth and nature of subsoil and topsoil within the back garden of plot 223 (HDTP223-02) and the arisings from the excavation.
