Document: Remediation Verification Report

Project: Needham Market Quarry

Reference No.: GN17820_RV21

Date: January 2021

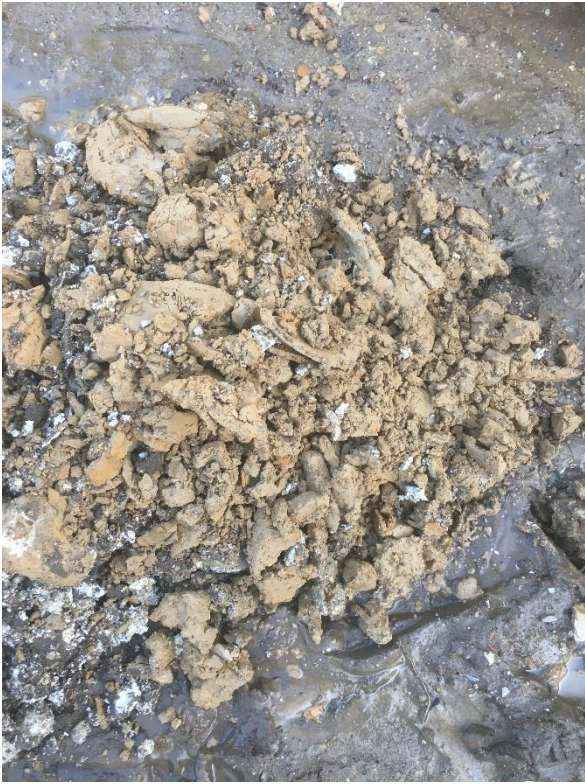
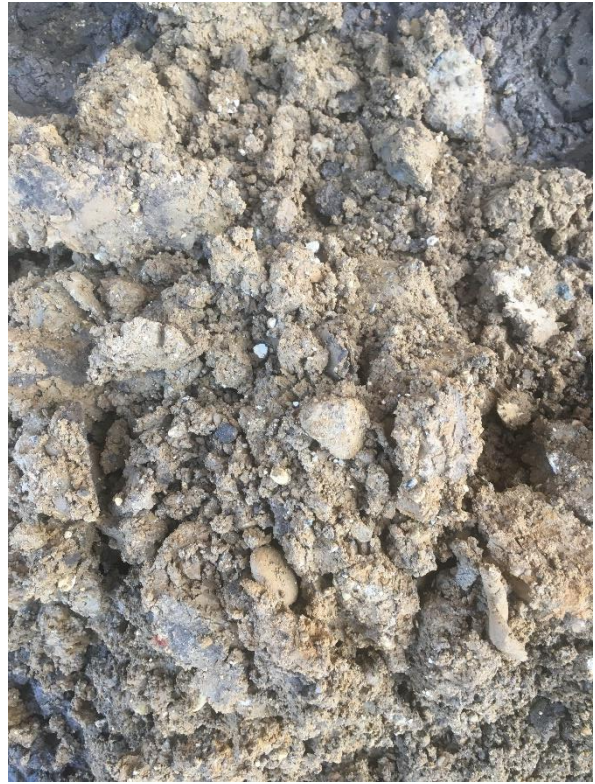
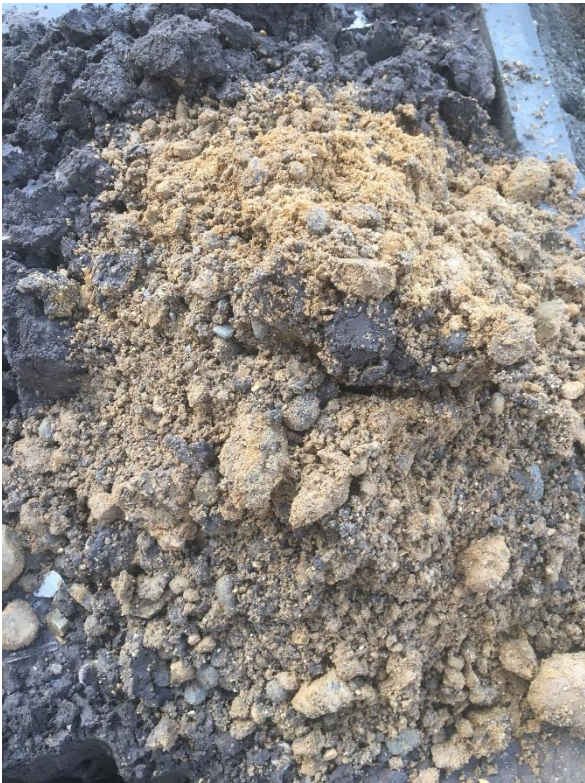
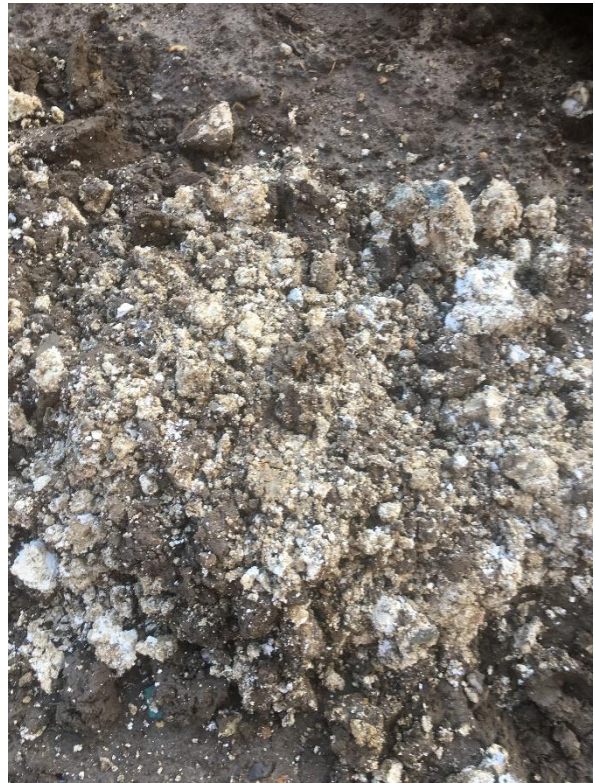
Photographs 1 - 4, taken on the 14th December 2020 showing the nature of the subsoil and topsoil within the cover systems for plots 3-7.

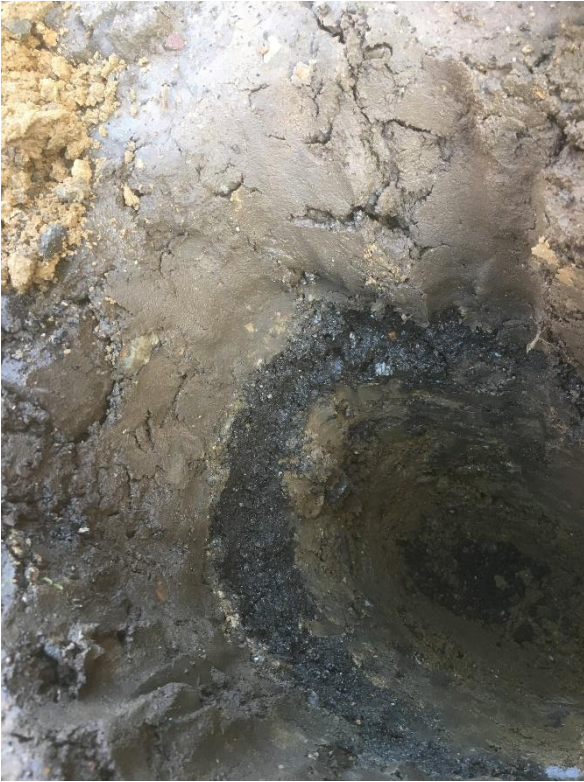
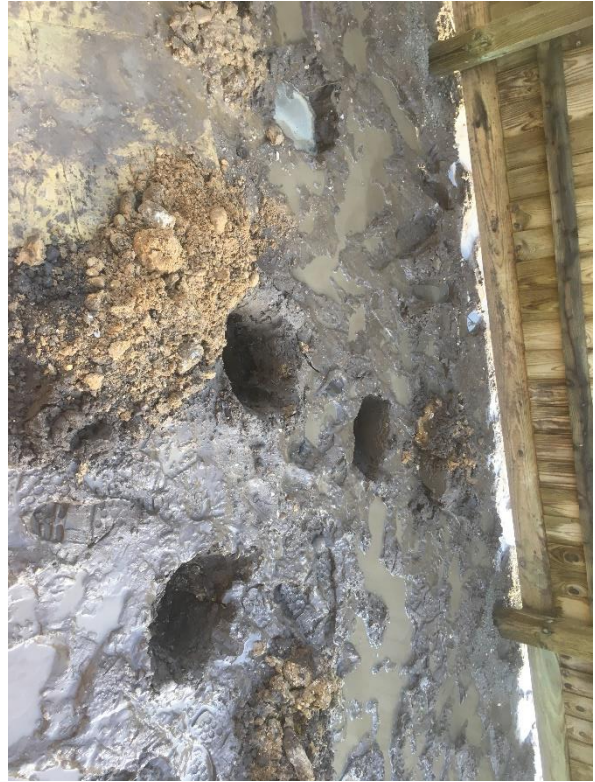
During this visit material described as a black gravelly sand was encountered within HDTP6-03 and HDTP7-03. Due to its appearance chemical testing was performed on two samples. The results of the chemical testing identified elevated concentrations of a number of polycyclic aromatic hydrocarbons (PAH) such that it was not considered chemically suitable to remain within the cover systems for these gardens. After discussions with the site manager, it was concluded that this material was used as a subbase below the nearby paved footpaths and contained asphalt chippings which is thought to be the source of the elevated PAHs. An

Photographs 5-6, taken on the 14th December 2020 showing the black material found, and the attempt to delineate the material within plot 7. The material in question was not present in the three surrounding exploratory locations.

engineer returned to site on the 05/01/21 and the 07/01/21 to observe groundworkers removing this material and replacing with additional topsoil from stockpile S02. Prior to backfilling, samples of the base and sides of the shallow excavation were obtained for chemical testing to ensure no cross contamination had occurred/all chemically unsuitable material had been removed. Photographs of this exercise are included within the appendix.

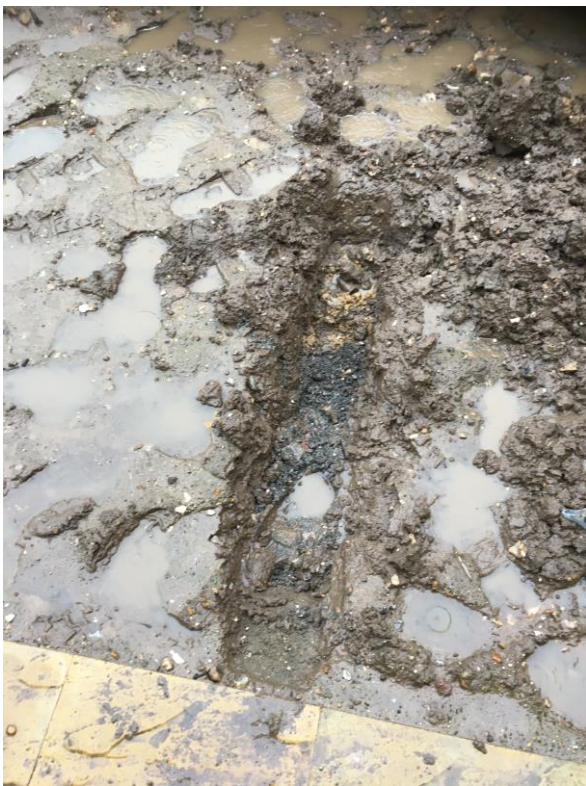
Photograph 7, taken on the 5th January 2021 showing the black material extending away from the paved footpath in plot 7.

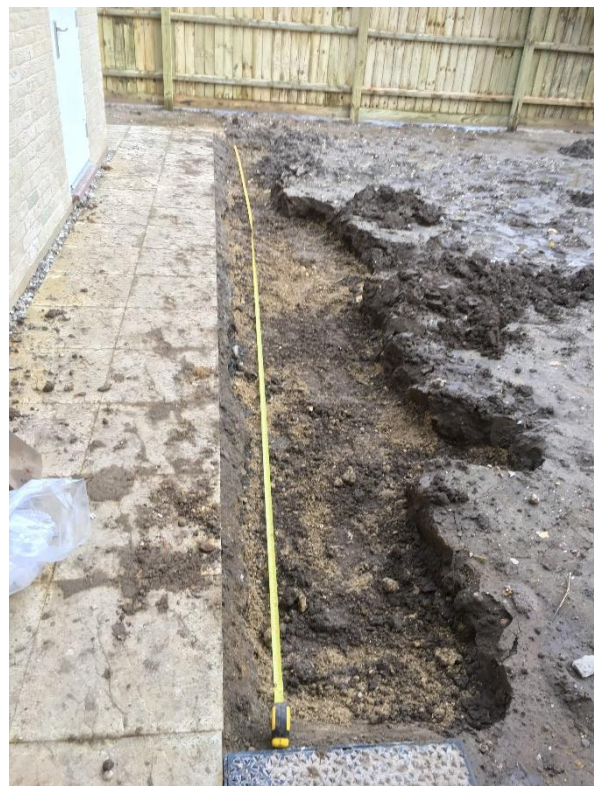
Photograph 8, taken on the 7th January 2021 showing the excavation of the black material encountered in plot 7.

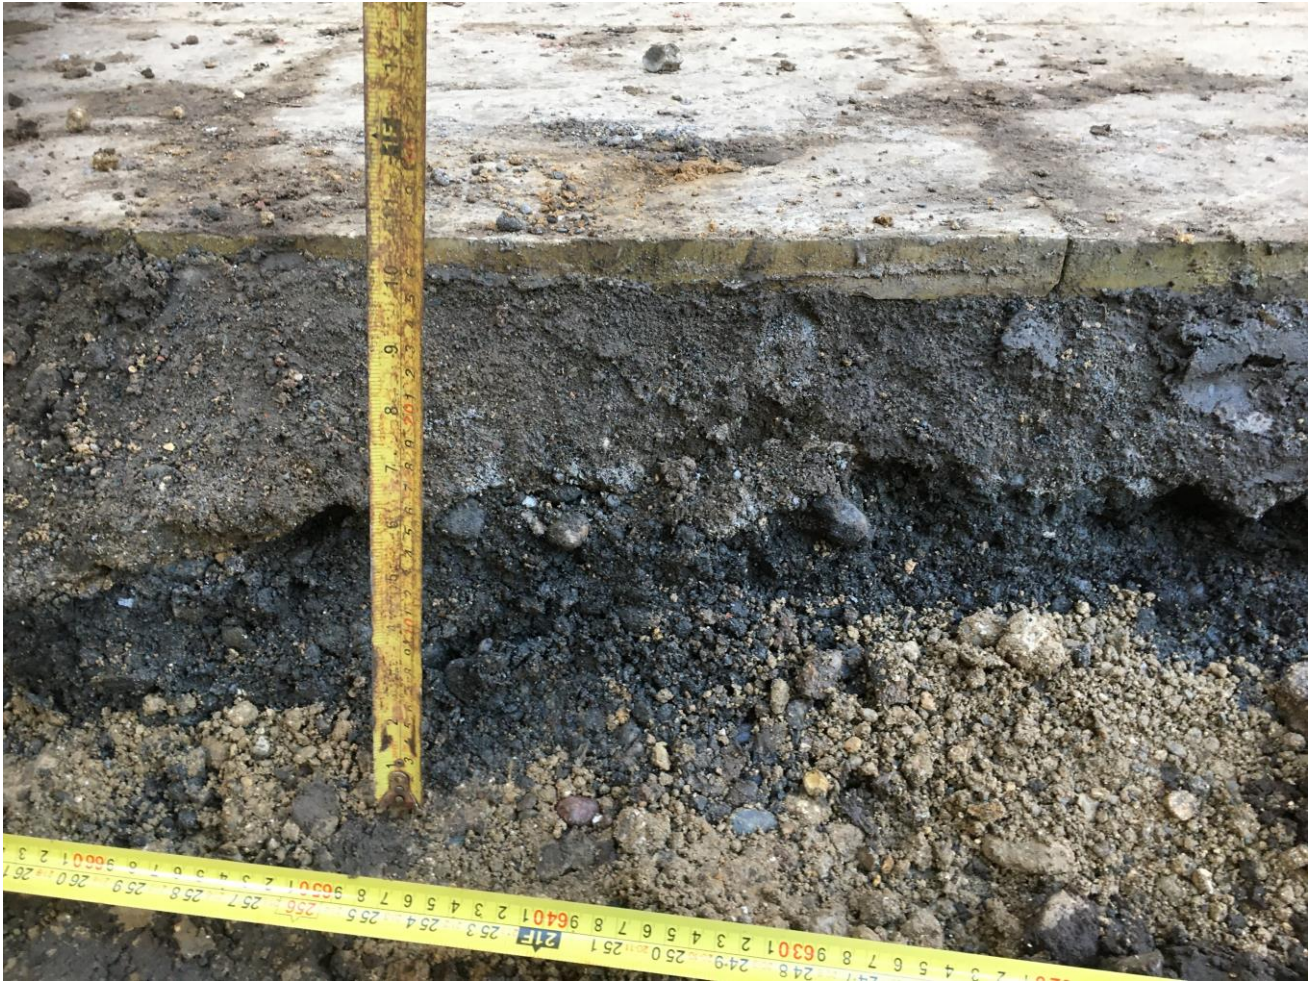
When the results of the laboratory analysis are compared against available S4UL screening levels, slightly elevated concentrations of benzo(a)anthracene, benzo(b)fluoranthene, benzo(a)pyrene and dibenzo(a,h)anthracene have been identified (within both samples). Due to these exceedances, the shallow black material was deemed to pose a significant risk to human health and as such it was necessary for the material to be removed.

Photograph 9, taken on the 7th January 2021 showing the black material found as a subbase underlying the paved footpath in plot 7. A concrete apron was observed extending at approximately 45° from the footpath which generally capped the subbase material.
