**Document:** Remediation Verification Report

**Project:** Needham Market Quarry

**Reference No.:** GN17820\_RV17

**VERIFICATION REPORT**  
**FOR REMEDIAL ACTIVITY**  
**AT**  
**NEEDHAM MARKET QUARRY**

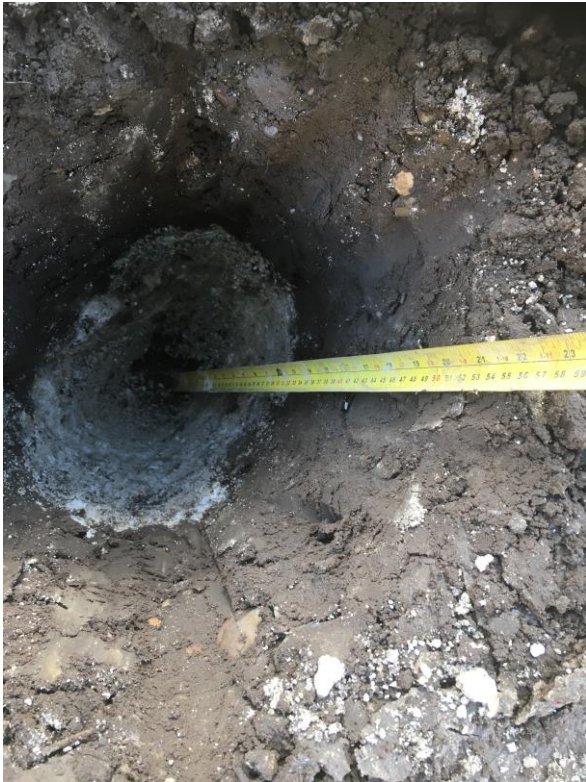
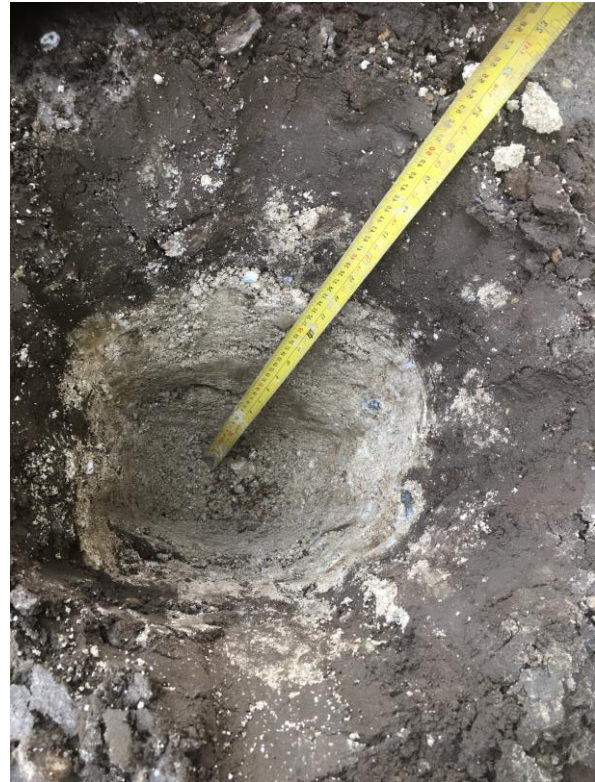
**Photographs 1 - 2**, taken on the 4<sup>th</sup> February 2020, showing the depth and nature of subsoil and topsoil within the front and rear garden area of plot 250 (HDTP250-06 and HDTP250-04).

This material was used for the topsoil (ground level up to 350mm depth) within the all pits excavated in plots 250, 263 and 264. The minimum thickness of 150mm of topsoil was encountered in all of the trial pits during the verification exercise.

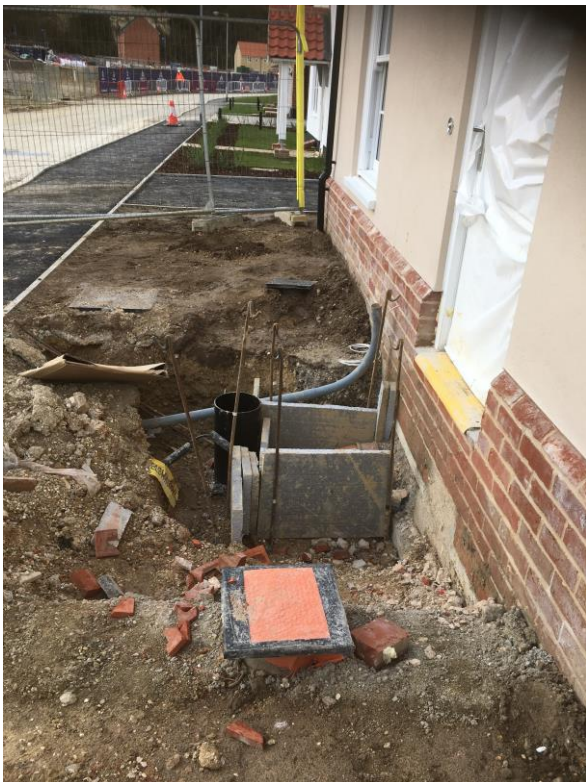
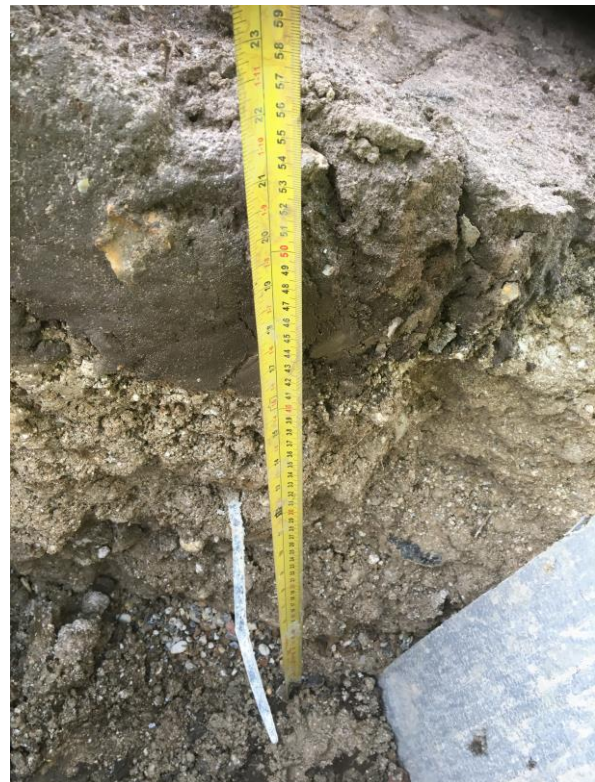
**Photographs 3 - 4**, taken on the 4<sup>th</sup> February 2020, showing the open excavation at the front of plot 250.

At the time of the visit, work was being completed to the front of plot 250 outside of the front door. The engineer was able to observe the open excavation and no unsuitable material was encountered. A footpath comprising paving slabs will also cover this area.

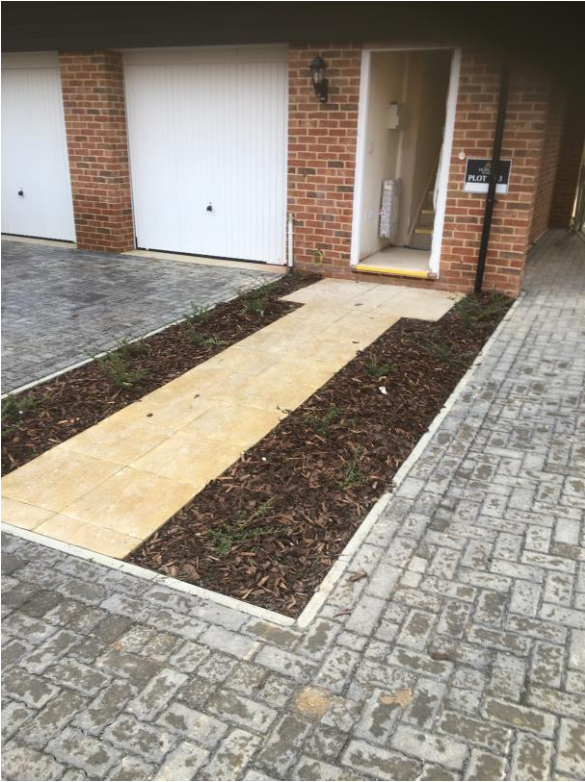
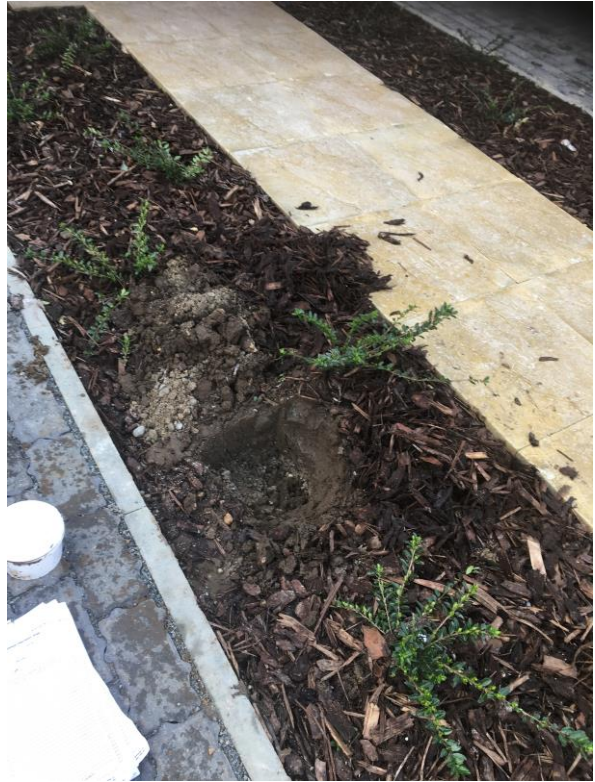
**Photographs 5 - 6**, taken on the 4<sup>th</sup> February 2020, showing the area of soft landscaping adjacent to the footpath to plot 263 which comprises topsoil over concrete.

Plot 263 comprised a flat with no rear garden area however trial pits were completed in the front garden area. A small strip of topsoil adjacent to the footpath leading up to plots 263 was shown to overlie concrete. Other acceptable deviations to the RMS were recorded where services were encountered in plots 250, 263 and 264.

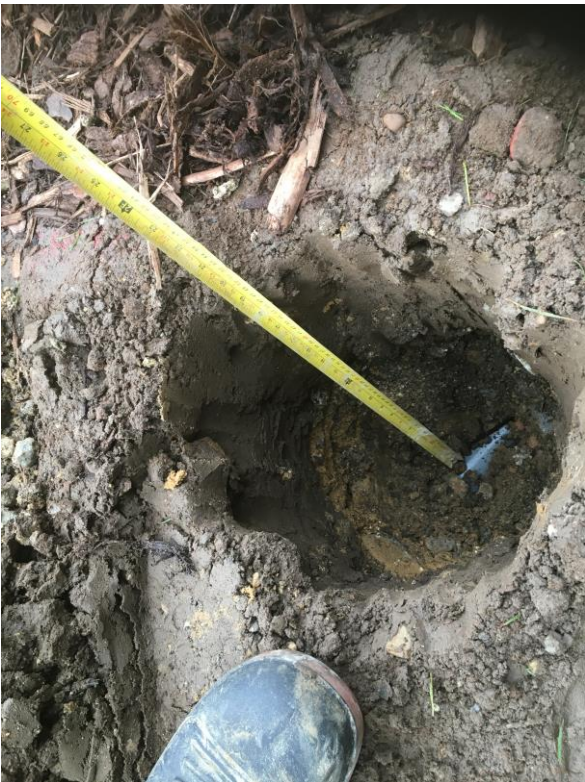
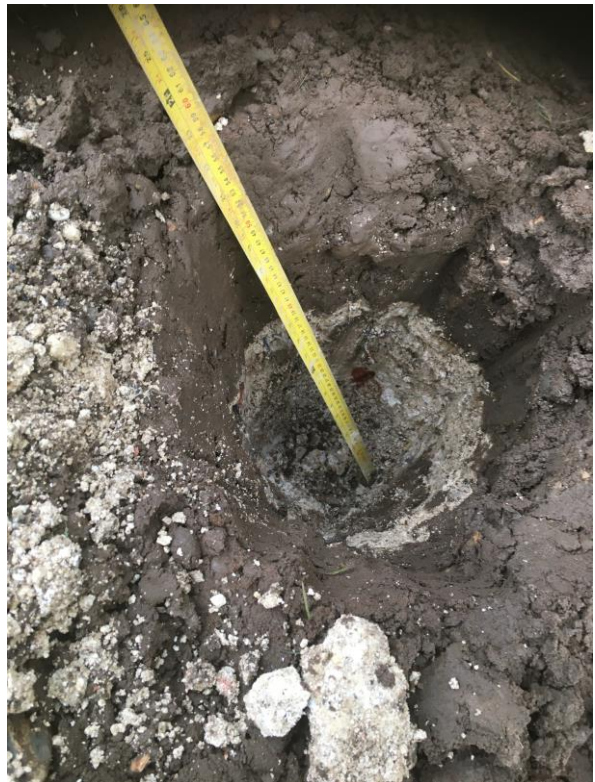
**Photographs 7 - 8**, taken on the 4<sup>th</sup> February 2020, showing the depth and nature of subsoil and topsoil within the front garden areas of plots 263 (HDTP263-01 and HDTP263-02).

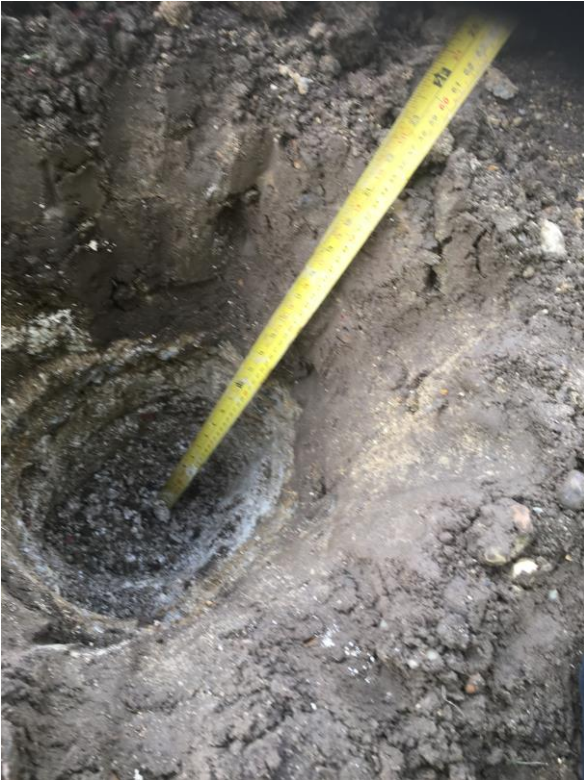
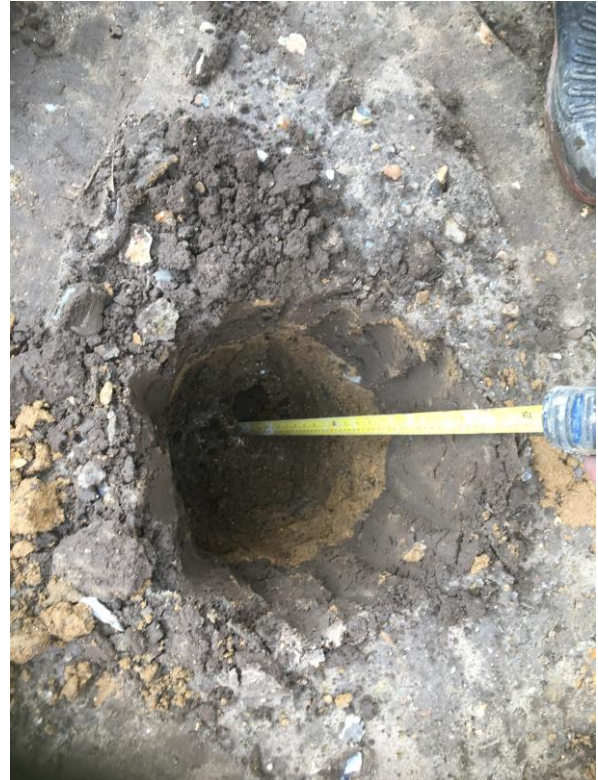
**Photographs 9 - 10**, taken on the 4<sup>th</sup> February 2020, showing the depth and nature of subsoil and topsoil within the front and rear garden areas of plots 264 (HDTP264-01 and HDTP264-05).

The materials encountered were considered satisfactory for use as subsoil from visual inspection. Samples were taken of the different made ground horizons from trial pits in the rear garden of plot 264.

During the site visit on the 04/02/20, four soil samples from the subsoil in the rear gardens of plot 264 were also scheduled for an asbestos screen to provide further confidence that these soils are suitable for use. The results of this testing has also been appended to this report (20-85062).
