HISTORIC BUILDING RECORDING AT  
HALL FARM, BOSTON ROAD,  
EAST HECKINGTON, LINCOLNSHIRE

PREPARED FOR MR. JAMES BRAMMA OF JB ARCHITECTURAL DESIGN SERVICES ON  
BEHALF OF HIS CLIENT - MR. NICK LOWETH  
PART 2: THE EAST RANGE

March 2021

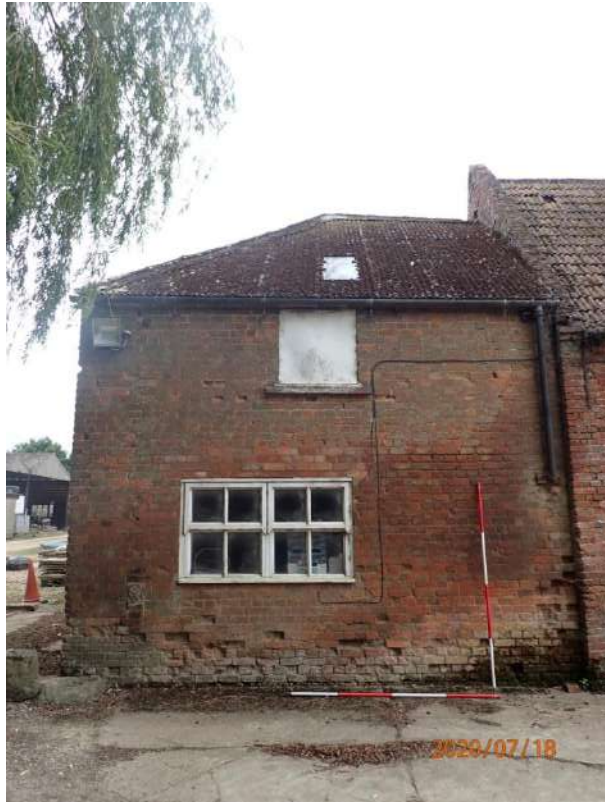
**Plate 166: View of the North Elevation of the East Range, from the north**

**Plate 166** presents a detailed view of the North Elevation of the East Range and thus of the northern end of this building. The brickwork wall fabric here is in the familiar English Bond, of courses of brick stretchers alternating with courses of brick headers. At just below roof levels is modern UPVC horizontal guttering that extends onto a cast metal downpipe to the right. At first floor levels is a north facing window opening, the exterior of which has been boarded over. A timber sill along with a modern concrete sill below this within the brickwork are featured. Below this is a second ground floor north facing window opening. This opening is occupied by a timber frame of a head, surrounds and a sill along with a modern glazed timber casement window of four lights with horizontal timber transoms and two vertical timber glazing bars. There is limited brick repair in brick stretchers above where this modern window was inserted into the wall fabric here.

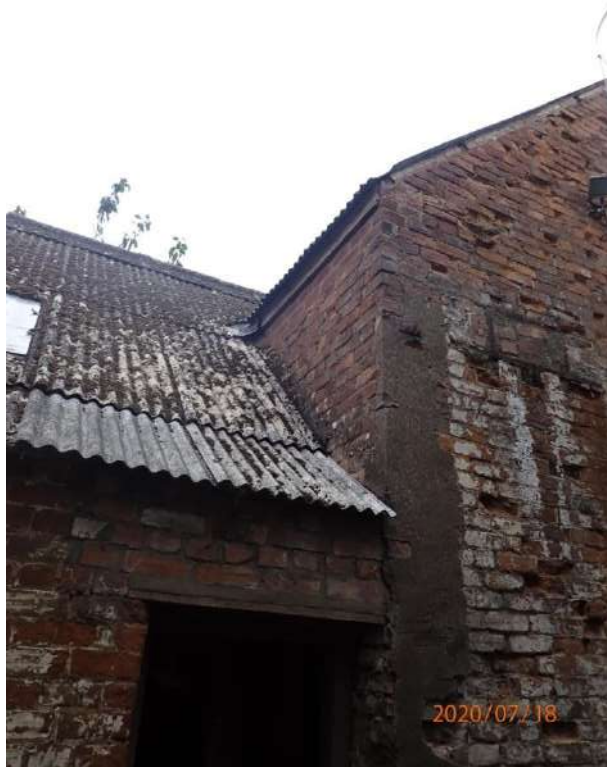
**Plate 167: View of the West Elevation of the East Range, from the south**

**Plate 167** presents a detailed image of the southern portion of the West Elevation of the East Range and the point at which the South Range of this outbuilding complex is bonded to this West Elevation. The brickwork wall fabric of this West Elevation is composed of courses of brick stretchers alternating with courses of brick headers in English Bond. At just below roof levels is a horizontal timber fascia board.

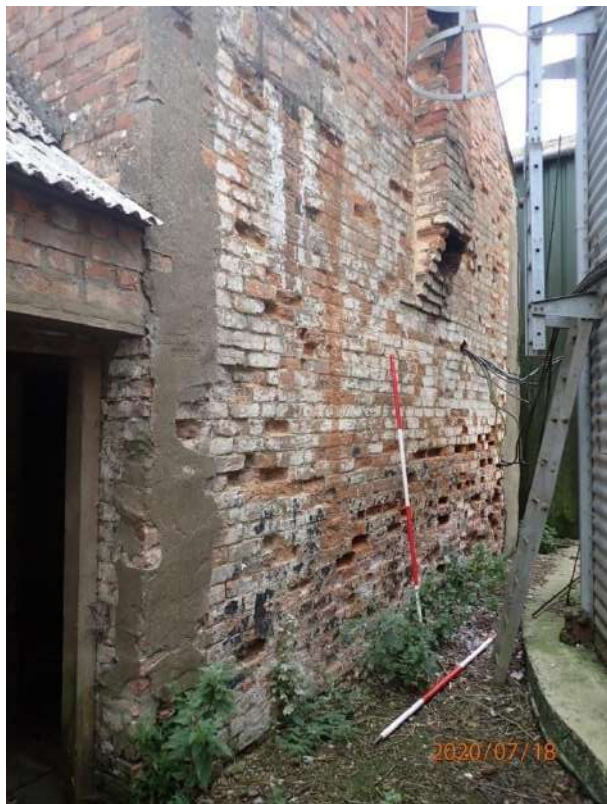
**Plate 168: View of the South Elevation of the East Range, from the west**

**Plates 168-172** provide a number of detailed views of the South Elevation of this East Range from different vantage points. The brickwork wall fabric here was difficult to discern, but appears to be composed of two-three courses of brick stretchers alternating with one course of brick headers in English Garden Wall Bond. Of particular note is the external vertical brick chimney stack, which is mostly composed of courses of brick stretchers, and which is stepped at its base. This extends up to the gabled roof line. To the right and at the upper levels of this brickwork wall fabric are two cast metal wall braces.

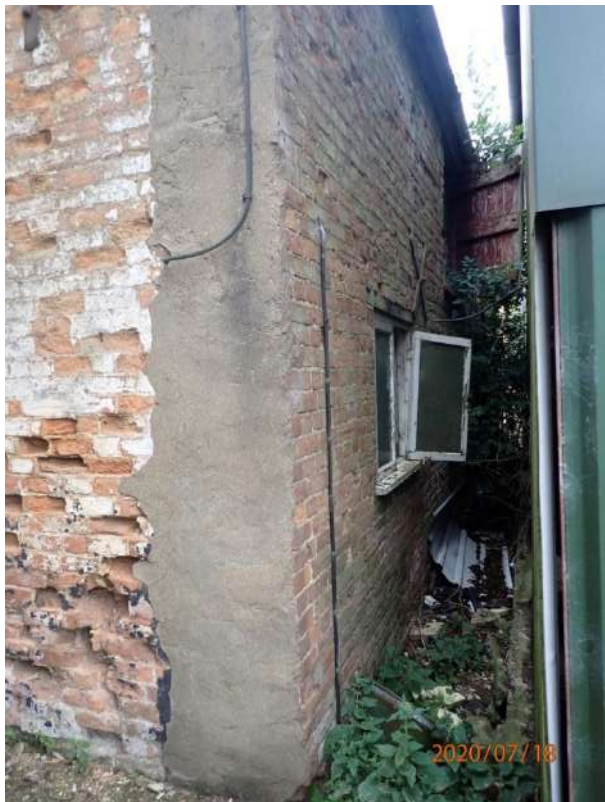
**Plate 173: View of the East Elevation of the East Range, from the south**

**Plates 173 and 174** present several oblique views of the southern end of the East Elevation of this East Range. The brickwork wall fabric here is in English Garden Wall Bond, of three courses of brick stretchers alternating with one course of brick headers. At just below roof levels are horizontal timber fascia boards to which is attached modern Upvc horizontal guttering. At ground floor levels is an east facing window opening, which is occupied by a glazed two light modern timber casement window with a timber frame of a head, surrounds and a sill. Above the opening is an horizontal timber lintel that is incorporated into the brickwork wall fabric here. In the background and at first floor levels is a probable former hay loft opening. A timber door that is composed of a series of vertical tongued and grooved timber planks that are attached to an internal framework of horizontal timbers are visible.

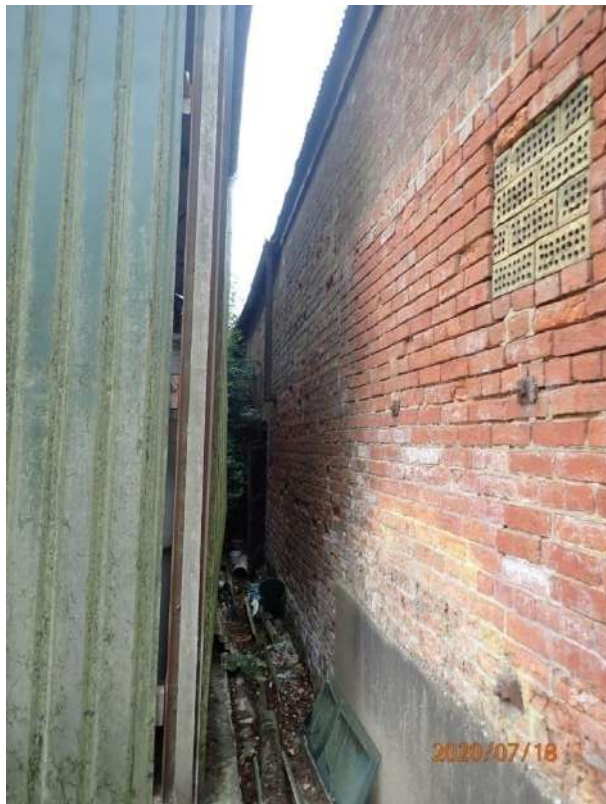
**Plate 175: View of the East Elevation of the East Range, from the north**

**Plate 175** furnishes a further oblique view of the southern end of the East Elevation of this East Range from a different northern position. The brickwork wall fabric of this portion of this East Elevation is composed of 3-4 courses of brick stretchers alternating with one course of brick headers in a variation of English Garden Wall Bond. At just below roof levels are horizontal timber fascia boards to which is attached the remains of modern Upvc horizontal guttering and a partial cast metal downpipe.

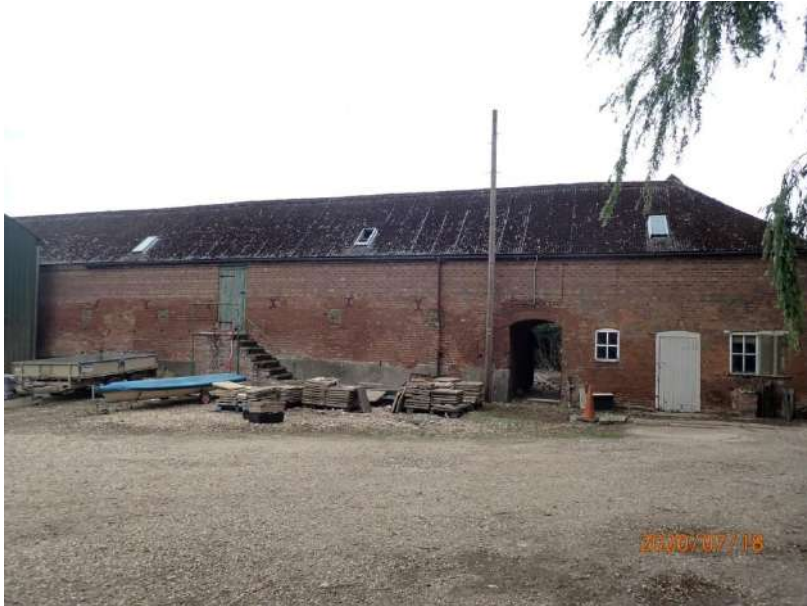
**Plate 176: View of the East Elevation of the East Range, from the east**

**Plates 176 and 177** present general views of the central and northern portions of the East Elevation of this East Range.

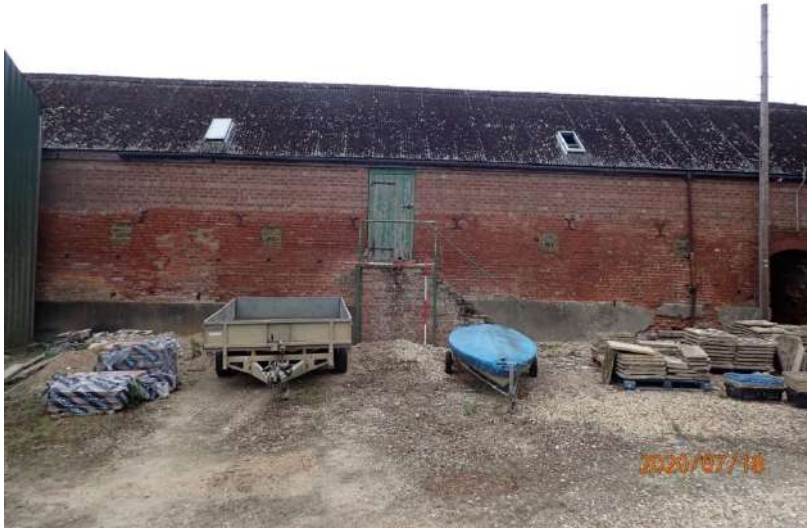
**Plate 178: View of the East Elevation of the East Range, from the east**

**Plates 178-180** furnish detailed images of the central portion of the East Elevation of this East Range from several different vantage points. The brickwork wall fabric here is composed of three courses of brick stretchers alternating with one course of brick headers in English Garden Wall Bond. It is also clear from the nature of this brickwork wall fabric, that this Elevation has been subject to modern repair and/or alteration, probably in the 20th century as the upper levels of this brickwork appear to be of more modern origin. A series of cast metal wall cross braces have also been inserted into the brickwork wall fabric close to the join between the earlier and more modern brickwork wall fabric. Also inserted into the brickwork wall fabric are a series of panels, that are infilled with air vent bricks. The lowermost levels of this wall fabric have been covered over with an horizontal band of cement rendering. At just below roof levels are horizontal timber fascia boards to which is attached cast metal horizontal guttering that extends onto a vertical cast metal downpipe to the right.

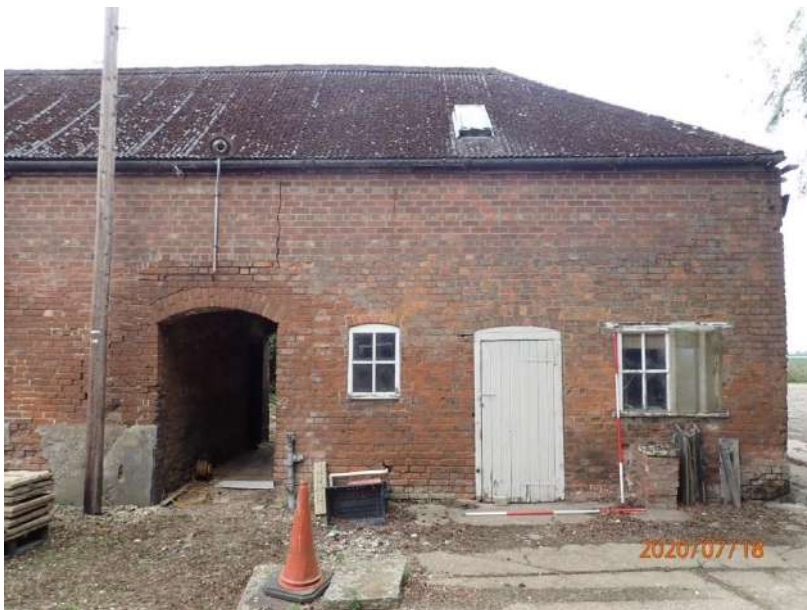
**Plate 181: View of the East Elevation of the East Range, from the east**

**Plate 181** presents a detailed image of the northern end of this East Elevation. The lower levels of the brickwork wall fabric here are in English Bond, of courses of brick stretchers alternating with courses of brick headers. Here also, the upper levels of this northern portion have also been

subject to the same modern 20th century programme of repair and/or alteration with the addition of further modern brickwork in English Garden Wall Bond as in the central portion of this East Elevation. Though at the very northern end and approaching the north-east corner of the building is original brickwork, which is up to the two storeys in height of the building. The brickwork at this point is in English Bond in contrast to the adjoining brickwork, which is in English Garden Wall Bond.

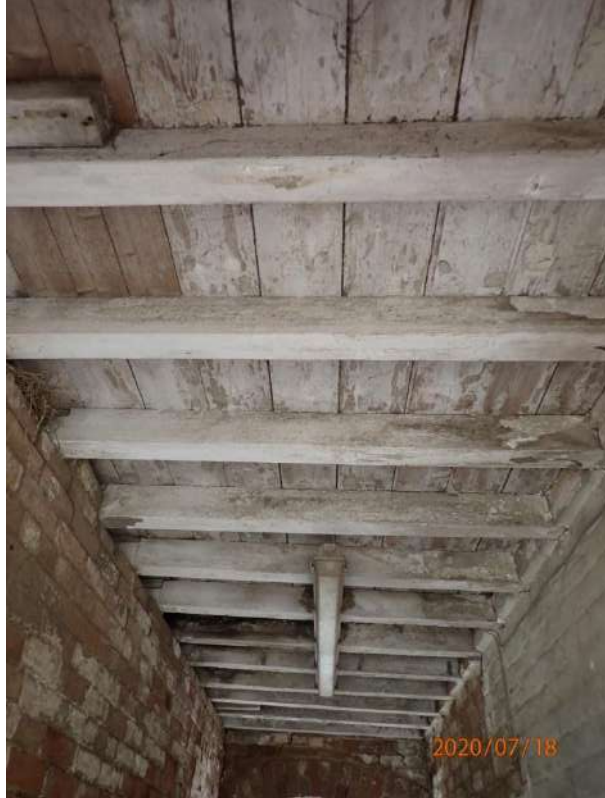
**Plate 183: View of the interior of the northern tunnel within the East Range, from the east**

**Plates 183 and 185** feature the nature of the ceiling of the north tunnel, which is composed of a series of north-south aligned horizontal timber joists, which support a first floor, floor covering of horizontal timber planking, which are east-west orientated.

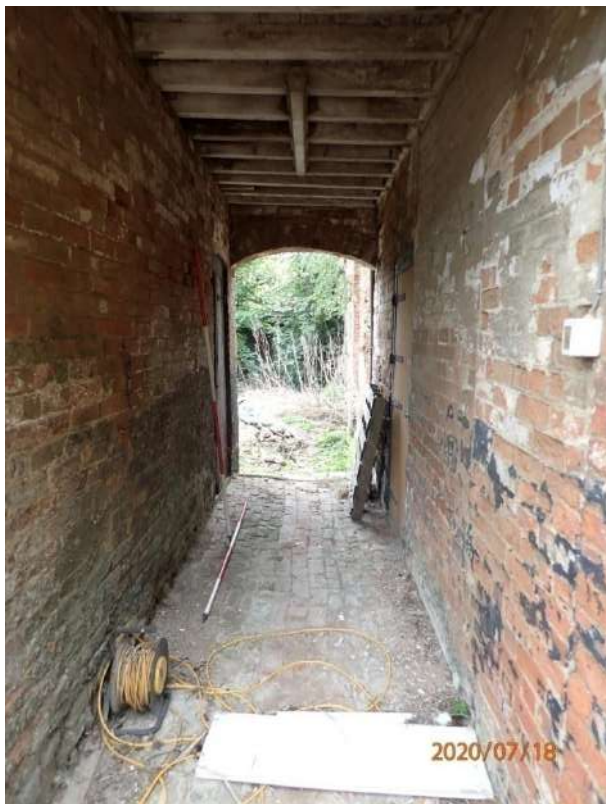
**Plate 186: General view of the interior of the northern tunnel within the East Range, from the east**

**Plates 186 and 188** present general views of the interior of the north tunnel from both eastern and western vantage points.

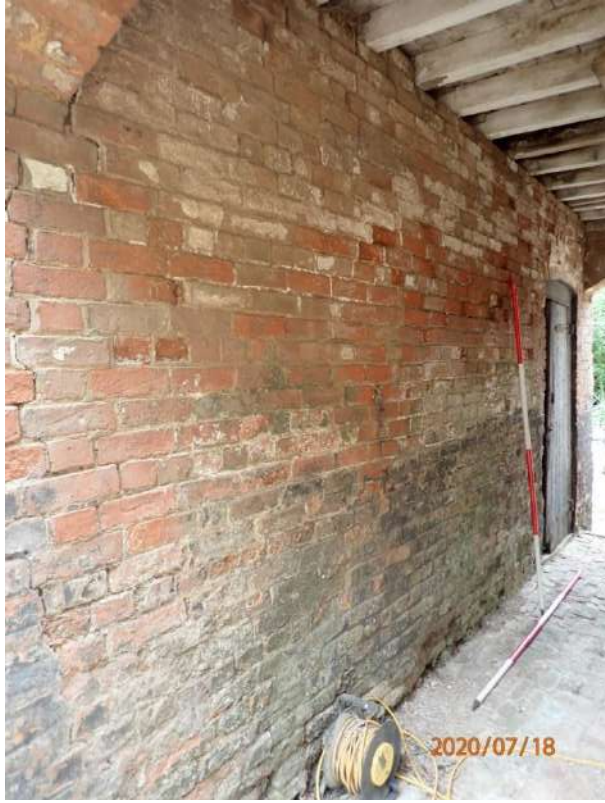
**Plate 187: View of the south wall of the northern tunnel within the East Range, from the east**

**Plates 187 and 189** feature detailed views of the south wall of the north tunnel. The brickwork wall fabric here is composed of three courses of brick stretchers alternating with one course of brick headers in English Garden Wall Bond. The southern ends of the ceiling joists may be seen to be inserted into the uppermost levels of this wall fabric. At the western end of this wall is a south facing entrance opening that leads onto the ground floor **Cell 8**. This opening is occupied by a timber frame of a head and surrounds and a door that is composed of a series of vertical tongued and grooved timber planks. The door is attached to the frame by two horizontal cast metal strap hinges. Above the opening is a curved head in brick composed of brick stretchers laid on edge.

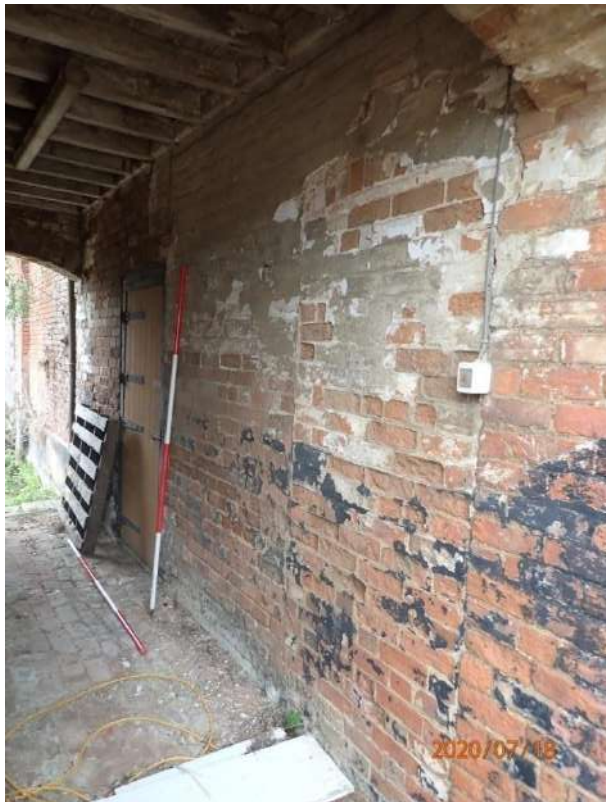
**Plate 190: View of the north wall of the northern tunnel within the East Range, from the east**

**Plates 190 and 191** provide detailed views of the opposing north wall of the tunnel. The brickwork wall fabric here is composed of three courses of brick stretchers alternating with one course of brick headers in English Garden Wall Bond. The northern ends of the ceiling joists may be seen to be inserted into the uppermost levels of this wall fabric. At the eastern end of this brickwork is

an infilled former north facing entrance opening, which is marked by two vertical dividing lines. The brick infilling matches that of the surrounding brickwork. Above this former opening is a curved head in brick that is composed of brick stretchers laid on edge. At the western end of this north wall is a north facing entrance opening that leads onto the ground floor **Cell 7**. This second opening is occupied by a timber frame of a head and surrounds and a modern door that is composed of a series of vertical tongued and grooved timber planks. The door is attached to the frame by four horizontal cast metal strap hinges. Above the opening is a curved head in brick that is composed of brick stretchers laid on edge.

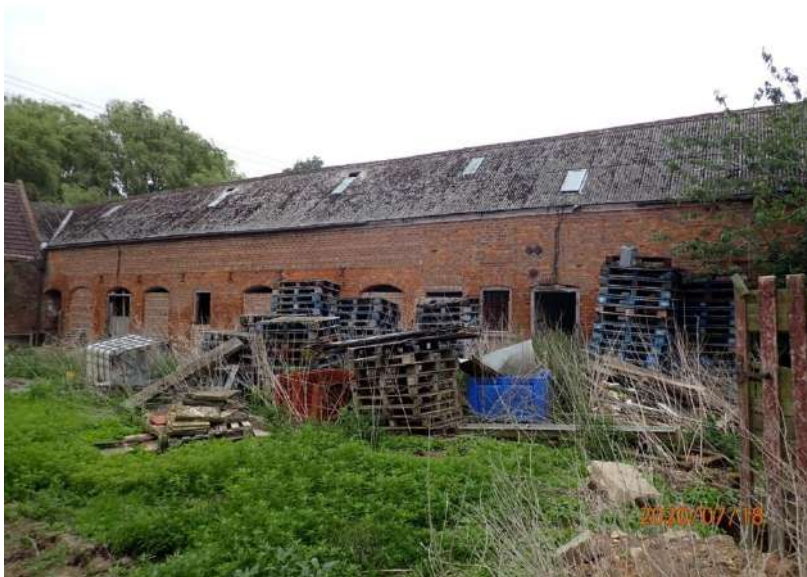
**Plate 192: General view of the West Elevation of the East Range, from the west**

**Plates 192 and 193** present general views of the two storey East Elevation of this East Range from western viewpoints.

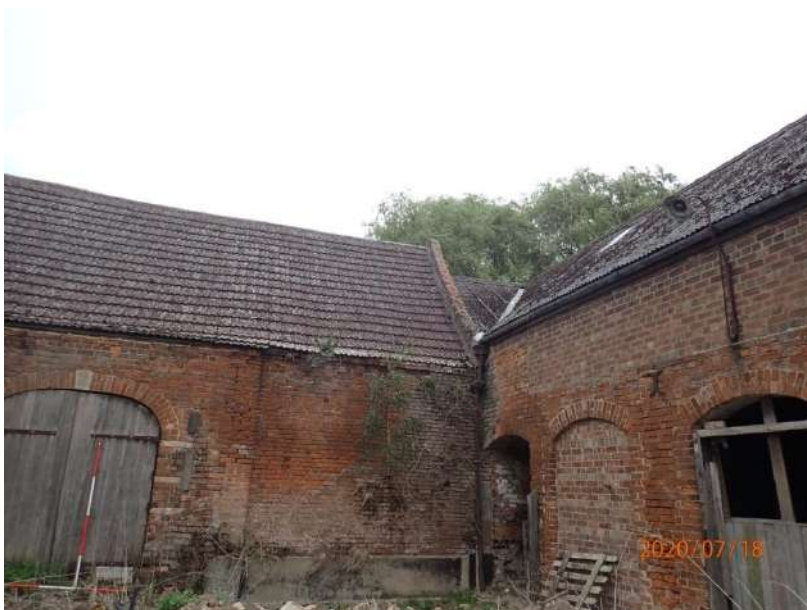
**Plate 194: View of the West Elevation of the East Range, from the south**

**Plate 194** provides a detailed image of the short western return of the East Range at its northern end where it is bonded to the East Elevation of the adjoining North Range.

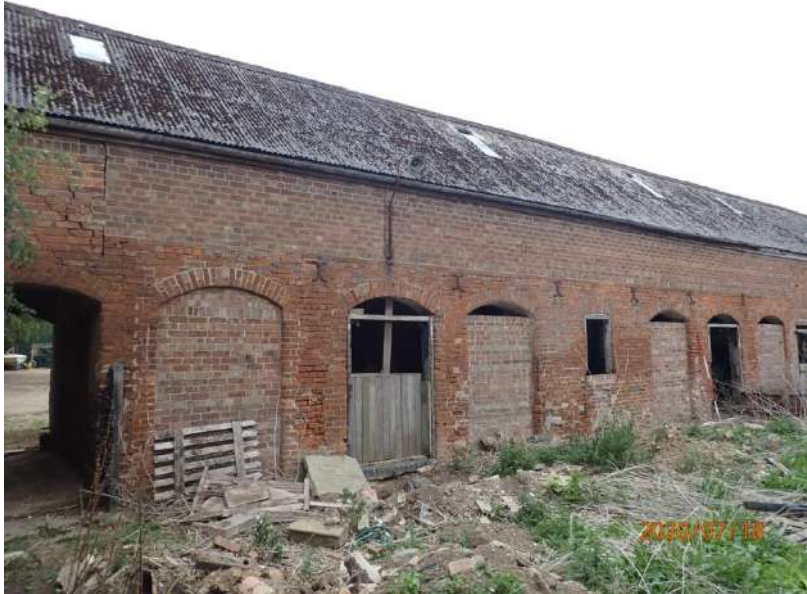
**Plate 195: View of the West Elevation of the East Range, from the north-west**

**Plates 195-199** present a number of detailed images of this East Elevation, though the detail at the southern end of this Elevation was not accessible at the time of this survey and so could not be discerned due to dense tree and overgrowth and stacked wooden pallets here.

At ground floor levels and to the right of the arched tunnel are a series of six west facing openings or bays. The edges of each these are faced with bull nosed brick stretchers. Four of these have been blocked off and infilled with brick, probably in the 20th century by the nature of the bricks themselves. This brick infilling is composed of three courses of brick stretchers alternating with one course of brick headers in English Garden Wall Bond, with three of the infills topped with a single course of brick headers. Each opening or bay also has a rounded arch or head composed of splayed and alternating brick headers and brick stretchers laid on edge. The two remaining openings have had timber door frames of heads and surrounds inserted into each opening. One of these openings has a single timber half door attached to the door frame, which is composed of a series of vertical tongued and grooved timber planks. The second opening is open to the elements. At the base or threshold of the second opening in this grouping of six, is a single course of bull nosed stone quarry bricks.

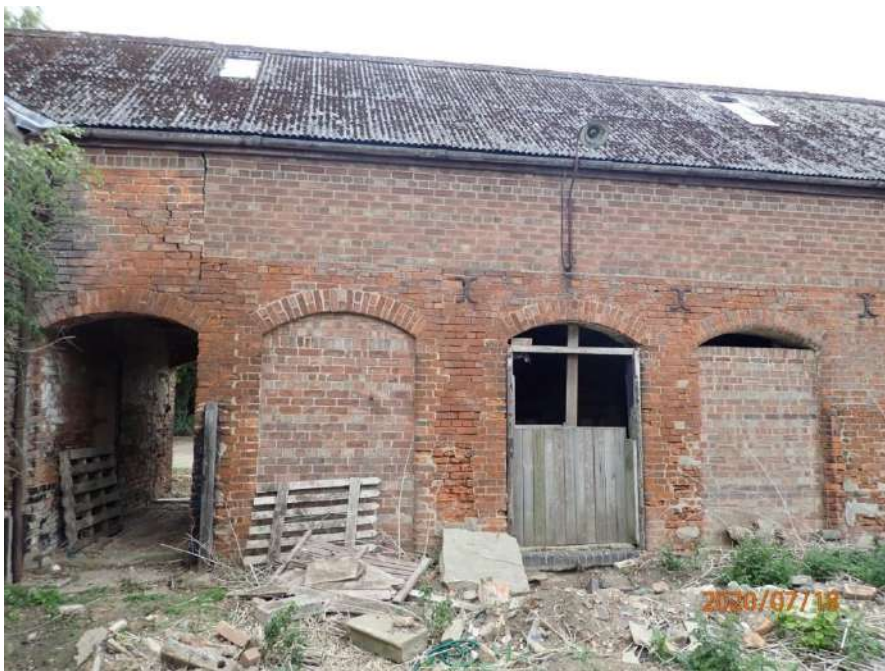
**Plate 196: View of the West Elevation of the East Range, from the west**

In between the third and fourth of these ground floor west facing openings or bays, is a small west facing window opening. This is unglazed and is occupied by a timber frame of a head and surrounds. Above the opening is a curved head in brick composed of brick stretchers laid on end.

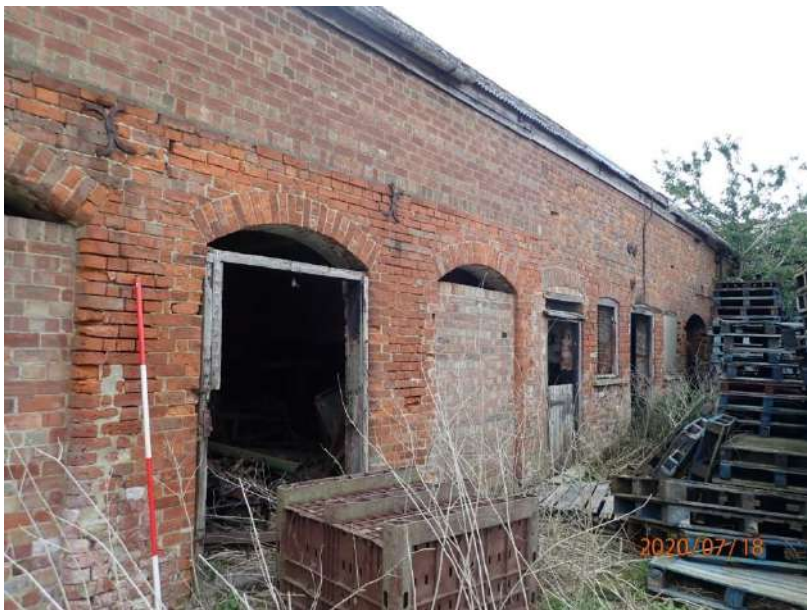
**Plate 198: View of the West Elevation of the East Range, from the north-west**

**Plates 198 and 199** feature the ground floor doors and window openings at the southern end of this East Range. To the right of and beyond the southernmost of the group of west facing openings or bays already discussed, is the first of two discernible ground floor west facing entrance openings.

This first west facing ground floor entrance opening is occupied by a timber frame of a head and surrounds which does not fully occupy this opening. Attached to this door frame is a timber half door that is composed of a series of vertical tongued and grooved timber planks. Above the head of the door frame is a horizontal timber lintel and above this, modern brick infilling and a curved head in brick composed of brick stretchers laid on edge.

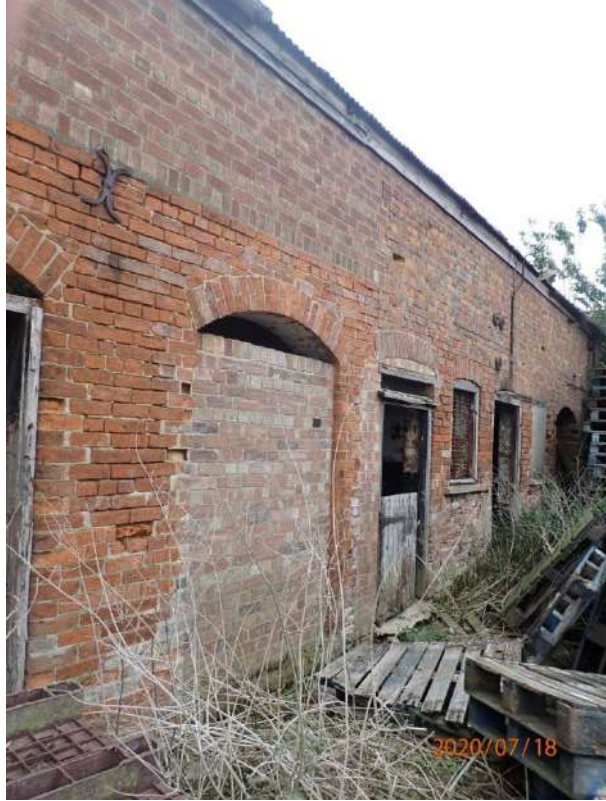
**Plate 199: View of the West Elevation of the East Range, from the north**

To the right, is a second west facing ground floor window opening. This is unglazed and is occupied by a timber frame of a head and surrounds with a stone sill at the base of the opening. The opening is infilled with wire netting. Above the opening is a curved head in brick composed of brick stretchers laid on edge.

To the right, is a third ground floor west facing window opening, which has been boarded over with modern timber boarding. A stone sill is visible at the base of the opening. Above the opening is a curved head in brick composed of brick stretchers laid on edge.

To the right and at the very southern end of this East Elevation is a second east-west orientated tunnel, which was not accessible from the eastern side at the time of this survey. The head of the tunnel is discernible and is arched with a curved head in brick composed of alternating brick stretchers and brick headers laid on end.

Above these various openings and at first floor levels, is further evidence for extensive modern repair and addition to this building. This is denoted by the modern 20th century brickwork at these first floor levels, that is composed of three courses of brick stretchers alternating with one course of brick headers in English Garden Wall Bond. The division between the lower level original brickwork and the modern repair/addition is also marked by a line of further cast metal cross wall braces. This area of modern repair and addition also ceases at a further vertical dividing line at the southern end of this Elevation. This second vertical division extends up to roof levels above and just beyond the southernmost and sixth of the grouping of the aforementioned ground floor west facing openings or bays. Beyond this vertical dividing line in this brickwork, the original brickwork extends up to the full building height of two storeys and up to the roof levels to the end of the remainder of this southern portion of this Elevation.

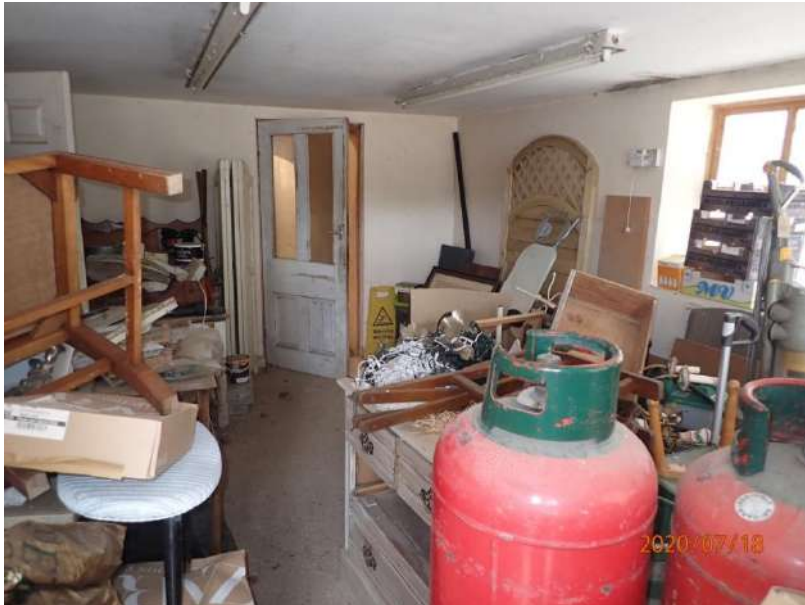
**Plate 200:** General view of the interior of Cell 6, from the east

**Plate 200** presents a general view of the interior of **Cell 6**. The ceiling as well as all four walls of this room space have been rendered over with modern plasterwork. The flooring of **Cell 6**, is of modern concrete.

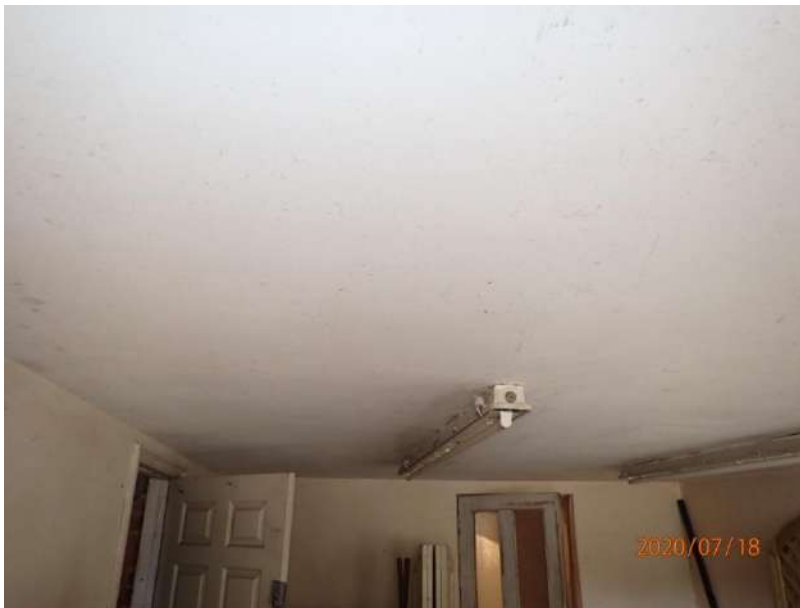
**Plate 201:** View of the ceiling of Cell 6, from the east

**Plates 201 and 202** feature the ceiling of **Cell 6**.

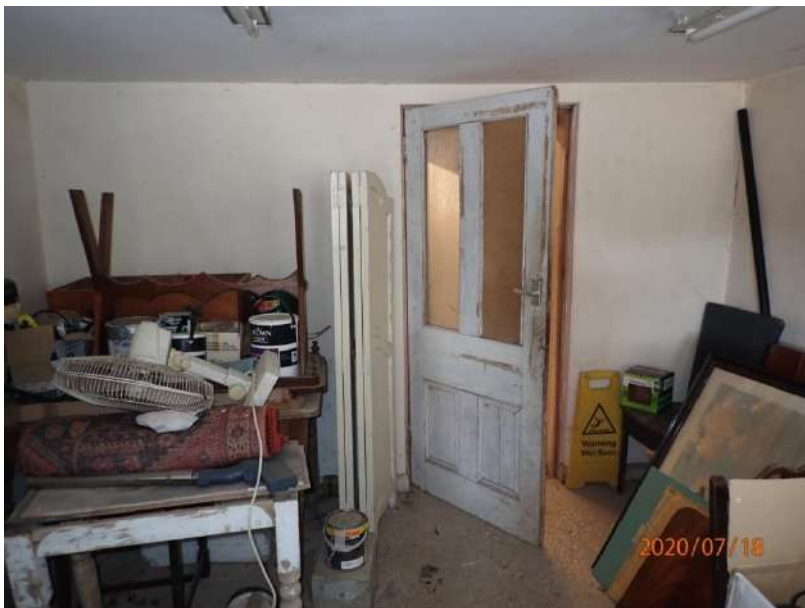
**Plate 203: View of the west wall of Cell 6, from the east**

**Plate 203** shows the west wall of **Cell 6** and in particular the west facing entrance opening that leads onto the ground floor of the adjoining North Range or **Cell 1** to the west. This opening is occupied by a modern timber frame of a head and surrounds and a four panelled timber door, including two lights, one of which is unglazed.

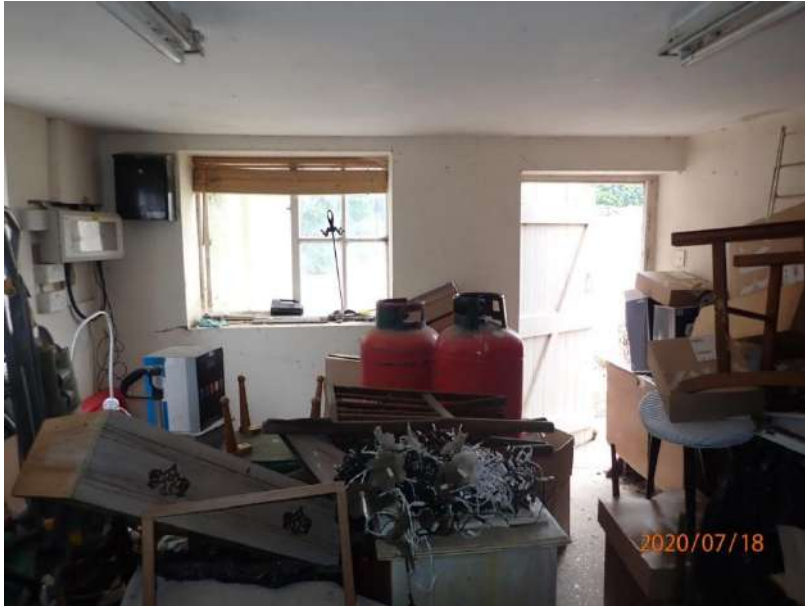
**Plate 204: View of the east wall of Cell 6, from the west**

**Plate 204** features the east wall of **Cell 6**, including the inner face of the west facing entrance opening that was recorded externally at the East Elevation of this building. The opening is occupied by a timber frame of a head and surrounds and a door that is composed of a series of vertical tongued and grooved timber planks that are attached to an internal framework of angled and horizontal timbers. To the left, is the inner face of the slightly recessed east facing window opening that was also recorded externally at the East Elevation of this building.

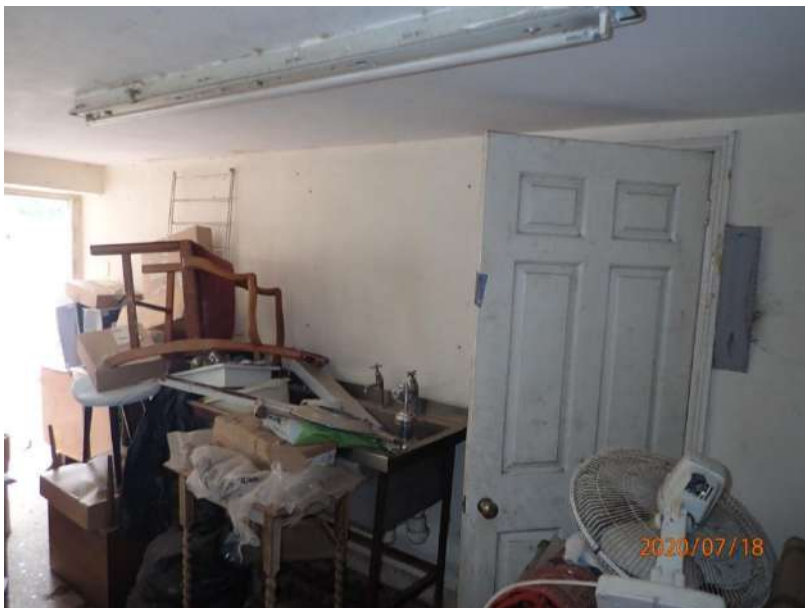
**Plate 205: View of the south wall of Cell 6, from the west**

**Plates 205 and 206** present images of the south wall of **Cell 6**. These show the south facing entrance opening that leads onto the adjoining **Cell 7** to the south. This opening contains a timber frame of a head and surrounds of architrave along with a modern six panelled timber door.

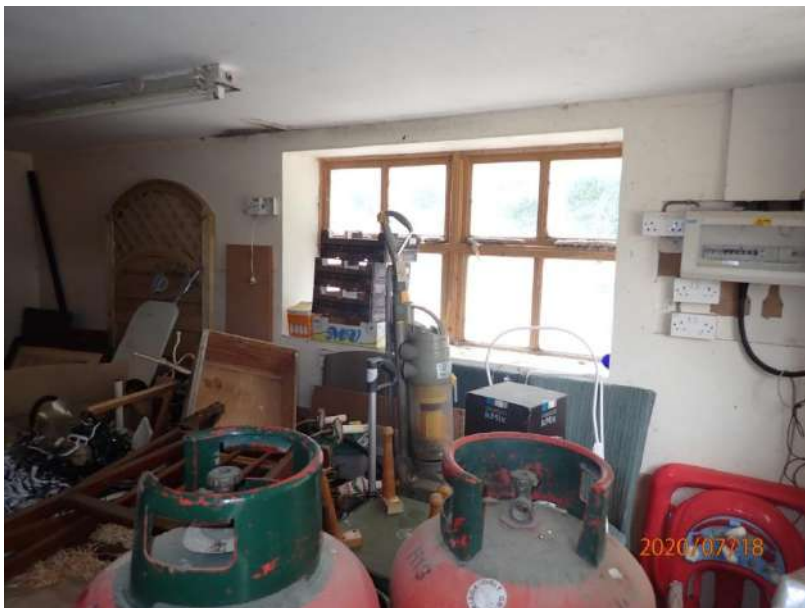
**Plate 207: View of the north wall of Cell 6, from the south**

**Plate 207** features the north wall of **Cell 6** including the slightly recessed inner face of the ground floor north facing window opening that was recorded externally at the North Elevation of this building. This opening is occupied by a modern glazed eight light timber casement window with one central vertical timber mullion, two horizontal timber transoms and two vertical timber glazing bars.

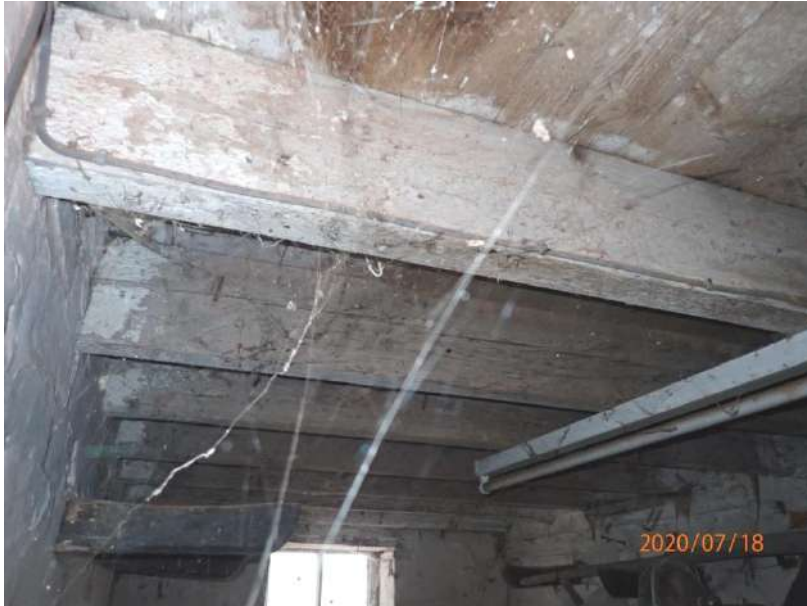
**Plate 208: View of the ceiling of Cell 7, from the west**

**Plates 208 and 215** present views of the nature of the ceiling of **Cell 7**. Shown are the series of north-south orientated horizontal timber joists, the ends of which are inserted into the uppermost levels of the brickwork wall fabric of the north and south walls of **Cell 7**. To these joists are attached the first floor east-west aligned horizontal timber floor planking above.

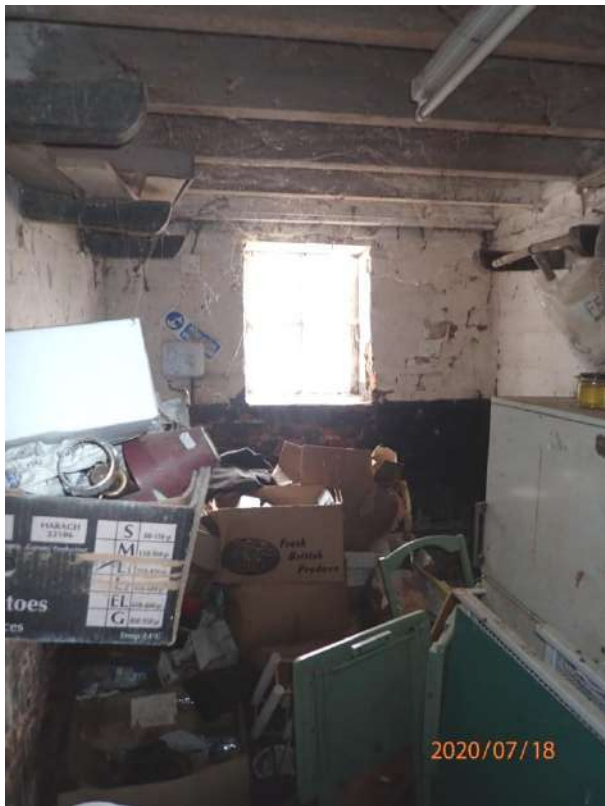
**Plate 209: View of the east wall of Cell 7, from the west**

**Plate 209** features the east wall of **Cell 7**. The nature of the brickwork wall fabric of this east wall has become obscured by being covered over with paintwork. Also shown is the slightly recessed inner face of the ground floor east facing window opening that was recorded externally at the East Elevation of this building.

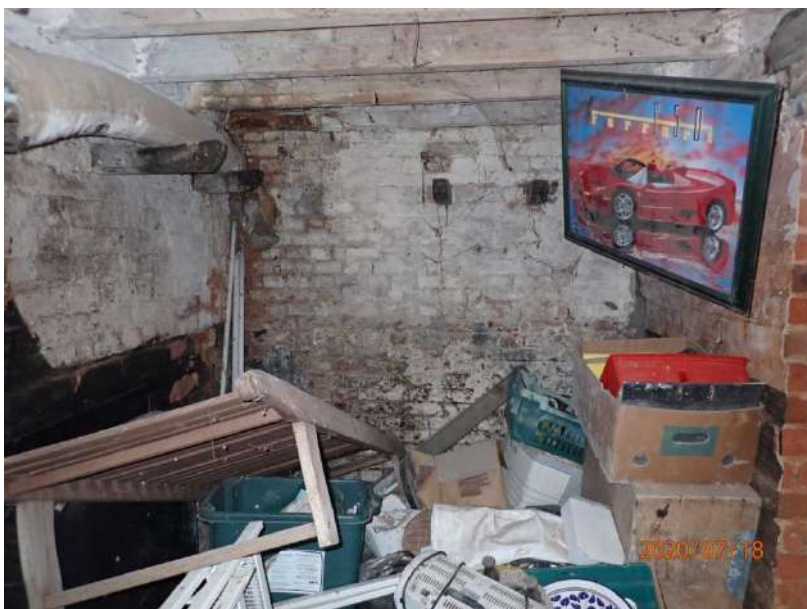
**Plate 210: View of the west wall of Cell 7, from the east**

**Plate 210** presents a detailed image of the west wall of **Cell 7**. Here also the detail of the brickwork wall fabric of this east wall has become obscured by being covered over with paintwork.

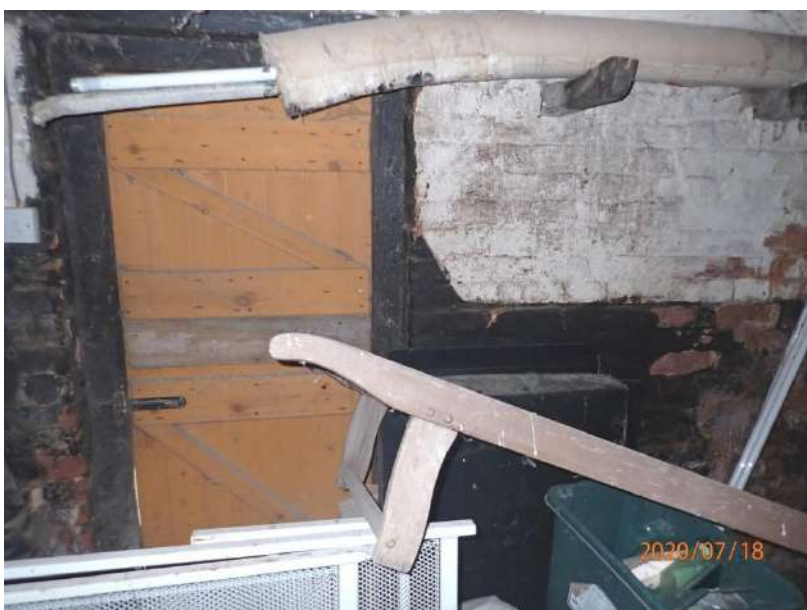
**Plate 211: View of the south wall of Cell 7, from the north**

**Plates 211 and 212** provide views of the south wall of **Cell 7**. Here also the detail of the brickwork wall fabric has become obscured by being covered over with paintwork. The main feature of this south wall is the inner face of the south facing entrance opening that was recorded externally at the north wall of the northern tunnel. This opening leads onto this tunnel. There is a modern door composed of a series of vertical tongued and grooved timber planks that are attached to an internal timber framework of angled and horizontal timbers. Surrounding the door is a timber

frame of a head and surrounds. Above the opening is an horizontal timber lintel, which is incorporated into the brickwork wall fabric here. This door may have originally been two timber half doors, which have been fixed together.

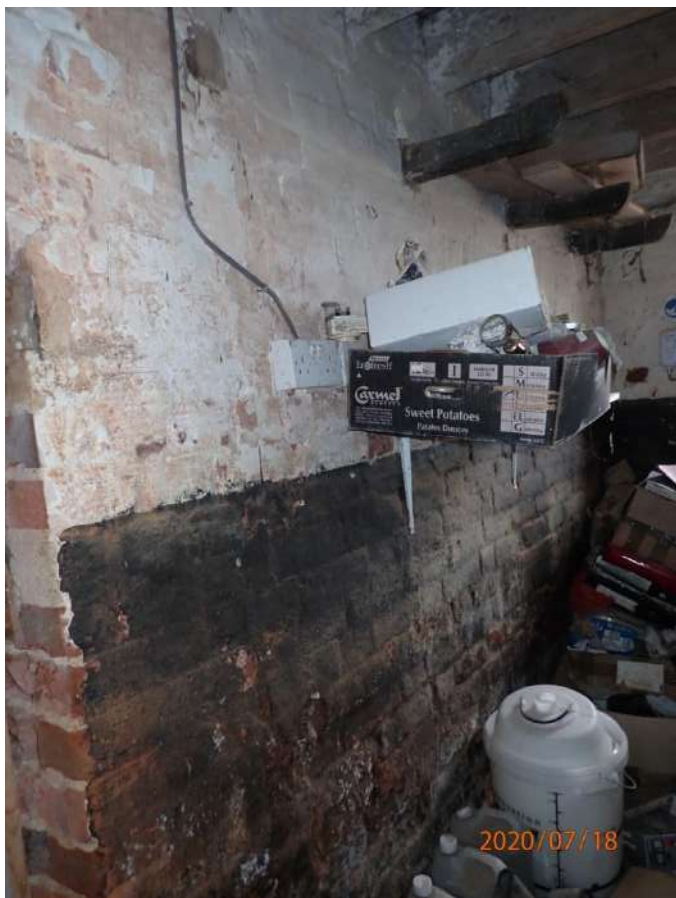
Plate 213: View of the north wall of Cell 7, from the west

**Plates 213 and 214** show the north wall of **Cell 7**. Here also the detail of the brickwork wall fabric has become obscured by being covered over with paintwork. The main feature of this north wall is the inner face of the north facing entrance opening that extends onto the adjoining **Cell 6** to the north. This slightly recessed opening is occupied by a timber frame of a head and surrounds and a modern six panelled timber door. Above the opening is an horizontal timber lintel, which is incorporated into the brickwork wall fabric here.

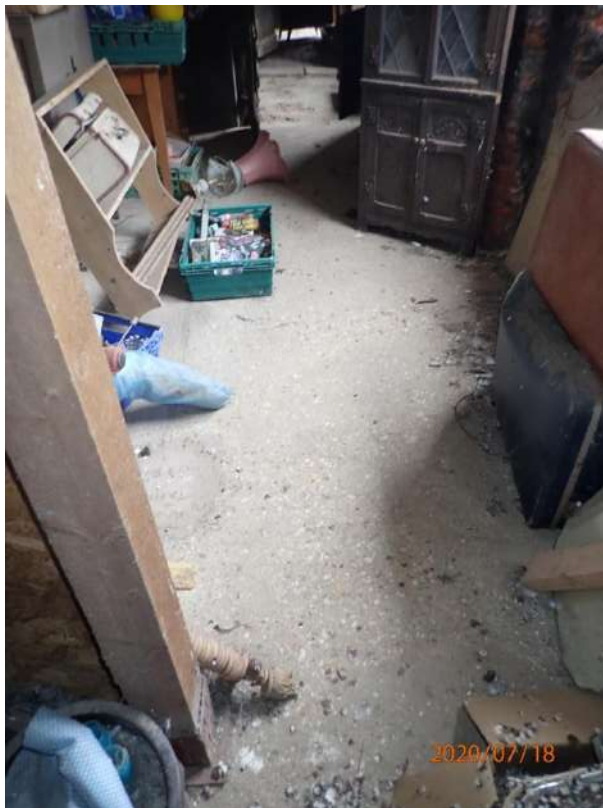
**Plate 218: View of the flooring of Cell 8, from the north**

**Plate 218** by contrast shows the nature of the flooring at the southern end of **Cell 8**, which is of modern concrete.

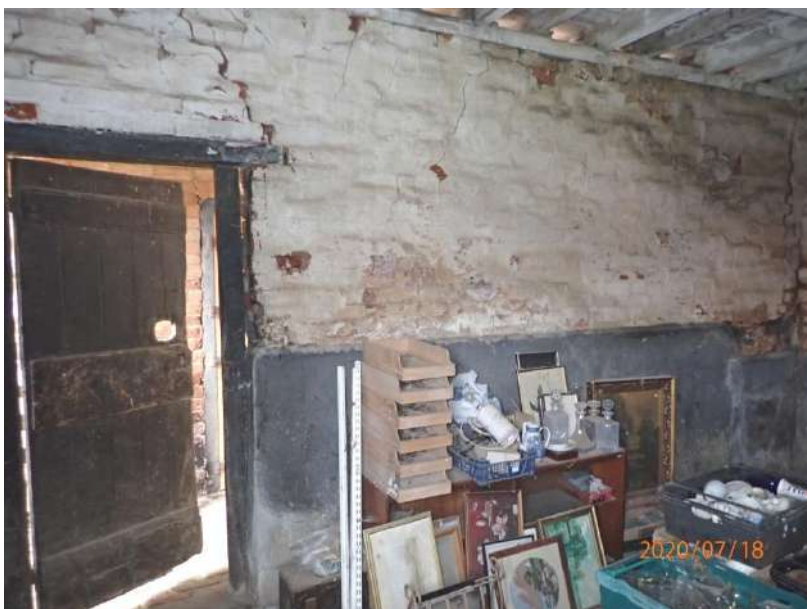
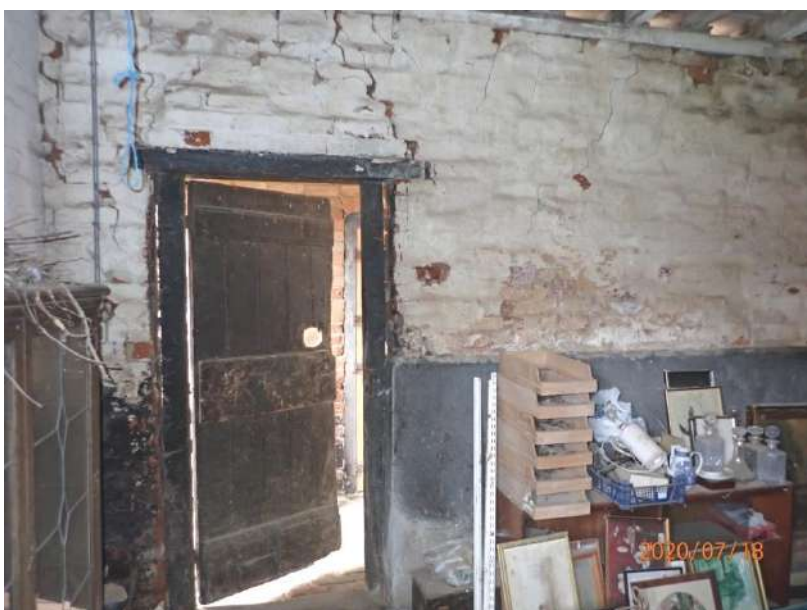
**Plate 219: View of the north wall of Cell 8, from the south**

**Plate 220: View of the north wall of Cell 8, from the south**

**Plates 219 and 220** provide detailed images of the north wall of **Cell 8**. Here the detail of the underlying brickwork wall fabric has become obscured by being covered over with paintwork. This has been enhanced by the lower levels of this north wall also being covered over with cement rendering. Also shown is the inner face of the north facing entrance opening that extends onto the adjacent northern tunnel. This entrance is occupied by a timber frame of a head and surrounds and a door that is composed of a series of vertical tongued and grooved timber planks that are affixed to an internal framework of horizontal timbers. An horizontal timber walplate may be seen to extend along the top of this north wall.

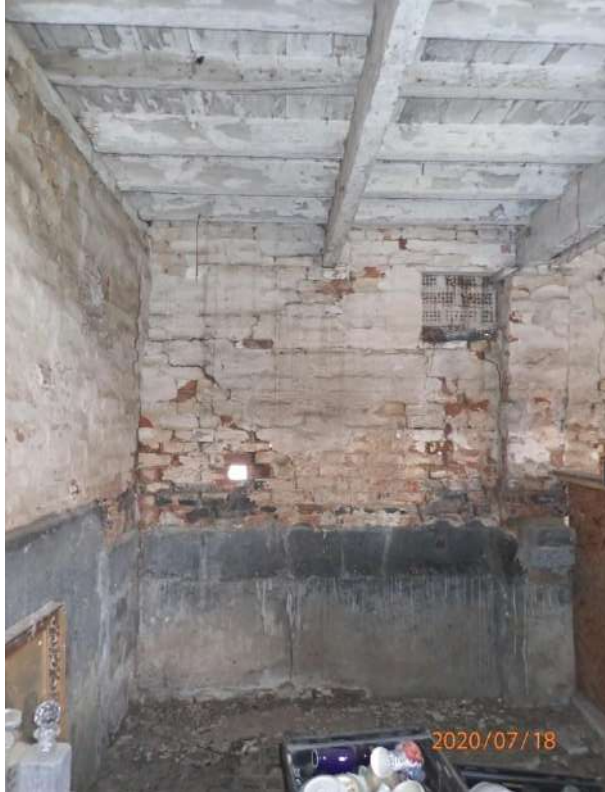
**Plate 221: View of the east wall of Cell 8, from the west**

**Plates 221-222 and 226** all present images of the east wall of **Cell 8**. Here also, the detail of the underlying brickwork wall fabric has become obscured by being covered over with paintwork. This has been enhanced by the lower levels of this east wall also being covered over with cement rendering. Also shown are the inner faces of two of the panels with air vent bricks, which were recorded externally at the East Elevation of this building. To the left, is a vertical brick pillar, which is bonded to the wall fabric of this east wall. It may be observed that one of the four east-west

orientated principal horizontal timbers joists of the ceiling structure rests on the top of this pillar. The remaining three principal horizontal timber joists are inserted into the uppermost levels of the wall fabric of this east wall.
