HISTORIC BUILDING RECORDING AT  
HALL FARM, BOSTON ROAD,  
EAST HECKINGTON, LINCOLNSHIRE

PREPARED FOR MR. JAMES BRAMMA OF JB ARCHITECTURAL DESIGN SERVICES ON  
BEHALF OF HIS CLIENT - MR. NICK LOWETH  
PART 2: THE EAST RANGE

March 2021

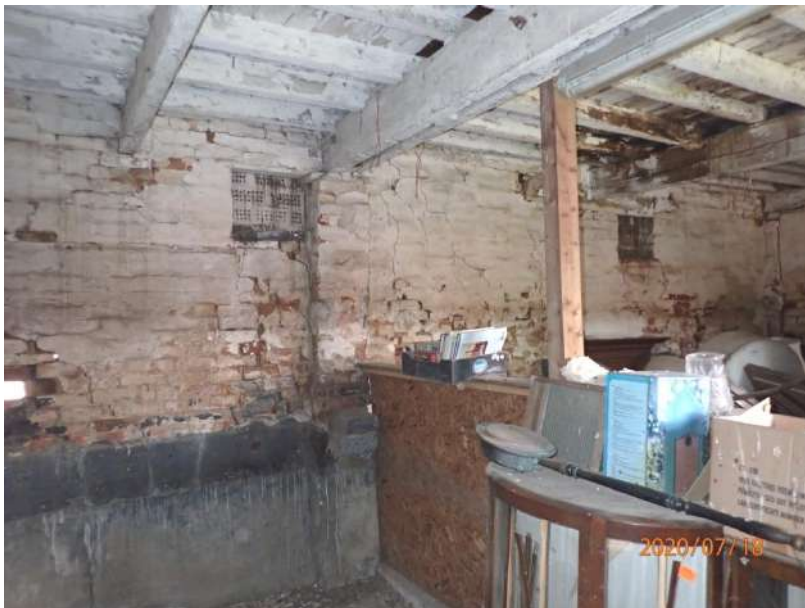
**Plate 222: View of the east wall of Cell 8, from the west**

**Plates 221-222 and 226** all present images of the east wall of **Cell 8**. Here also, the detail of the underlying brickwork wall fabric has become obscured by being covered over with paintwork. This has been enhanced by the lower levels of this east wall also being covered over with cement rendering. Also shown are the inner faces of two of the panels with air vent bricks, which were recorded externally at the East Elevation of this building. To the left, is a vertical brick pillar, which is bonded to the wall fabric of this east wall. It may be observed that one of the four east-west

orientated principal horizontal timbers joists of the ceiling structure rests on the top of this pillar. The remaining three principal horizontal timber joists are inserted into the uppermost levels of the wall fabric of this east wall.

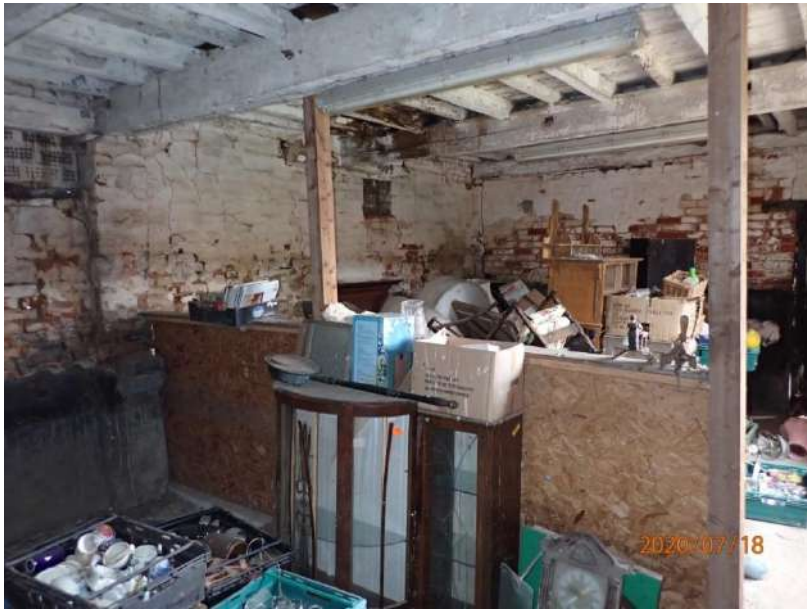
**Plate 223: General view of the interior of Cell 8, from the north-west**

**Plate 223** presents a general view of the interior of **Cell 8** from a northern position.

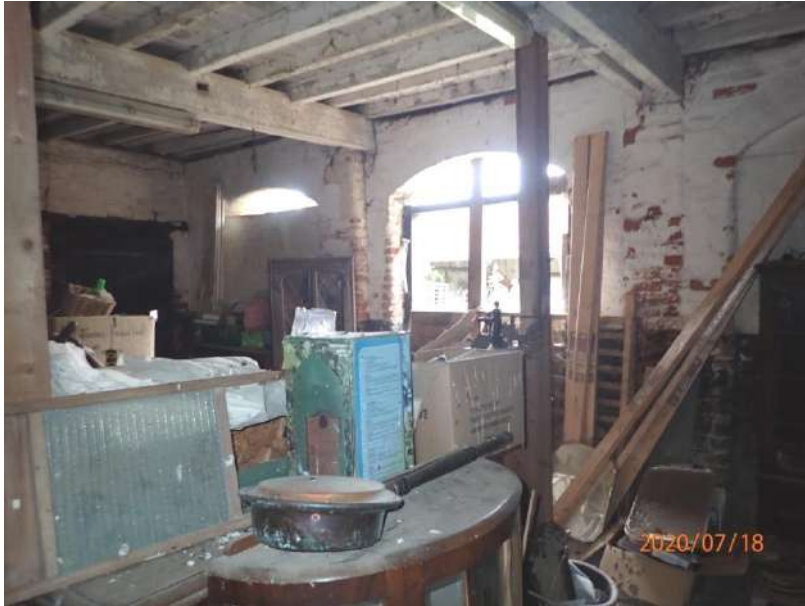
**Plate 225:** View of the west wall of Cell 8, from the north-east

**Plate 225** presents a general overall view of the west wall of **Cell 8**. Here also, much of the detail of the brickwork wall fabric of the remainder of this west wall has become obscured by being covered over with paintwork. The western ends of two of the principal horizontal timber ceiling joists are inserted into the uppermost levels of the brickwork wall fabric here.

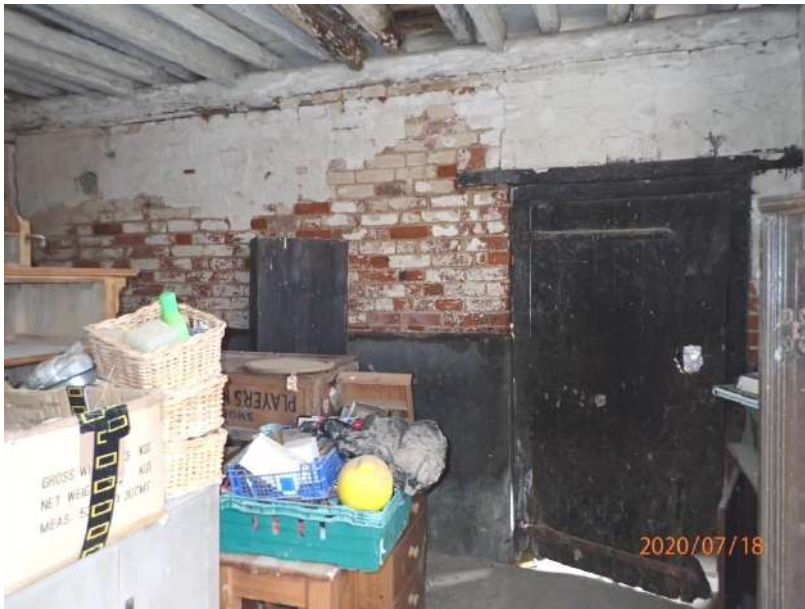
**Plate 227: View of the south wall of Cell 8, from the north**

**Plate 227** presents a detailed view of the south wall of **Cell 8**, which is also the internal dividing wall with the adjacent **Cell 9** to the south. The detail of parts of the brickwork wall fabric of this south wall have become obscured by being covered over with paintwork, which has been enhanced by the lower levels of this south wall having been rendered over by a band of cement. Where the detail of the wall fabric is discernible, the brickwork appears to be composed of a mix of courses of mixed brick headers and brick stretchers and of other courses of brick stretchers. An horizontal timber walplate may be seen to extend along the top of this south wall. Also featured is the inner face of a south facing entrance opening that leads onto the adjacent **Cell 9** to the south. The opening is occupied by a timber frame of a head and surrounds and a door that is composed of a series of vertical tongued and grooved timber planks. The door is attached to the frame by two horizontal cast metal strap hinges. Above the opening is an horizontal timber lintel that is incorporated into the brickwork wall fabric here.

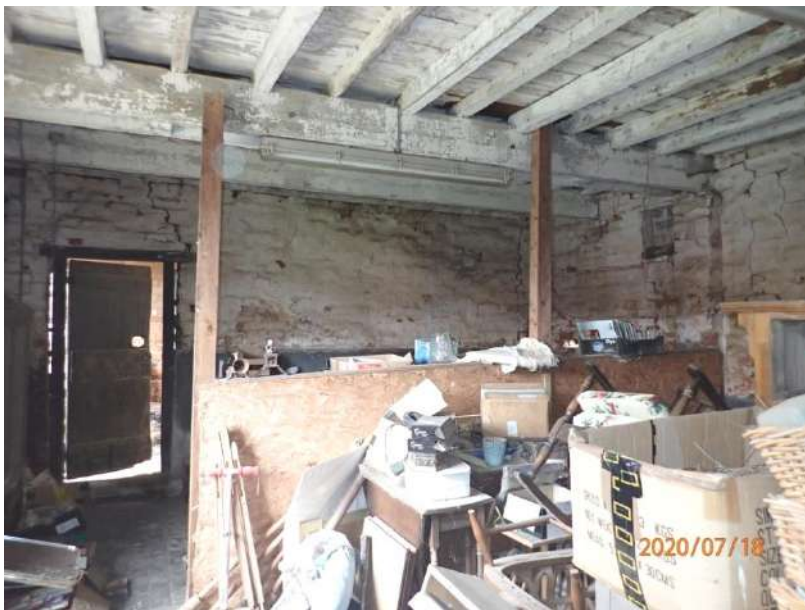
**Plate 228: General view of the interior of Cell 8, from the south**

**Plate 228** presents a further general view of the interior of **Cell 8** from a southern position.

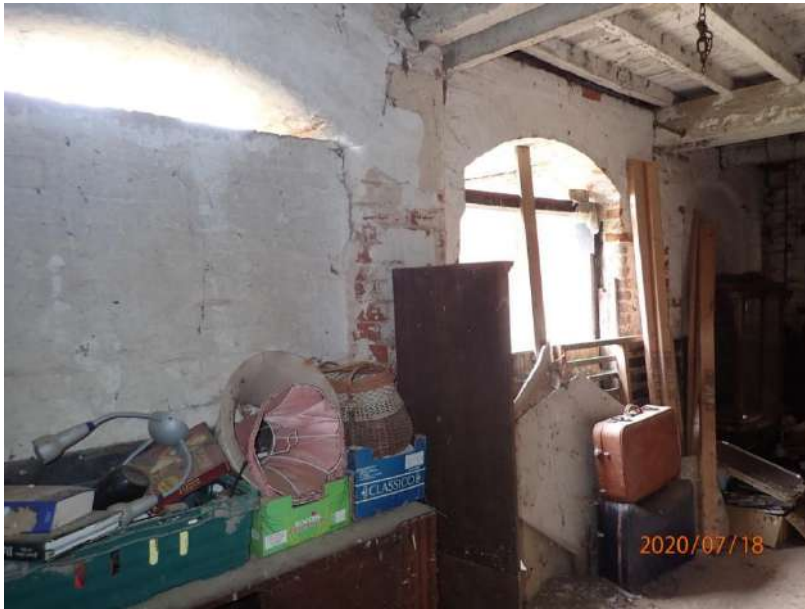
**Plate 229: View of the west wall of Cell 8, from the south-east**

**Plates 229-232** provide further detailed images of the west wall of **Cell 8**. **Plate 229** presents a view of the inner faces of the second and third west facing openings or bays within this west wall and shows the western ends of two of the principal horizontal timber joists of the ceiling structure inserted into the uppermost levels of the brickwork wall fabric here.

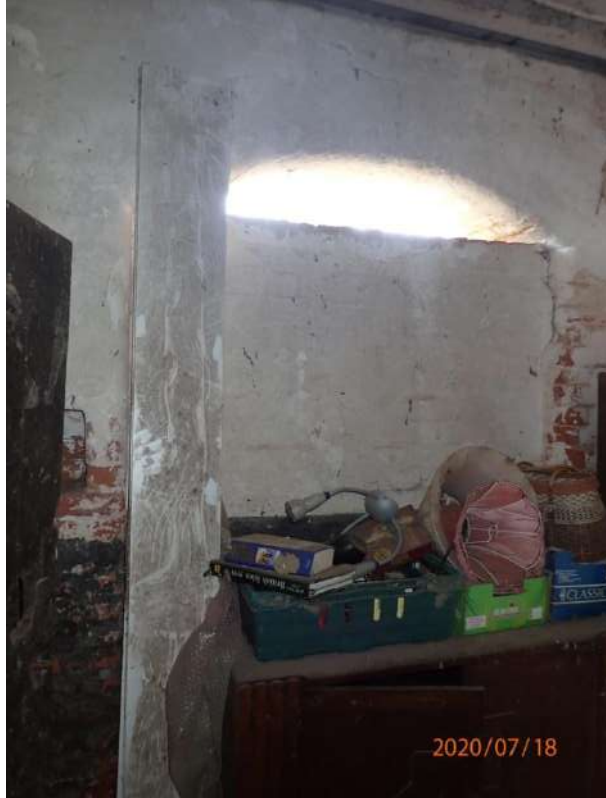
Plate 230: View of the west wall of Cell 8, from the east

**Plate 230** features the inner face of the third of the west facing openings or bays that were recorded externally at the West Elevation of this building. This opening also has been almost entirely infilled with brick, leaving open a small gap just below the brick arch. However, the detail of this brick infilling, and of this arch along with the brickwork around this opening has become obscured by being covered over with paintwork.

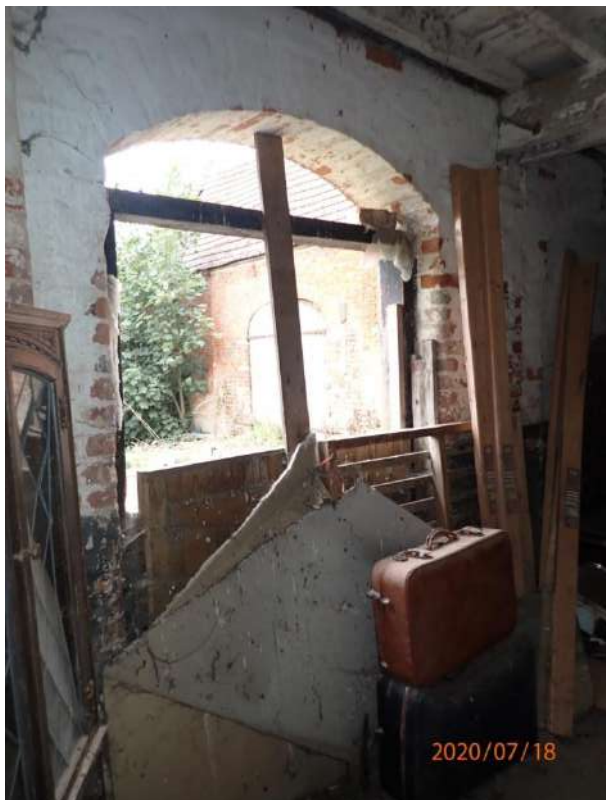
Plate 231: View of the west wall of Cell 8, from the east

**Plate 231** shows the inner face of the second of the west facing openings or bays that was also recorded externally at the West Elevation of this building. The opening appears to contain the remains of a timber door frame of a head and surrounds, but otherwise appears to be open. Here also, the detail of the brick arch above this opening along with the detail of the brickwork around the opening has also become obscured by being covered over with paintwork.

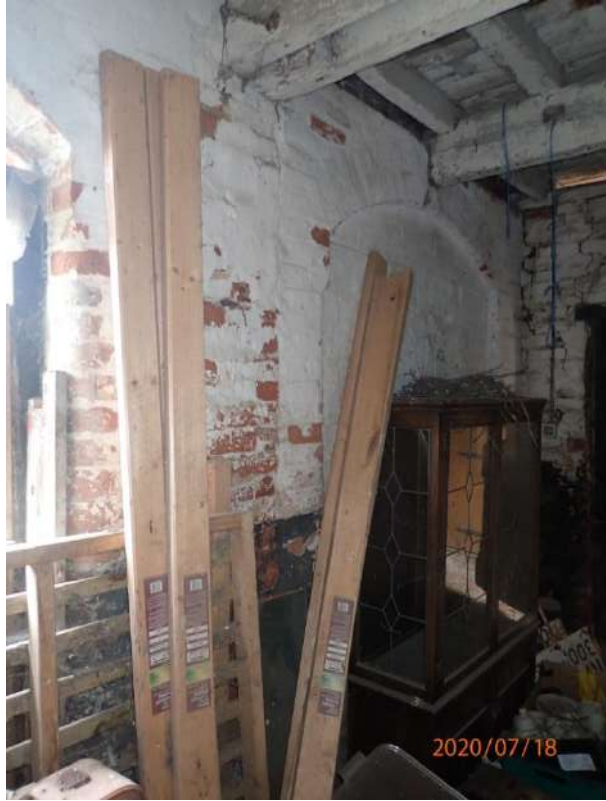
**Plate 232: View of the west wall of Cell 8, from the east**

**Plate 232** furnishes a further view of the northern end of the west wall of **Cell 8**, from a different southern position and shows the inner face of the first of the west facing openings or bays.

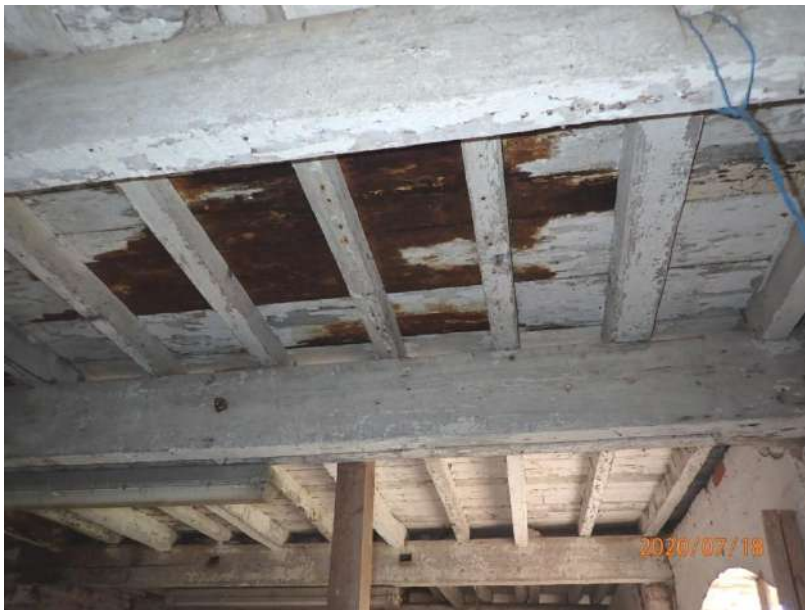
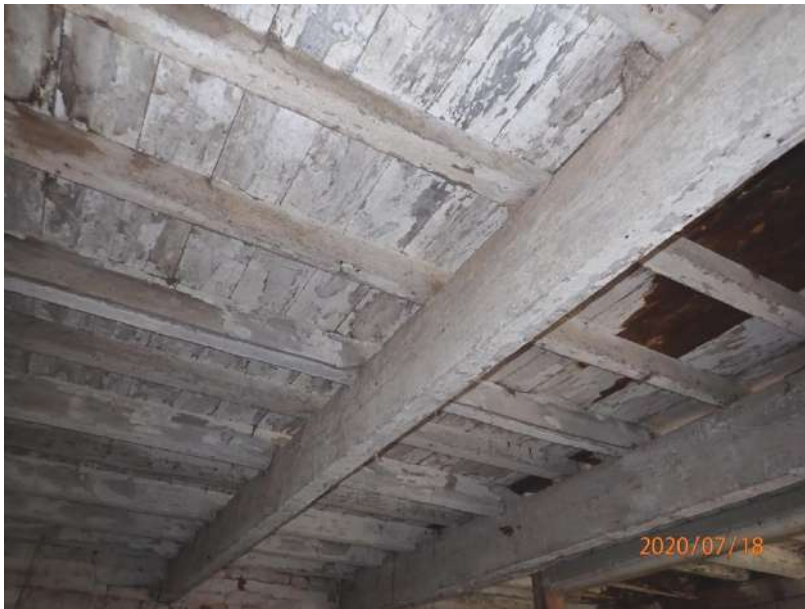
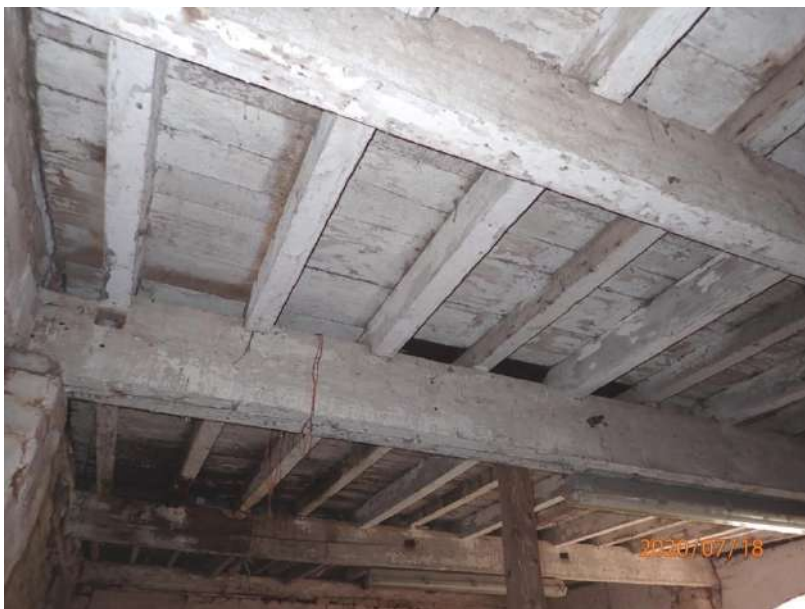
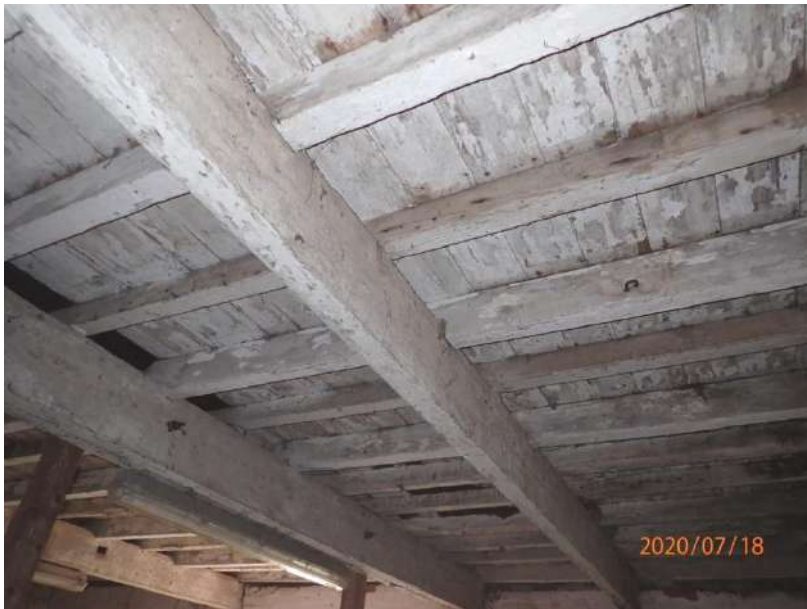
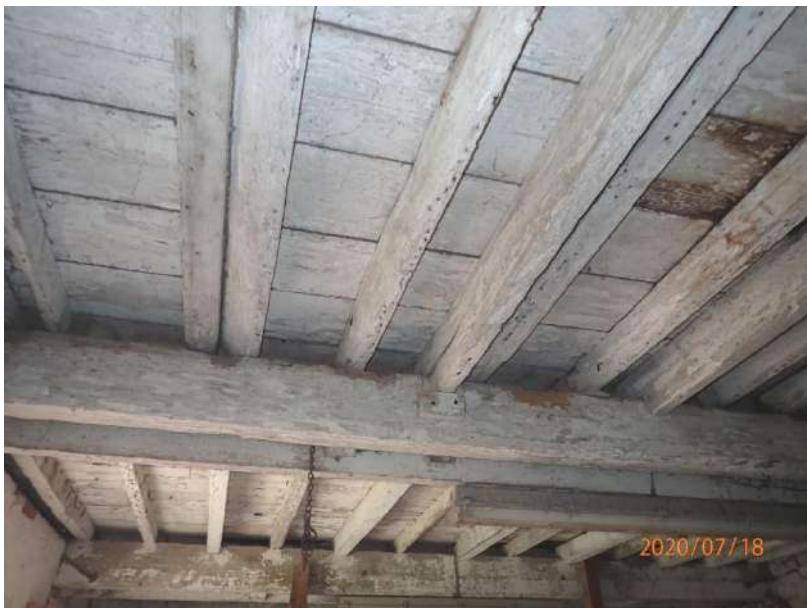
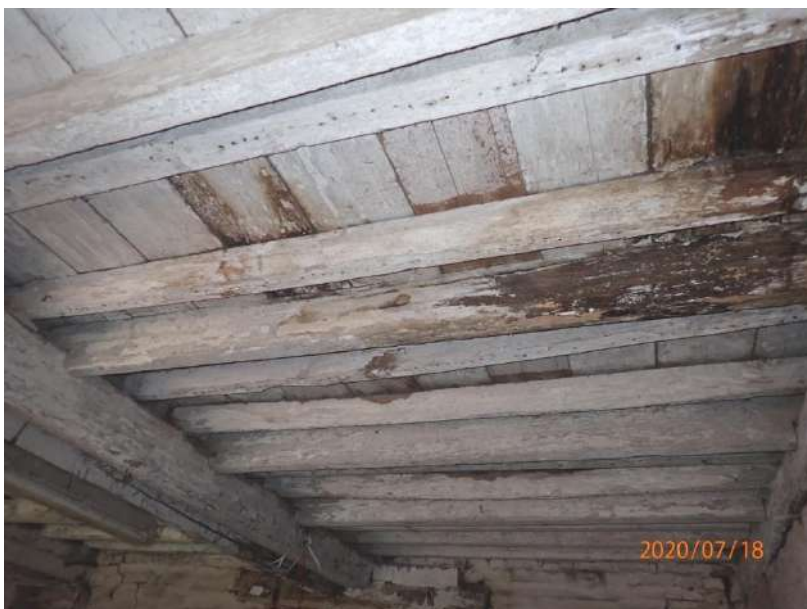
**Plates 233-238** present a number of views from differing positions of the nature of the ceiling of **Cell 8**. The principal component parts of this structure comprise the four east-west orientated principal horizontal timber joists, the eastern and western ends of three of which are inserted into the uppermost levels of the east and west walls of **Cell 8** with the eastern end of the fourth resting on the top of a vertical brick column that is bonded to the east wall. Attached to the horizontal timber wallplates that extend along the top of the north and south walls of **Cell 8**, are the series of north-south aligned secondary horizontal timber joists. These in turn support the first floor, floor covering of horizontal timber planking above.

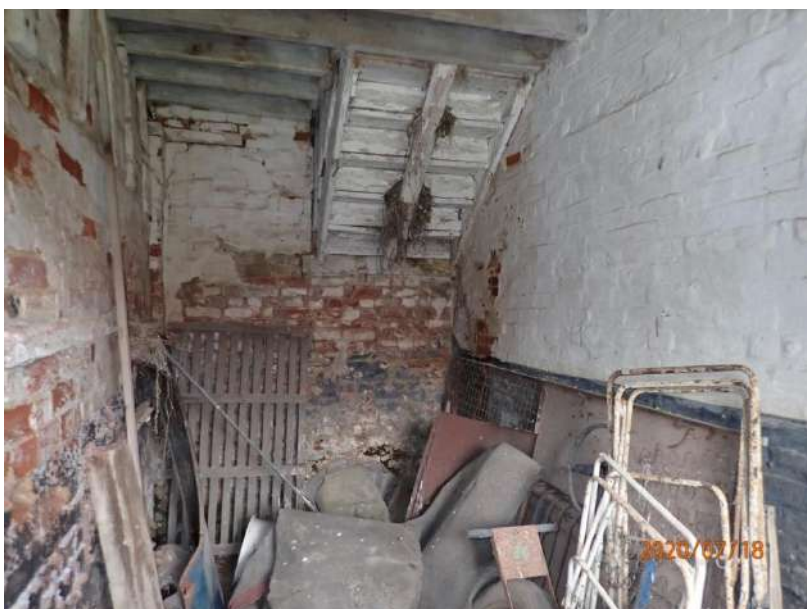
**Plate 239: View of the east wall of Cell 9, from the west**

**Plate 239** shows the east wall of **Cell 9** and in particular the inner face of the timber steps of the external stairwell, that were recorded externally at the East Elevation of the building and which provide the access into the first floor above. Much of the detail of the brickwork wall fabric of this east wall has become obscured by being covered over with paintwork though it is still possible to discern individual courses of brick headers and of brick stretchers.

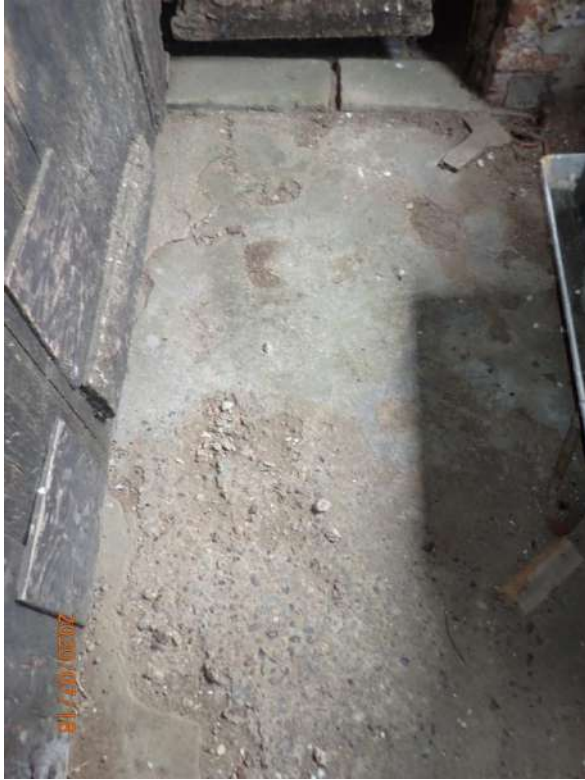
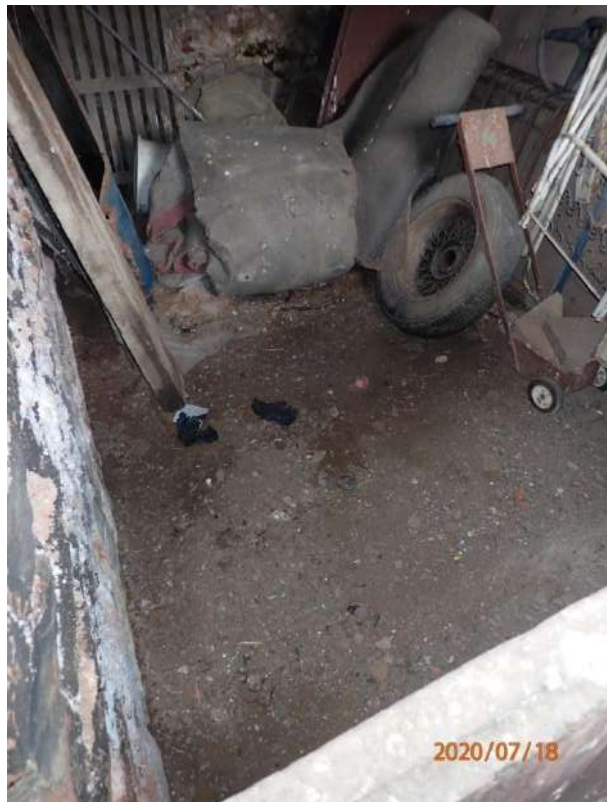
**Plates 240 and 241** present two images of the nature of the flooring of **Cell 9**, which is of modern concrete.

Plate 240: View of the flooring of Cell 9, from the north

Plate 241: View of the flooring of Cell 9, from the west

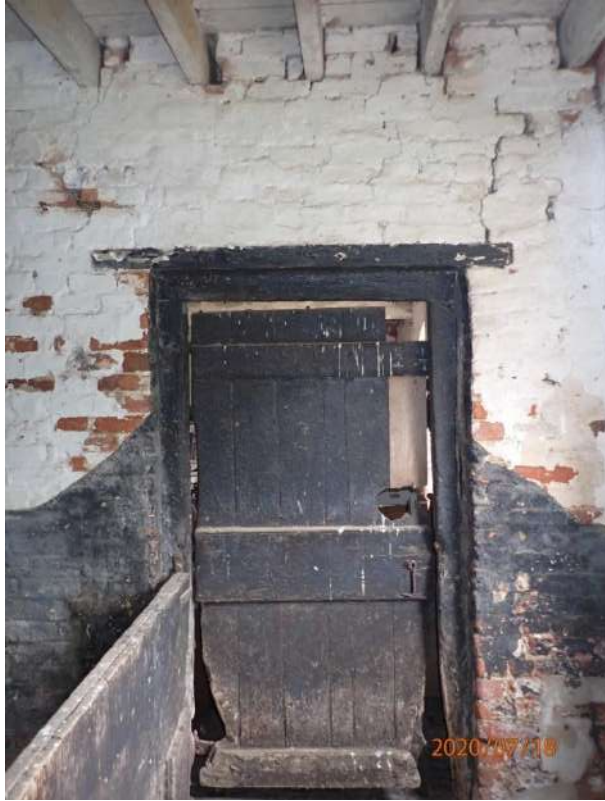
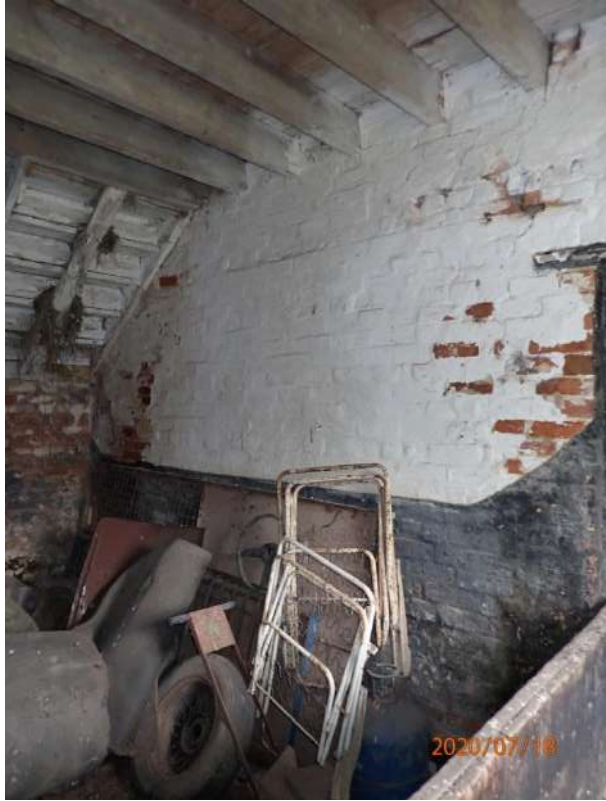
**Plate 242: View of the south wall of Cell 9, from the north**

**Plates 242 and 243** furnish images of the south wall of **Cell 9** which is also the internal dividing wall with the adjacent **Cell 10** to the south. Here also most of the detail of the nature of the brickwork wall fabric of this south wall has become obscured by being covered over with paintwork. Also featured is the inner face of the south facing entrance opening that leads onto the adjoining **Cell 10** to the south. This opening contains a timber frame of a head and surrounds along with a door that is composed of a series of vertical tongued and grooved timber planks that are affixed to an internal framework of horizontal timbers. Above the opening is an horizontal timber lintel that is incorporated into the brickwork wall fabric. The southern ends of the north-south orientated horizontal timber ceiling joists may be seen to be inserted into the uppermost levels of the wall fabric here.

Plate 243: View of the south wall of Cell 9, from the north

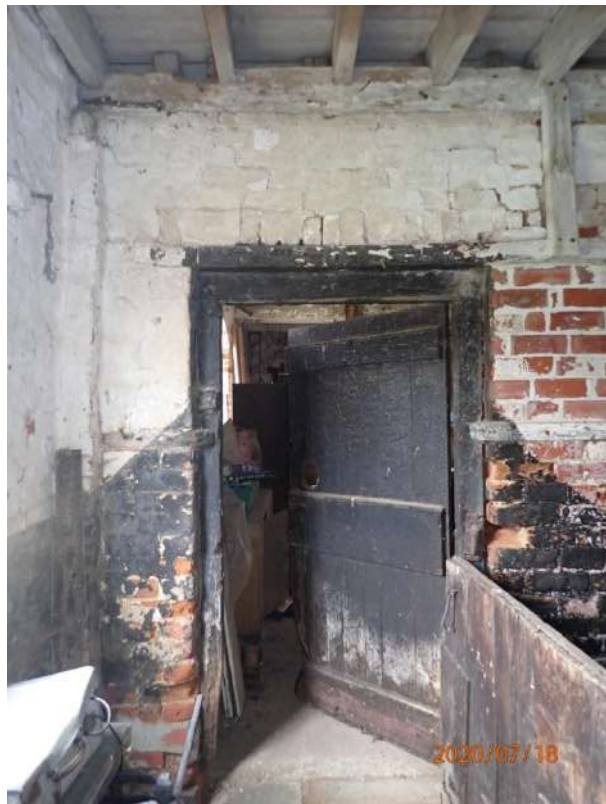
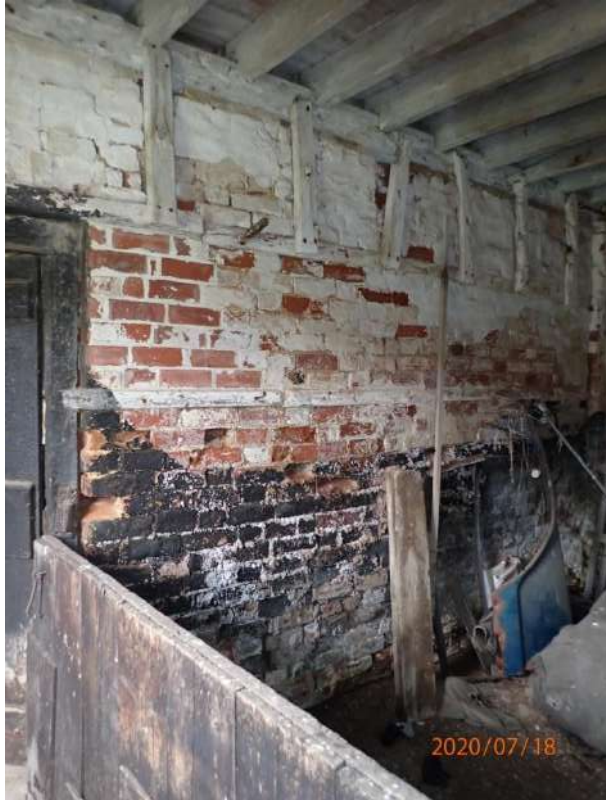
**Plates 244 and 245** provide views of the north wall of **Cell 9**, which is also the internal dividing wall with the adjacent **Cell 8** to the north. Here also most of the detail of the nature of the brickwork wall fabric of this north wall has become obscured by being covered over with paintwork. Also featured is the inner face of the north facing entrance opening that leads onto the adjoining **Cell 8** to the south. This opening is occupied by a timber frame a head and surrounds along with a door that is composed of a series of vertical tongued and grooved timber planks that are affixed to an internal framework of horizontal timbers. Above the opening is an horizontal timber lintel that is incorporated into the brickwork wall fabric. An horizontal timber wallplate may be seen to extend along the top of this north wall, into which are inserted the northern ends of the north-south orientated horizontal timber ceiling joists.

Plate 244: View of the south wall of Cell 9, from the north

**Plate 245: View of the south wall of Cell 9, from the west**

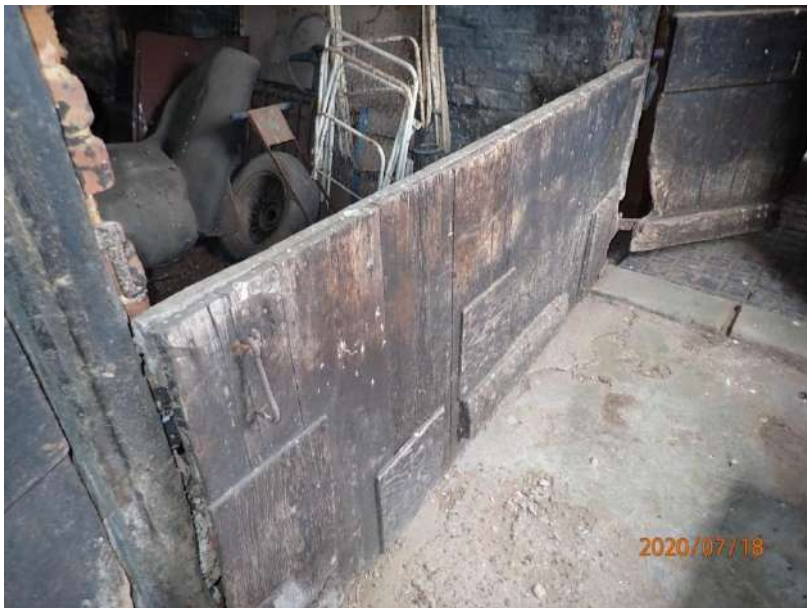
**Plate 246: View of the low timber partition, from the north**

**Plate 246** features a low timber partition that extends along the width of **Cell 9**, and which is composed of a series of vertical timber planks.

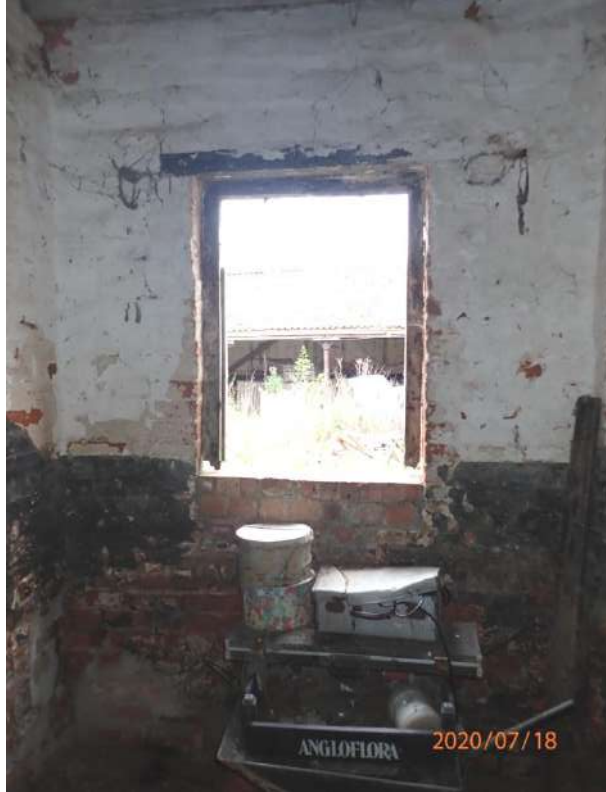
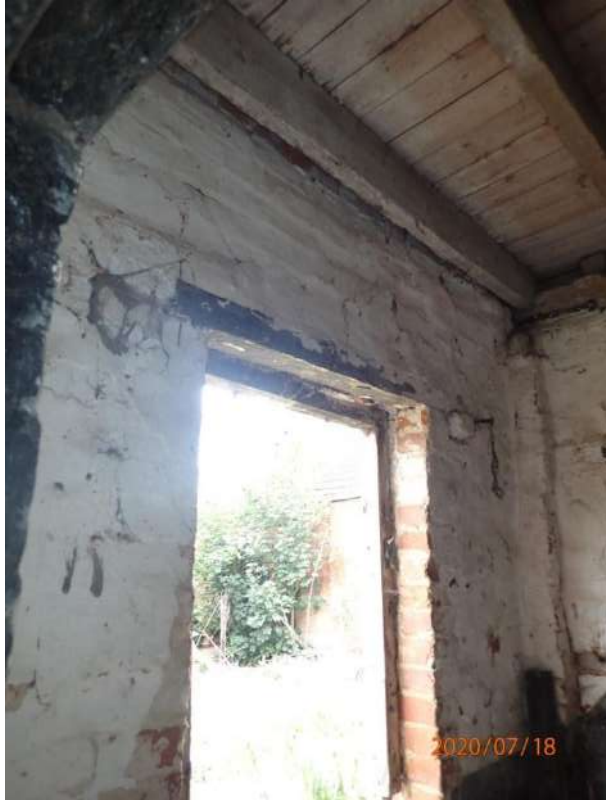
**Plate 247: View of the west wall of Cell 9, from the east**

**Plates 247 and 248** present views of the west wall of **Cell 9**. Here also the detail of the nature of the brickwork wall fabric of this west wall has become obscured by being covered over with paintwork. Also featured is the inner face of a ground floor west facing window opening that was recorded externally at the West Elevation of this building. The opening is open to the elements and the remains of a timber frame of a head and surrounds survive. There is also limited modern brick infilling at the base of this opening. Above the opening is an horizontal timber lintel which is incorporated into the brickwork wall fabric here.

**Plate 248: View of the west wall of Cell 9, from the south**

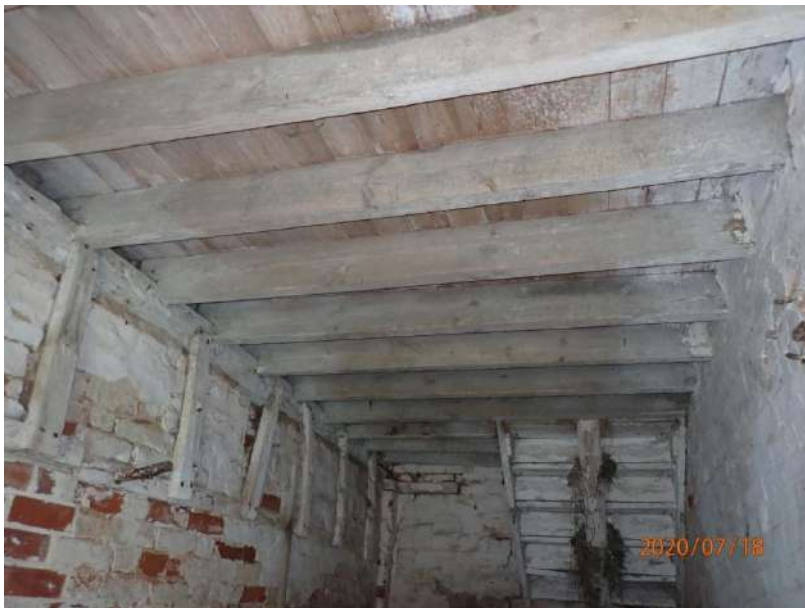
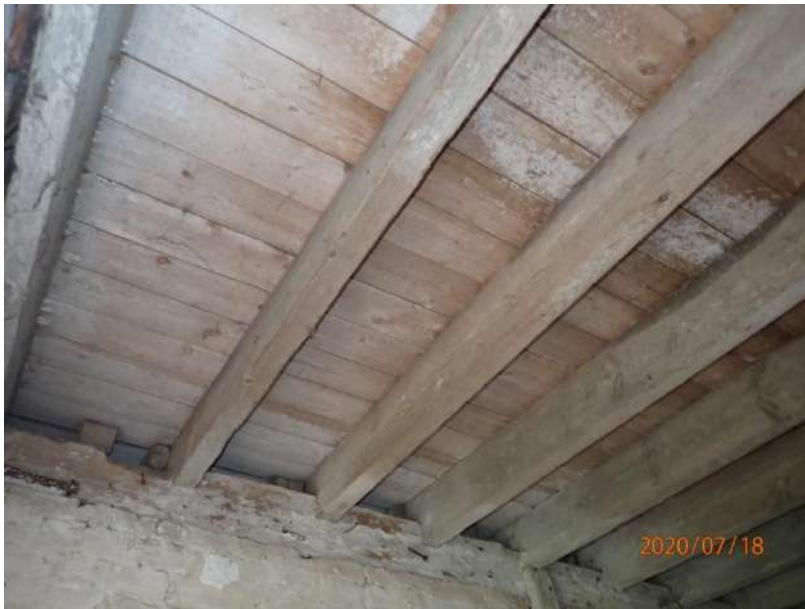
**Plates 249 and 250** provide detailed images of the nature of the ceiling structure above **Cell 9**. These show the series of north-south orientated horizontal timber ceiling joists, the southern ends of which are inserted into the wall fabric of the south wall, with their northern ends inserted into a timber wallplate that extends along the top of the north wall of **Cell 9**. The joists in turn support the first floor, floor covering of horizontal timber planking above.

**Plate 249: View of the ceiling of Cell 9, from the west**

**Plate 250: View of the ceiling of Cell 9, from the south**

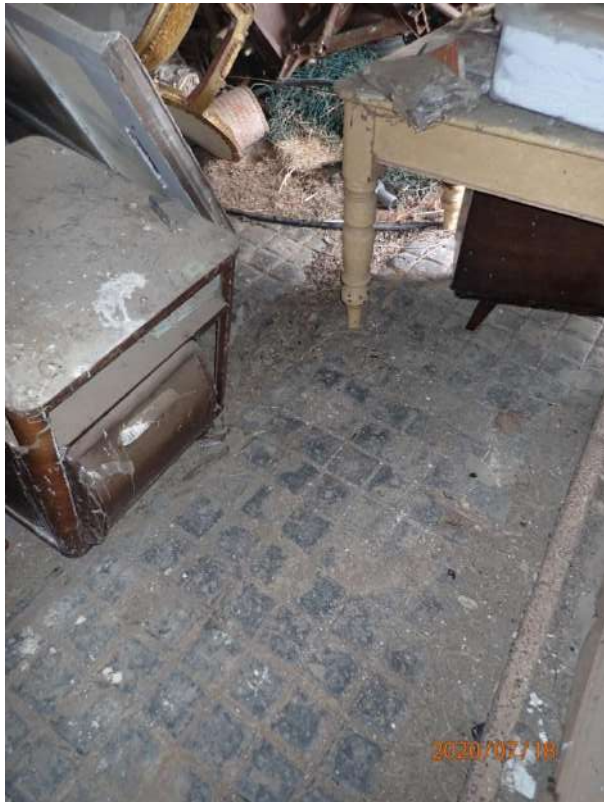
**Plate 251: View of the flooring of Cell 10, from the north**

**Plate 251** furnishes a view of the nature of the flooring of **Cell 10**, which is composed of courses of granite sets laid on bed.

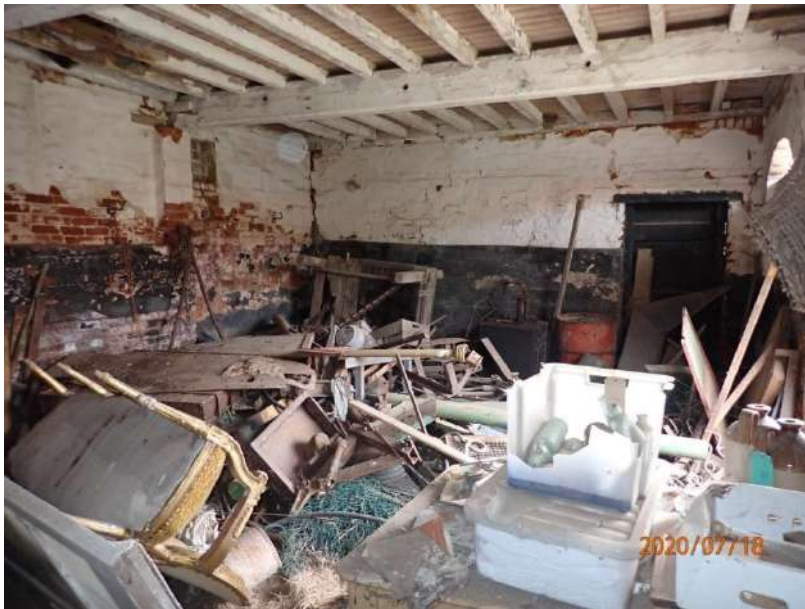
**Plate 252: General view of the interior of Cell 10, from the north**

**Plate 252** presents a general view of the interior of **Cell 10** from a northern perspective.

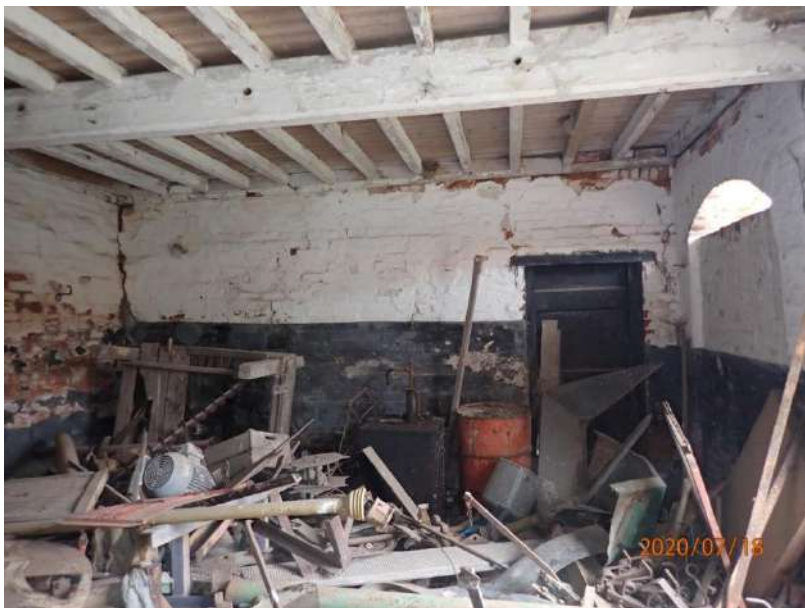
**Plate 253: View of the south wall of Cell 10, from the north**

**Plate 253** features the south wall of **Cell 10**, which is also the internal dividing wall with the adjacent **Cell 11** to the south. Here also the detail of the nature of the brickwork wall fabric of this south wall has become obscured by being covered over with paintwork. An horizontal timber wallplate may be seen to extend along the top of this south wall. Also shown is the inner face of a south facing entrance opening which leads onto the adjoining **Cell 11** to the south. This opening is occupied by a timber frame of a head and surrounds along with a door that is composed of a series of vertical tongued and grooved timber planks that are affixed to an internal framework of horizontal timbers. Above this opening is an horizontal timber lintel that is incorporated into the brickwork wall fabric.

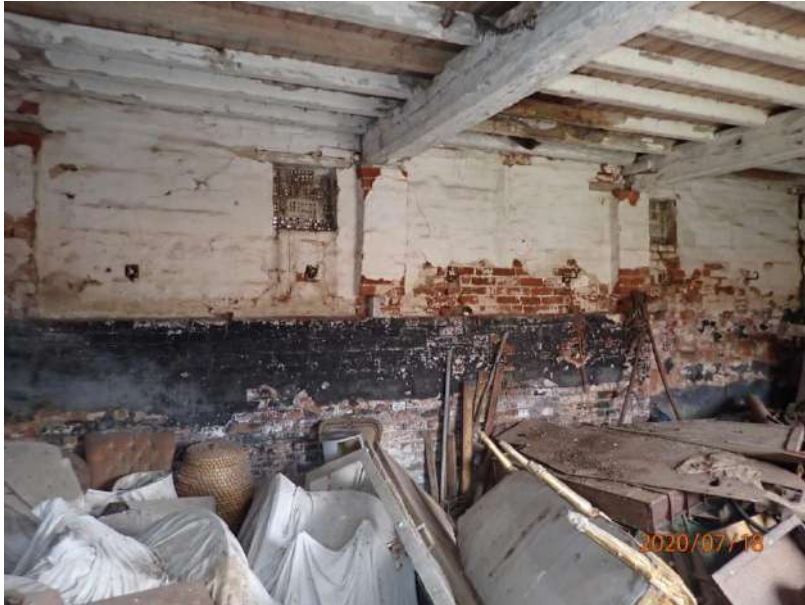
**Plate 254: View of the east wall of Cell 10, from the west**

**Plate 254** features the east wall of **Cell 10**. Here also, most of the detail of the nature of the brickwork wall fabric of this east wall has become obscured by being covered over with paintwork, though it was possible to discern individual courses of brick headers and of brick stretchers. Also shown are the inner faces of two of the panels infilled with air vent bricks that were recorded externally at the East Elevation of this building. Bonded to this wall fabric are two decorative brick pilasters. The eastern ends of the two principal east-west orientated horizontal timber ceiling joists may be seen to rest on the top of these pilasters.

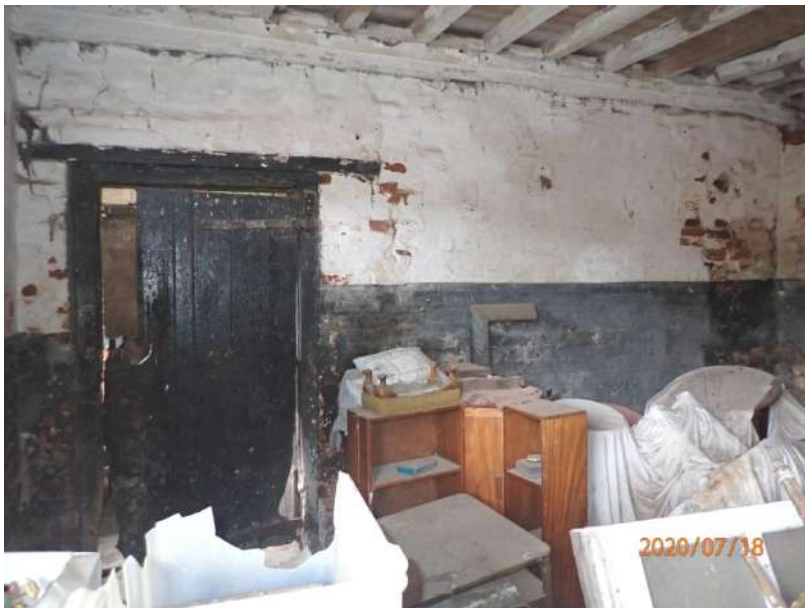
**Plate 255: View of the north wall of Cell 10, from the south**

**Plate 255** presents a view of the north wall of **Cell 10**, which is also the internal dividing wall with the adjacent **Cell 9** to the south. Here also the detail of the nature of the brickwork wall fabric of this north wall has become obscured by being covered over with paintwork. An horizontal timber wallplate may be seen to extend along the top of this north wall. Also featured is the inner face of

the north facing entrance opening that leads onto the adjoining **Cell 9** to the north. This opening contains a timber frame of a head and surrounds and a door that is composed of a series of vertical tongued and grooved timber planks. The door is attached to the frame by two horizontal metal strap hinges. Above this opening is an horizontal timber lintel that is incorporated into the brickwork wall fabric.

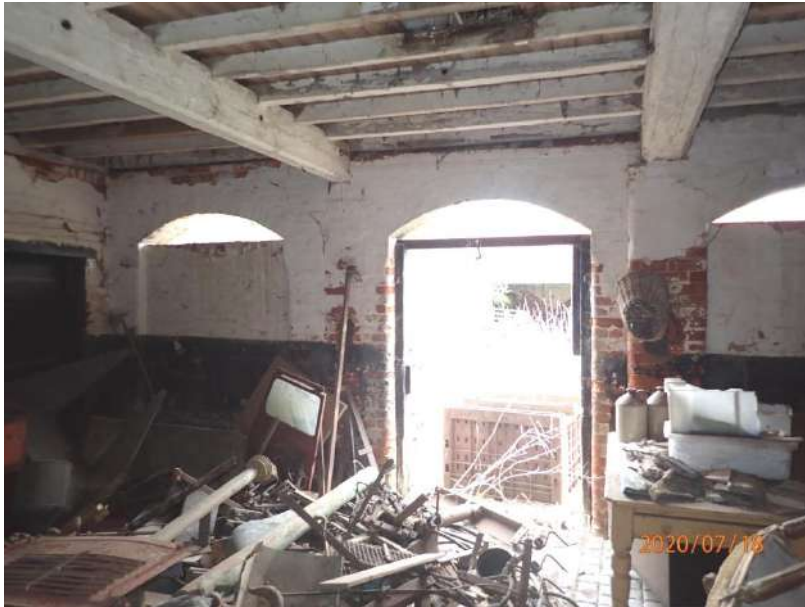
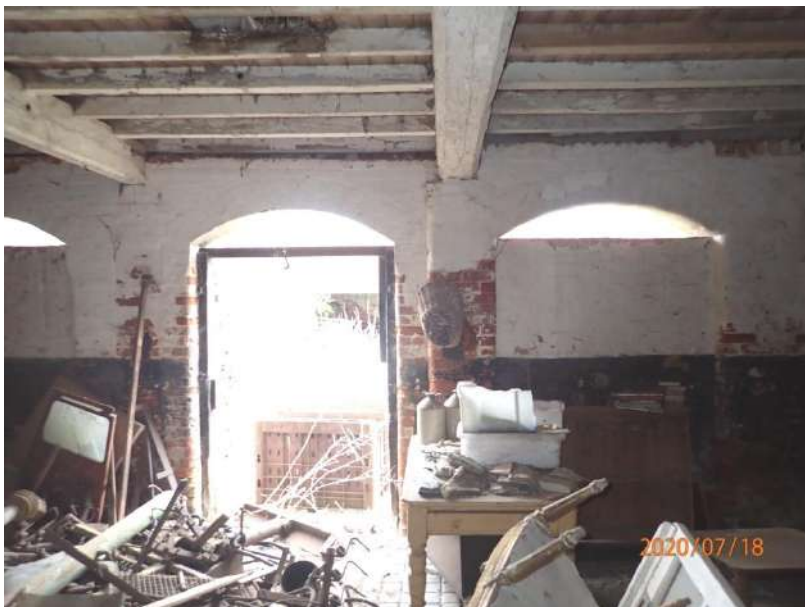
**Plate 256: View of the west wall of Cell 10, from the east**

**Plate 257: View of the west wall of Cell 10, from the east**

**Plates 256 and 257** show the west wall of **Cell 10**, including the inner faces of the final three (of six) west facing openings or bays that were recorded externally at the West Elevation of this building. Two of these openings have been infilled with brick, leaving open a small gap below each brick arch. The central opening is open to the elements though fragments of a door frame of a head and surrounds survive. Here also, the detail of the nature of the brickwork wall fabric of this west wall has become obscured by being covered over with paintwork. The western ends of

the two principal horizontal timber ceiling joists may be seen to be inserted into the uppermost levels of the wall fabric.

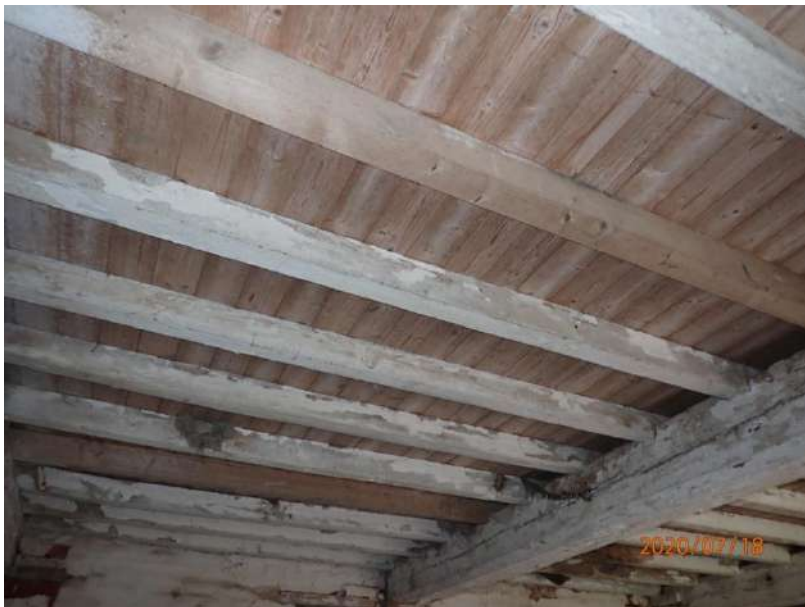
**Plate 259: View of the ceiling of Cell 10, from the west**

**Plates 259-261** present several detailed images of the nature of the ceiling structure of **Cell 10**. The main component parts of this structure comprise the two east-west orientated principal horizontal ceiling joists. The eastern ends of these joists rest on the top of the two brick pilasters on the east wall, whilst their western ends are inserted into the wall fabric of the west wall. Attached to these in turn are a series of secondary north-south aligned horizontal secondary ceiling joists, which provide support to the first floor, floor covering of horizontal timber planking above.

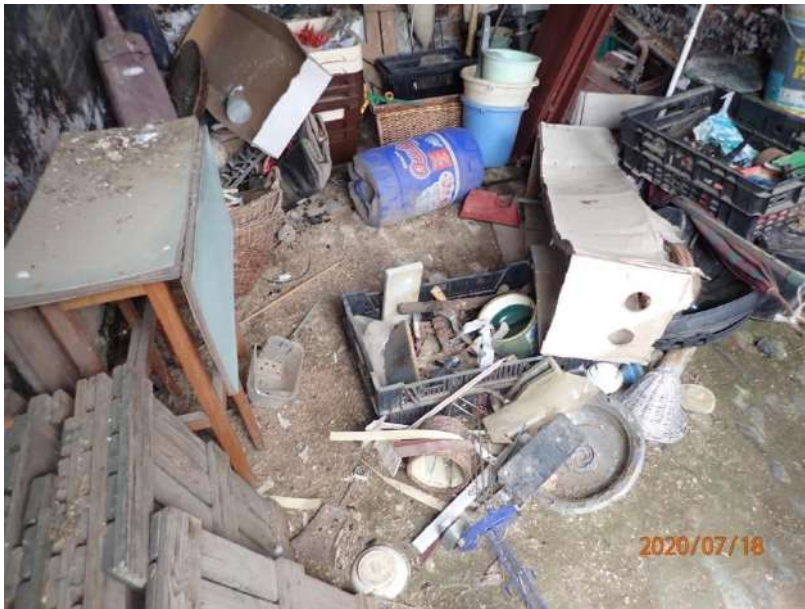
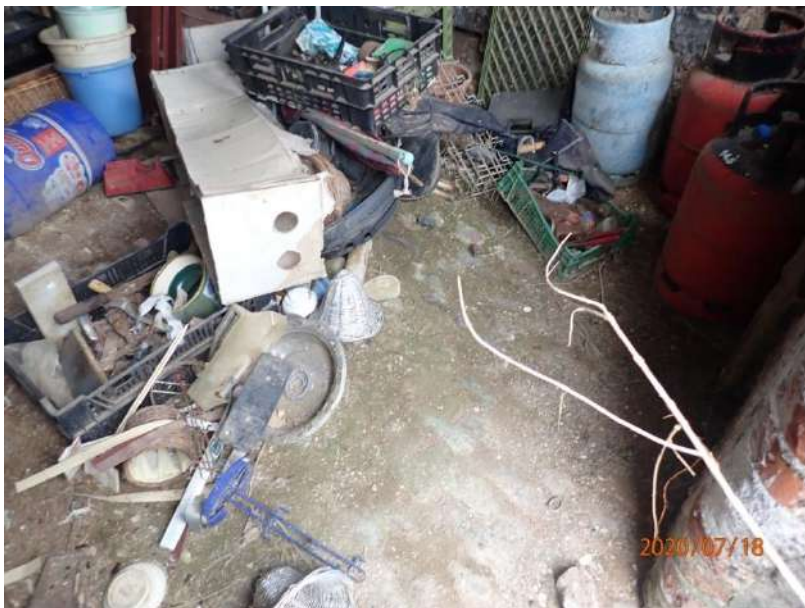
**Plates 262 and 263** feature the nature of the flooring within **Cell 11**, which appears to be composed of courses of well worn brick stretchers laid on bed.

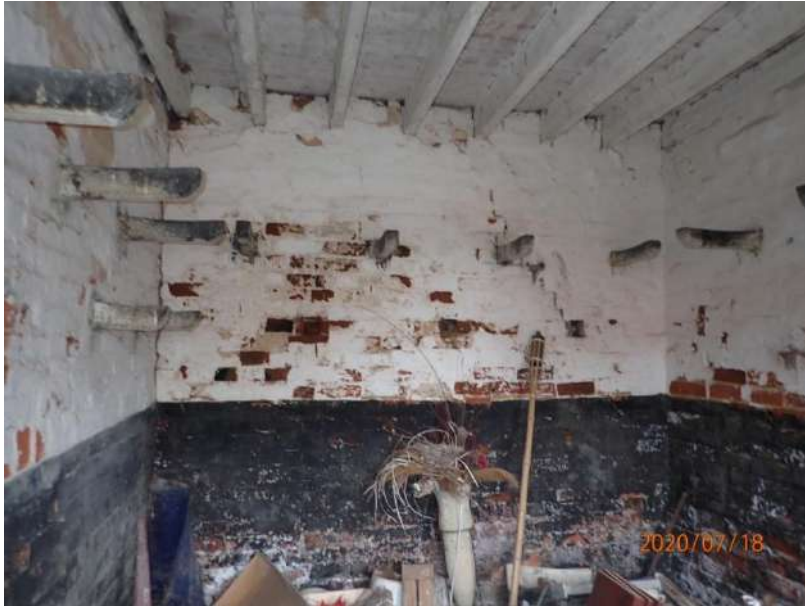
**Plate 264: View of the east wall of Cell 11, from the west**

**Plate 264** presents a detailed image of the east wall of **Cell 11**. The detail of the nature of the brickwork wall fabric of this east wall has become obscured by being covered over with paintwork. The eastern ends of the east-west orientated horizontal timber ceiling joists may be seen to be inserted into the uppermost levels of this wall fabric.
