HISTORIC BUILDING RECORDING AT  
HALL FARM, BOSTON ROAD,  
EAST HECKINGTON, LINCOLNSHIRE

PREPARED FOR MR. JAMES BRAMMA OF JB ARCHITECTURAL DESIGN SERVICES ON  
BEHALF OF HIS CLIENT - MR. NICK LOWETH  
PART 2: THE EAST RANGE

March 2021

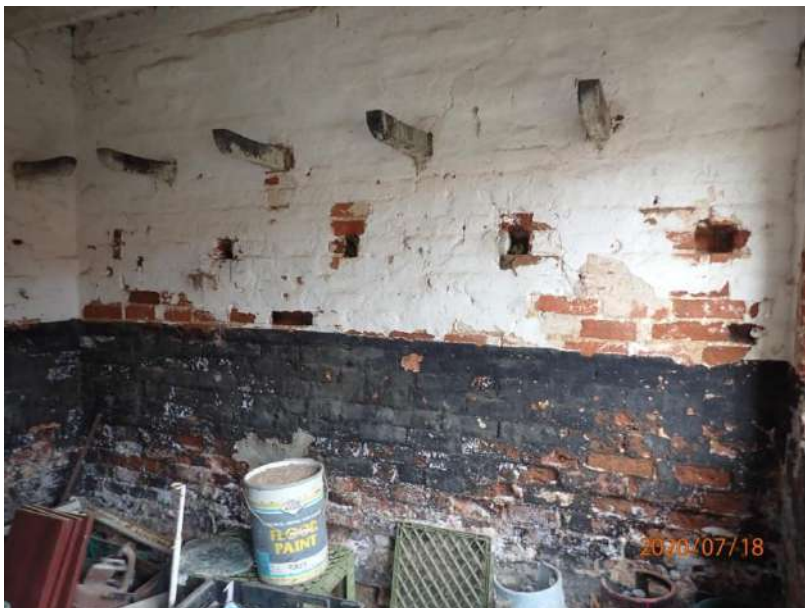
**Plate 265: View of the south wall of Cell 11, from the north**

**Plate 265** features the south wall of **Cell 11**, which is also the internal dividing wall with the adjacent **Cell 12** to the south. Here also, the detail of the nature of the brickwork wall fabric of this east wall has become obscured by being covered over with paintwork. An horizontal timber wallplate extends along the top of this south wall.

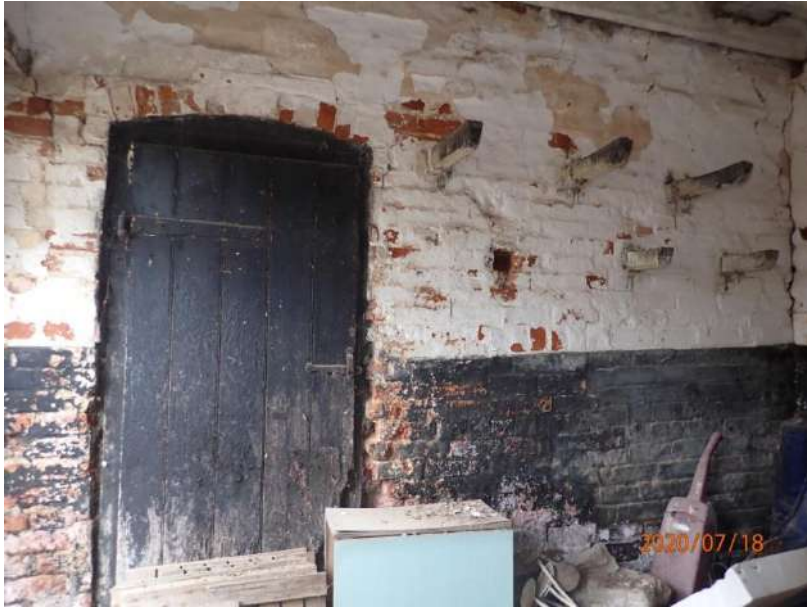
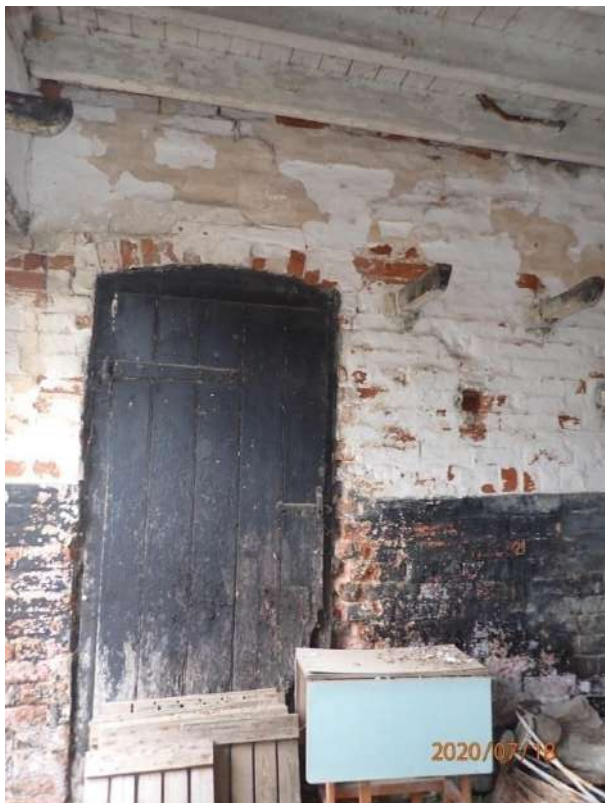
**Plates 266 and 267** detail the north wall of **Cell 11**, which is also the internal dividing wall with the adjacent **Cell 10** to the north. Here also, the detail of the nature of the brickwork wall fabric of this north wall has become obscured by being covered over with paintwork. Also featured is the inner face of a north facing entrance opening that leads onto the adjoining **Cell 10** to the north. This opening is occupied by a timber frame of a head and surrounds and a door that is composed of a series of vertical tongued and grooved timber planks. The door is attached to the frame by two

horizontal metal strap hinges. Above the opening is a curved head in brick composed of brick stretchers laid on edge.

**Plate 266: View of the north wall of Cell 11, from the south**

**Plate 267: View of the north wall of Cell 11, from the south**

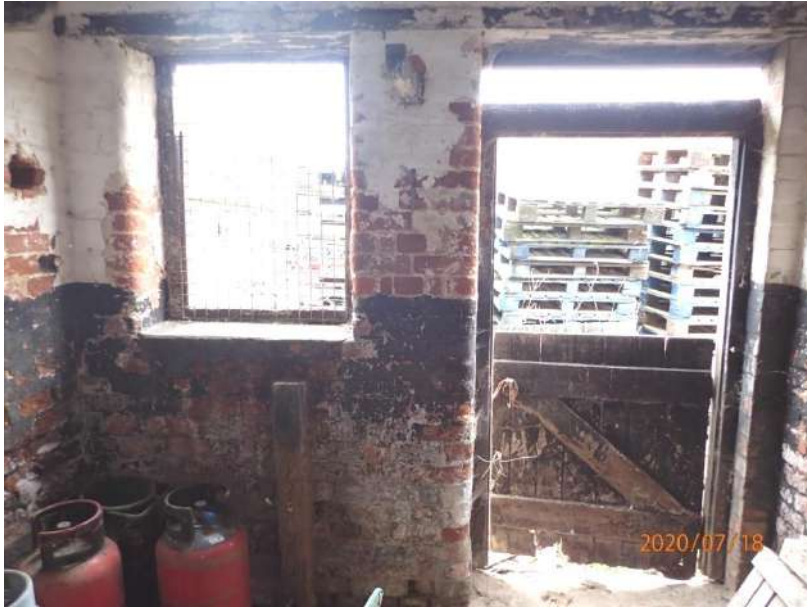
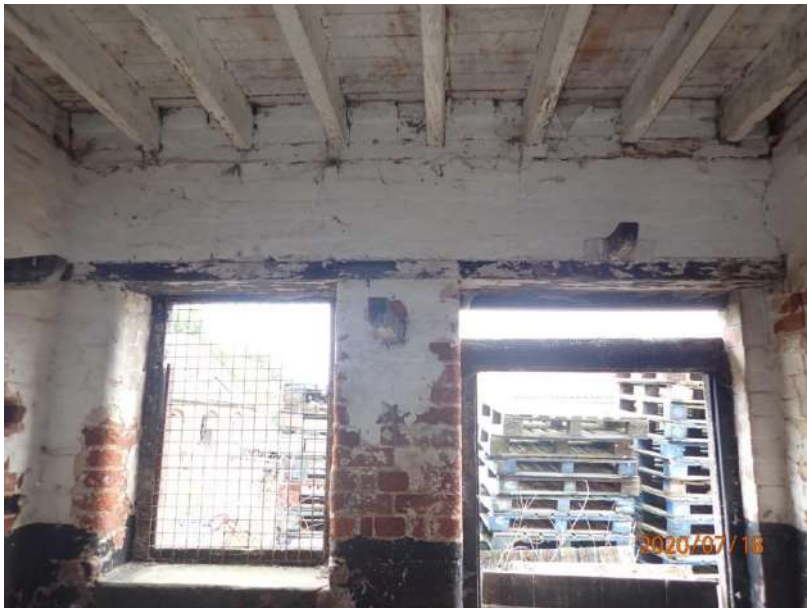
**Plate 268: View of the west wall of Cell 11, from the east**

**Plate 269: View of the west wall of Cell 11, from the east**

**Plates 268 and 269** furnish views of the west wall of **Cell 11**. Here also, most of the detail of nature of the brickwork wall fabric here has become obscured by being covered over with paintwork, though it is still possible to discern individual courses of brick stretchers and of courses of mixed brick headers and half bat bricks. Also shown are the inner faces of an entrance opening and alongside this, a slightly recessed west facing window opening, both of which were recorded externally at the West Elevation of this building. The window opening is unglazed and is infilled with wire netting. Within the opening is a timber frame of a head and surrounds. The entrance opening is also occupied by a timber frame of a head and surrounds along with a timber half door that is composed of a series of vertical tongued and grooved timber planks that are affixed to an internal framework of angled and horizontal timbers. The upper half door is absent. There are also the remains of a further timber frame consisting of a head alone, above the present

frame. Above the window and entrance opening is an horizontal timber lintel, which is incorporated into the wall fabric.

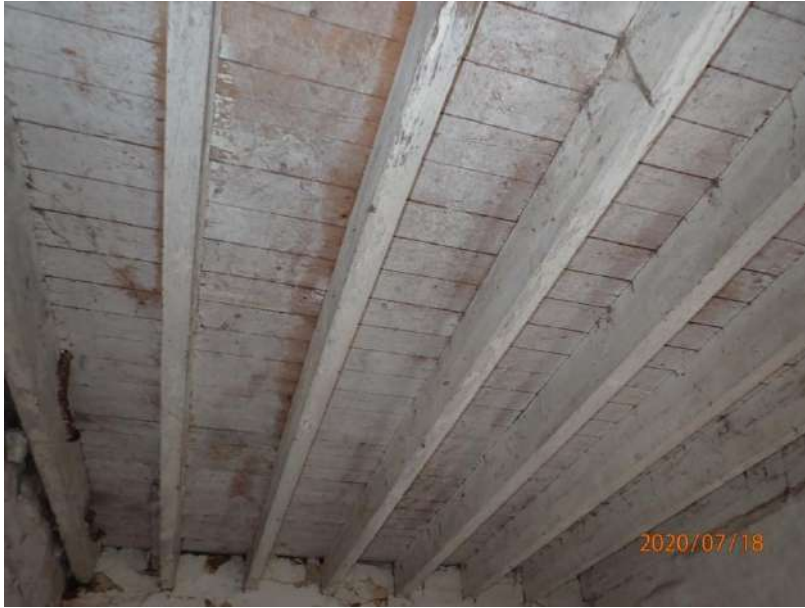
**Plate 270: View of the ceiling of Cell 11, from the west**

**Plates 270 and 271** present images of the nature of the ceiling structure of **Cell 11**. These show the series of east-west orientated horizontal timber joists, the ends of which are inserted into the uppermost levels of the east and west walls of **Cell 11**. These joists in turn support the first floor, floor covering of horizontal timber planking above.

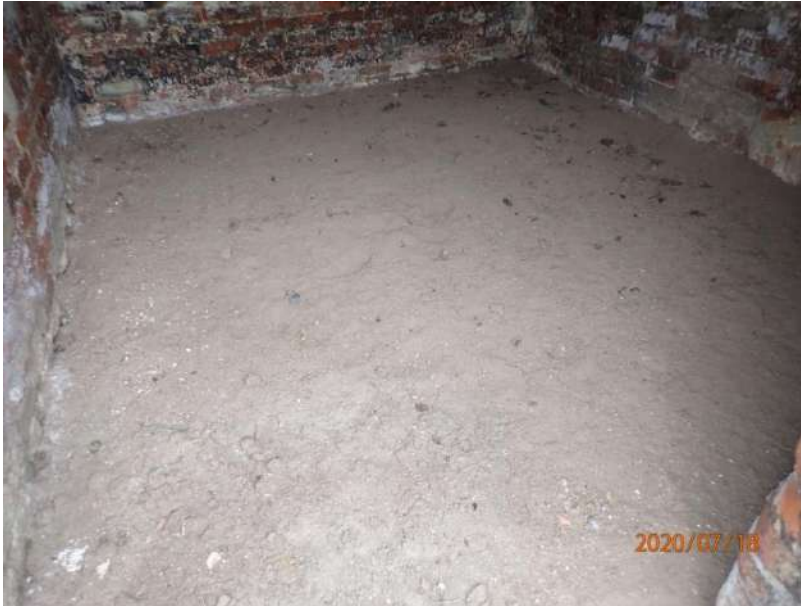
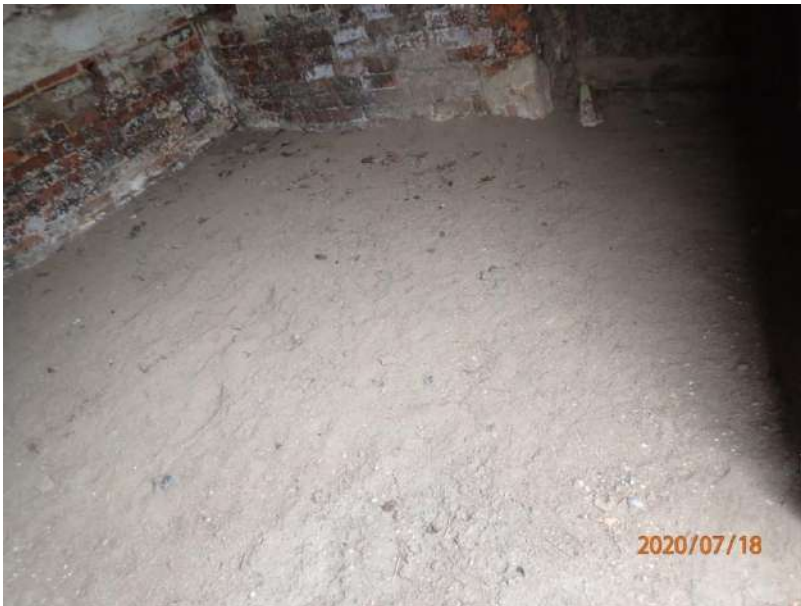
**Plates 272 and 273** feature the nature of the flooring of **Cell 12**, which is of earth.

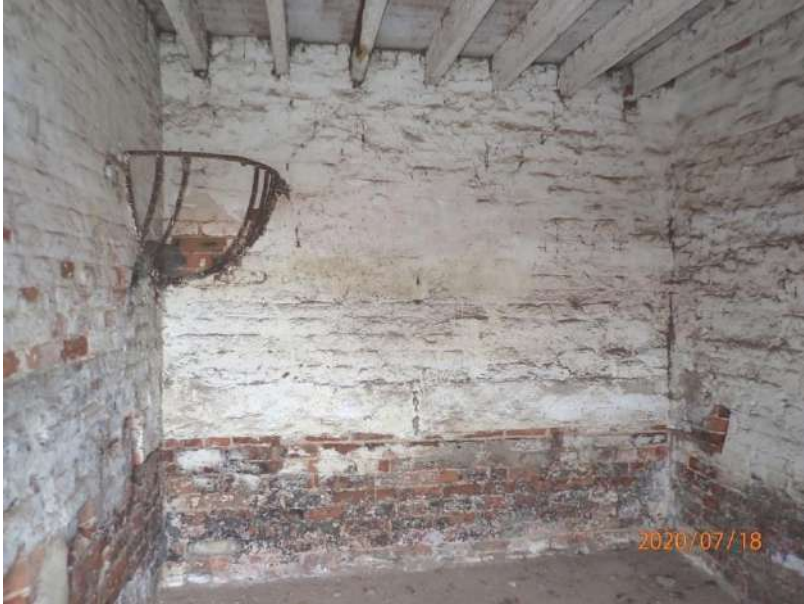
**Plate 274: View of the east wall of Cell 12, from the west**

**Plate 274** features the east wall of **Cell 12**. Here also, most of the detail of the nature of the brickwork wall fabric has become obscured by being covered over with paintwork. However, at the lower levels, it is possible to discern individual courses of mixed brick headers and brick stretchers. It may also be seen that the eastern ends of the horizontal timber ceiling joists are inserted into the uppermost levels of this wall fabric.

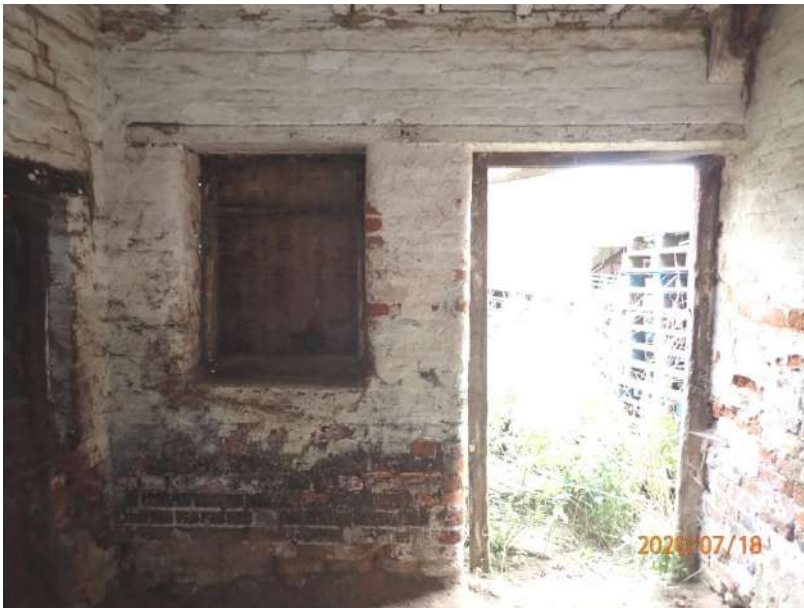
**Plate 275: View of the west wall of Cell 12, from the east**

**Plate 275** features the west wall of **Cell 12**. Here also, most of the detail of the nature of the brickwork wall fabric has become obscured by being covered over with paintwork. However, at the lower levels, it is possible to discern individual courses of brick headers and of brick stretchers. The western ends of the horizontal timber ceiling joists are inserted into the uppermost levels of this wall fabric. Also shown are the inner faces of a west facing window opening and a west facing entrance opening that were recorded externally at the southern end of the West Elevation of this building. The slightly recessed widow opening has been boarded over externally. The entrance opening is occupied by a timber frame of a head and surrounds. The door is absent. Above both is an horizontal timber lintel which is incorporated into the wall fabric.

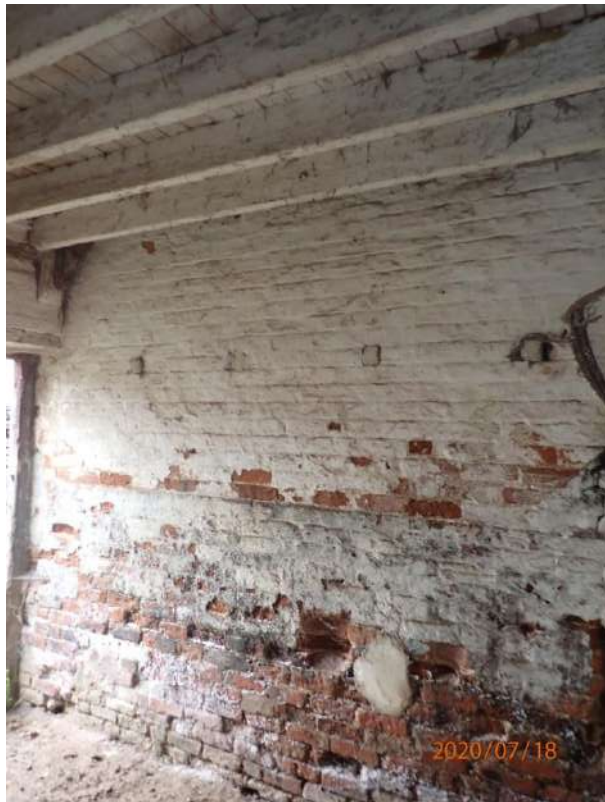
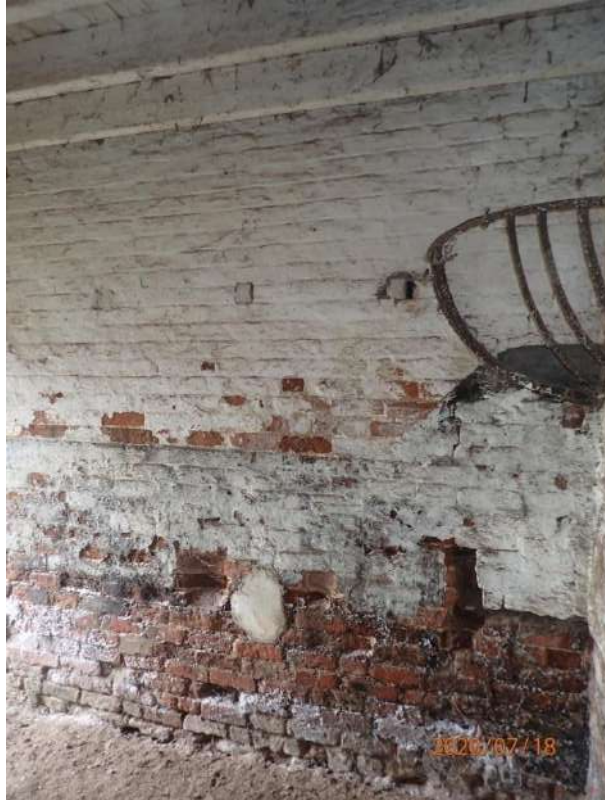
**Plates 276 and 277** detail the north wall of **Cell 12**, which is also the internal dividing wall with the adjacent **Cell 11** to the north. Here also, most of the detail of the nature of the brickwork wall

fabric has become obscured by being covered over with paintwork. However, at the lower levels, it is possible to discern individual courses of brick stretchers. A metal hay feeder is attached to the corner of the north and east walls.

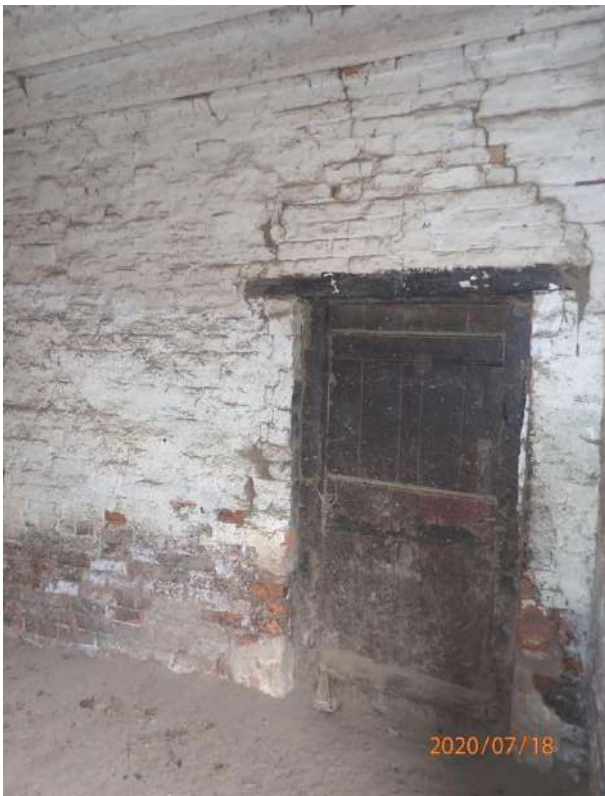
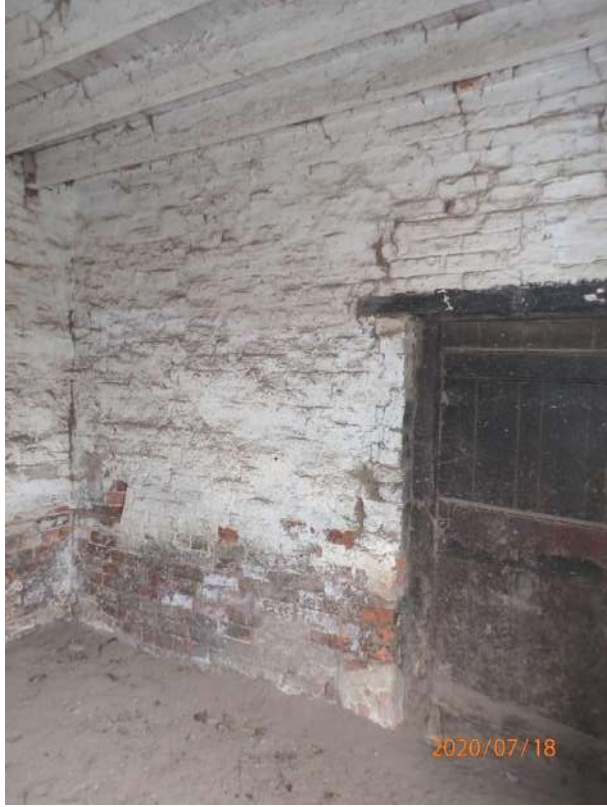
**Plates 278 and 279** present detailed views of the south wall of **Cell 12**. Here also, most of the detail of the nature of the brickwork wall fabric has become obscured by being covered over with paintwork. However, at the lower levels, it is possible to discern individual courses of brick stretchers and of mixed brick headers and brick stretchers. Also shown is the inner face of a south facing entrance opening that leads onto the southern tunnel within the East Range. This opening is occupied by a timber frame of a head and surrounds along with a door that is composed of a series of vertical tongued and grooved timber planks that are affixed to an internal framework of horizontal timbers. Above the opening is an horizontal timber lintel that is incorporated into the brickwork wall fabric here.

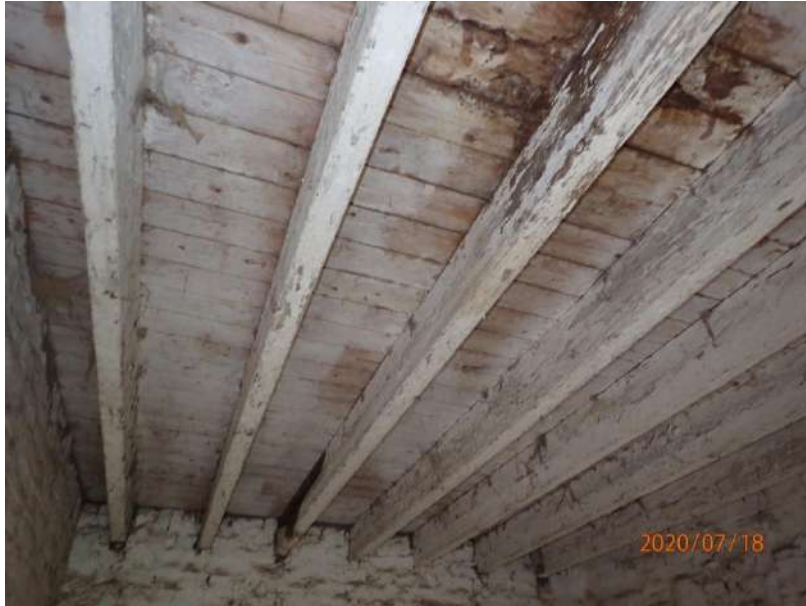
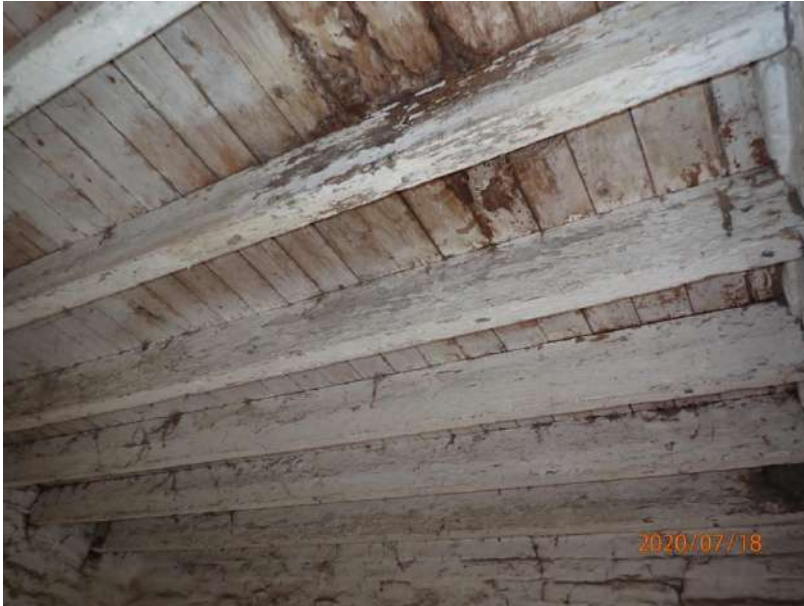
**Plates 280 and 281** detail the nature of the ceiling structure of **Cell 12**. These show the series of east-west orientated horizontal timber joists, the ends of which are inserted into the uppermost levels of the east and west walls of **Cell 12**. These joists in turn support the first floor, floor covering of horizontal timber planking above.

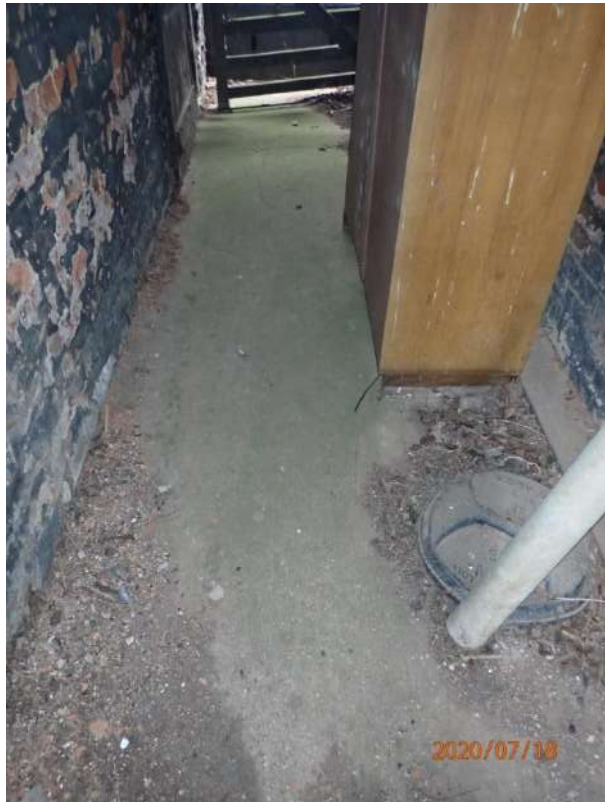
**Plate 282: View of the interior of the south tunnel, from the east**

**Plate 282** features the nature of the flooring of the south tunnel, which is of modern concrete.

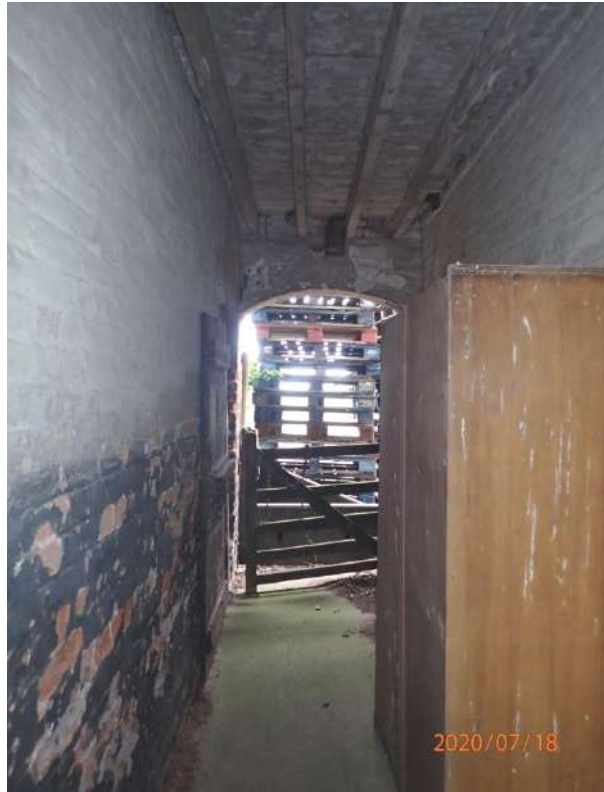
**Plate 283: View of the interior of the south tunnel, from the east**

**Plate 283** presents a general view of the interior of the south tunnel from an eastern vantage point.

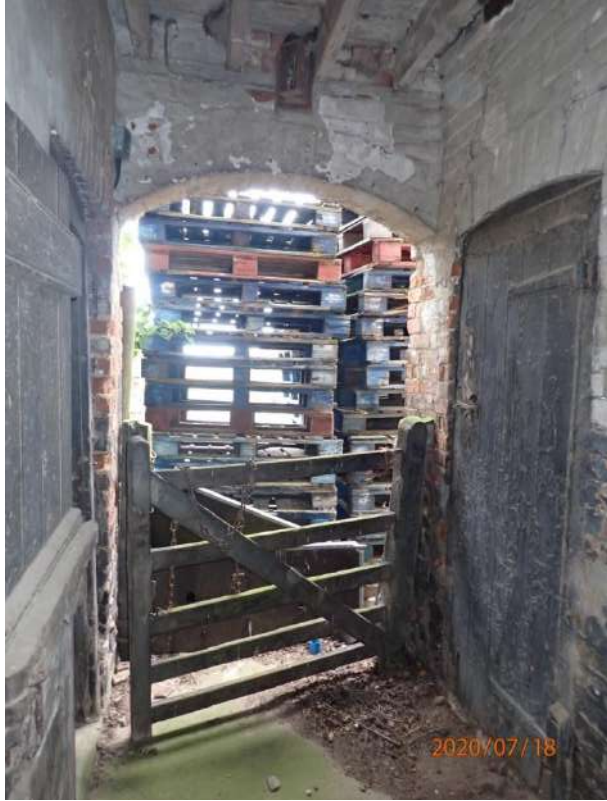
**Plate 284: View of the interior of the south tunnel, from the east**

**Plate 284** provides a detailed view of the inner face of the western end of the south tunnel. Access into this west end was obtained via the five barred timber gate shown. The nature of the brickwork of this rounded arch at the head of this opening and also above this opening was difficult to discern owing to there being covered over with layers of paintwork, which has obscured the underlying detail here. An horizontal timber wallplate may be seen at the upper levels of the brickwork wall fabric.

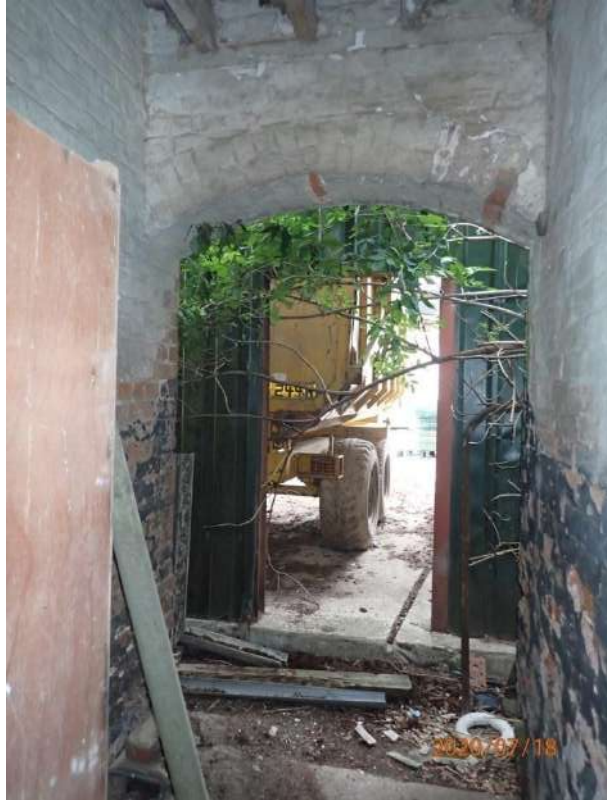
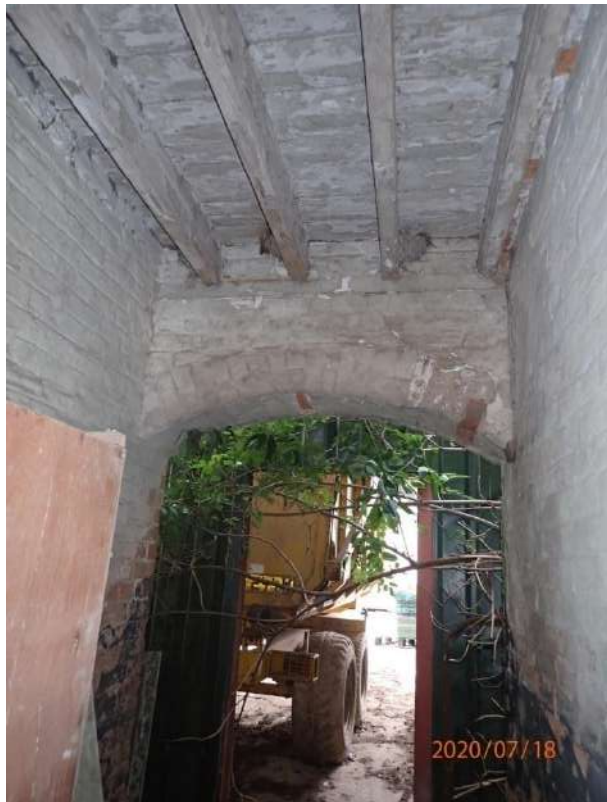
**Plates 286 and 287** feature the inner face of the eastern end of the south tunnel, which is open to the east, but which was not accessible at the time of this survey. The nature of the brickwork of this rounded arch at the head of this opening had been covered over with paintwork, though it was possible to discern the nature of the brickwork of this arch, which is composed of splayed brick stretchers alternating with brick headers, which are all laid on end. The brickwork above the arch has also been painted over, similarly obscuring the detail, so the nature of this brickwork could not be discerned. An horizontal timber wallplate may be seen at the upper levels of the brickwork wall fabric.

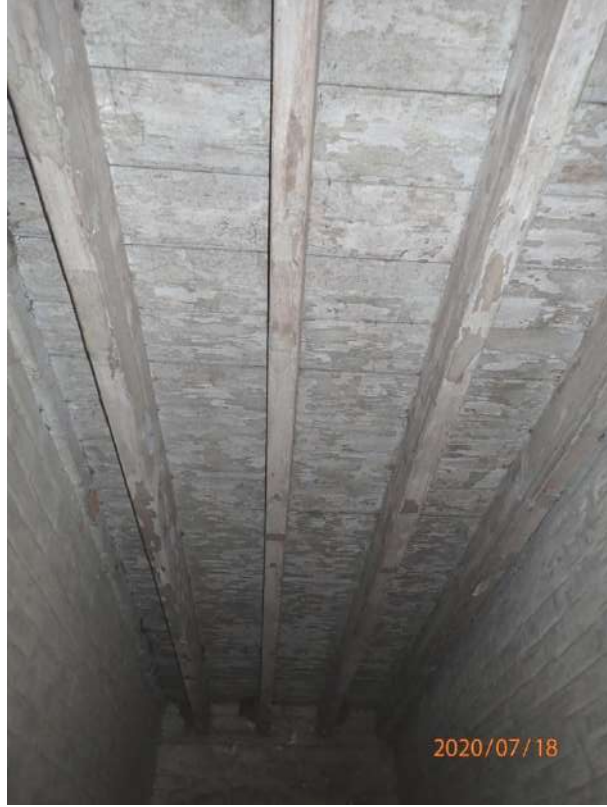
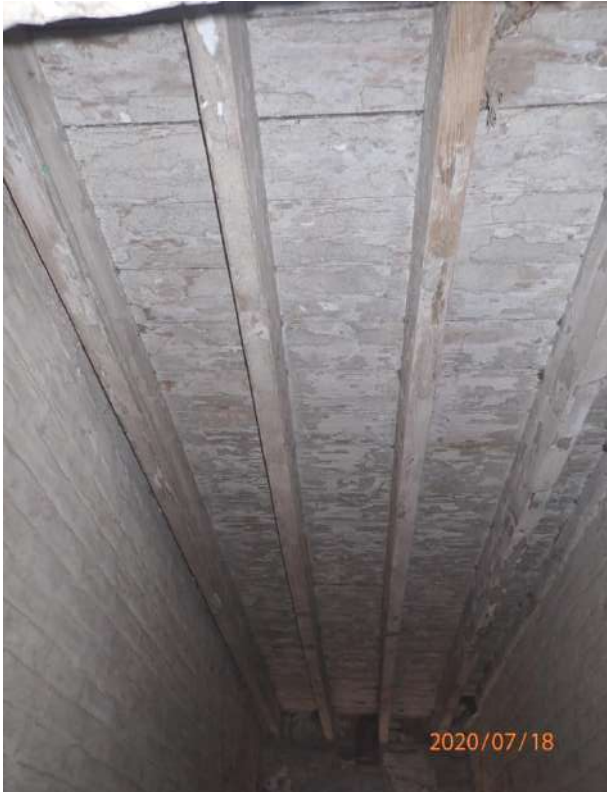
**Plates 288 and 289** present images of the nature of the ceiling structure of the south tunnel from two different vantage points. This structure is composed of a series of east-west orientated horizontal timber ceiling joists, the ends of which are inserted into the uppermost levels of the brickwork wall fabric of the eastern and western ends of the tunnel. The joists in turn support the first floor, floor covering of horizontal timber planking above.

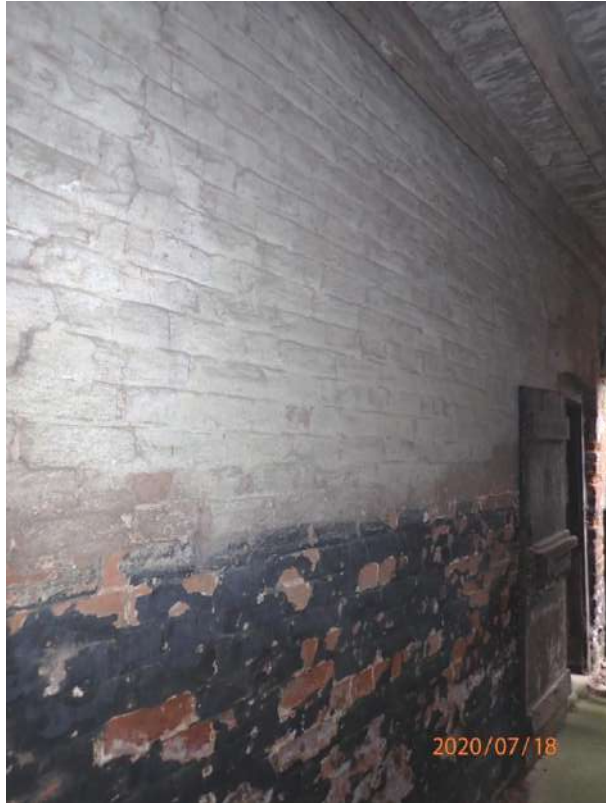
**Plate 290: View of the interior of the south tunnel, from the west**

**Plate 290** provides a detailed view of the south wall of the south tunnel. Here also, the detail of the nature of the underlying brickwork wall fabric had become obscured by being covered over with paintwork.

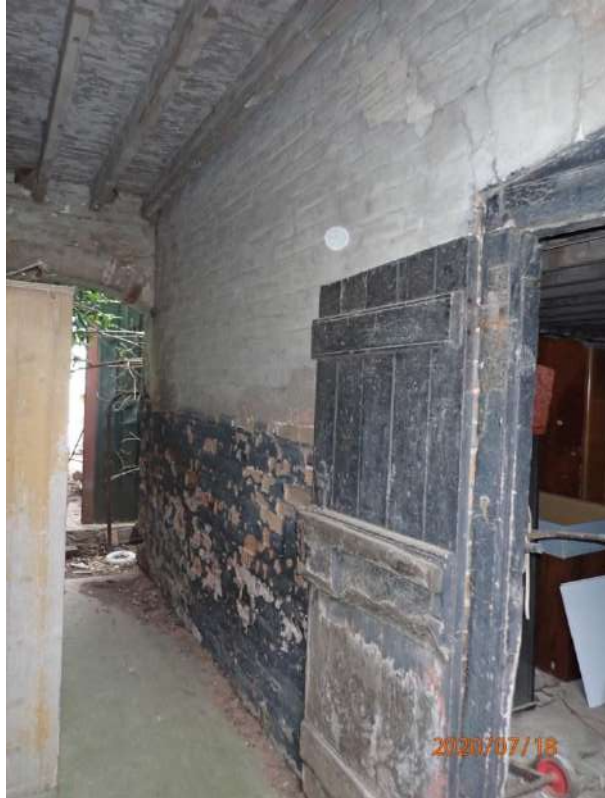
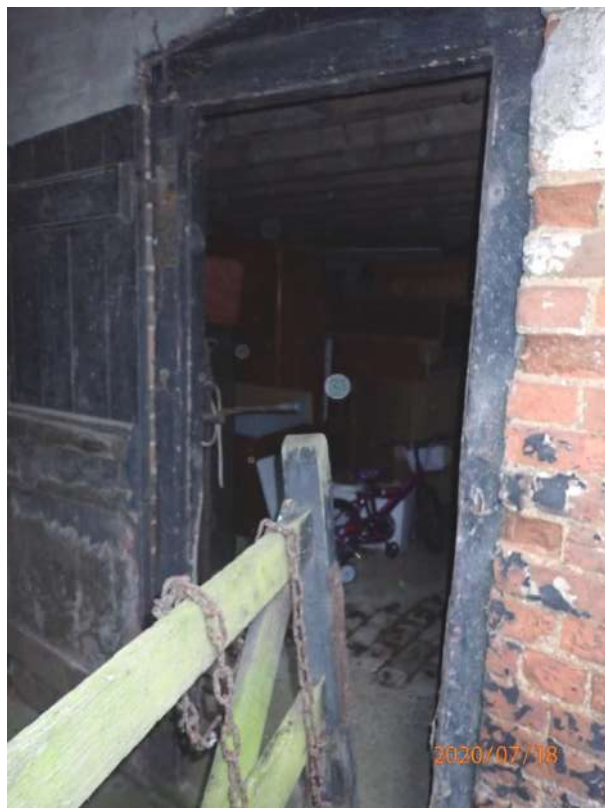
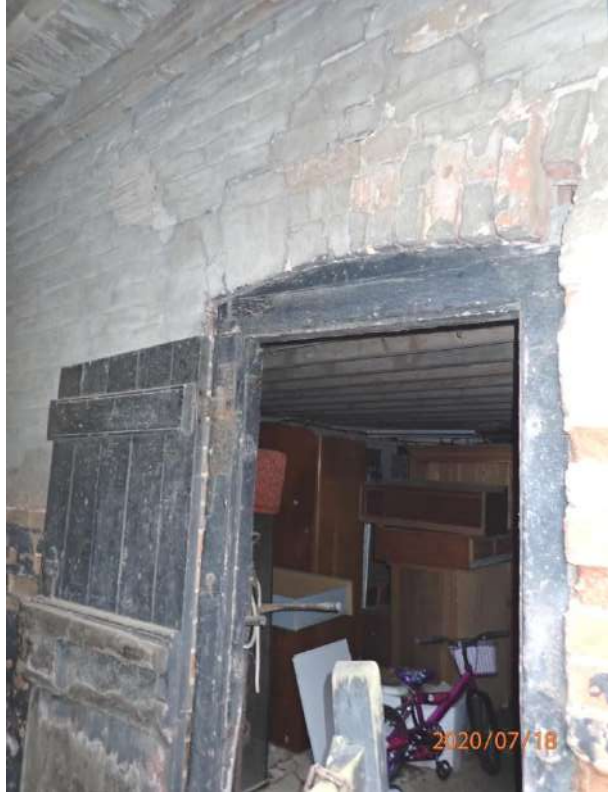
**Plate 291** features the opposing north wall of the south tunnel. Here also, the detail of the nature of the underlying brickwork wall fabric had become obscured by being covered over with paintwork. **Plates 292 and 293** also show in detail the south facing entrance opening at the western end of the south tunnel, that leads on into the adjoining **Cell 13** to the south. This opening is occupied by a timber frame of a head and surrounds and a door that is composed of a series of vertical tongued and grooved timber planks that are affixed to an internal framework of horizontal timbers. Above the opening is a curved head in brick composed of brick stretchers alternating with brick headers laid on end.

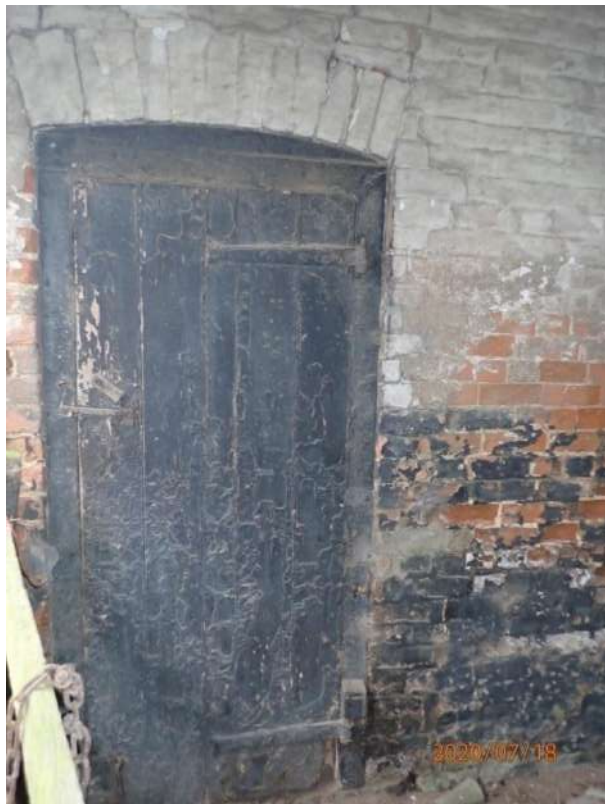
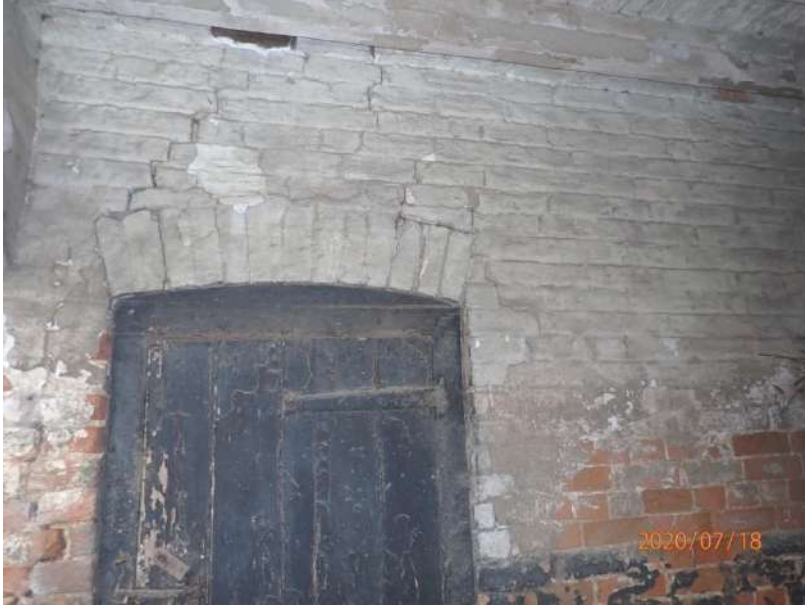
**Plates 294 and 295** present detailed images of the north facing entrance opening that is situated at the western end of this south tunnel and which leads onto the adjacent **Cell 12** to the north. This second opening is occupied by a timber frame of a head and surrounds and a door that is composed of a series of vertical tongued and grooved timber planks. The door is attached to the frame by two cast metal horizontal strap hinges. Above the opening is a curved head in brick composed of brick stretchers laid on end.

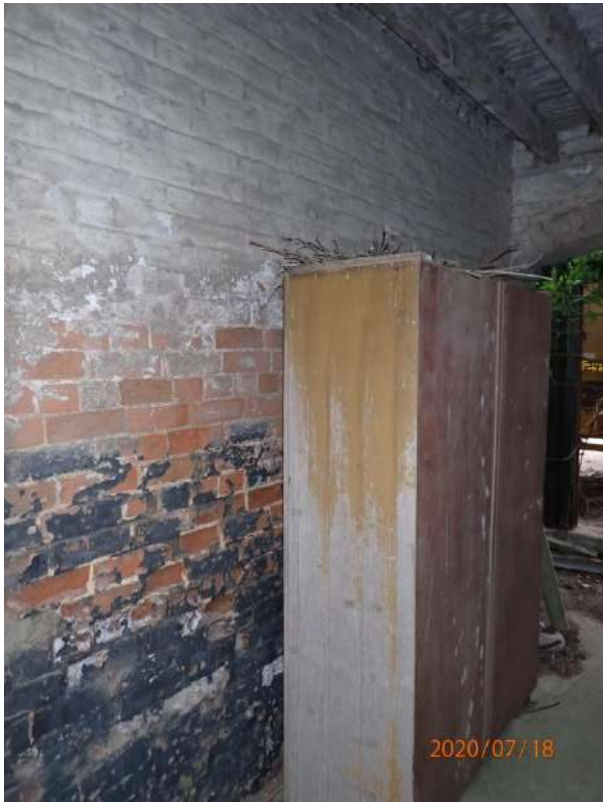
**Plate 296: View of the interior of the south tunnel, from the west**

**Plate 296** presents a view of the north wall of the south tunnel. Here also, much of the detail of the nature of the underlying brickwork wall fabric had become obscured by being covered over with paintwork. However, at the lower levels, courses of brick stretchers and of further courses of mixed brick headers and bricks stretchers could be discerned where this paintwork was absent.

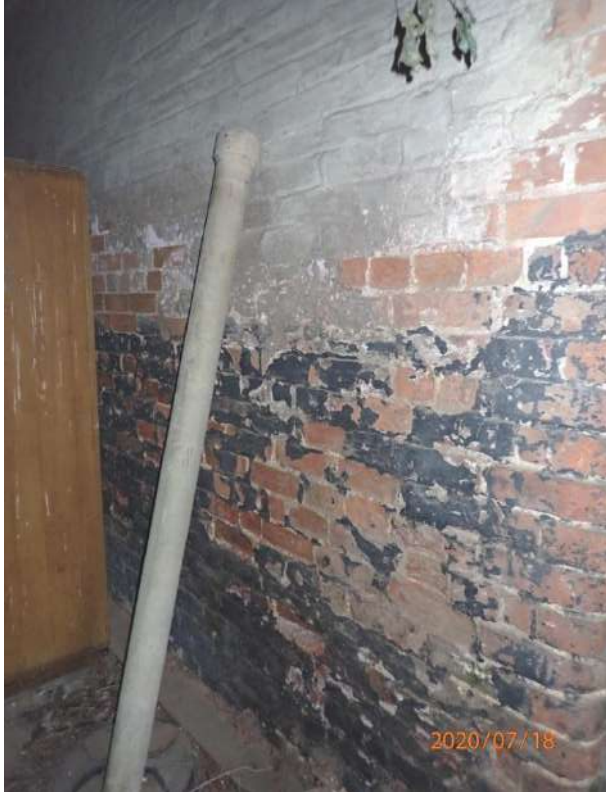
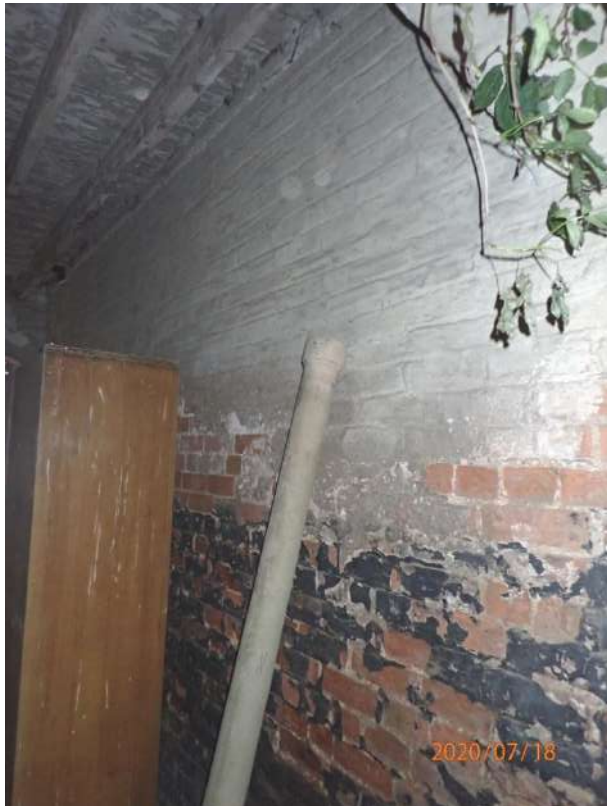
**Plates 297 and 298** feature the north wall of the south tunnel at its eastern end. Here also, much of detail of the nature of the underlying brickwork wall fabric had become obscured by being covered over with paintwork. However, at the lower levels, courses of brick stretchers, of courses of brick headers and of further courses of mixed brick headers and bricks stretchers could be discerned where this paintwork was absent.

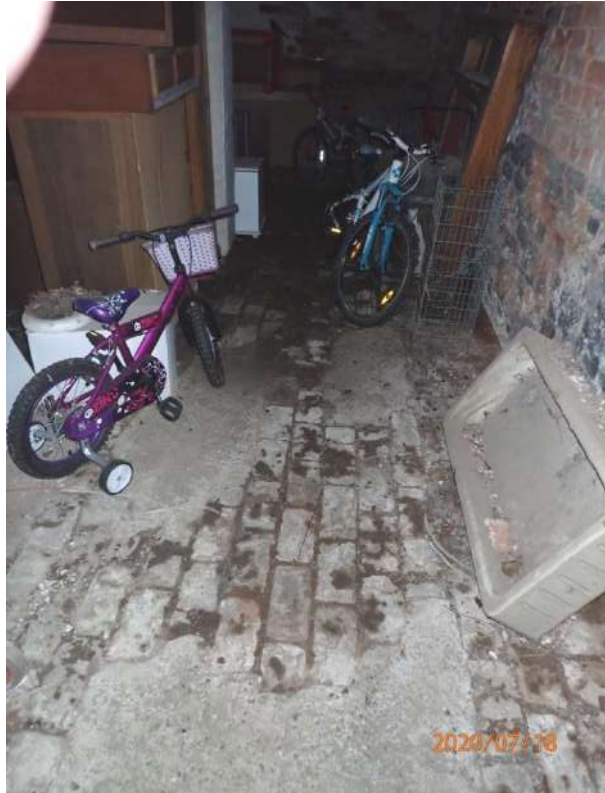
**Plate 299: View of the flooring of Cell 13, from the north**

**Plate 299** presents a view of the nature of the flooring of **Cell 13**, which is composed of courses of brick stretchers laid on bed.

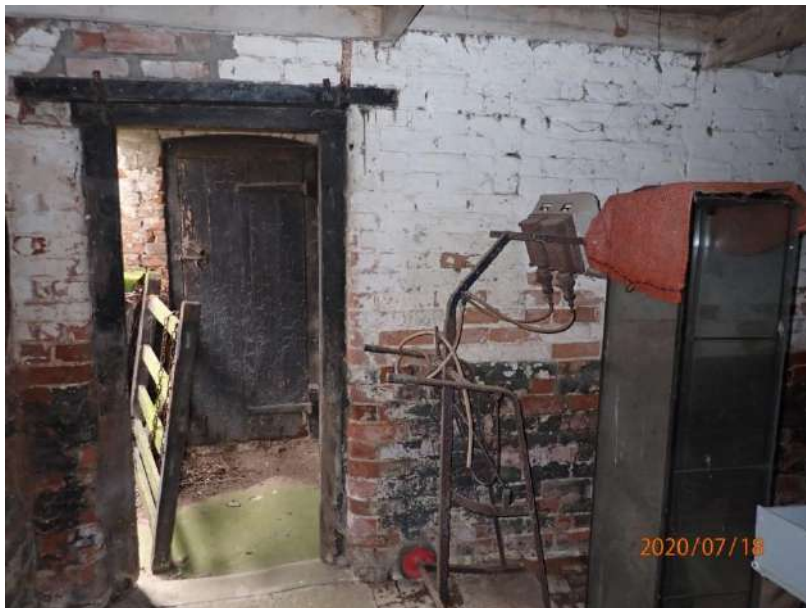
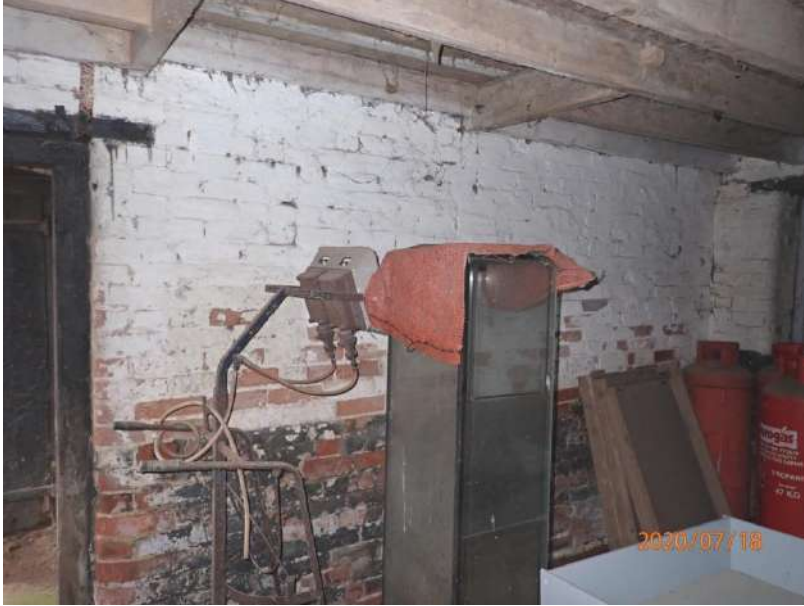
**Plates 301 and 302** feature the north wall of **Cell 13**. Here also, much of the detail of the nature of the brickwork wall fabric had become obscured by being covered over with paintwork, though at the lower levels, where this was absent, individual courses of brick headers and of brick stretchers could be seen. Also shown is the inner face of the north facing entrance opening that leads onto the adjoining south tunnel. This opening is occupied by a timber frame of a head and surrounds. An horizontal timber lintel is above the opening and is incorporated into the brickwork wall fabric. Horizontal timber wallplates may be seen to extend along the upper levels of this wall.

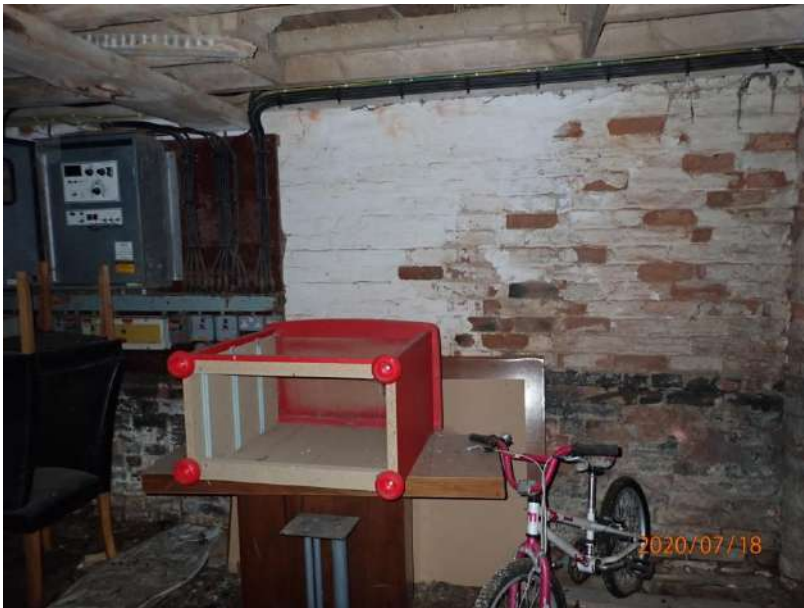
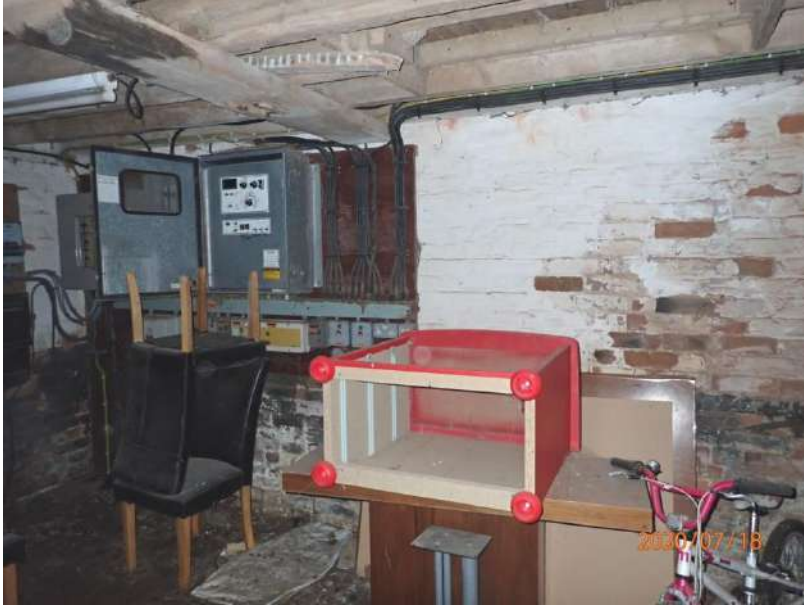
**Plates 303 and 304** show the south wall of **Cell 13**. Here also, the detail of the nature of the brickwork wall fabric had become obscured by being covered over with paintwork.

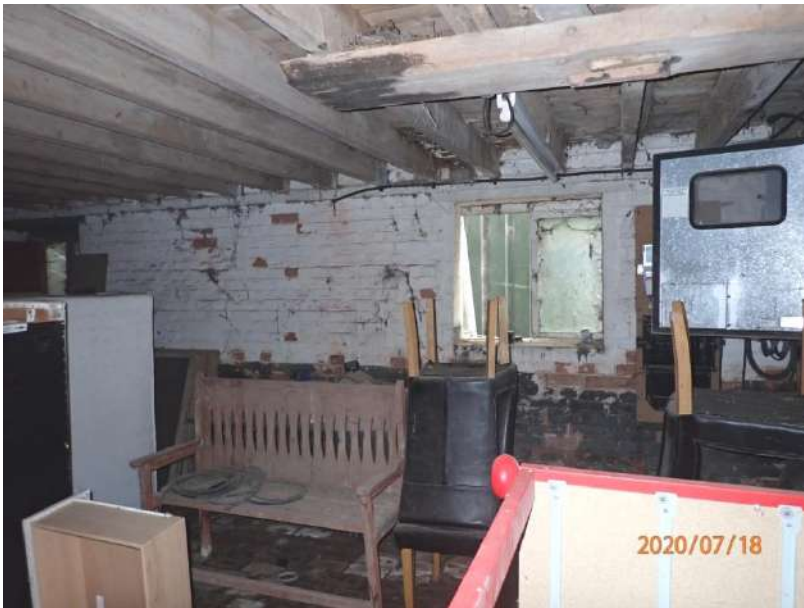
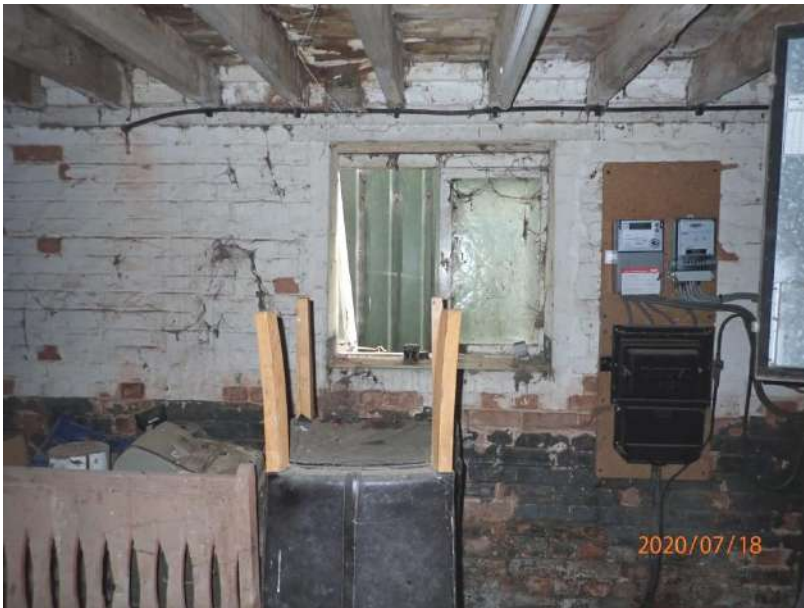
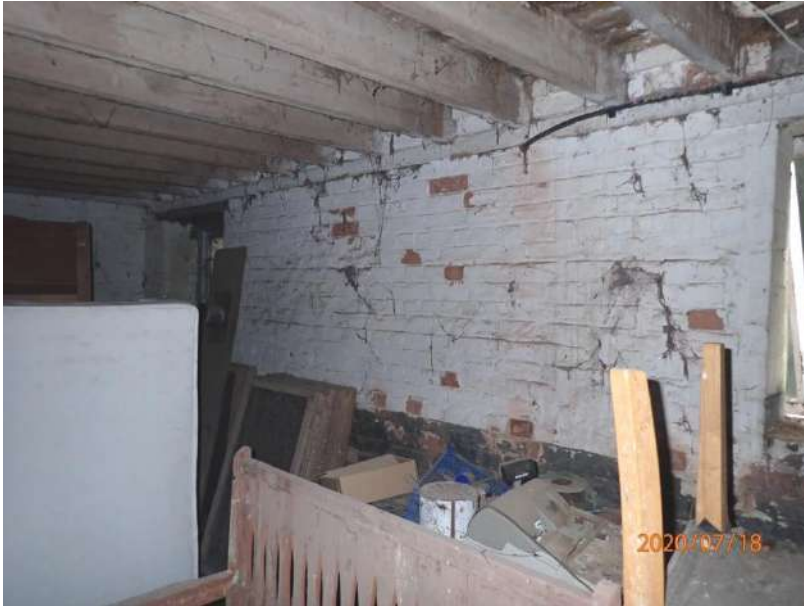
**Plates 305 and 307-308** all feature the east wall of **Cell 13**. Here also, the detail of the nature of the brickwork wall fabric had become obscured by being covered over with paintwork. Horizontal timber wallplates may be seen to extend along the upper levels of this east wall. Also featured is the inner face of the ground floor east facing window opening that was recorded externally at the East Elevation of this building. This opening is occupied by a timber frame of a head and surrounds and by a modern glazed two light timber casement window with a central vertical timber mullion. Above the opening is an horizontal timber lintel which is incorporated into the brickwork wall fabric.
