HISTORIC BUILDING RECORDING AT  
HALL FARM, BOSTON ROAD,  
EAST HECKINGTON, LINCOLNSHIRE

PREPARED FOR MR. JAMES BRAMMA OF JB ARCHITECTURAL DESIGN SERVICES ON  
BEHALF OF HIS CLIENT - MR. NICK LOWETH  
PART 2: THE EAST RANGE

March 2021

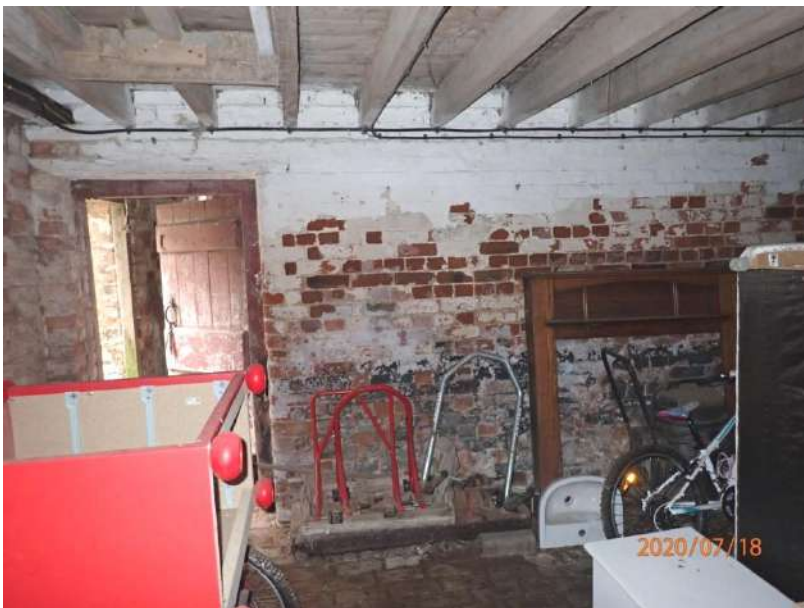
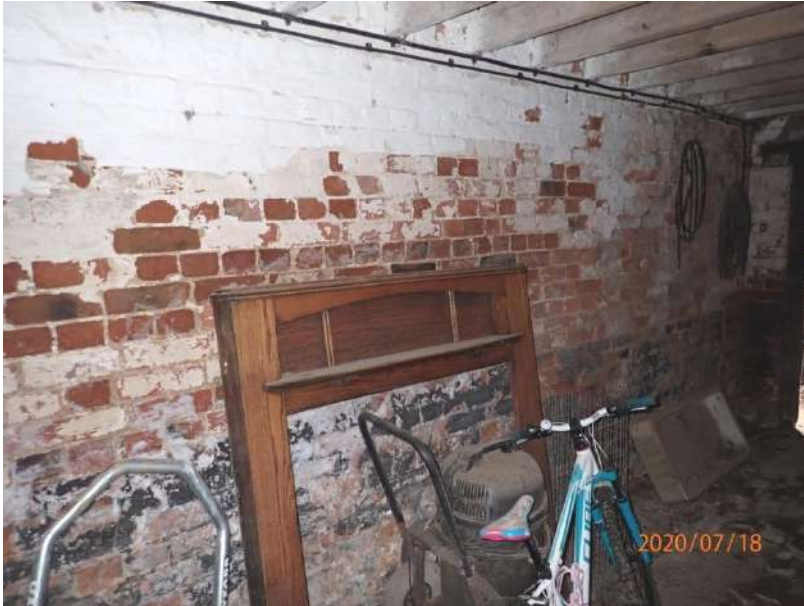
**Plates 309 and 310** feature the west wall of **Cell 13**, which is also the intrnal dividing wall with the South Range to the west. Despite the brickwork wall fabric having paintwork in places, this wall fabric is composed of courses of brick stretchers alternating with courses of brick headers in English Bond. To the left, is a west facing entrance opening, which leads on into the interior of the South Range to the west. This opening is occupied by a timber frame of a head and surrounds and a door that is composed of a series of vertical timber planks that are attached to an internal framework of horizontal timbers. At the base of the opening is a stone threshold.

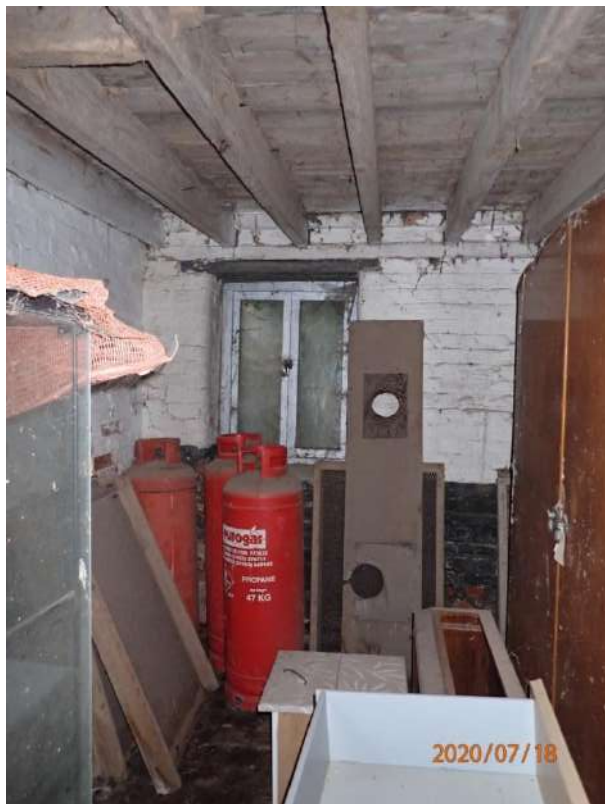
**Plate 311:** View of the east wall of Cell 13, from the west

**Plate 311** presents a view of the northern end of the east wall of **Cell 13**. Here also, the detail of the nature of the brickwork wall fabric had become obscured by being covered over with paintwork. Here also is the inner face of a ground floor east facing window opening, that was not accessible externally. This slightly recessed opening is occupied by a timber frame of a head and surrounds and by an unglazed two light modern timber casement window. Above the opening is

an horizontal timber lintel and above this in turn an horizontal timber wallplate, both of which are incorporated into the brickwork wall fabric here.

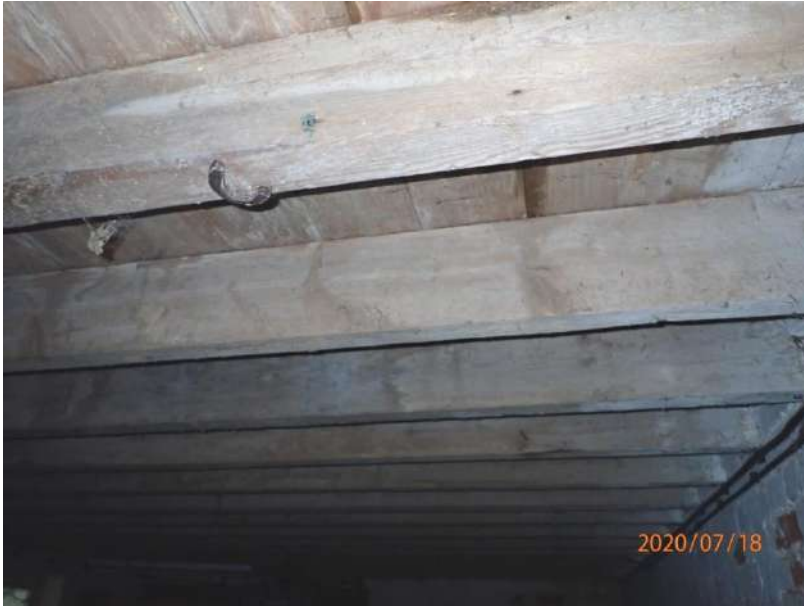
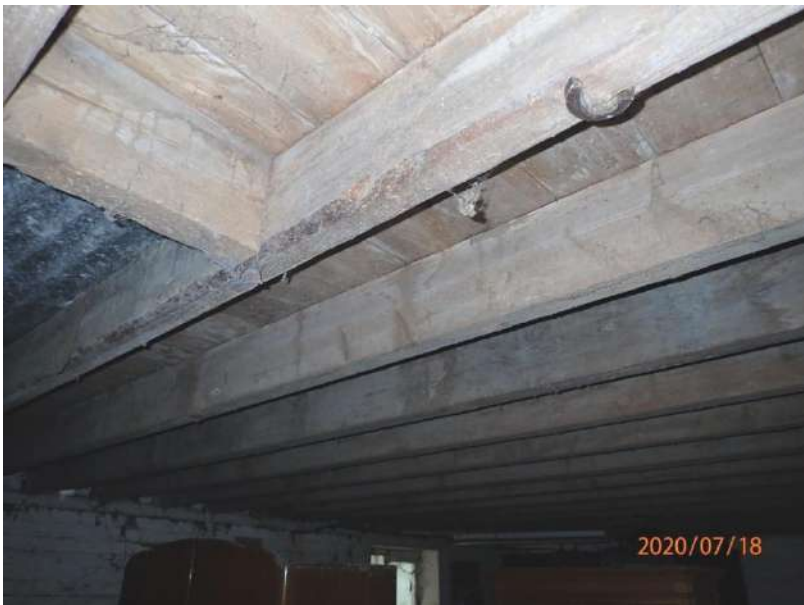
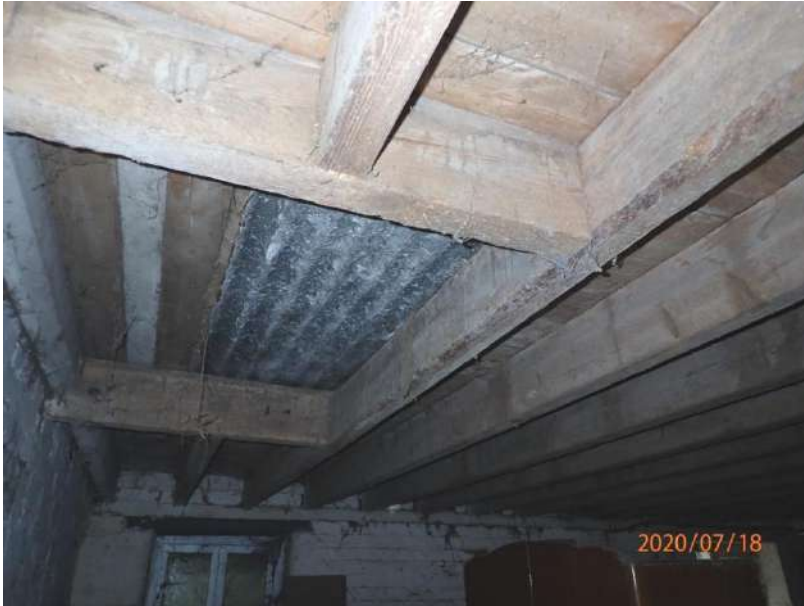
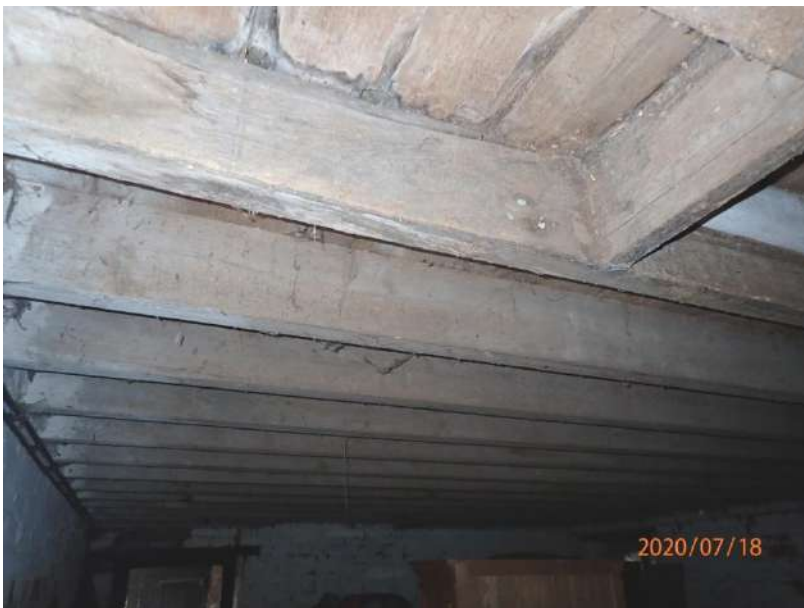
**Plates 312-315** feature a number of images of the nature of the ceiling structure of **Cell 13**. This is composed of a series of east-west orientated horizontal timber ceiling joists, the ends of which are inserted into timber wallplates within the east and west walls. The joists in turn support the first floor, floor covering of horizontal timber planking above.

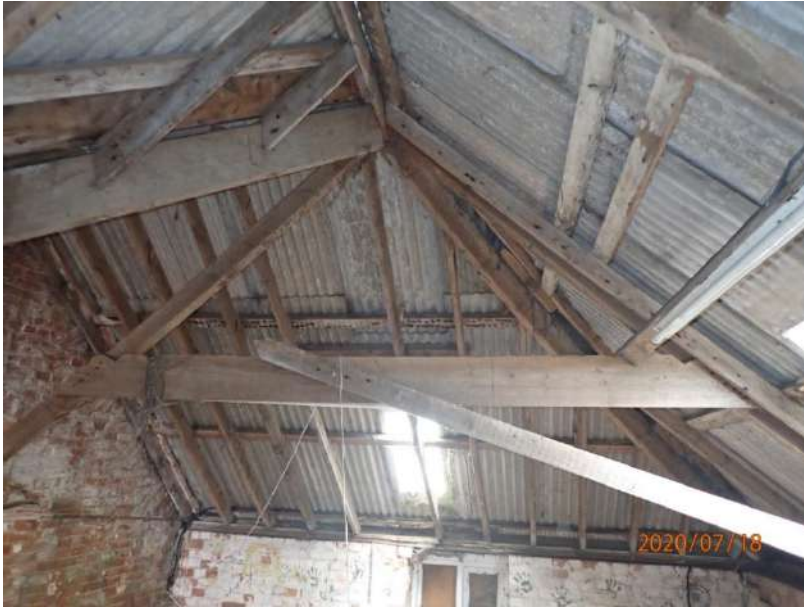
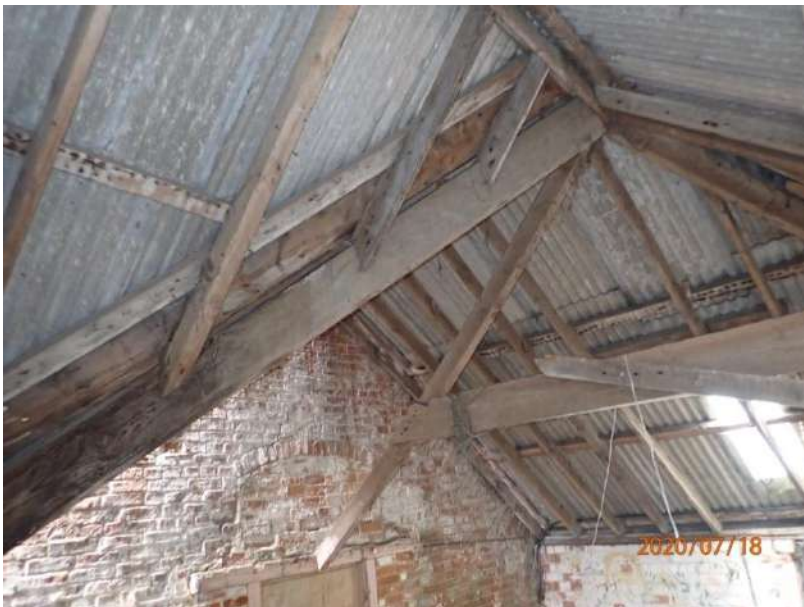
**Plates 318 and 319** provide detailed views of the nature of the roof supporting structure above **Cell 14** and hence at the northern end of this East Range. The roof structure of the long north-south axis of the building is gabled. However, at the northern end of the building there is a short return to the west where this building is bonded to the North Range. This west return is also reflected in the nature of the roof structure here, which is half hipped. Thus this roof structure has two component parts, the gabled long axis with a further half hipped structure to the west. The basic framework of this structure is provided by the timber rafters which occur along both sides of these two component parts. To the rafters are attached the series of horizontal timber purlins, which also extend along both sides of these two component parts. The purlins also form a box like structure at the north-eastern corner of the building. This structure is reinforced by various angled and additional hip rafters, which occur at each corner of the structure. The framework of rafters and hip rafters in turn support the roof covering of corrugated metal sheeting. In addition, a

substantial east-west orientated horizontal timber tie beam provides additional support to this structure.

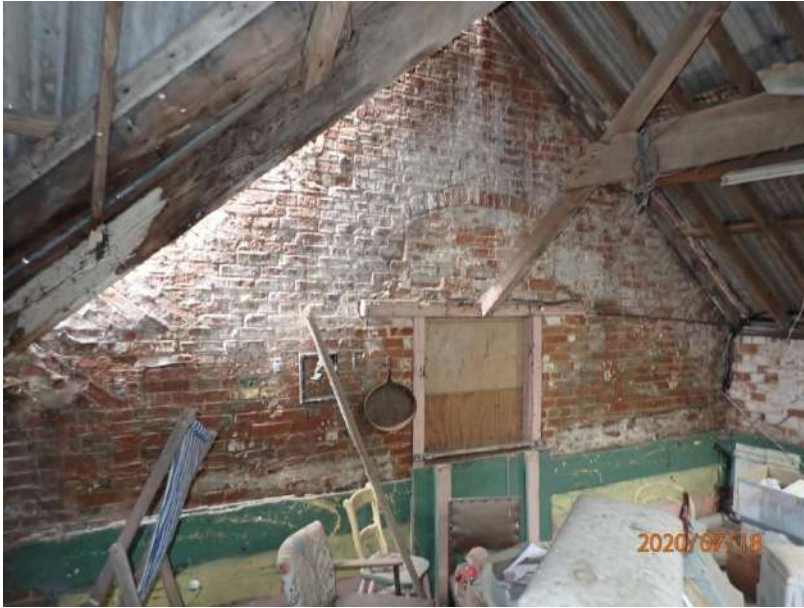
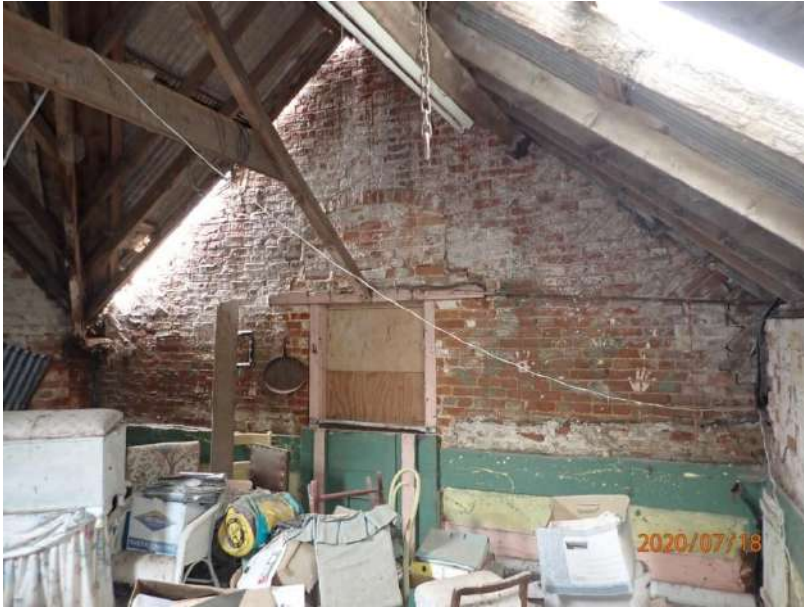
**Plates 320 and 324** present detailed views of the west wall of **Cell 14**, which is also the upper levels of the West Elevation of the adjoining North Range. The brickwork wall fabric here is composed of three courses of brick stretchers that alternate with one course of brick headers in English Garden Wall Bond. At the edges of this west wall, which are visible, the decorative and triangular shaped brick dressings that are each composed of brick stretchers alternating with mixed brick headers and stretchers, which are laid on bed at an angle. These were also recorded externally. An infilled former first floor window opening is also featured. This is denoted by a curved head in brick of brick stretchers laid on edge. The former opening below this curved head has been infilled with brick. Also shown and below this is an infilled former probable first floor hay

loft opening into the interior of the former threshing barn (North Range). This opening is occupied by a timber frame of a head and surrounds and has been boarded over.

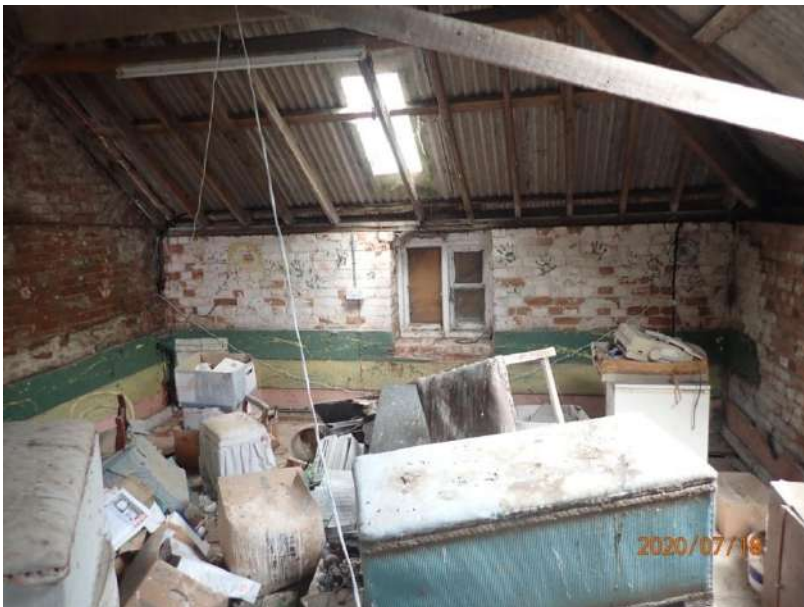
**Plate 321: View of the north wall of Cell 14, from the south**

**Plate 321** provides a view of the north wall of **Cell 14**. The brickwork wall fabric of this north wall is in English Bond, of courses of brick stretchers alternating with courses of brick headers. Horizontal timber wallplates may be seen to extend along the top of this north wall. The bottom ends of the timber rafters of the overlying roof structure are attached to these wallplates. Also shown is the inner face of the slightly recessed first floor north facing window opening, which was recorded externally at the North Elevation of this building. This opening is occupied by a timber frame of a head and surrounds along with a partially glazed modern timber casement window, originally of four lights. Two lights have been removed and have been boarded over. There is also one central vertical timber mullion and one horizontal timber glazing bar intact.

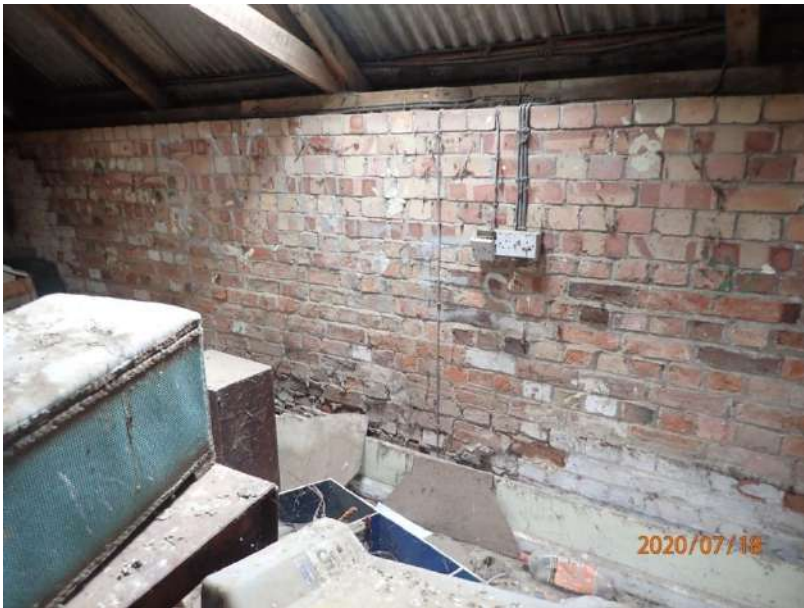
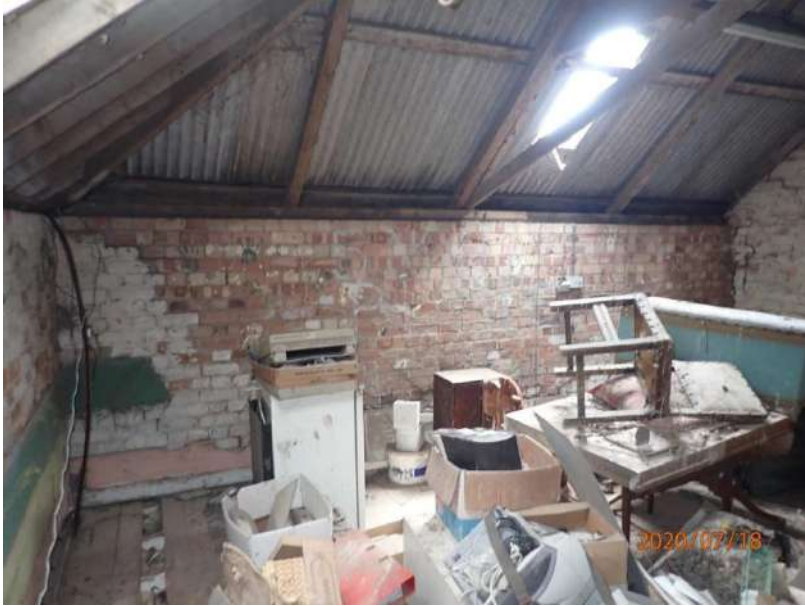
**Plates 323 and 330** feature the east wall of **Cell 14**, which was also recorded externally as an area of modern repair and addition in the East Elevation of this building. This is reflected in the nature of the brickwork of this east wall, which is of modern origin and composed of courses of brick stretchers alternating with courses of brick headers in English Bond. Horizontal timber wallplates may be seen to extend along the top of this north wall. The bottom ends of the timber rafters of the overlying roof structure are attached to these wallplates.

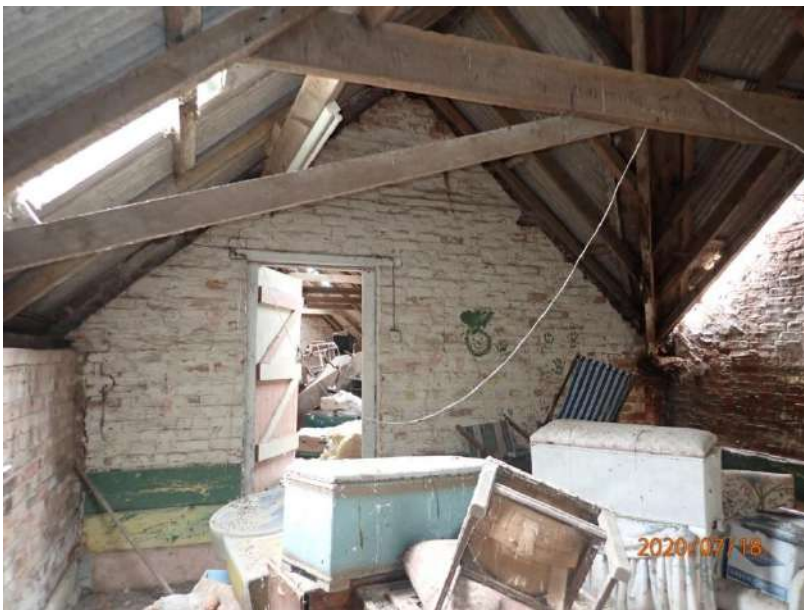
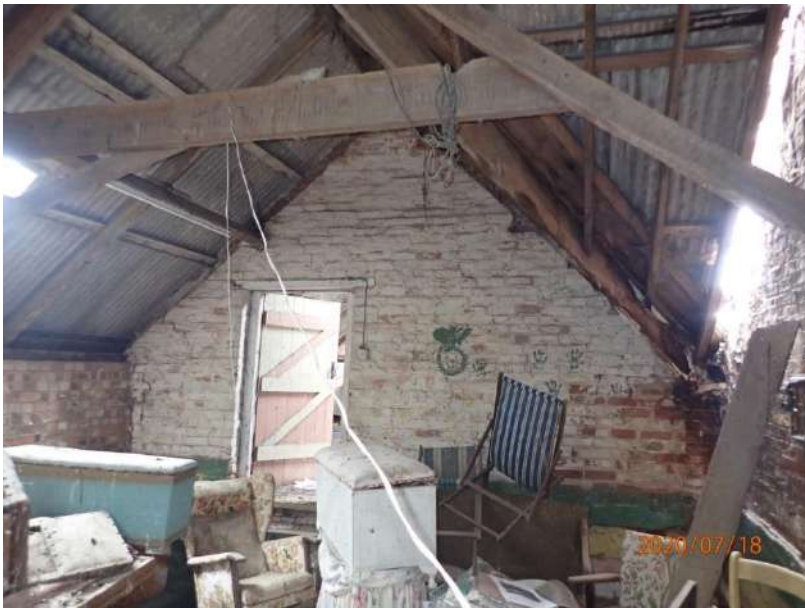
**Plates 325 and 331** present images of the south wall of **Cell 14**, which is also the internal dividing wall with the adjoining **Cell 15** to the south. Here, the detail of the nature of the brickwork wall fabric of this south wall has become obscured by being covered over with layers of paintwork. The central feature of this south wall is the south facing entrance which leads on into **Cell 15** to the south. This opening is occupied by a timber frame of a head and surrounds and a door that is composed of a series of vertical tongued and grooved timber planks that are attached to an internal framework of angled and horizontal timbers. Above the opening is an horizontal timber lintel, that is incorporated into the brickwork. Of note is the difference in floor levels between **Cells 14 and 15**, with steps leading down from this entrance into the interior of **Cell 14**, the floor of which is at a lower level.

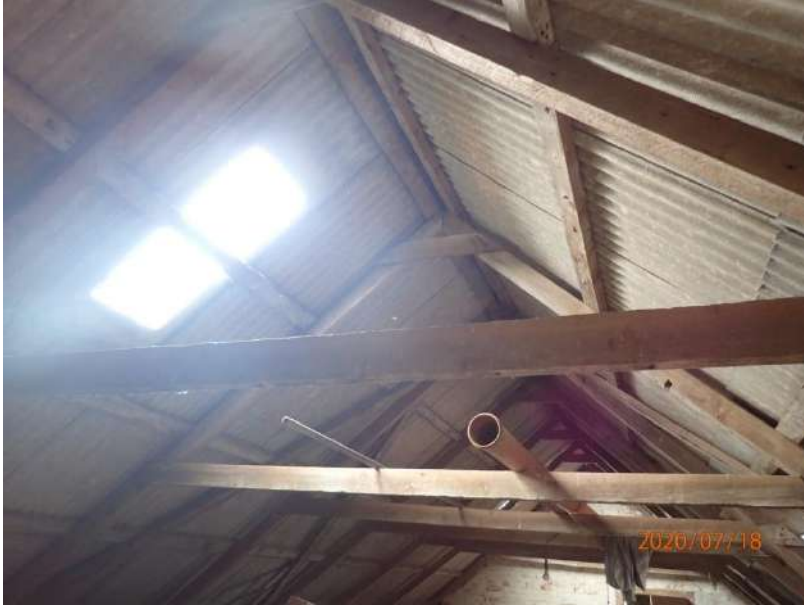
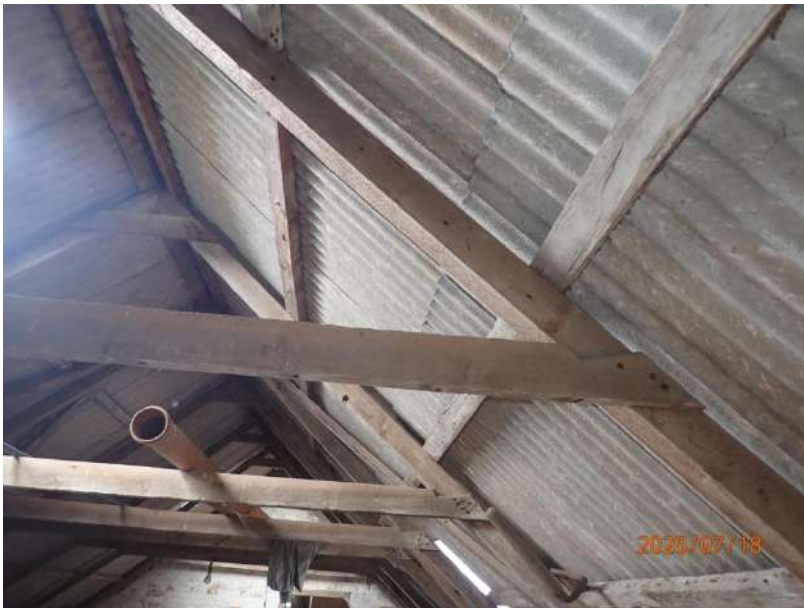
**Plates 334 and 335** furnish views of the nature of the roof supporting structure above **Cell 15**. This is a relatively simple structure that comprises a framework of timber rafters, which extend along both sides of this structure. Attached to the rafters are a series of horizontal timber purlins which also extend along both sides of this structure and also along the roof apex. The bottom ends of the timber rafters are attached to horizontal timber wallplates that extend along the top of the east and west walls, whilst their upper ends are affixed to the purlins at the roof apex. Providing additional strength and support to this structure are a further series of horizontal timber collars that are attached to the rafters. The rafters and purlins in turn support the roof covering of modern corrugated metal sheeting.

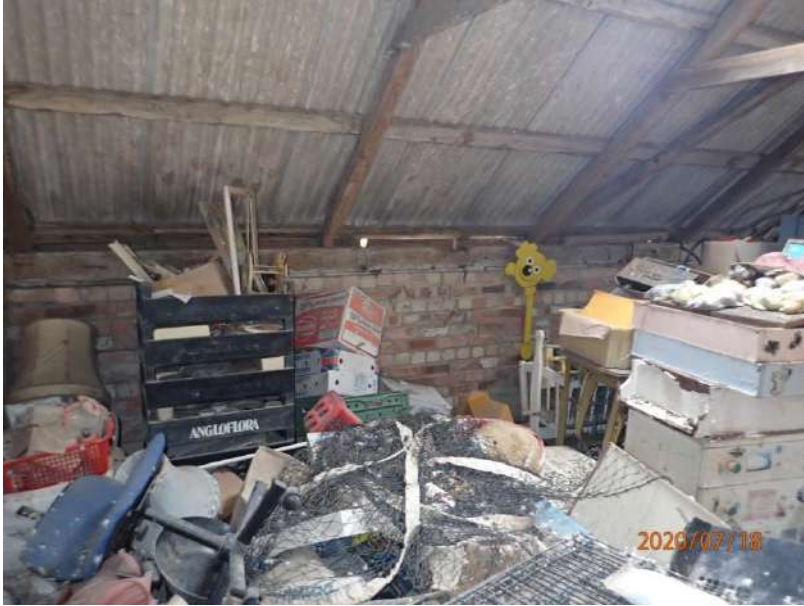
**Plate 336: View of the west wall of Cell 15, from the east**

**Plates 336 and 337** feature the low west wall of **Cell 15**, which was also recorded externally as an area of modern repair and addition at the West Elevation of this building. This is reflected in the nature of the brickwork of this west wall, which is of modern origin and composed of courses of brick stretchers alternating with courses of brick headers in English Bond. Horizontal timber wallplates may be seen to extend along the top of this west wall.

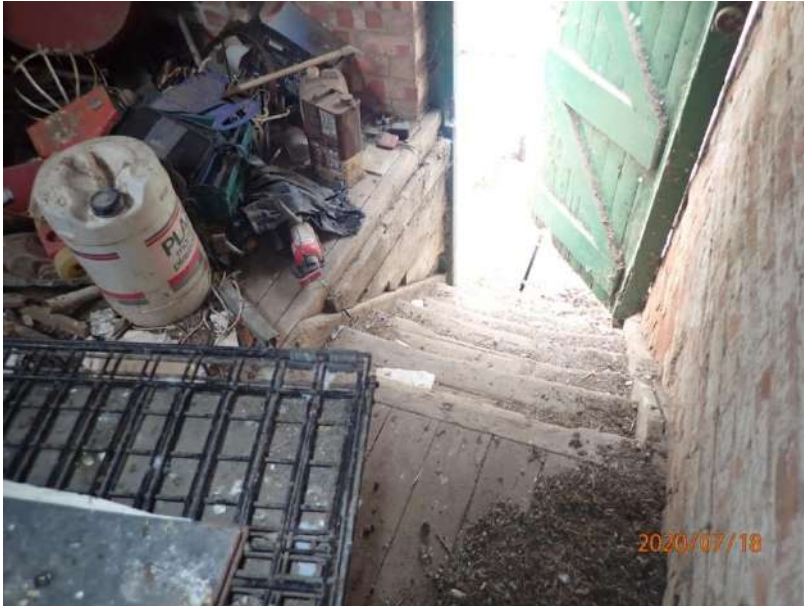
**Plate 338: View of the stairwell, down to the exterior of the building, from the west**

**Plate 338** shows the wooden steps that lead downwards to the external stairwell that was recorded externally at the East Elevation of the building. This stairwell is the access into the first floor of this East Range.

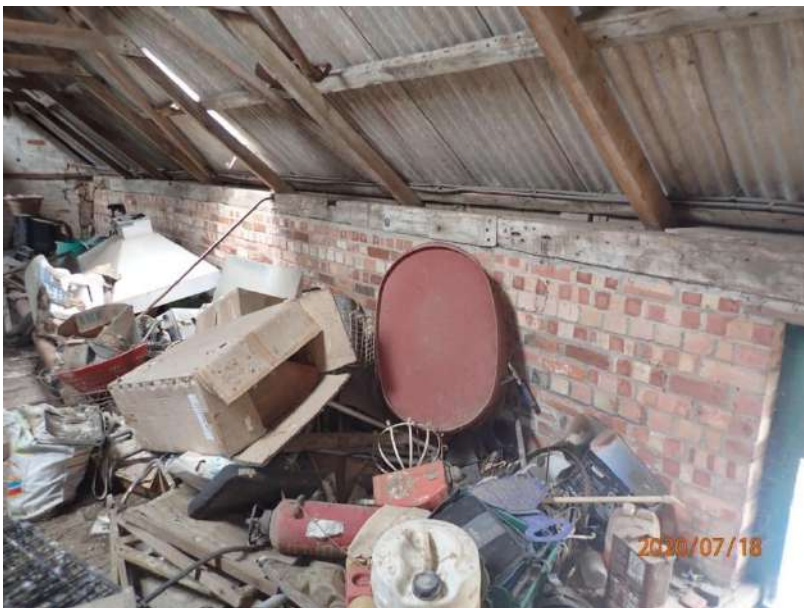
**Plate 339: View of the east wall of Cell 15, from the south**

**Plate 339** provides a detailed view of the east wall of **Cell 15**, which was also recorded externally as an area of modern repair and addition at the East Elevation of this building. This is reflected in the nature of the brickwork of this east wall, which is of modern origin and composed of courses of brick stretchers alternating with courses of brick headers in English Bond. Horizontal timber wallplates may be seen to extend along the top of this east wall.

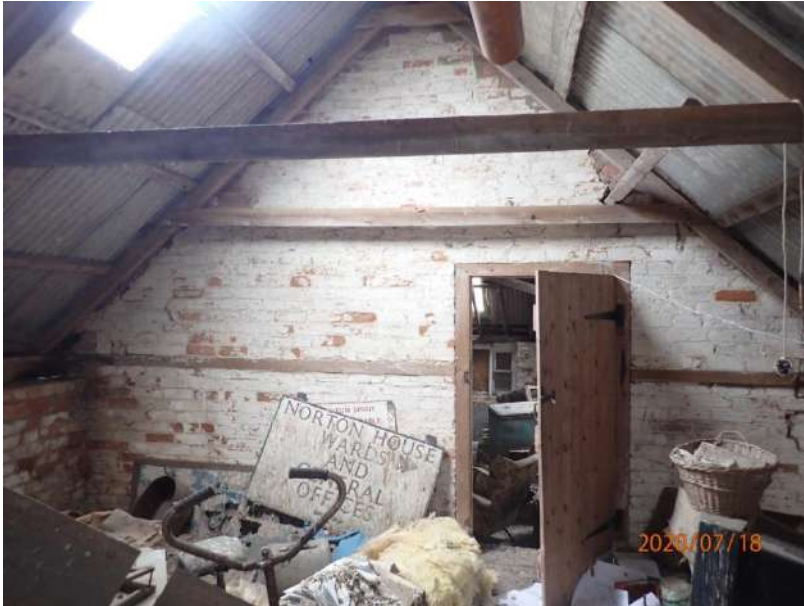
**Plate 340: View of the north wall of Cell 15, from the south**

**Plate 340** presents a detailed view of the north wall of **Cell 15**, which is also the internal dividing wall with the adjoining **Cell 14** to the north. Here, the detail of the nature of the brickwork wall fabric of this north wall has become obscured by being covered over with paintwork. At the mid levels, an horizontal timber wallplate may be seen to be incorporated into this brickwork wall fabric. The northern ends of the horizontal timber purlins of the overlying roof structure are also inserted into this wall fabric.

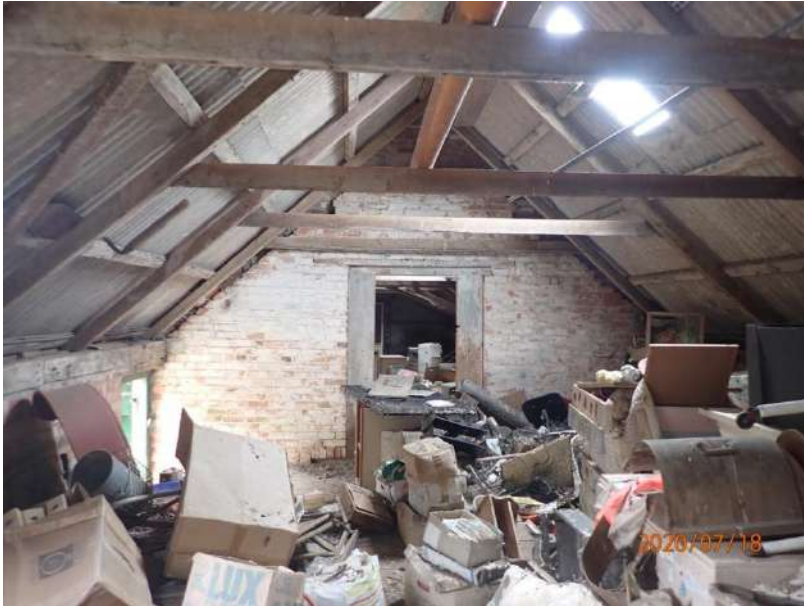
**Plate 346: View of the south wall of Cell 15, from the north**

**Plate 346** provides a view of the south wall of **Cell 15**, which is also the internal dividing wall with the adjacent **Cell 16** to the south. Although much of the detail of the brickwork wall fabric here has become obscured by paintwork, it is still possible to discern that this wall fabric is composed of 3-4 courses of brick stretchers alternating with one course of brick headers in a variation of English Garden Wall Bond. The southern ends of the horizontal timber purlins of the overlying roof structure are also inserted into this wall fabric. The central feature of this south wall is the south facing entrance opening that extends onto **Cell 16** to the south. This opening is occupied by a timber frame of a head and surrounds with an horizontal timber lintel occurring above this opening, which is incorporated into the brickwork wall fabric.

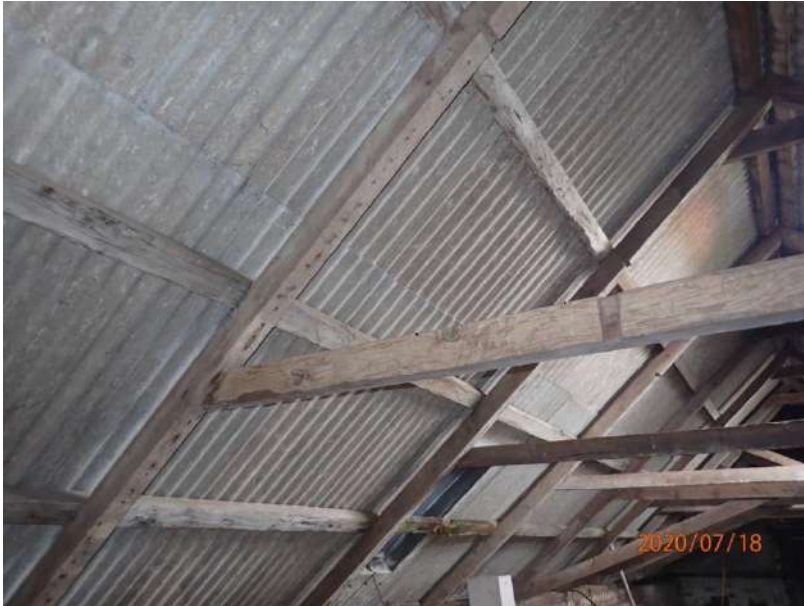
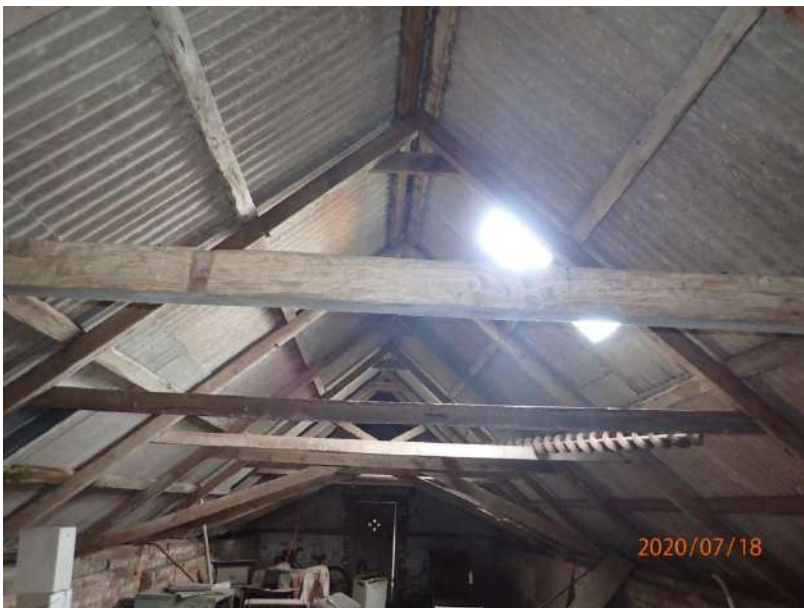
**Plates 352-354** furnish views of the nature of the roof supporting structure above **Cell 16**. This is a relatively simple structure that comprises a framework of timber rafters, which extend along both sides of this structure. Attached to the rafters are a series of horizontal timber purlins which also extend along both sides of this structure and also along the roof apex. The bottom ends of the timber rafters are attached to horizontal timber wallplates that extend along the top of the east and west walls, whilst their upper ends are affixed to the purlins at the roof apex. Providing additional strength and support to this structure are a further series of horizontal timber collars that are attached to the rafters. The rafters and purlins in turn support the roof covering of modern corrugated metal sheeting.

rafters. It is considered that this may be associated with the modern era of repair and addition to this building, which was also noted in the brickwork wall fabric of the east and west walls.

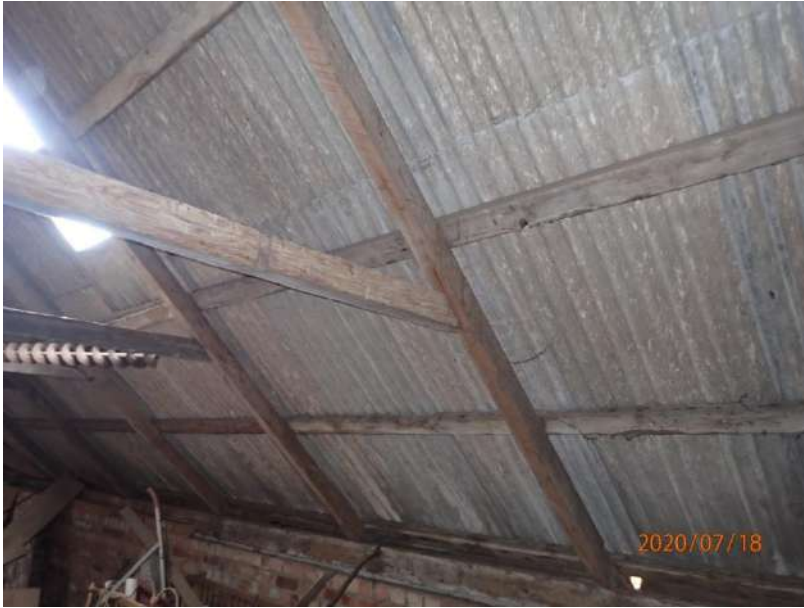
**Plate 354: View of the roof supporting structure of Cell 16, from the north**

This roof structure also appears to have been further reinforced and strengthened by the addition of a number of angled timber cross braces, which are attached to the wallplates, collars and

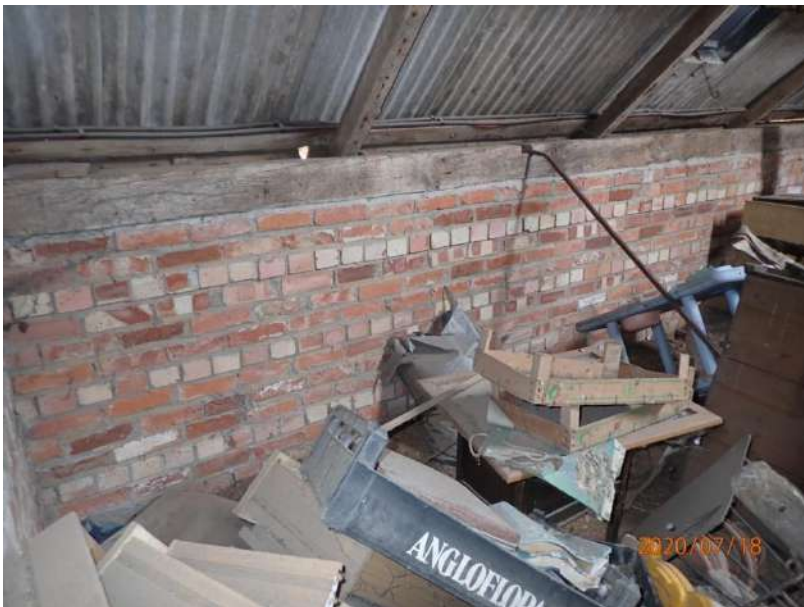
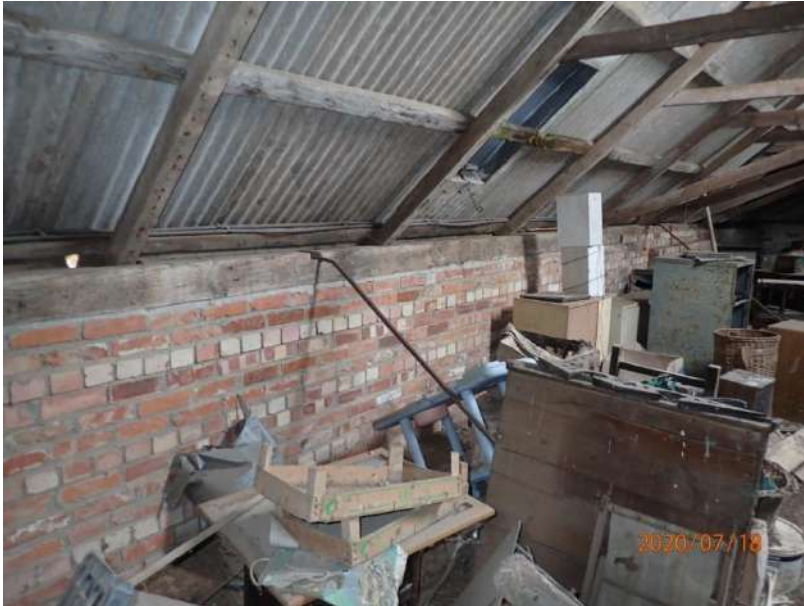
**Plates 355 and 356** present views of the east wall of **Cell 16**, which was also recorded externally as an area of modern repair and addition at the East Elevation of this building. This is reflected in the nature of the brickwork of this east wall, which is of modern origin and composed of courses of brick stretchers alternating with courses of brick headers in English Bond. Horizontal timber wallplates may be seen to extend along the top of this east wall.

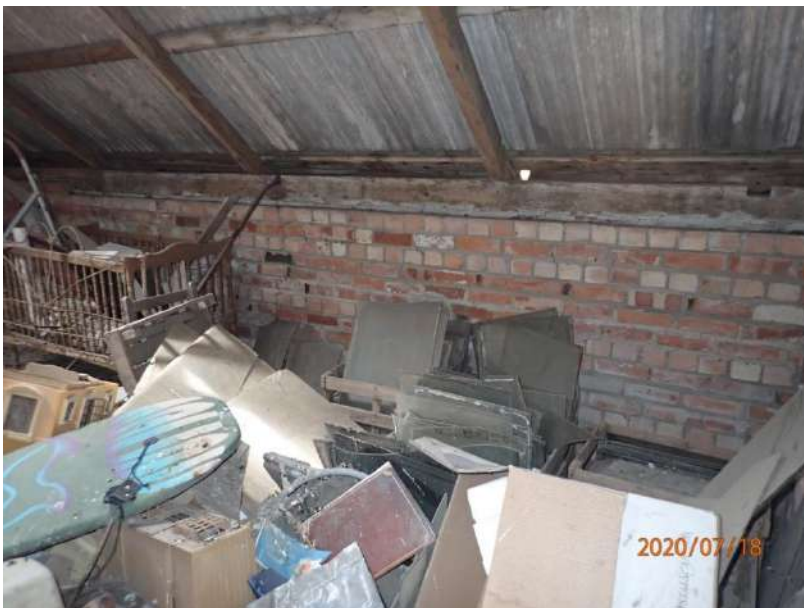
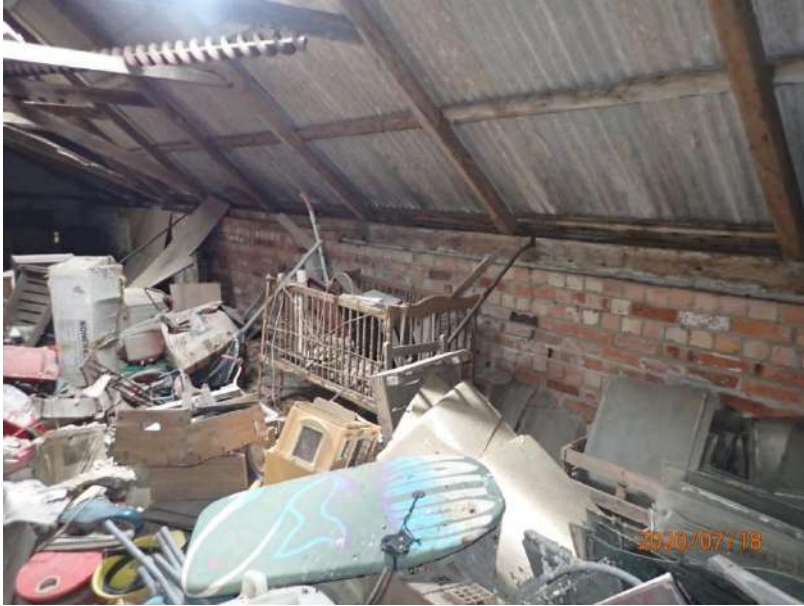
**Plates 357 and 358** present images of the opposing west wall of **Cell 16**, which was also recorded externally as an area of modern repair and addition at the West Elevation of this building. This is reflected in the nature of the brickwork of this west wall, which is of modern origin and composed of courses of brick stretchers alternating with courses of brick headers in English Bond. Horizontal timber wallplates may be seen to extend along the top of this west wall.

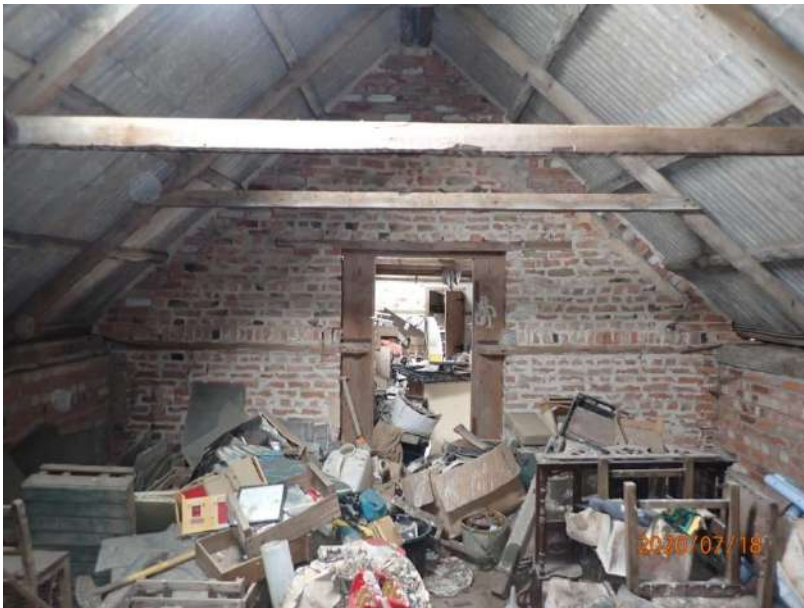
**Plate 359: View of the north wall of Cell 16, from the south**

**Plate 359** furnishes a view of the north wall of **Cell 16**, which is also the internal dividing wall with the adjoining **Cell 15** to the north. Although this brickwork has been repointed, it is still possible to discern the nature of the wall fabric, which is composed of 3-4 courses of brick stretchers alternating with one course of brick headers in a variation of English Garden Wall Bond. At mid levels, horizontal timber wallplates have been incorporated into the brickwork wall fabric here and above this is a decorative string course of brick headers laid on edge. The northern ends of the horizontal timber purlins of the overlying roof structure may also be seen to be inserted into this wall fabric. The inner face of the north facing entrance opening that extends onto the adjoining **Cell 15** is also featured. This opening is occupied by a timber frame of a head and surrounds. The door is absent. Above the opening is an horizontal timber lintel, which is also incorporated into the wall fabric.

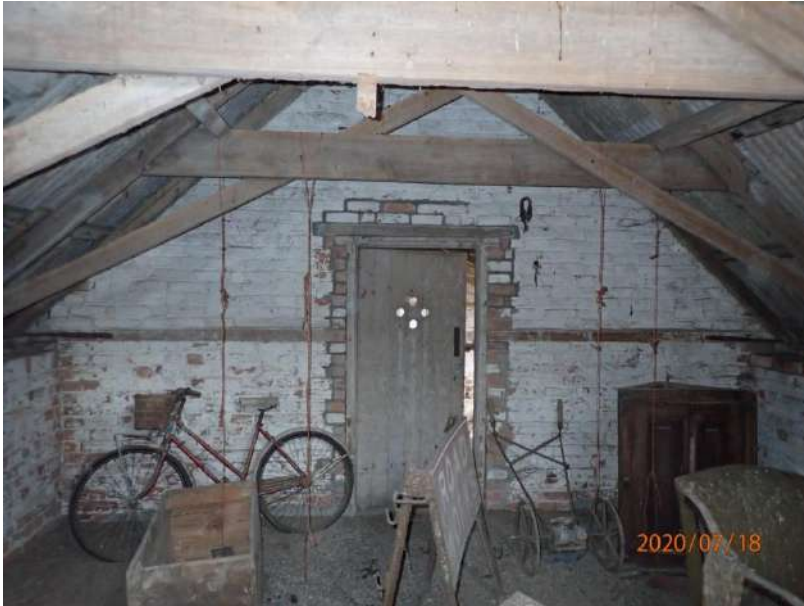
**Plate 360: View of the south wall of Cell 16, from the north**

**Plate 360** features the south wall of **Cell 16**, which is also the internal dividing wall with the adjacent **Cell 17** to the south. Here the detail of the nature of the brickwork wall fabric of this south wall has become obscured by being covered over with paintwork. At mid levels, horizontal timber wallplates have been incorporated into this brickwork wall fabric. The southern ends of the horizontal timber purlins of the overlying roof structure are also inserted into this wall fabric. The central feature of this south wall is the south facing entrance opening that extends onto the adjoining **Cell 17**. This is a modern addition as adjudged by the brick repair of headers and stretchers around the door frame surrounds. This opening is occupied by a timber frame of a head and surrounds along with a door that is composed of a series of vertical tongued and grooved timber planks. Above the opening is an horizontal timber lintel, that is also incorporated into this brickwork wall fabric.

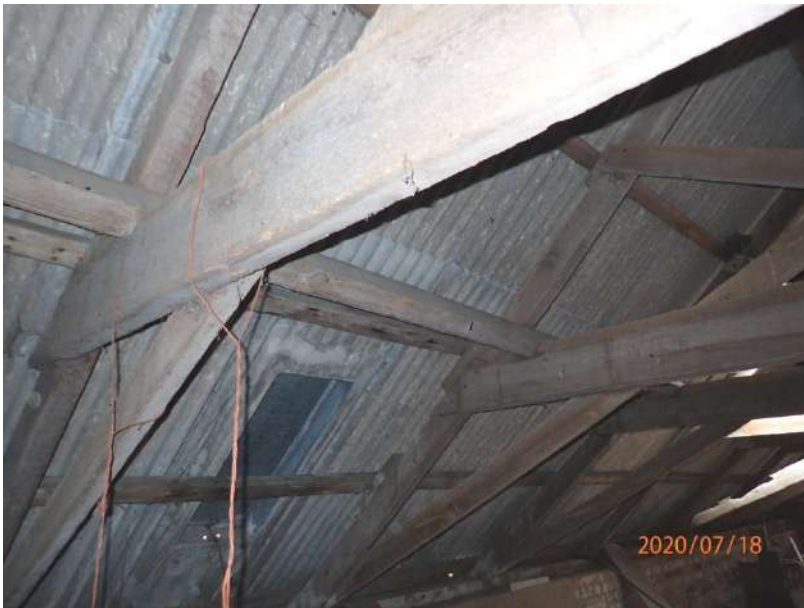
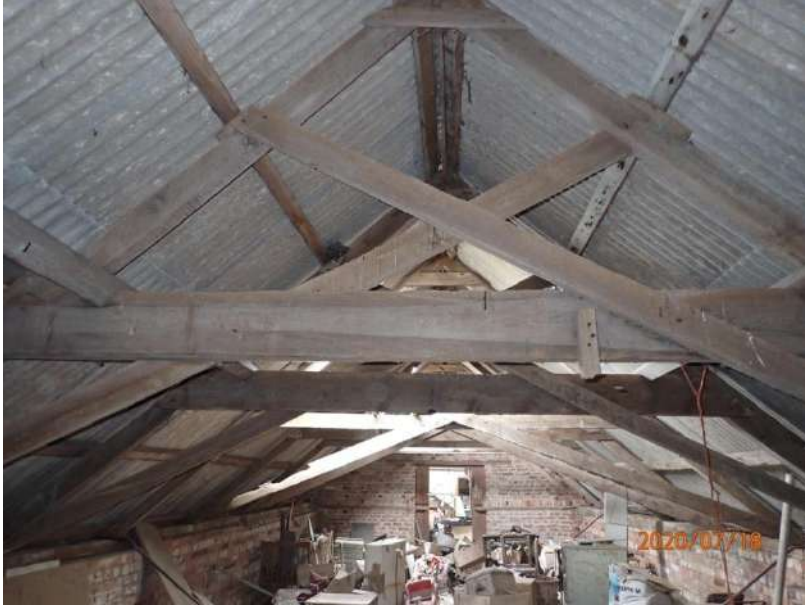
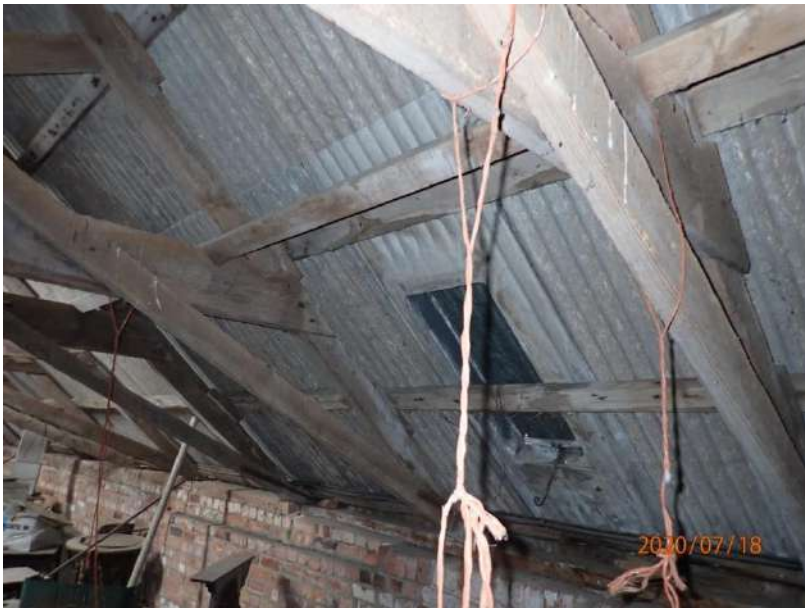
**Plats 361-363** provide further detailed images of the nature of the roof supporting structure of **Cell 16** from different southern positions.

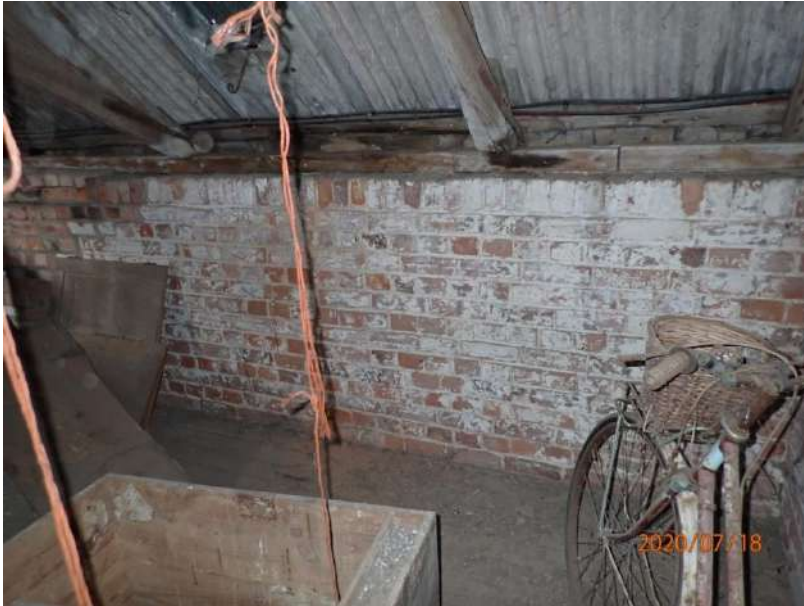
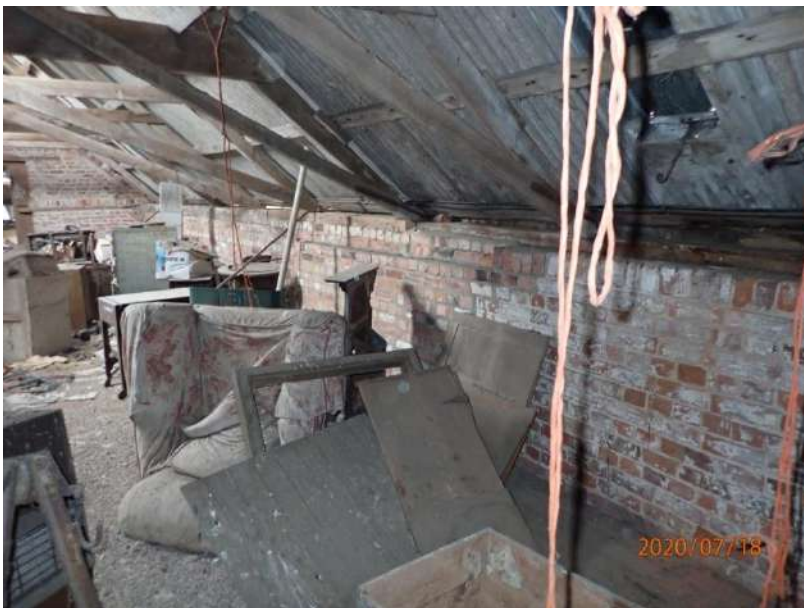
**Plates 364 and 365 provide further views of the east wall of Cell 16.**
