HISTORIC BUILDING RECORDING AT  
HALL FARM, BOSTON ROAD,  
EAST HECKINGTON, LINCOLNSHIRE

PREPARED FOR MR. JAMES BRAMMA OF JB ARCHITECTURAL DESIGN SERVICES ON  
BEHALF OF HIS CLIENT - MR. NICK LOWETH  
PART 2: THE EAST RANGE

March 2021

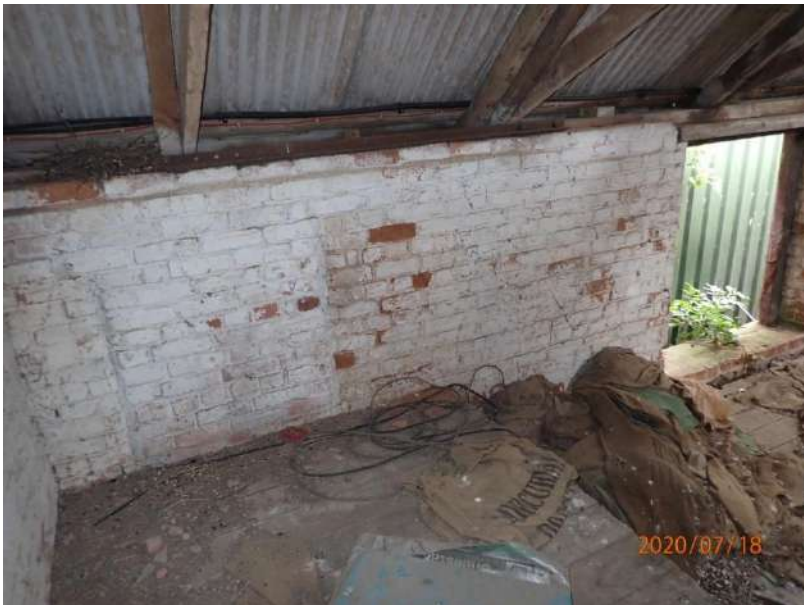
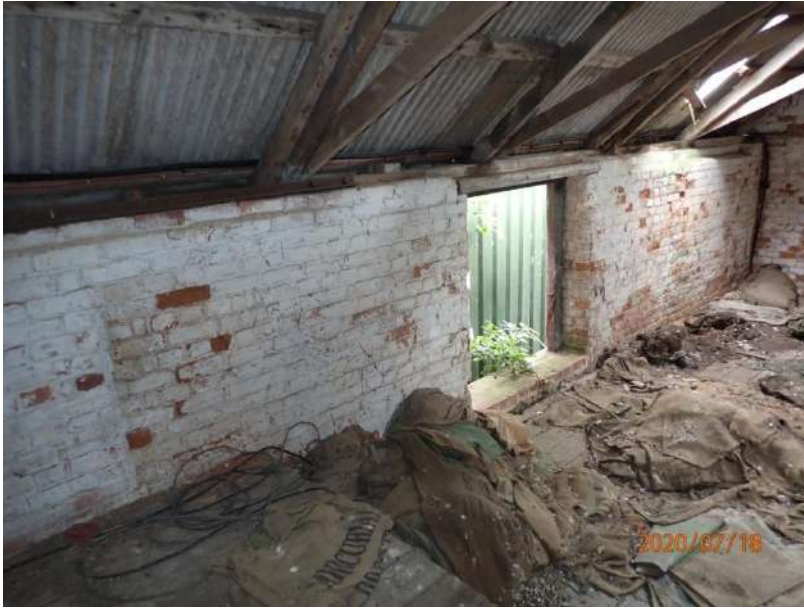
**Plates 367 and 368** present views of the east wall of **Cell 17**. The brickwork wall fabric of this east wall is in English Garden Wall Bond, of courses of brick stretchers alternating with courses of brick headers. Horizontal timber wallplates may be seen to extend along the top of this east wall. Also featured is the inner face of a first floor east facing former hay loft or grain loft opening. The door is absent. This was not accessible externally. The opening is occupied by a timber frame of a

head and surrounds and a brick threshold at the base of the opening. Above the opening, is an horizontal timber lintel, which is incorporated into the brickwork wall fabric.

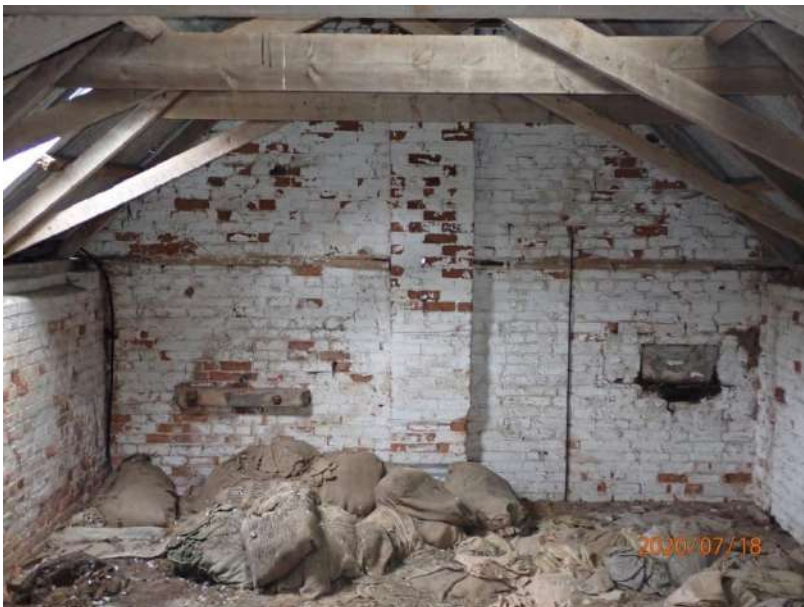
**Plate 369: View of the south wall of Cell 17, from the north**

**Plate 369** furnishes a detailed image of the south wall of **Cell 17**. The nature of the brickwork wall fabric of this south wall could not be discerned with certainty as it was covered over with paintwork, which has obscured this detail. At mid levels, horizontal timber wallplates have been inserted into this wall fabric. These occur to either side of the central feature of this south wall, which is the inner face of the vertical brick chimney breast. This was also recorded externally at the South Elevation of this East Range. The chimney breast appears to be composed mostly of brick stretchers. The southern ends of the horizontal timber purlins of the overlying roof structure may also be seen to be inserted into this wall fabric.

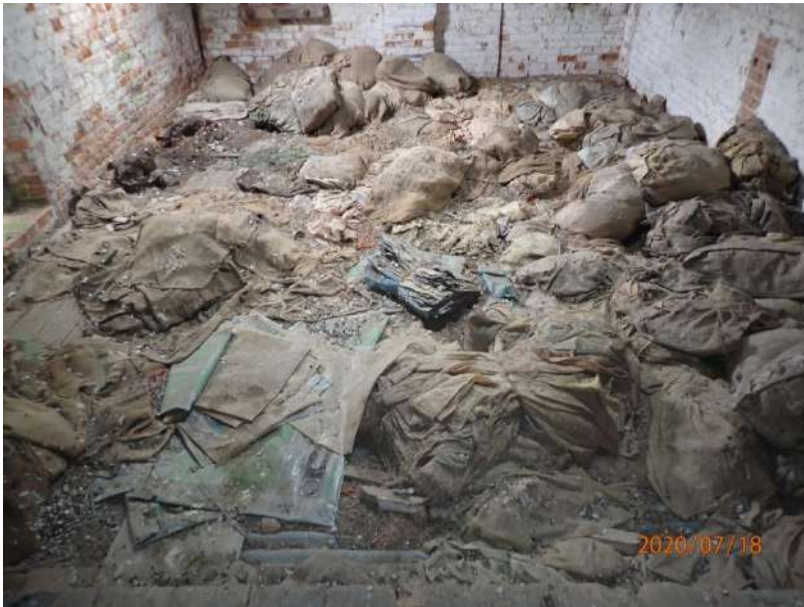
**Plate 370: View of the flooring of Cell 17, from the north**

**Plate 370** presents a view of the nature of the flooring of **Cell 17**, which is of timber planking.

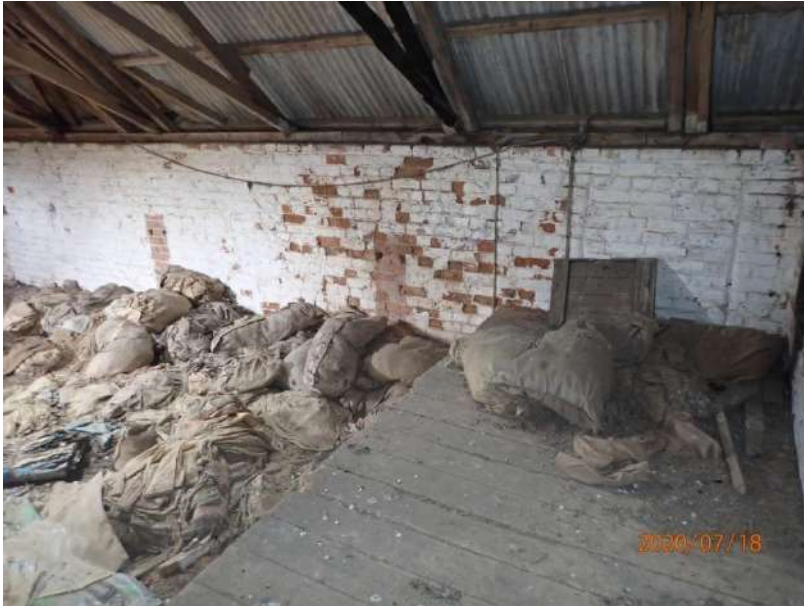
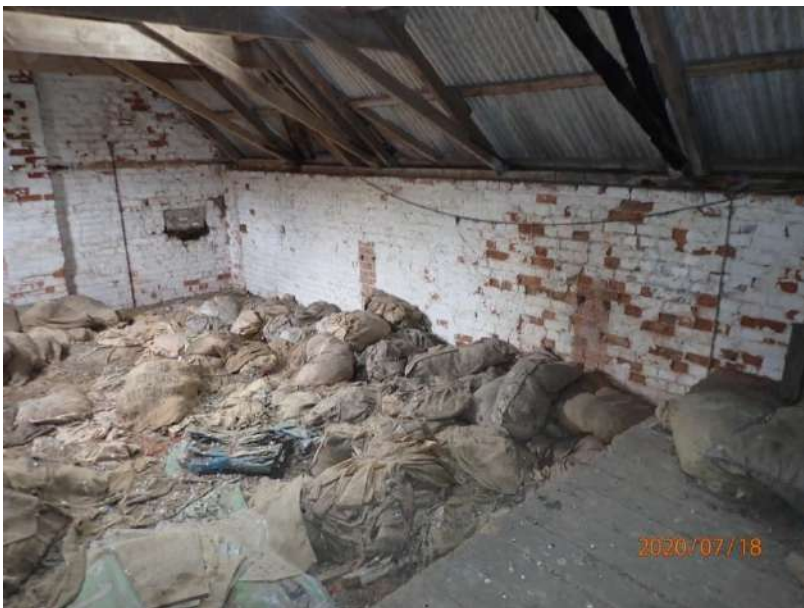
**Plates 372 and 373** feature the west wall of **Cell 17**. Here also, the detail of the nature of the brickwork wall fabric could not be discerned with certainty as this detail has become obscured by being covered over with paintwork. Horizontal timber wallplates may be seen to extend along the top of this west wall.

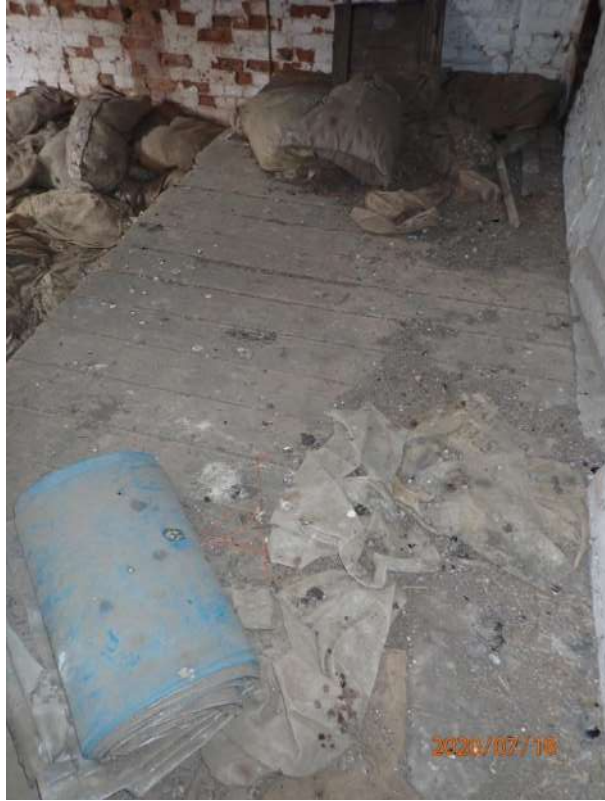
**Plate 374: View of the timber platform at the northern end of Cell 17, from the east**

**Plate 374** presents a detailed image of a timber loading or storage platform at the northern end of **Cell 17**. This is composed of a series of horizontal timber planks.

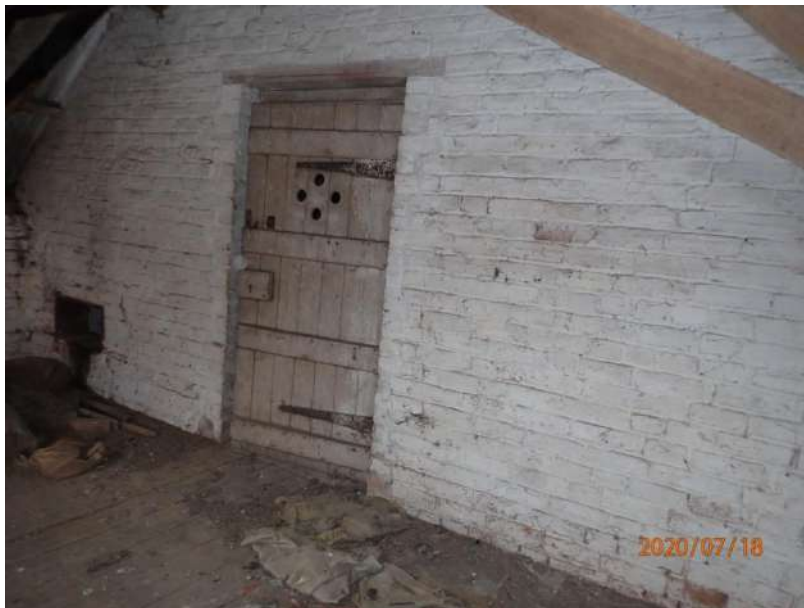
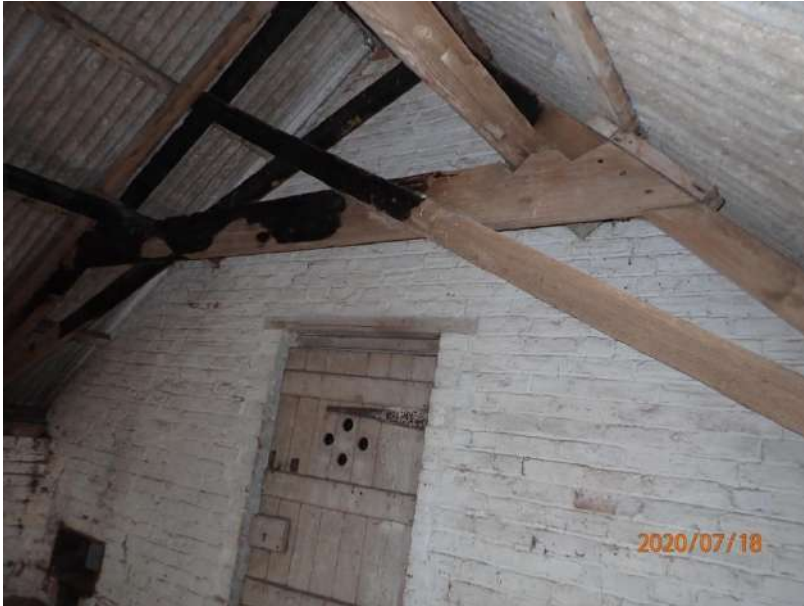
**Plates 375 and 376** present views of the north wall of **Cell 17**, which is also the internal dividing wall with the adjacent **Cell 16** to the south. Here also, the detail of the nature of the brickwork wall fabric could not be discerned with certainty as this detail has become obscured by being covered over with paintwork. The northern ends of the horizontal timber purlins of the overlying roof structure may be seen to be inserted into this wall fabric. The central feature of this north wall is the north facing entrance opening which extends onto the adjacent **Cell 16** to the north. This opening is occupied by a timber frame of a head and surrounds and a door that is composed of a series of vertical tongued and grooved timber planks that are affixed to an internal framework of horizontal timbers. The door is attached to the frame by two metal strap hinges. Above the opening is an horizontal timber lintel that is incorporated into the wall fabric.

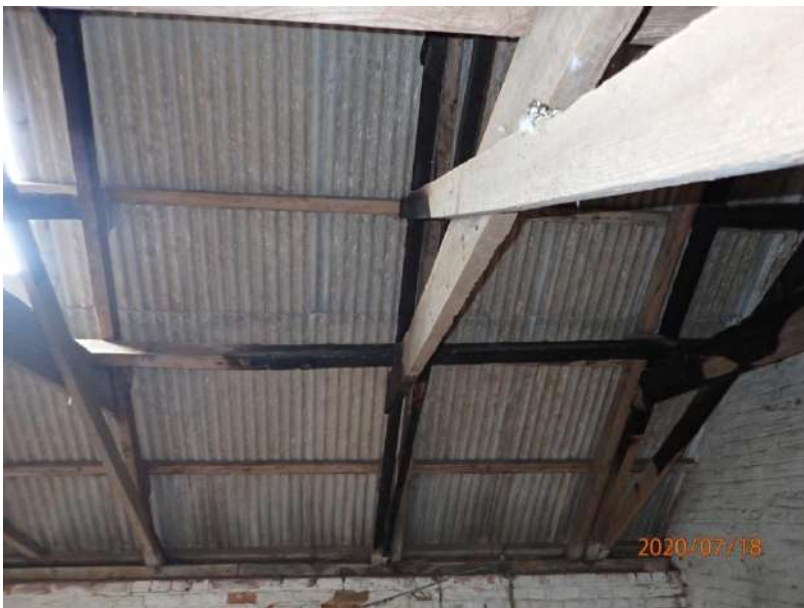
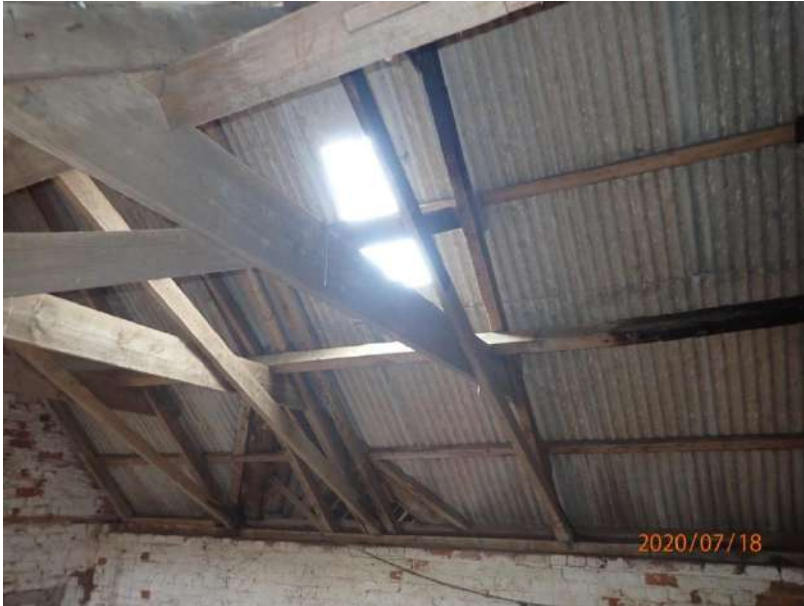
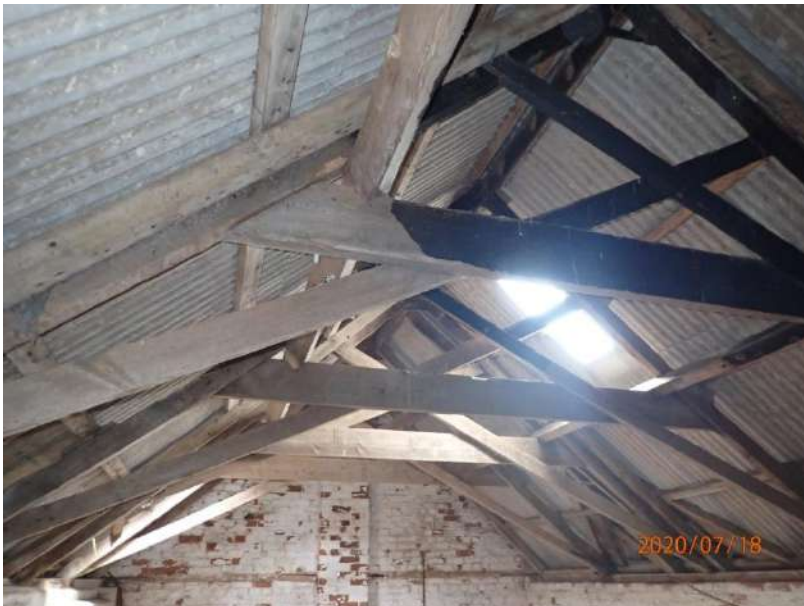
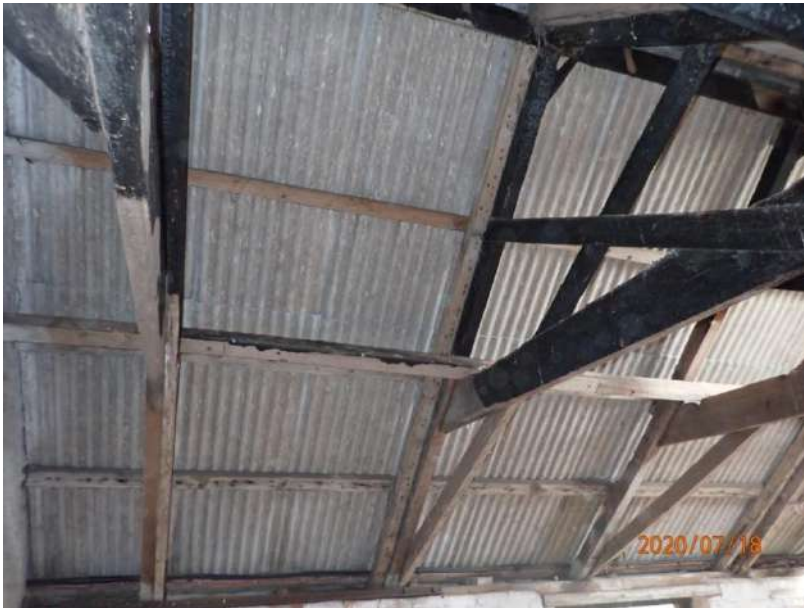
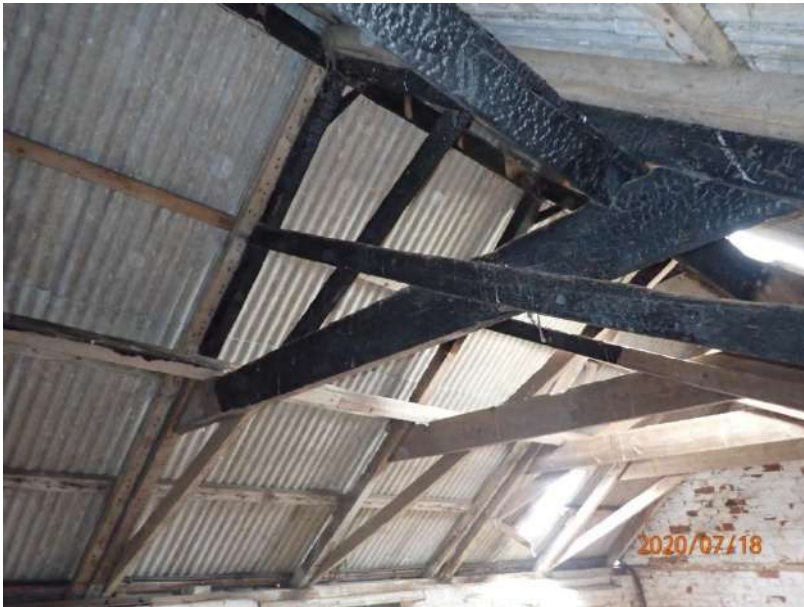
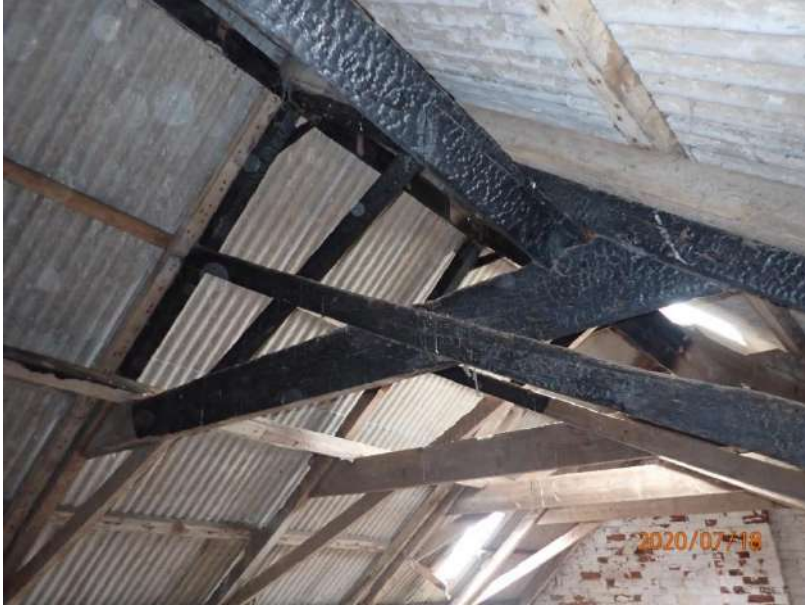
**Plates 377-382** present views of the nature of the roof supporting structure above **Cell 17**. This is a relatively simple structure that comprises a framework of timber rafters, which extend along both sides of this structure. Attached to the rafters are a series of horizontal timber purlins which also extend along both sides of this structure and also along the roof apex. The bottom ends of the timber rafters are attached to horizontal timber wallplates that extend along the top of the east and west walls, whilst their upper ends are affixed to the purlins at the roof apex. Providing additional strength and support to this structure are a further series of horizontal timber collars that are attached to the rafters. The rafters and purlins in turn support the roof covering of modern corrugated metal sheeting.

This roof structure also appears to have been further reinforced and strengthened by the addition of a large number of angled timber cross braces, which are attached to the wallplates, collars and

rafters. It is considered that this may be associated with the modern era of repair and addition to this building, which was also noted in the brickwork of the east and west walls. Some of the timbers also show evidence of charring.
