HISTORIC BUILDING RECORDING AT  
HALL FARM, BOSTON ROAD,  
EAST HECKINGTON, LINCOLNSHIRE

PREPARED FOR MR. JAMES BRAMMA OF JB ARCHITECTURAL DESIGN SERVICES ON  
BEHALF OF HIS CLIENT - MR. NICK LOWETH  
PART 3: THE SOUTH RANGE

Neville Hall

March 2021

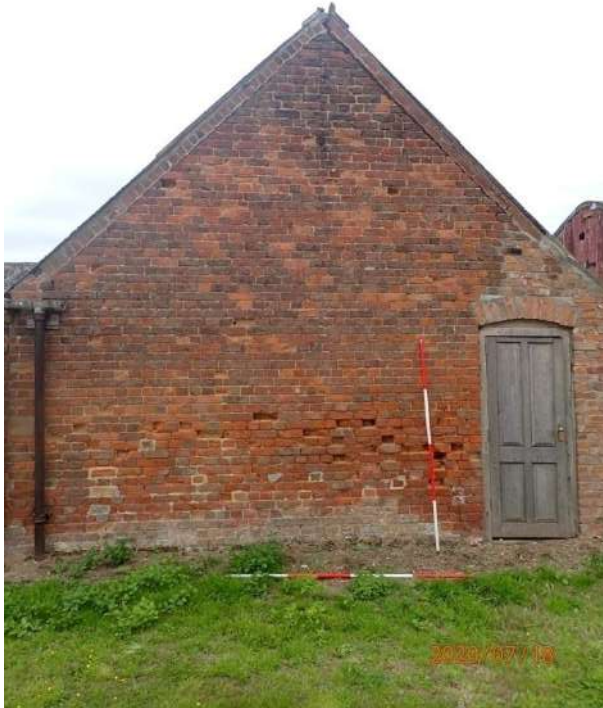
**Plate 383: View of the West Elevation of the South Range, from the west**

**Plate 383** presents a detailed view of the West Elevation of the South Range. The brickwork wall fabric of this West Elevation is in English Bond, of courses of brick stretchers alternating with courses of brick headers. The brickwork at the gable ends comprise brick stretchers laid on edge. To the right is the outer face of a west facing enhance opening, which is slightly elevated above ground levels. This opening is occupied by the timber frame of a head and surrounds and a four panelled timber door. Above the opening is a curved head in brick of brick stretchers laid on end. To the left, is a vertical cast metal downpipe which extends onto modern Upvc horizontal guttering along the North Elevation.

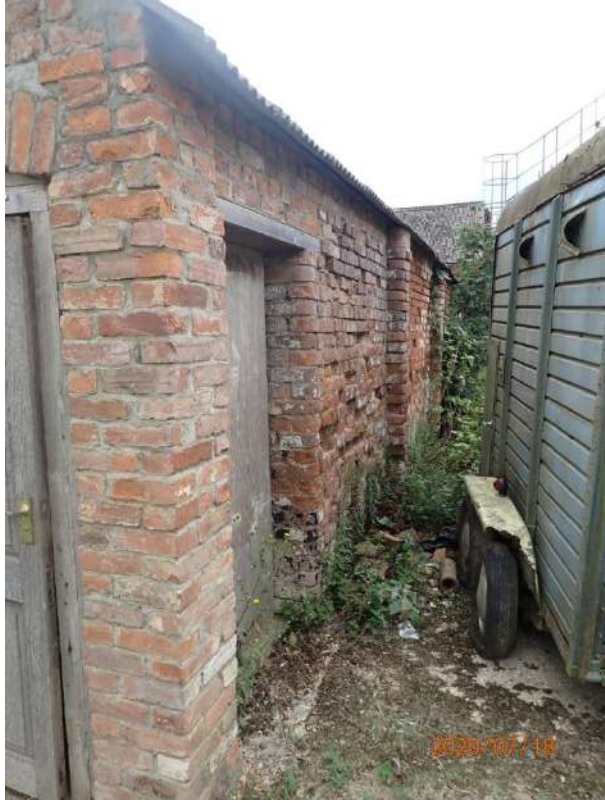
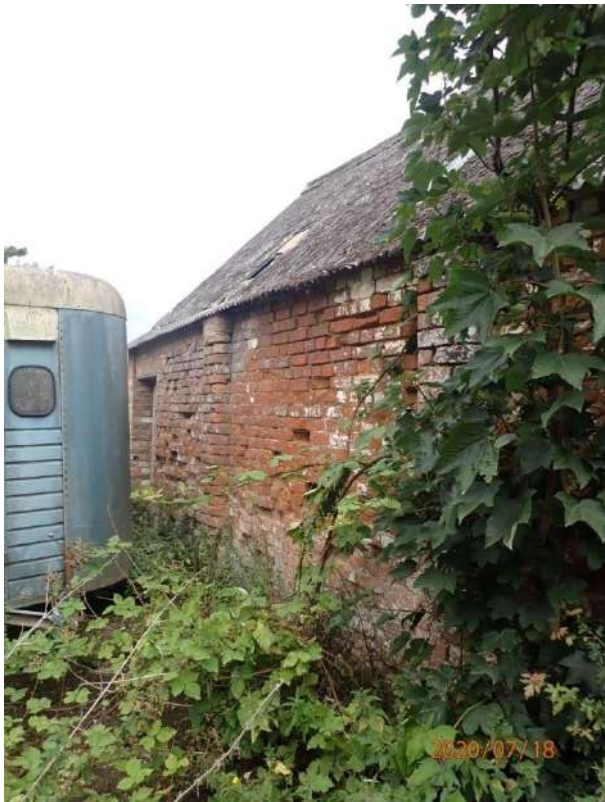
**Plates 384 and 385** present oblique views of the western portion of the South Elevation of this South Range. The brickwork wall fabric here is of the same English Bond. In addition, several vertical and decorative brick pilasters have been incorporated into this external brickwork. These are composed of courses of bull nosed brick stretchers. At the western end of this Elevation may be seen a north facing and recessed entrance opening, which has been boarded over. Above the opening is an horizontal timber lintel that has been incorporated into this wall fabric.

**Plate 384: View of the South Elevation of the South Range, from the west**

**Plate 385: View of the South Elevation of the South Range, from the east**

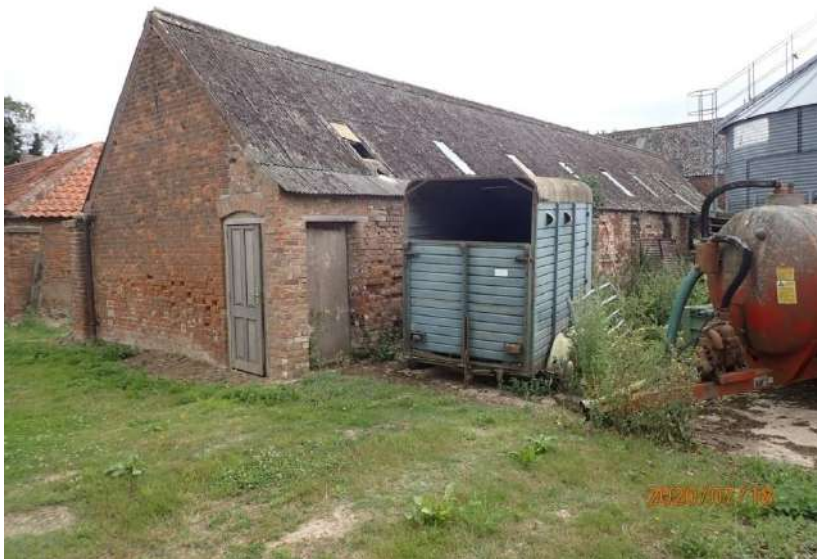
**Plate 386: General view of the South Range, from the south-west**

**Plate 386** furnishes a general view of the South Range from a south-western position.

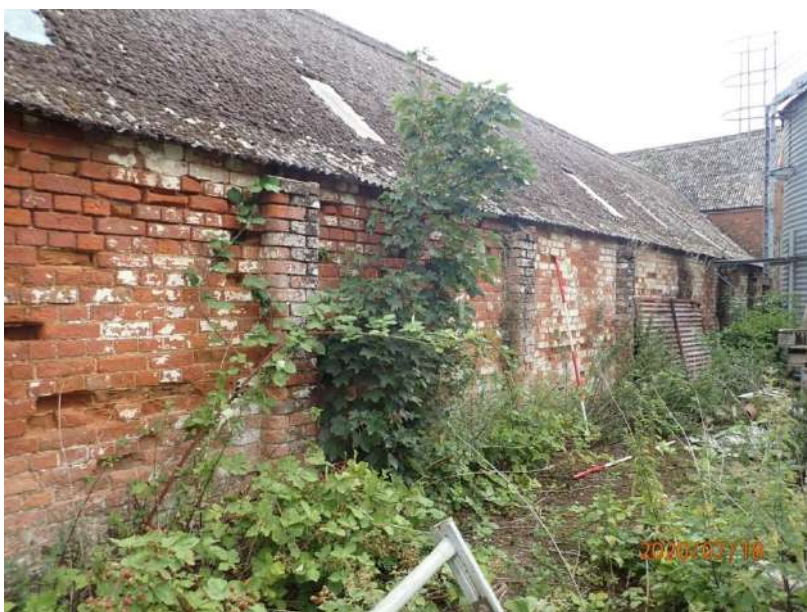
**Plate 387: View of the South Elevation of the South Range, from the south-west**

**Plate 387-390** provide several further oblique views from western vantage points of this South Elevation. The brickwork wall fabric here is in the same English Bond. Further decorative vertical brick pilasters that are bonded to this South Elevation and are composed of courses of bull nosed brick stretchers may also be observed.

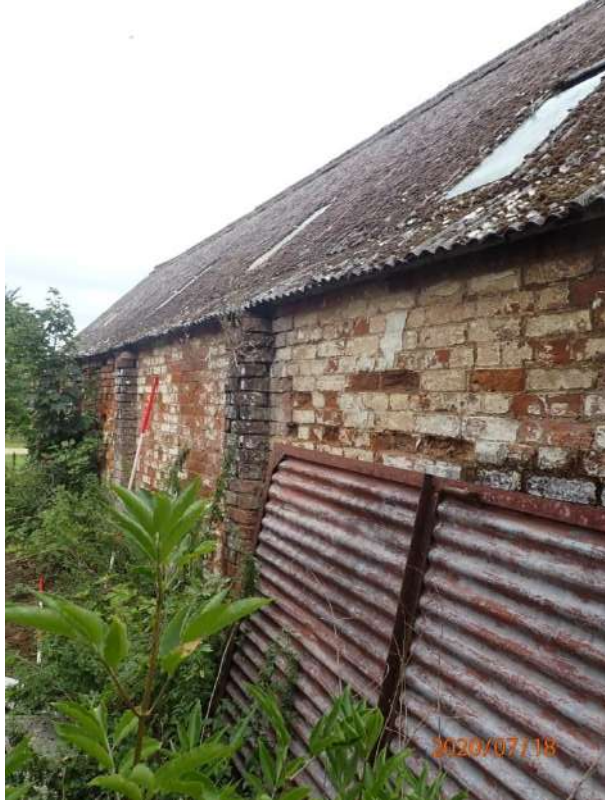
**Plate 391: View of the South Elevation of the South Range, from the east**

**Plates 391-393** present further views of this South Elevation from different eastern vantage points. The brickwork wall fabric here is in the same English Bond. Further decorative vertical brick pilasters that are bonded to this South Elevation and are composed of courses of bull nosed brick stretchers may also be observed. At the eastern end of this Elevation is a second north facing entrance opening that leads on into the interior of this South Range. This recessed opening is occupied by a timber frame of a head and surrounds. The door is absent. Above the opening is an horizontal timber lintel that has been incorporated into this wall fabric.

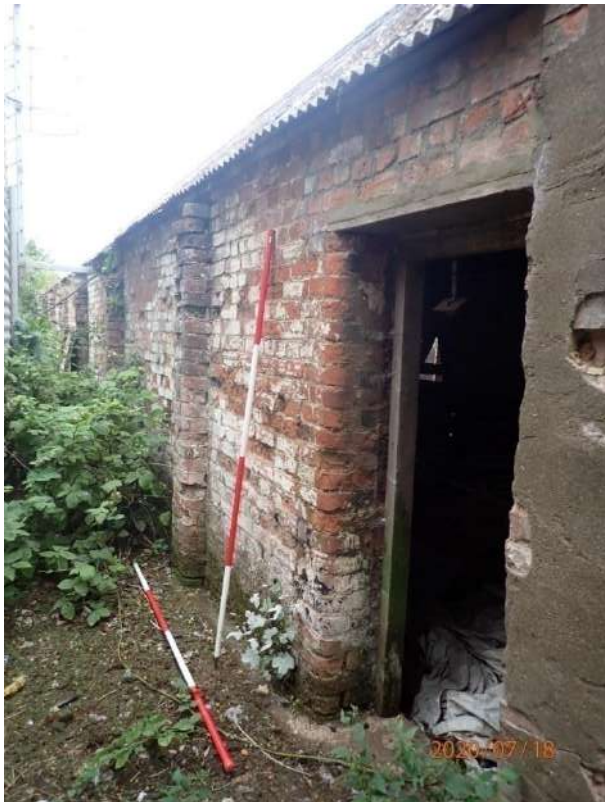
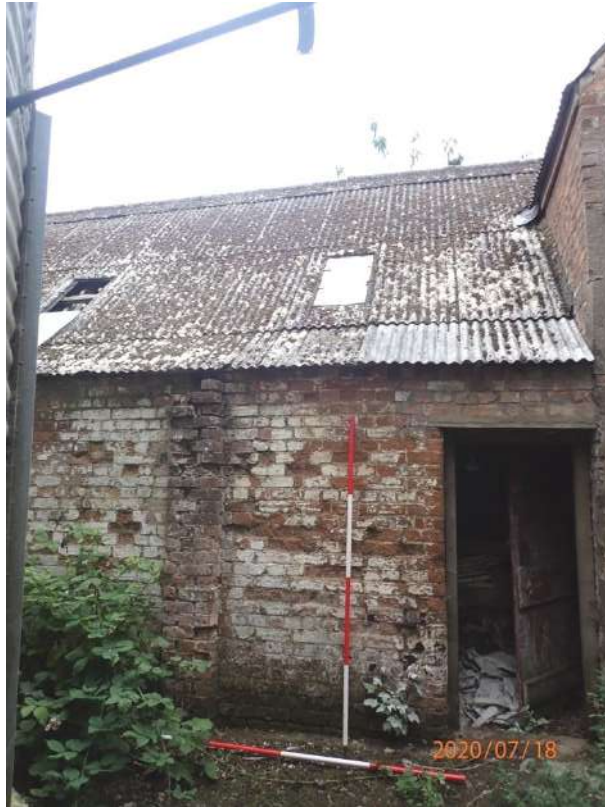
**Plate 392: View of the South Elevation of the South Range, from the east**

**Plate 393: View of the South Elevation of the South Range, from the south**

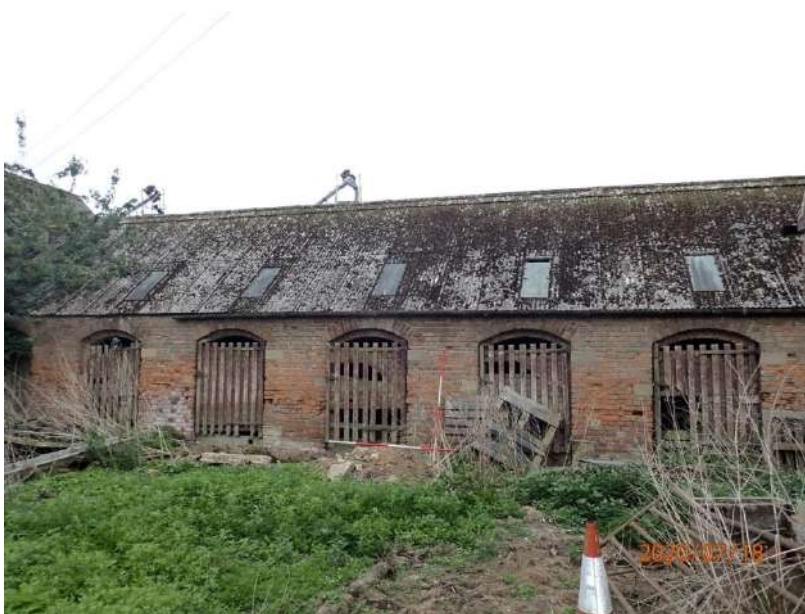
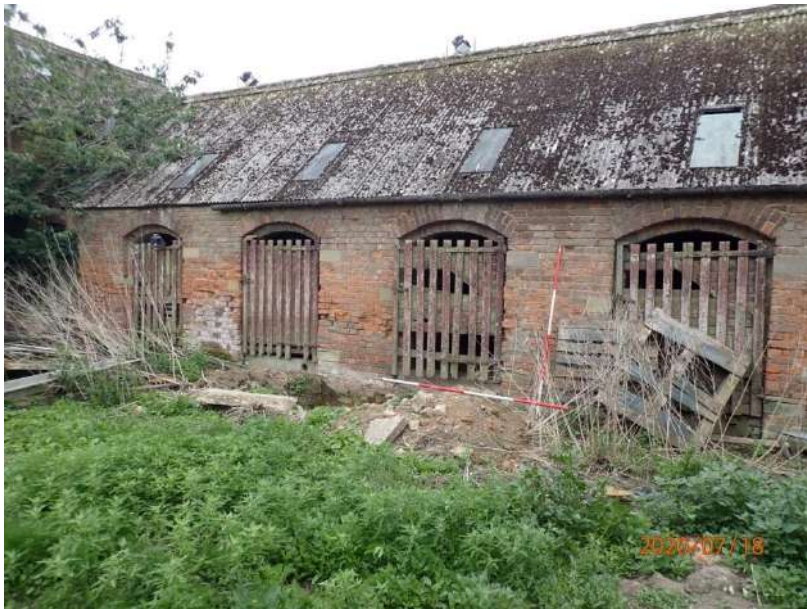
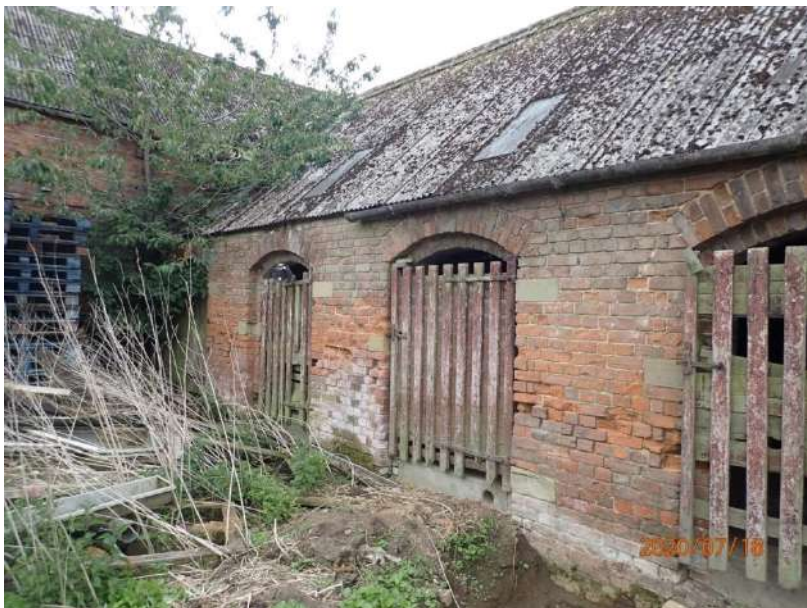
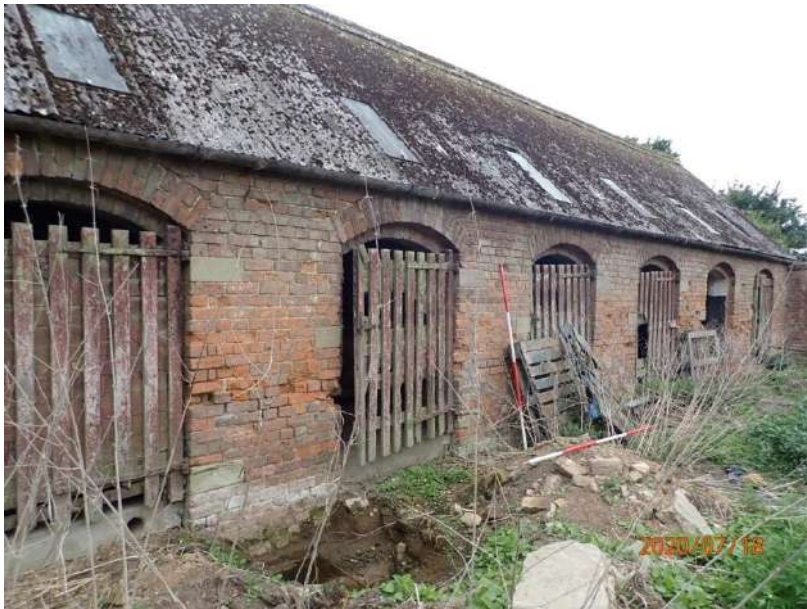
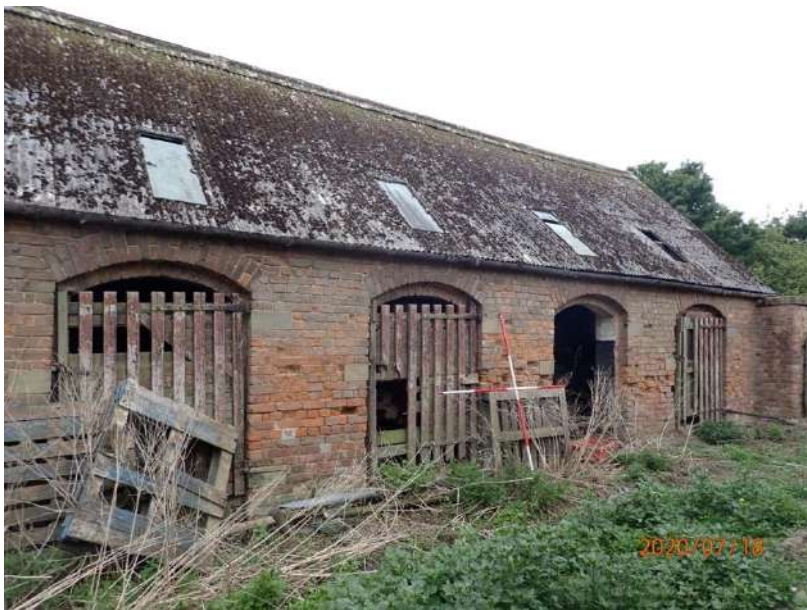
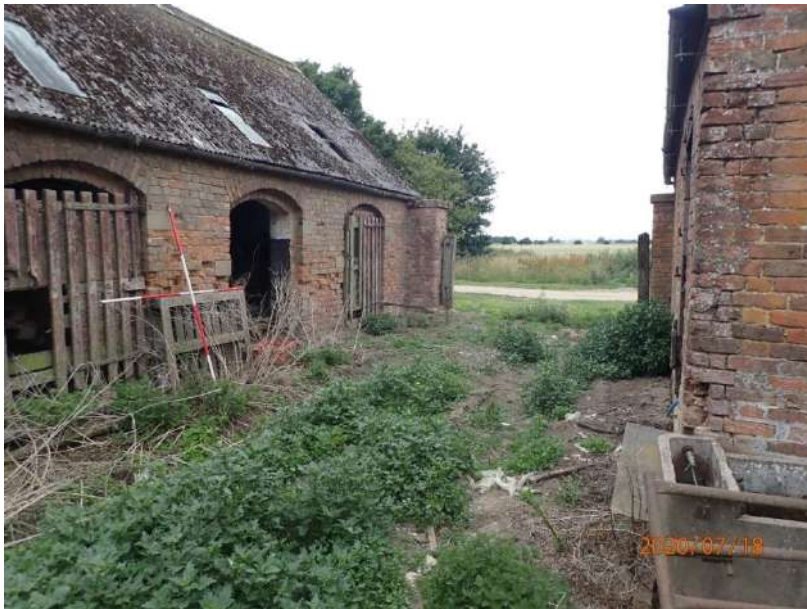
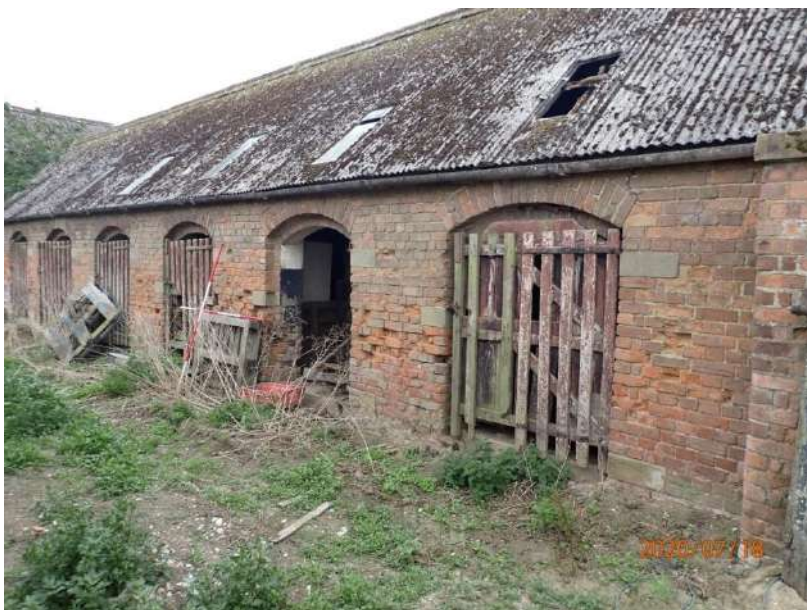
**Plates 394-400** furnish a number of views from differing vantage points of the North Elevation of this South Range. The brickwork wall fabric here is in the same English Bond, of courses of brick stretchers alternating with courses of brick headers. At just below roof levels is modern Upvc horizontal guttering. The main feature of this North Elevation comprise the series of eight north facing entrance openings. Seven of these eight openings are occupied by timber gates that are composed of a series of vertical timber slats. To either side of each opening and incorporated into the brickwork wall fabric are decorative, worked, shaped and faced stone ashlars. Above each opening are rounded heads in brick composed of alternating brick headers and brick stretchers laid on end. Below this head is a secondary recessed head composed of brick stretchers laid on edge. At the base of each opening are concrete thresholds.

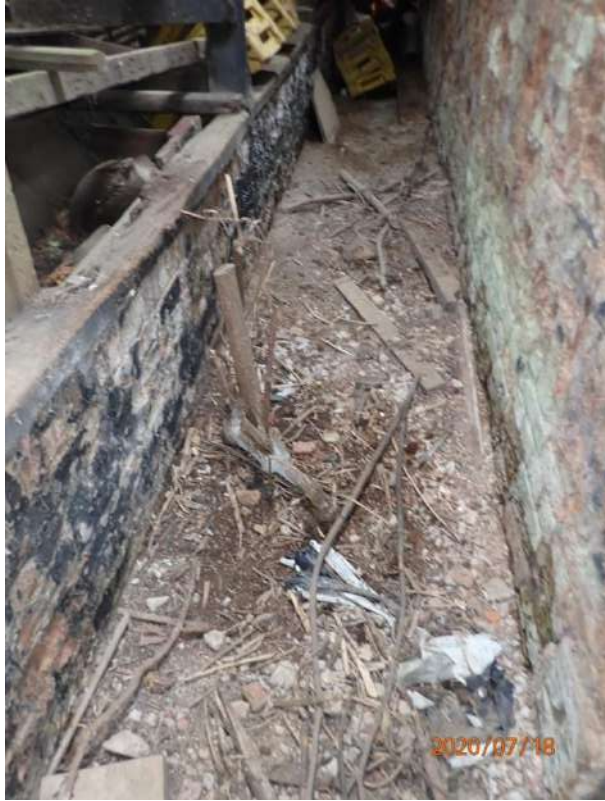
**Plate 401: View of the flooring of Cell 18, from the west**

**Plate 401** presents a view of the nature of the flooring of **Cell 18**, which is probably of modern concrete.

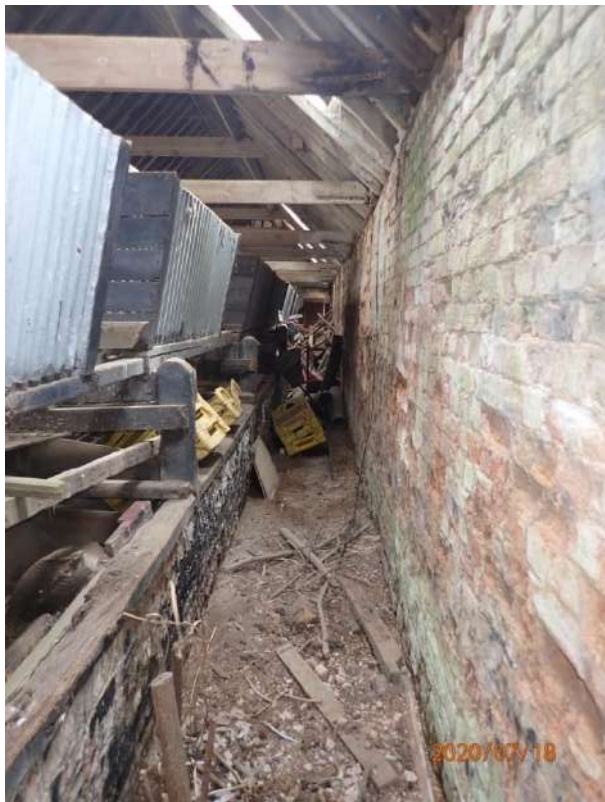
**Plate 402: General view of the interior of Cell 18, from the west**

**Plate 402** features a general view of the interior of **Cell 18** from a western vantage point.

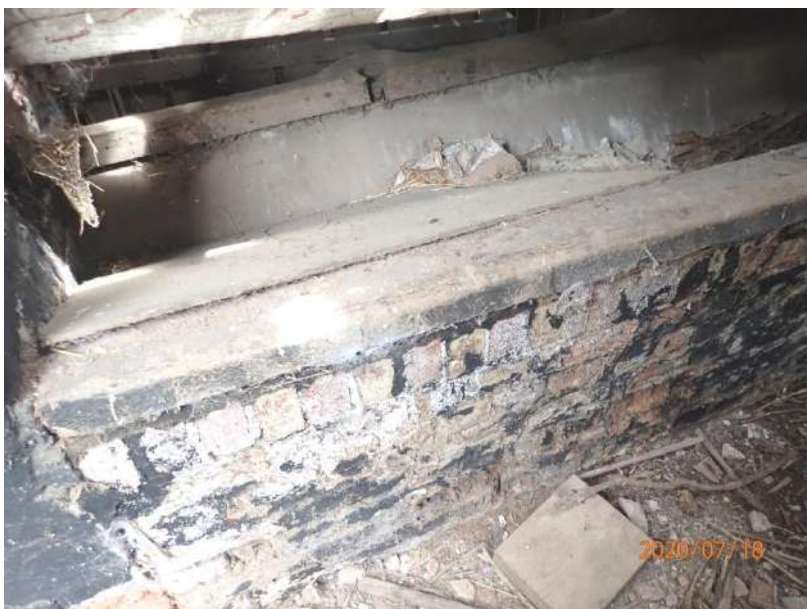
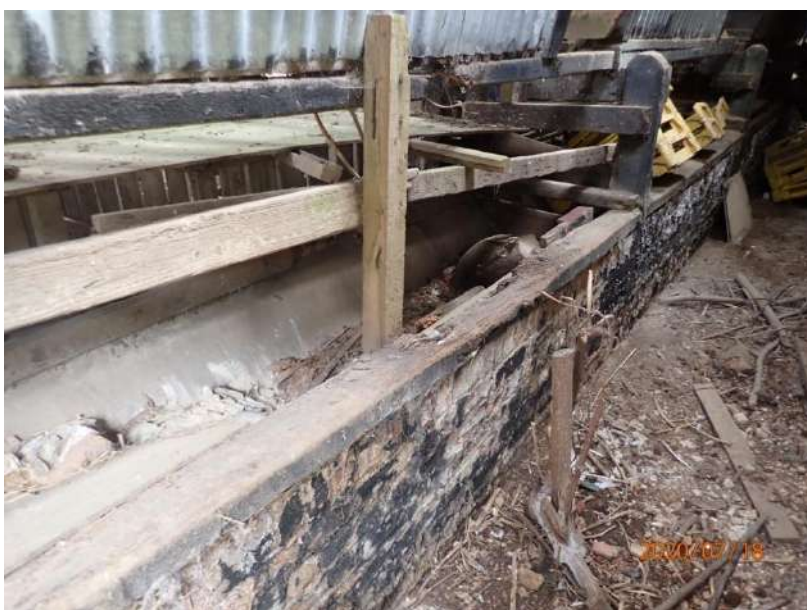
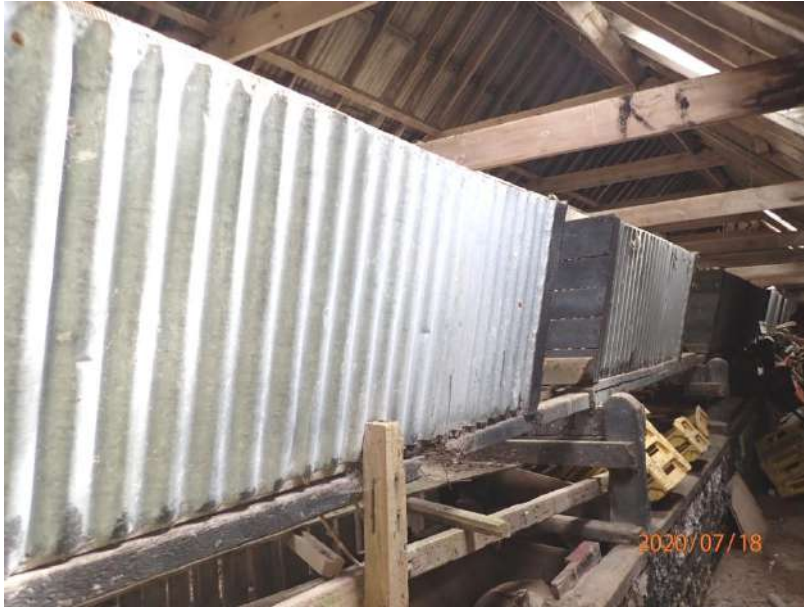
**Plats 403-405** provide detail views of an animal feed trough and above these various modern metal feed containers that line and flank the northern side of **Cell 18**. The low animal feed trough is constructed of brick, though the detail of the brickwork was difficult to discern as it was covered over with paintwork, which has obscured the detail. Various horizontal timbers atop the brickwork with the interior of the feed trough being lined with concrete. The metal feed containers rest on an timber framework.

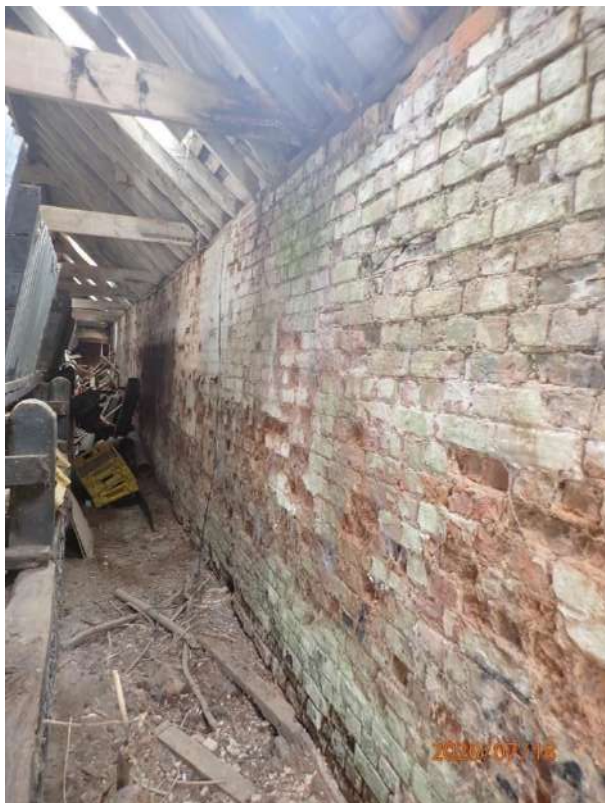
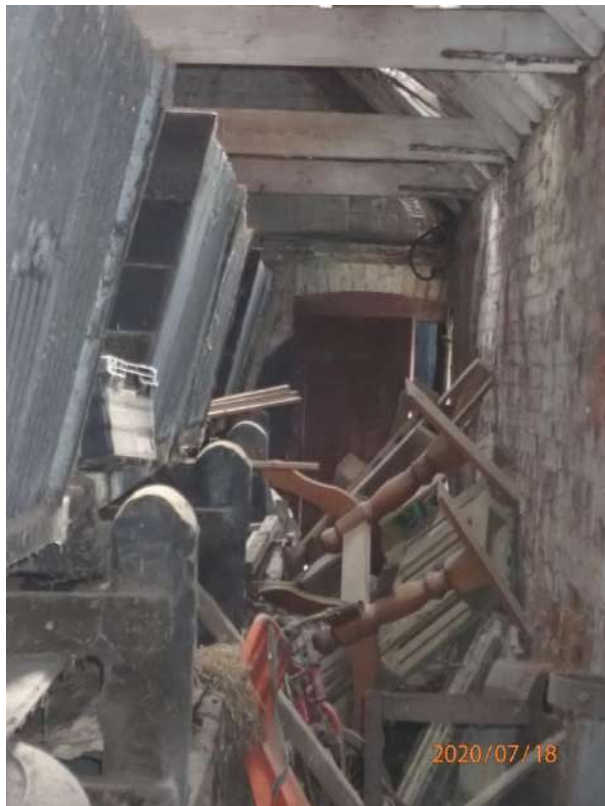
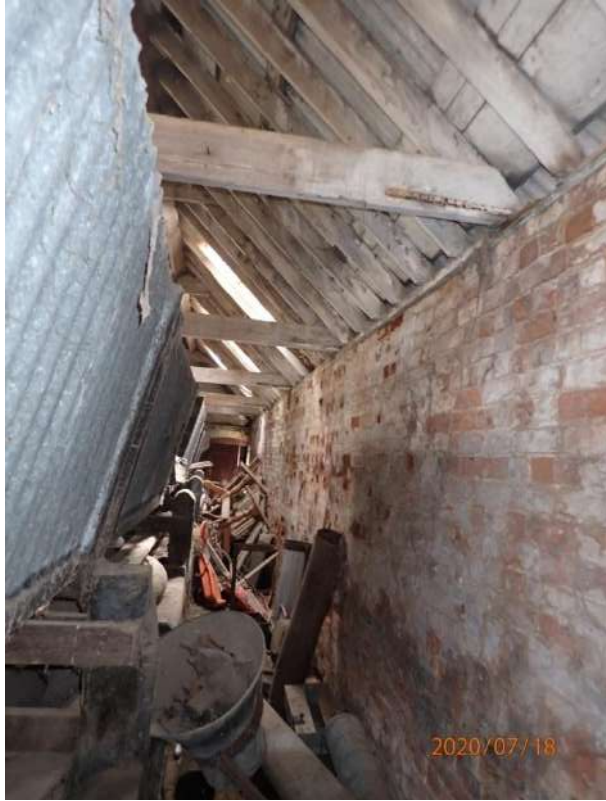
**Plates 406-409** present a number of images of the interior of **Cell 18** from western positions. The brickwork wall fabric of the south wall of this South Range to the right is in English Bond, composed of courses of brick stretchers that alternate with courses of brick headers. Extending along the top of this south wall are various horizontal timber wallplates. It may also be observed

that the southern ends of the horizontal timber tie beams of the overlying roof structure are attached to these wallplates.

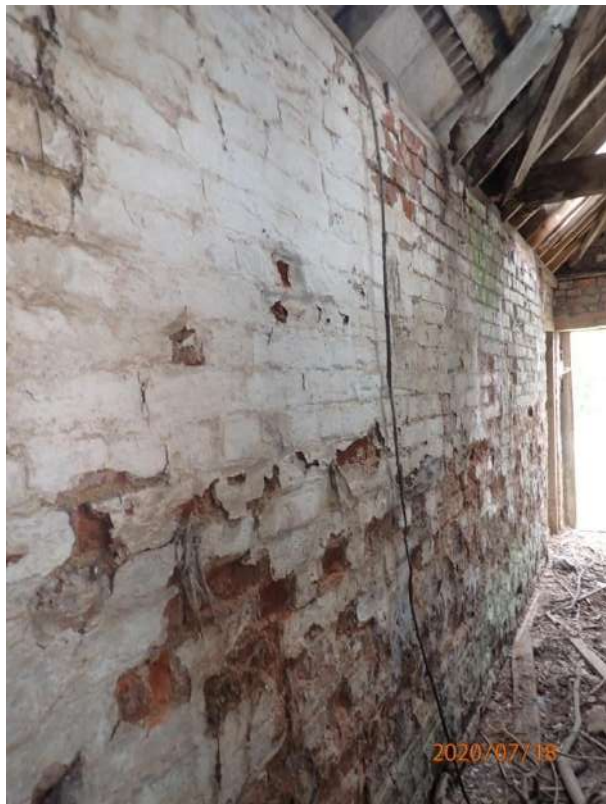
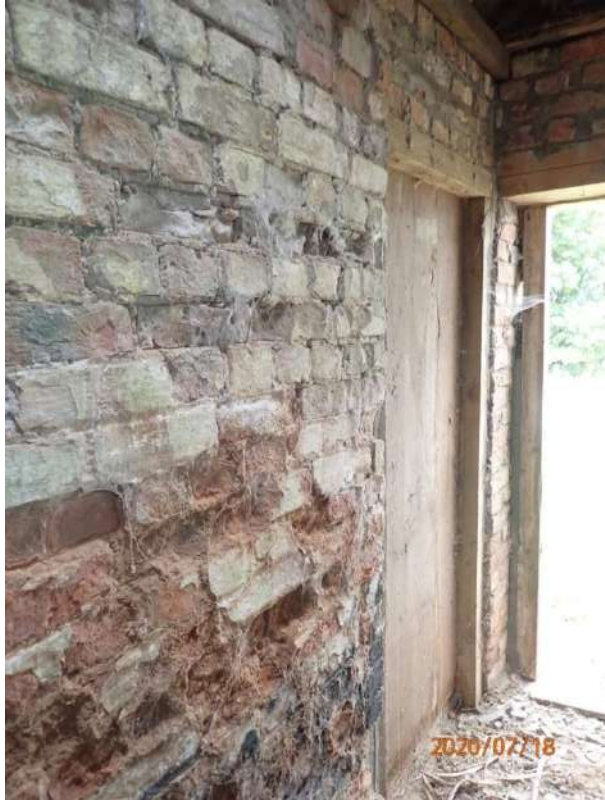
**Plates 410 and 411** present views of the western end of **Cell 18** and in particular show the inner faces of two entrance openings, one which faces to the west and the second to the south. Both were recorded externally at the West and South Elevations of this building respectively. Both openings are occupied by timber frames of heads and surrounds. The south facing entrance has been entirely boarded over. The west facing entrance also contains a four panelled timber door. Above each opening are horizontal timber lintels that are incorporated into the brickwork wall fabric.

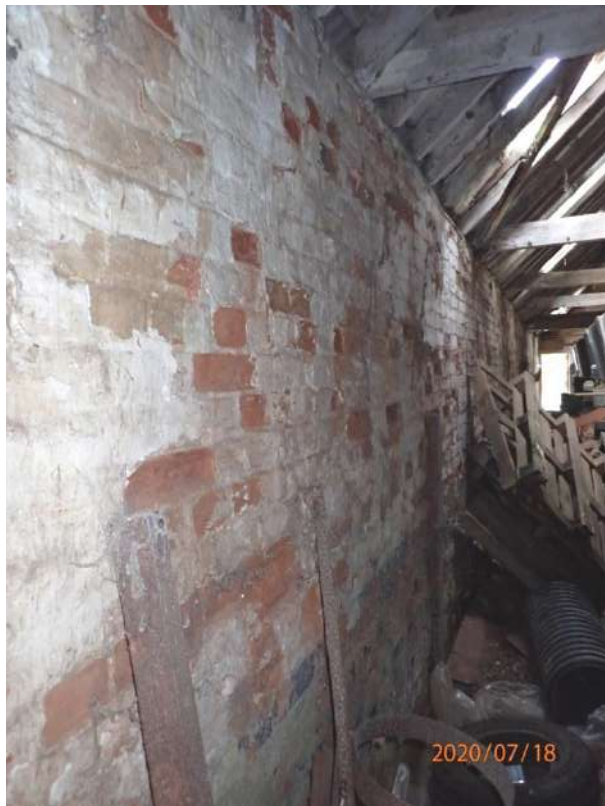
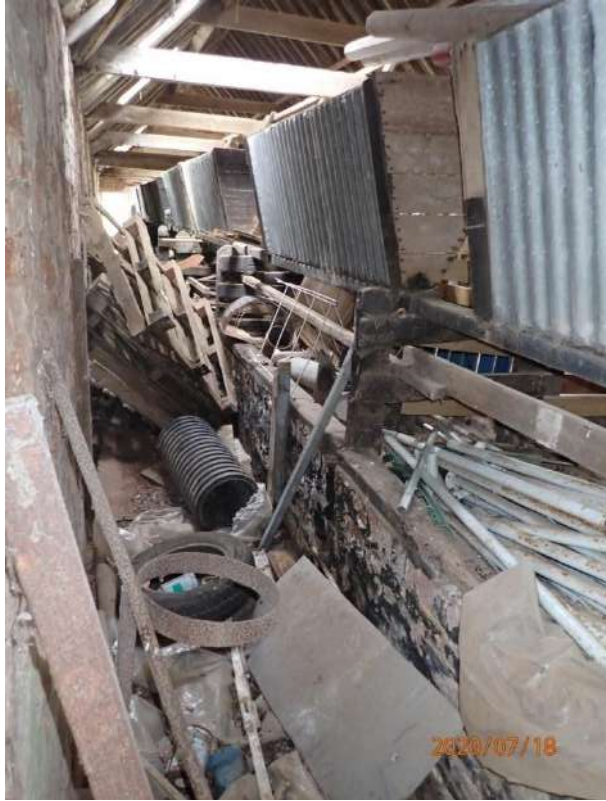
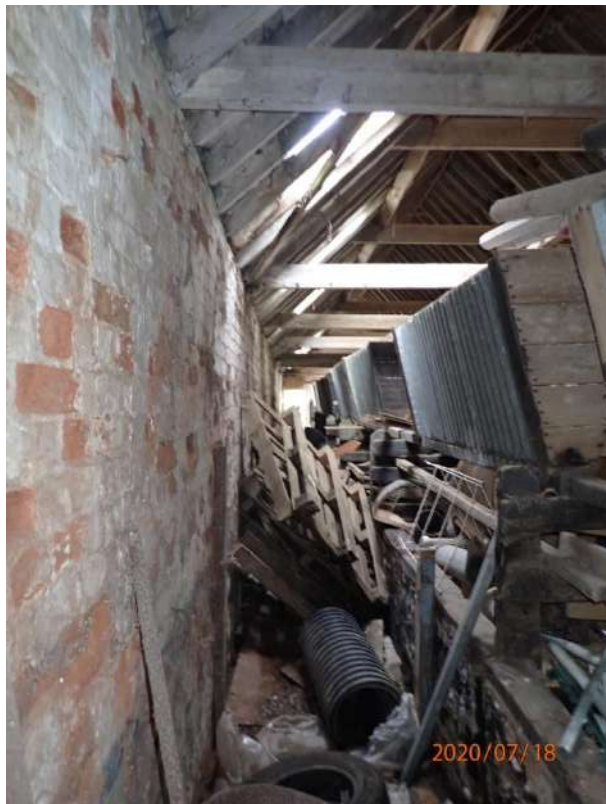
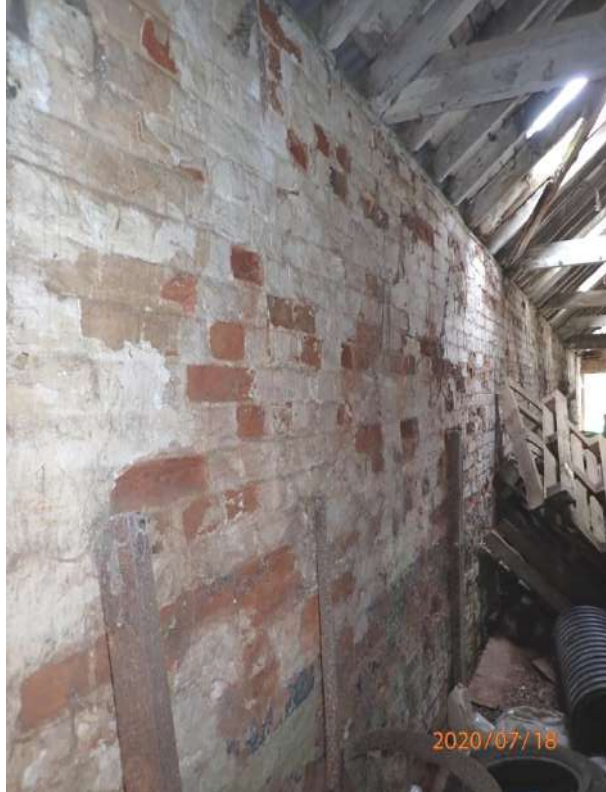
**Plates 412-415** were all taken from the eastern end of **Cell 18** and provide further detailed views of **Cell 18** from these differing eastern vantage points.

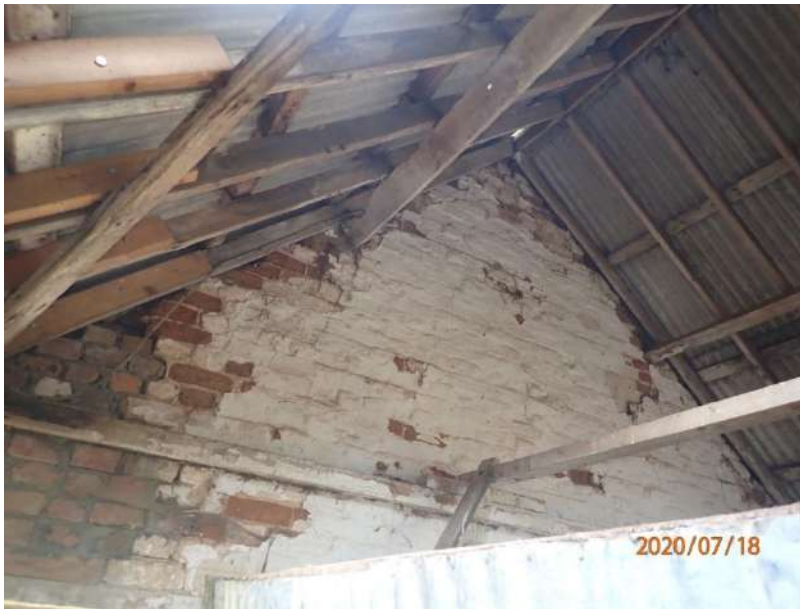
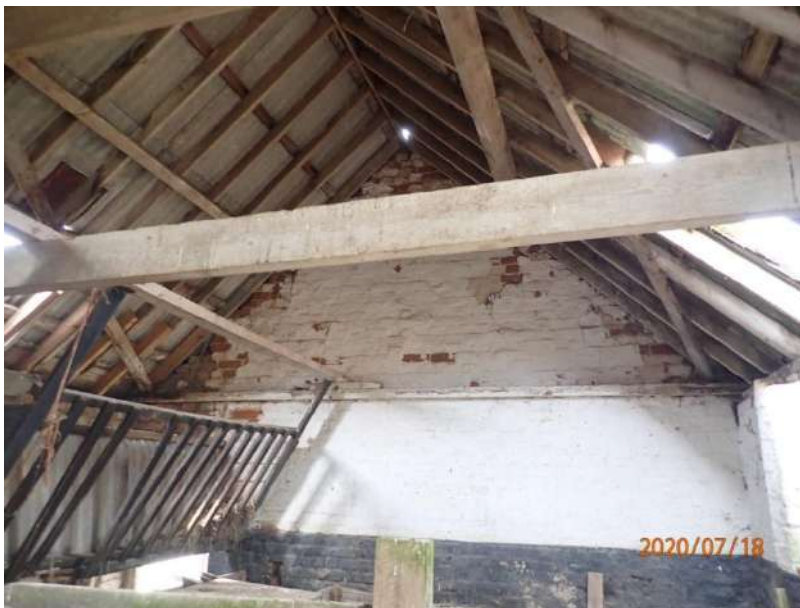
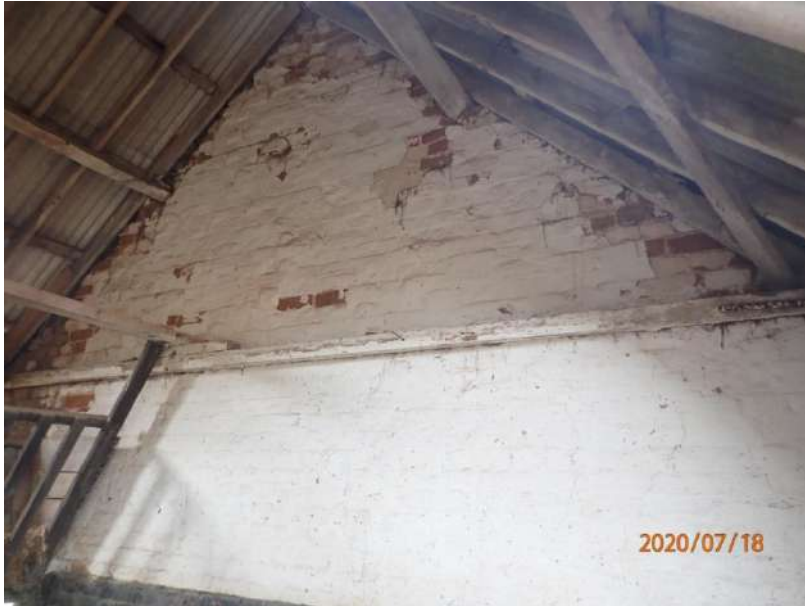
**Plates 416-420** present a number of detailed views of the west wall of the South Range from differing perspectives. The detail of the nature of the brickwork wall fabric of this west wall could not be determined as it was obscured by being covered over with paintwork. An horizontal timber wallplate may be seen at the upper levels, which is incorporated into the brickwork wall fabric. The western ends of the horizontal timber purlins of the overlying roof structure are inserted into the upper levels of the brickwork wall fabric.

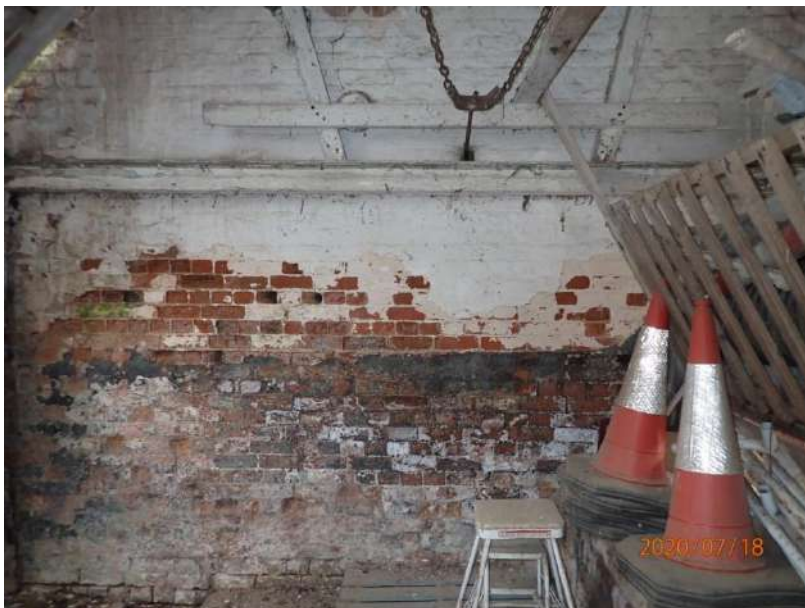
**Plate 421: View of the east wall of the South Range, from the west**

**Plates 421 and 422** furnish several images of the east wall of the South Range, which is also the internal dividing wall with **Cell 17** of the East Range. Although most of the detail of the brickwork wall fabric of this east wall has become obscured by being covered over with paintwork, at the lower levels, this paintwork is absent. Here the brickwork is in English Bond, composed of courses of brick stretchers alternating with courses of brick headers. An horizontal timber wallplate may be seen at the upper levels, which is incorporated into this brickwork wall fabric. The eastern ends of the horizontal timber purlins of the overlying roof structure are inserted into the upper levels of the brickwork wall fabric.
