HISTORIC BUILDING RECORDING AT  
HALL FARM, BOSTON ROAD,  
EAST HECKINGTON, LINCOLNSHIRE

PREPARED FOR MR. JAMES BRAMMA OF JB ARCHITECTURAL DESIGN SERVICES ON  
BEHALF OF HIS CLIENT - MR. NICK LOWETH  
PART 3: THE SOUTH RANGE

Neville Hall

March 2021

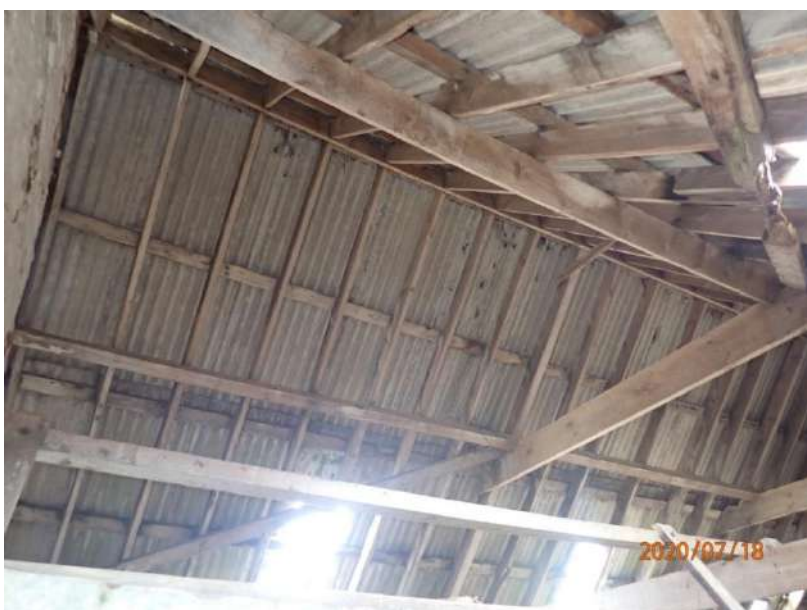
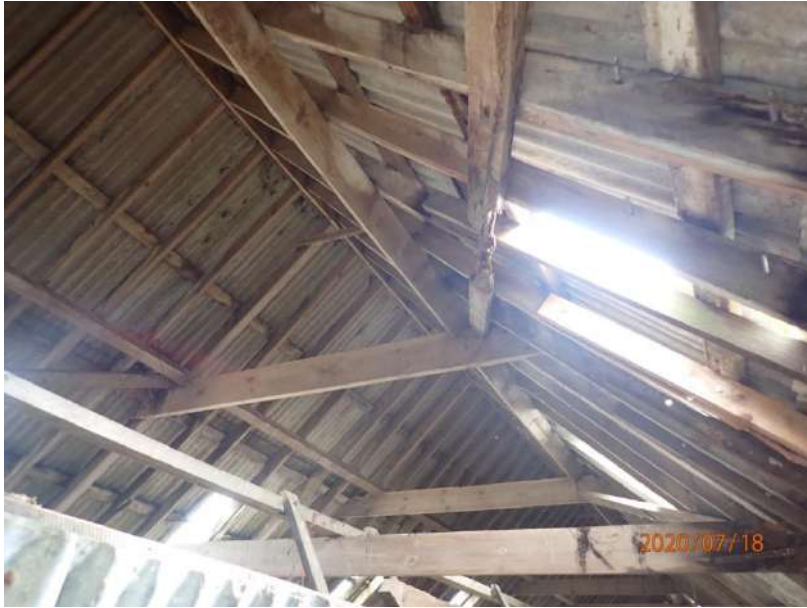
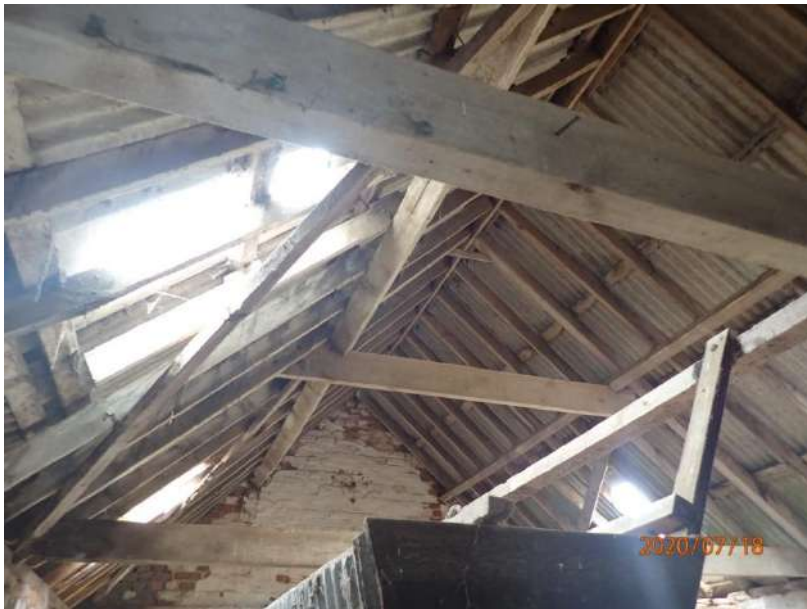
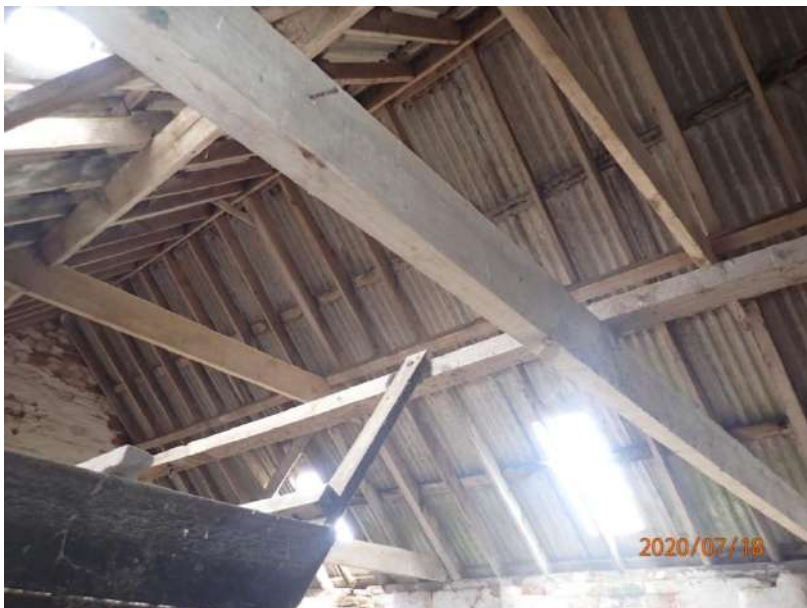
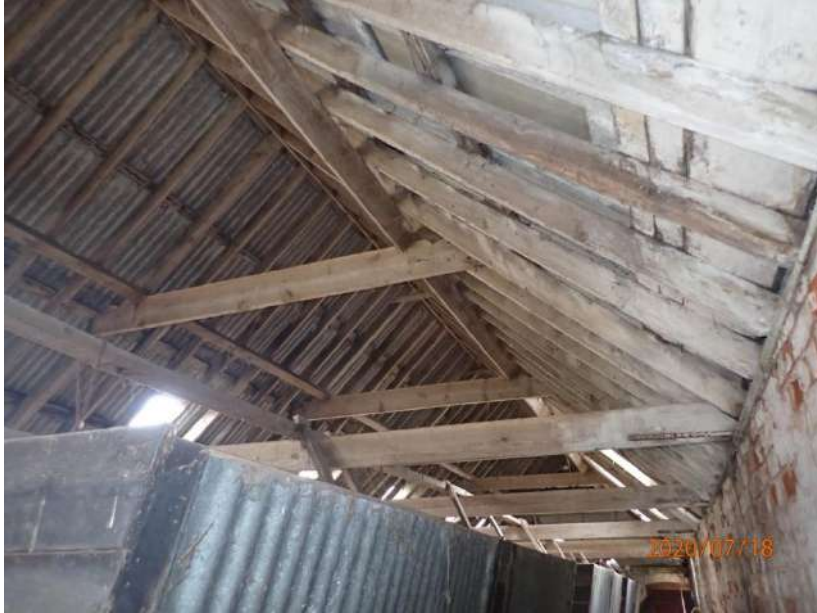
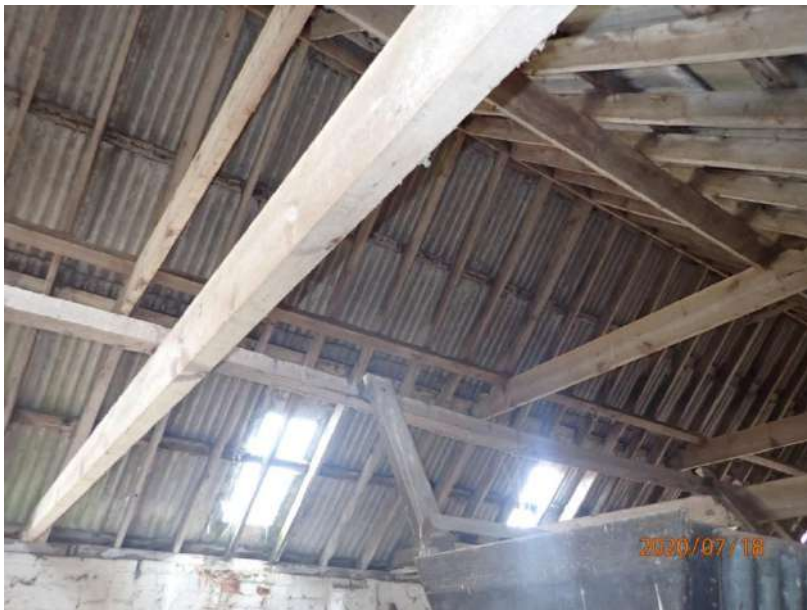
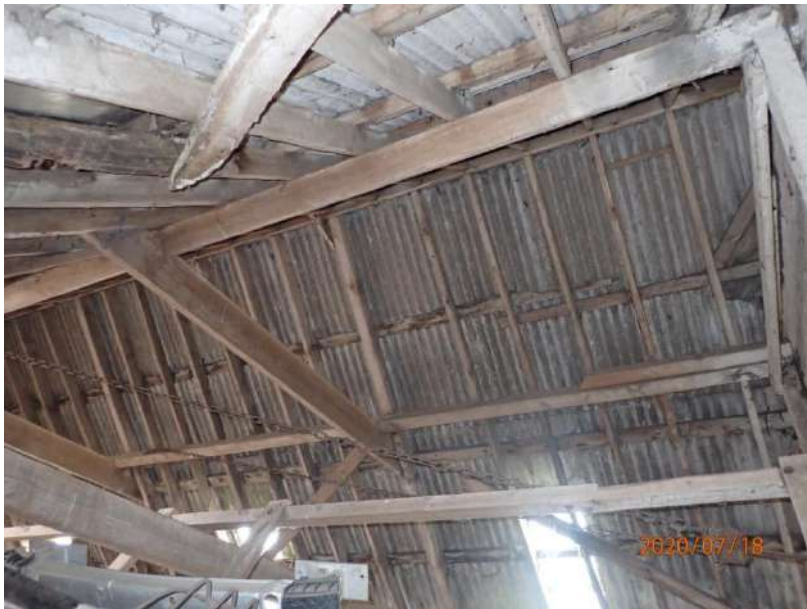
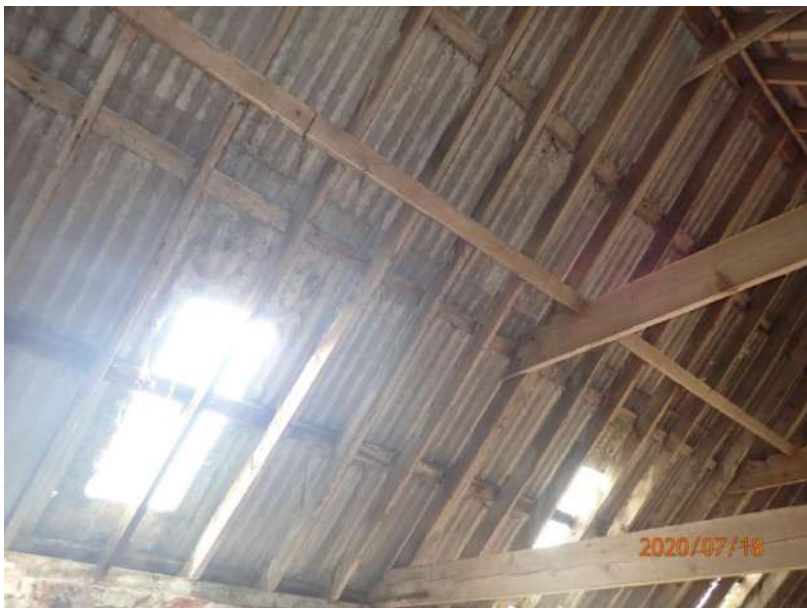
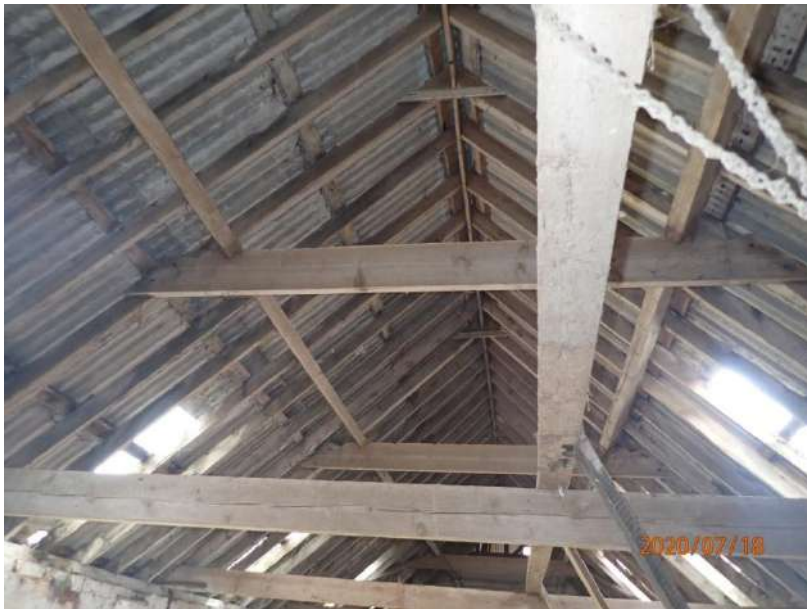
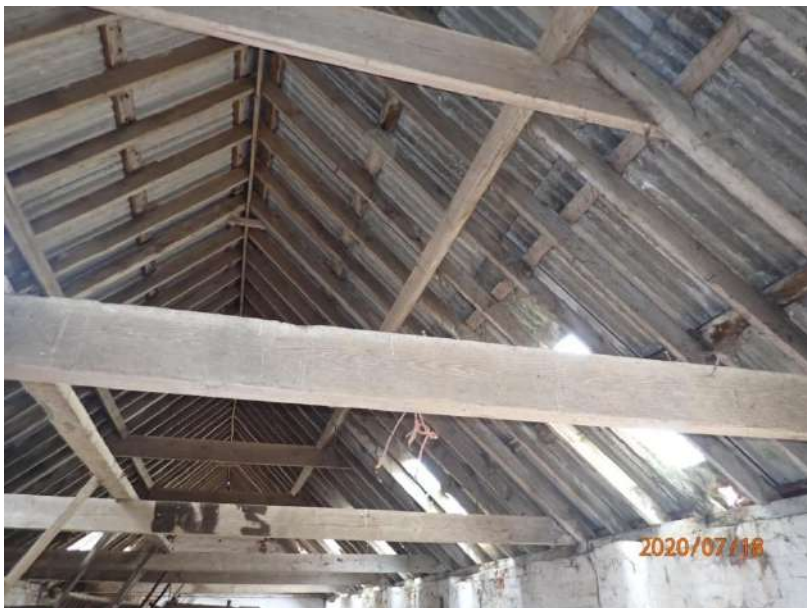
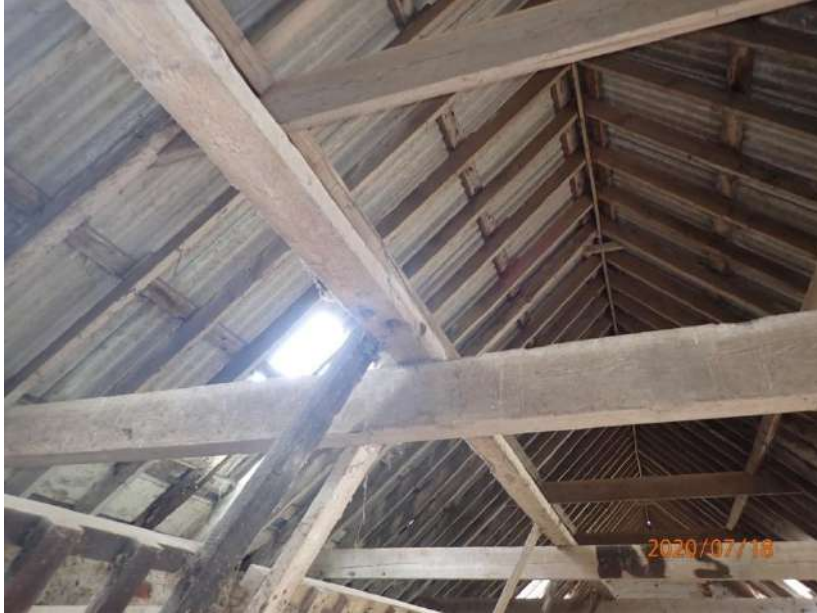
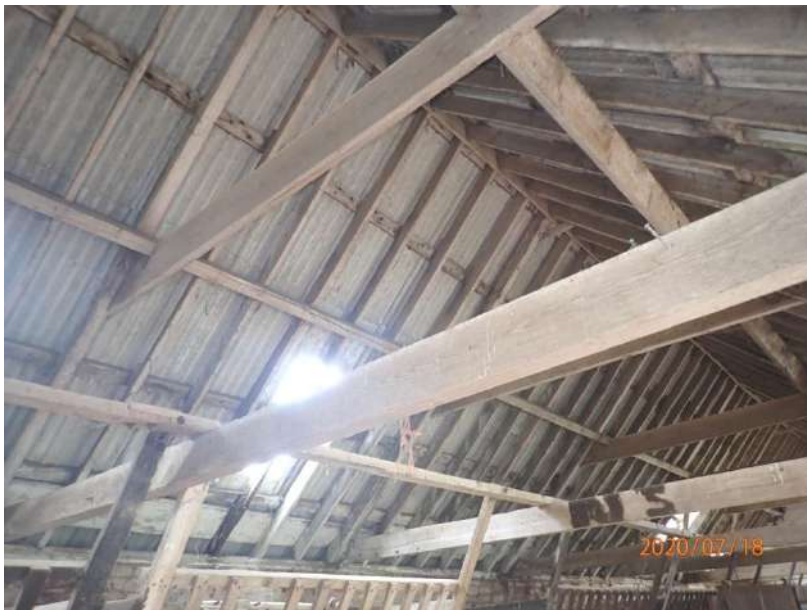
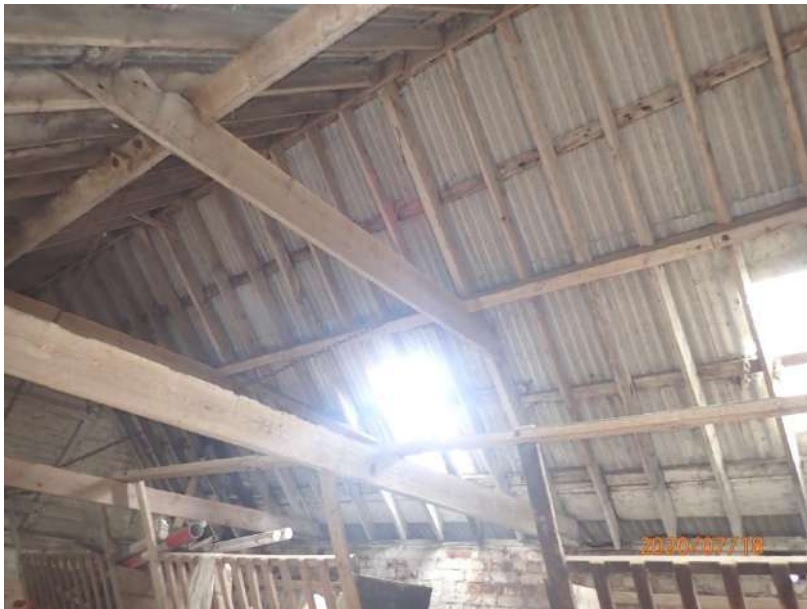
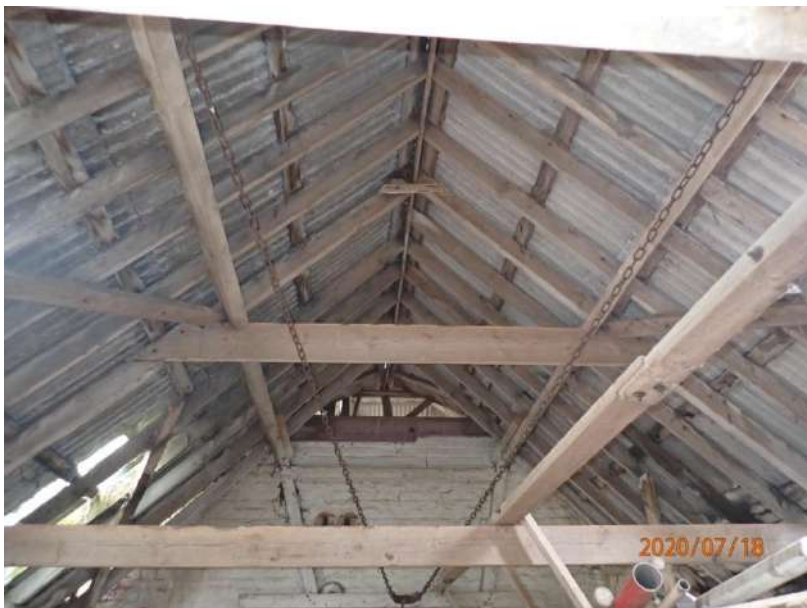
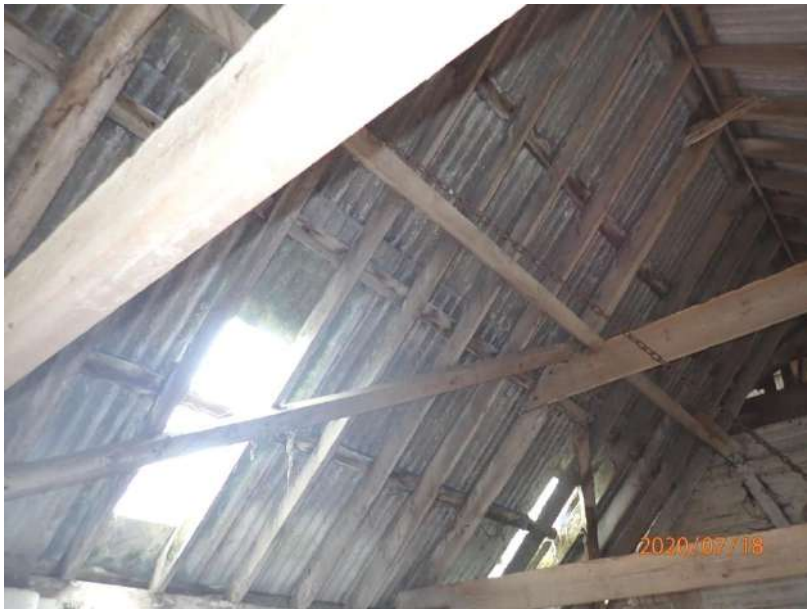
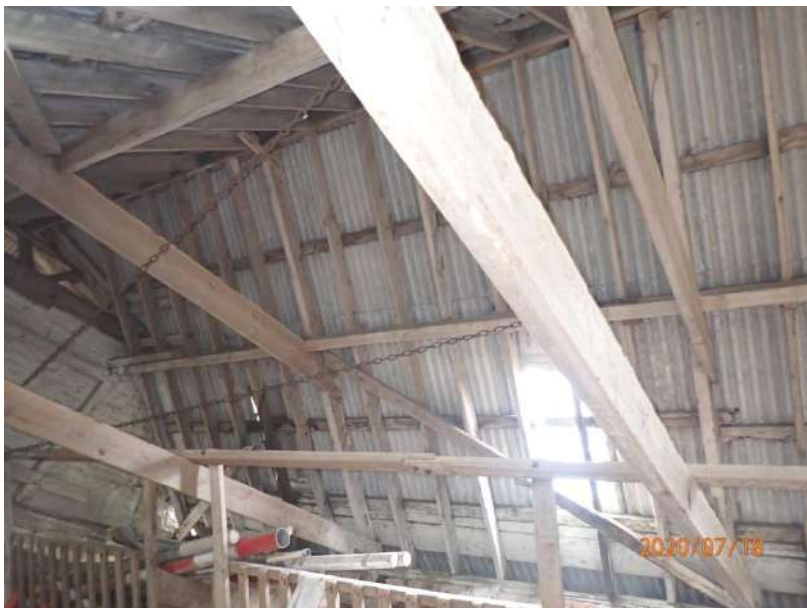
**Plates 423-441** present a large number of images from many differing positions of the nature of the roof supporting structure of this South Range. This is a relatively simple structure. The main elements of this structure is the framework of timber rafters that extend along both sides of this structure and which support the roof covering of modern corrugated metal sheeting. The rafters are in turn attached to a second framework of horizontal timber purlins that also extend along both sides of this structure and also at the roof apex. The bottom ends of the rafters are attached to the horizontal timber wallplates that extend along the top of the north and south walls, whilst their upper ends are affixed to the purlins that extend along the roof apex.. The eastern and western ends of the horizontal timber purlins are inserted into the brickwork wall fabric of the east and west walls. This structure is further reinforced and strengthened by a series of horizontal timber tie beams at the lower levels and horizontal timber collars at the upper levels. The collars are attached to the rafters and the tie beams to the wallplates.

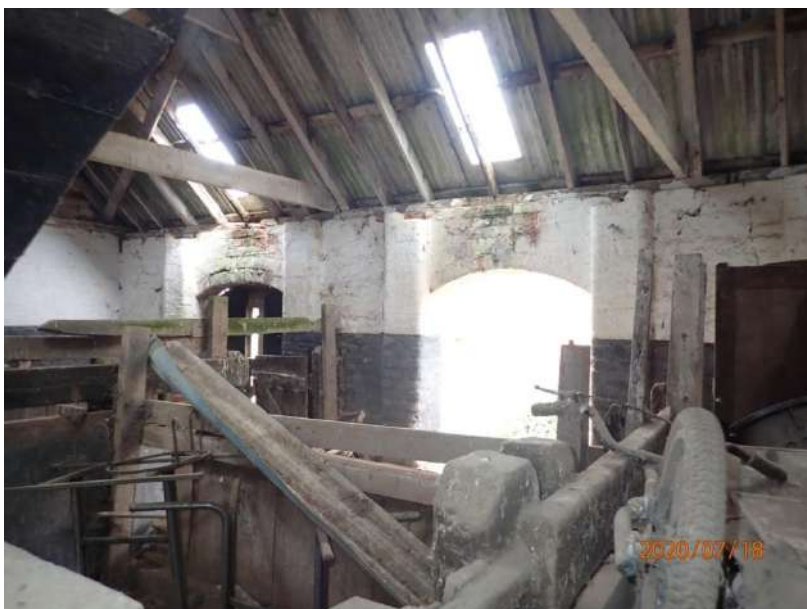
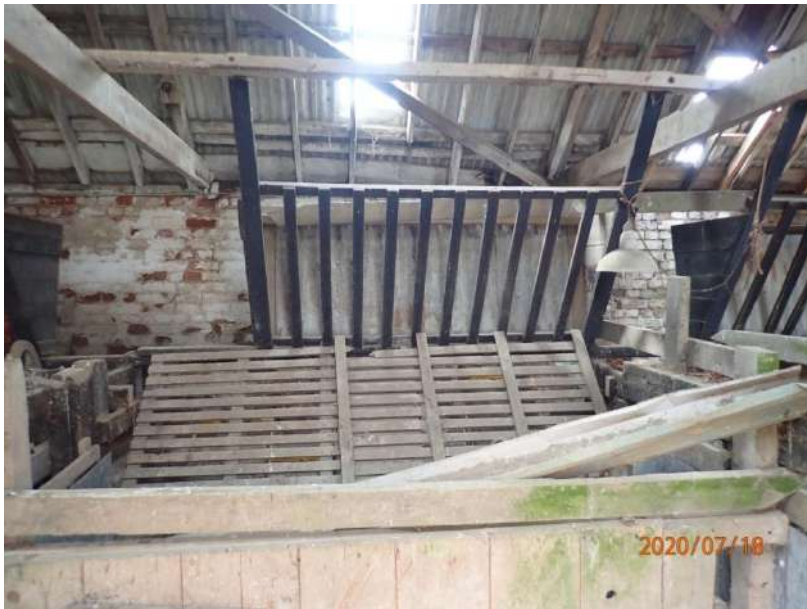
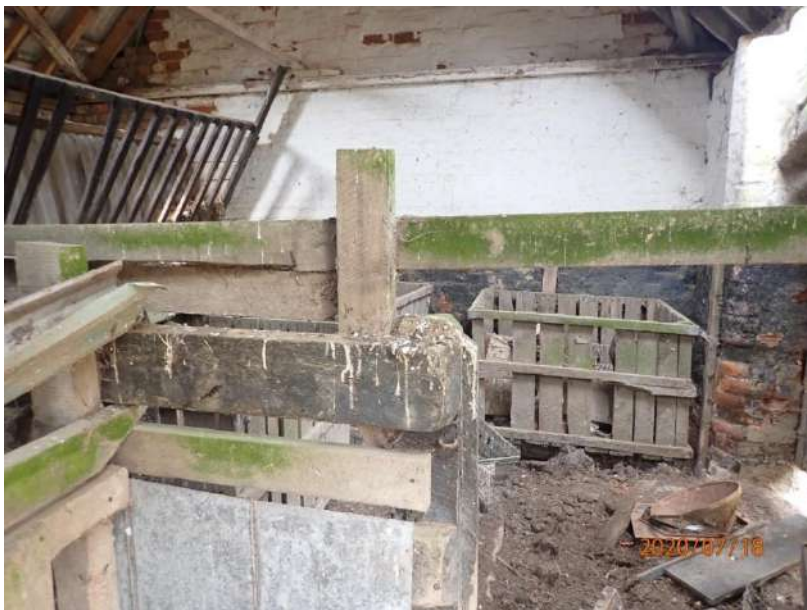
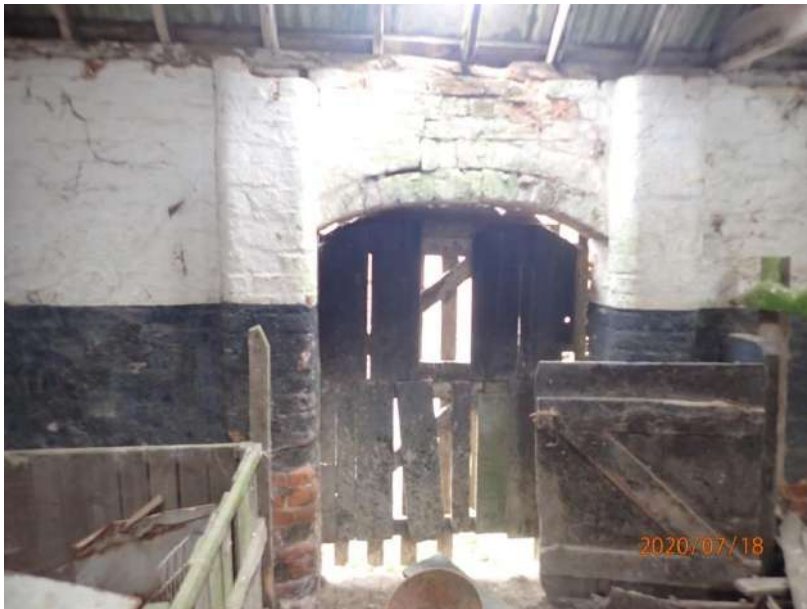
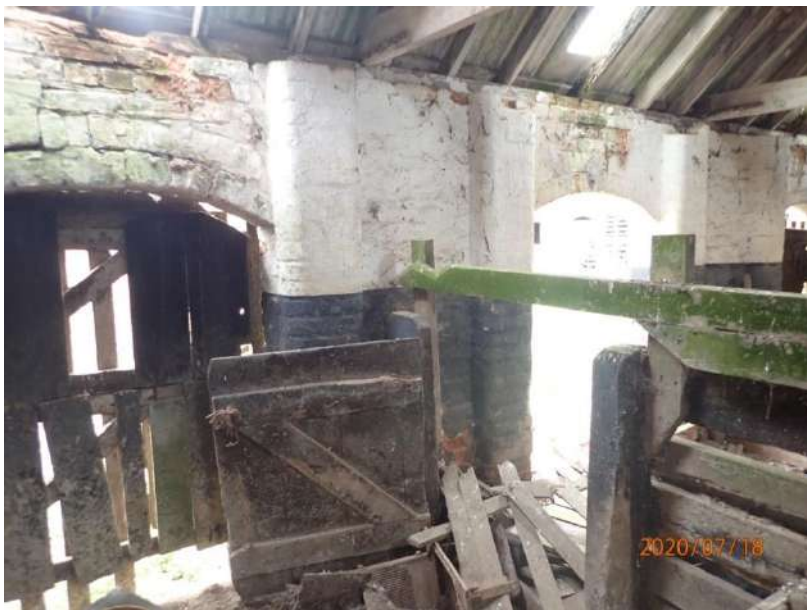
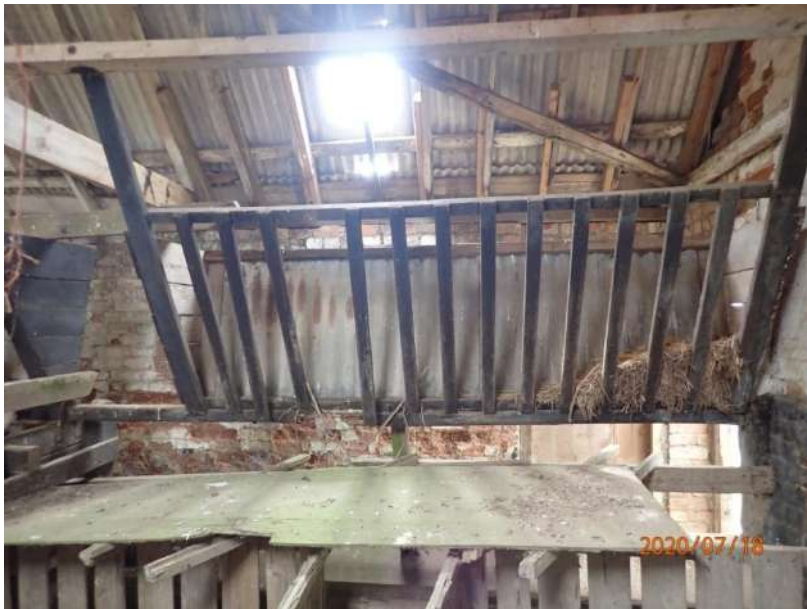
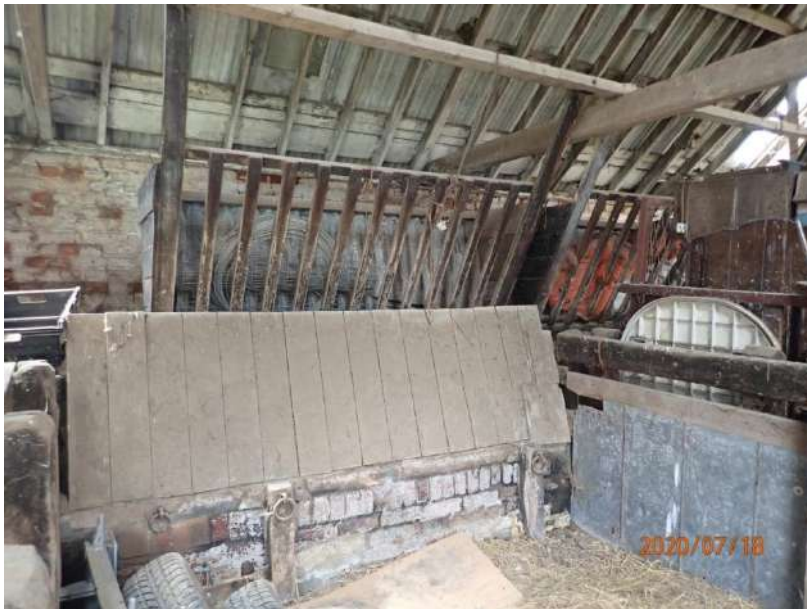
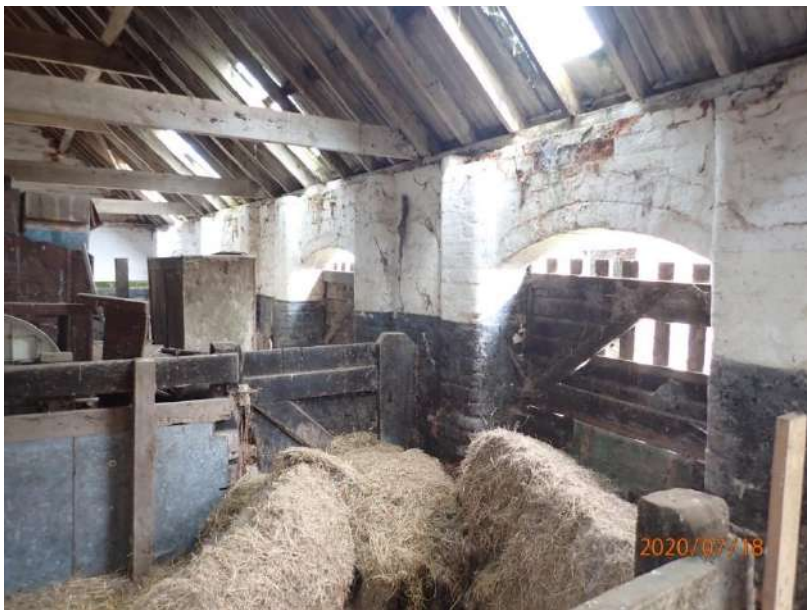
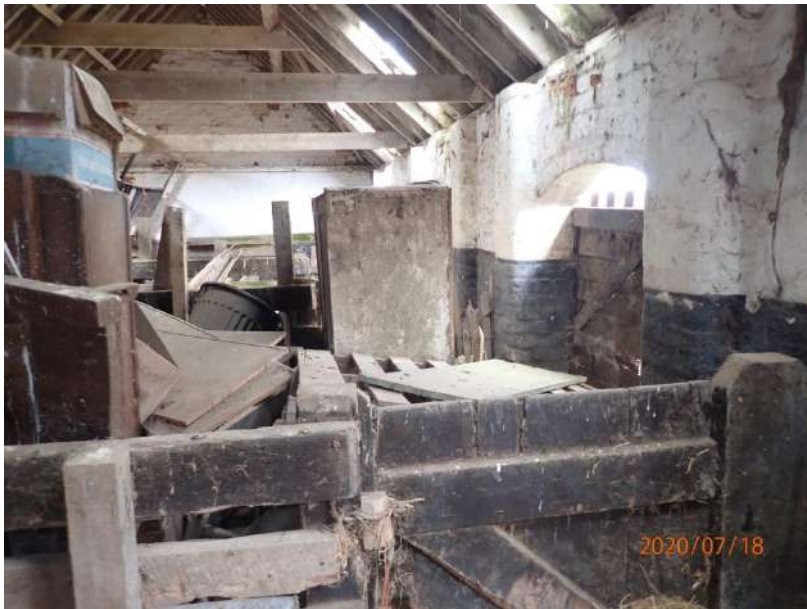
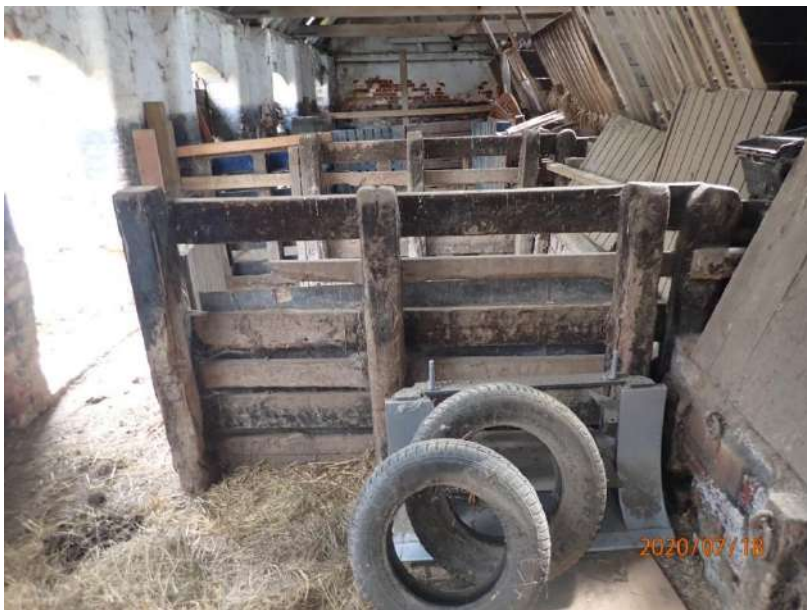
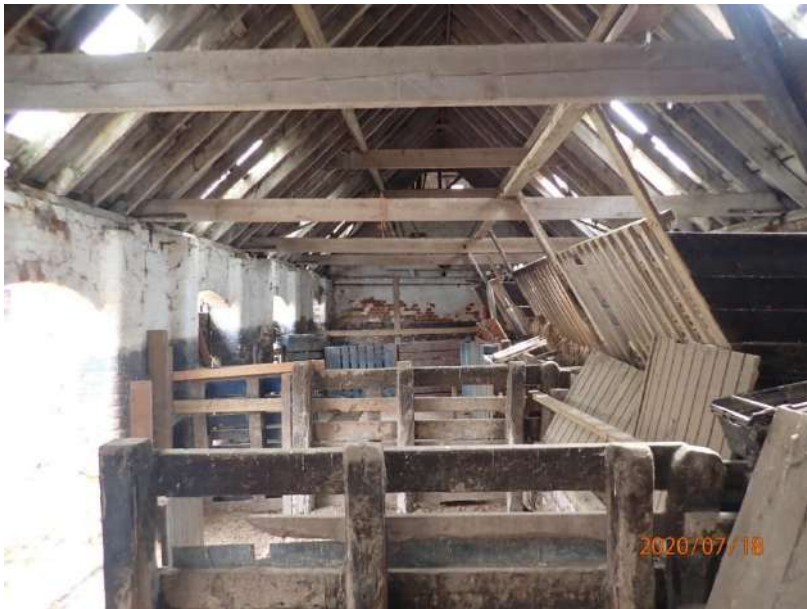
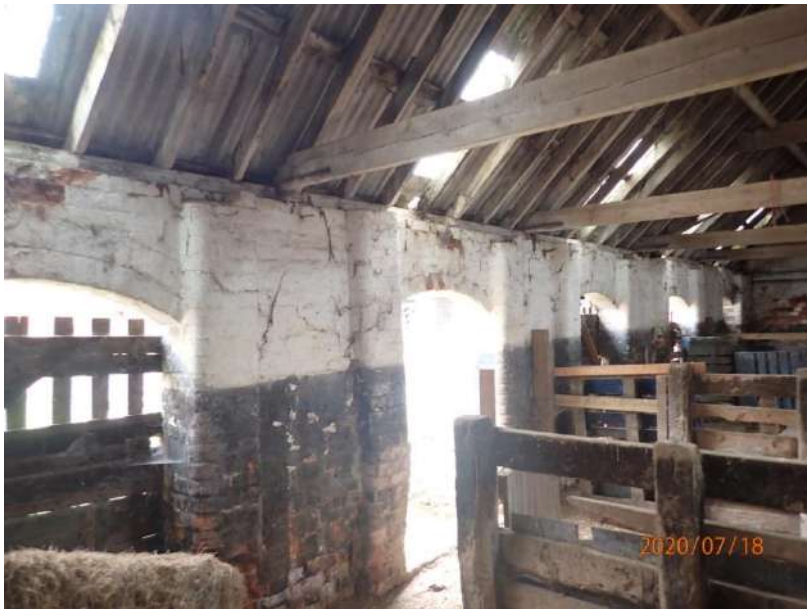
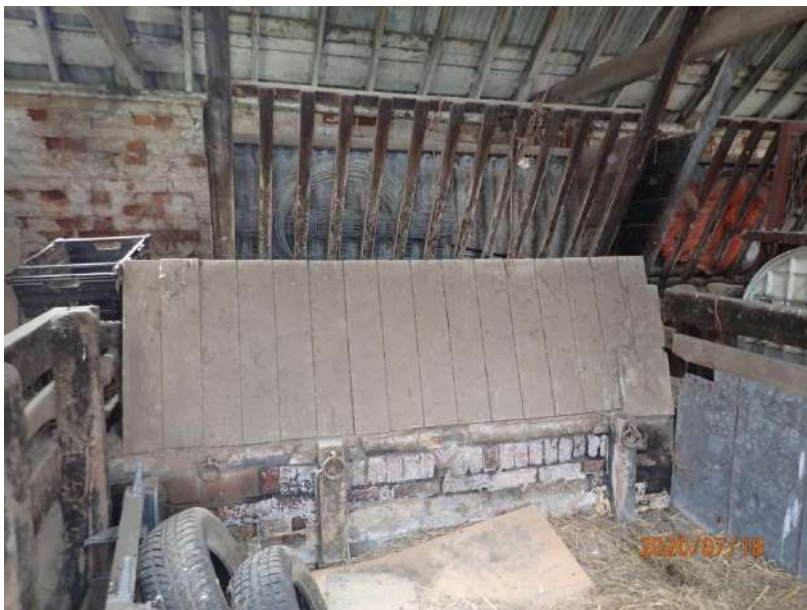
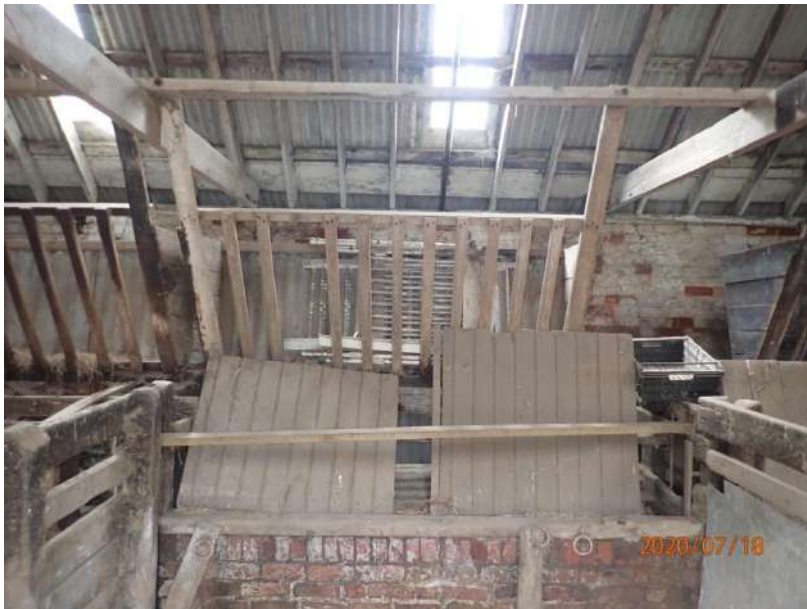
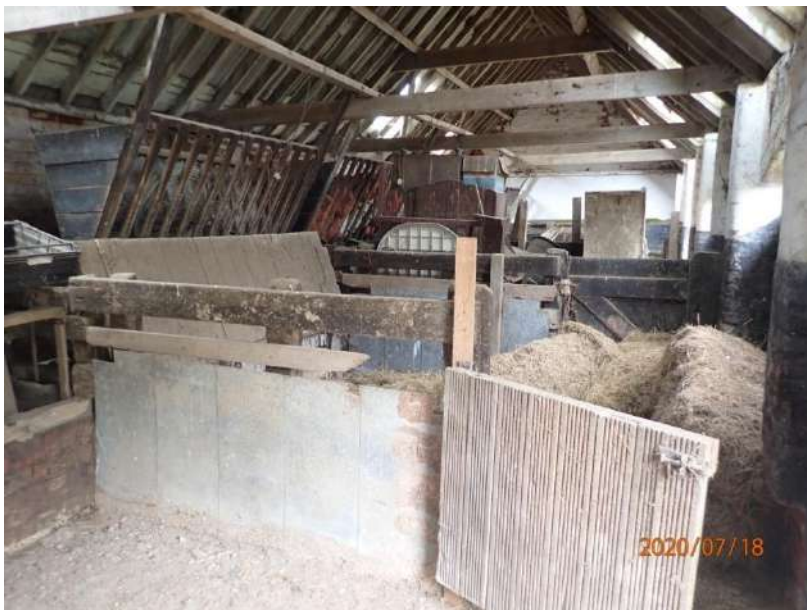
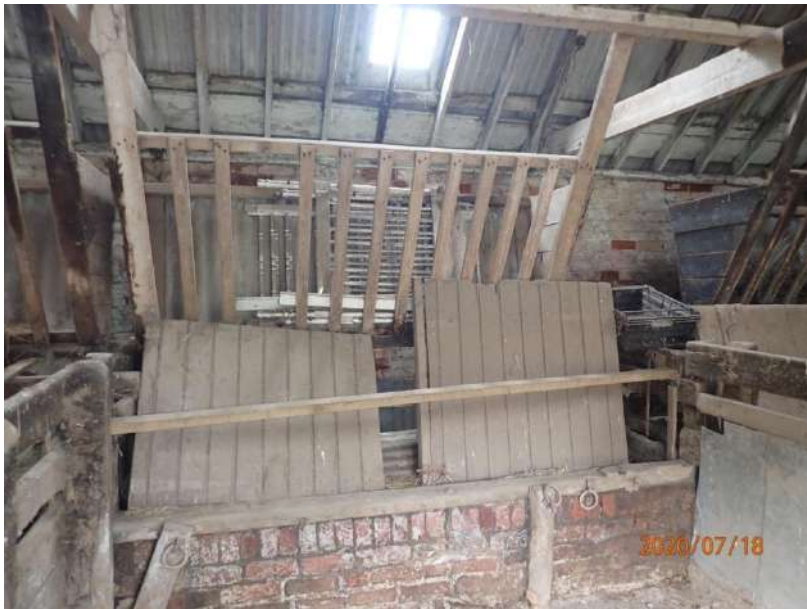
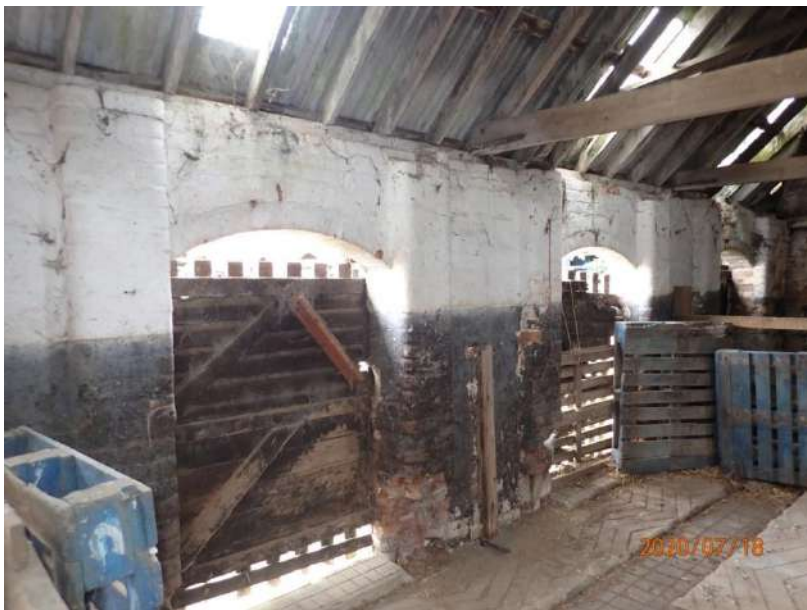
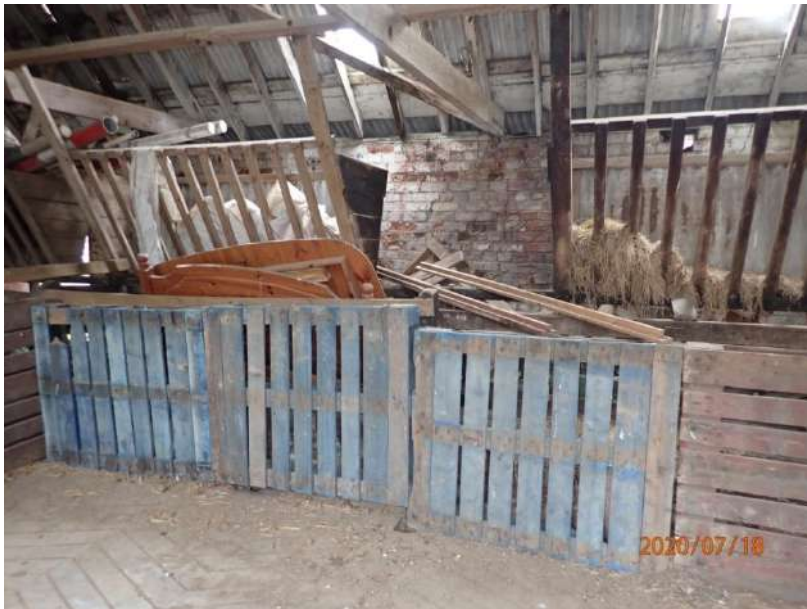
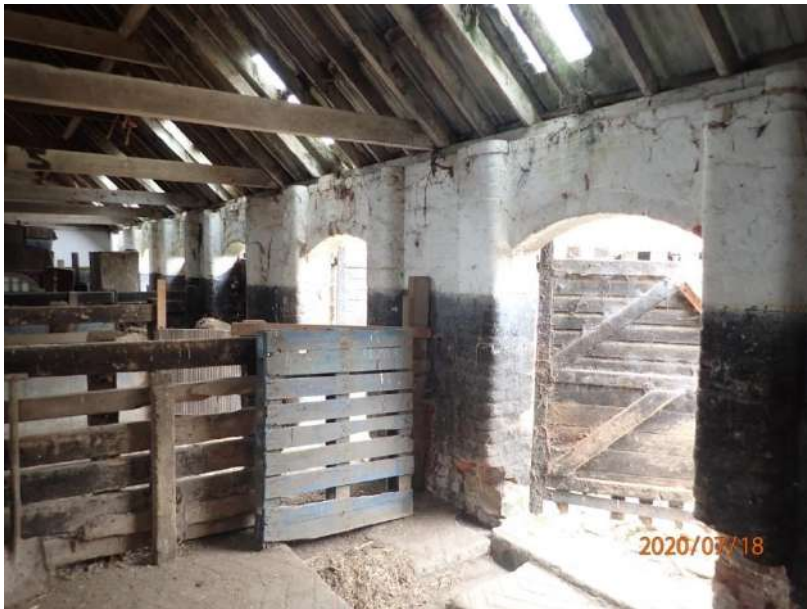
**Plats 442-478** present a large number of images from many different positions of the remainder of the interior of the South Range. This comprises the north wall of the South Range along with the series of eight separate former animal stalls, of which only some were accessible at the time of this survey.

The detail of the nature of the brickwork wall fabric of the north wall of this South Range was difficult to discern, as this detail had become much obscured by being covered over with paintwork. Extending along the top of this north wall are a series of horizontal timber wallplates. The main features of this north wall are the series of eight north facing entrance openings, one to each of the eight internal animal stalls. Seven of these eight openings are occupied by timber gates that are composed of a series of vertical timber slats. The inner faces of these openings are featured here with each opening being occupied by various internal timber frameworks to which the vertical timber slats of the timber gates are affixed to. Each opening is flanked to either side by decorative vertical brick pilasters, which appear to be composed of courses of bull nosed brick stretchers. Above each opening are rounded arches or heads in brick. the detail of which was also difficult to discern as these were also covered over with layers of paintwork, which obscured the underlying detail of the brickwork.

The flooring of each of the eight animal stalls is composed of concrete with a shallow east-west orientated drainage channel cut within it, which extends along the northern side of the building. At the rear of each stall are a series of modern elevated timber hay feeders, which are attached by various timber frameworks to the horizontal timber tie beams of the overlying roof structure. In front of these in turn is a second low animal feed trough, which is constructed of brick. This appears to be composed of courses of brick stretchers that are topped with a single course of brick stretchers laid on edge on a different orientation. Above this in turn, are a series of horizontal timbers along the frontal edges of the trough. The interiors of the trough are lined with modern concrete. Each of the animal stalls are divided and separated from each other by a series of various low timber partitions, some of which have attached low timber gates.

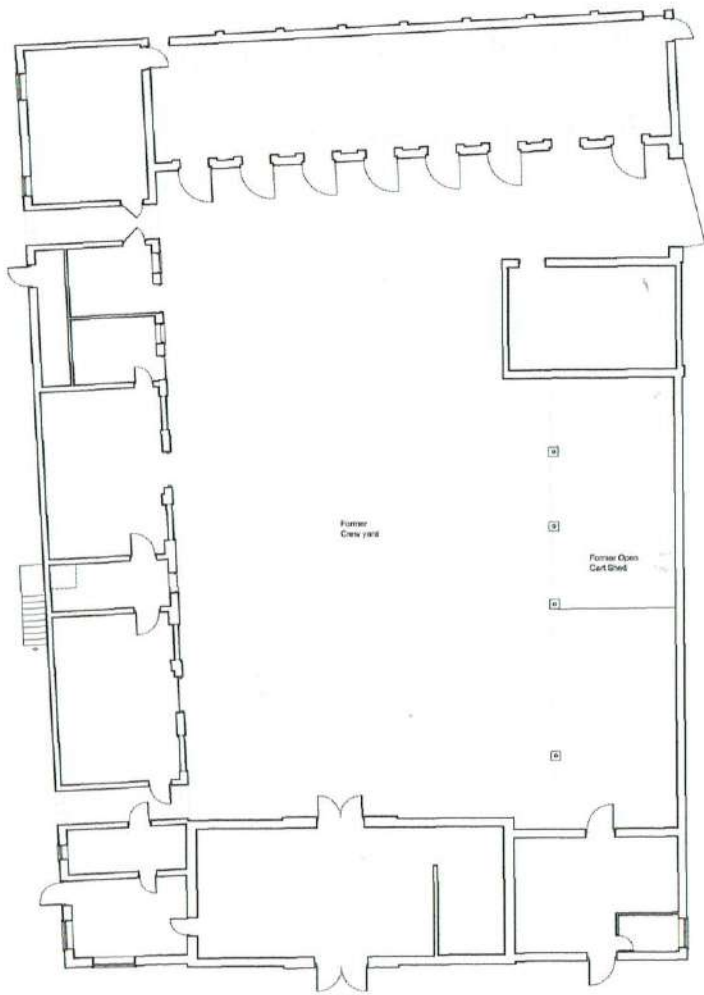
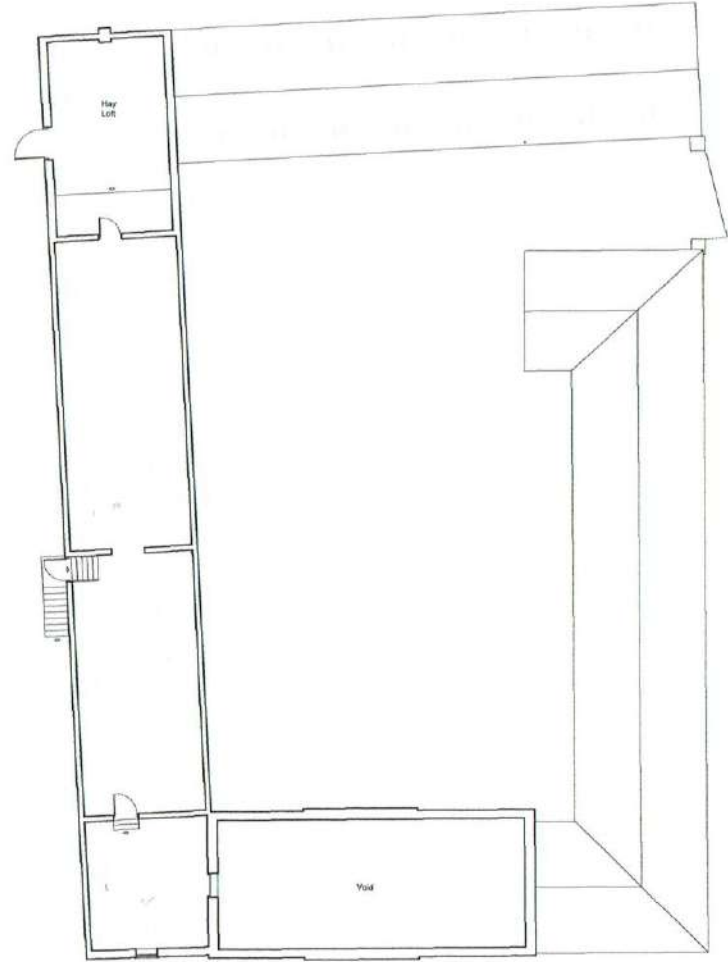
**Figure 3:** Plan showing the existing layout of the development site including ground and first floor plans at an original scale of 1:100, (not to scale), (extract from Architects plan)

- 3.7 **Figures 2 and 3** feature the existing layout of the development site. The aforementioned small extension that was added in the 20th century to the eastern end of the North Range of this complex, appears to have gone by the present time.
